Xcel Energy, Inc.  
Sherburne County Generating Station  
13999 Industrial Blvd.  
Becker, MN, 55308

**Re: 2021 Annual Inspection of Bottom Ash Pond No. 2**

## Bottom Ash Pond No. 2 Annual Inspection - 2021

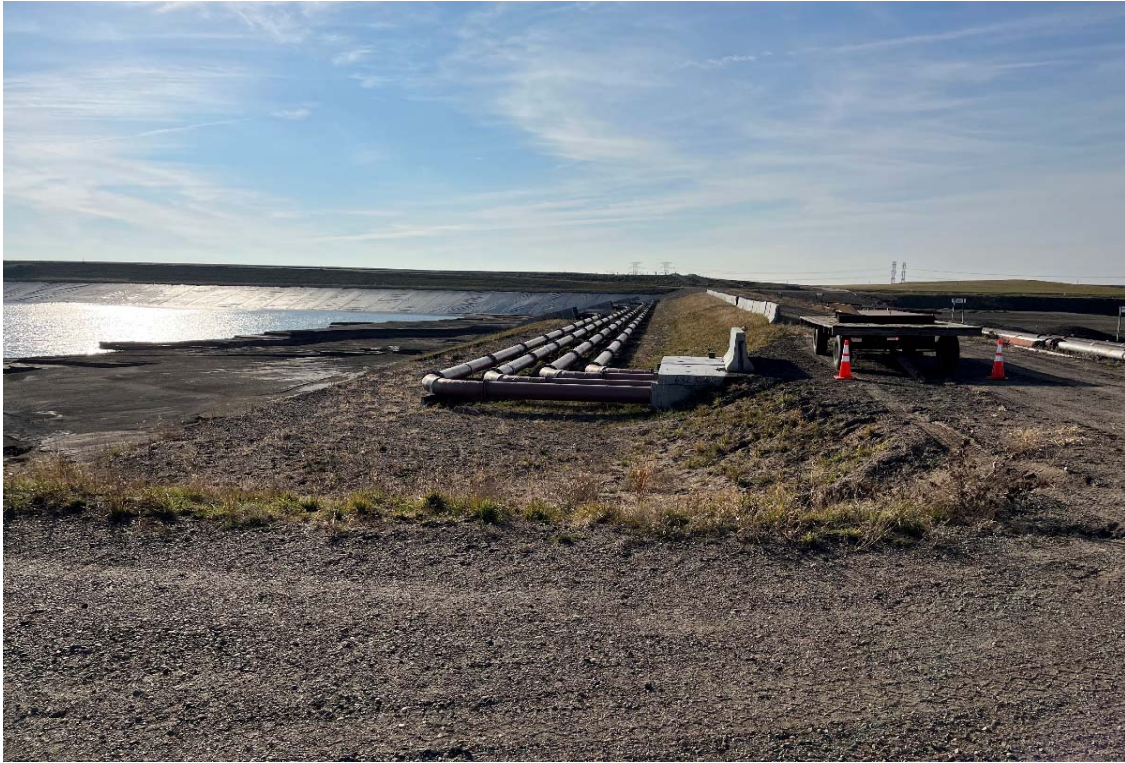
Photo 1	Bottom ash sluice piping, interior of west dike looking south.
11/5/2021

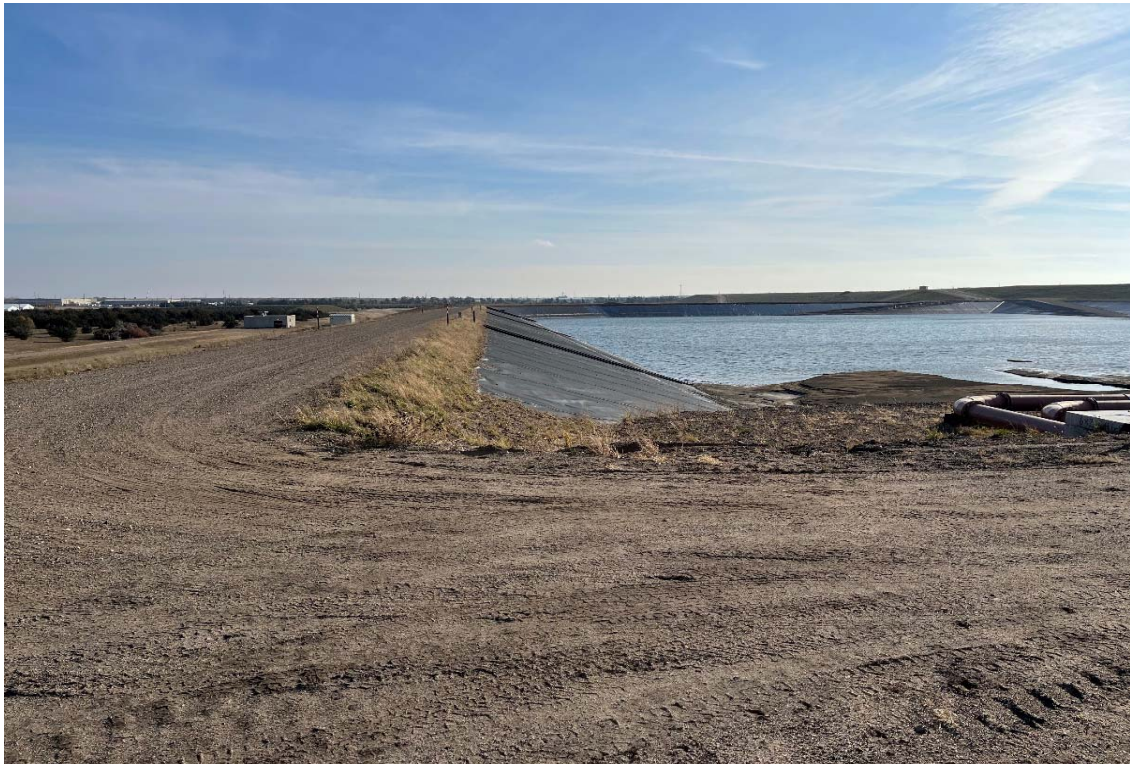
Photo 2	Interior of north dike, looking east
11/5/2021

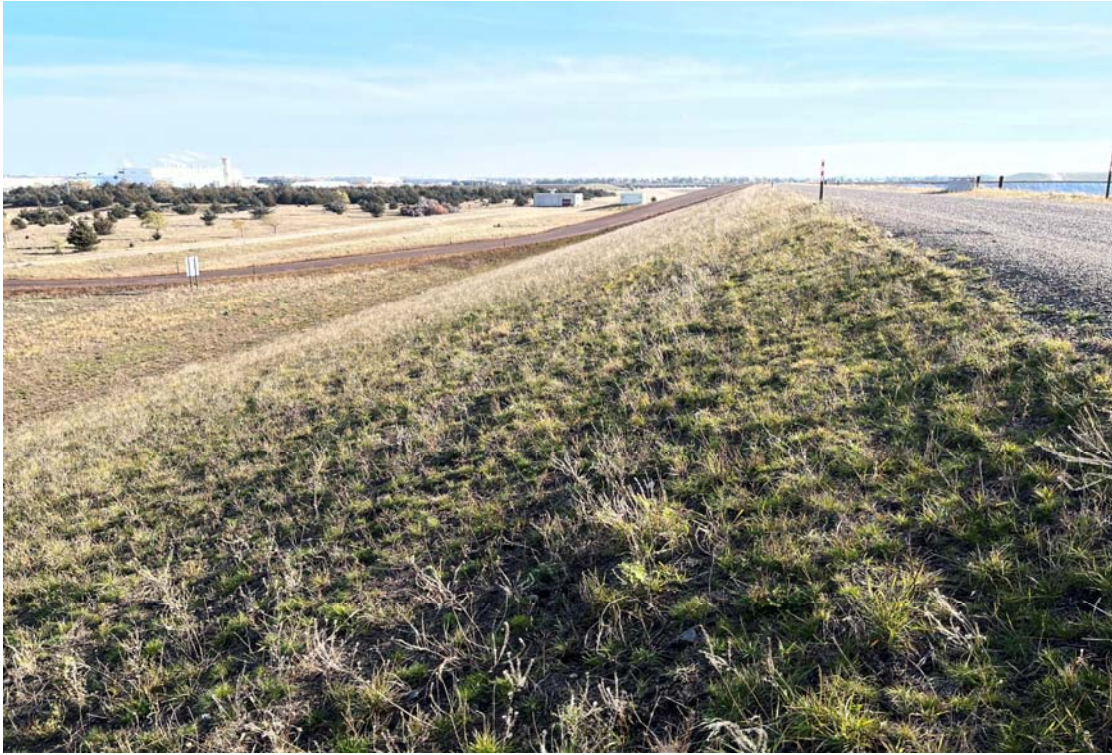
The exterior of BAP2 was inspected for structural weakness in the form of seepage by walking a traverse at the base, mid-slope, and top of the dike. Signs of seepage would include moss or marshy vegetation at the toe along the base, soft or saturated areas, patches of grass more lush than the surrounding area, or flowing "springs". There were no signs that seepage had previously or is presently occurring on BAP2.

Photo 3	Exterior of north dike, looking east.
11/5/2021

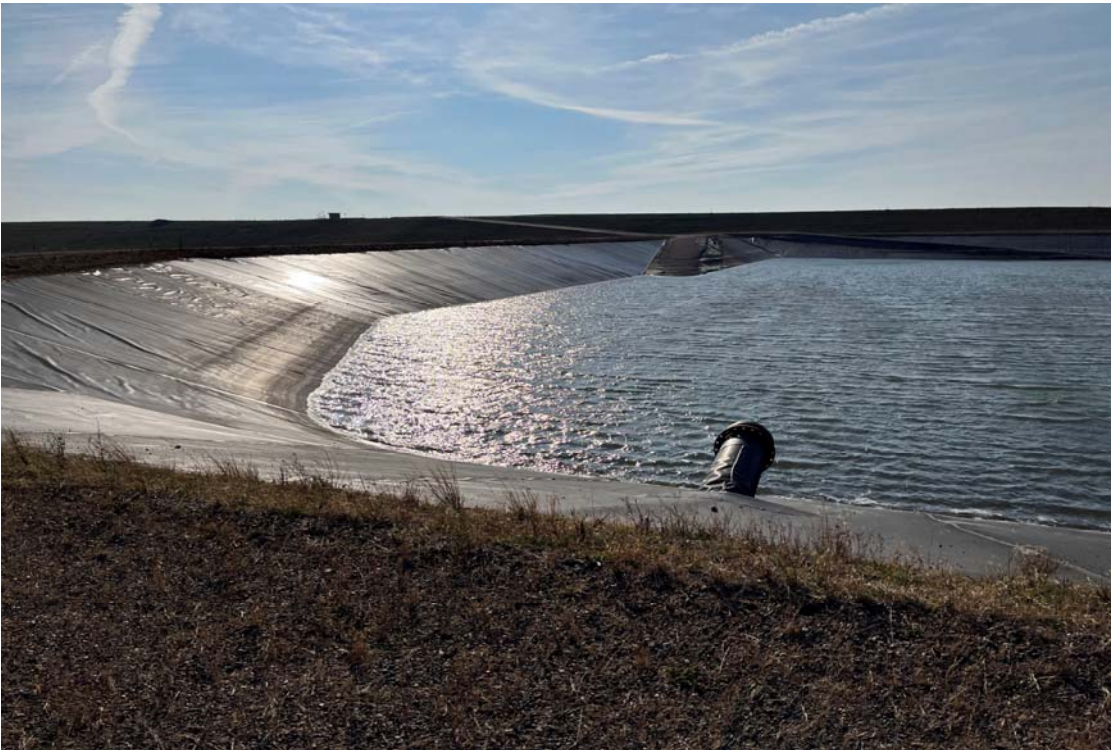
Photo 4	Interior of east dike, looking southeast.
11/5/2021

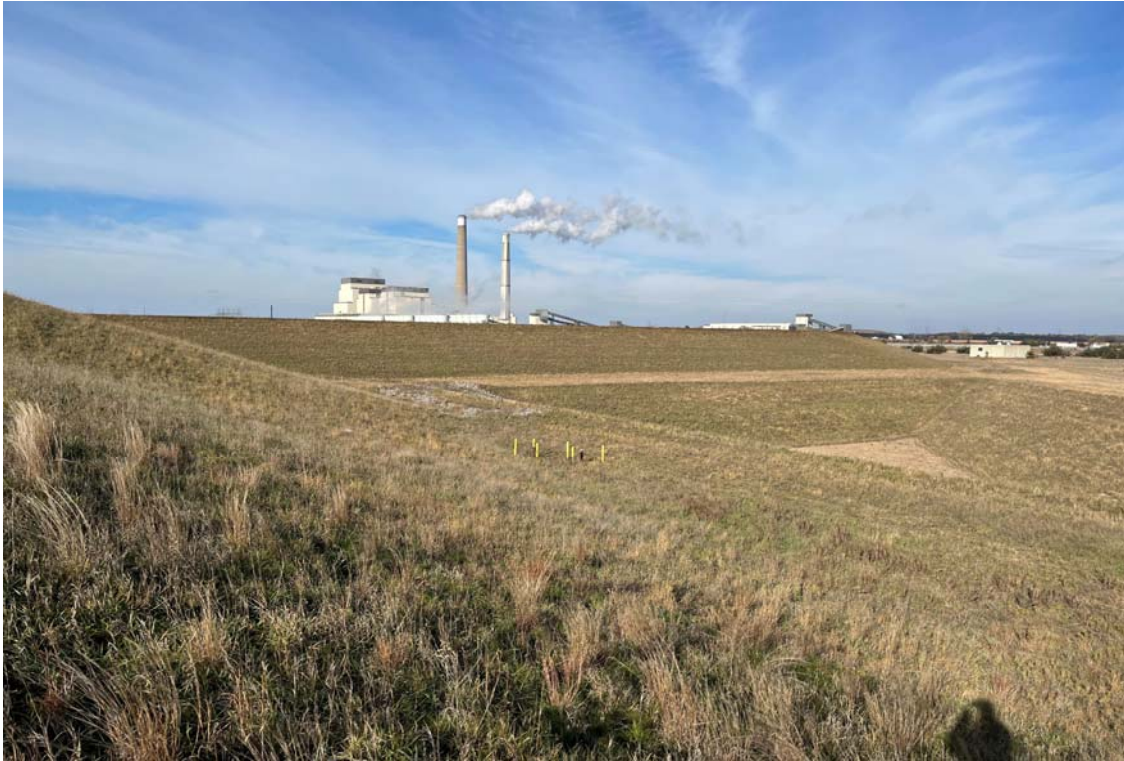
Photo 5	Exterior of east dike, looking northwest.
11/5/2021

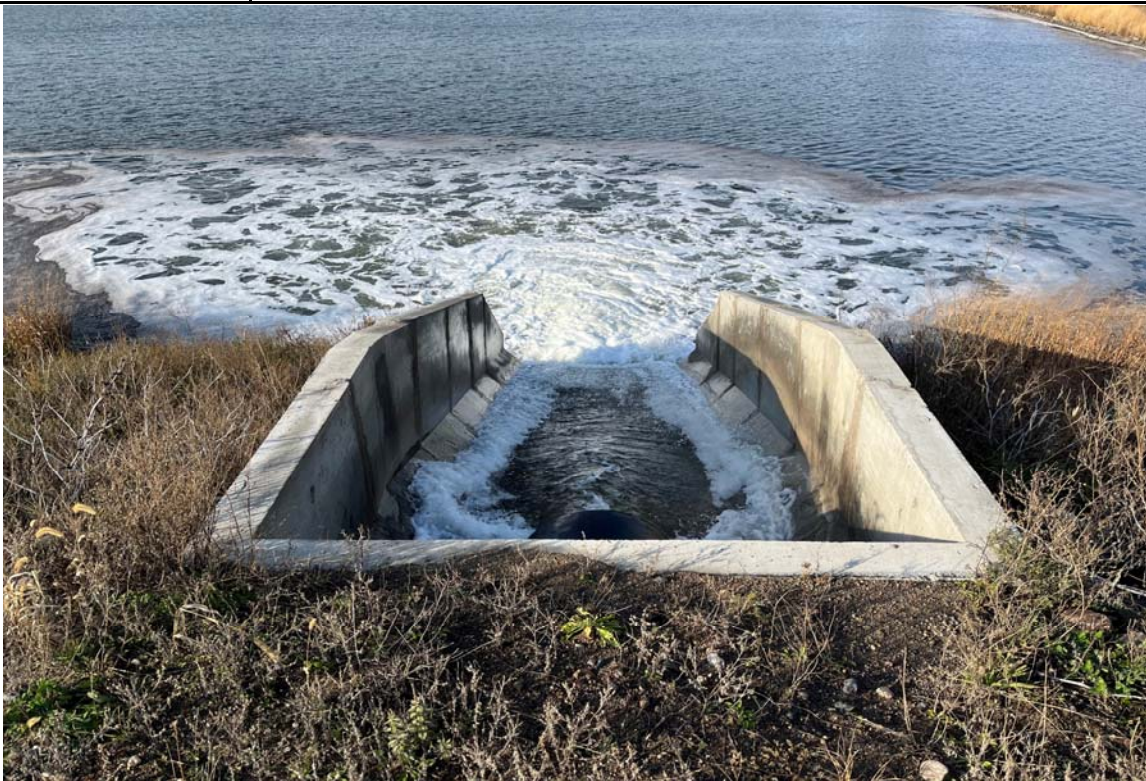
The outlet pipe corridor was inspected for signs of a leakage, such as saturated areas or sinkholes. No signs of leakage were observed along the pipe corridor between BAP2 and the Recycle Basin.

Photo 6	BAP2 outfall into Recycle Basin.
11/5/2021
