2016 Annual Inspection Report

for Compliance with the Coal
Combustion Residuals Rule
(40 CFR Part 257)

Pawnee Station

January 18, 2017

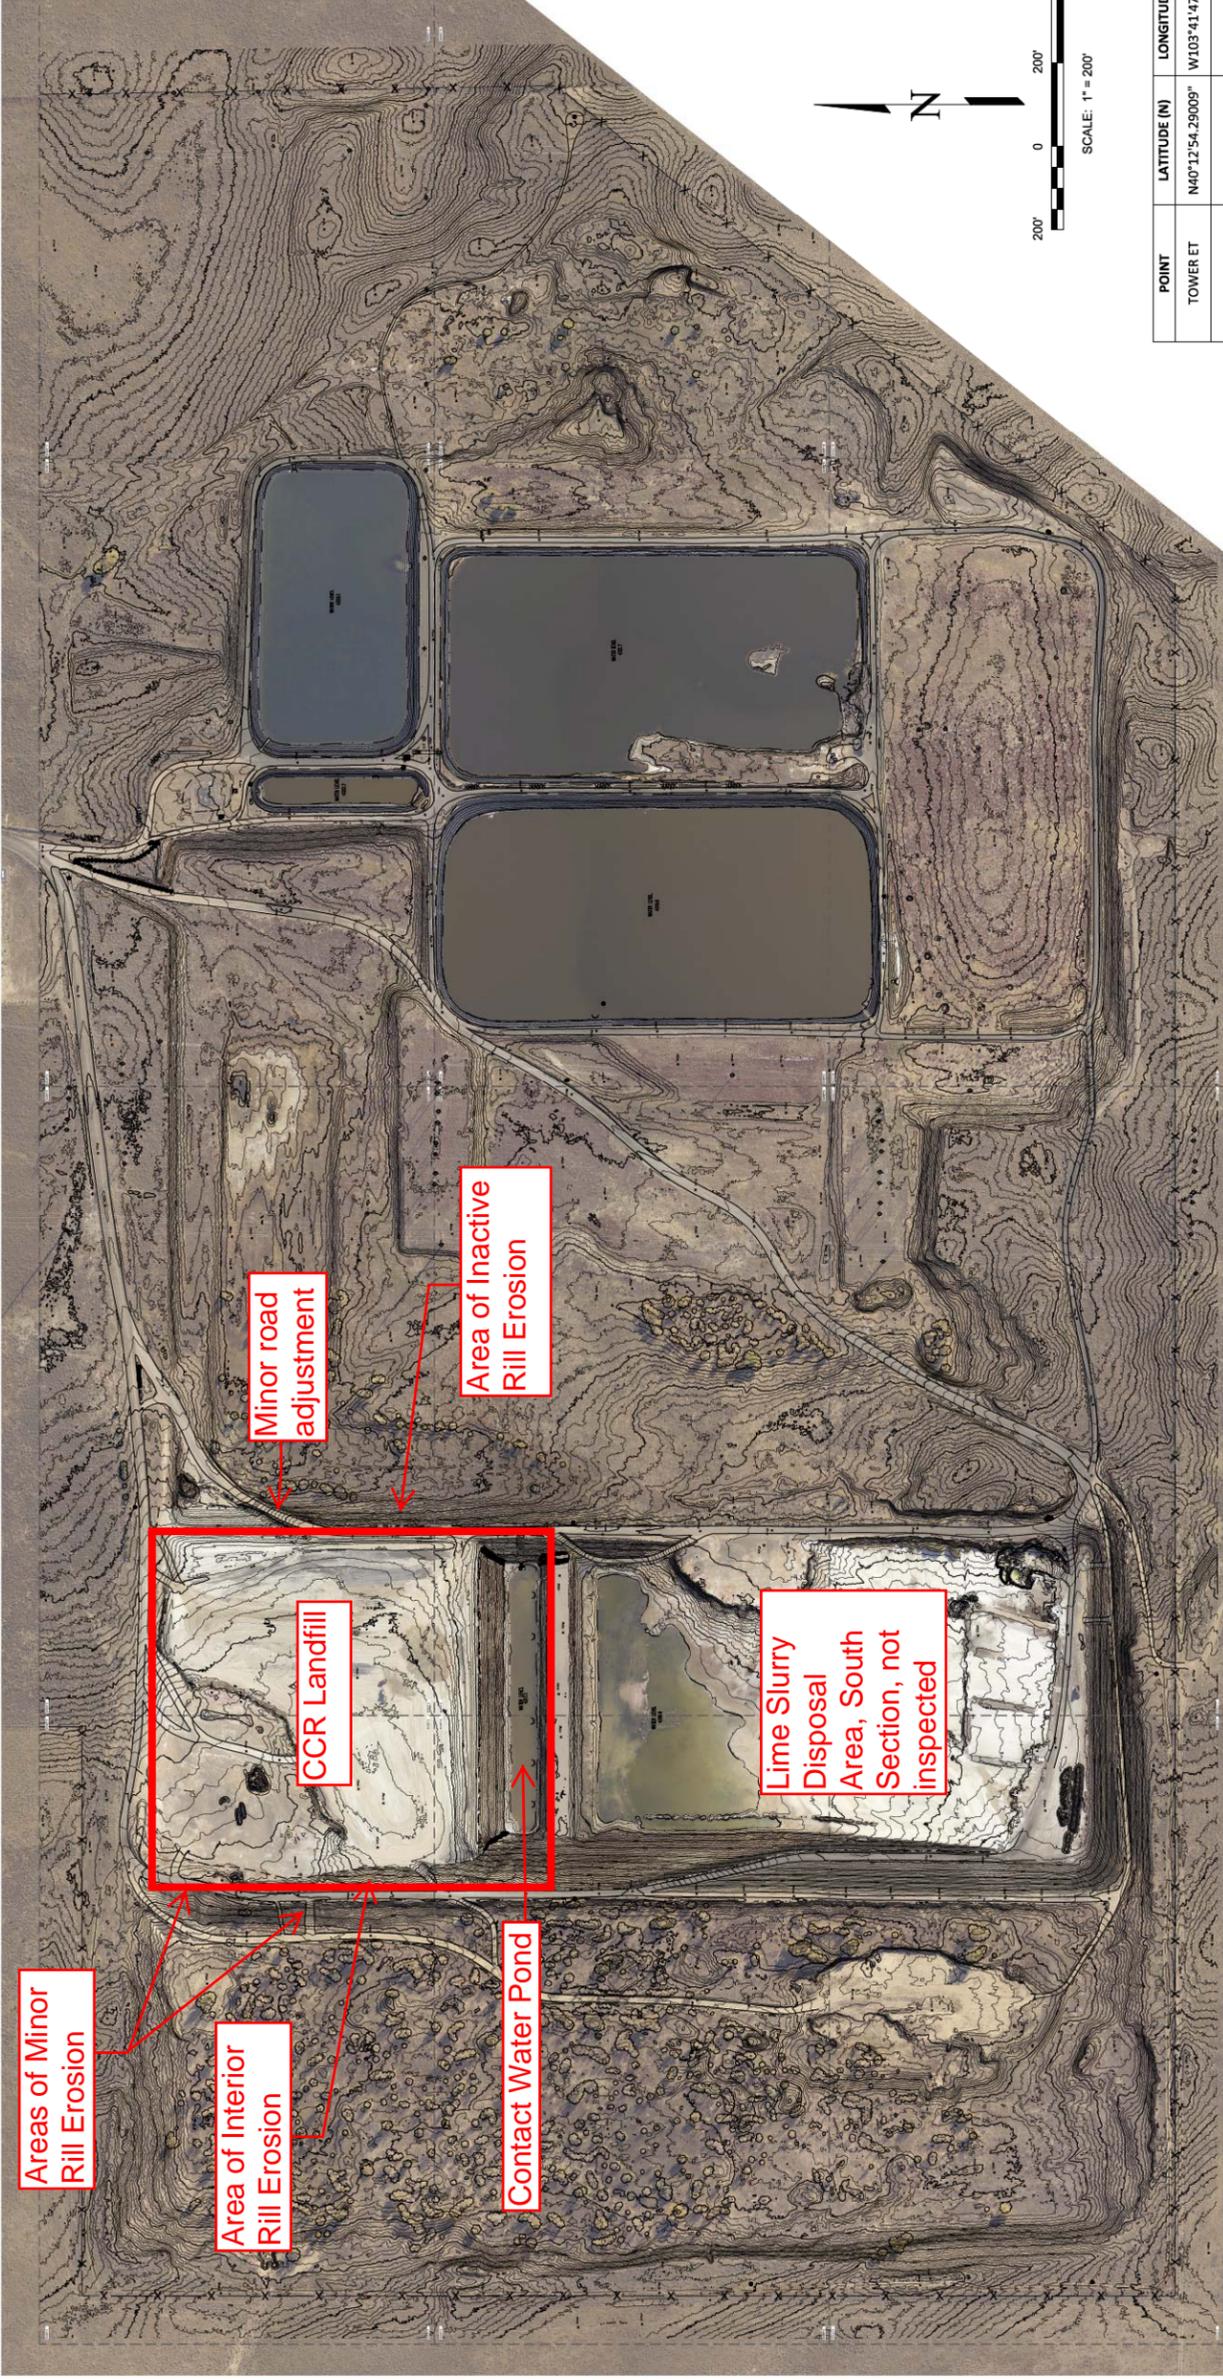
Appendix A – Landfill Site Map

The Federal CCR Rules require that site geometry changes be identified since the last inspection. The general site footprint changed in the northeast corner of the site due to a road realignment. The north-south road along the northeast side of the landfill was modified since last year's inspection and routed further east for a short portion of the road, roughly a 20 foot lateral shift at its greatest distance. This realignment was made as part of storm water features construction and to accommodate the permitted landfill limit with the proper landfill embankment toe slope. Other than this road alignment, the remainder of the CCR landfill footprint has not changed. The remainder of the landfill geometry has not changed except the fill elevation and soil cover is higher due to the continued disposal of CCR at the site.

Notes in red added by HDR Engineering for CCR Annual Inspection Report, January 2017
