2020 Annual Inspection Report

for Compliance with the Coal
Combustion Residuals Rule
(40 CFR Part 257)

Comanche Station

January 18, 2021

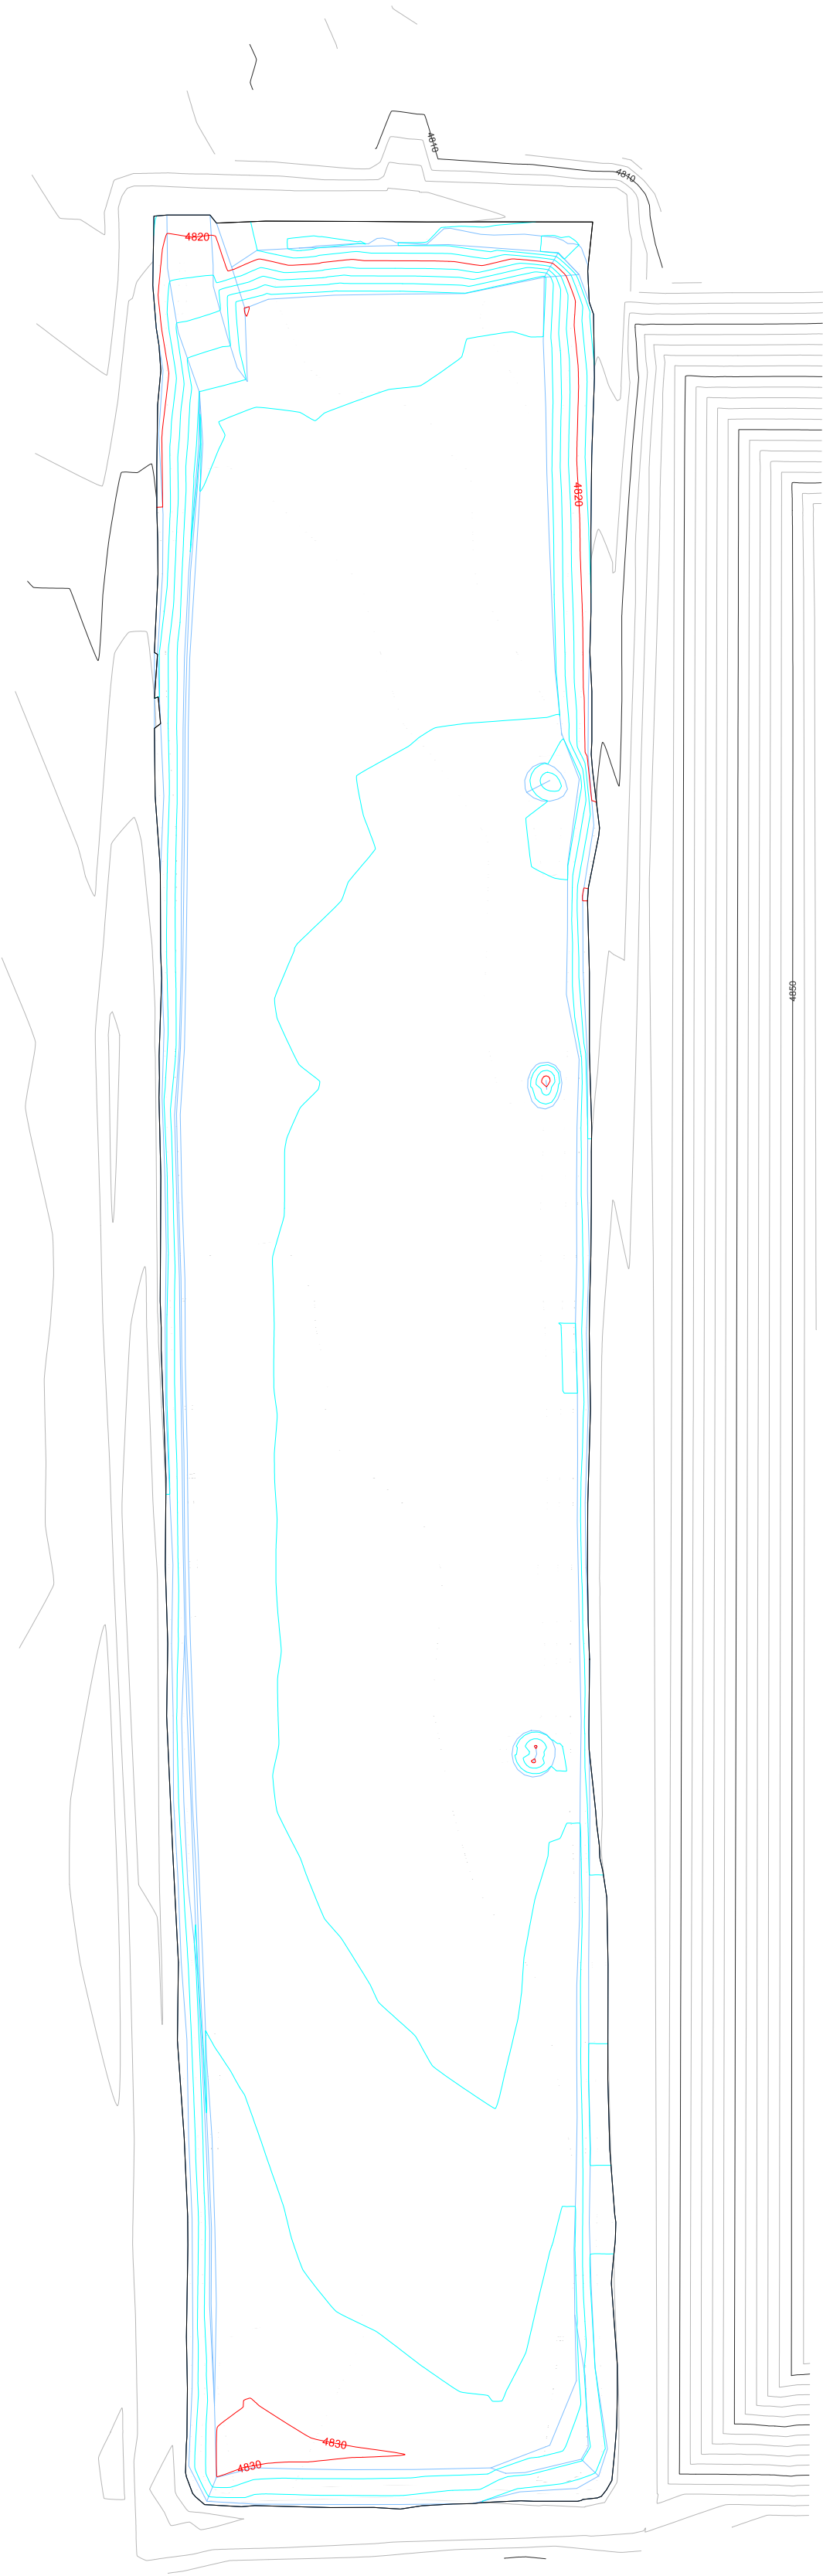
Appendix A – Cell 2E Topographic Survey

The Federal CCR Rules require that site geometry changes be identified since the last inspection. The site geometry changed since the prior inspection due to continued CCR disposal and soil cover placement. Normal CCR disposal operations have increased the height of Cell 2E by approximately 10 feet to a top deck elevation of 4830 feet. The landfill sides slopes continue to be maintained at approximately a 4H:1V slope for Cell 2E. Cell 2E has an approximate depth of 15 feet.

Volume Placed Cell 2 Dec. 2019 - Dec. 2020 - 139,692 CU. YDS.
