2021 Annual Inspection Report

for Compliance with the Coal
Combustion Residuals Rule
(40 CFR Part 257)

Comanche Station

January 15, 2022

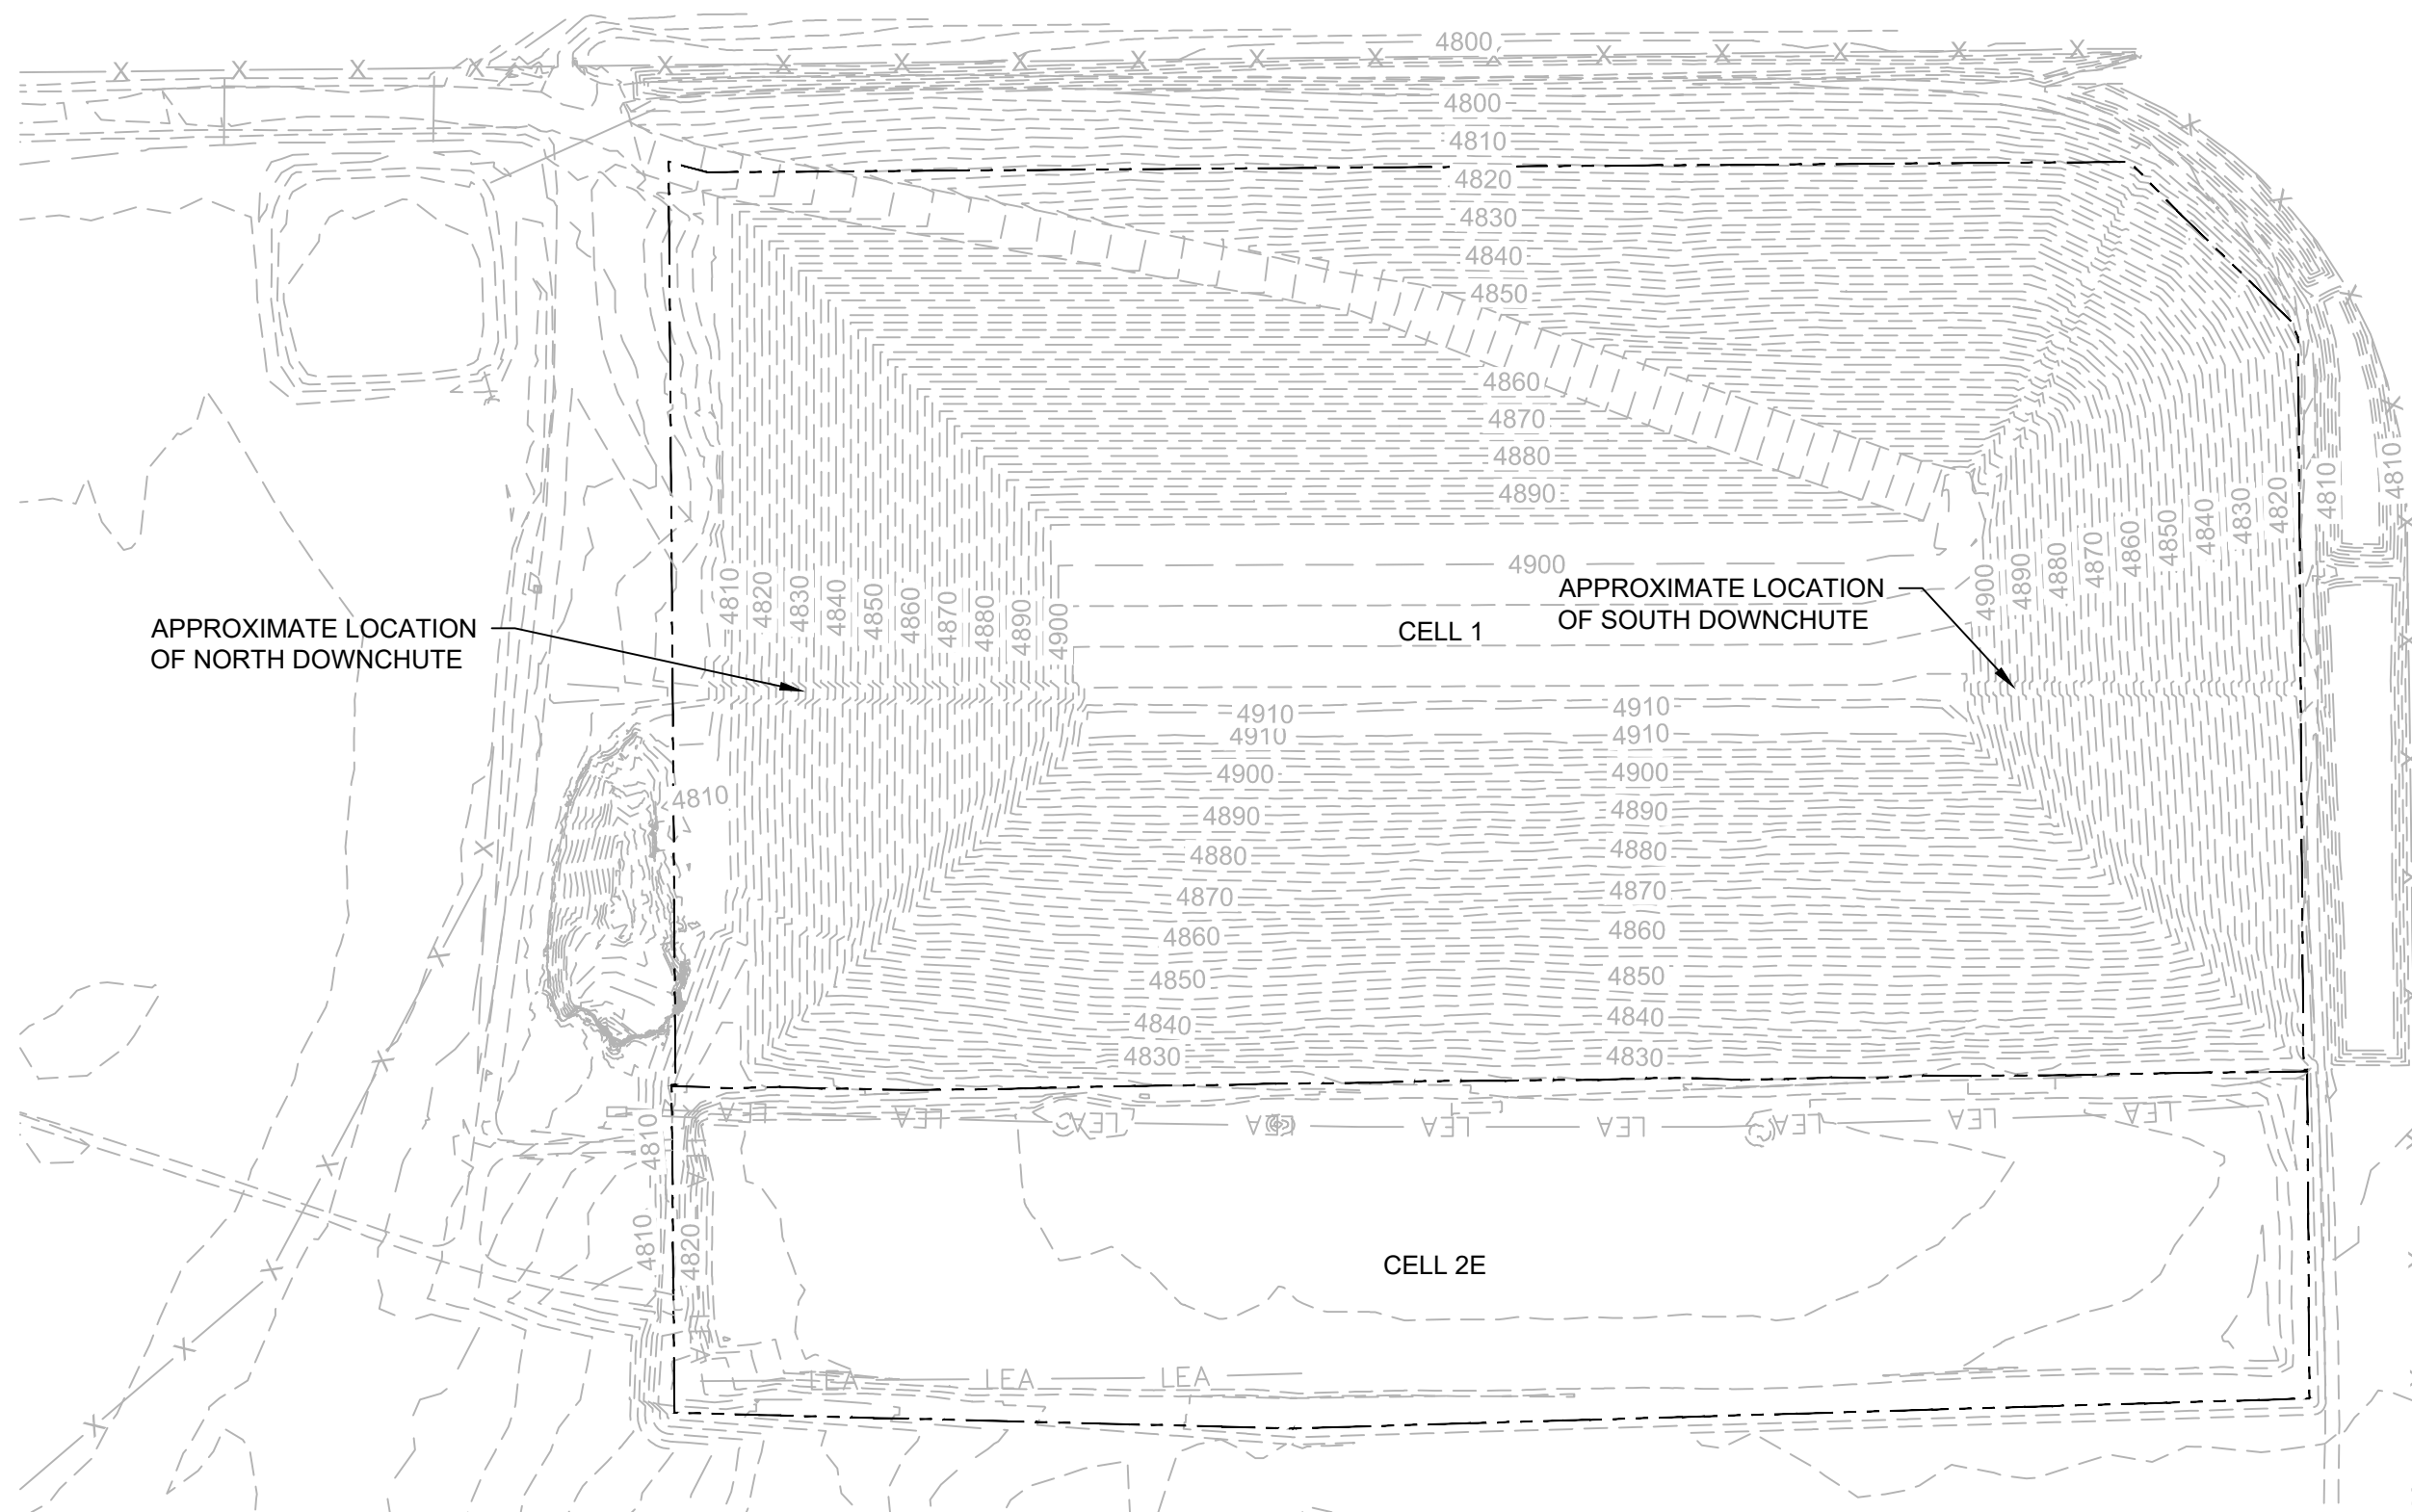
Appendix A – 2021 Annual Inspection Figure

The Federal CCR Rules require that site geometry changes be identified since the last inspection. The site geometry changed since the prior inspection due to continued CCR disposal and soil cover placement. Normal CCR disposal operations have increase the height of the Cell 2E by approximately 20 feet to a top deck elevation of 4850 feet. The landfill sides slopes continue to be maintained at approximately a 4H:1V slope for Cell 2E. Cell 2E has an approximate depth of 35 feet.

VOLUME PLACED WITHIN CELL 2E DECEMBER 2020 - NOVEMBER 2021 - 226,263 CY
