# 2017 Annual Inspection Report

for Compliance with the Coal  
Combustion Residuals Rule  
(40 CFR Part 257)

## **Hayden Station**

**January 18, 2018**

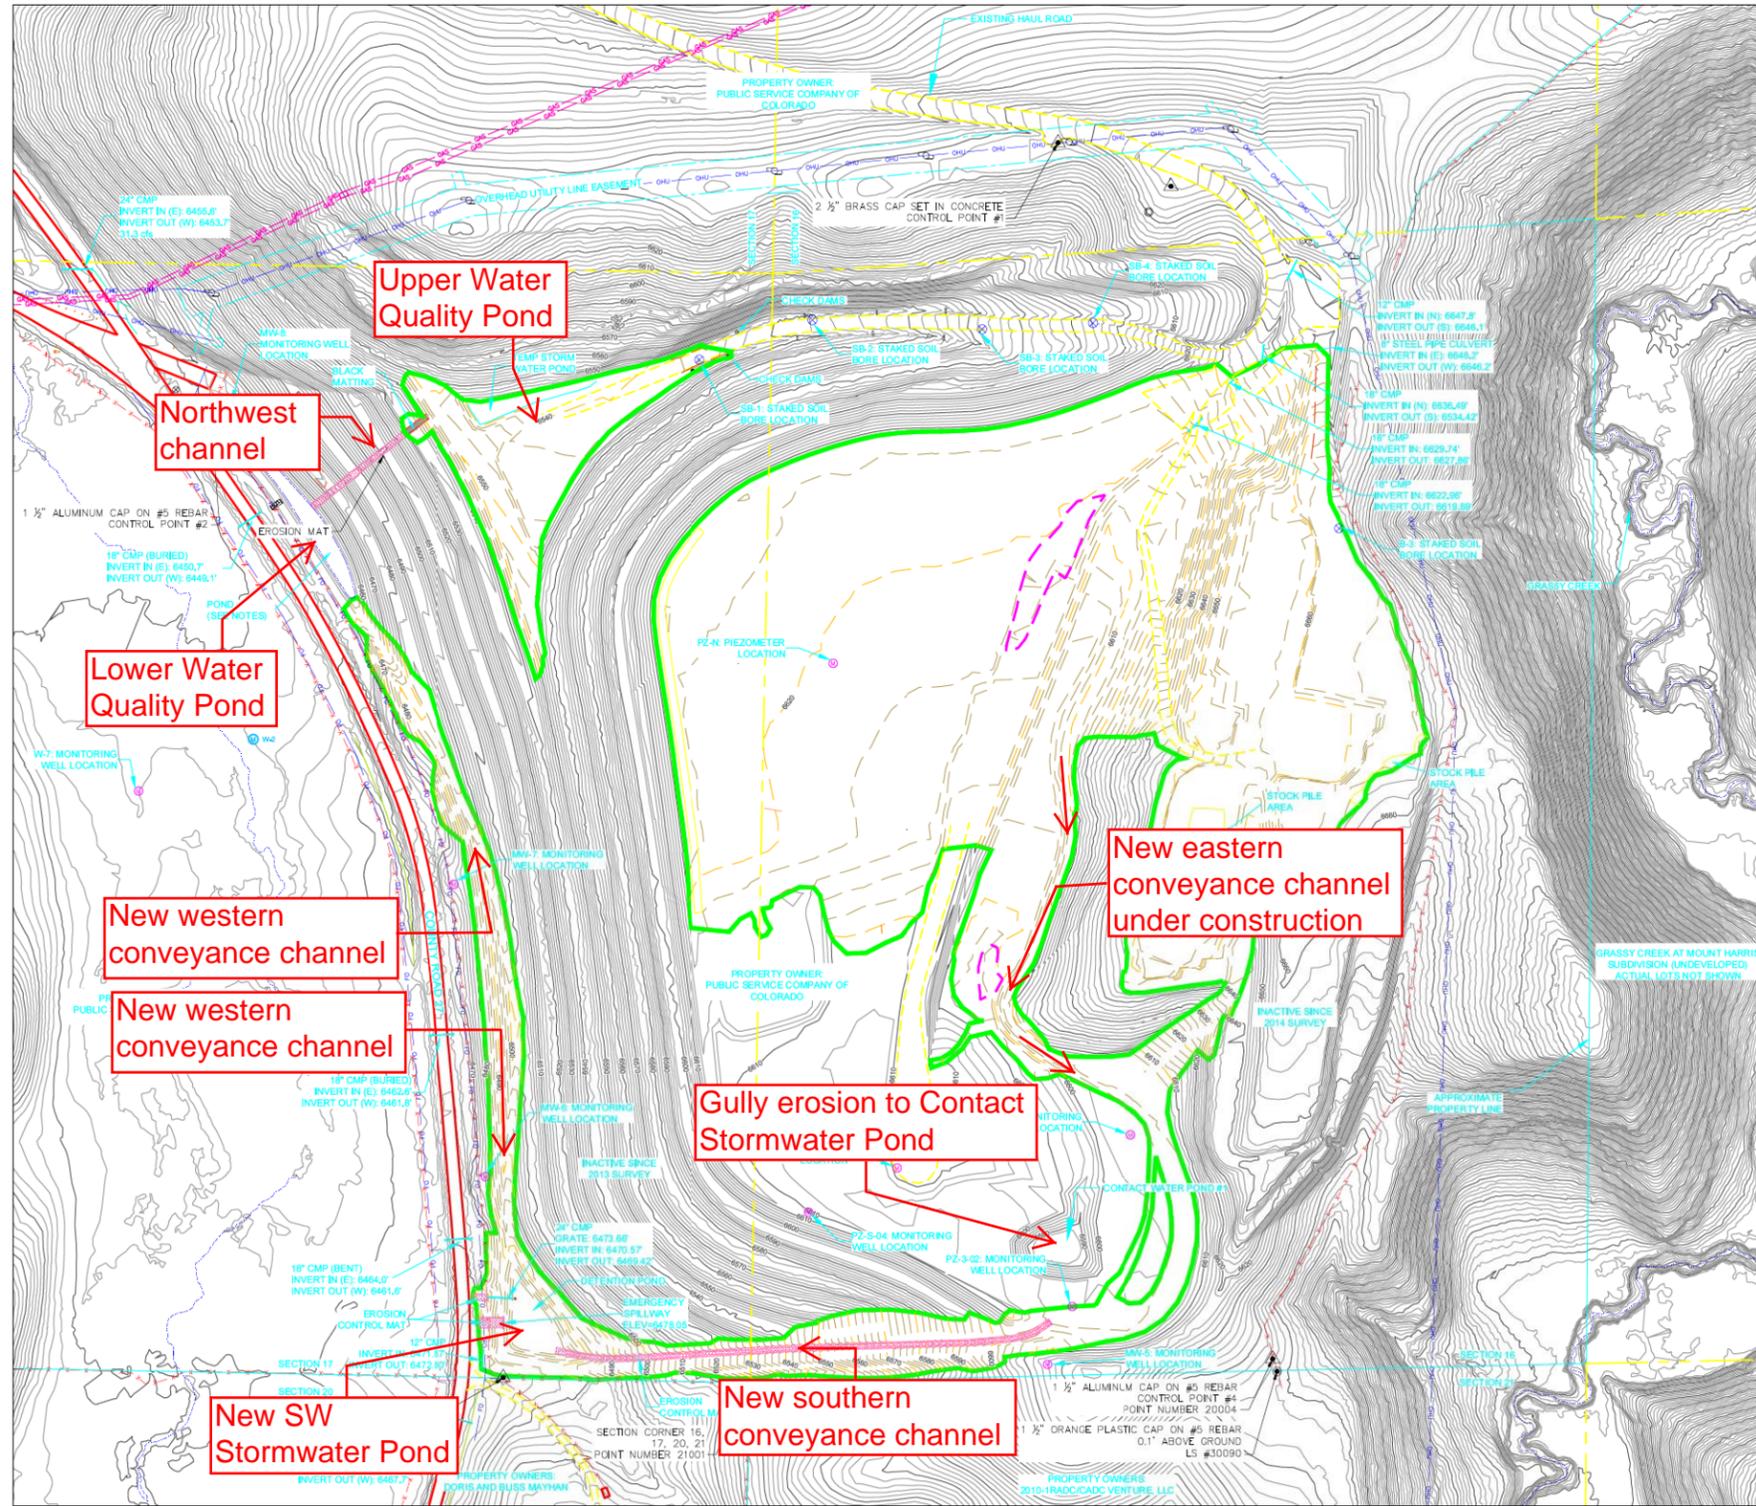
## Appendix A – Landfill Site Map

Notes in red text boxes added by HDR Engineering for CCR Annual Inspection Report, January 2018
