2020 Annual Inspection Report

for Compliance with the Coal
Combustion Residuals Rule
(40 CFR Part 257)

Pawnee Station - North Landfill

January 18, 2021

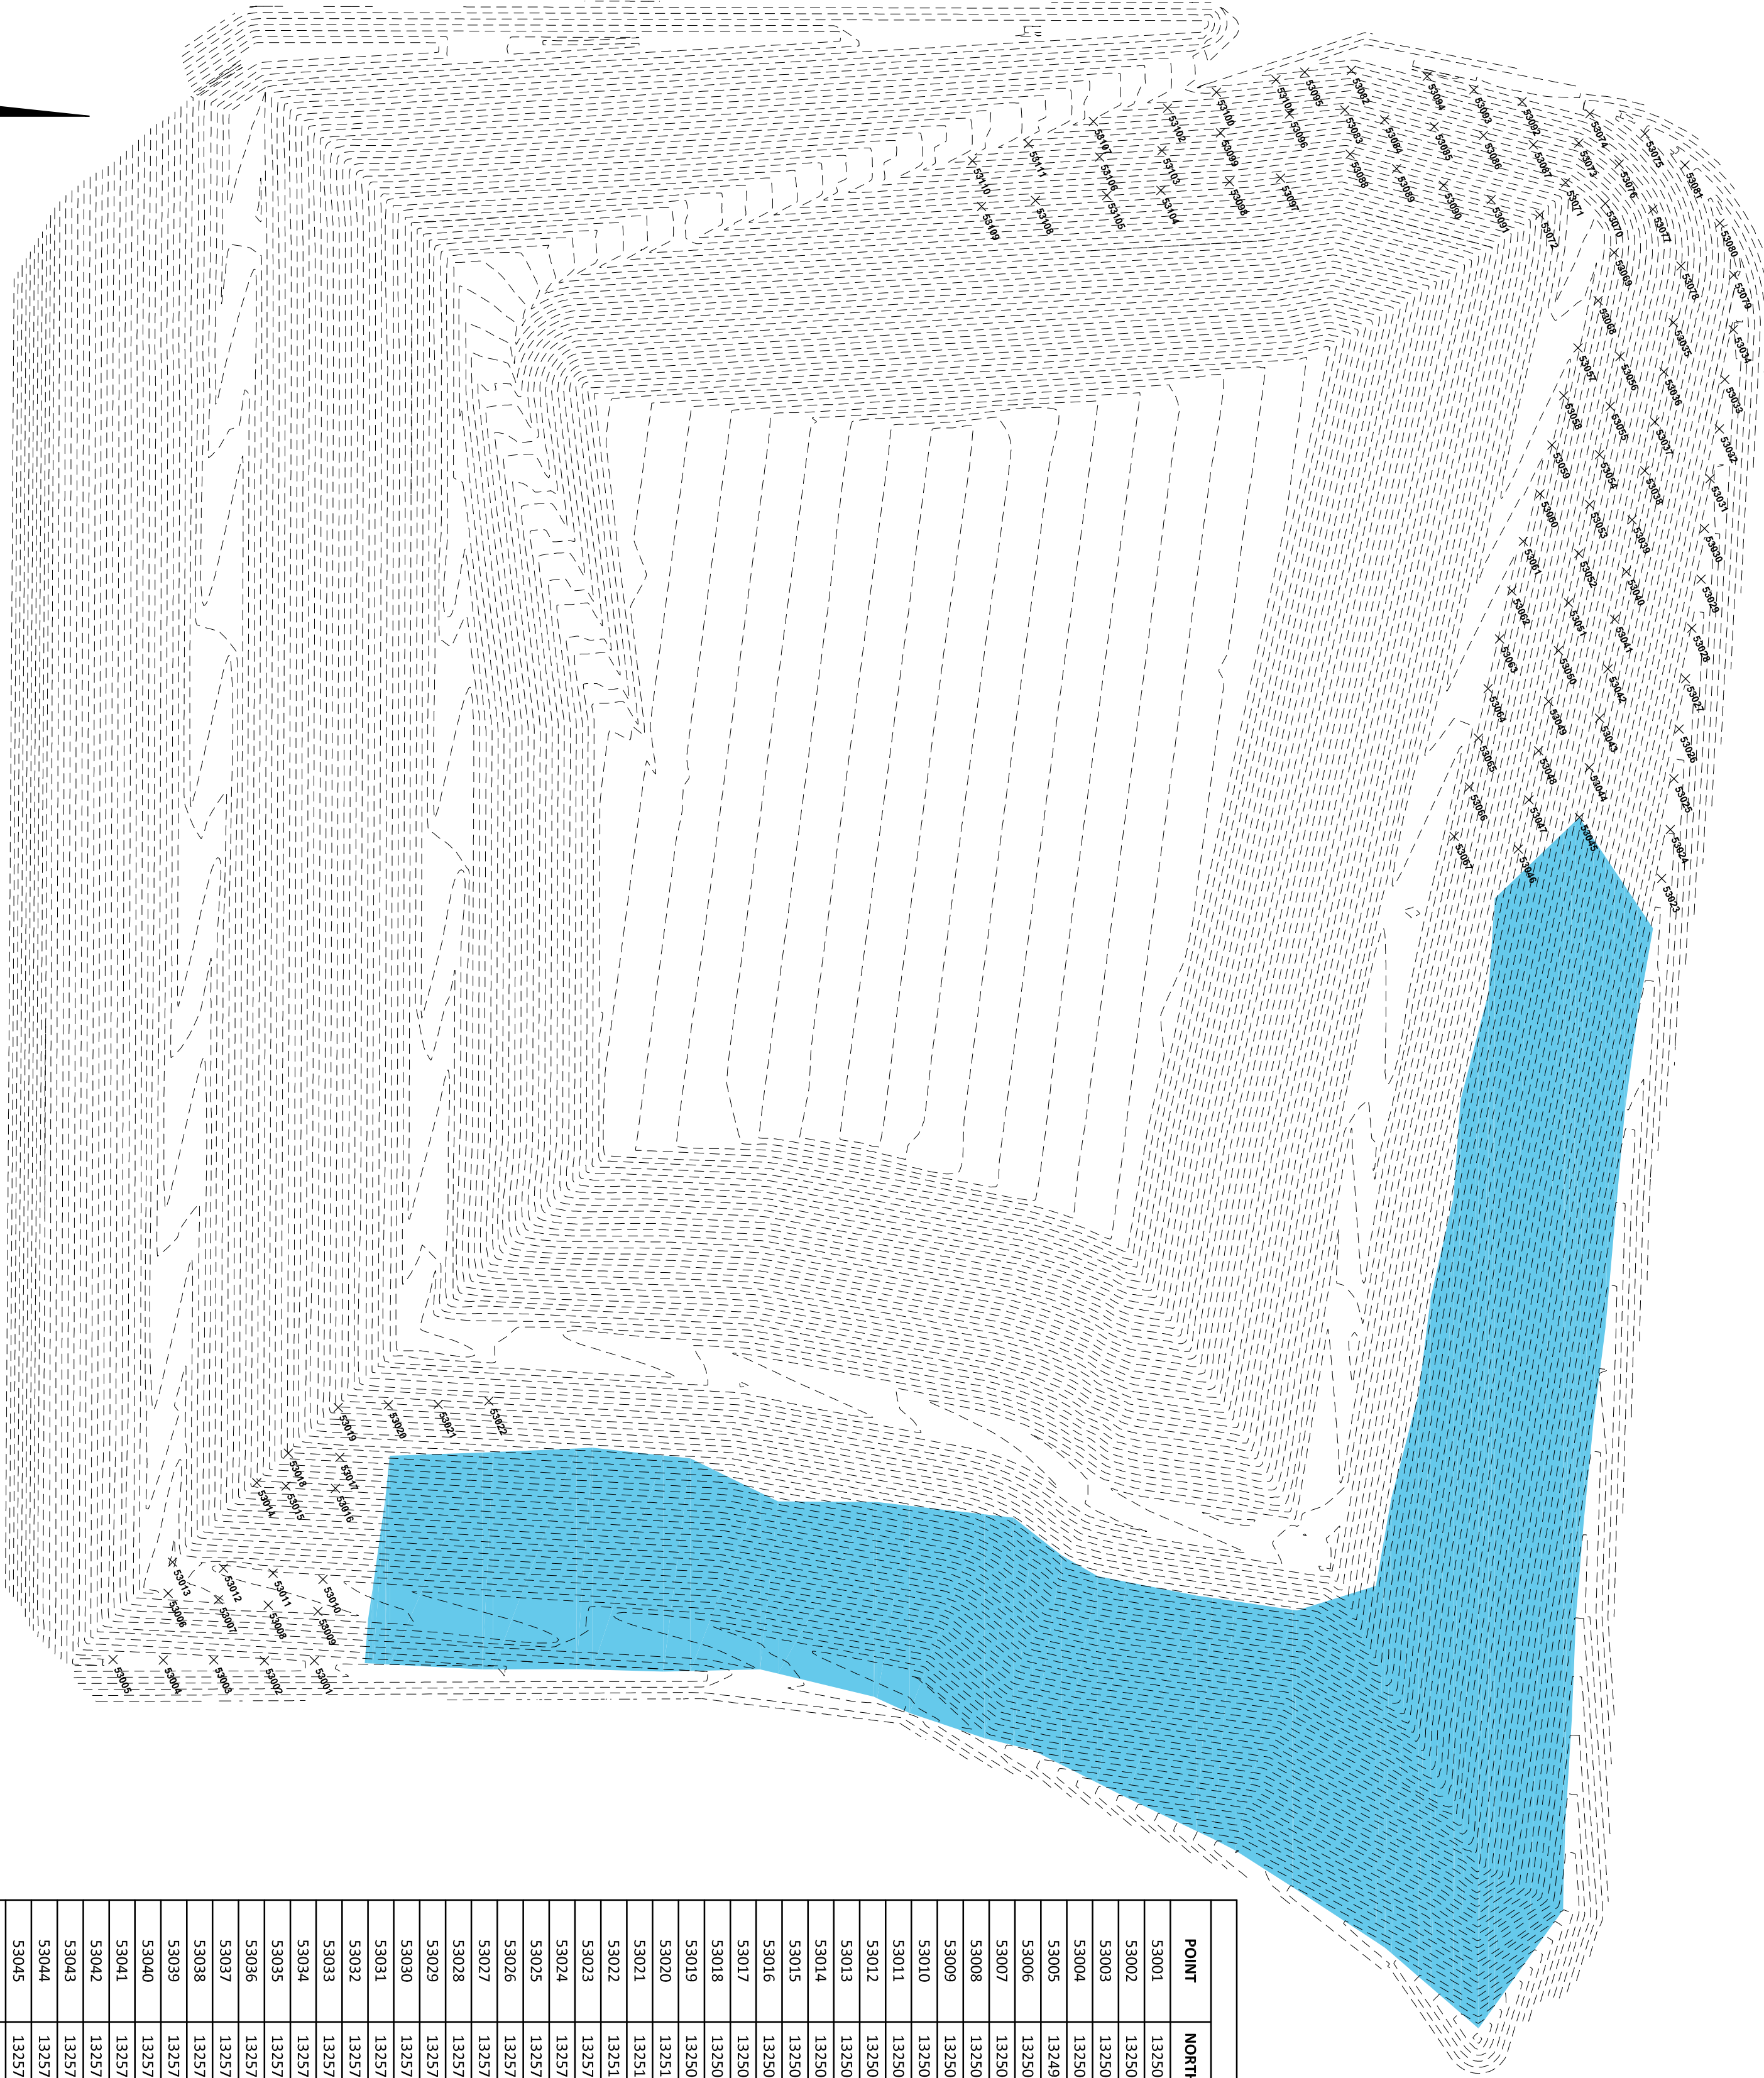
PAWNEE SEGS - UNIT 1
NORTH CCR LANDFILL
TOP OF CCR VERIFICATION

SURVEY PROVIDED TO SUPPORT TOPOGRAPHIC CHANGES
FOR ANNUAL INSPECTION REPORT. RED TEXT BOXED NOTES
BY HDR ENGINEERING FOR JANUARY 2021 SUBMITTAL.
