2022 Annual Inspection Report

for Compliance with the Coal
Combustion Residuals Rule
(40 CFR Part 257)

Pawnee Station – East Landfill

January 15, 2023

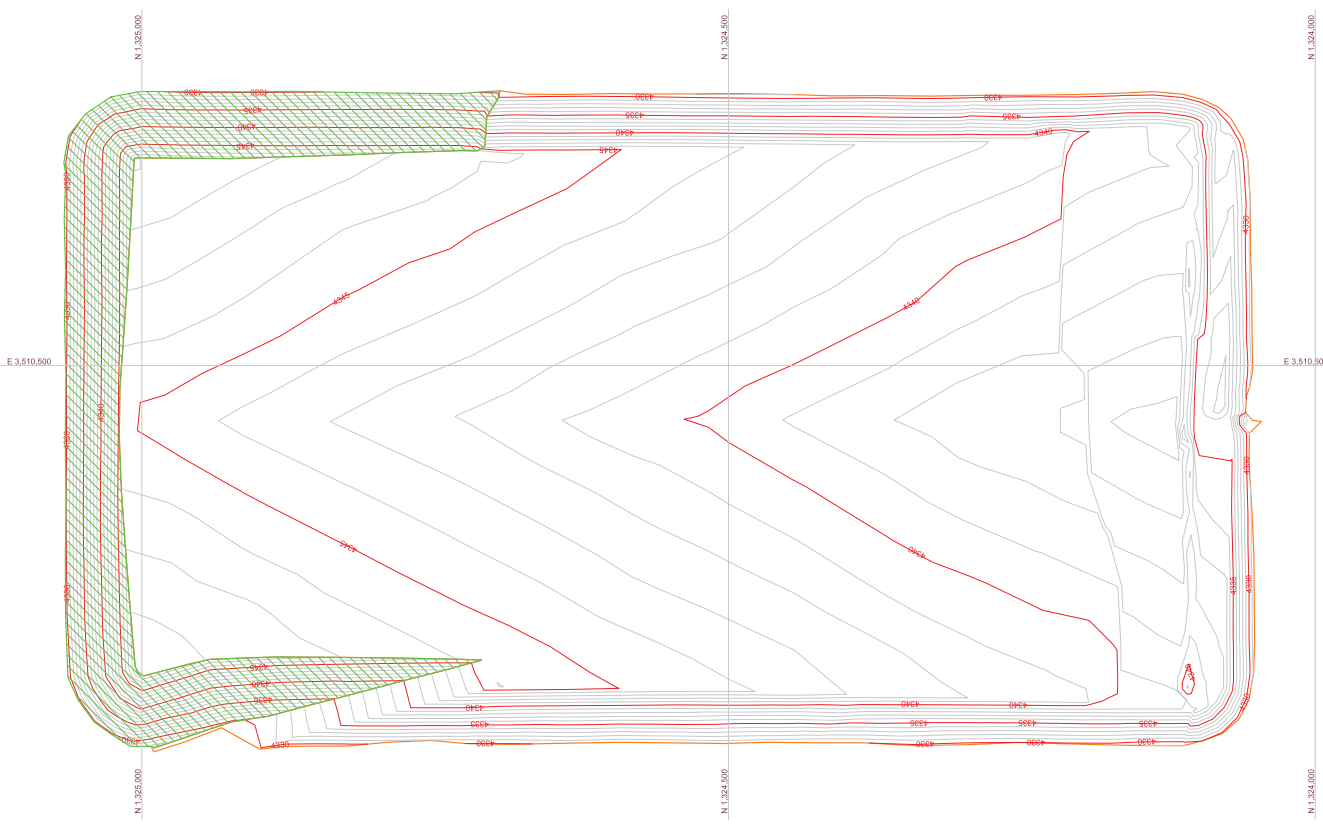
Sheet 1 of 2
Scale 1" = 50'

The Federal CCR Rule requires that site geometry changes be identified since the last inspection. Between September 2021 and August 2022, the top of waste grades increased by approximately 10-feet across the working area of the landfill (i.e., the top deck). The access road up to the working area of the landfill extended to the south-southeast as the landfill surface elevation increased. Fill operations have been consistent with the approved EDOP. The slope of the working area was similar to the prior year with a gradual decrease in elevation from north to south at about a 1.2 percent grade.

Surveyed remaining volume for East Landfill
as of 08/01/2022 - 356,861 cu. yds.
