2015 Initial Annual Inspection Report

for Compliance with the Coal
Combustion Residuals Rule
(40 CFR Part 257)

Pawnee Station

January 18, 2016

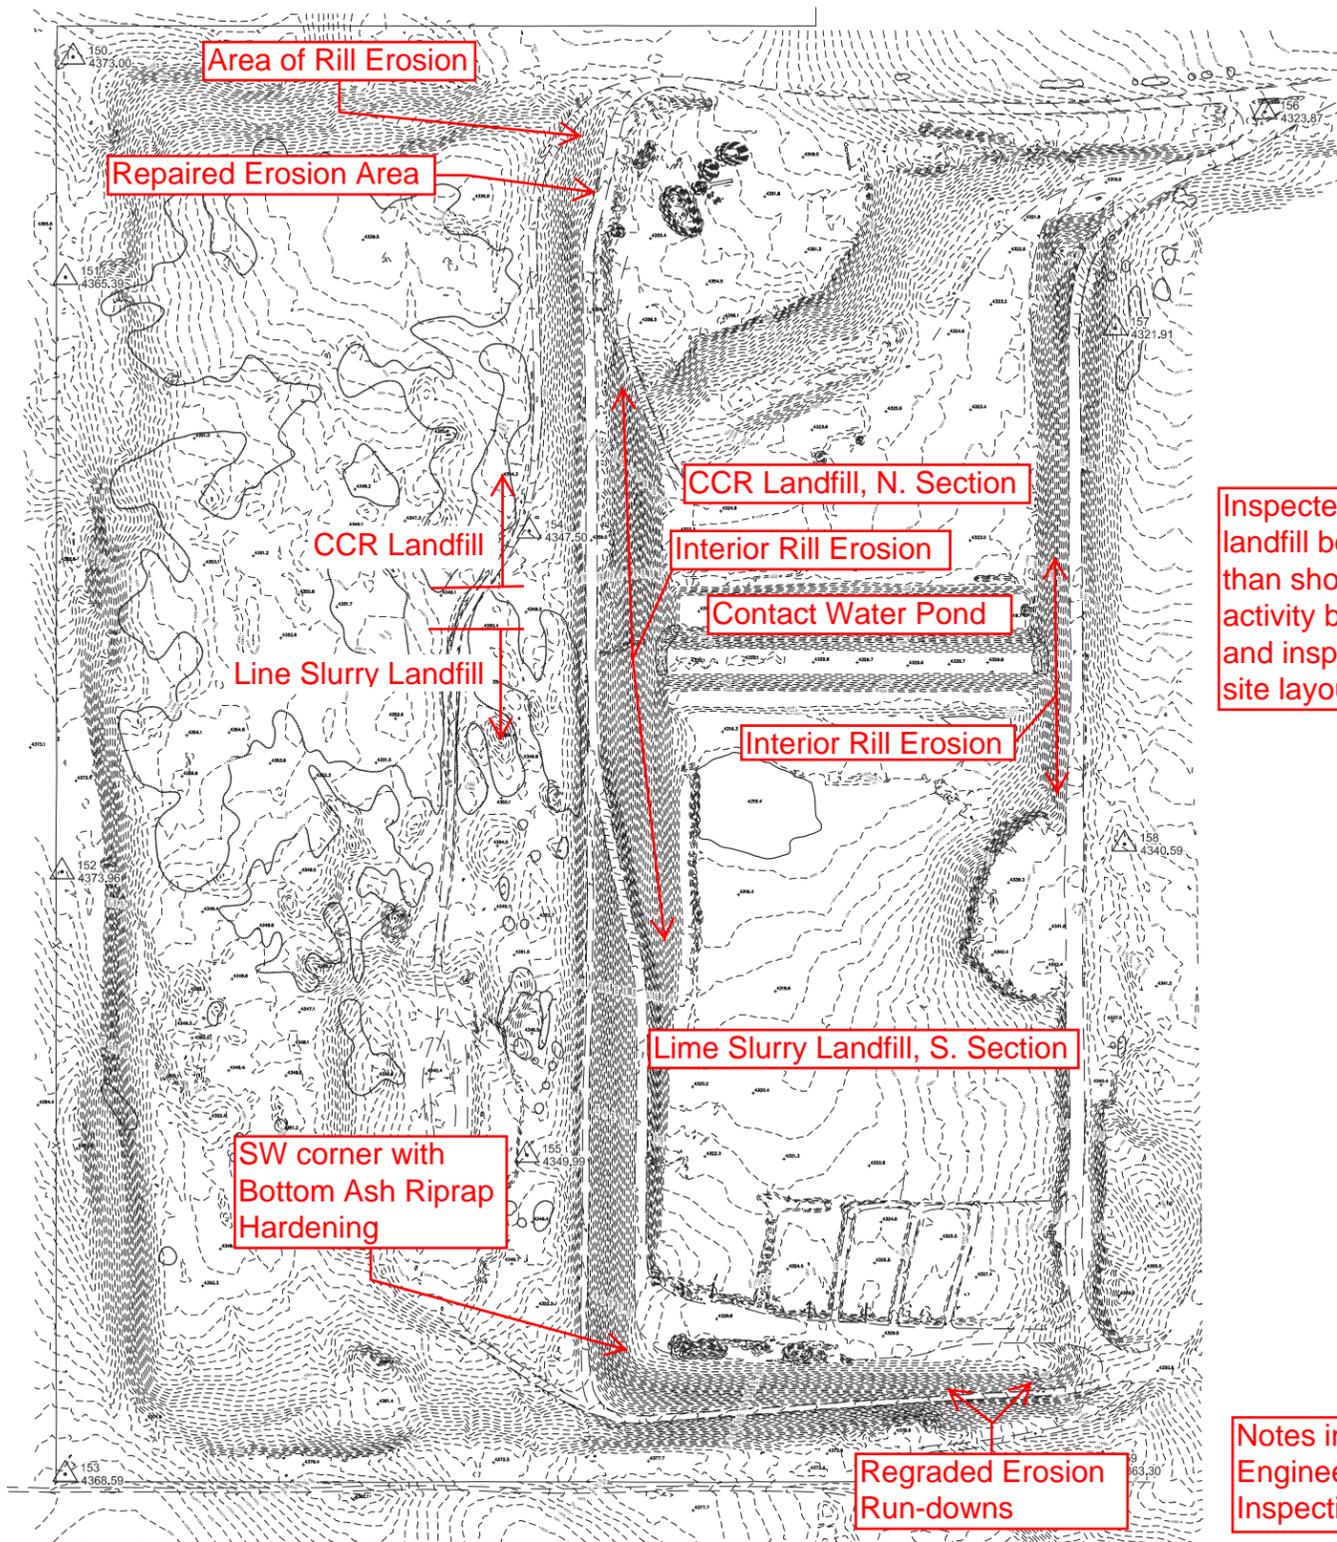
Appendix A – Landfill Site Map

Inspected site grades in the CCR landfill bottom area are higher than shown due to continued activity between the survey date and inspection date. The general site layout remains the same.
