2017 Annual Inspection Report

for Compliance with the Coal
Combustion Residuals Rule
(40 CFR Part 257)

Pawnee Station

January 18, 2018

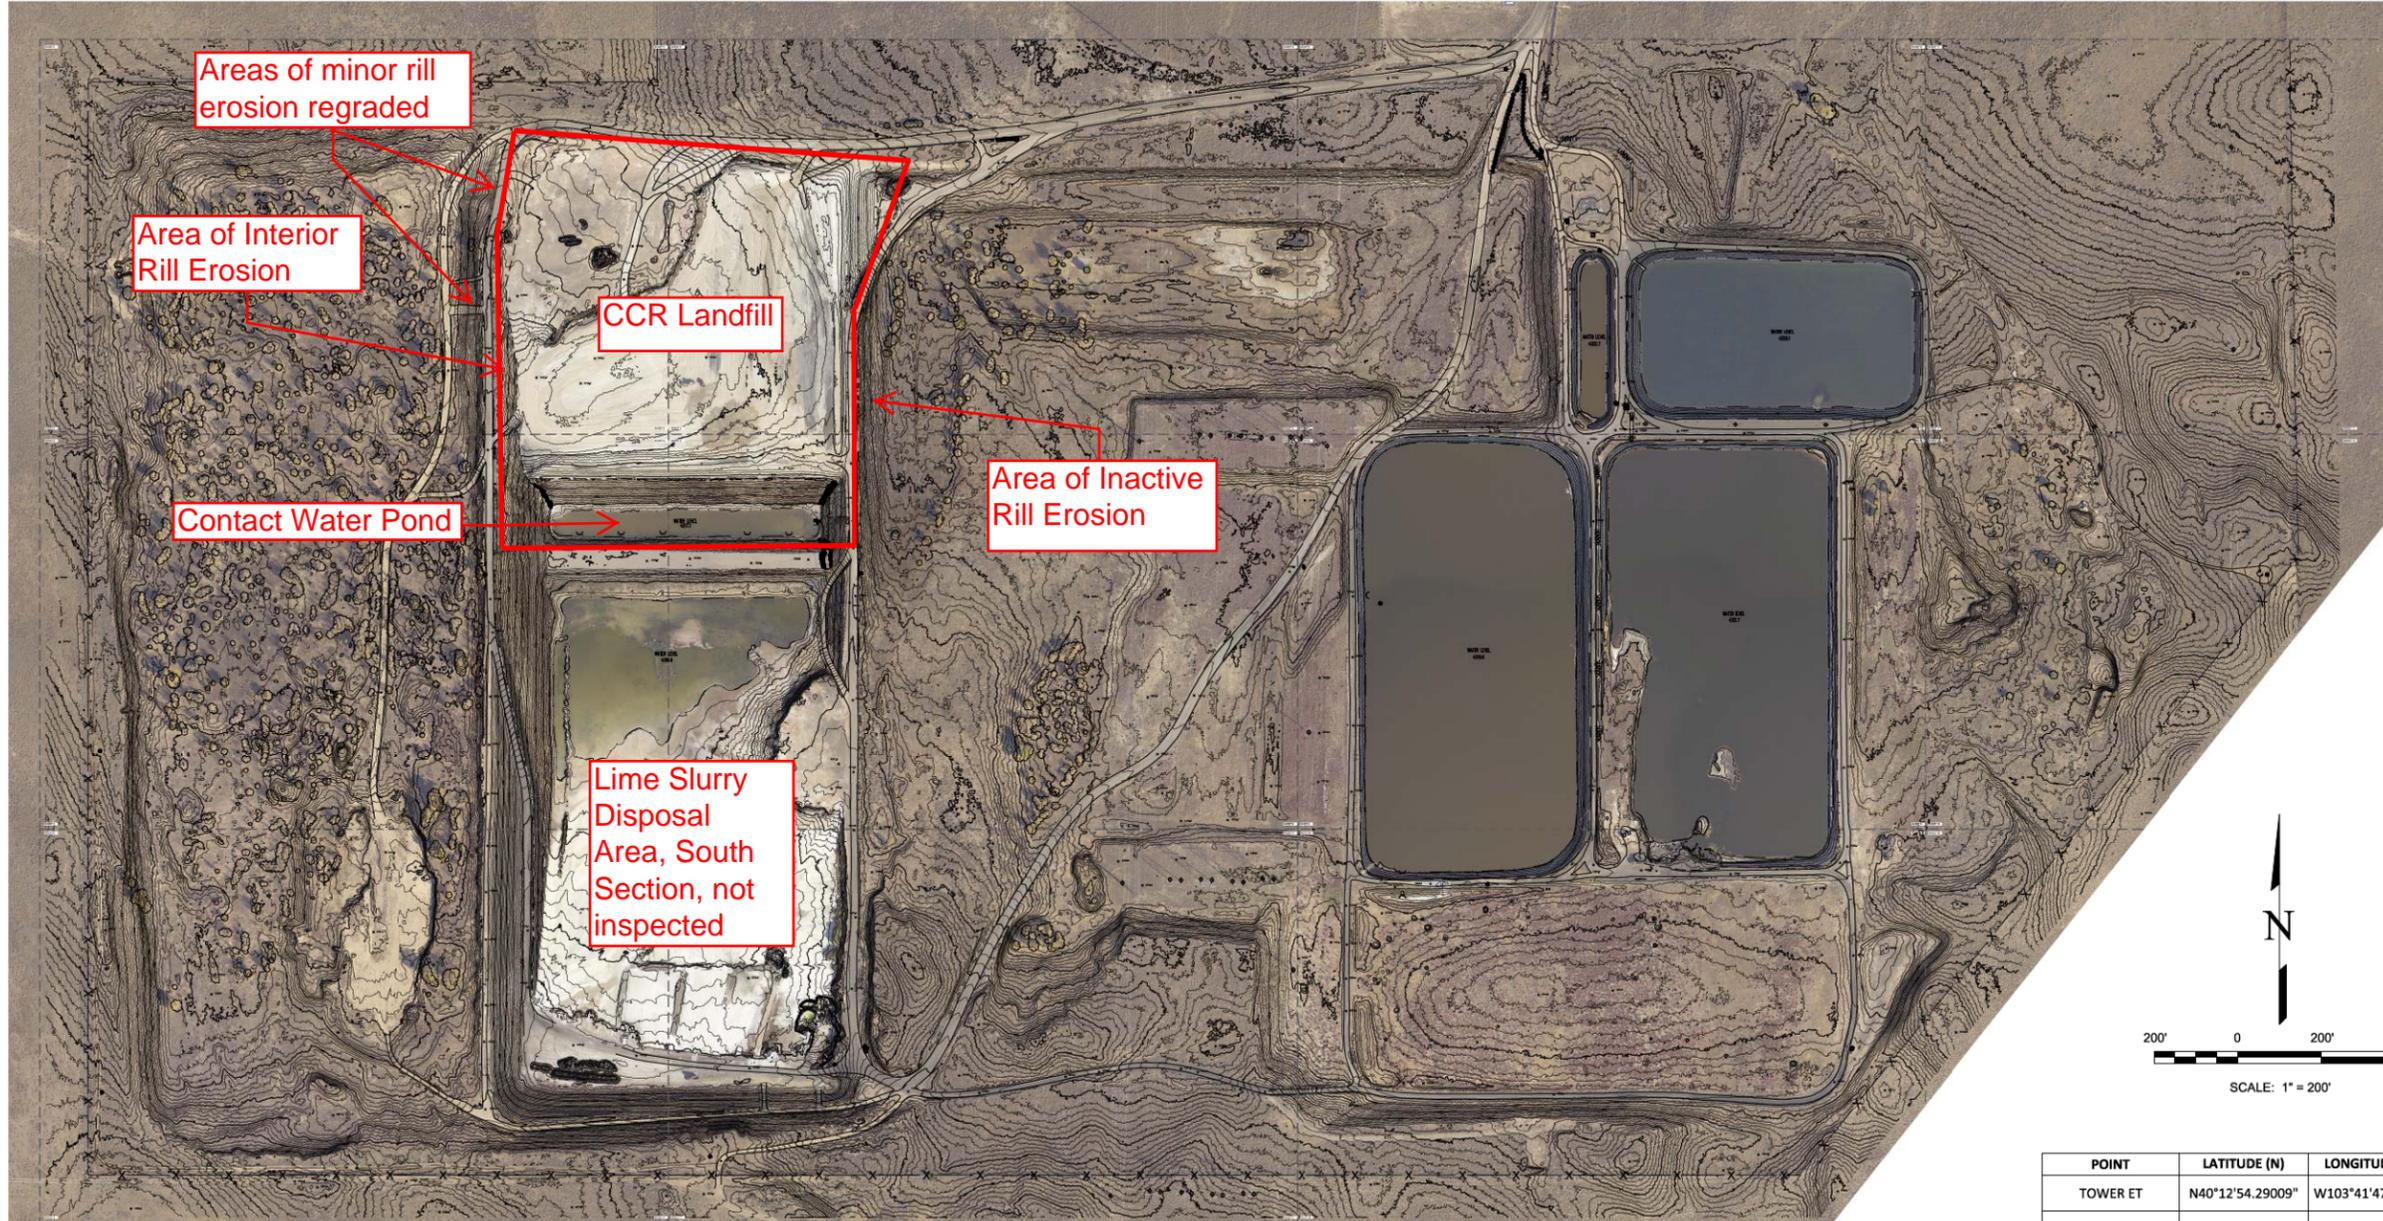
PAWNEE STATION TOPOGRAPHIC SURVEY

Notes in red added by HDR Engineering for CCR Annual Inspection Report, January 2018. See 7/2017 survey for updated survey surface within landfill cell.
