Xcel Energy, Inc.  
Sherburne County Generating Station  
13999 Industrial Blvd.  
Becker, MN, 55308

**Re: 2022 Annual Inspection of Scrubber Solids Pond No. 3**

## Pond 3 Annual Inspection - 2022

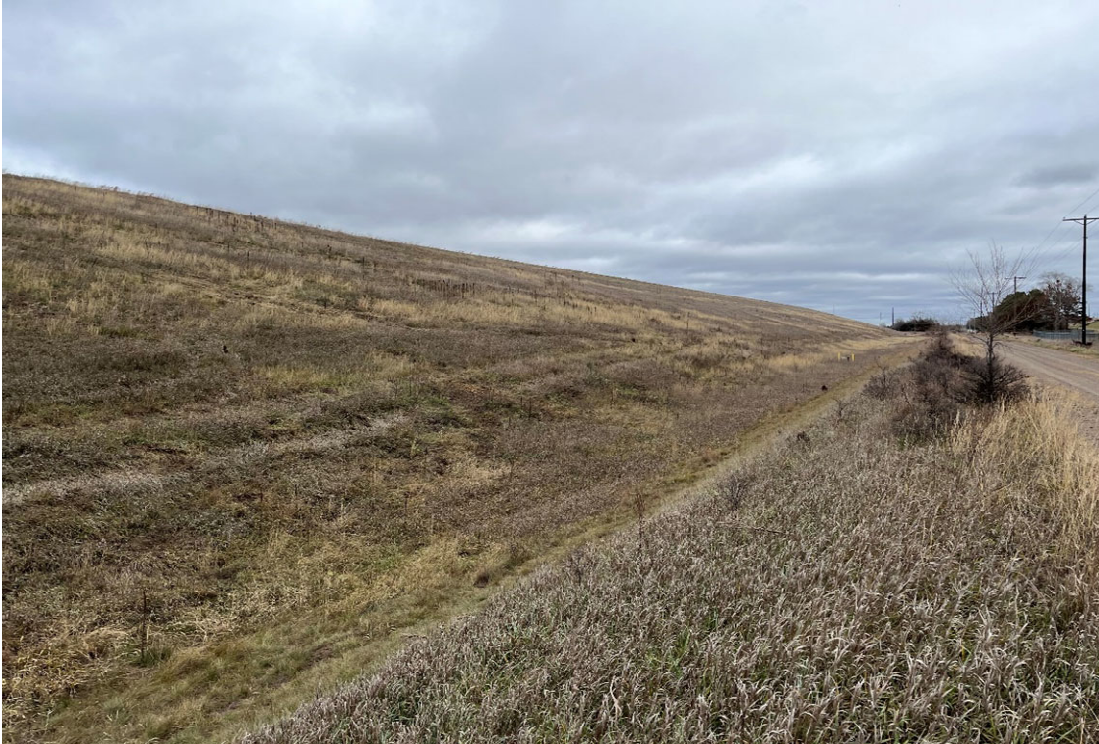
Photo 1	Outer slope of south embankment, looking east
11/11/2022

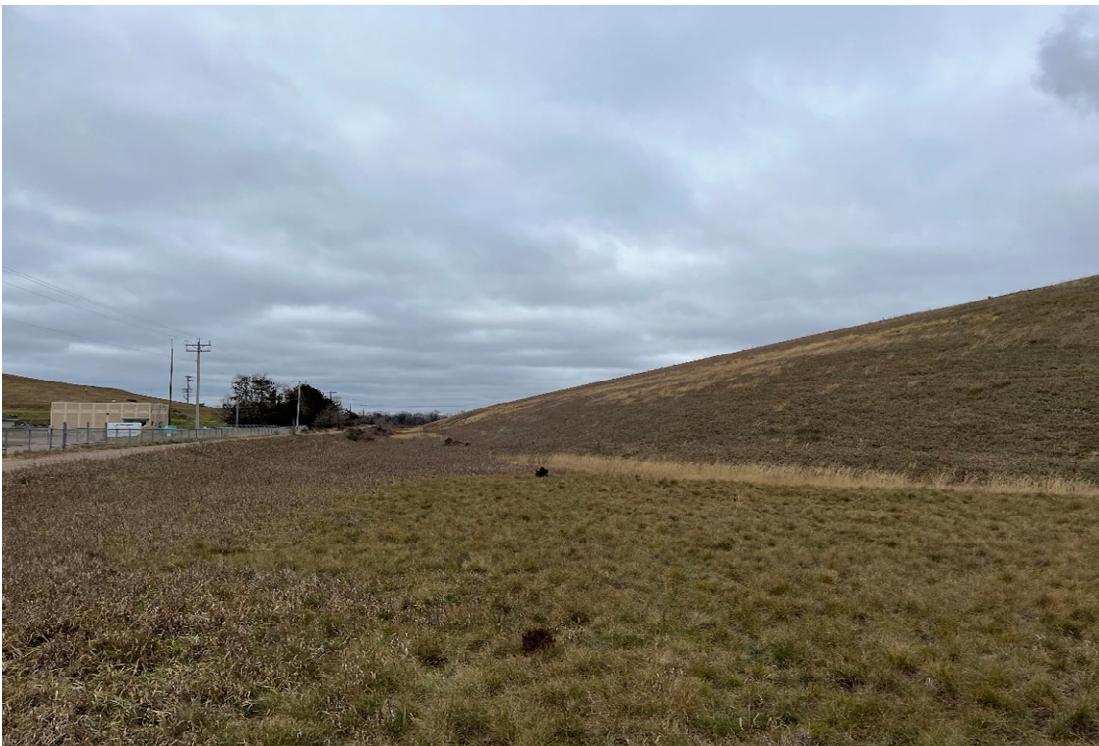
Photo 2	Outer slope of south embankment and southeast corner of pond, looking west
11/11/2022

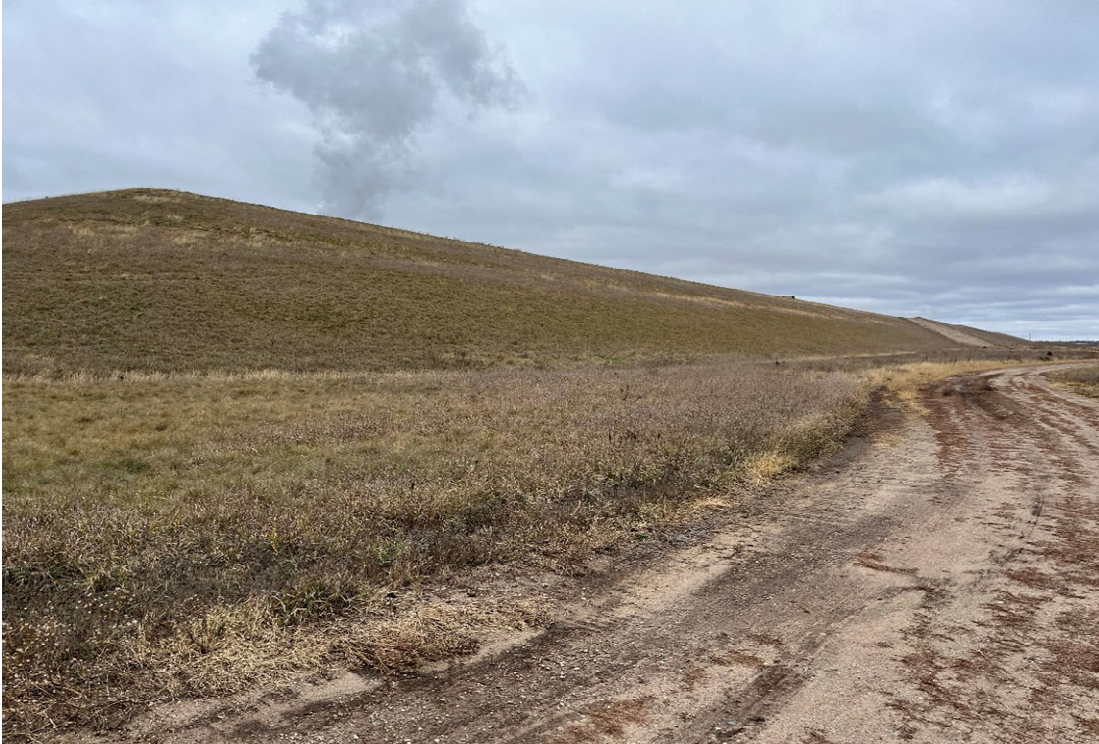
Photo 3	South end of east embankment, looking northwest.
11/11/2022

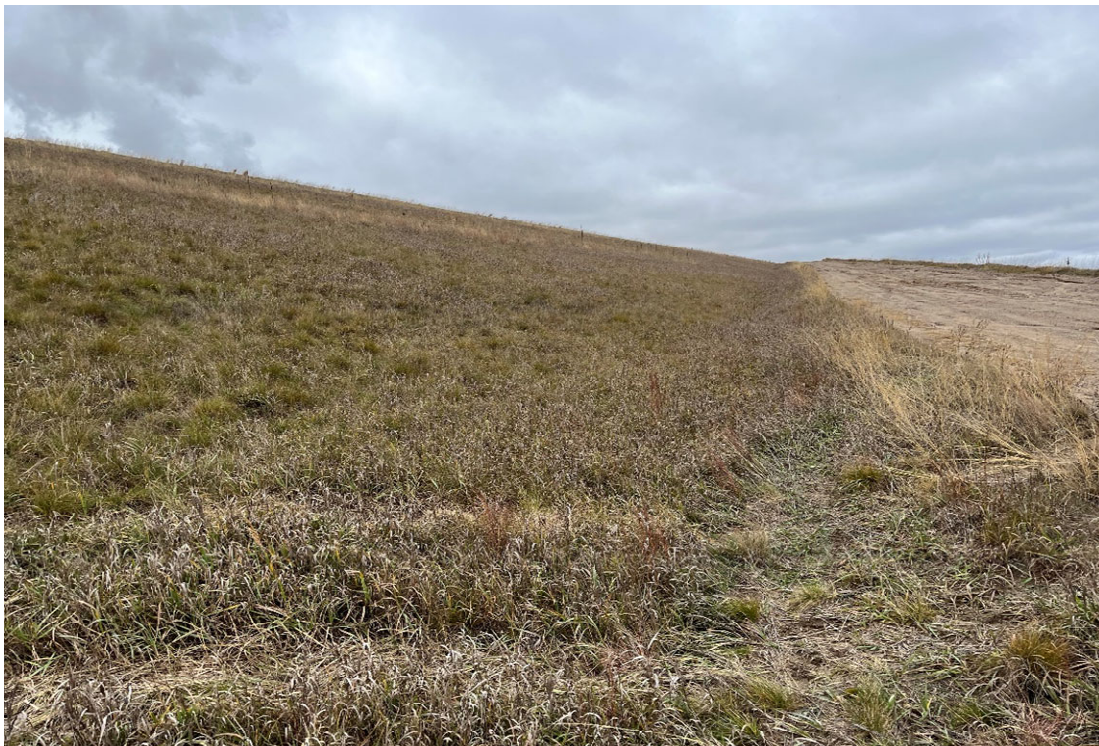
Photo 4	Mid-slope of east embankment, looking north
11/11/2022

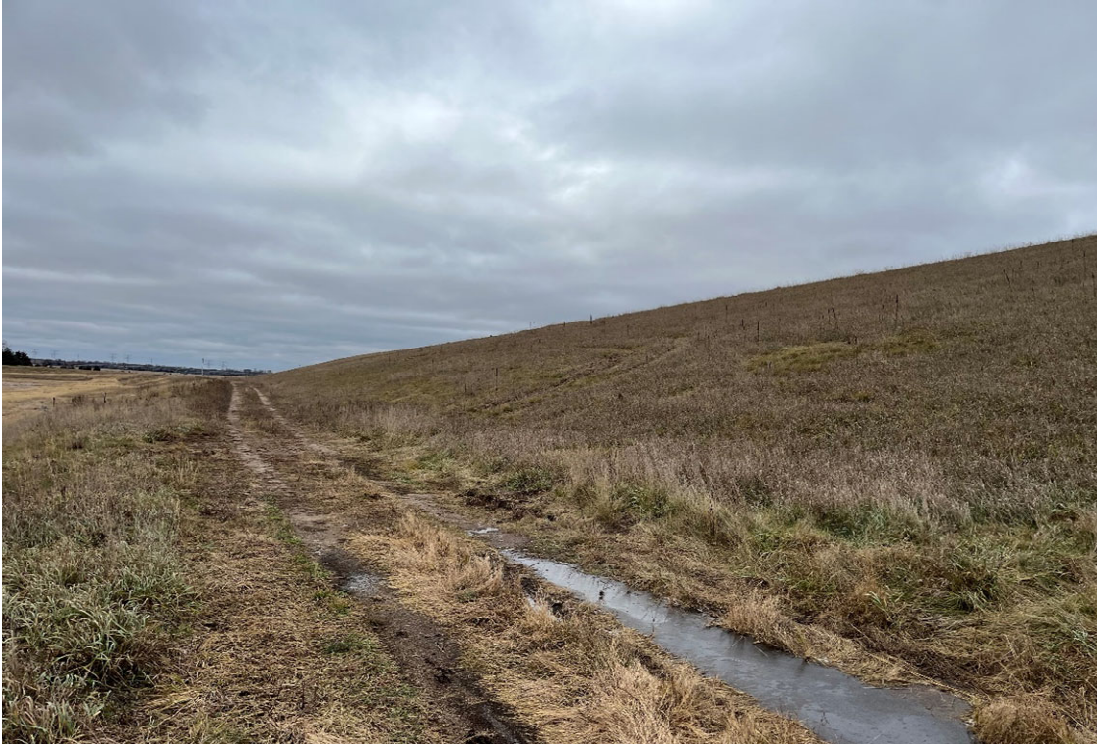
Photo 5	East embankment, looking south
11/11/2022

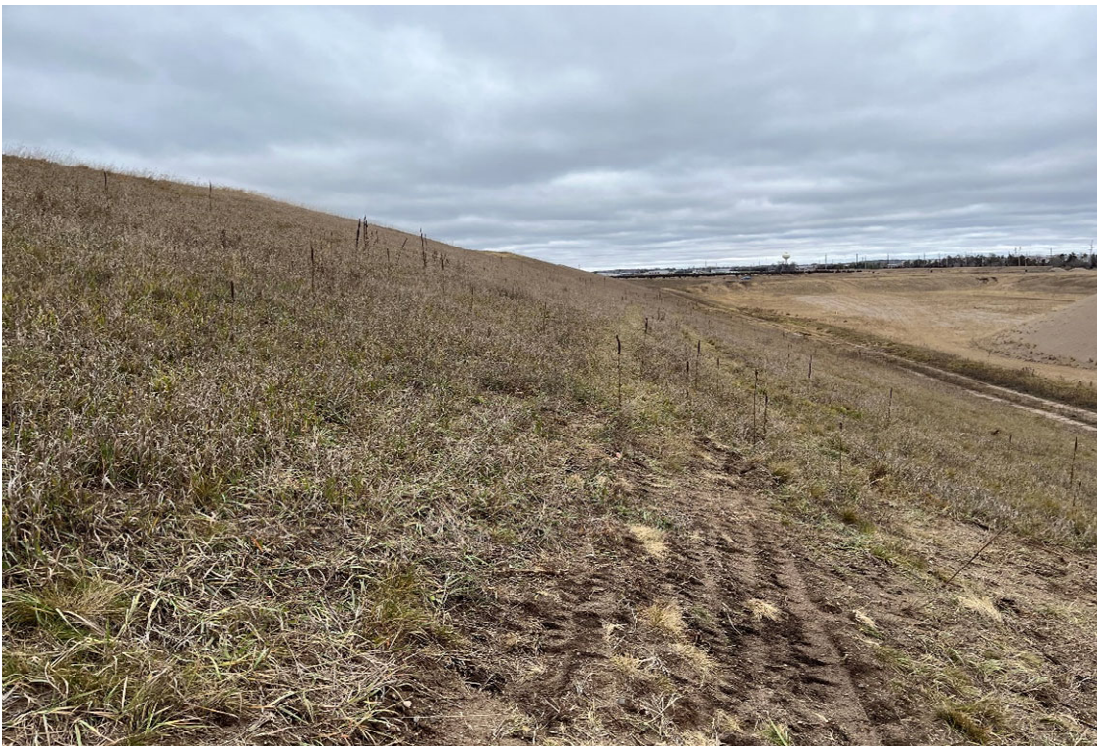
Photo 6	Mid-slope of east embankment, looking north.
11/11/2022

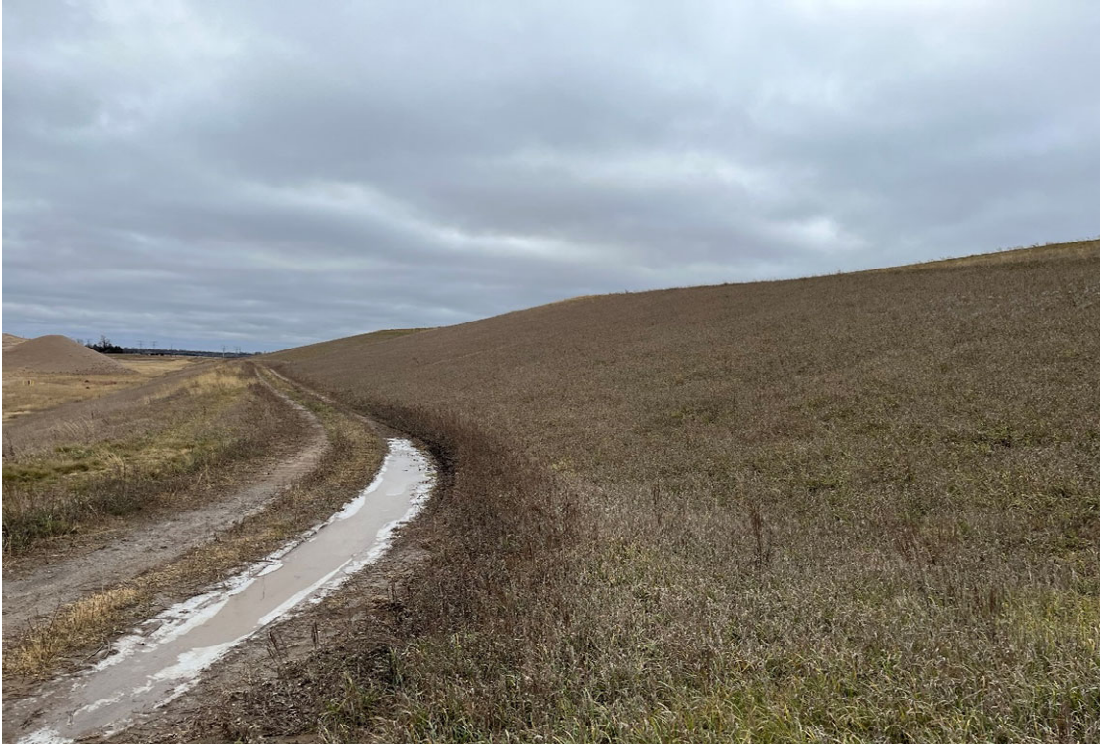
Photo 7	East embankment, looking south.
11/11/2022

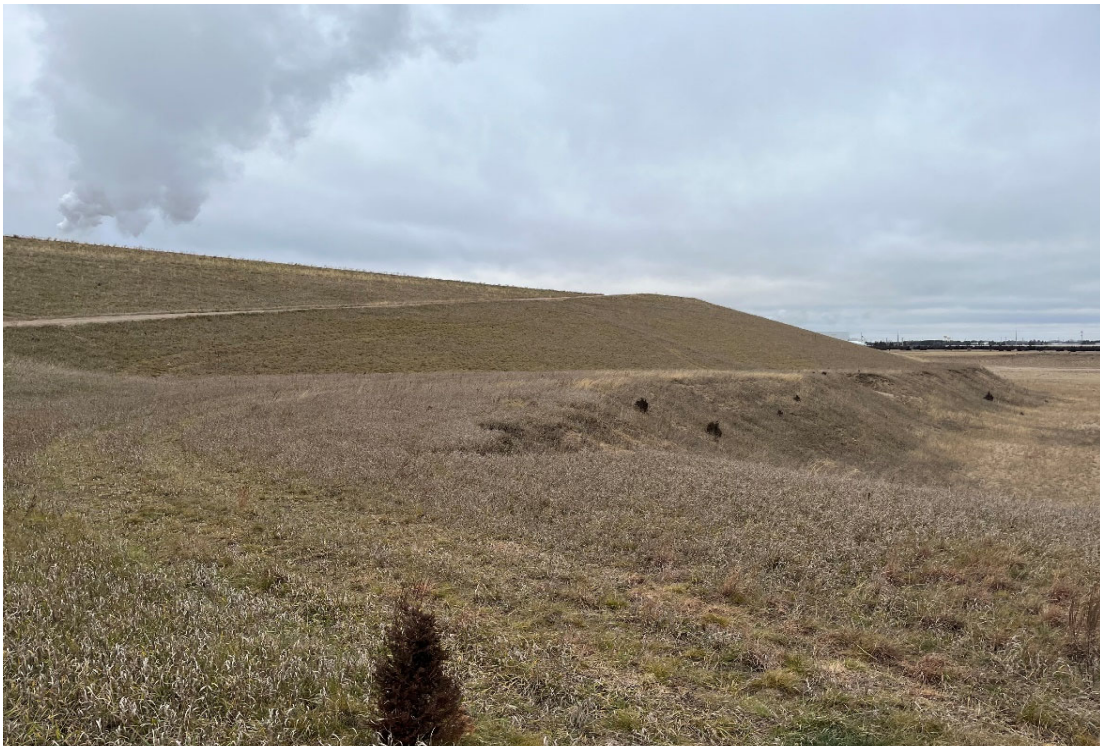
Photo 8	Exterior of north end of east embankment, looking northwest.
11/11/2022

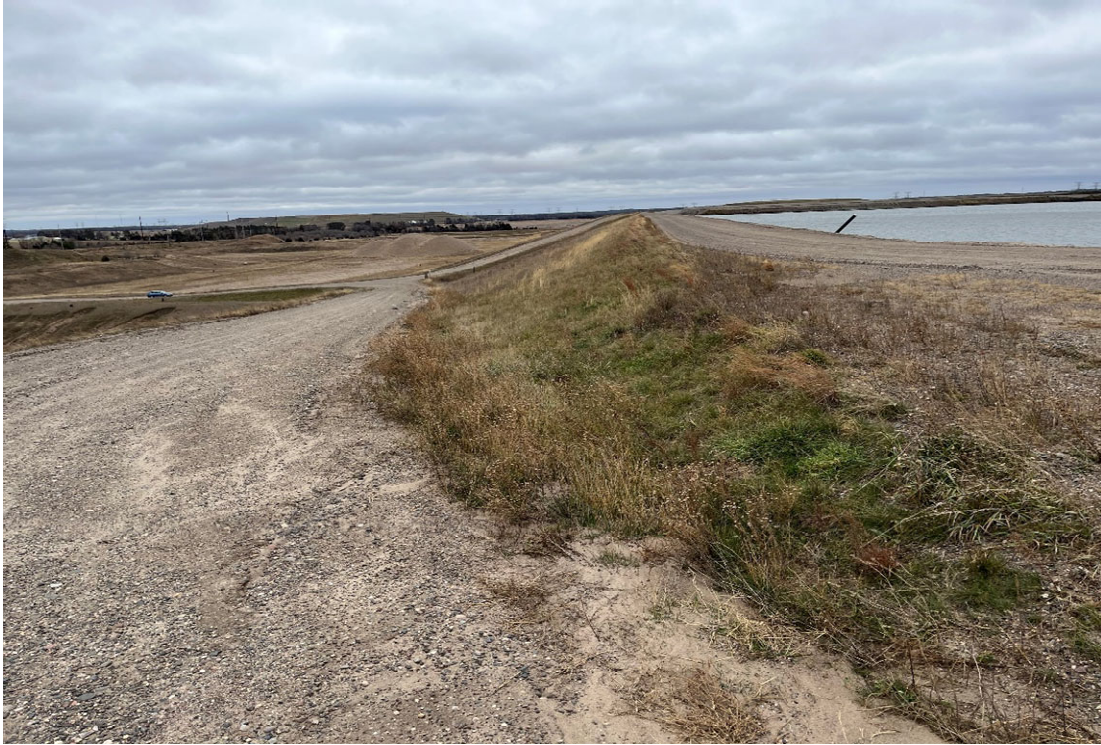
Photo 9	Top of northern access ramp on east embankment, looking south.
11/11/2022

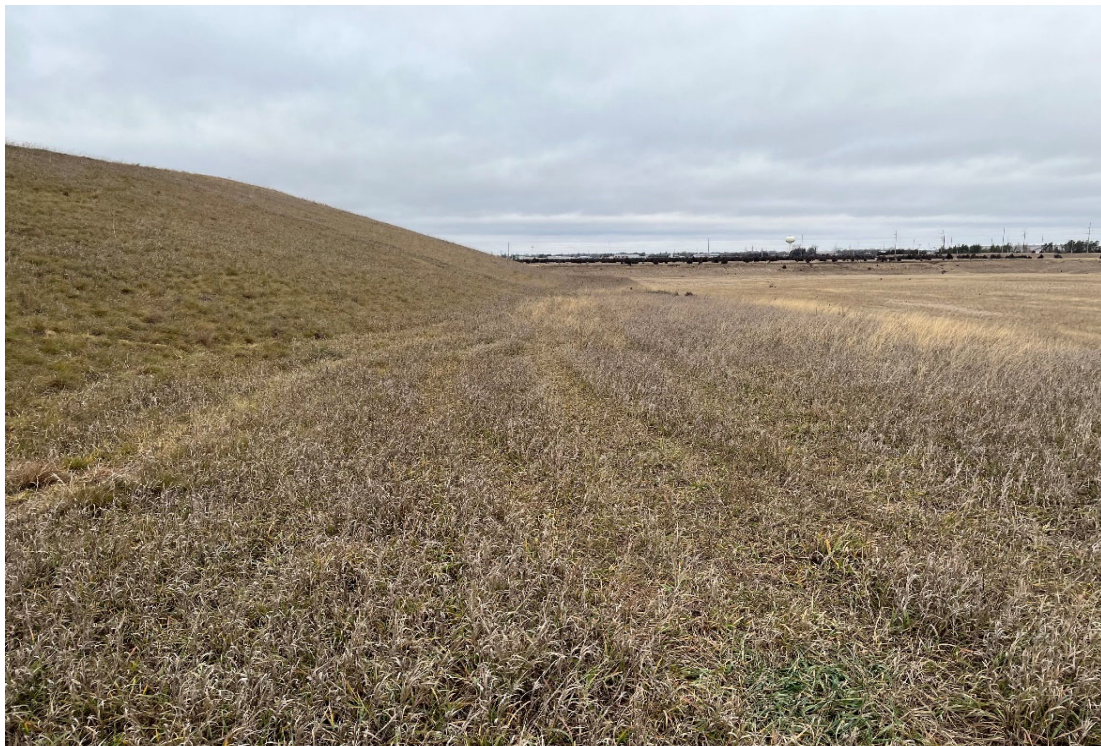
Photo 10	Northern end of east embankment, looking north.
11/11/2022

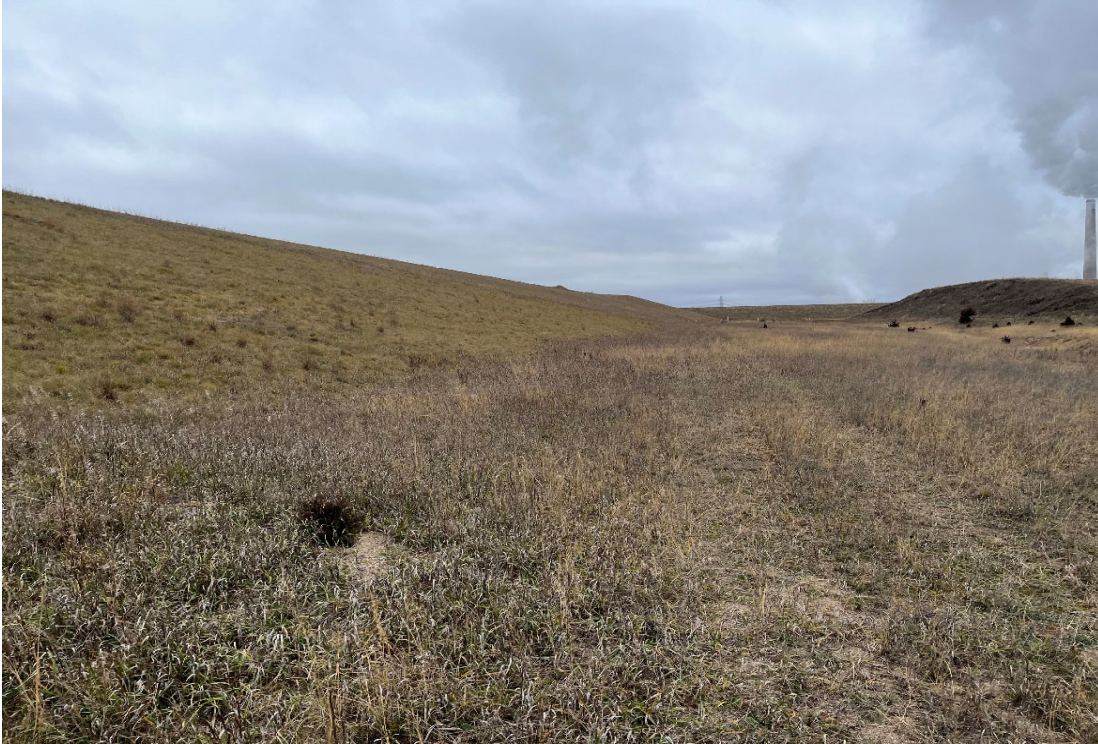
Photo 11	North embankment, looking west.
11/11/2022

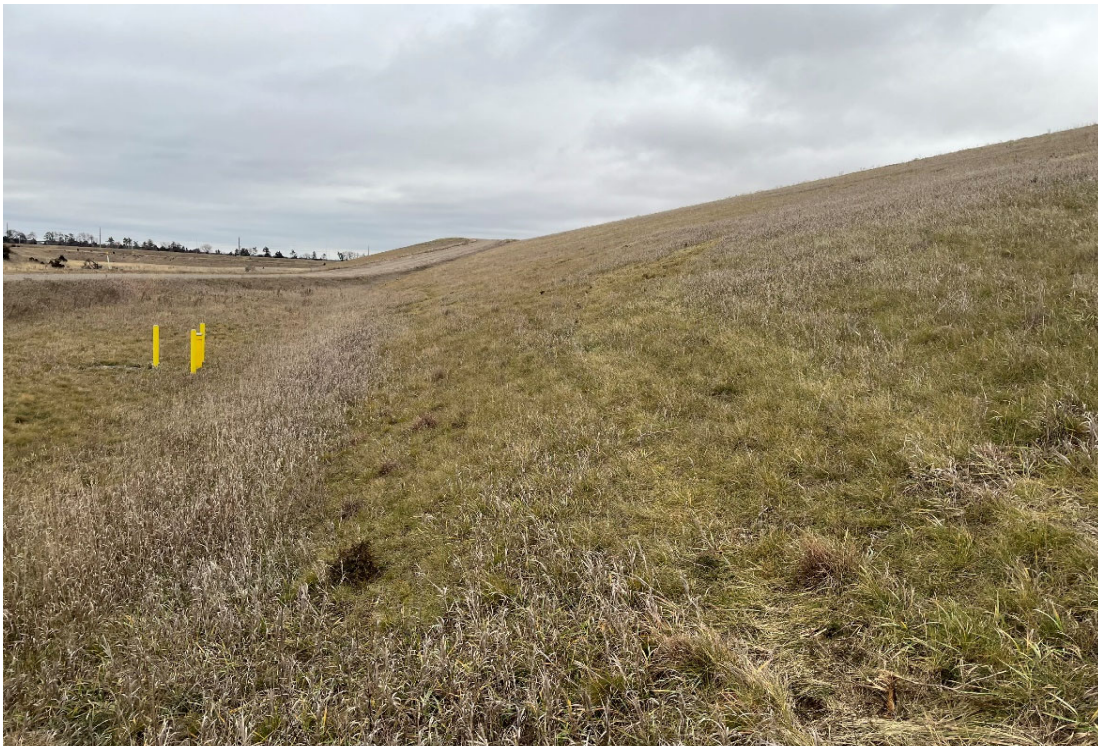
Photo 12	Outer slope of north embankment, looking east.
10/24/2019

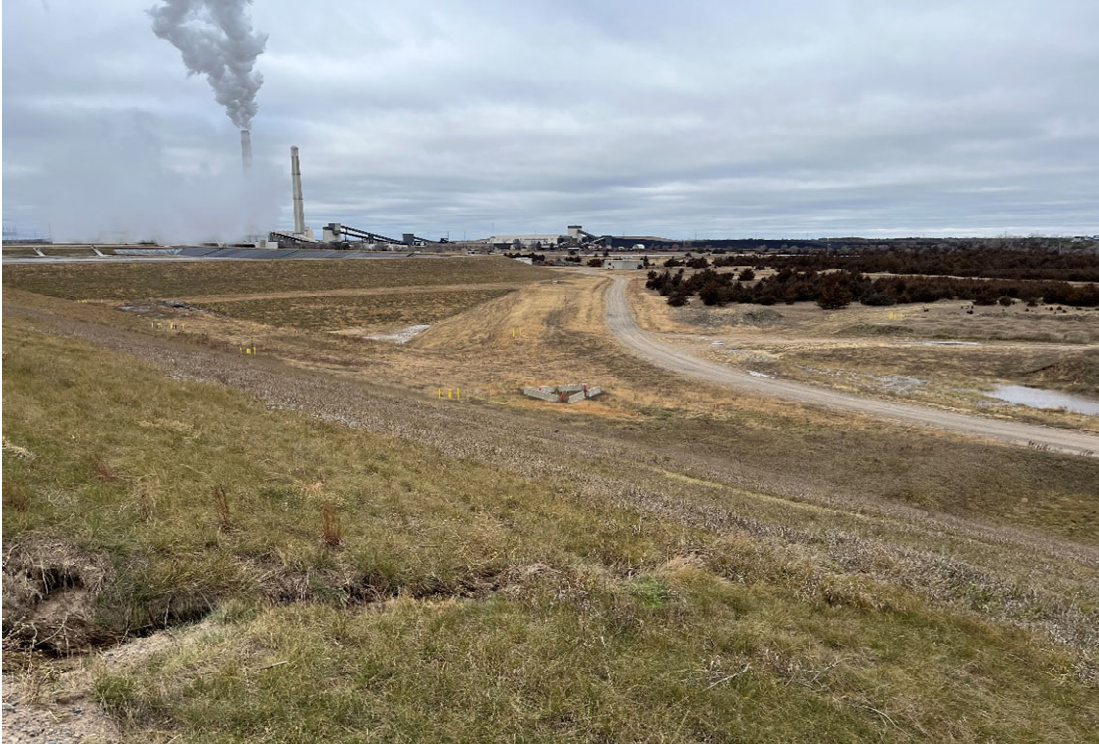
The discharge pipe corridor was inspected for signs of a leakage, such as saturated areas or sinkholes. No signs of leakage were observed along the pipe corridor or in the vault located north of Pond 3.

Photo 13	Pond 3 discharge pipe alignment, looking northwest
11/11/2022

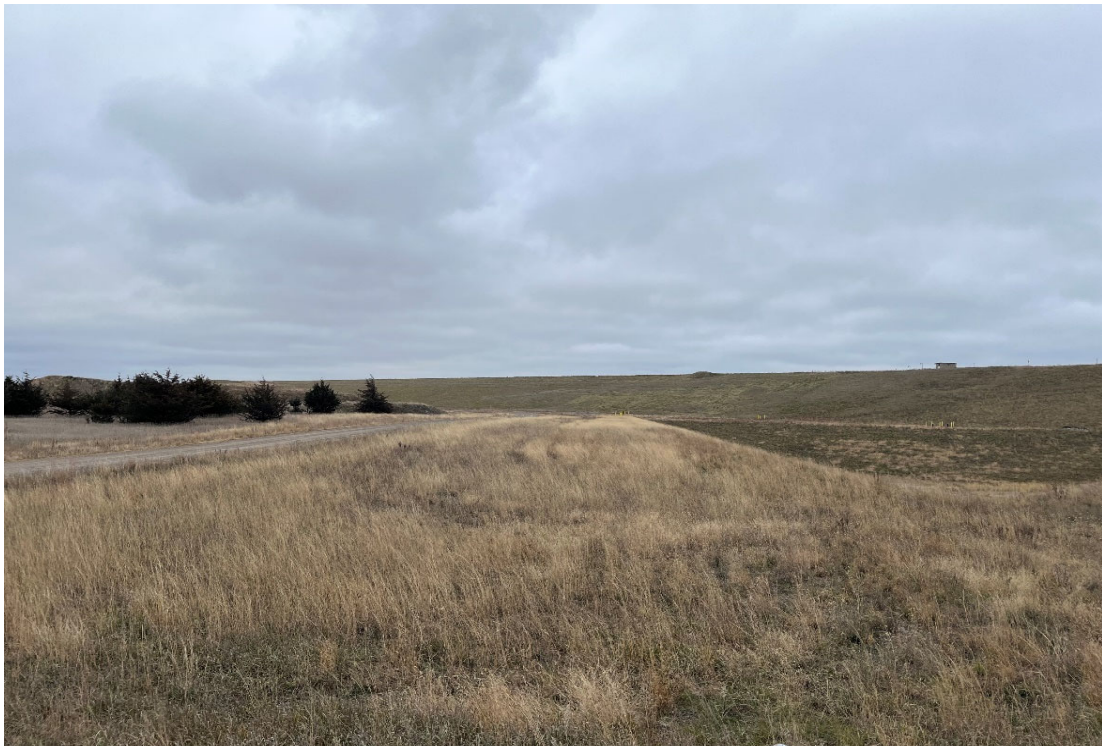
Photo 14	Pond 3 discharge pipe corridor, looking southeast.
11/11/2022

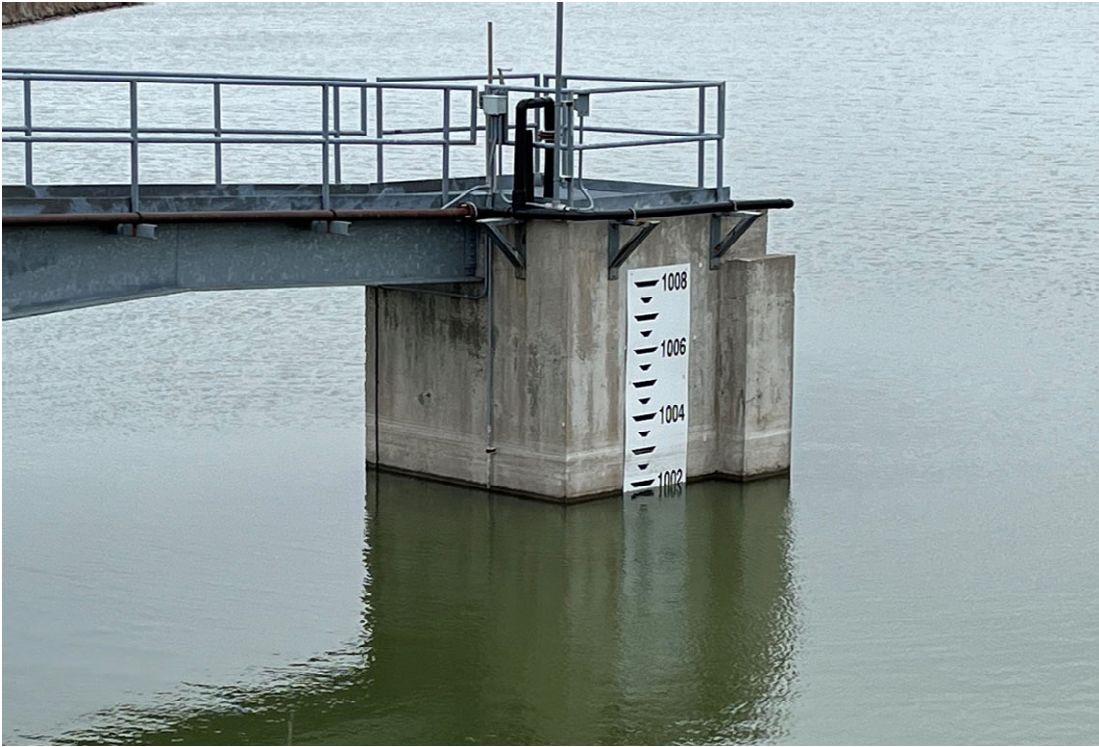
The only instrumentation on Pond 3 is a staff gauge used to determine water surface elevation in the north half of Pond 3, located on the west side of the discharge structure. The recordings of the staff gauge are discussed in Section iii. No instrumentation is needed for dike stability.

The Pond water level varied throughout the year ranging from a minimum elevation of 996.5 feet mean sea level (MSL) to a maximum elevation of 1003.6 feet MSL. The water level was at an elevation of 1001.8 feet MSL during the 2022 inspection.

Photo 15	Pond 3 staff gauge, reading an elevation of 1001.8 feet (mean sea level).
11/11/2022

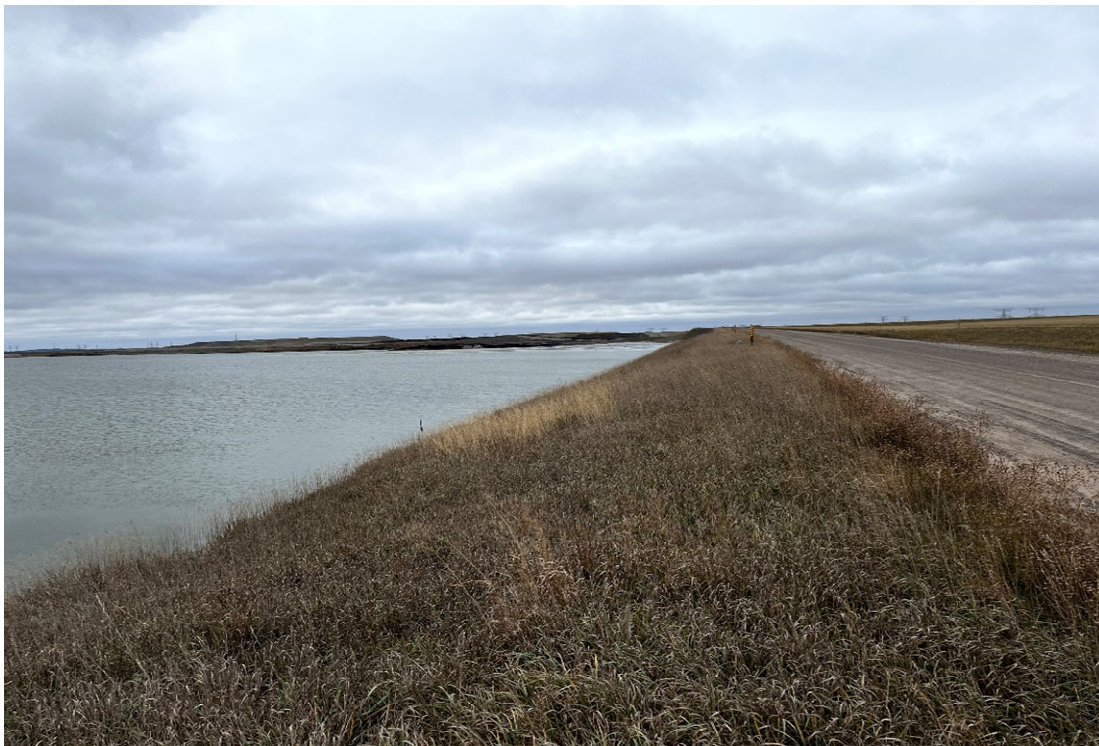
Photo 16	Interior of west embankment, looking south.
11/11/2022

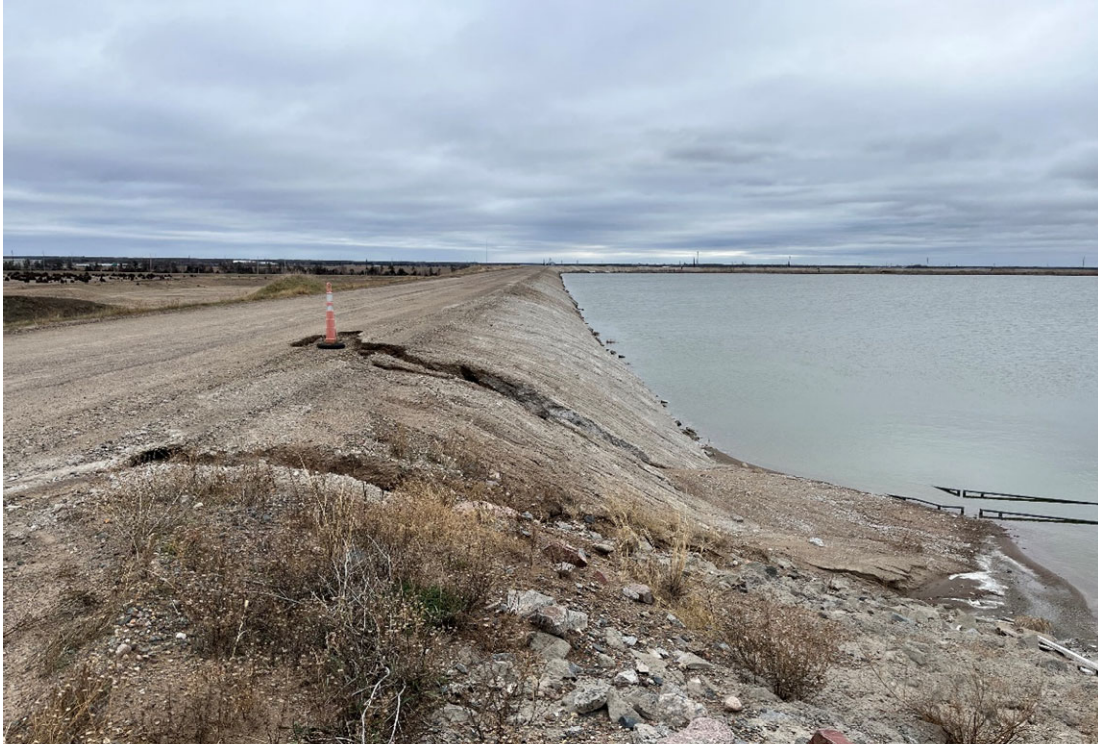
Photo 17	Interior of north embankment, looking east.
11/11/2022

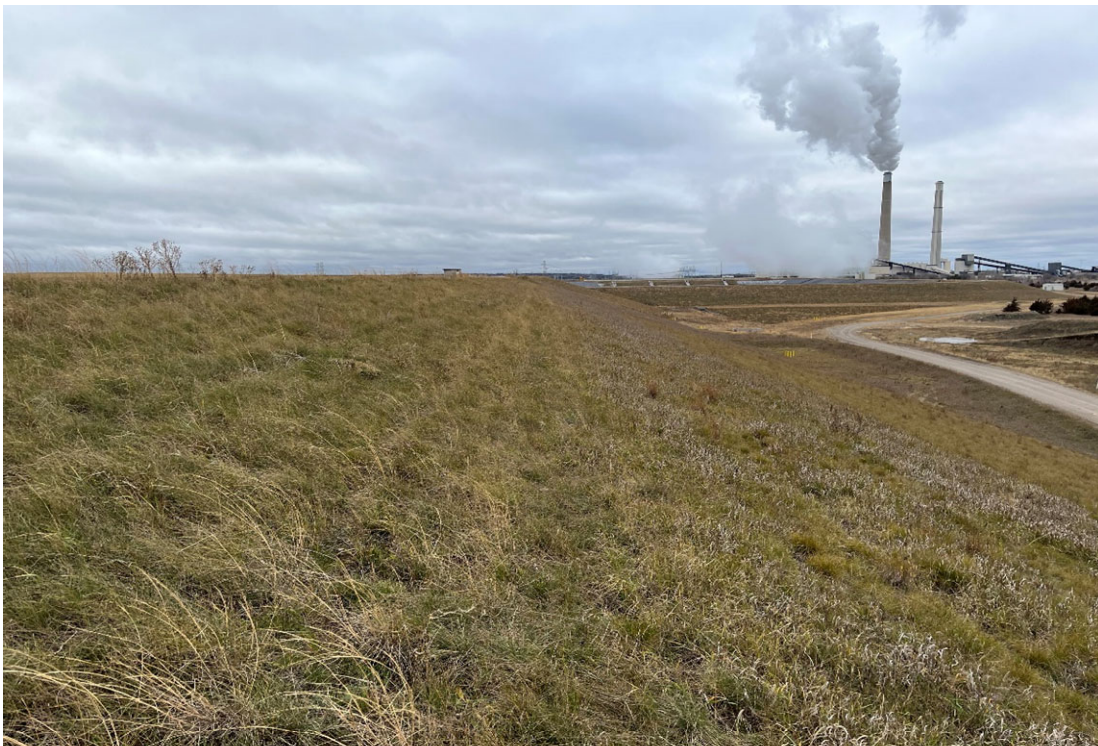
Photo 18	Top of outer slope of north embankment, looking west.
11/11/2022

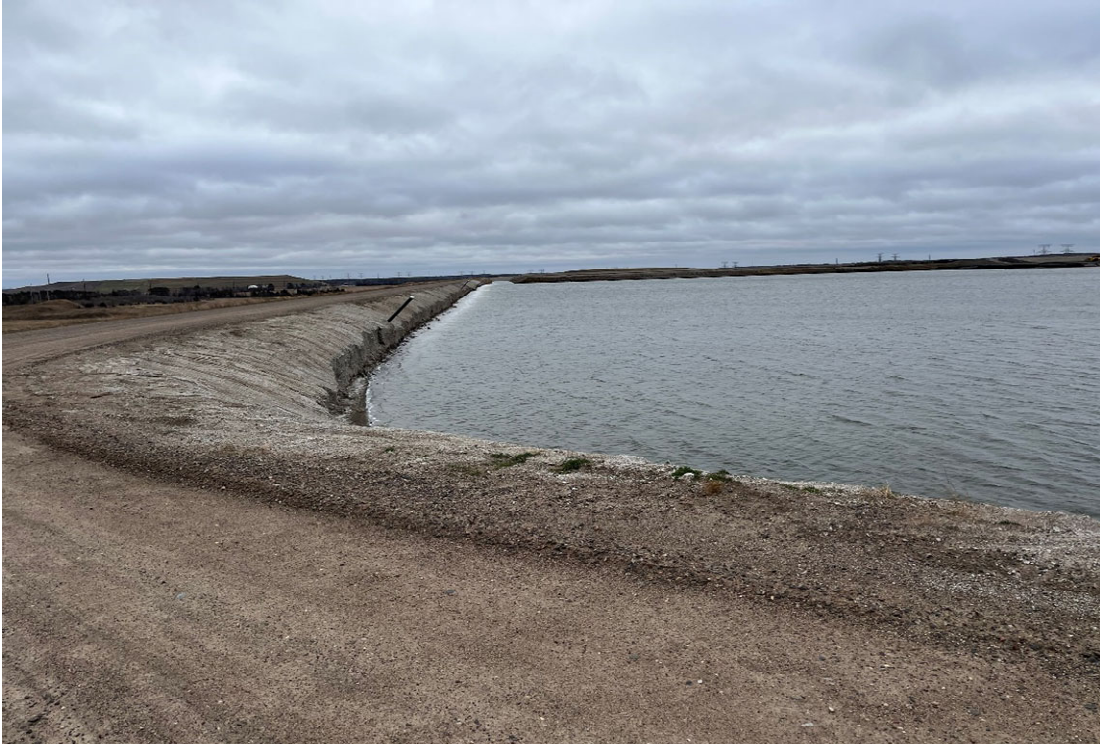
Photo 19	Interior of east embankment, looking south.
11/11/2022

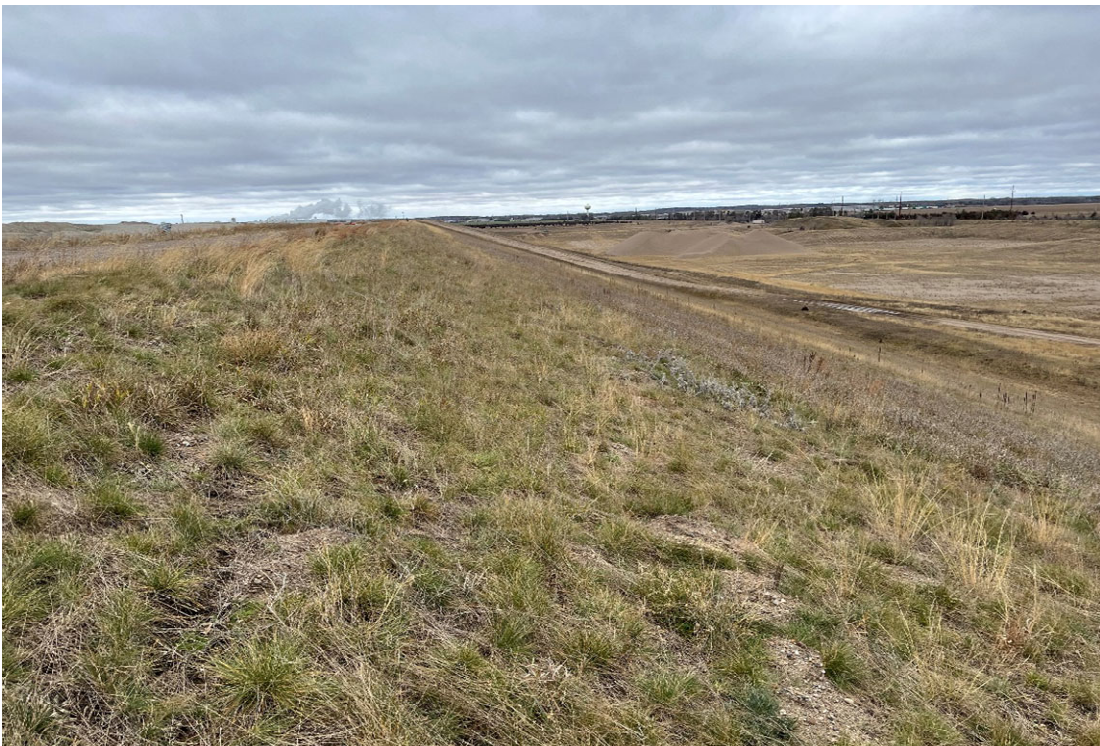
Photo 20	Top of east embankment, looking north.
11/11/2022

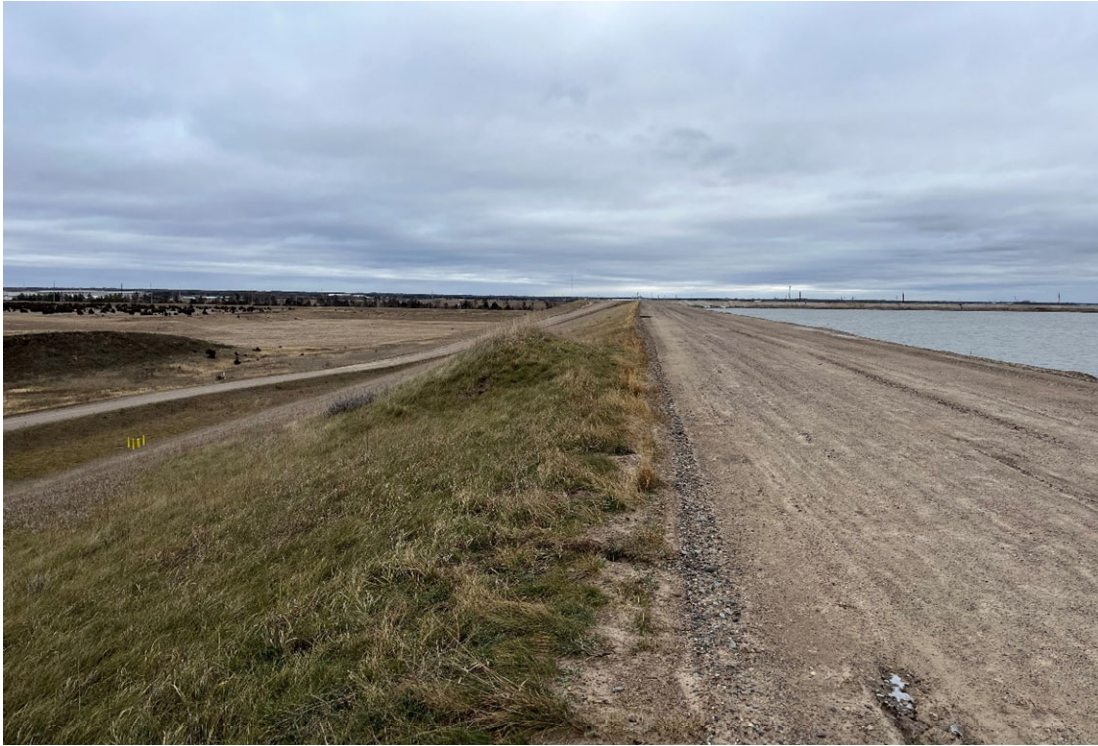
Photo 21	Top of east embankment, looking south.
11/11/2022

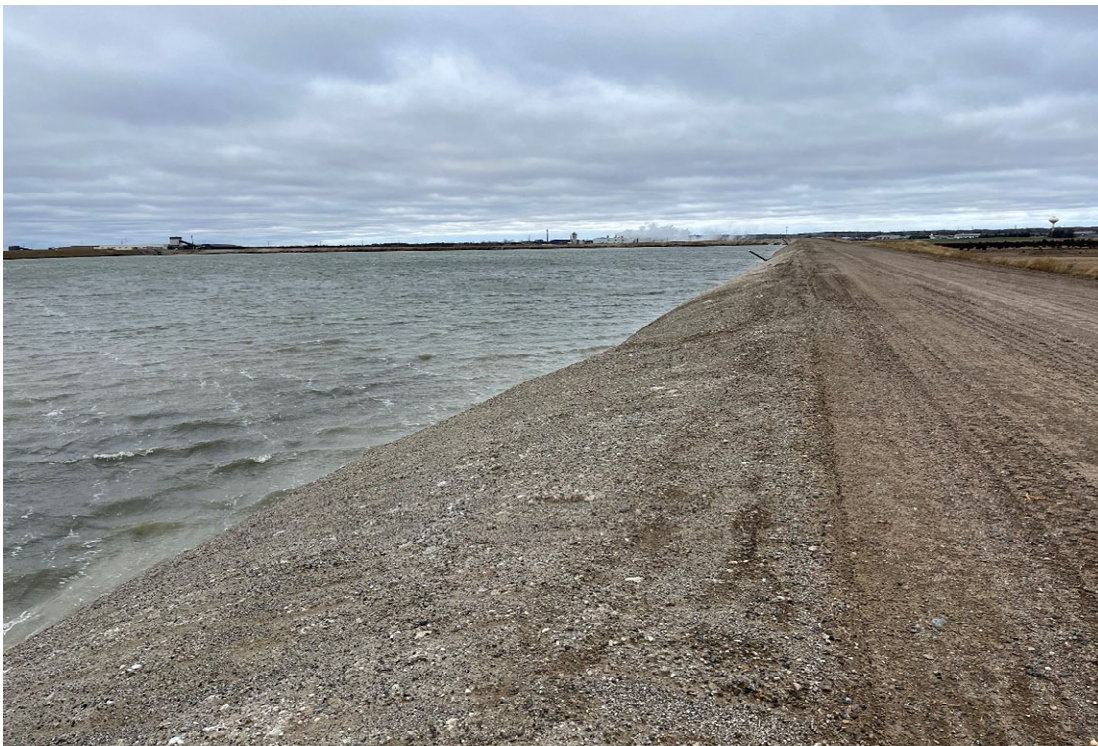
Photo 22	Interior of east embankment, looking north.
11/11/2022

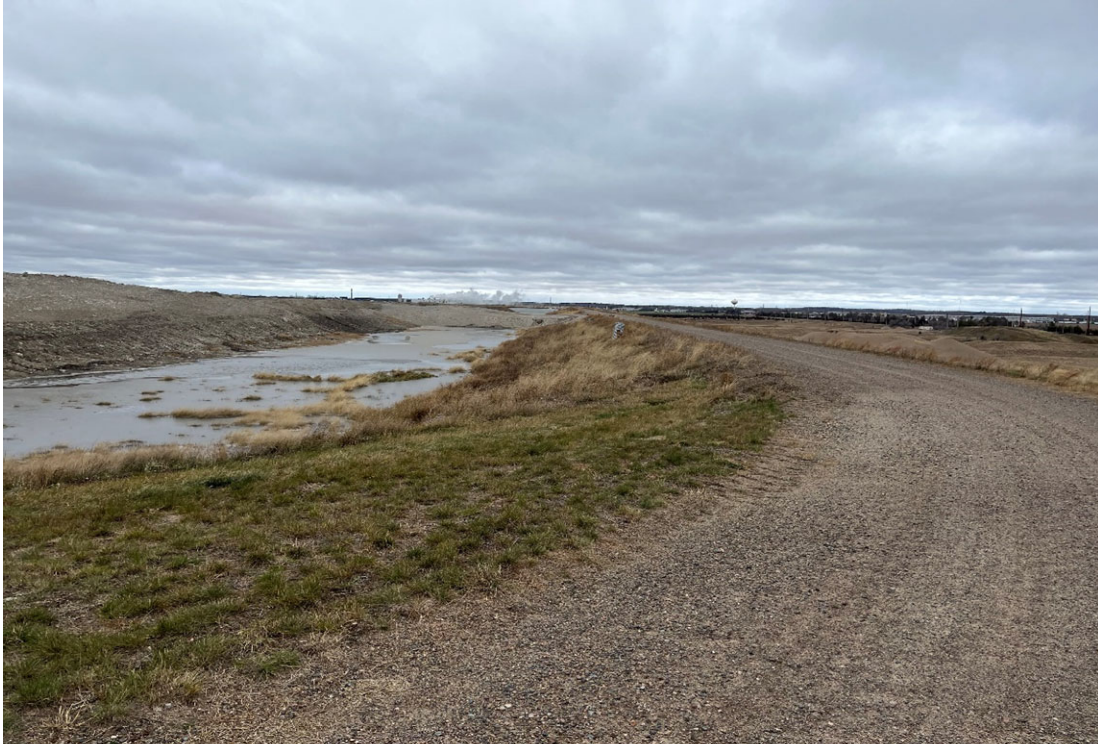
Photo 23	Left: CCR interior dike. Right: Interior of east embankment, looking north.
11/11/2022

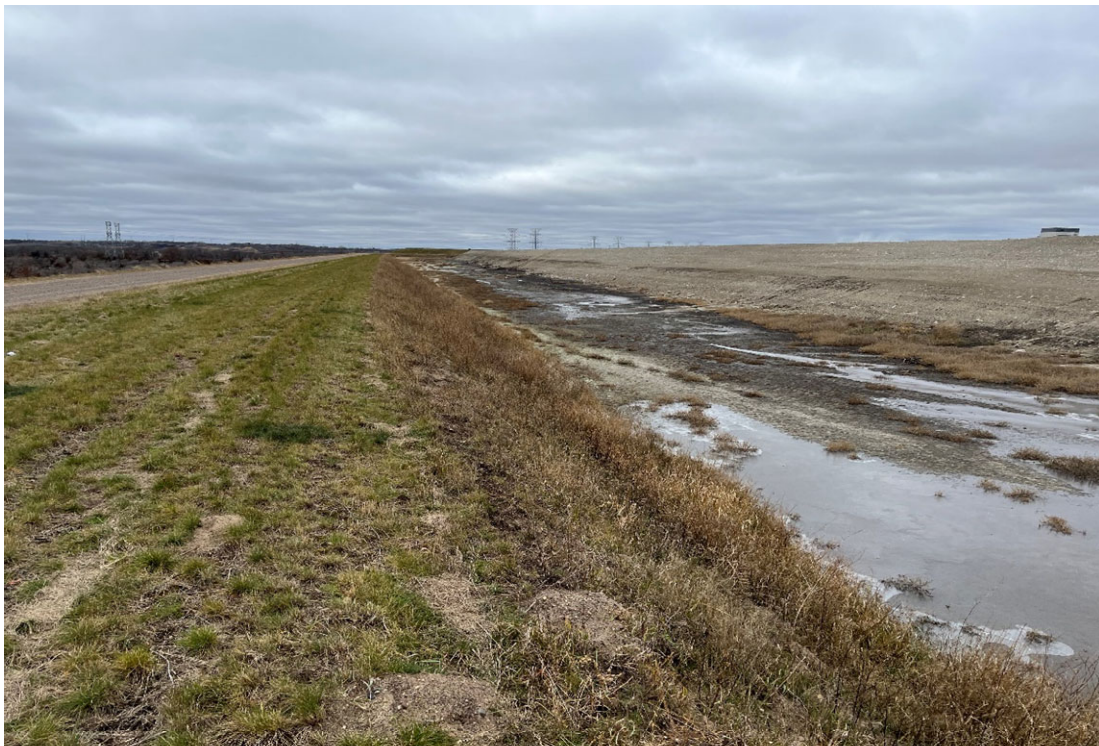
Photo 24	Left: Interior of south embankment. Right: CCR interior dike, looking west.
11/11/2022

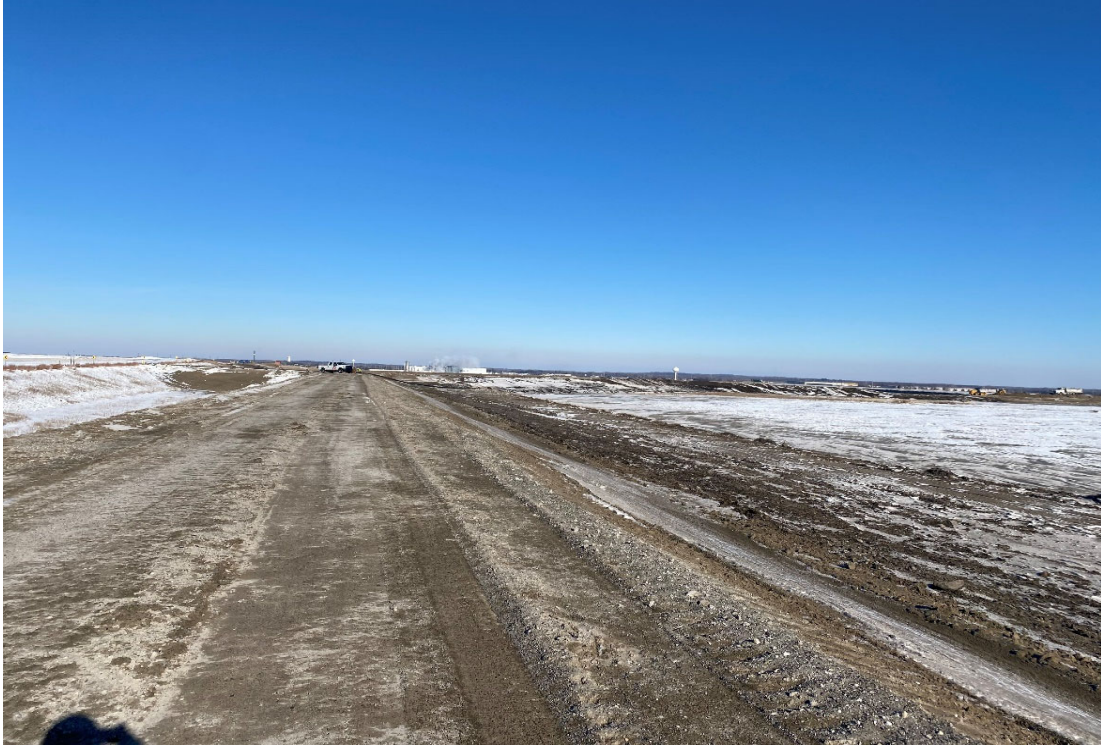
Photo 25	Interior of west embankment, looking north.
11/21/2022

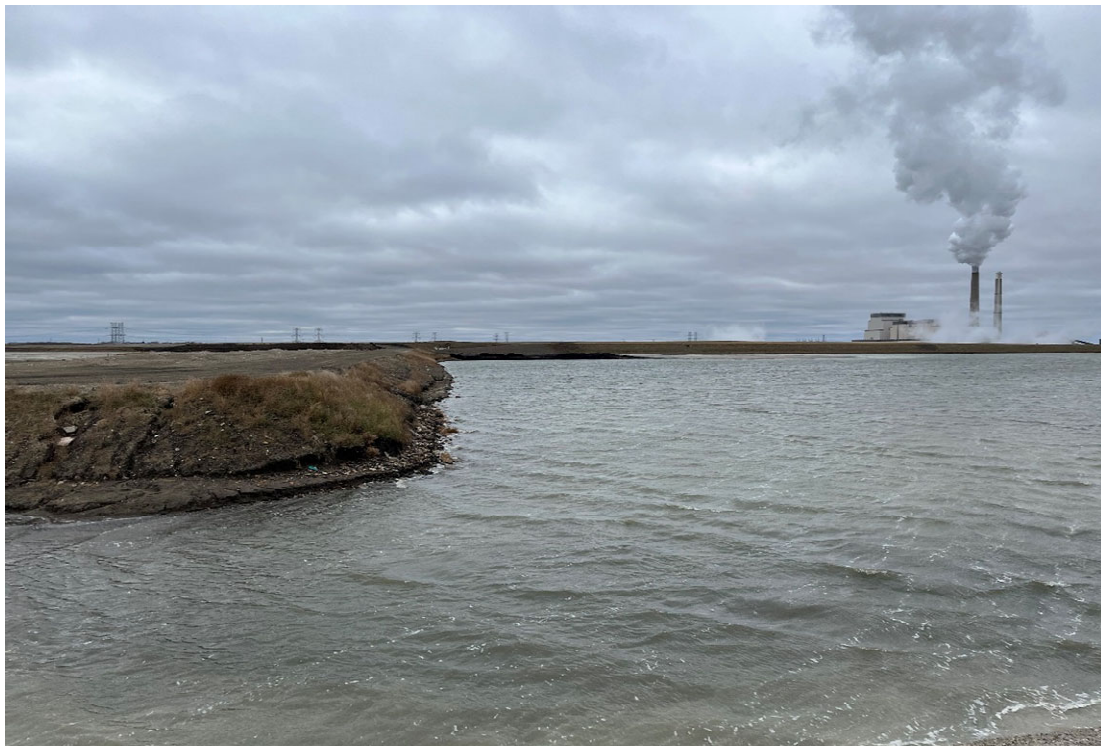
Photo 26	Interior pond dike, looking west.
11/11/2022
