January 4, 2021

Xcel Energy, Inc.
Sherburne County Generating Station
13999 Industrial Blvd.
Becker, MN, 55308

Re: 2020 Annual Inspection of Bottom Ash Pond

Bottom Ash Pond Annual Inspection - 2020

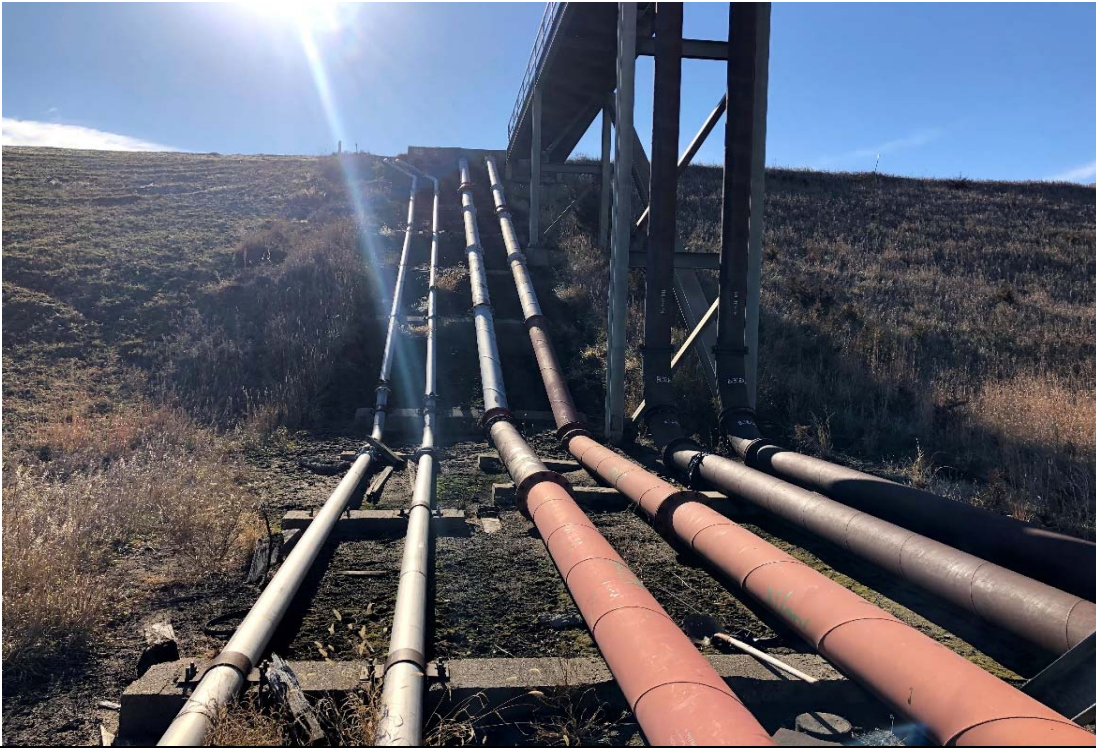
Photo 1	Bottom ash and scrubber pipes, looking south.
11/19/2020

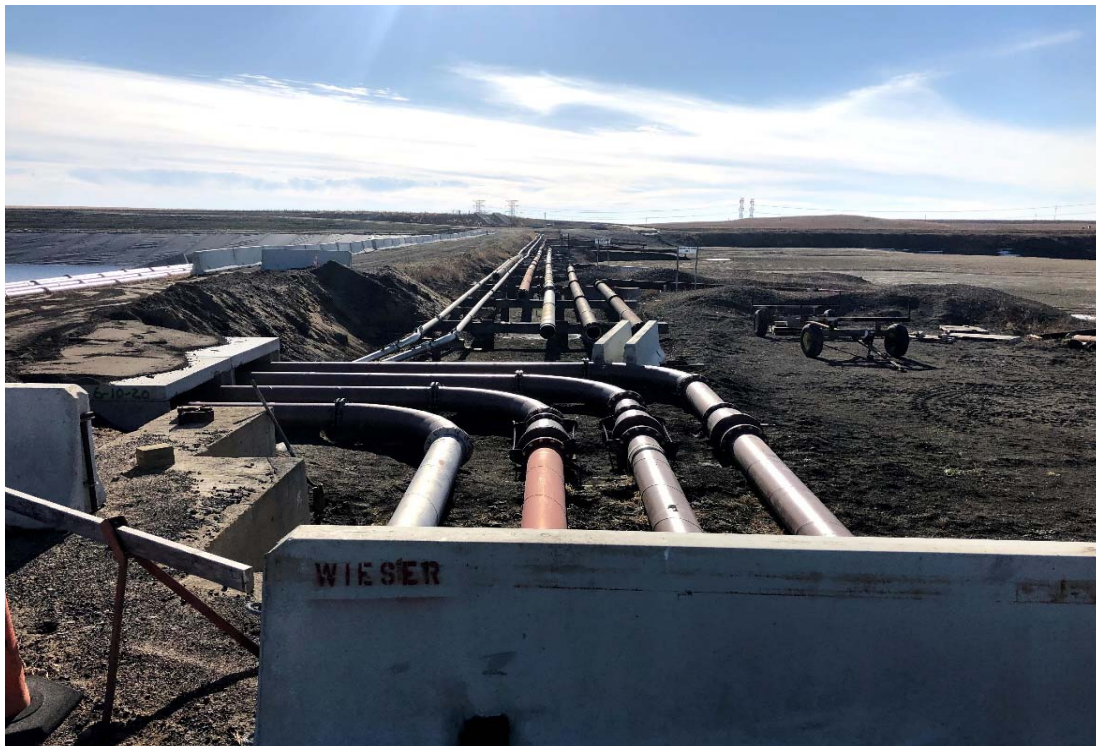
Photo 2	Interior of east embankment, looking south. Bottom ash pipe routed to new pond (Bottom Ash Pond 2).
11/19/2020

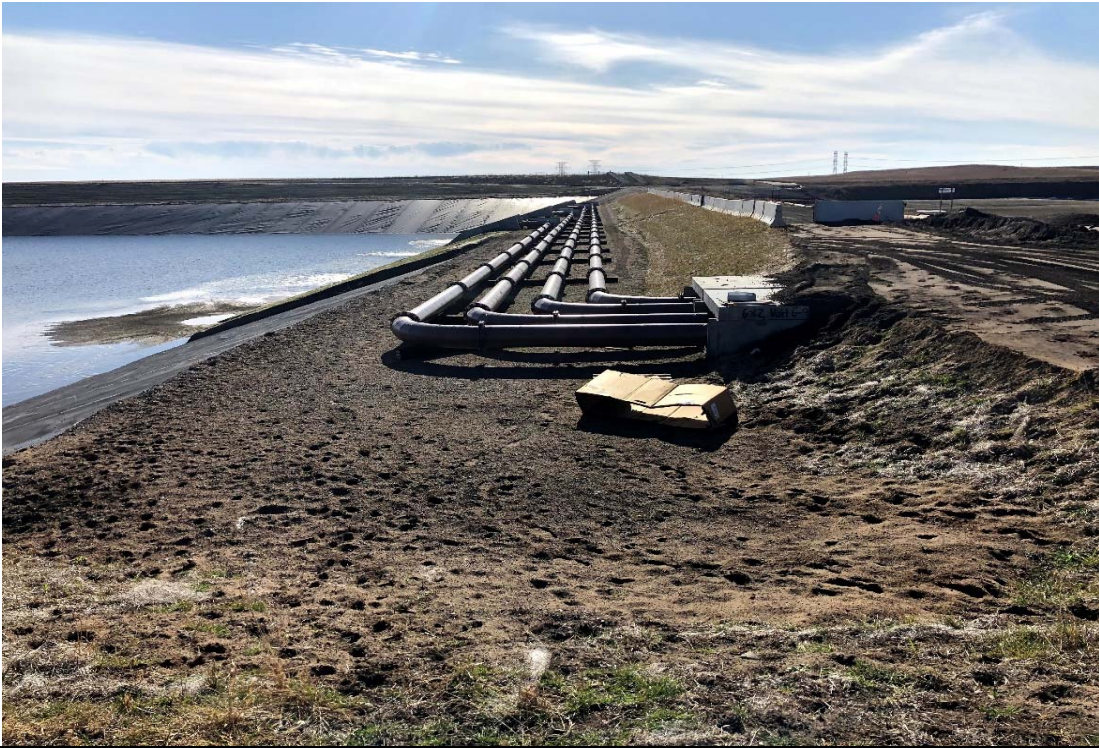
Photo 3	Exterior of east embankment (also shown: New Bottom Ash Pond),
11/19/2020	looking south.

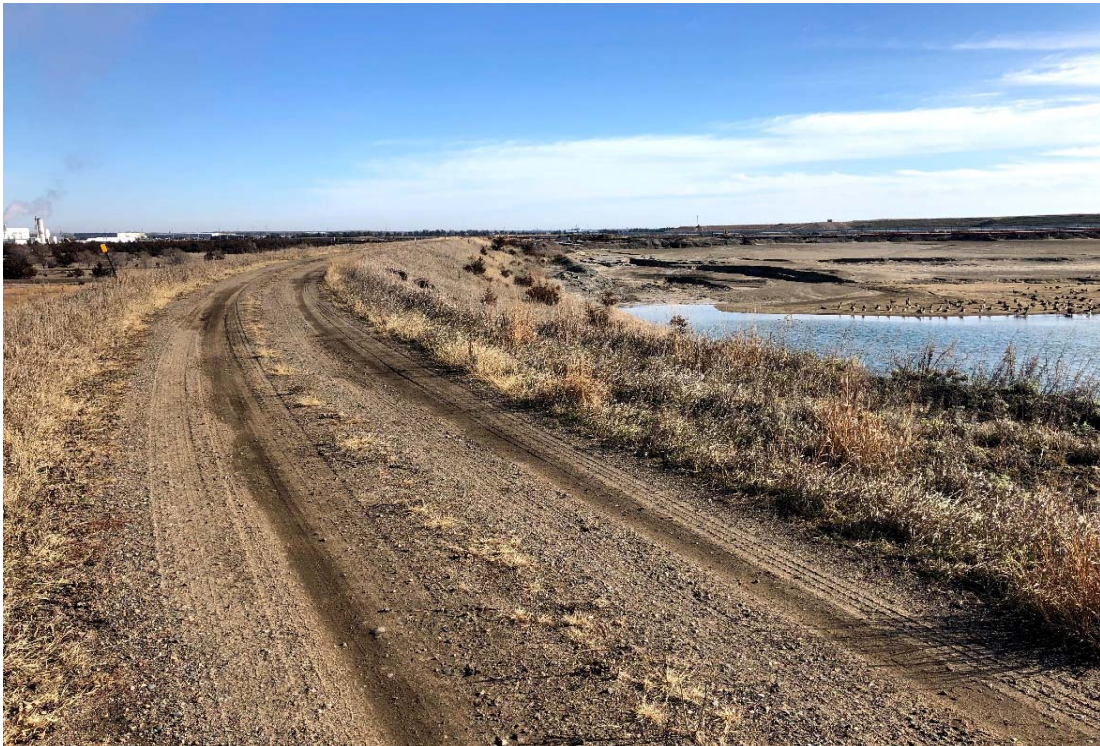
Photo 4	Top of north embankment, looking east.
11/19/2020

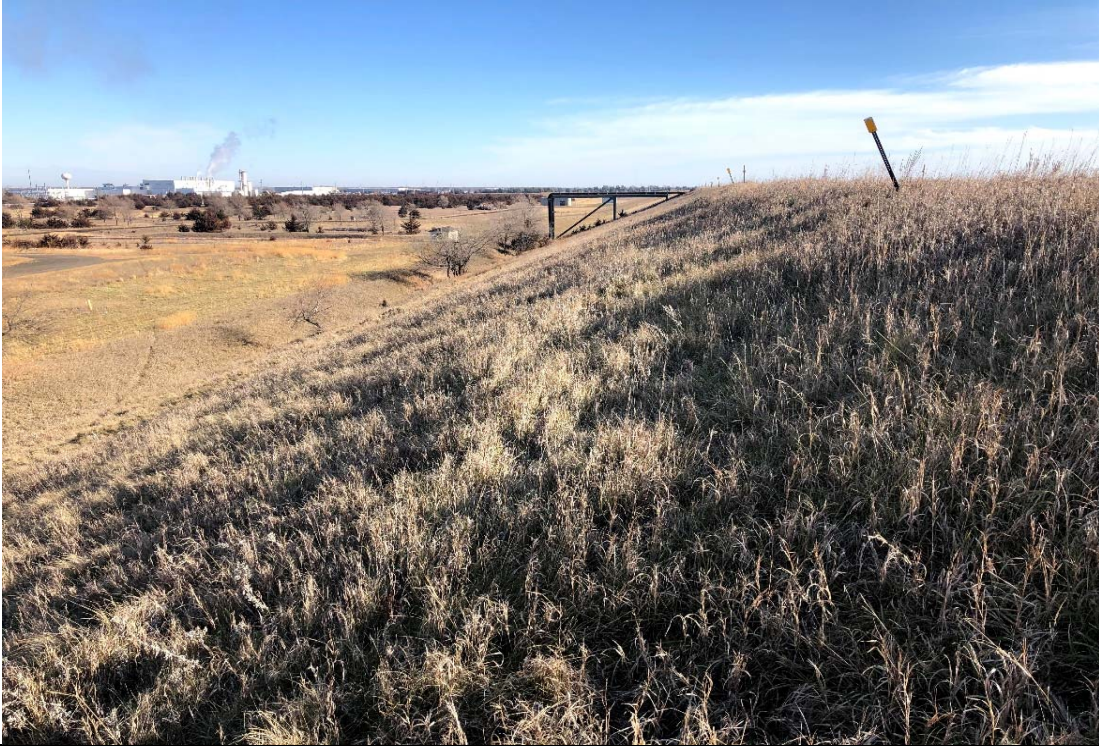
Photo 5	Exterior of north embankment, looking east.
11/19/2020

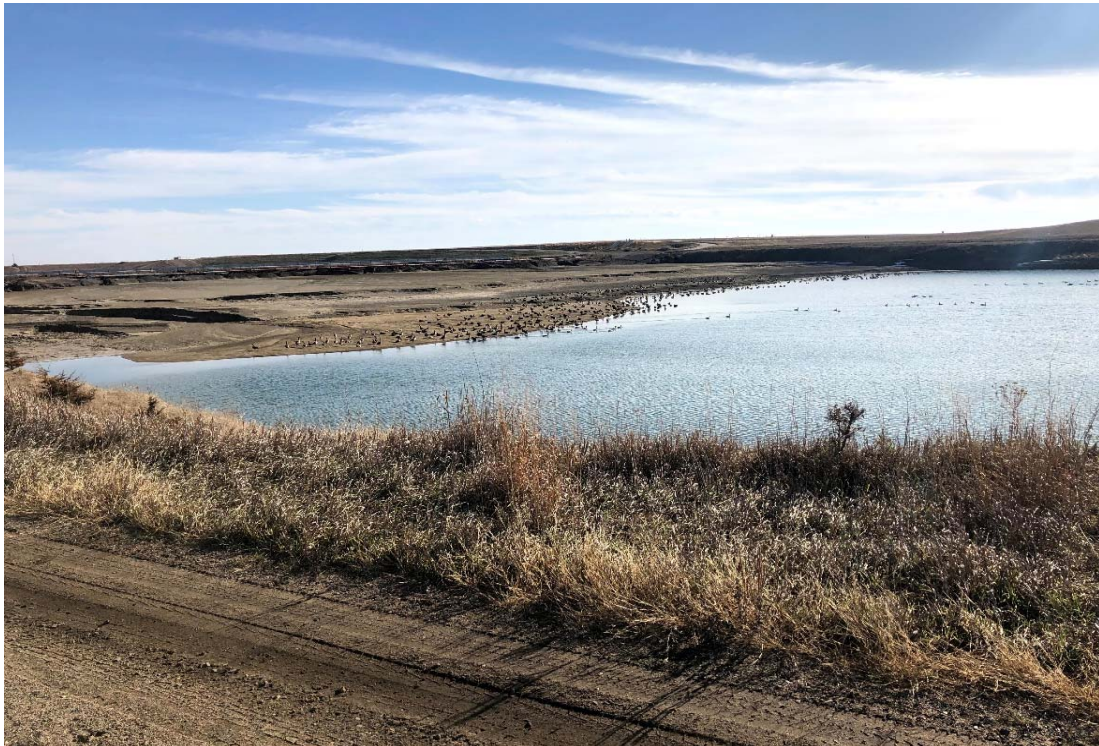
Photo 6	Interior of pond, looking southeast.
11/19/2020

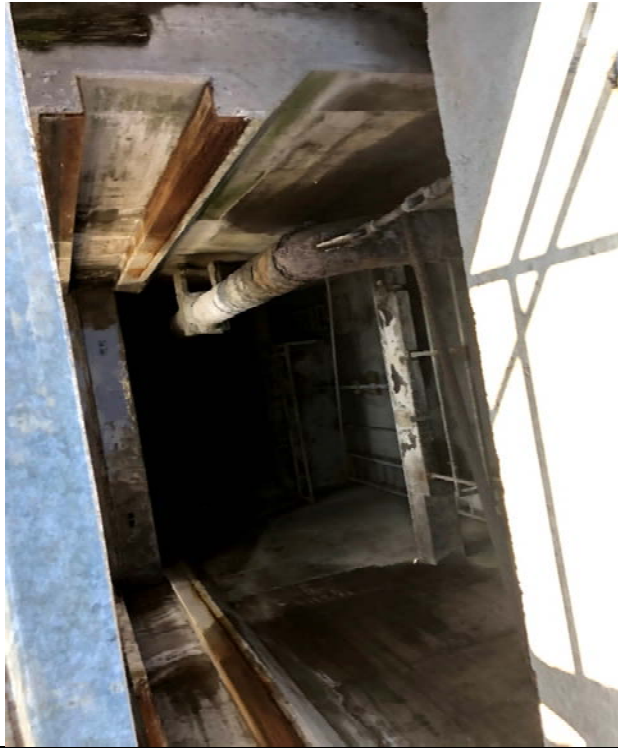
Photo 7	Interior of discharge structure.
11/19/2020

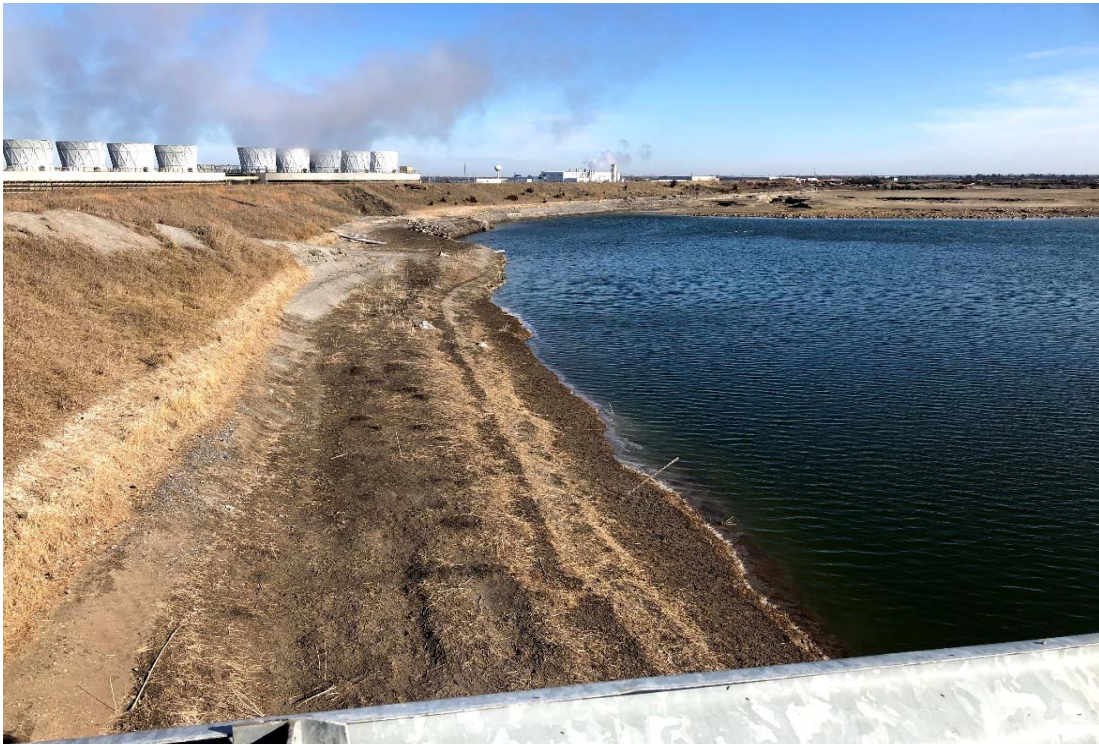
Photo 8	Pond interior, looking northeast.
11/19/2020

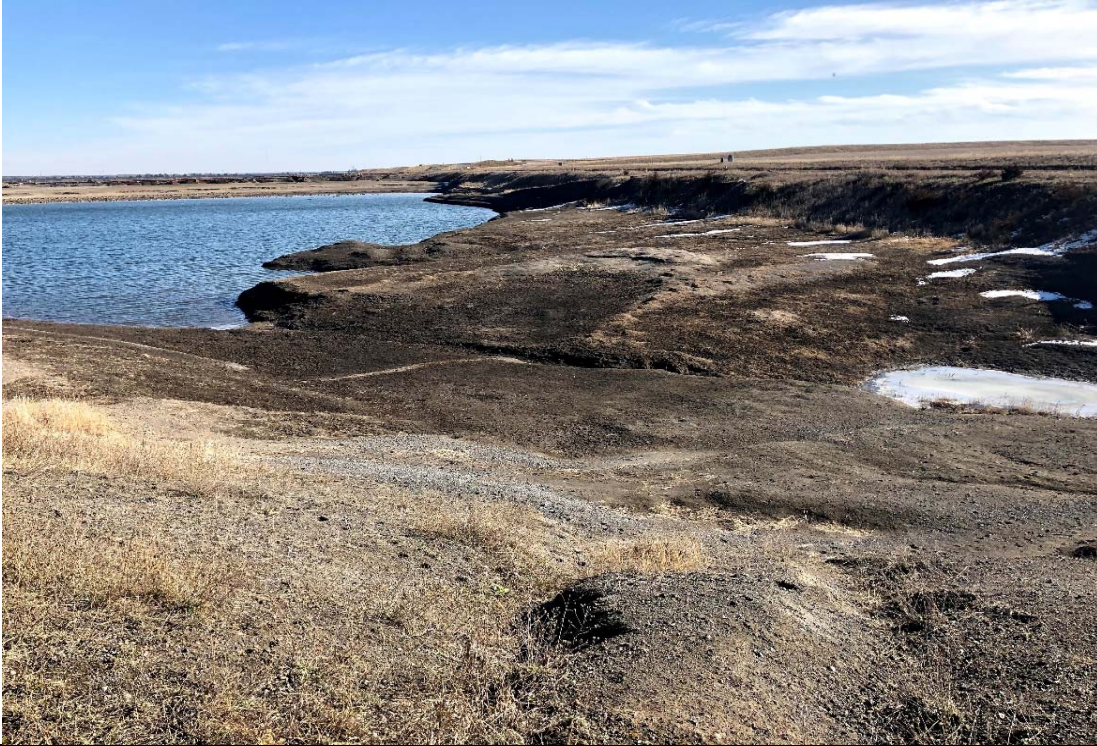
Photo 9	Interior of south embankment, looking east.
11/19/2020

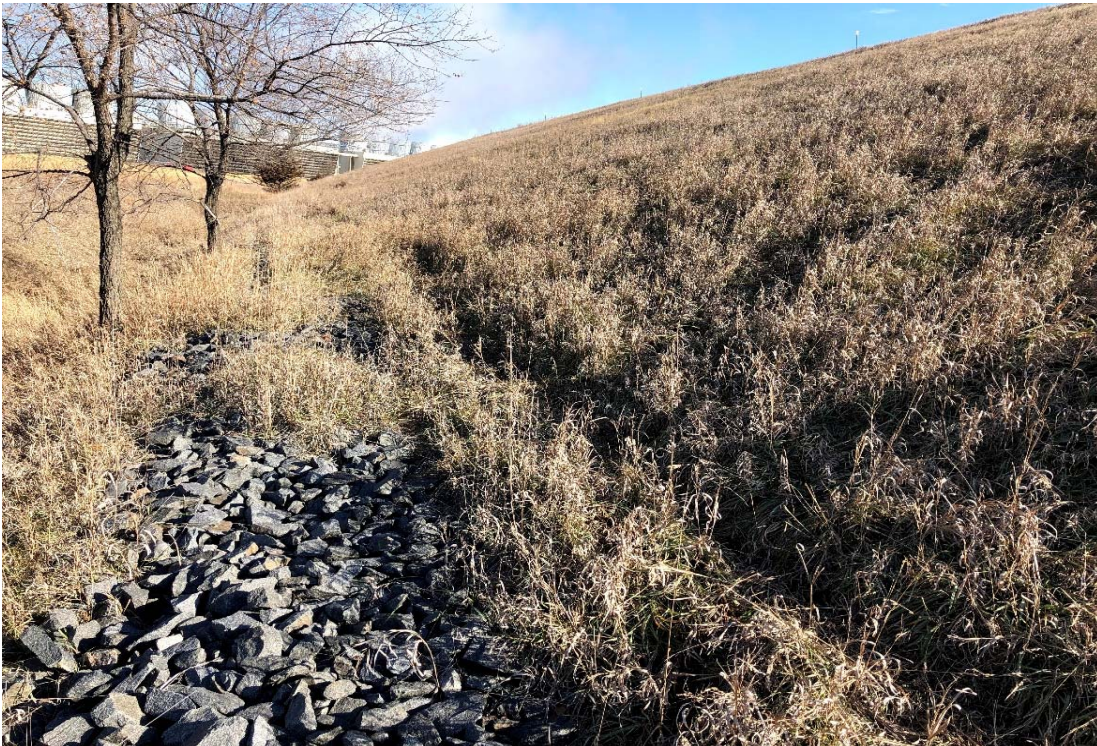
Photo 10	Mid-slope exterior of northwest embankment with toe drain, looking northeast.
11/19/2020

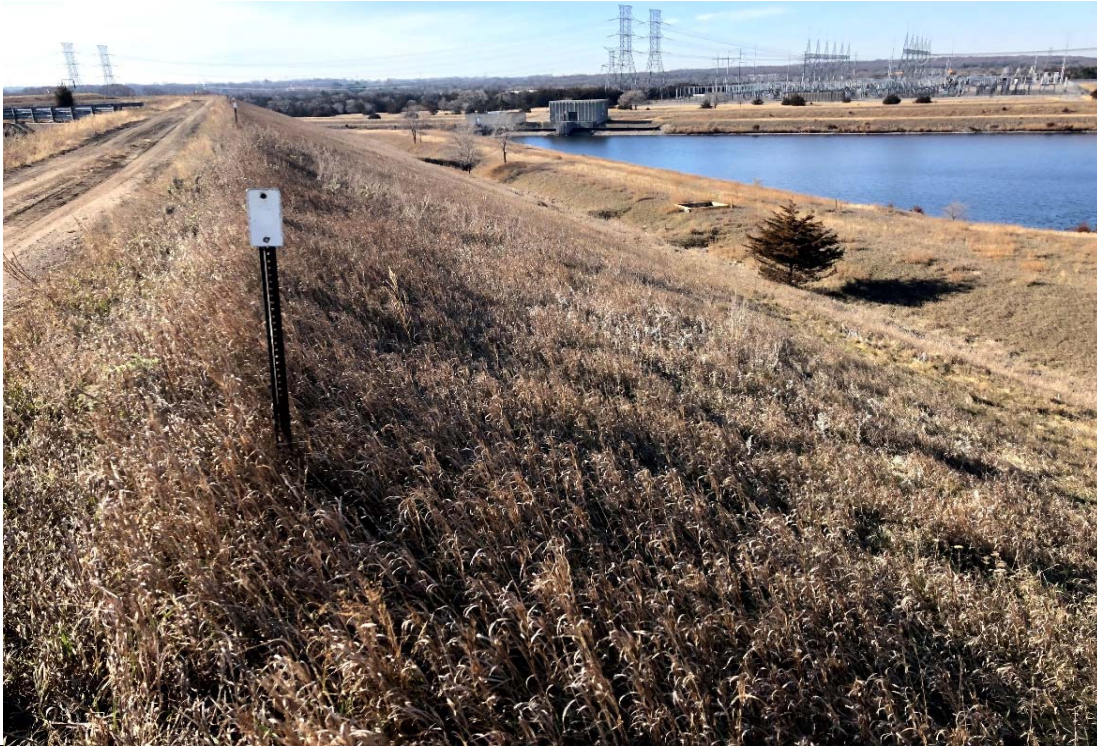
Photo 11	Exterior of northwest embankment, looking southwest.
11/19/2020

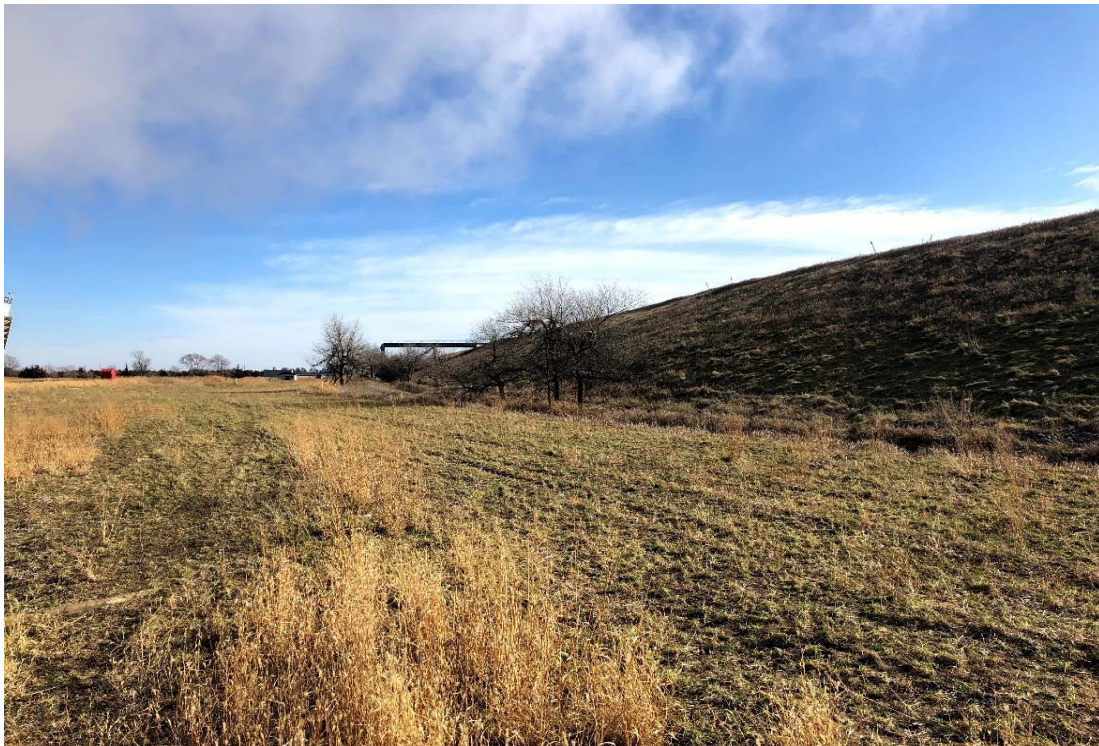
Photo 12	Bottom of north embankment, looking east.
11/19/2020

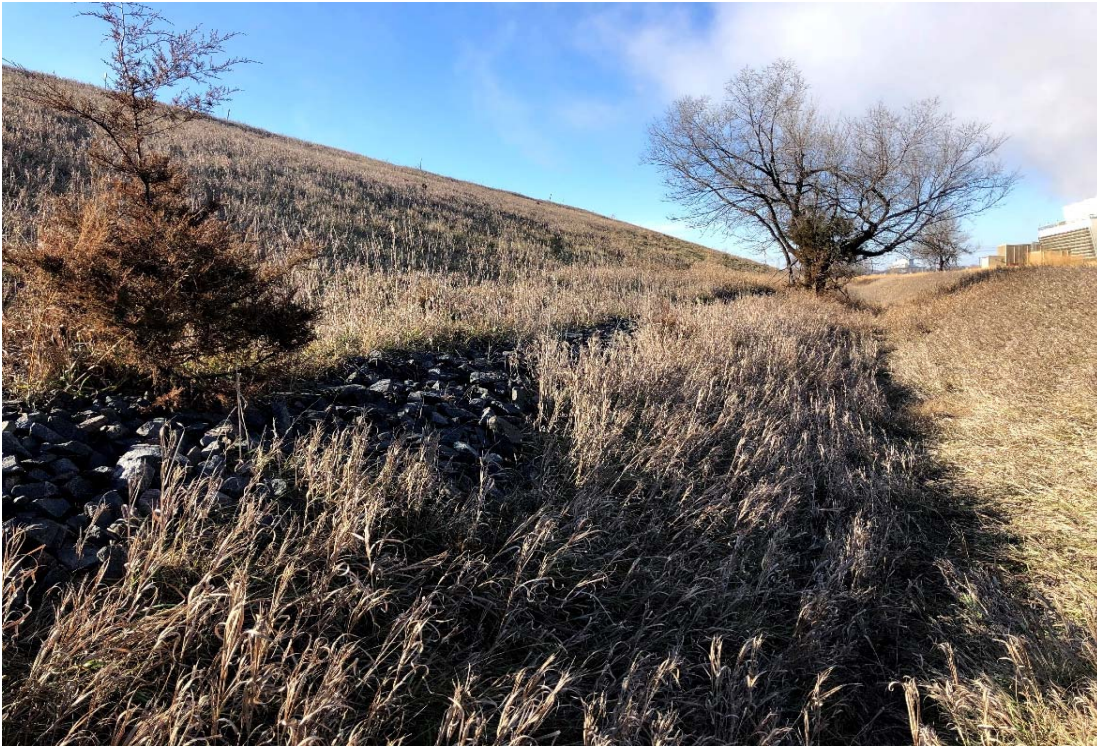
Photo 13	Toe drain of north slope, looking west.
11/19/2020
