Xcel Energy, Inc.  
Sherburne County Generating Station  
13999 Industrial Blvd.  
Becker, MN, 55308

**Re: 2020 Annual Inspection of Scrubber Solids Pond No. 3**

## Pond 3 Annual Inspection - 2020

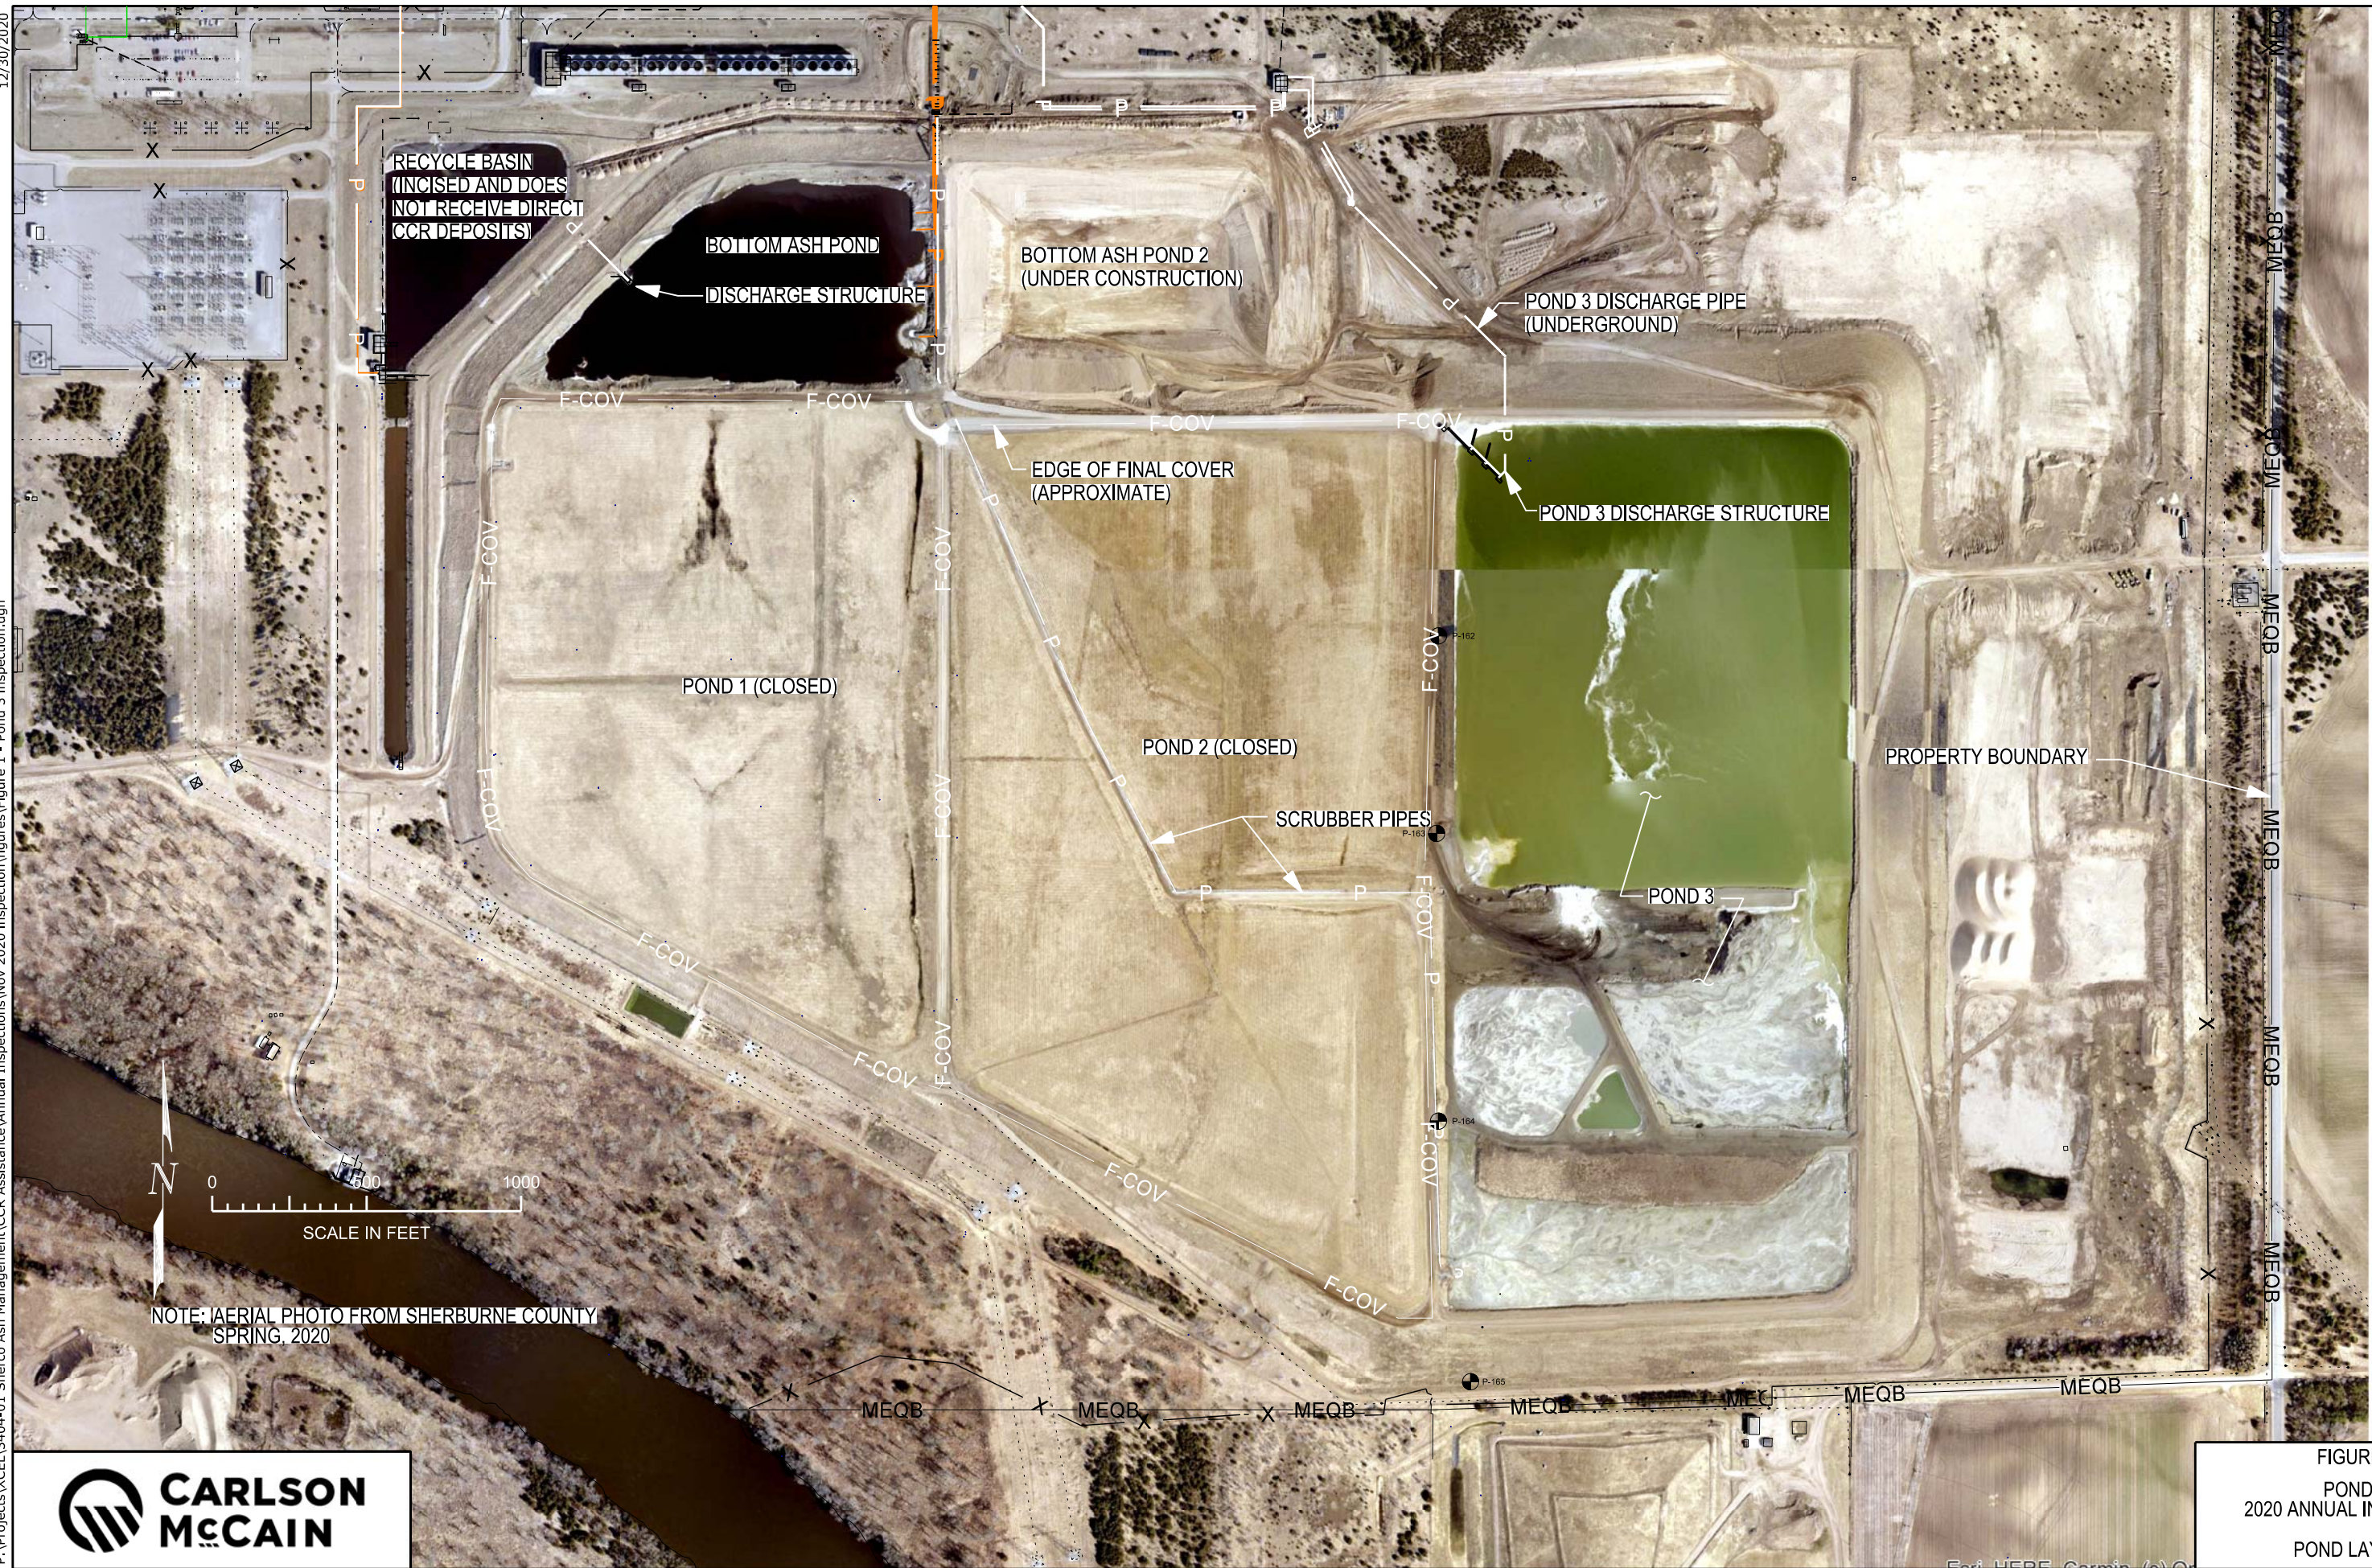
FIGURE 1  
POND 3  
2020 ANNUAL INSPECTION  
POND LAYOUT

Two forms of CCR are deposited or placed in Pond 3. Solid bottom ash is excavated and hauled from the Bottom Ash Pond (see figure 1) and used above the water level in Pond 3 and compacted as a structural fill, or deposited in the pond, and not compacted. The highest elevation of bottom ash diked

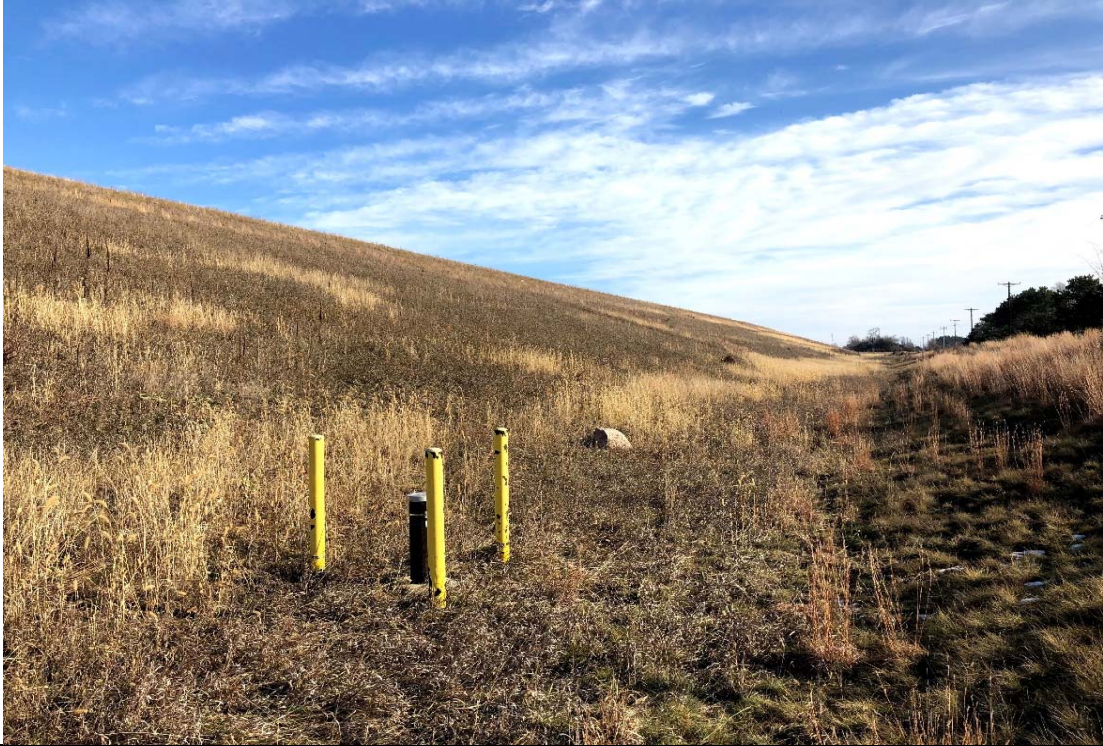
Photo 1	Outer slope of south embankment, looking east
11/19/2020

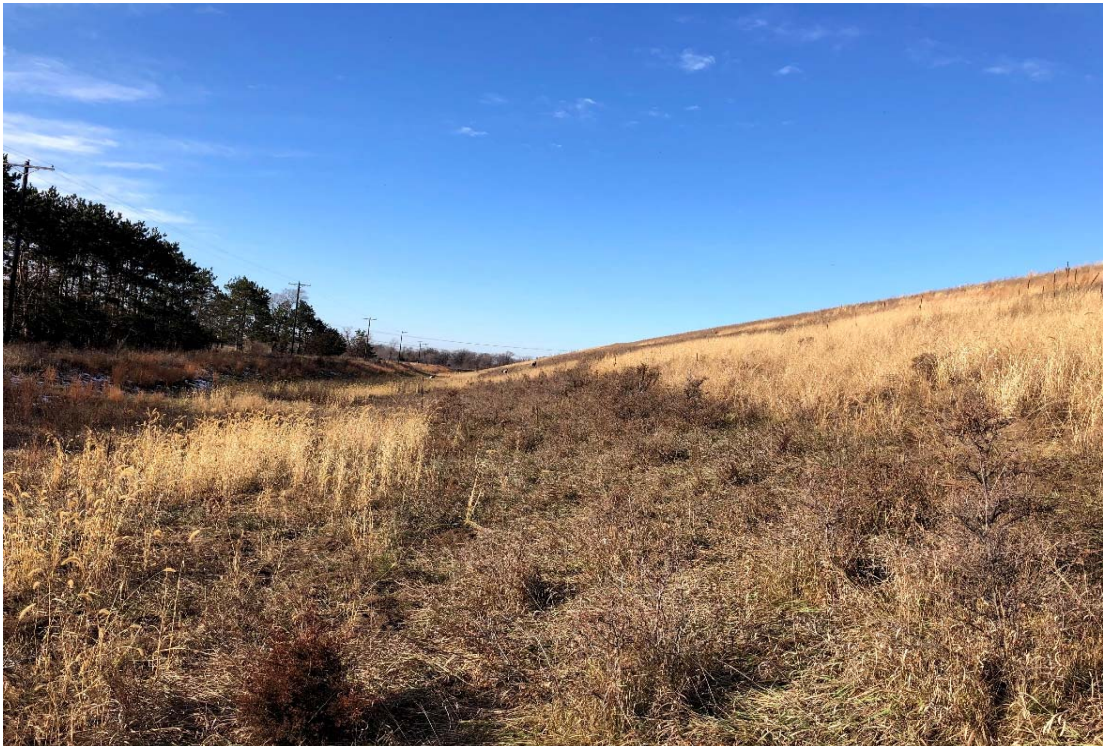
Photo 2	Outer slope of south embankment, looking west
11/19/2020

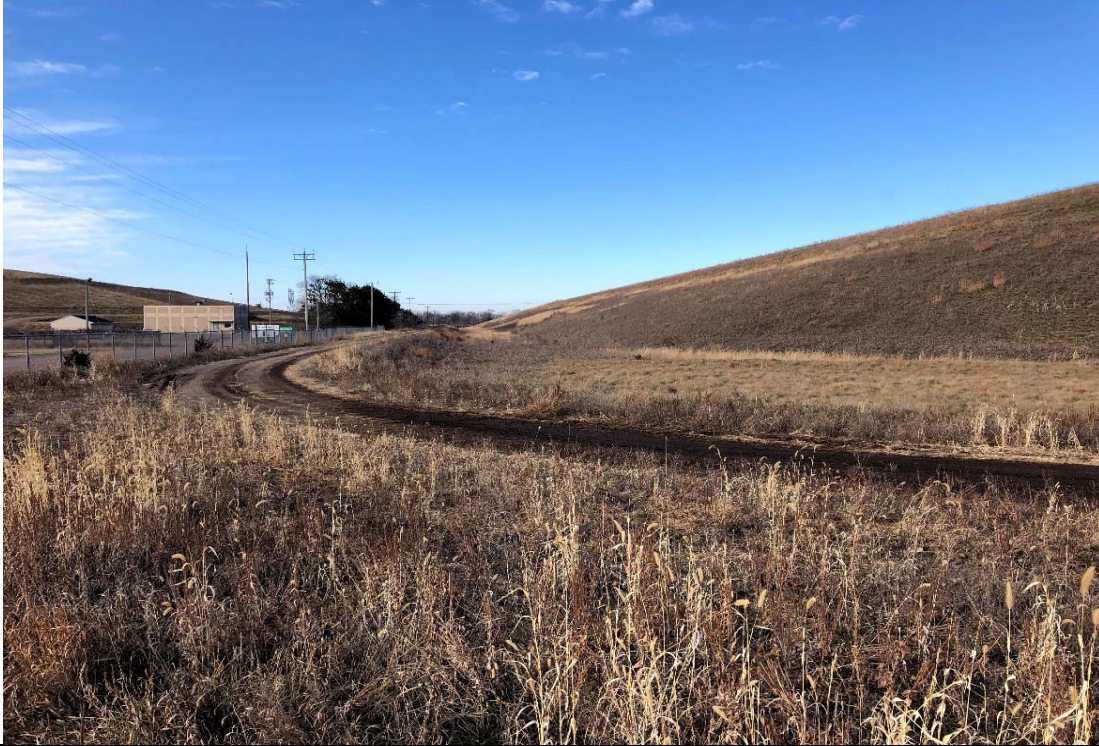
Photo 3	Outer slope of south embankment and southeast corner of pond, looking west
11/19/2020

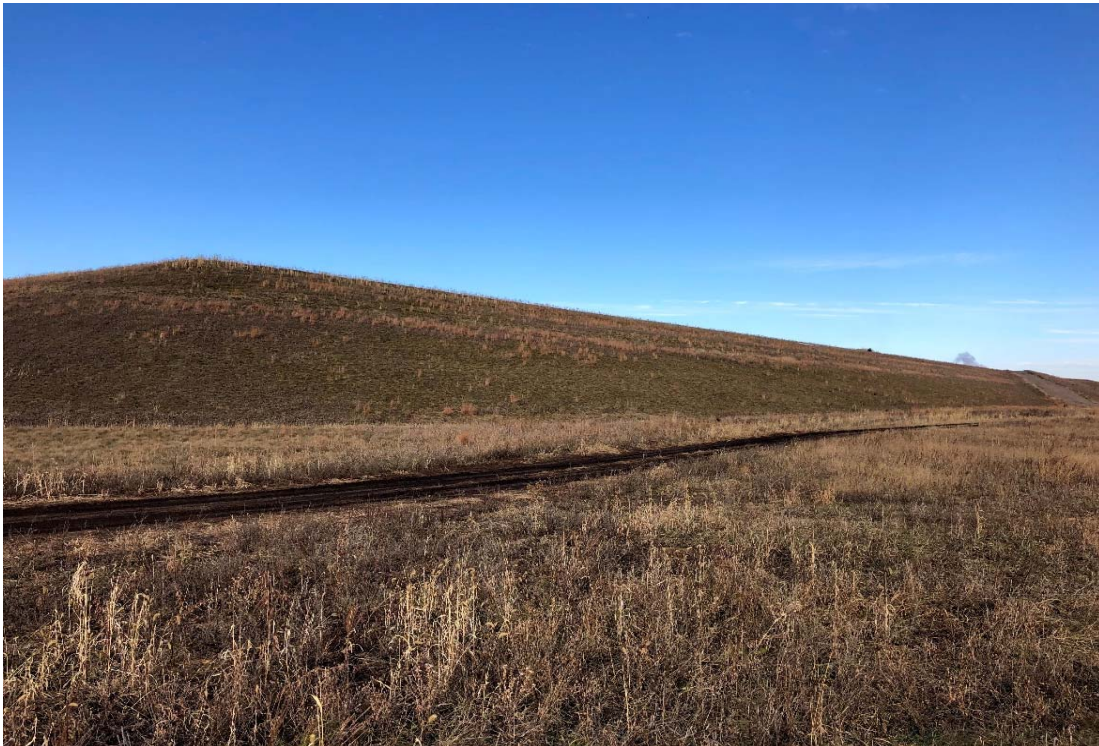
Photo 4	South end of east embankment, looking northwest.
11/19/2020

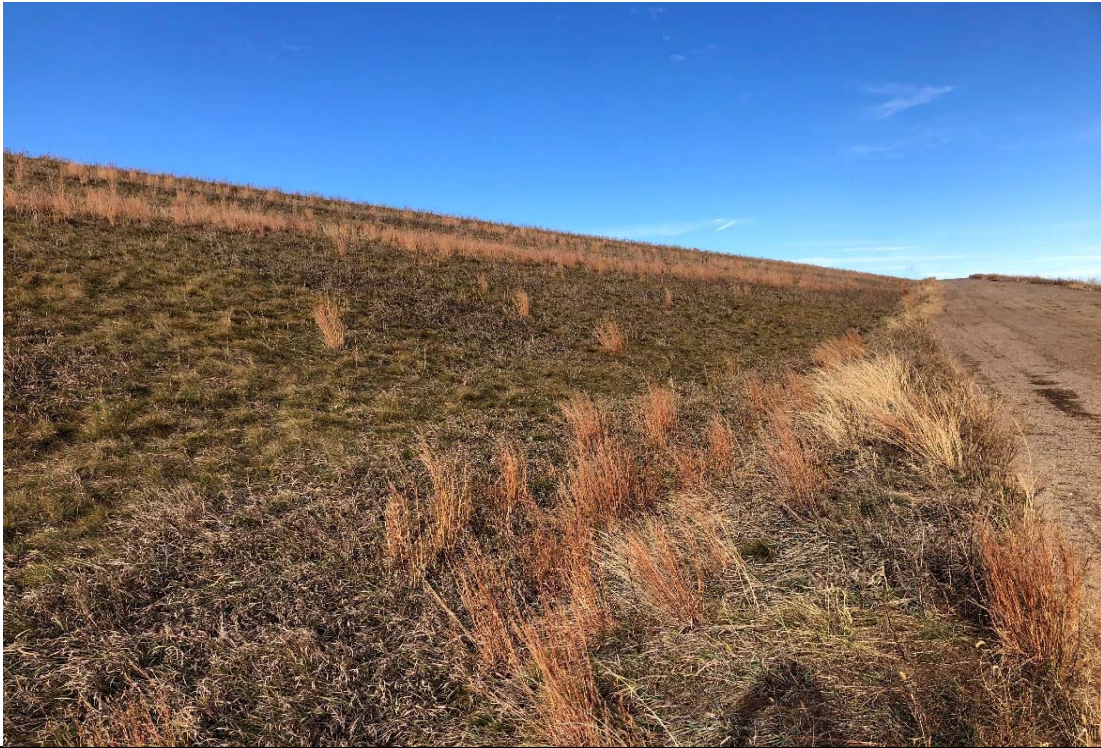
Photo 5	Mid-slope east embankment, looking north
11/19/2020

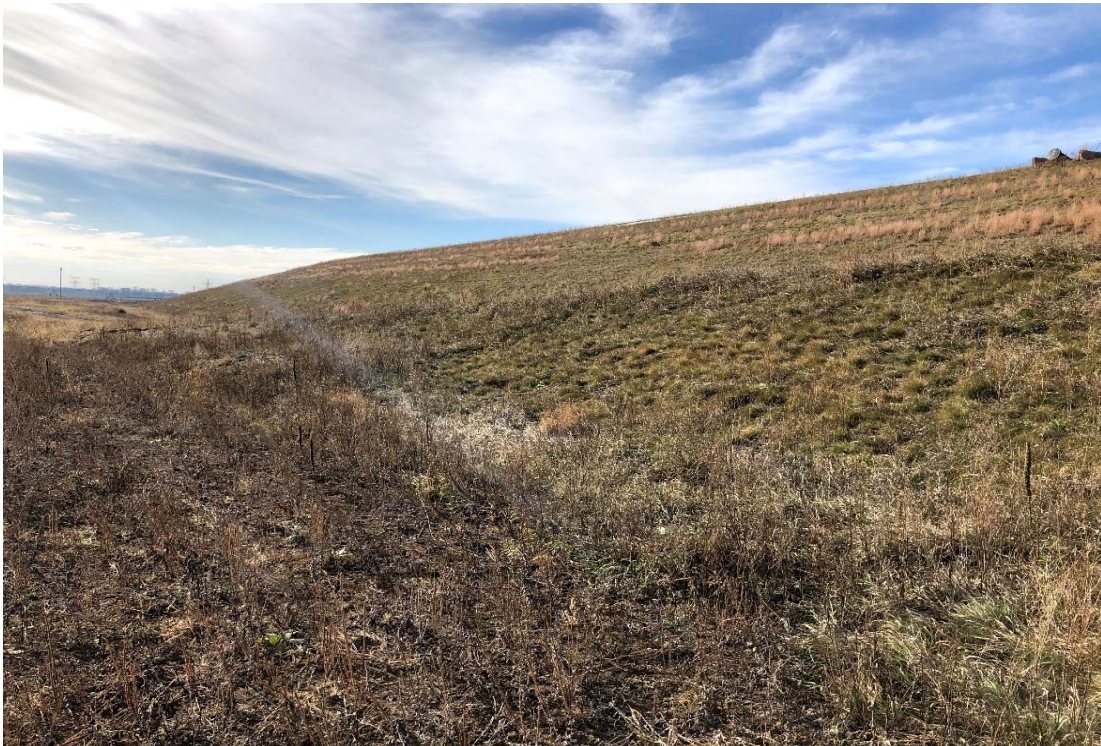
Photo 6	East embankment, looking south
11/19/2020

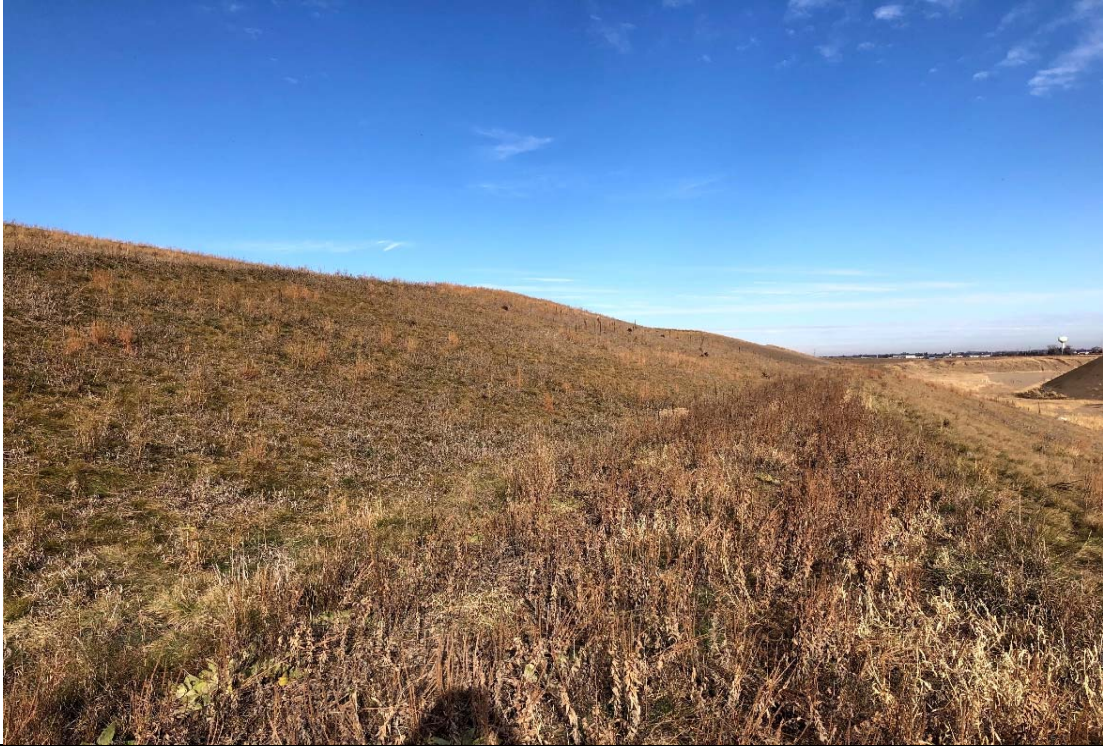
Photo 7	East embankment, looking north.
11/19/2020

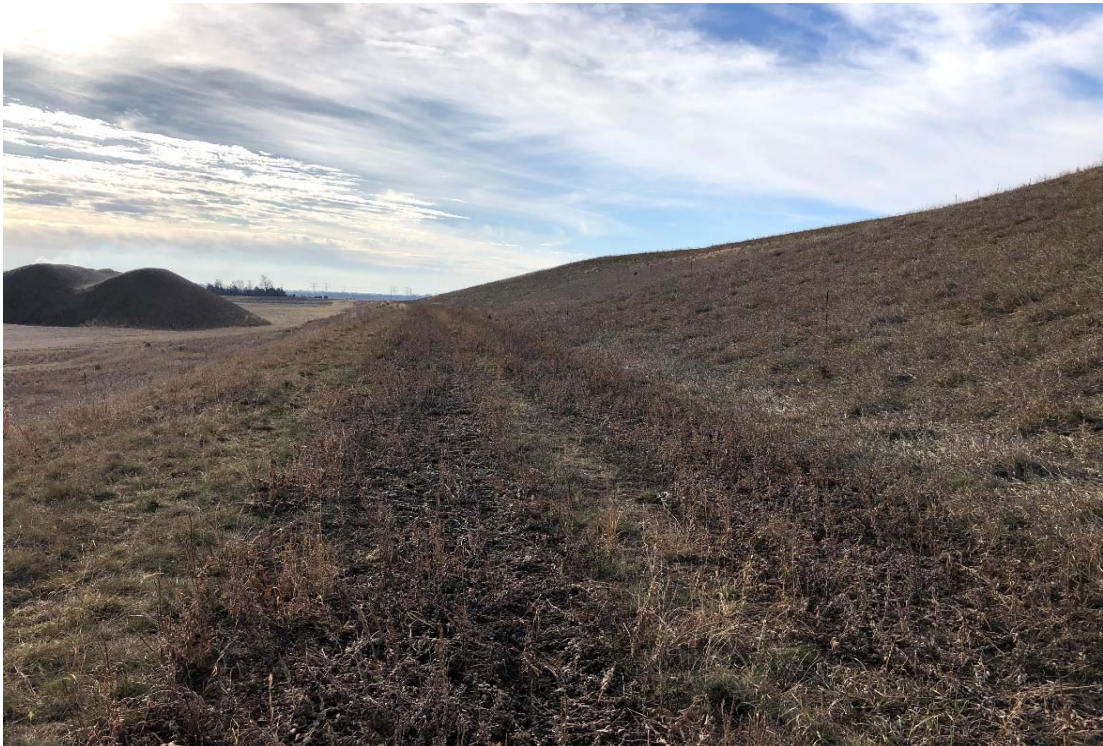
Photo 8	Middle of east embankment, looking south.
11/19/2020

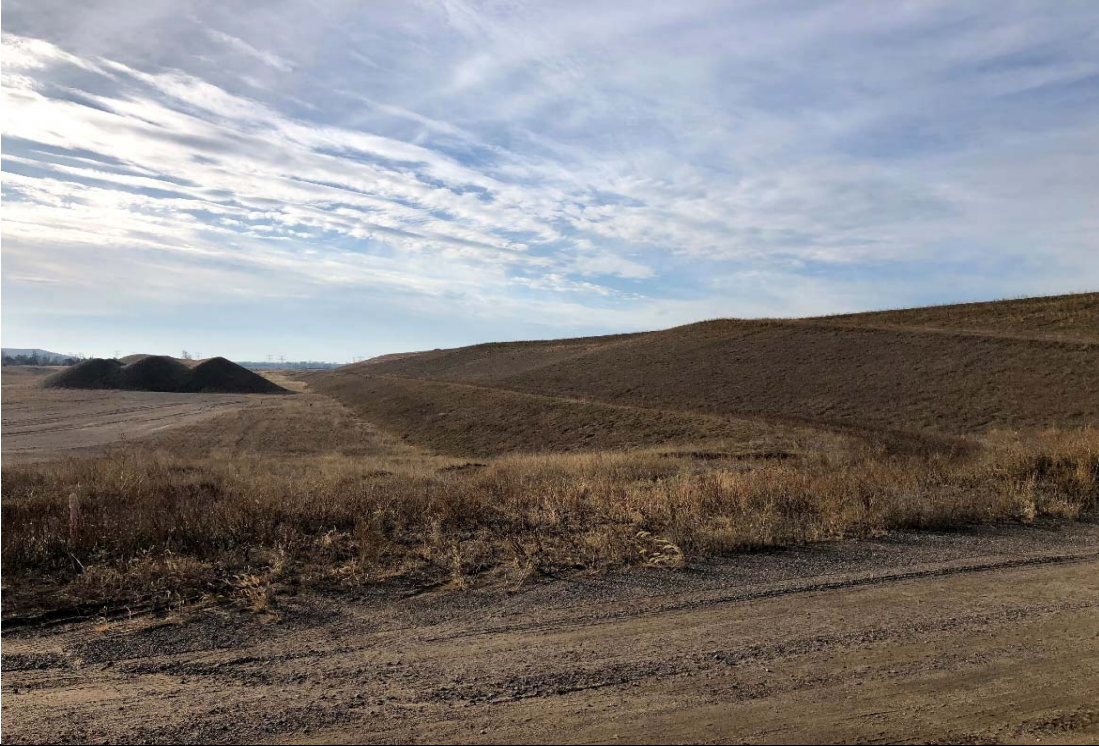
Photo 9	East embankment, looking south.
11/19/2020

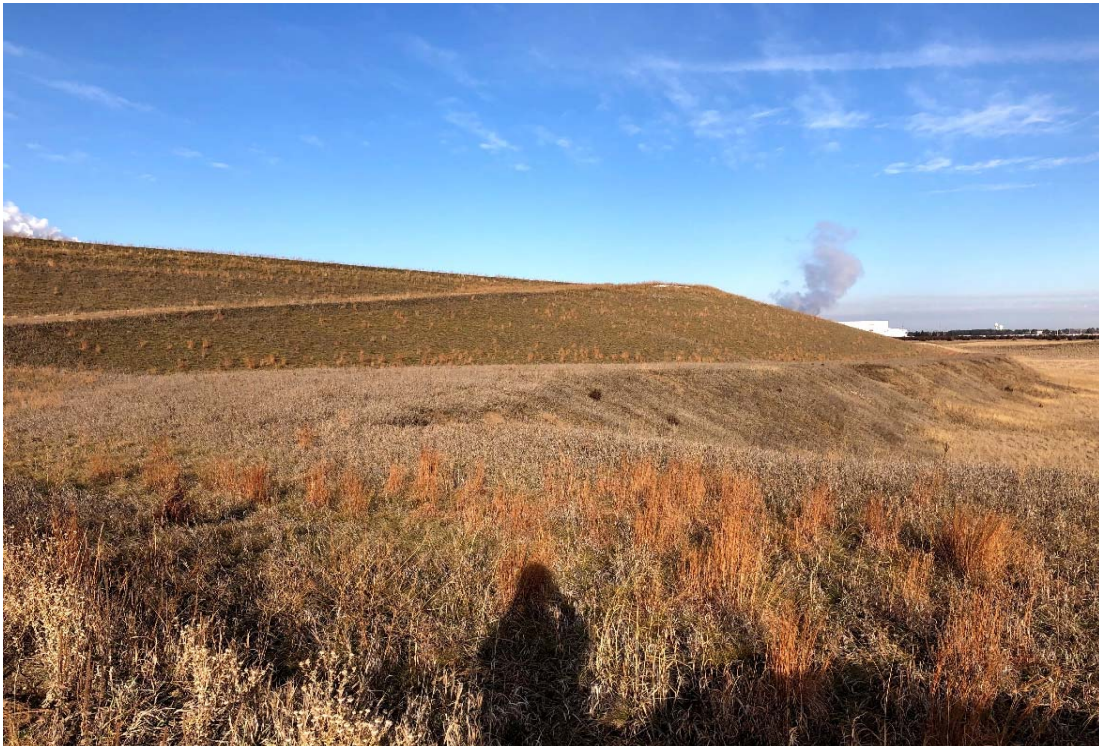
Photo 10	East embankment, looking north.
11/19/2020

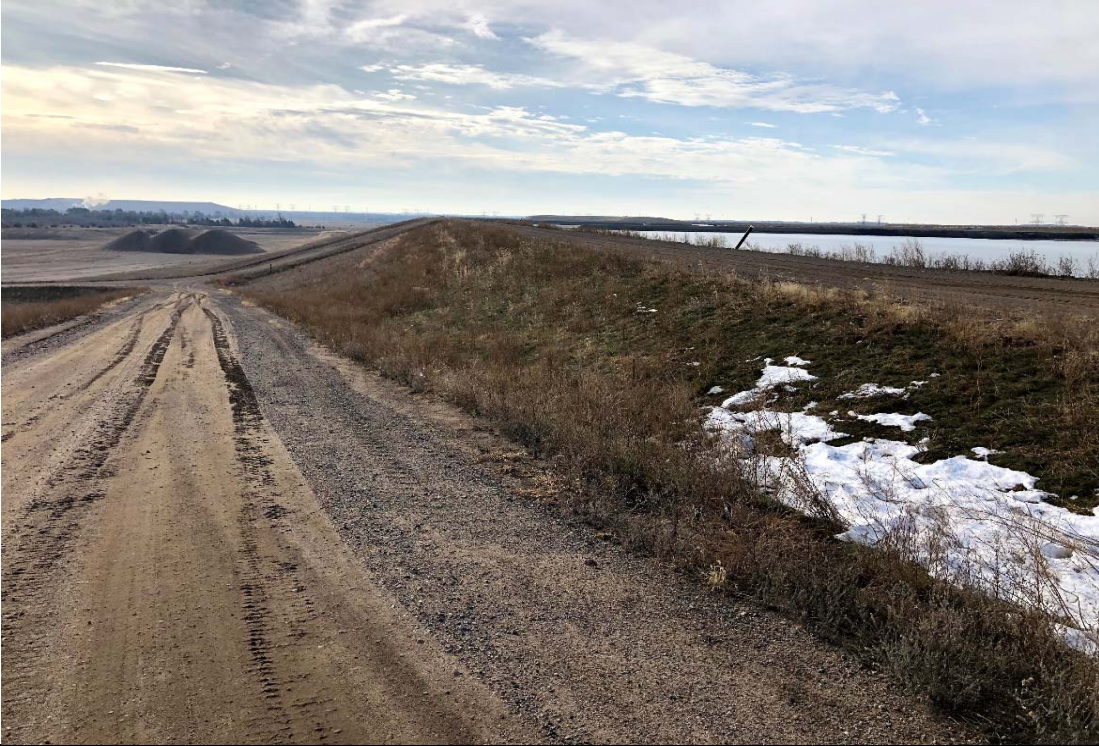
Photo 11	Top of northern access ramp on east embankment, looking south.
11/19/2020

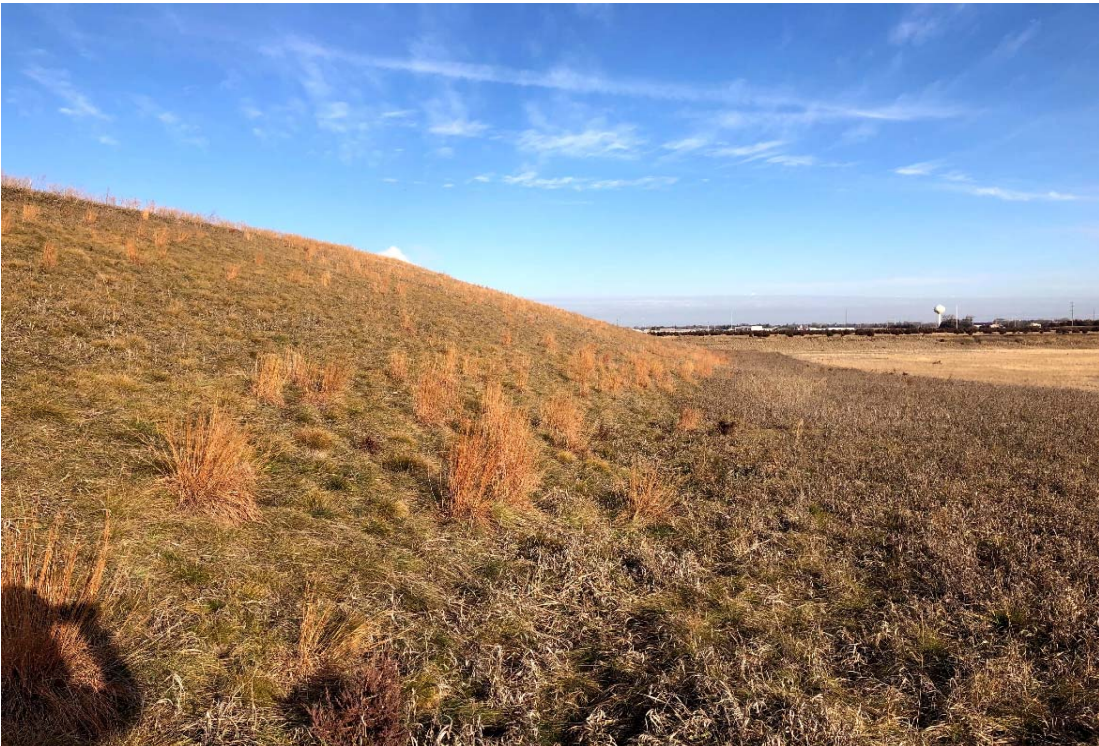
Photo 12	Northern end of east embankment, looking north.
11/19/2020

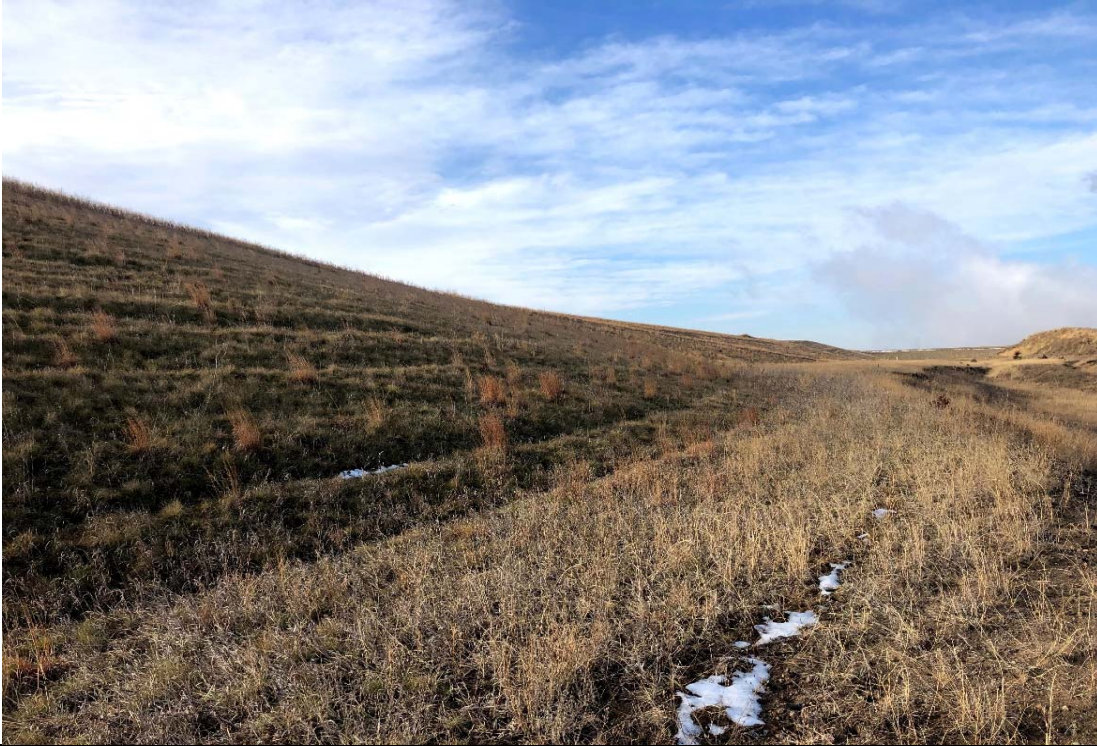
Photo 13	North embankment, looking west.
11/19/2020

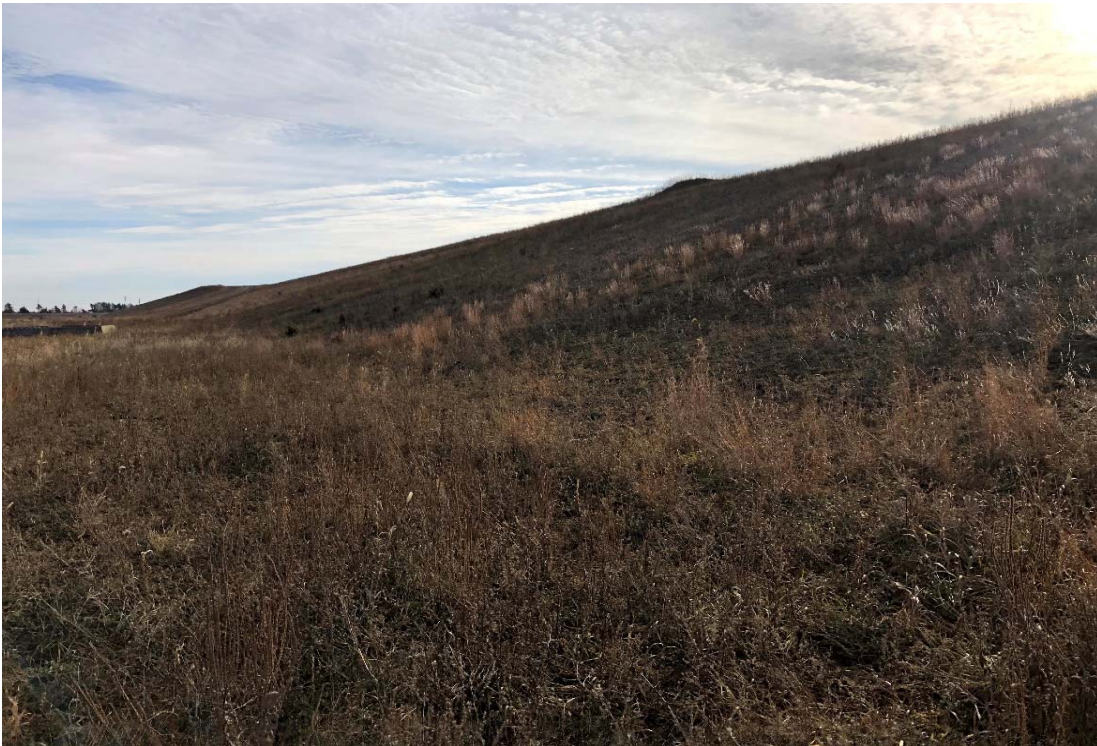
Photo 14	Outer slope of north embankment, looking east.
10/24/2019

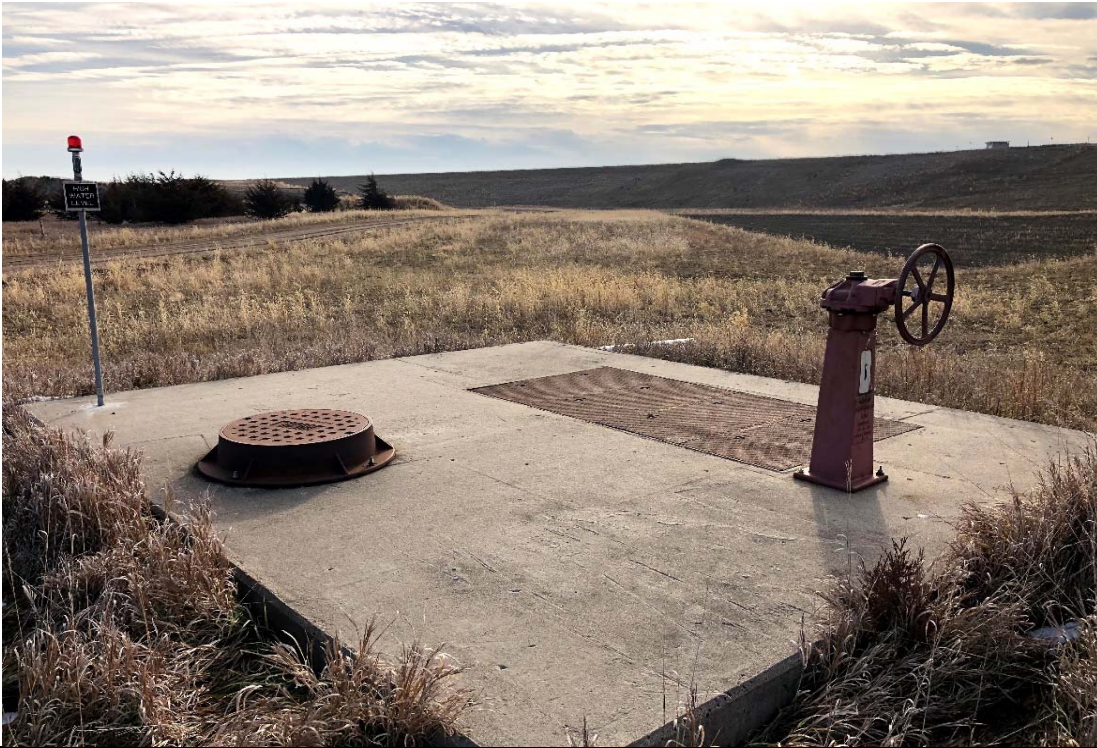
The discharge pipe corridor was inspected for signs of a leakage, such as saturated areas or sinkholes. No signs of leakage were observed along the pipe corridor or in the vault located north of Pond 3.

Photo 15	Pond 3 discharge pipe vault and pipeline corridor, looking southeast.
11/19/2020

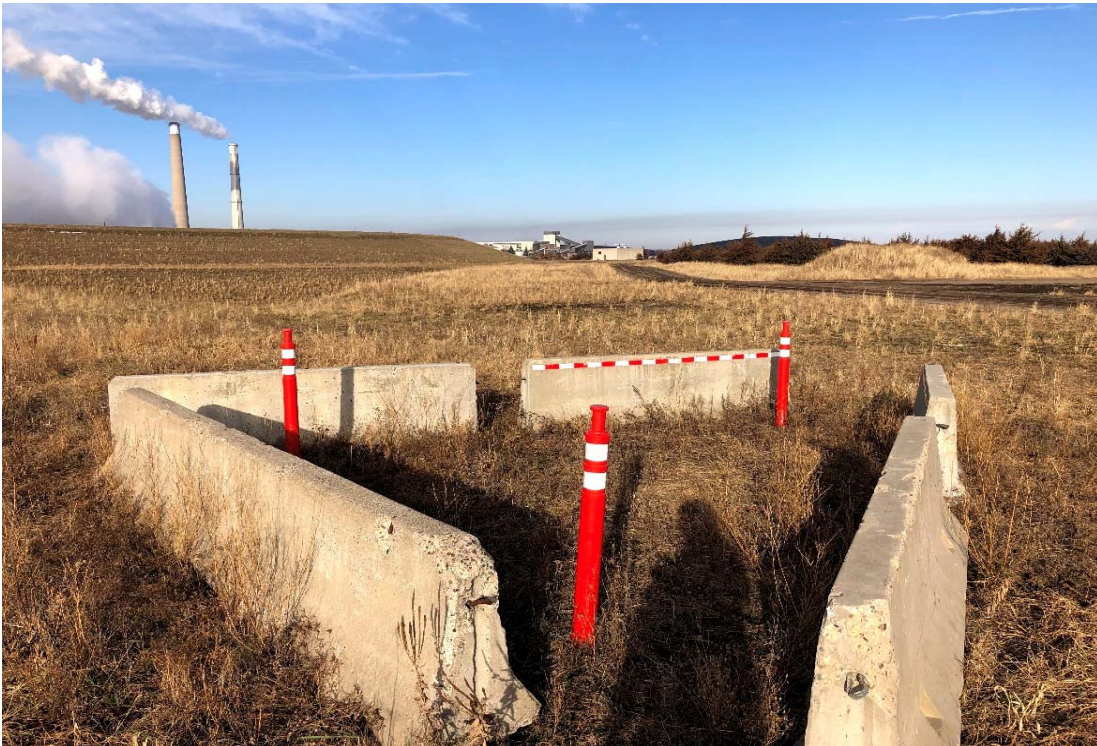
Photo 16	Pond 3 discharge pipe corridor, looking northwest.
11/19/2020

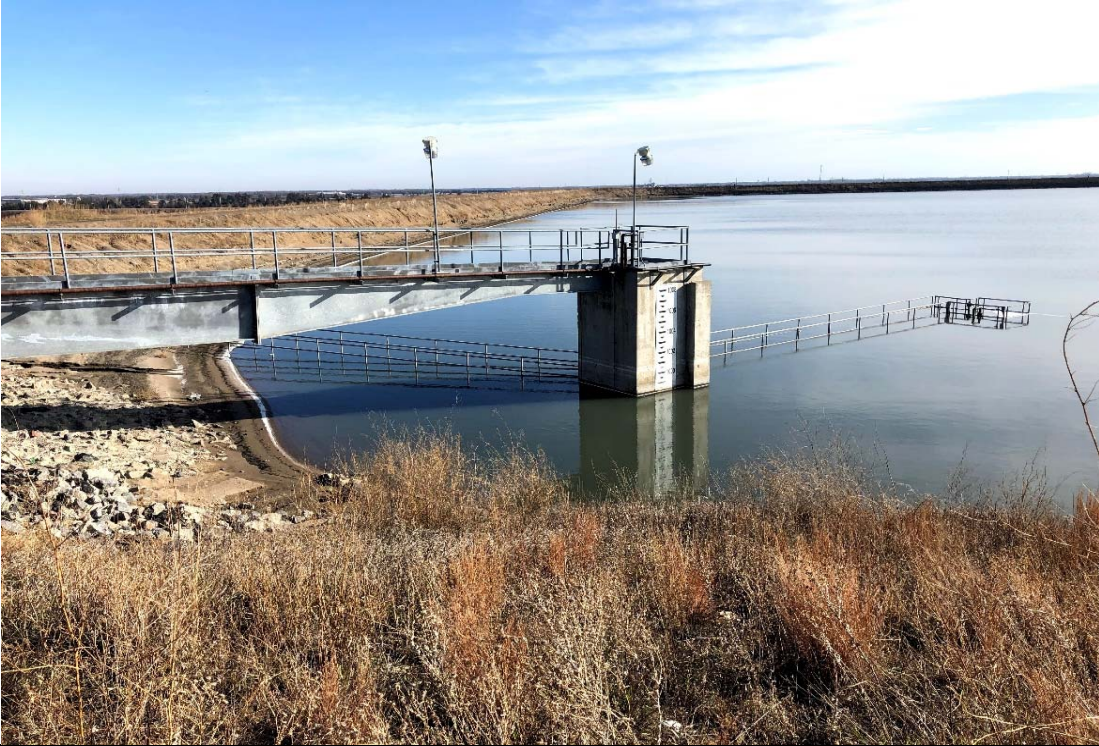
The only instrumentation on Pond 3 is a staff gauge used to determine water surface elevation, located on the west side of the discharge structure. The Pond water level was 998.8 feet above mean sea level (MSL) during the 2019 CCR inspection and fell to 998.3 feet MSL during the 2020 inspection. The top of clay liner elevation is 1010 feet MSL. No instrumentation is needed for dike stability.

Photo 17	Pond 3 staff gauge, reading an elevation of 998.25 feet (mean sea level).
11/19/2020

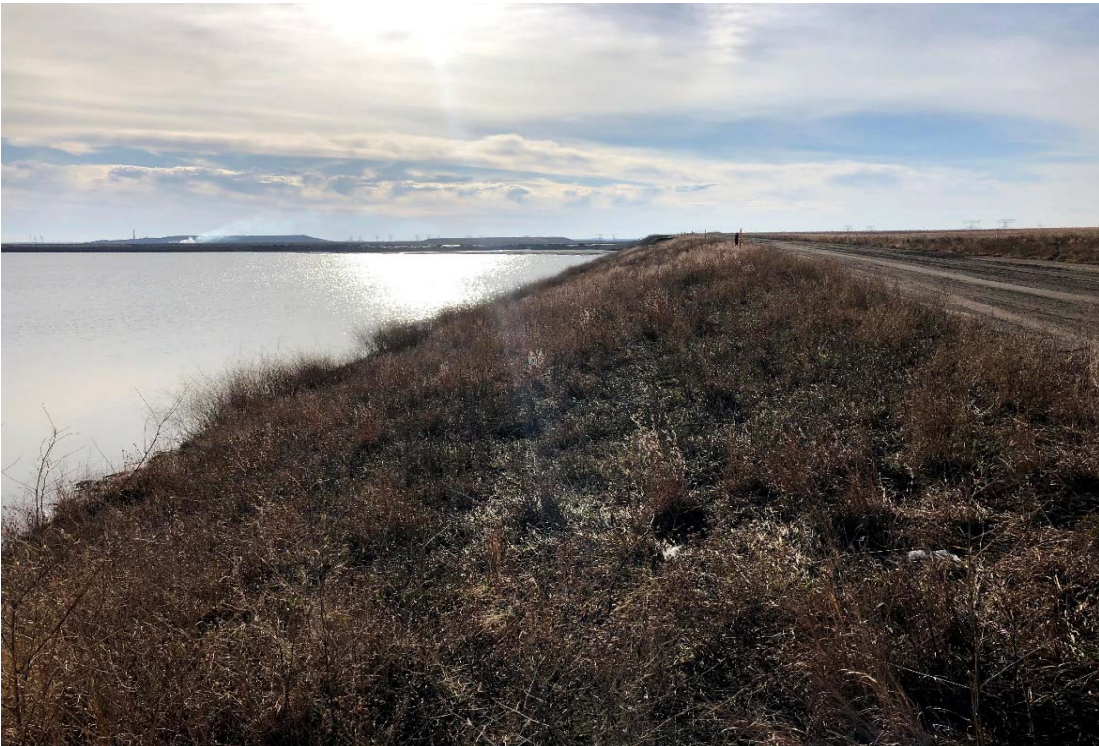
Photo 18	Interior of west embankment, looking south.
11/19/2020

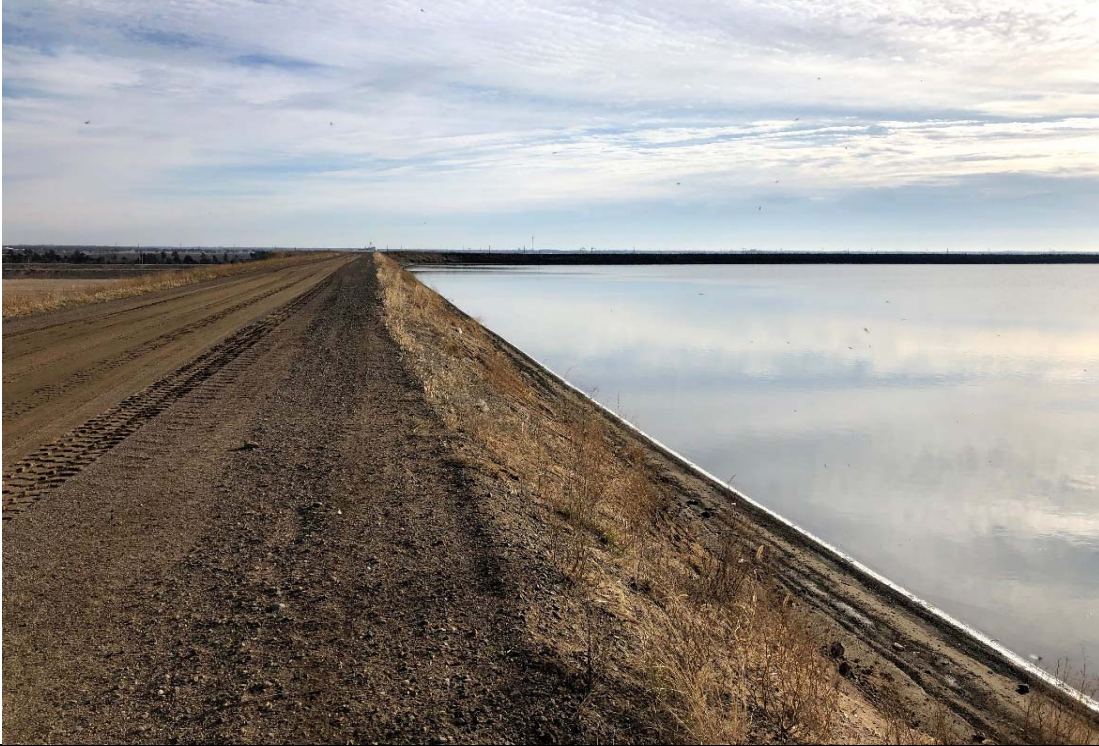
Photo 19	Interior of north embankment, looking east.
11/19/2020

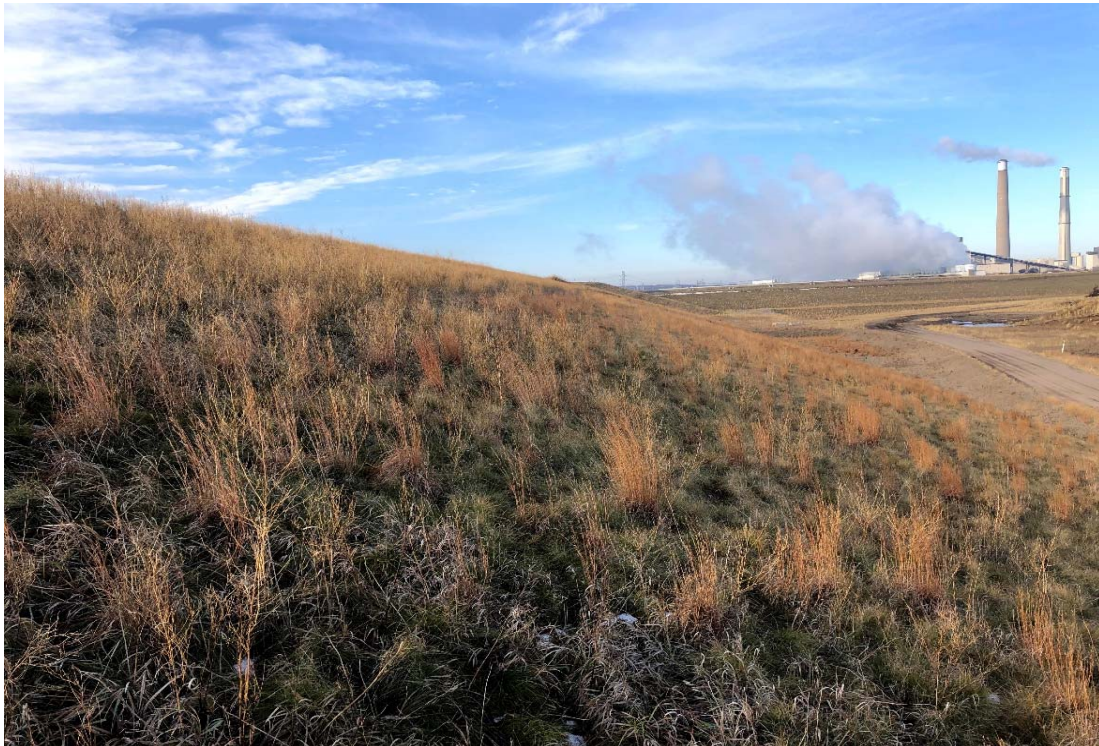
Photo 20	Top of outer slope of north embankment, looking west.
11/19/2020

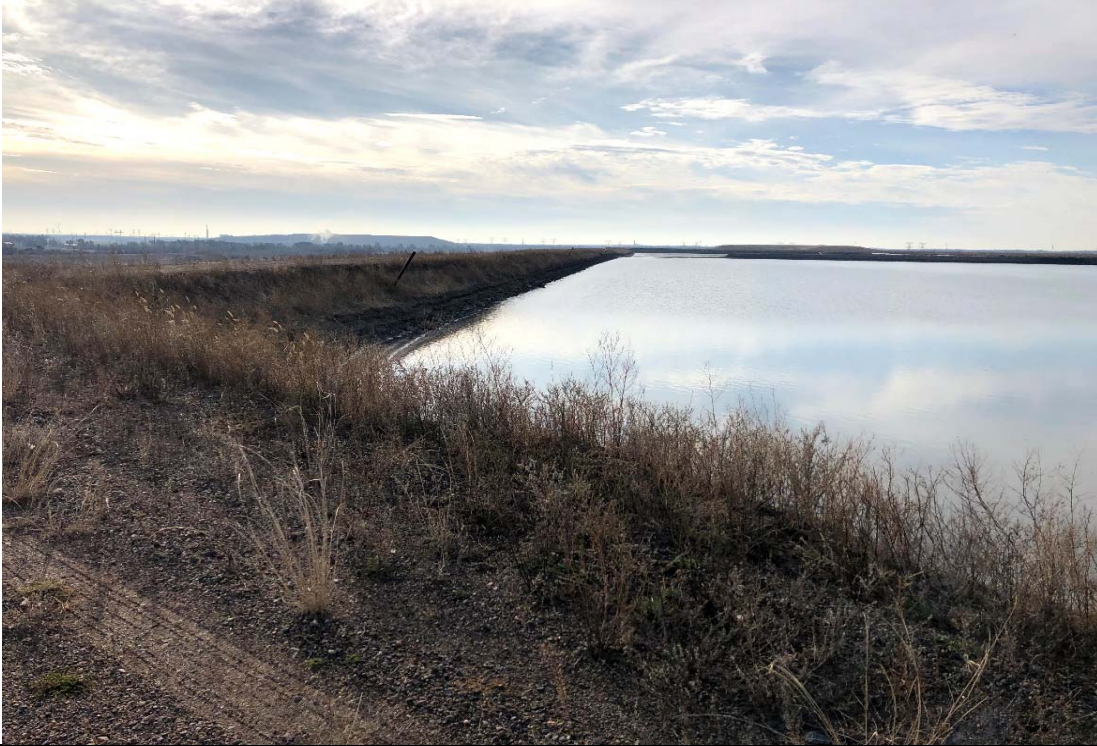
Photo 21	Interior of east embankment, looking south.
11/19/2020

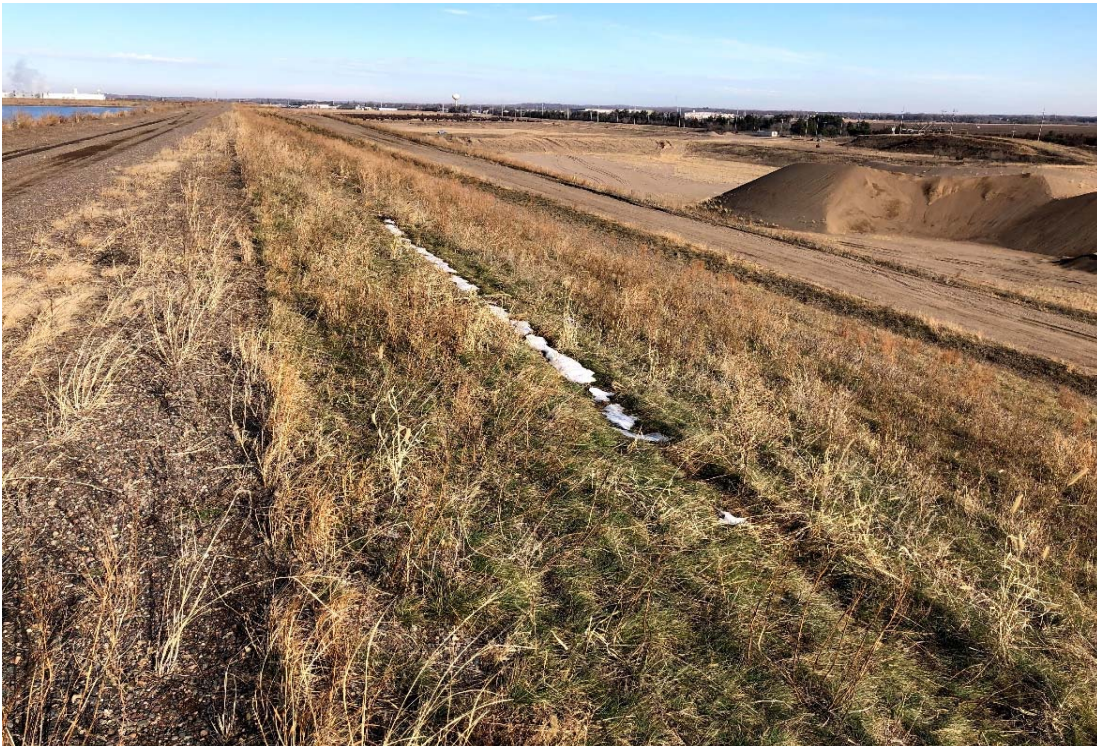
Photo 22	Top of east embankment, looking north.
11/19/2020

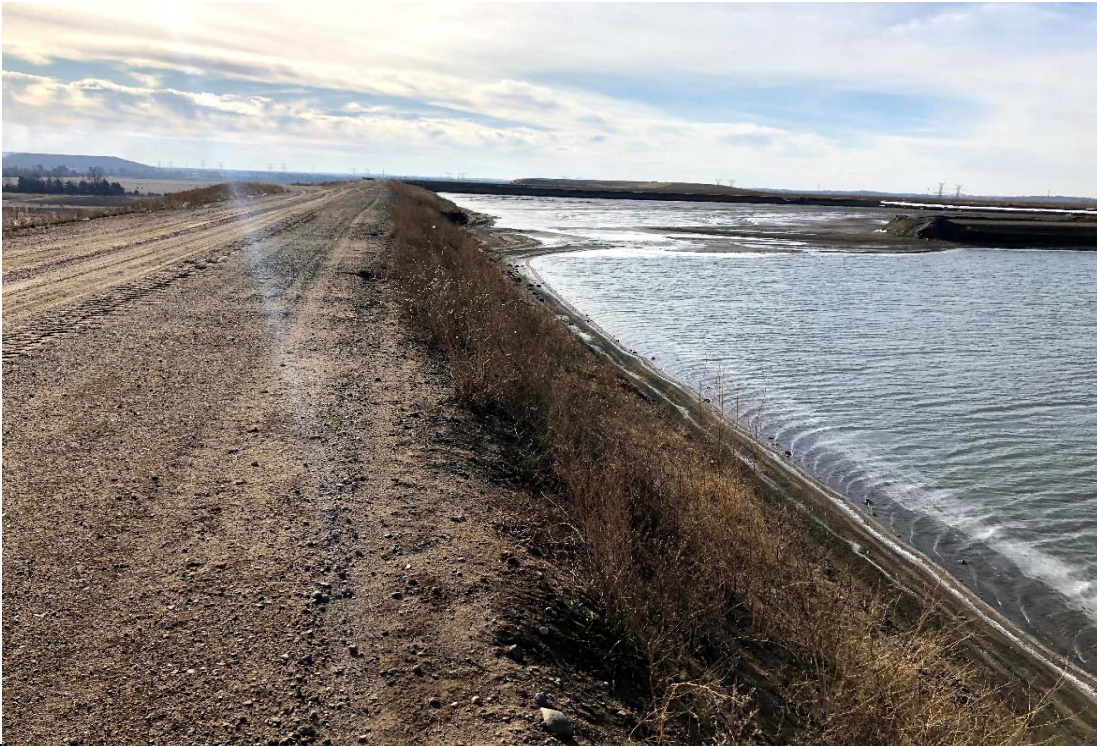
Photo 23	Interior of east embankment, looking south.
11/19/2020
