Xcel Energy, Inc.  
Sherburne County Generating Station  
13999 Industrial Blvd.  
Becker, MN, 55308

**Re: 2020 Annual Inspection of Scrubber Solids Pond No. 3**

## Pond 3 Annual Inspection - 2020

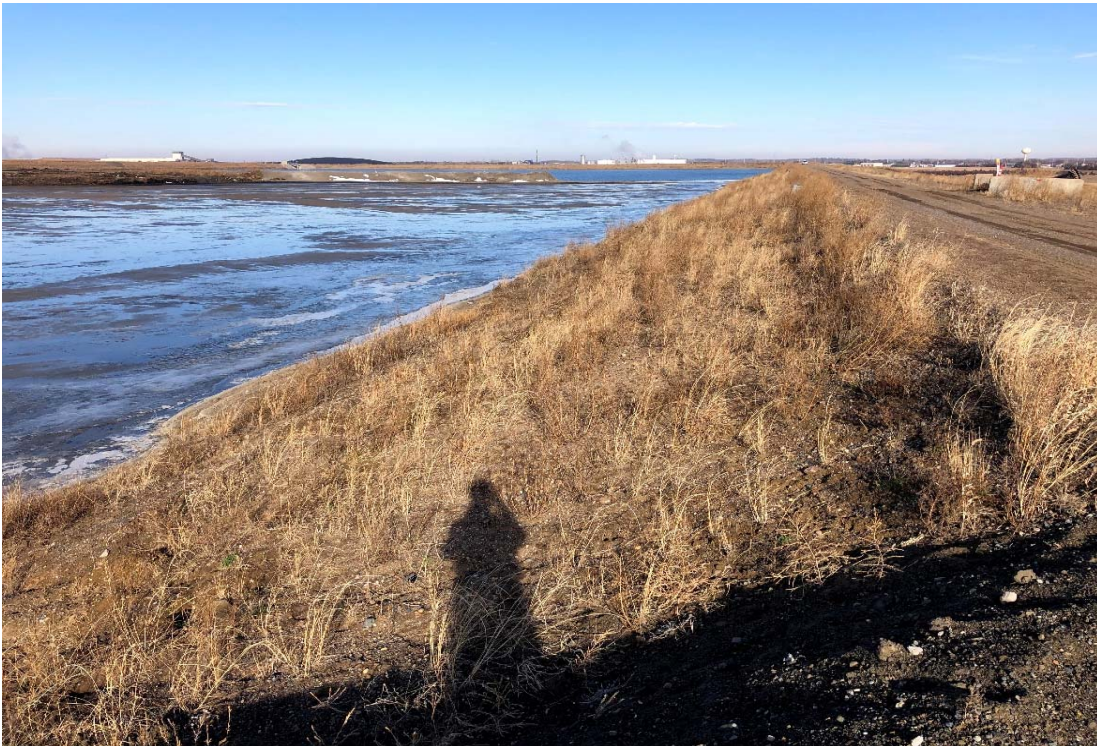
Photo 24	Interior of east embankment, looking north.
11/19/2020

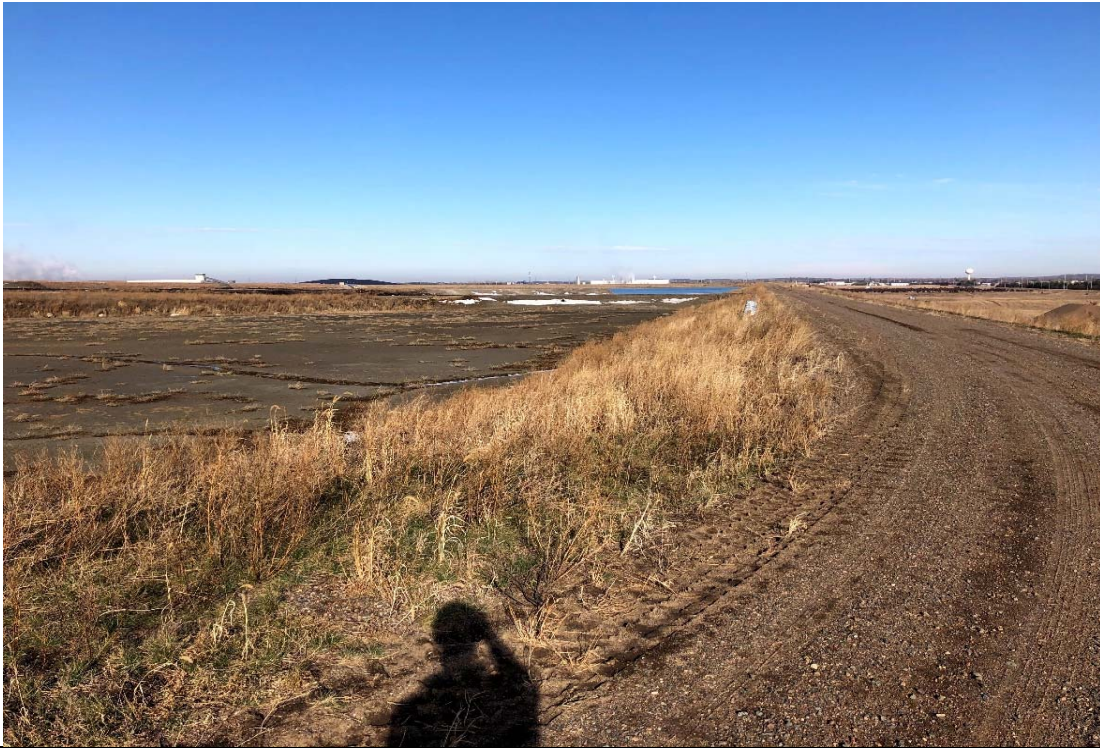
Photo 25	Interior of east embankment, looking north.
11/19/2020

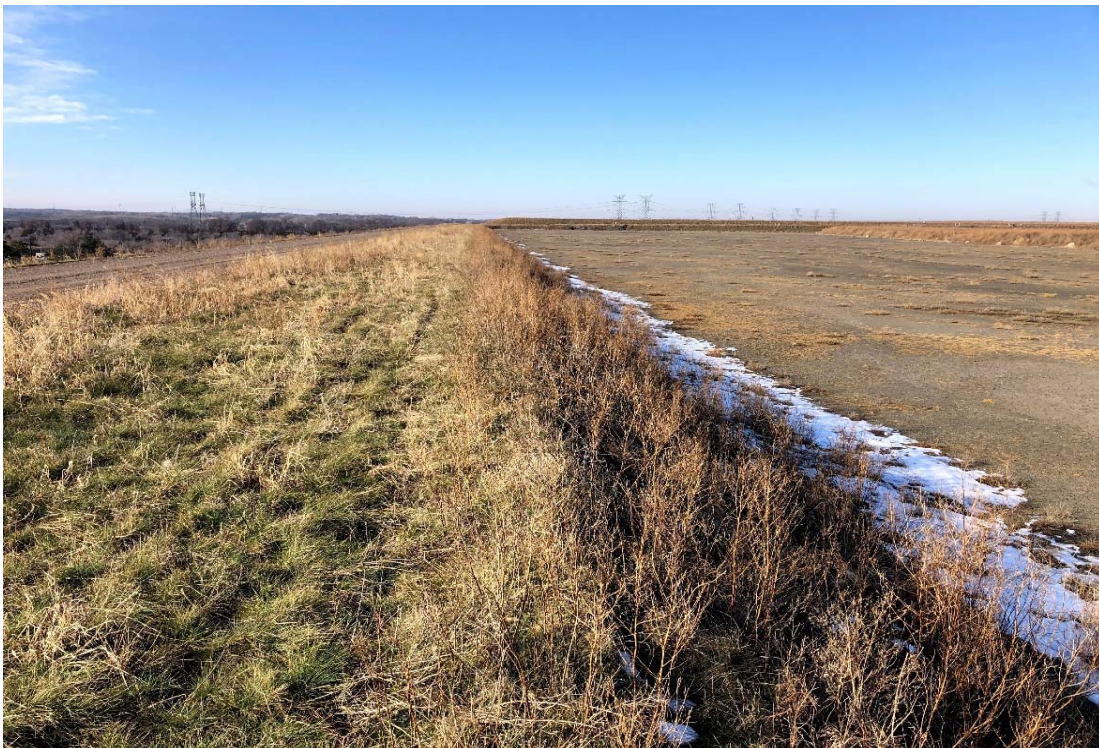
Photo 26	Interior of south embankment, looking west.
11/19/2020

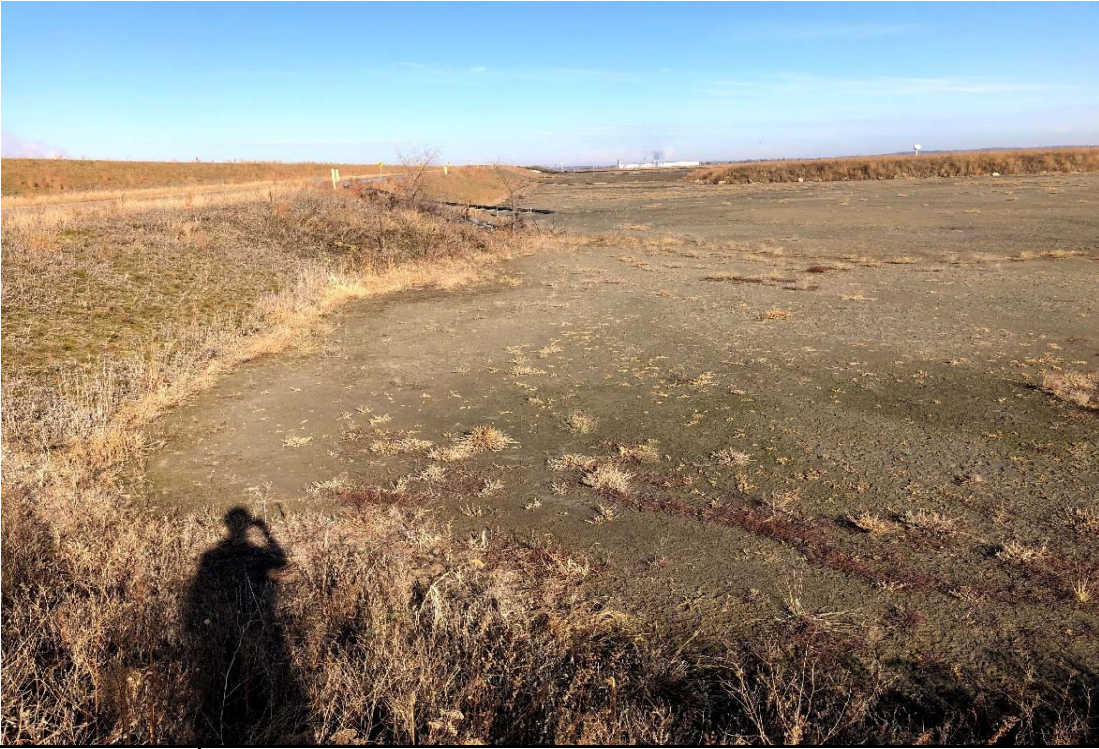
Photo 27	Interior of west embankment, looking north.
11/19/2020

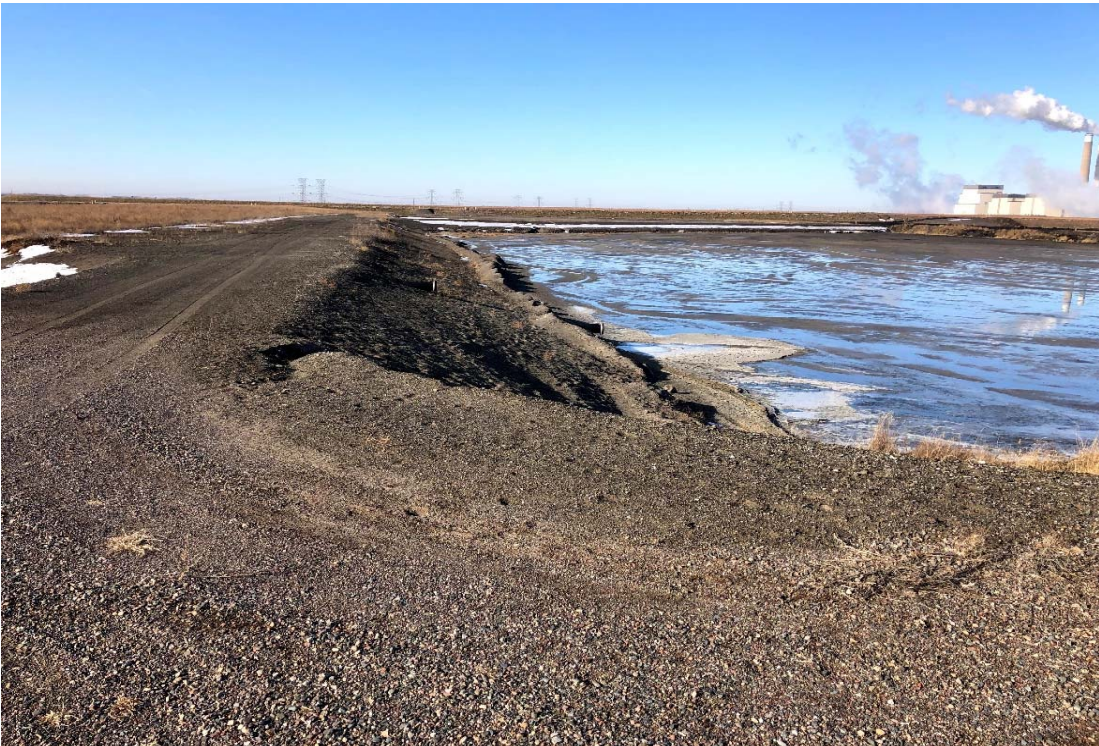
Photo 28	Interior pond dike, looking west.
11/19/2020
