Xcel Energy, Inc.
Sherburne County Generating Station
13999 Industrial Blvd.
Becker, MN 55308

Re: 2020 Annual Inspection of Unit 3 Landfill

FIGURE 1
UNIT 3 LANDFILL 2020
ANNUAL INSPECTION
PHOTO LOCATIONS

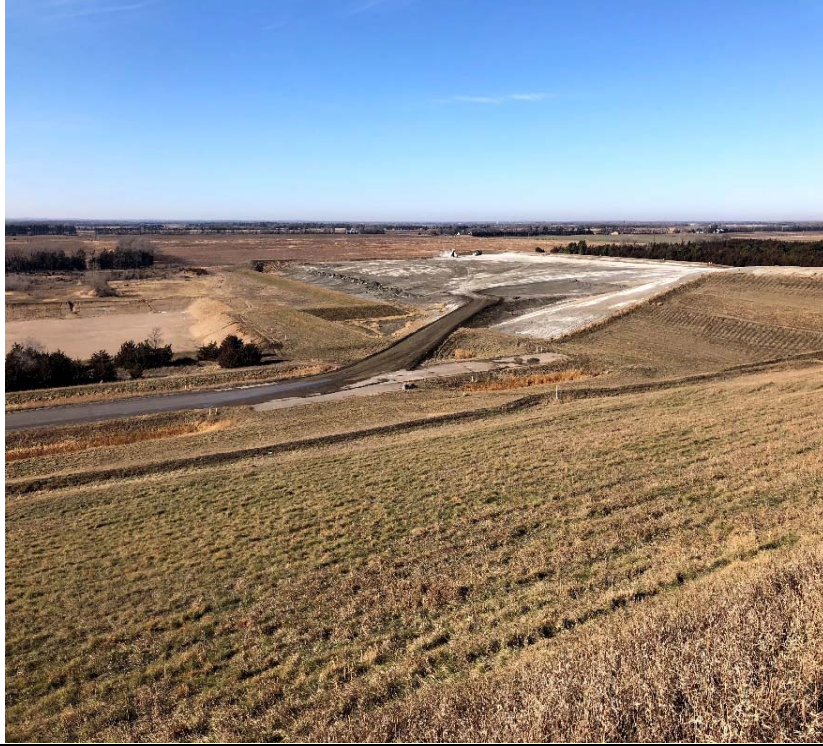
Photo 1	Left: excavation of future landfill cell. Right: existing final cover and active cell, looking northwest.
11/19/2020

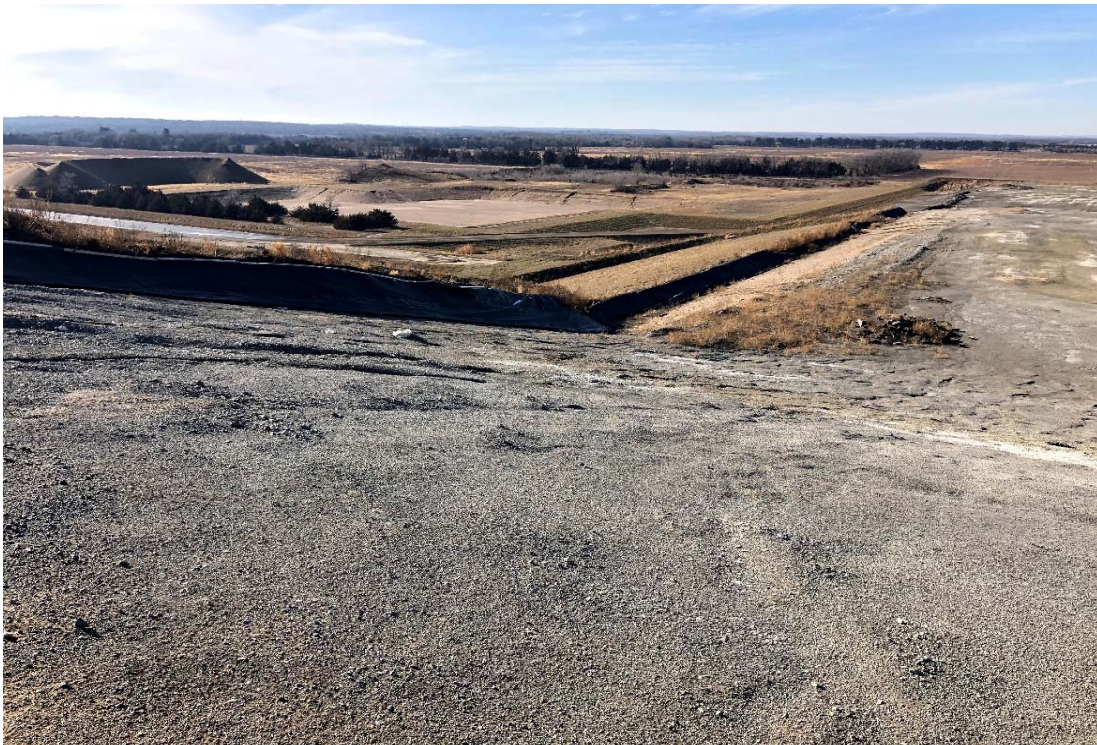
Photo 2	Run-on/run-off containment berm in foreground, looking southwest. Future cell excavation area in background.
11/19/2020

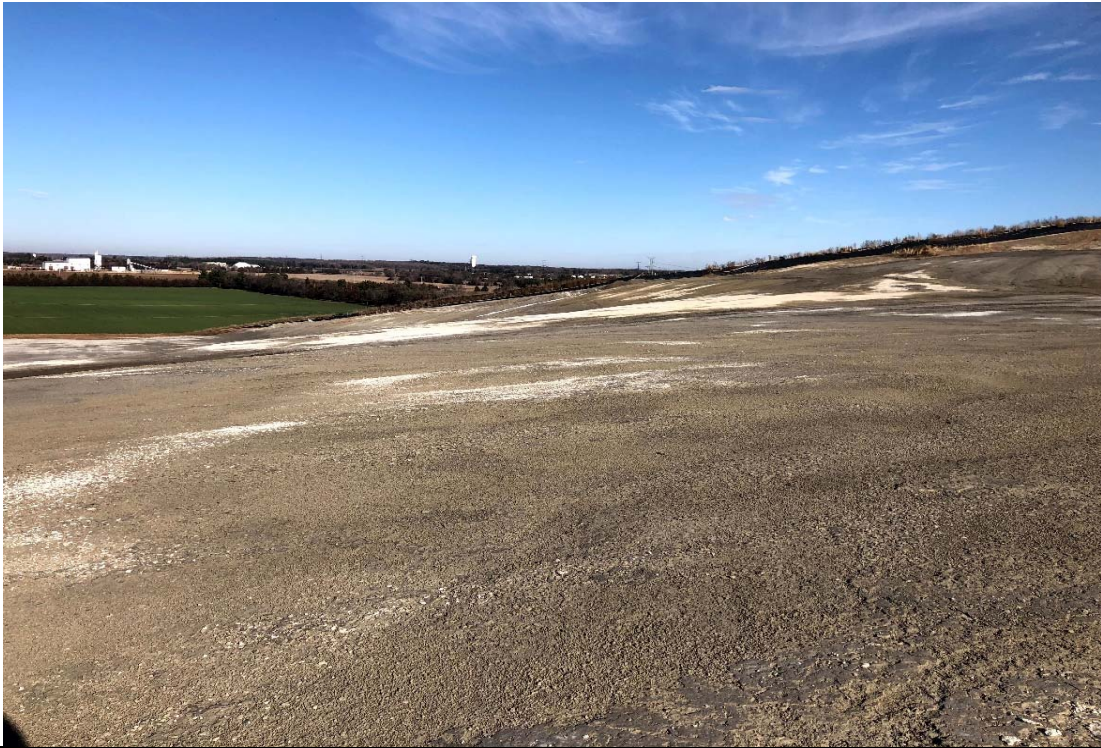
Photo 3	Active area of the landfill, looking north. Northeast leachate run-off
11/19/2020	containment berm in background.

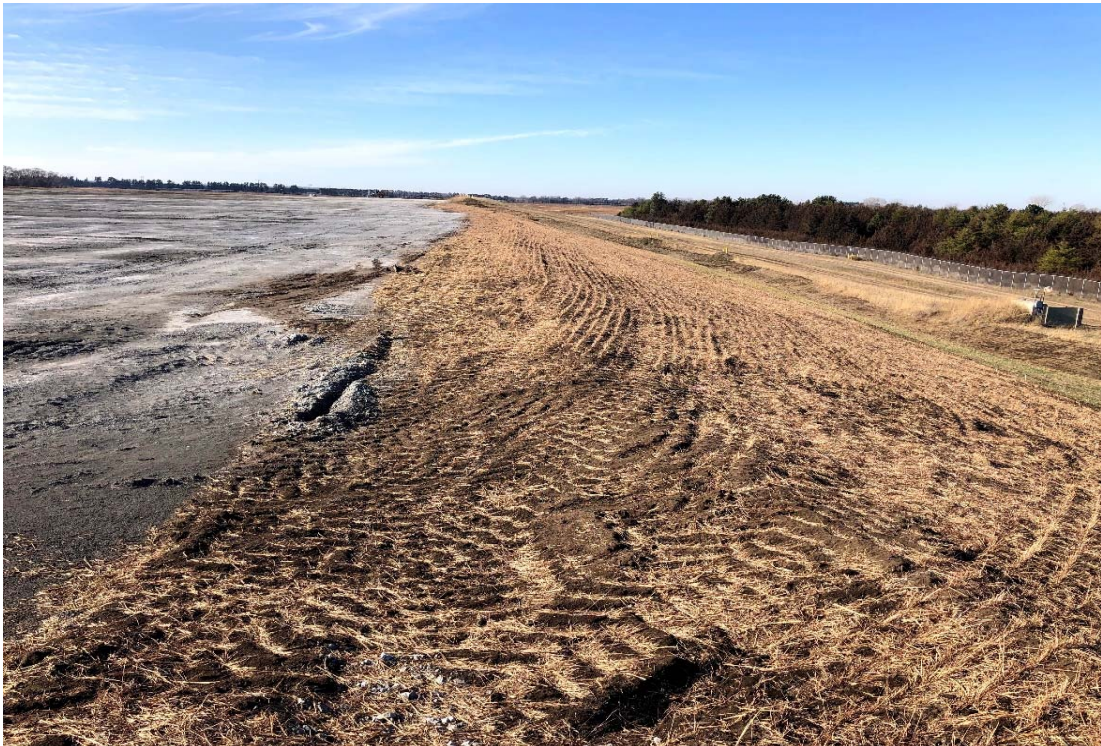
Photo 4	Active area of the landfill (right embankment covered with intermediate
11/19/2020	cover), looking west.

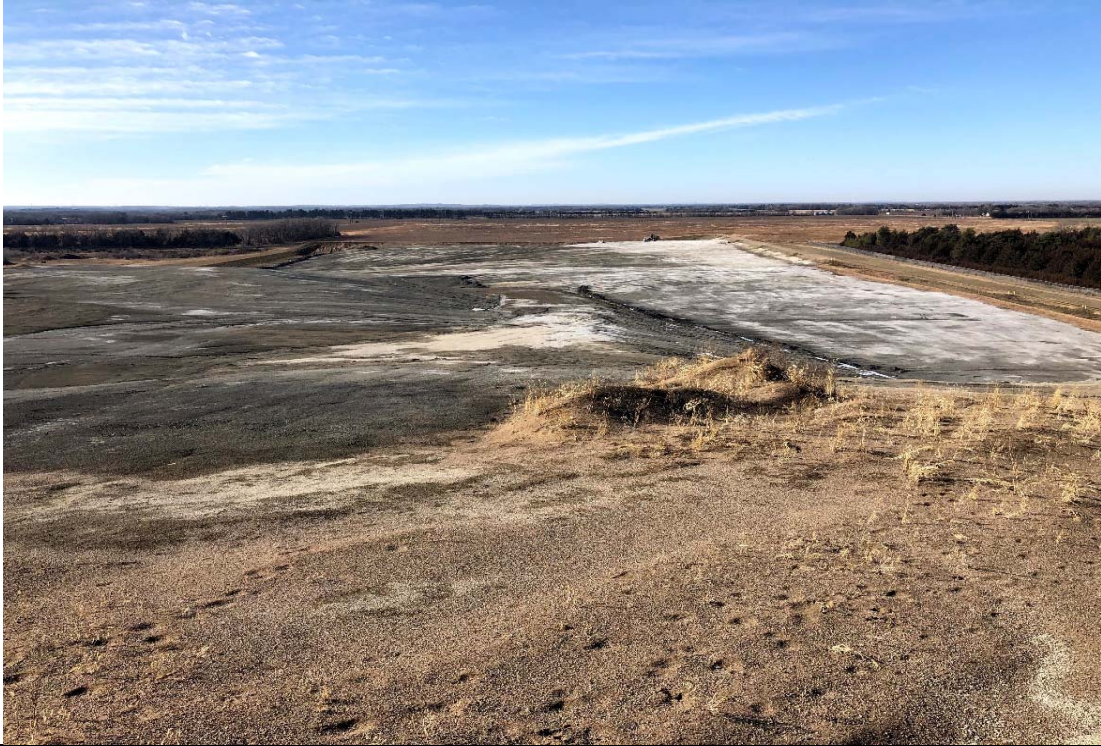
Photo 5	Active area of landfill, looking west.
11/19/2020

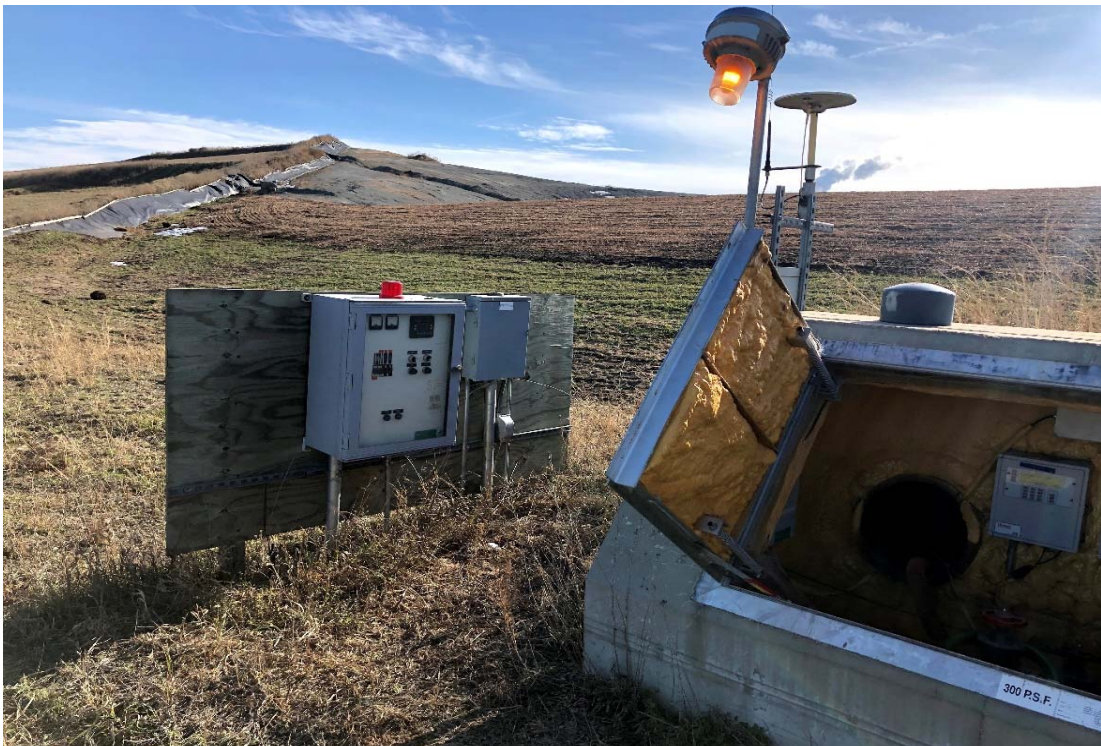
Photo 6	Foreground: Pumphouse and control panel. Background: Exterior north berm and final cover, looking south east.
11/19/2020

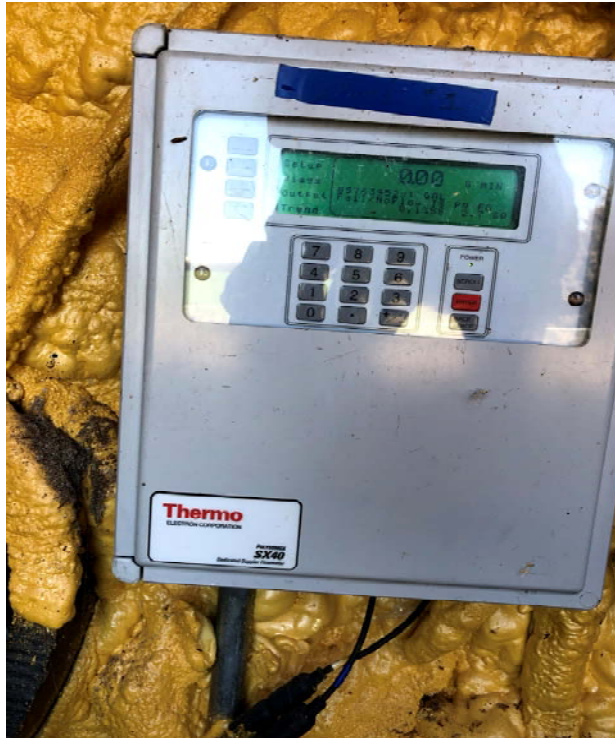
Photo 7	Display screen on properly functioning Pump No. 1.
11/19/2020

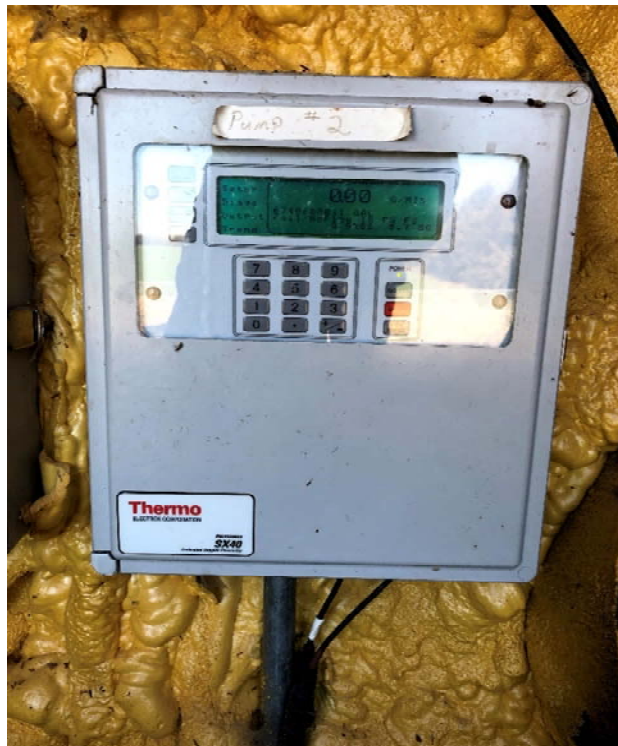
Photo 8	Display screen on properly functioning Pump No. 2.
11/19/2020

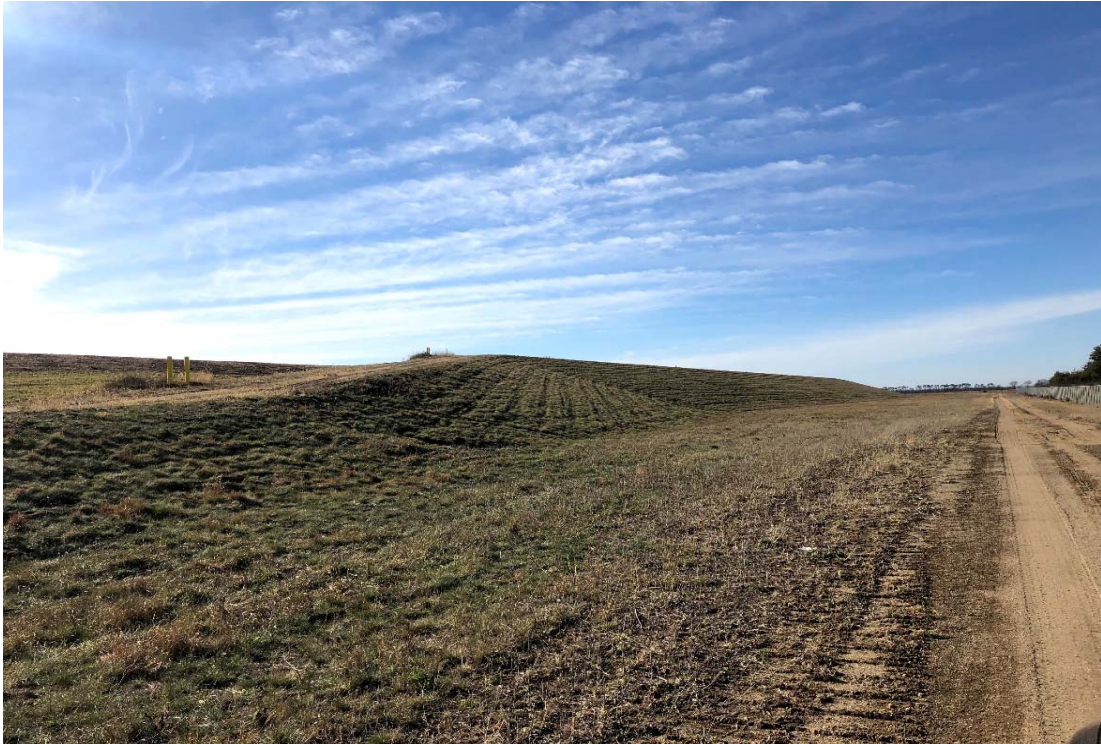
Photo 9	Exterior berm along the north side of the landfill, looking west.
11/19/2020

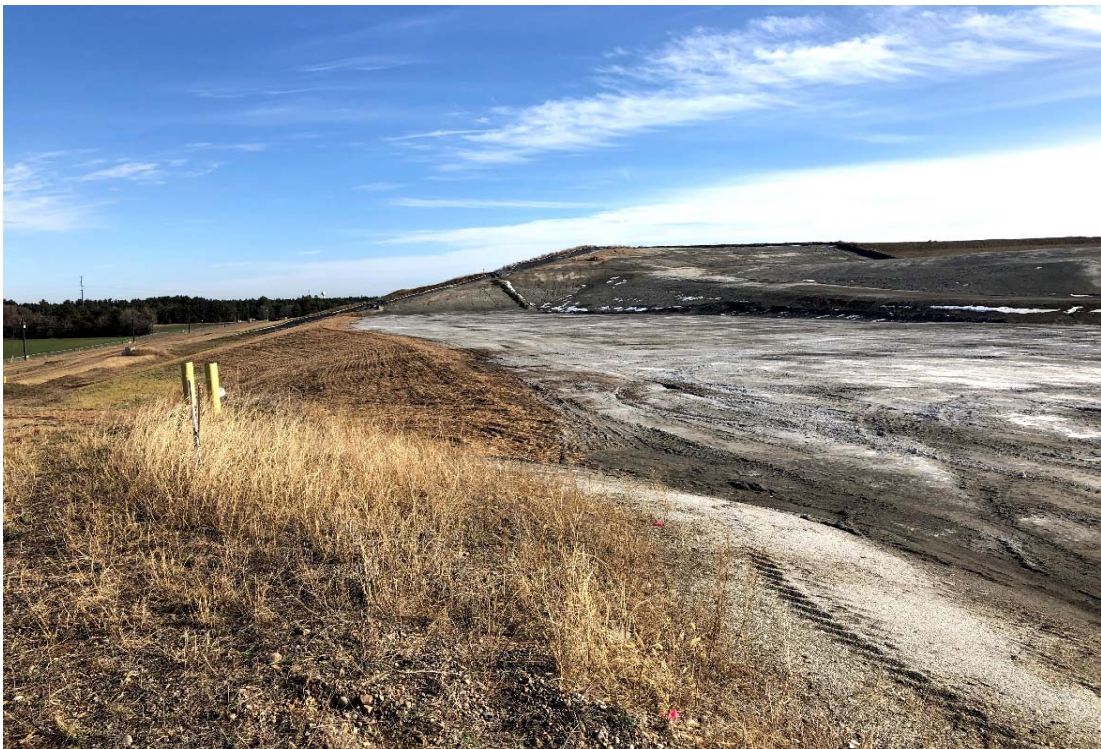
Photo 10	Left: Intermediate Cover. Right: Active area of landfill, looking east.
11/19/2020

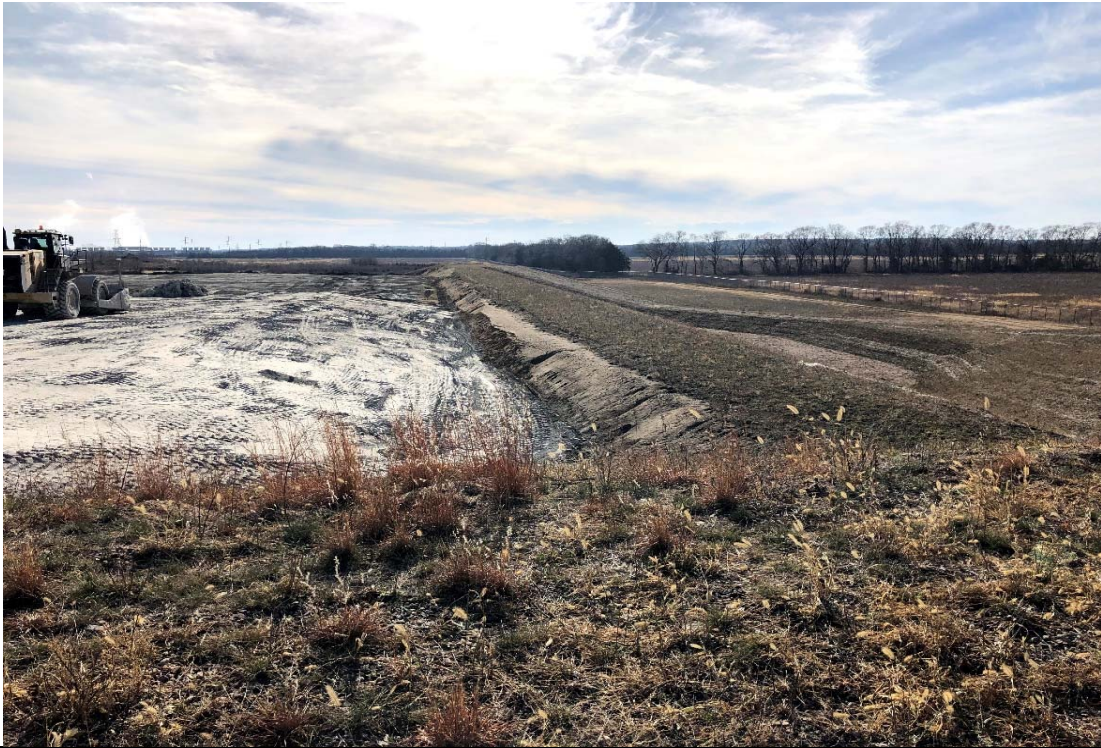
Photo 11	Left: Active area of landfill. Center: Interior of west berm, looking south.
11/19/2020

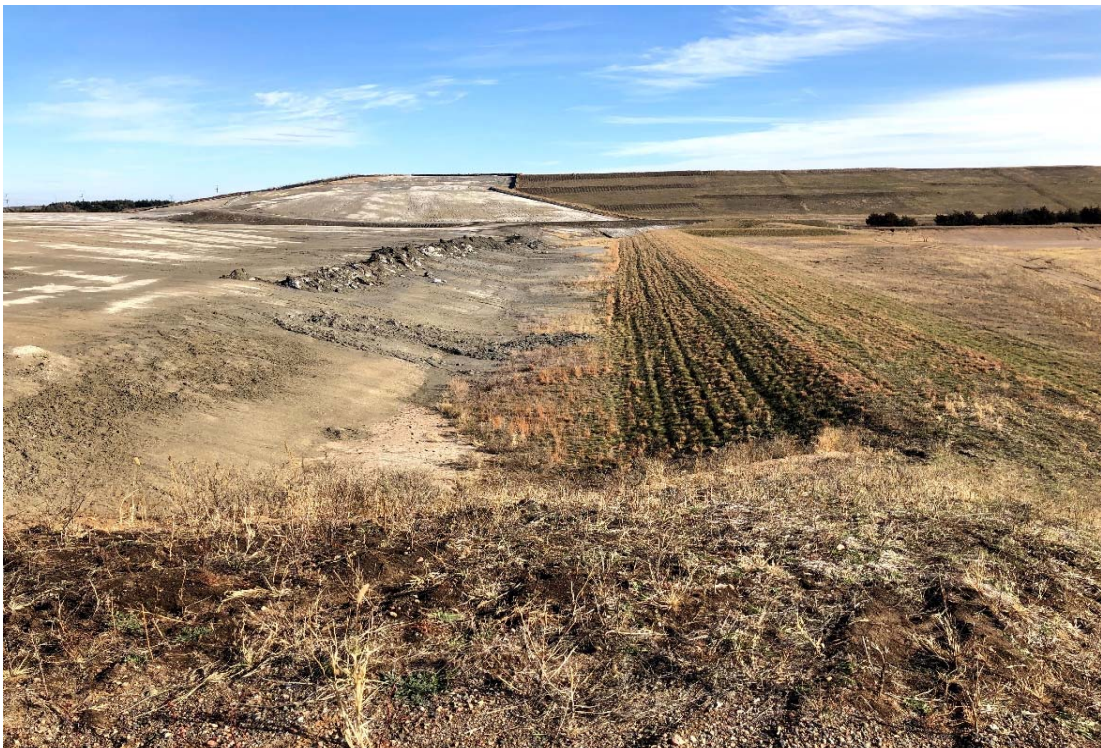
Photo 12	Left: Active area of landfill. Center: Southern berm, looking east.
11/19/2020
