2021 Annual Inspection Report

for Compliance with the Coal
Combustion Residuals Rule
(40 CFR Part 257)

Valmont Station

January 15, 2022

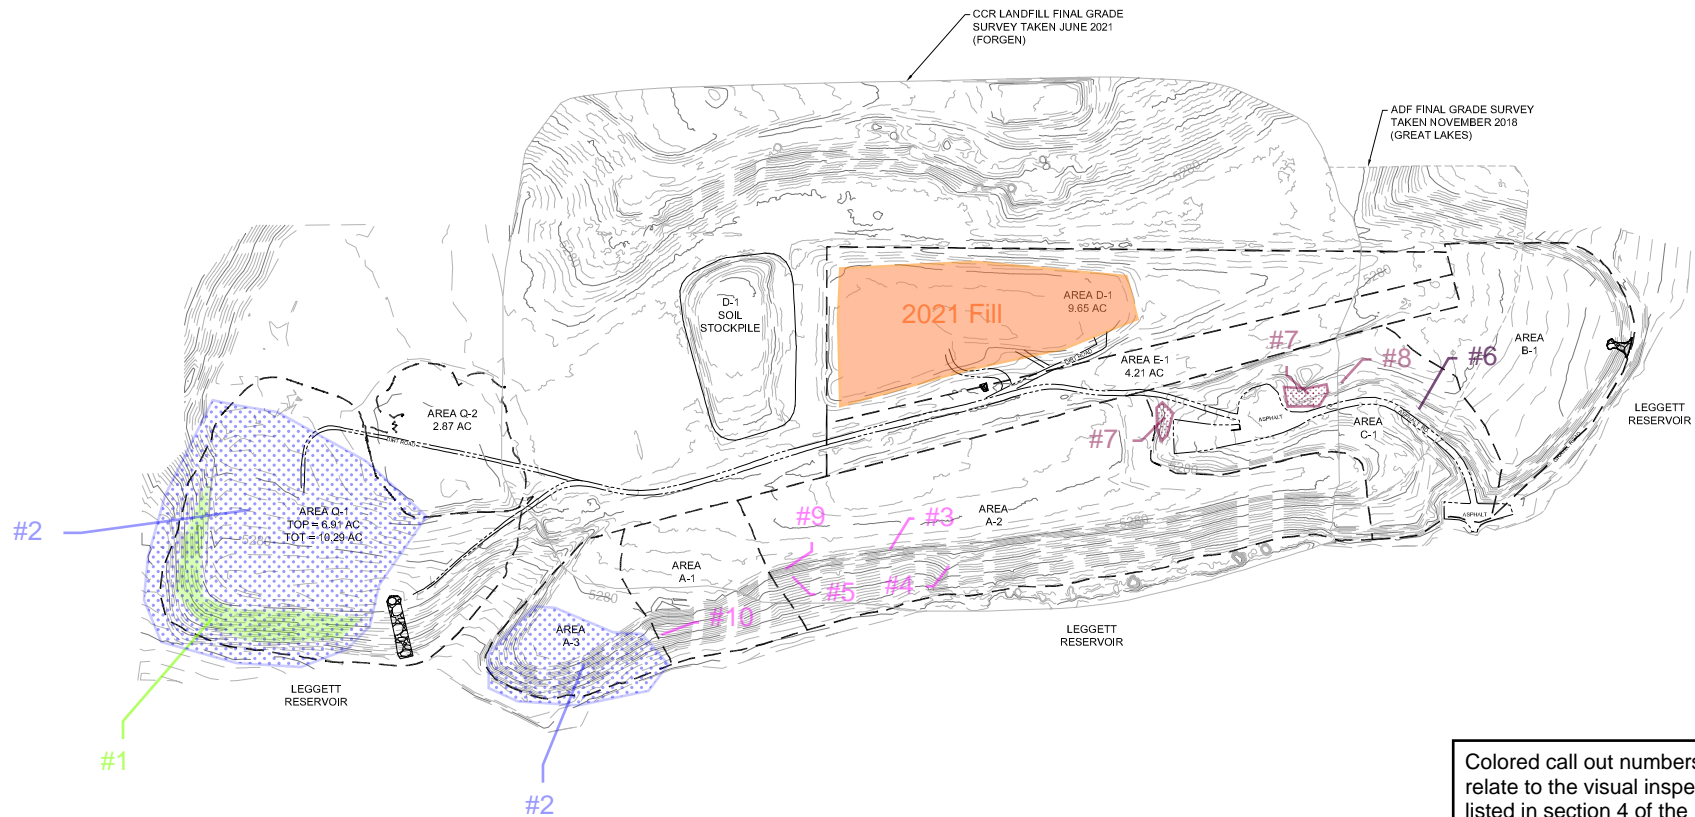
CCR Jan 2021 Annual Inspection Landfill Site Map - Figure 1.

1. The landfill side slopes along the south and west side of Area Q1 have minimal vegetation cover. It was noted during the 2020 annual inspection that despite the presence of regular benches to slow the stormwater flow, this area showed signs of minor rill erosion of varying depth. This rill erosion remains but has not become noticeably more pronounced in either depth or area of impact. This should continue to be monitored for worsening condition.

2. The western and southern side slopes of landfill areas Q1 and A3 have numerous active prairie dog burrows. The prairie dogs have continued to dig in Cell Q and have migrated toward A1. These burrows should continue to be monitored as they can impact local slope stability and become conduits for stormwater flow. Additionally, the prairie dogs have begun to dig up ash, creating small ash piles at the entrances to the burrows. These are no structural concerns but the burrowed ash does create containment

concerns. Some of the holes were managed previously by placing concrete over the holes, but prairie dogs re-dug holes adjacent many of the concrete plugs. PSCo reported that it is working with adjoining landowners to address the issue since prairie dog mitigation cannot be effectively addressed solely with on-site mitigation.

3. The southern slopes of Area A-2 show very small (less than 1-inch separation) tension cracks approximately 1-2 ft back from the top of the slope. The run of tension cracks is about 15' in total length comprised of multiple minor separate parallel cracks. This area requires continued monitoring for movement. There were no signs or new or expanded tension cracks since prior inspection.

4. Wildlife has created large burrow holes on the landfill side slope of Area A-2. No ash has been uncovered or is visible; however, there is bare soil on the south/downward facing side of A-2 located all around the east and west side of on-site riprap. This area will continue to be monitored and reseeding should be considered if the burrows are abandoned.

5. Minor sloughing observed on Area A-2 near burrows on the downward slope towards the reservoir. This area should be monitored for further deterioration.

6. Erosion was observed along the interior access road in cell C-1, specifically the west and south face of the steep cut face. This erosion is minimal due to the lack of sheet or concentrated flow over the cut face but the area should continue to be monitored. No ash was exposed and there are no signs of local slope instability.

8. Northeast of the 'Emergency Ash Holding Area' in cell C-1, there is approximately an 8 ft by 10 ft area of exposed ash. The cause or source of this ash exposure is undetermined but no structural or erosion concerns were apparent. Additional cover should be placed to cover exposed ash and then seeded.

10. It was noted during the 2020 inspection that the riprap down chute on south side of Area A-1 had become undermined by erosion and the weekly inspection reports in early 2021 noted that ash had become exposed in this location. Xcel resolved this issue as of 4/28/2021 by adding soil cover and seed after rebuilding and extending the riprap rundown further down slope.

Based on the site inspection, the landfill has no apparent structural weaknesses. Per Section 4 above, continued monitoring and minor repairs should be implemented as needed to address exposed ash, tension cracks, rill erosion, burrows, and apparent localized sloughing to prevent development of areas of structural weakness.
