2022 Annual Inspection Report

for Compliance with the Coal
Combustion Residuals Rule
(40 CFR Part 257)

Valmont Station

January 15, 2023

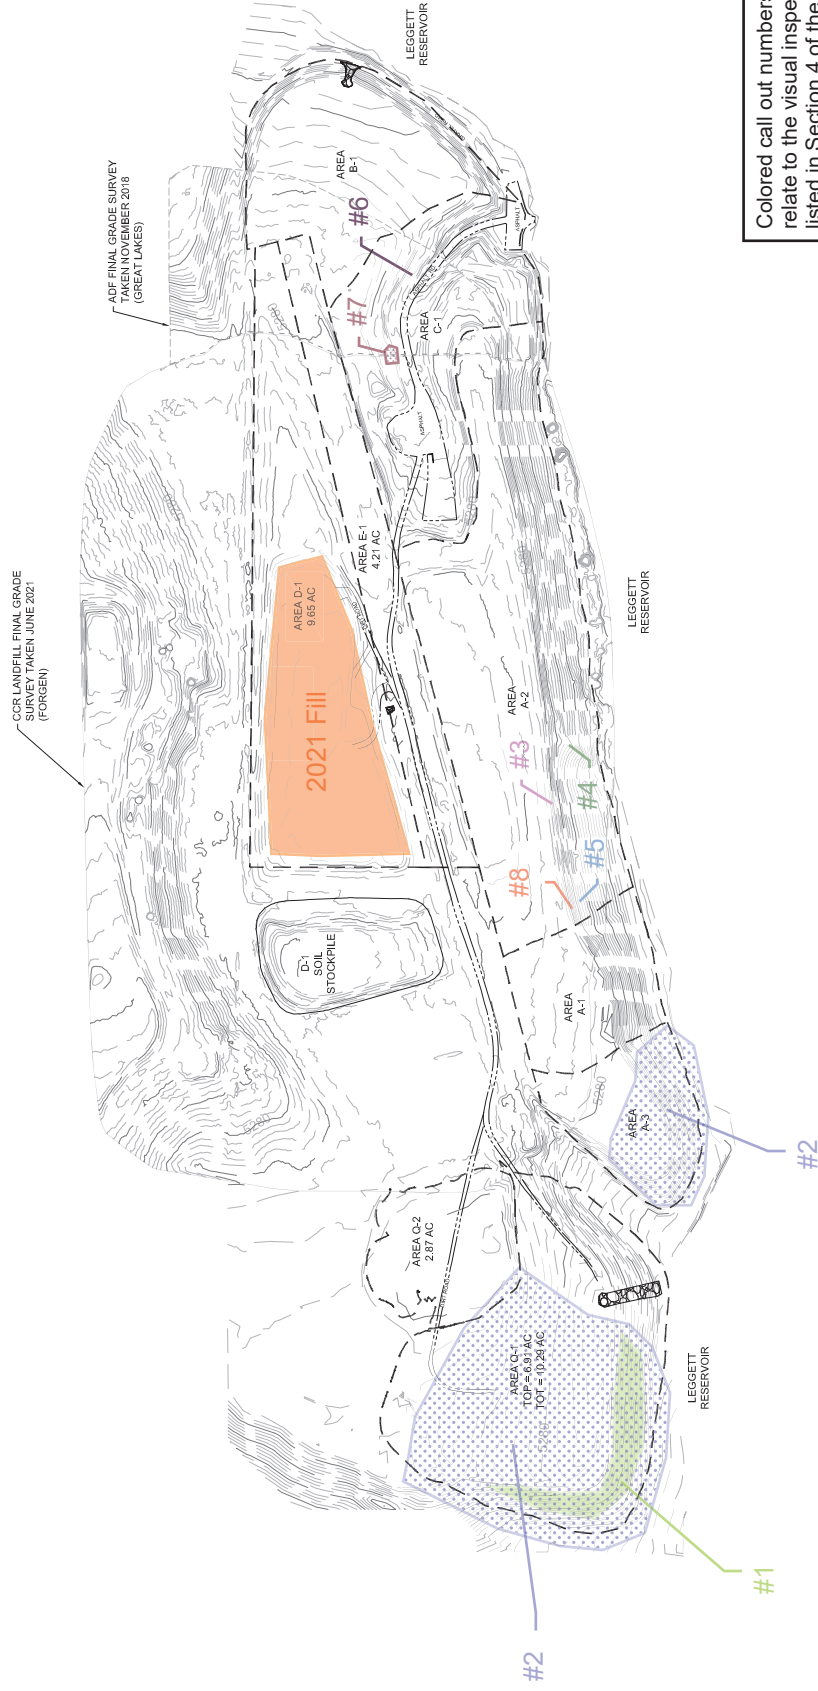
CCR Jan 2023 Annual Inspection Landfill Site Map - Figure 1.

1. The landfill side slopes along the south and west side of Area Q1 have minimal vegetation cover. It was noted during the 2020 annual inspection that despite the presence of regular benches to slow the stormwater flow, this area showed signs of minor rill erosion of varying depth. This rill erosion remains but has not become noticeably more pronounced in either depth or area of impact. This should continue to be monitored for worsening condition.
2. The western and southern side slopes of landfill areas Q1 and A3 have numerous active prairie dog burrows. The prairie dogs have continued to dig deeper in Cell Q and have migrated farther toward A1. These burrows should continue to be monitored as they can impact local slope stability and become conduits for stormwater flow. Additionally, the prairie dogs have begun to dig up ash, creating small ash piles at the entrances to the

burrows. These are no structural concerns but the burrowed ash does create containment concerns. Some of the holes were managed previously by placing concrete over the holes, but prairie dogs re-dug holes adjacent many of the concrete plugs. PSCo reported that it is working with adjoining landowners to address the issue since prairie dog mitigation cannot be effectively addressed solely with on-site mitigation.

3. The southern slopes of Area A-2 show very small (less than 1-inch separation) tension cracks approximately 1-2 ft back from the top of the slope. The run of tension cracks is about 15' in total length comprised of multiple minor separate parallel cracks. This area requires continued monitoring for movement. There were no signs or new or expanded tension cracks since prior inspection.

4. Wildlife has created large burrow holes on the landfill side slope of Area A-2. No ash has been uncovered or is visible; however, there is bare soil on the south/downward facing side of A-2 located all around the east and west side of on-site riprap. This area will continue to be monitored and reseeding should be considered if the burrows are abandoned.

5. Minor sloughing observed on Area A-2 near burrows on the downward slope towards the reservoir. This area should be monitored for further deterioration.

6. Erosion was observed along the interior access road in cell C-1, specifically the west and south face of the steep cut face. This erosion is minimal due to the lack of sheet or concentrated flow over the cut face but the area should continue to be monitored. No ash was exposed and there are no signs of local slope instability.

7. In the 2021 inspection it was noted that northeast of the 'Emergency Ash Holding Area' in cell C-1, there had been approximately an 8 ft by 10 ft area of exposed ash. The cause or source of this ash exposure was undetermined but no structural or erosion concerns were apparent. New cover has been placed in 2022 to cover exposed ash and was seeded.

8. PSCo previously installed hay bales to reduce concentrated flow on south slope of Area A-2. The down-gradient runout of this area was apparently seeded and mulched. Vegetation germination was not apparent. This area appears to have remained stable since remediation.

Based on the site inspection, the landfill has no apparent structural weaknesses. Per Section 4 above, continued monitoring and minor repairs should be implemented as needed to address exposed ash, tension cracks, rill erosion, burrows, and apparent localized sloughing to prevent development of areas of structural weakness.
