# 2018 Annual Inspection Report

for Compliance with the Coal  
Combustion Residuals Rule  
(40 CFR Part 257)

## **Valmont Station**

**January 18, 2019**

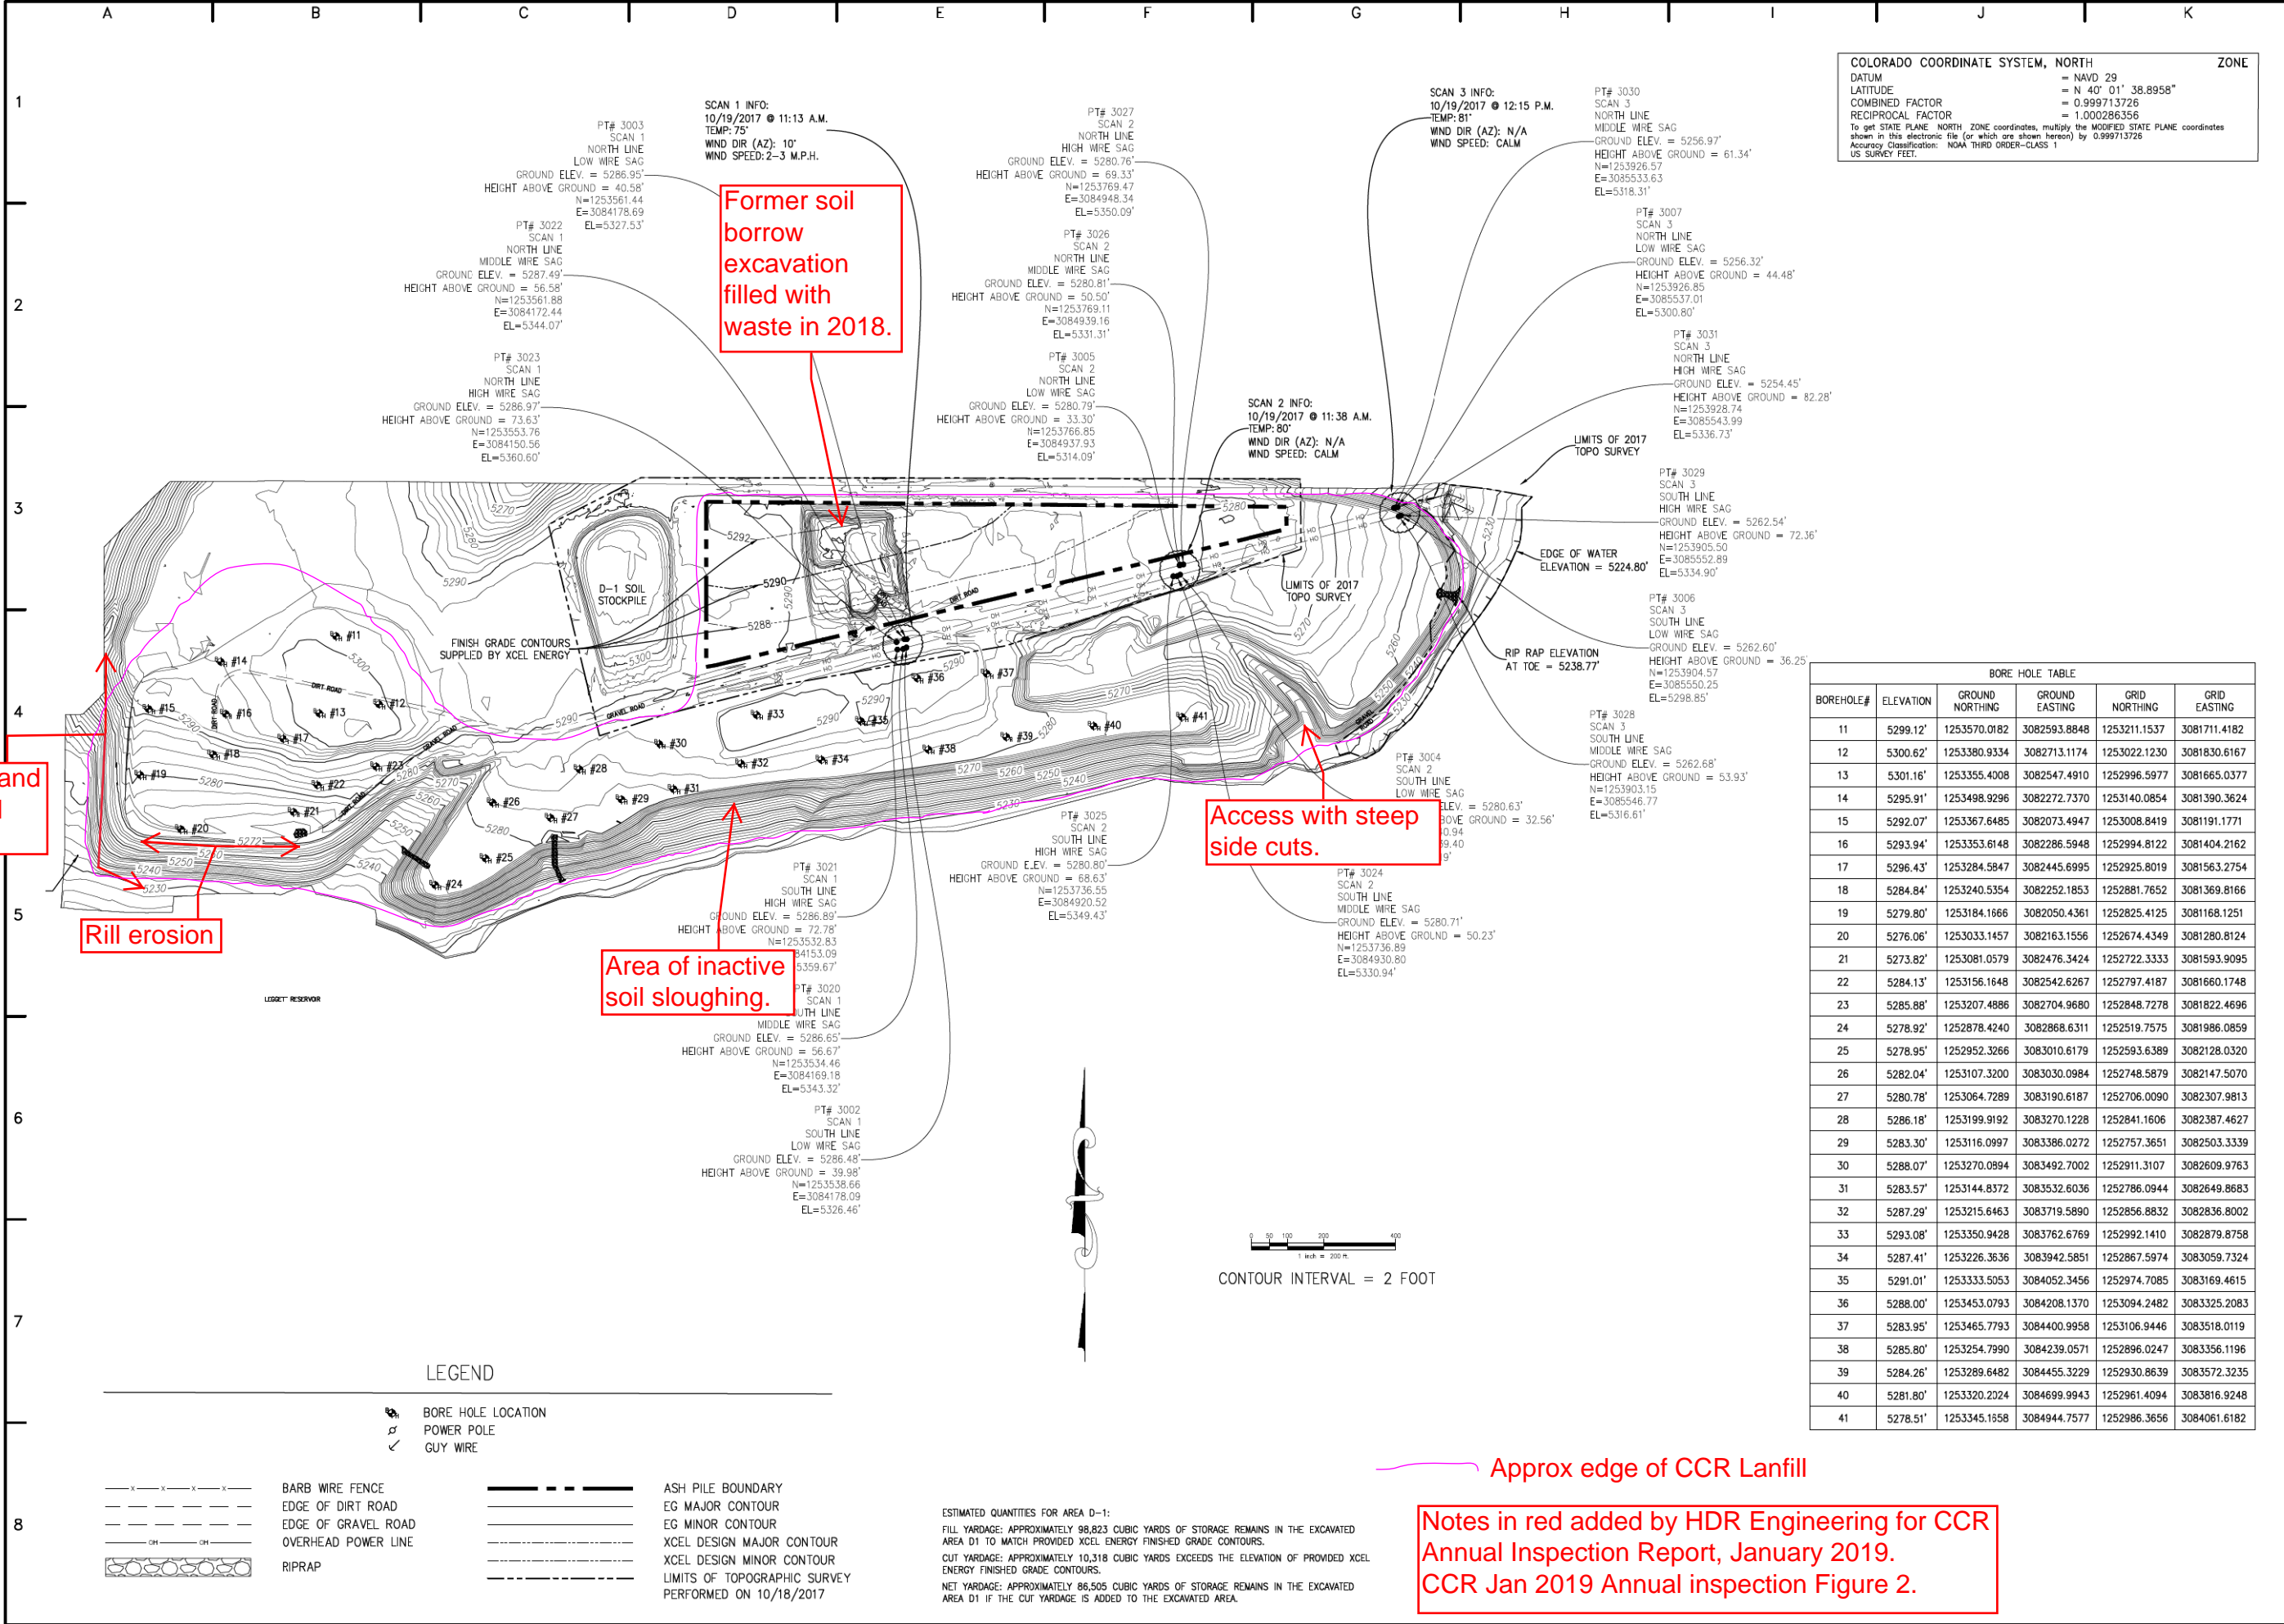
Notes in red added by HDR Engineering for CCR Annual Inspection Report, January 2019.  
 CCR Jan 2019 Annual inspection Figure 2.

ESTIMATED QUANTITIES FOR AREA D-1:  
 FILL YARDAGE: APPROXIMATELY 98,823 CUBIC YARDS OF STORAGE REMAINS IN THE EXCAVATED AREA D1 TO MATCH PROVIDED XCEL ENERGY FINISHED GRADE CONTOURS.  
 CUT YARDAGE: APPROXIMATELY 10,318 CUBIC YARDS EXCEEDS THE ELEVATION OF PROVIDED XCEL ENERGY FINISHED GRADE CONTOURS.  
 NET YARDAGE: APPROXIMATELY 86,505 CUBIC YARDS OF STORAGE REMAINS IN THE EXCAVATED AREA D1 IF THE CUT YARDAGE IS ADDED TO THE EXCAVATED AREA.
