Xcel Energy, Inc.  
Sherburne County Generating Station  
13999 Industrial Blvd.  
Becker, MN, 55308

**Re: 2018 Annual Inspection of Bottom Ash Pond**

FIGURE 1  
BOTTOM ASH POND  
2018 ANNUAL INSPECTION  
POND LAYOUT

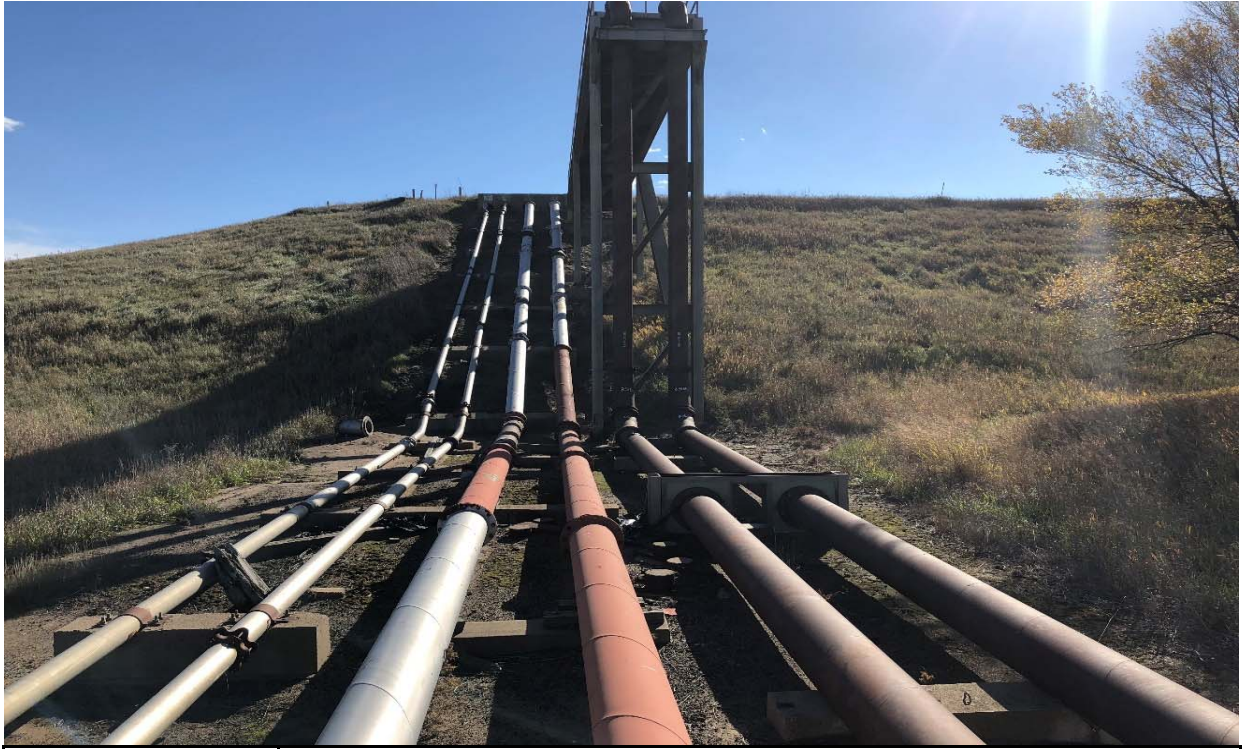
Photo 1	Bottom ash and scrubber pipes, looking south.
10/22/2018

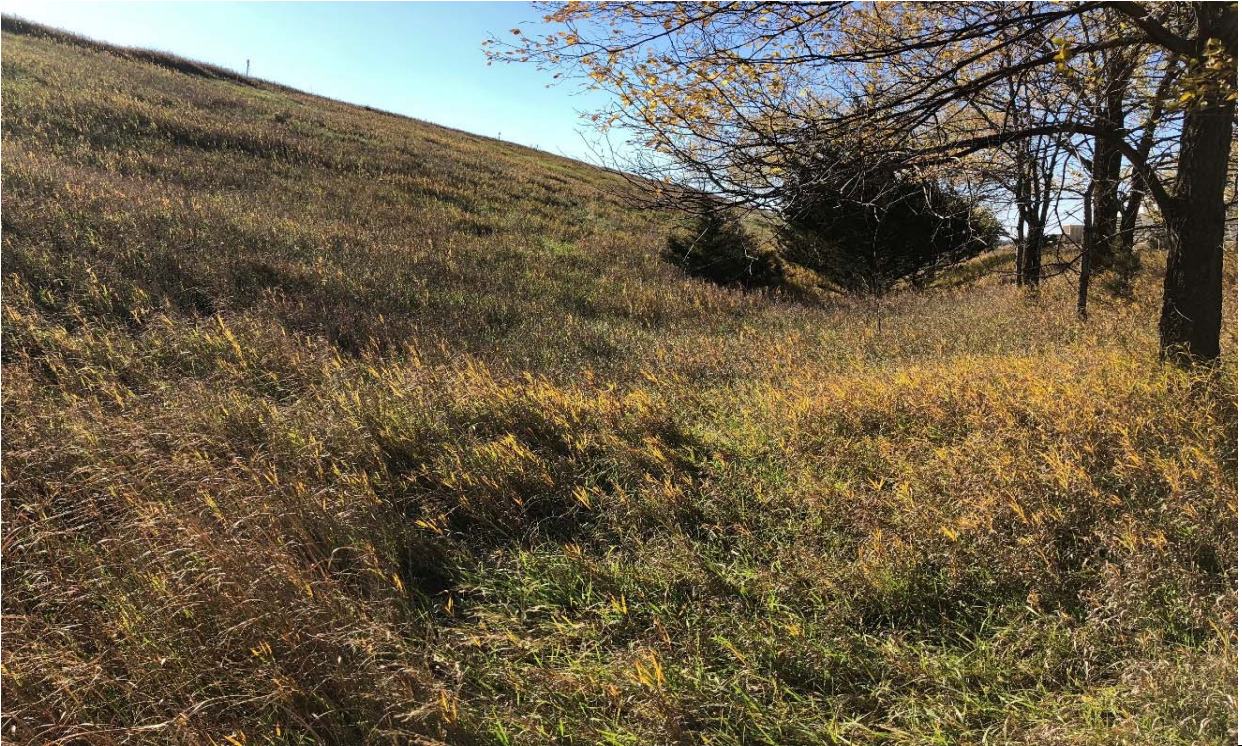
Photo 2	North embankment and perimeter ditch, looking west.
10/22/2018

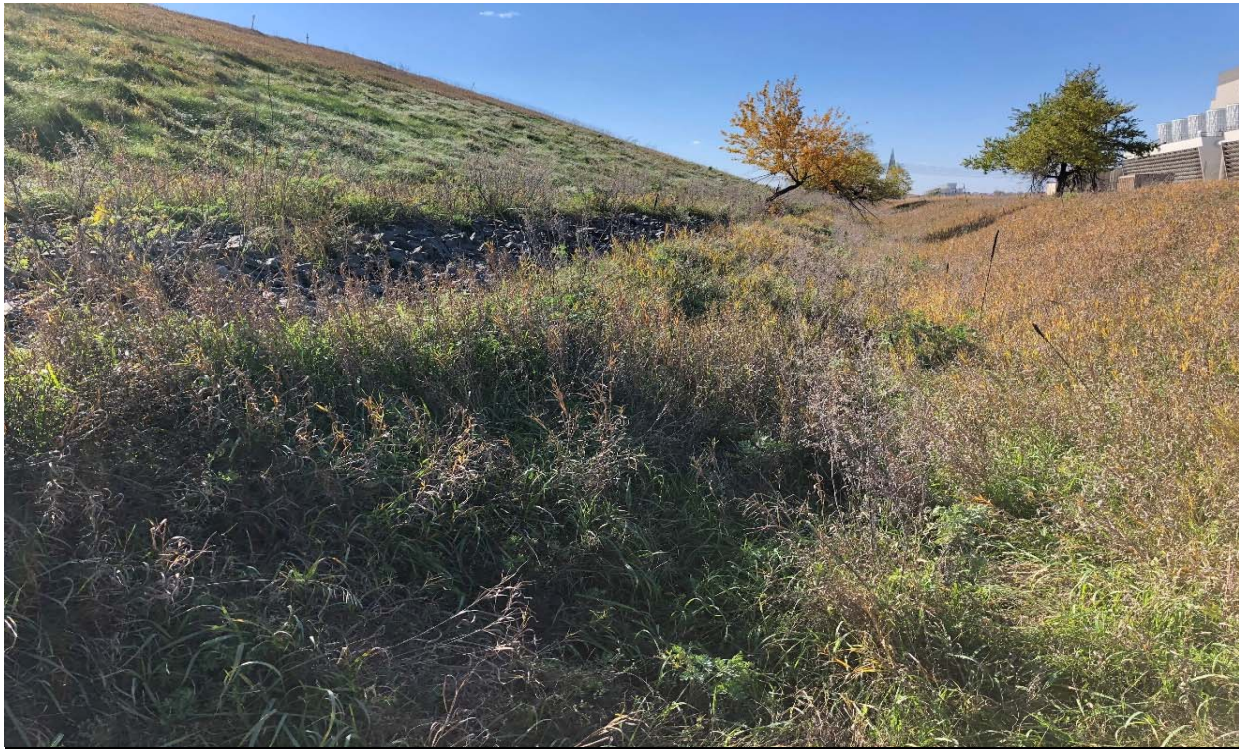
Photo 3	North embankment and riprap toe drain, looking west.
10/22/2018

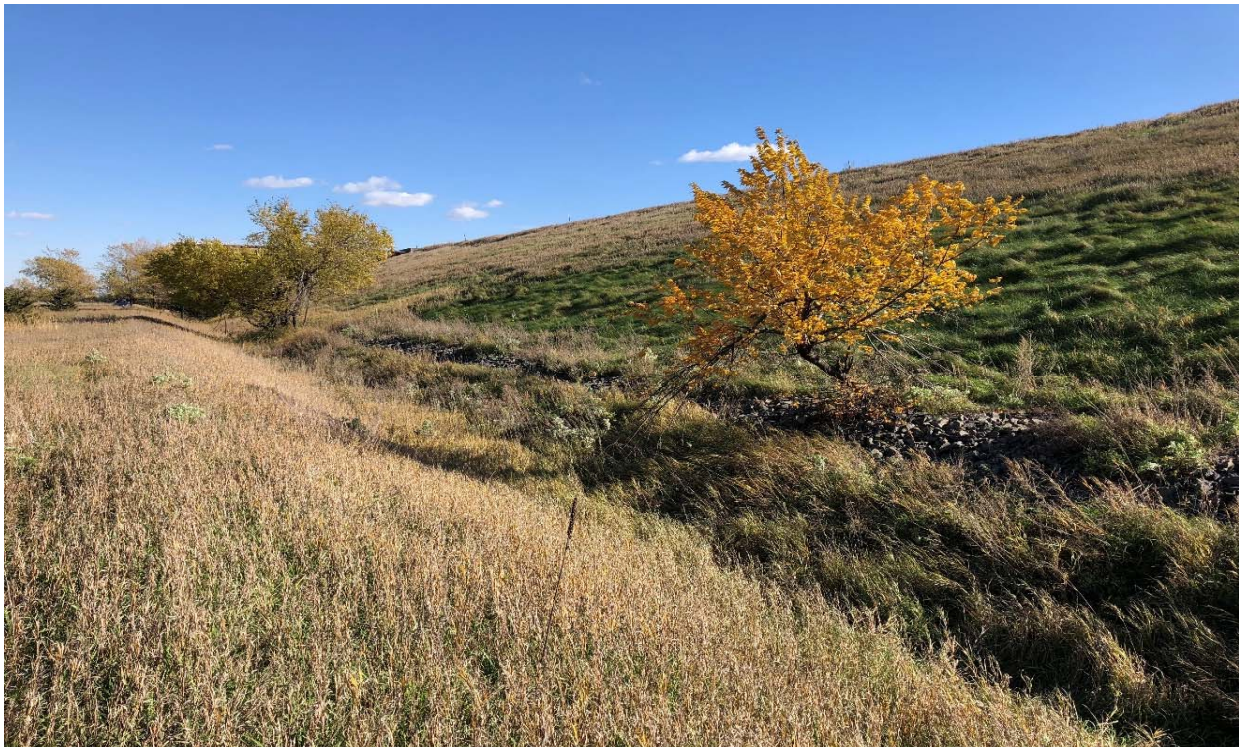
Photo 4	North embankment and riprap toe drain, looking east.
10/22/2018

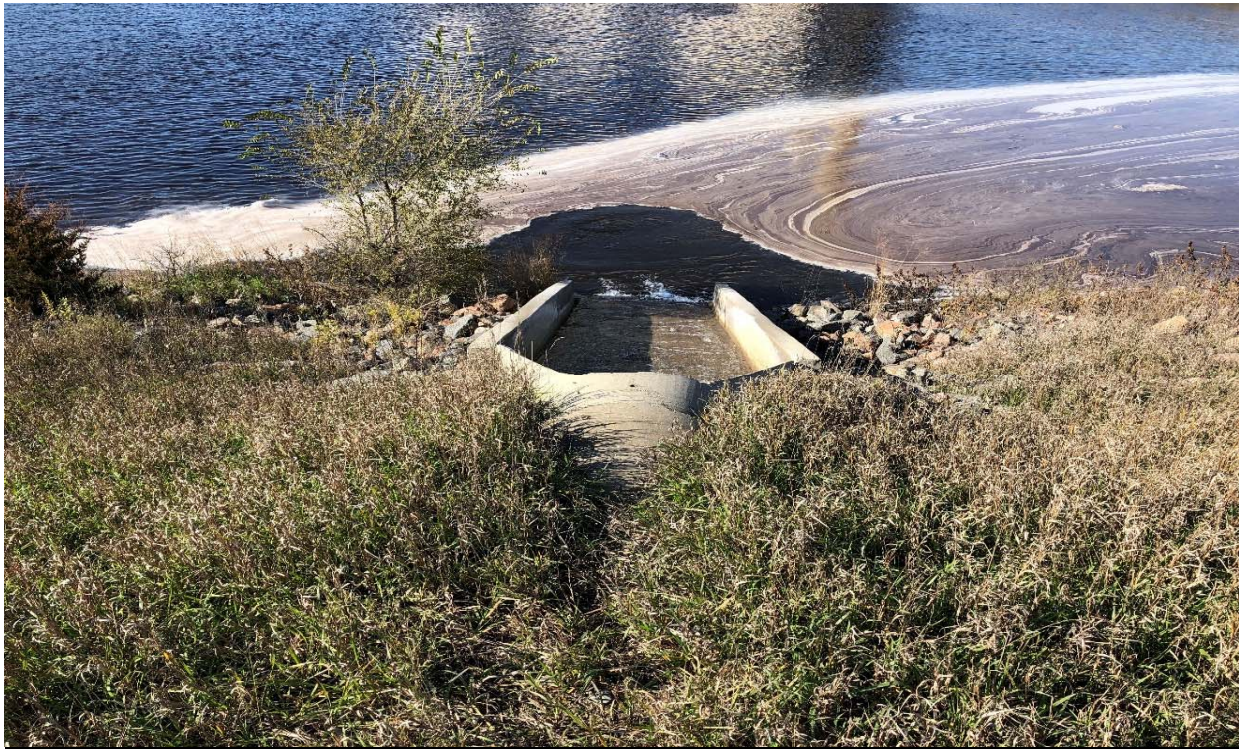
Photo 5	Bottom Ash Pond secondary outlet to Recycle Basin (Primary outlet is below the water level of the Recycle Basin).
10/22/2018

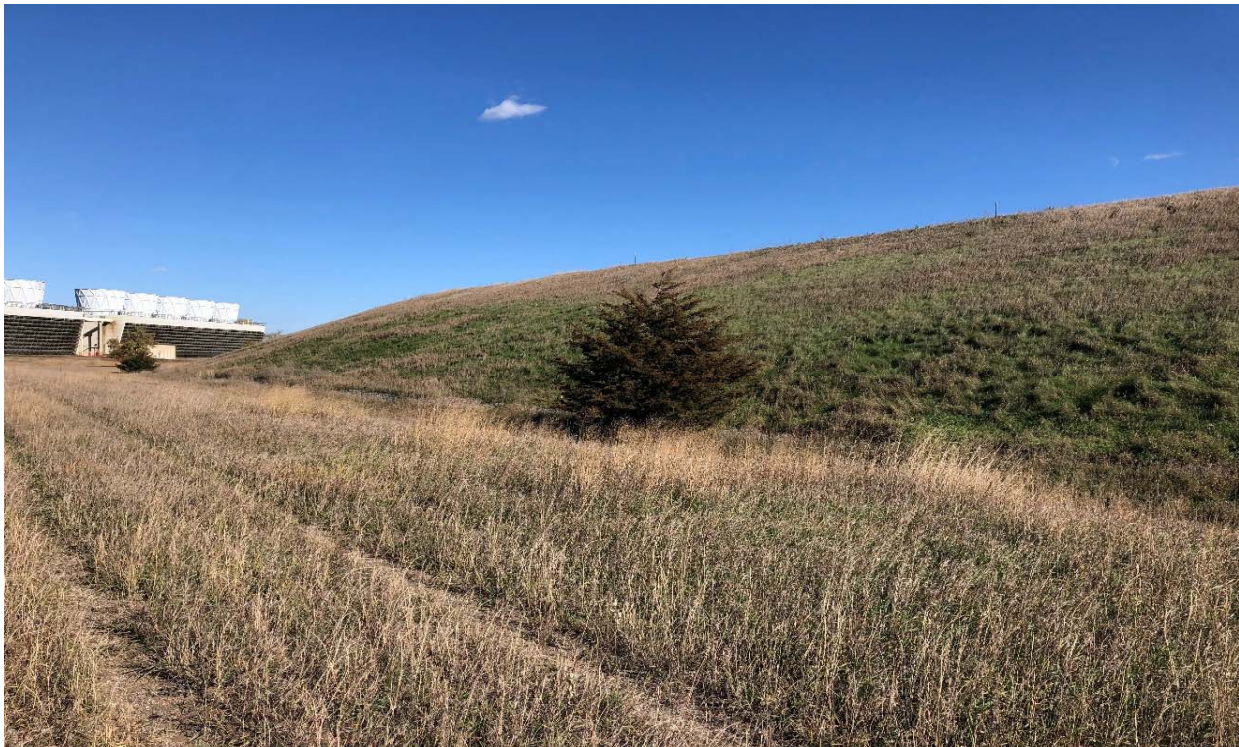
Photo 6	Northwest embankment, looking northeast.
10/22/2018

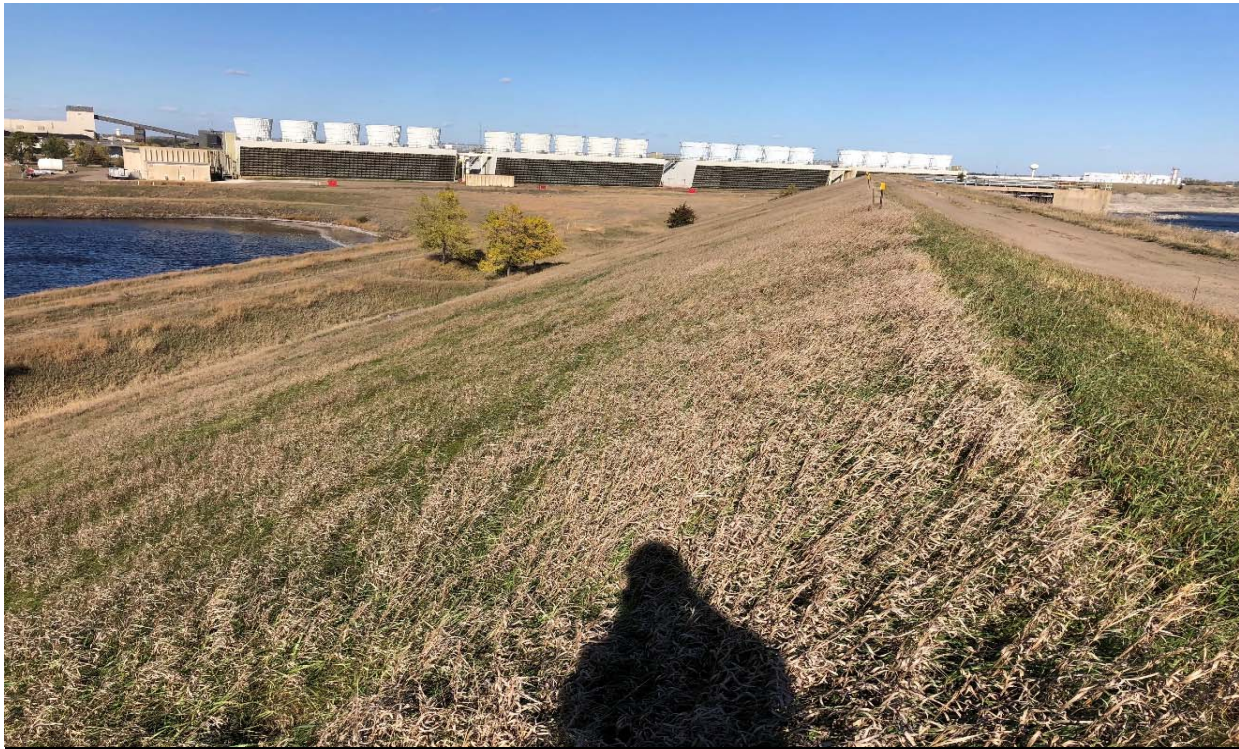
Photo 7	Northwest embankment, looking northwest.
10/22/2018

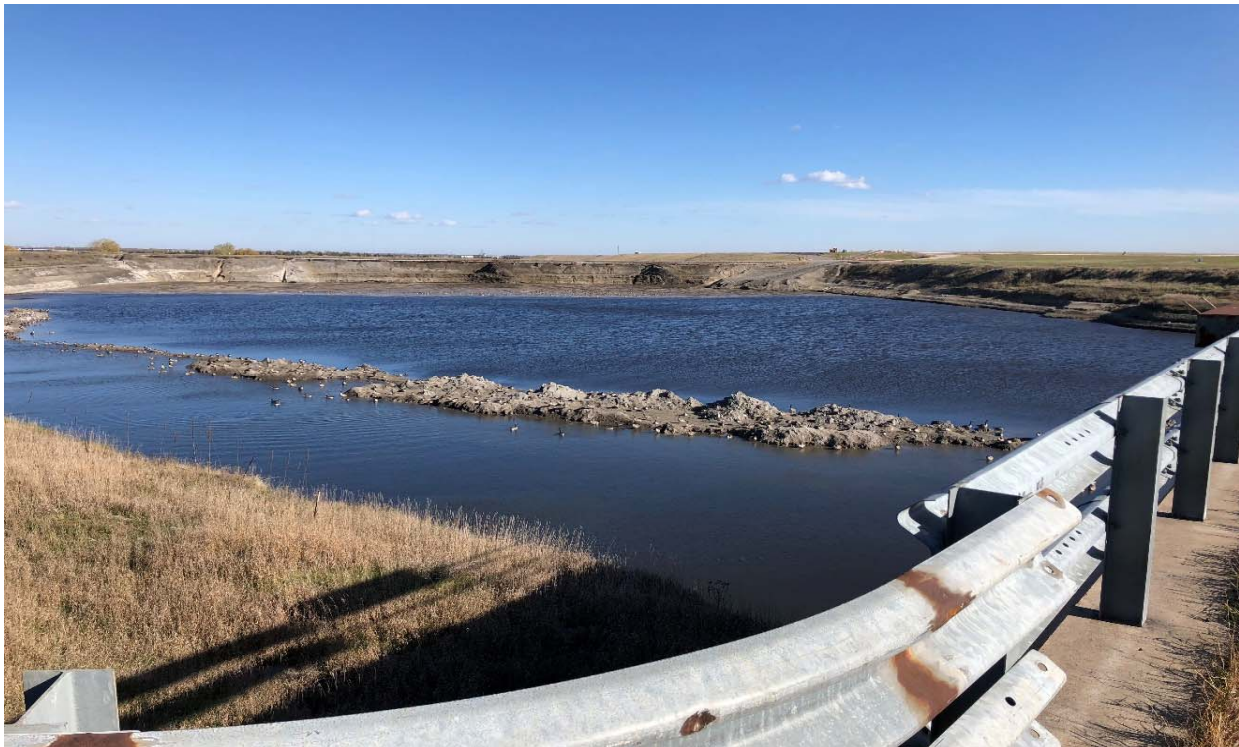
Photo 8	Pond interior, looking east.
10/22/2018

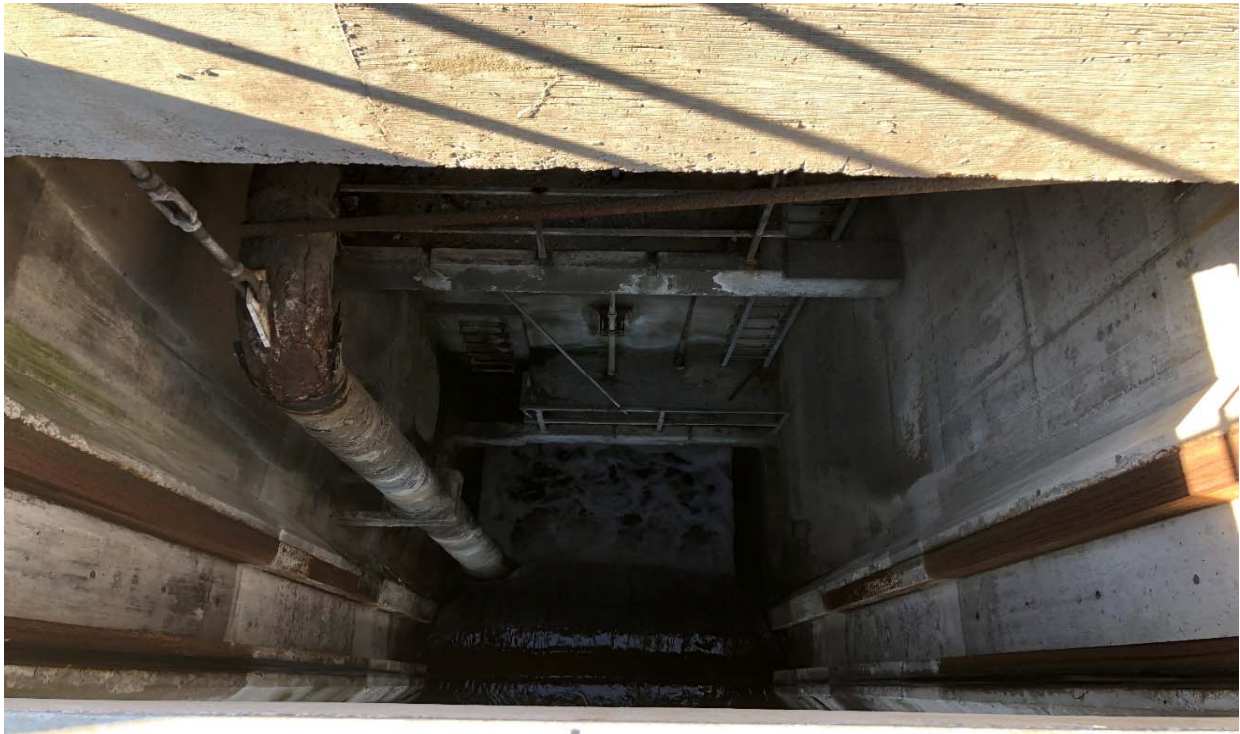
The water level in the BAP is controlled by concrete stop-logs in the discharge. All decreases in water level are attributed to the removal of stop logs.

Photo 9	Photo from inside the discharge structure. Shows stop-log metal channels
10/22/2018	and water flowing over concrete stop-log at the bottom of the channel.

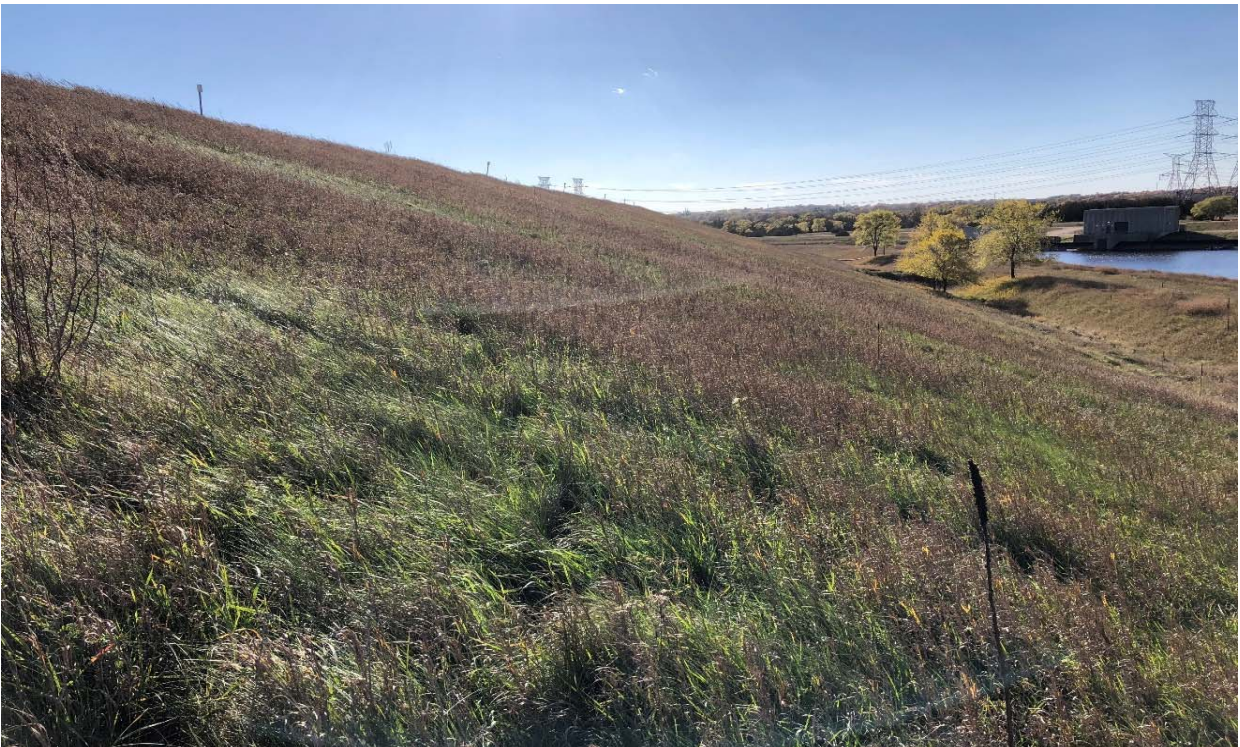
Photo 10	Mid-slope of northwest embankment, looking southwest.
10/22/2018

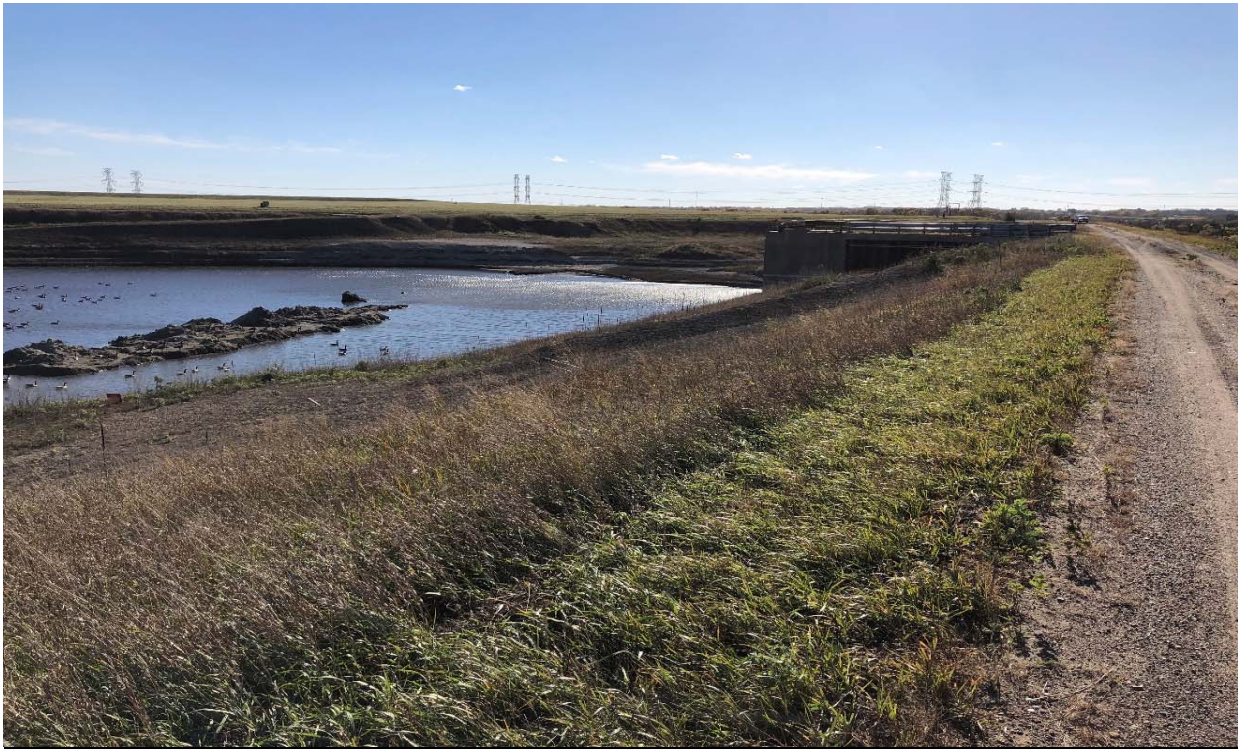
Photo 11	Pond interior, looking southwest.
10/22/2018

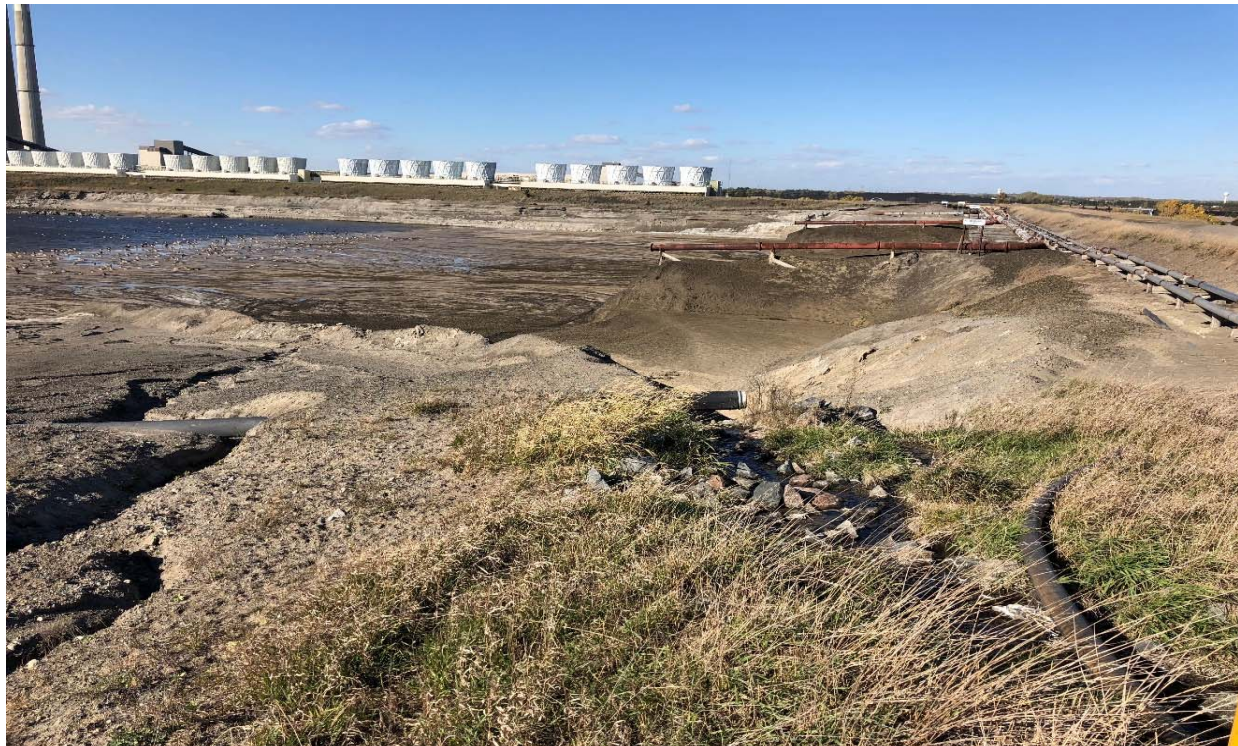
Photo 12	Pond interior, looking north.
10/22/2018

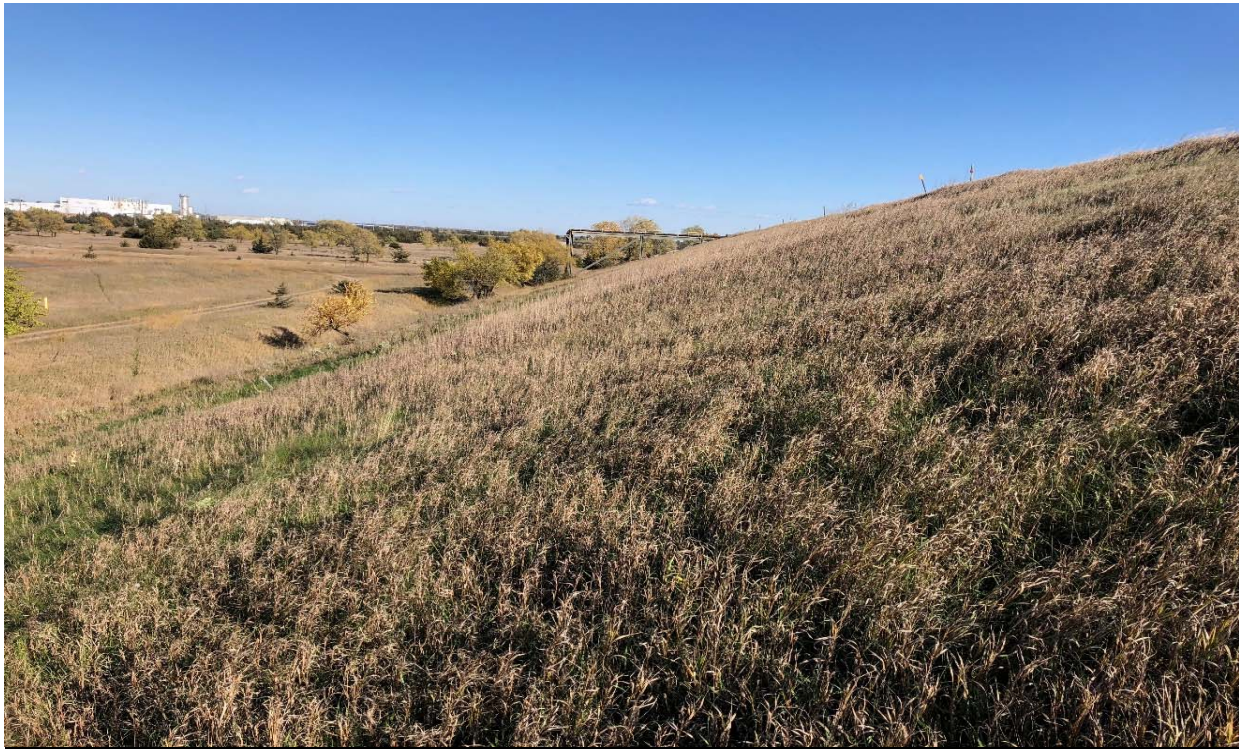
Photo 13	Mid-slope of north embankment, looking east.
10/22/2018

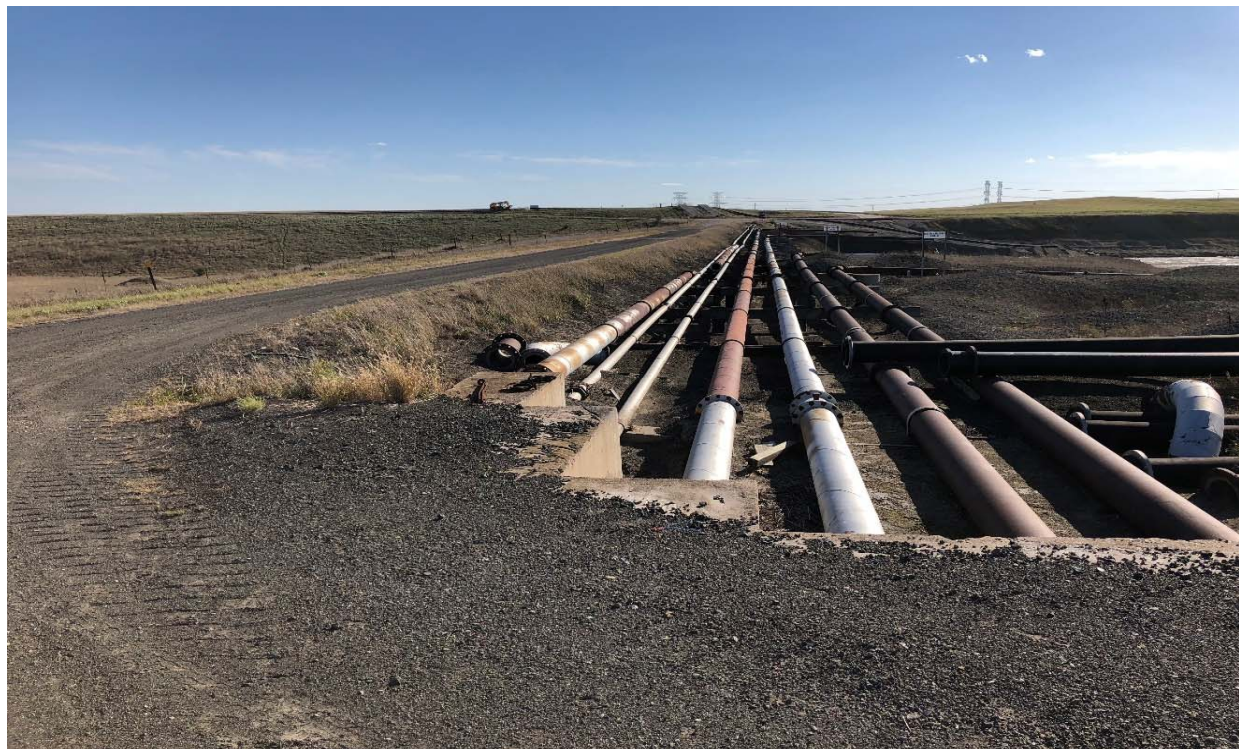
Photo 14	Interior of east embankment, looking south.
10/22/2018

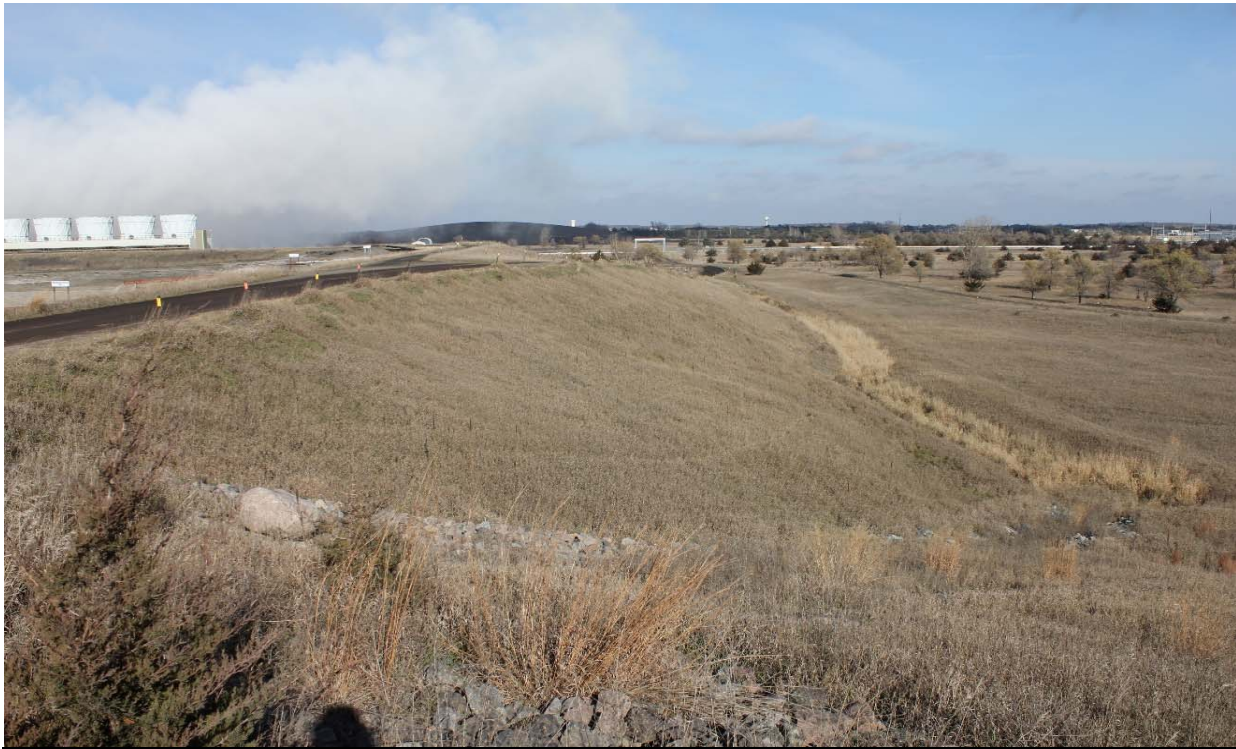
Photo 15	East embankment, looking north.
10/22/2018

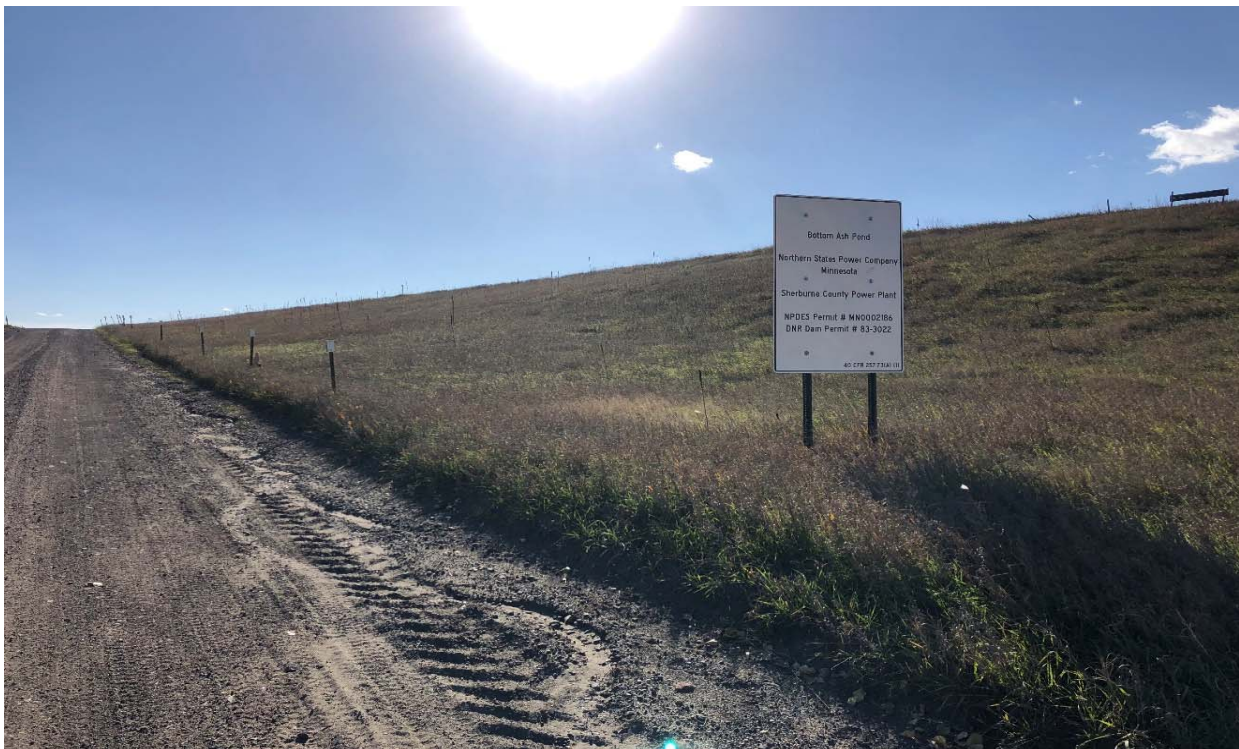
Photo 16	CCR Unit identification marker placed in accordance with Section 257.73.
10/22/2018
