Xcel Energy, Inc.  
Sherburne County Generating Station  
13999 Industrial Blvd.  
Becker, MN, 55308

**Re: 2017 Annual Inspection of Bottom Ash Pond**

## Bottom Ash Pond Annual Inspection - November 2017

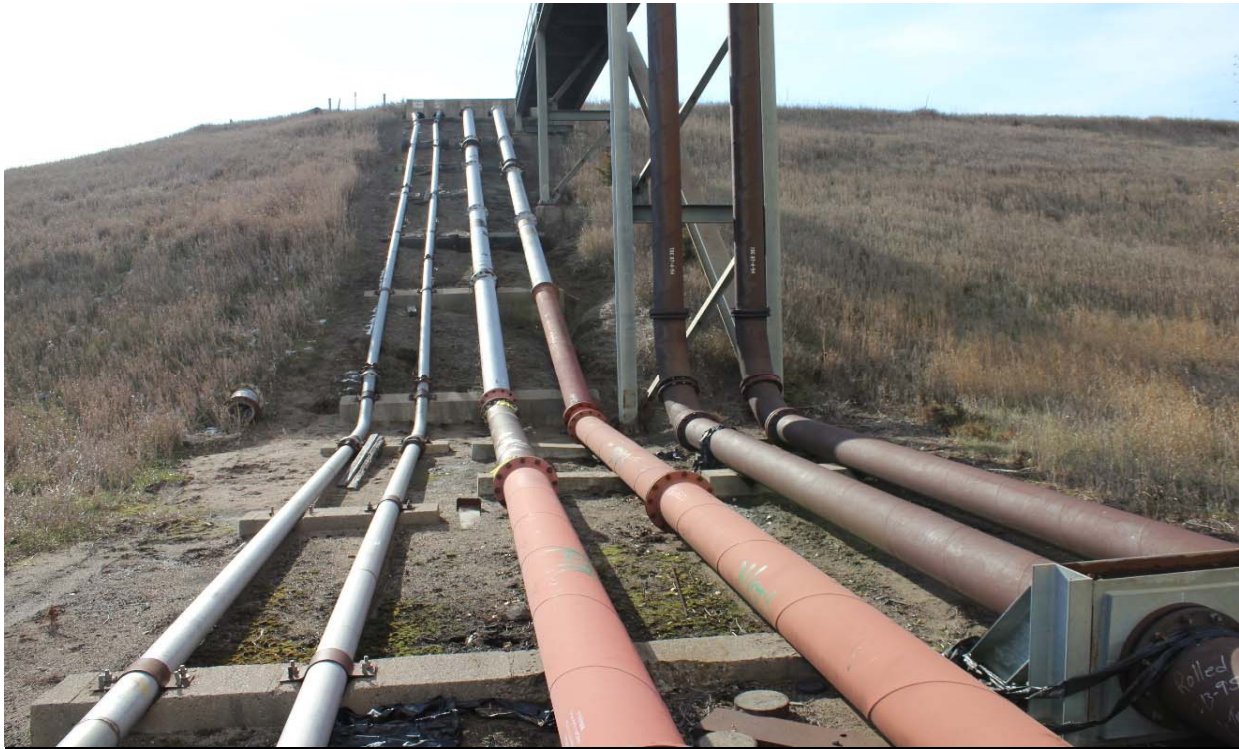
| Photo 1 | Bottom ash and scrubber pipes, looking south. |

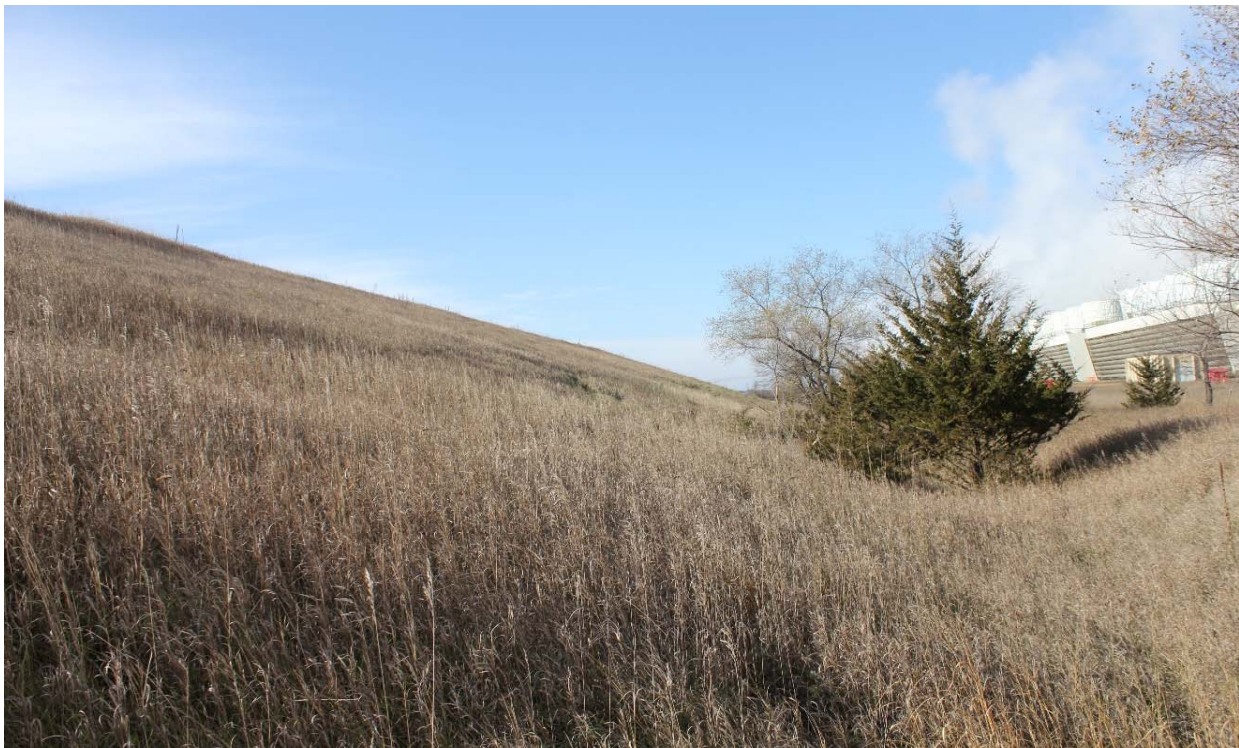
| Photo 2 | North embankment and perimeter ditch, looking west. |

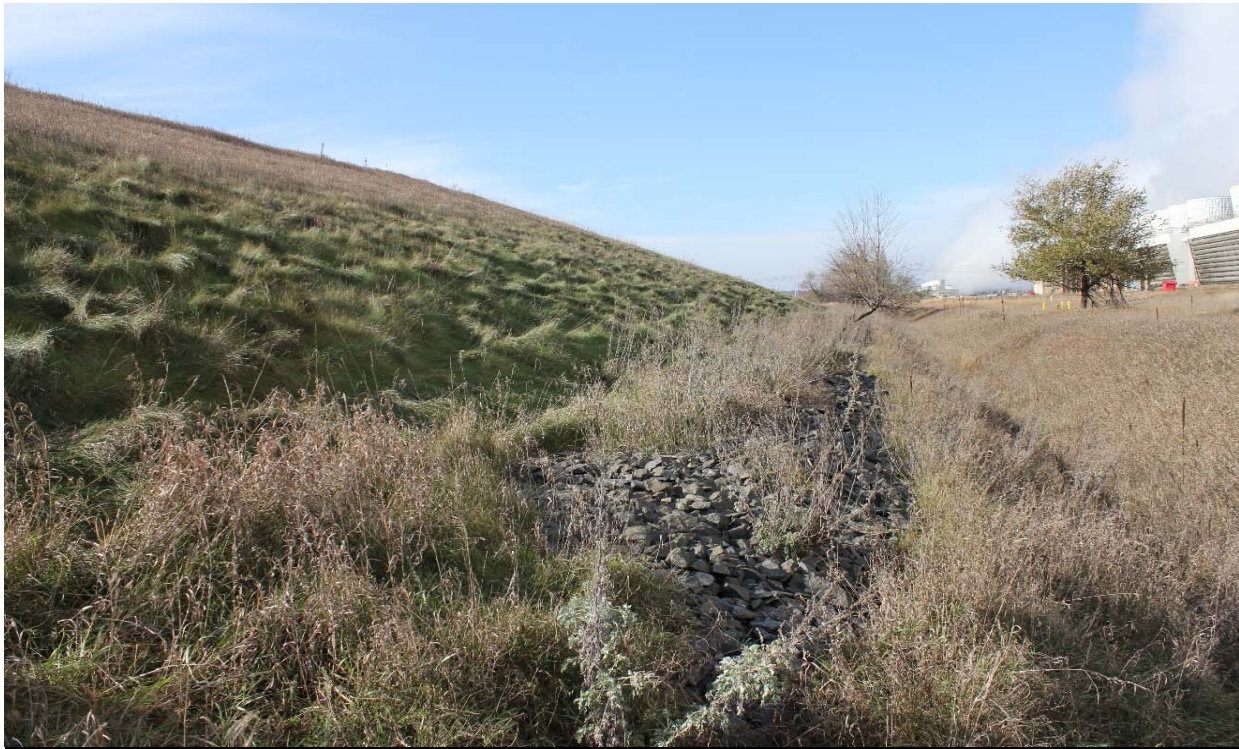
| Photo 3 | North embankment and riprap toe drain, looking west. |

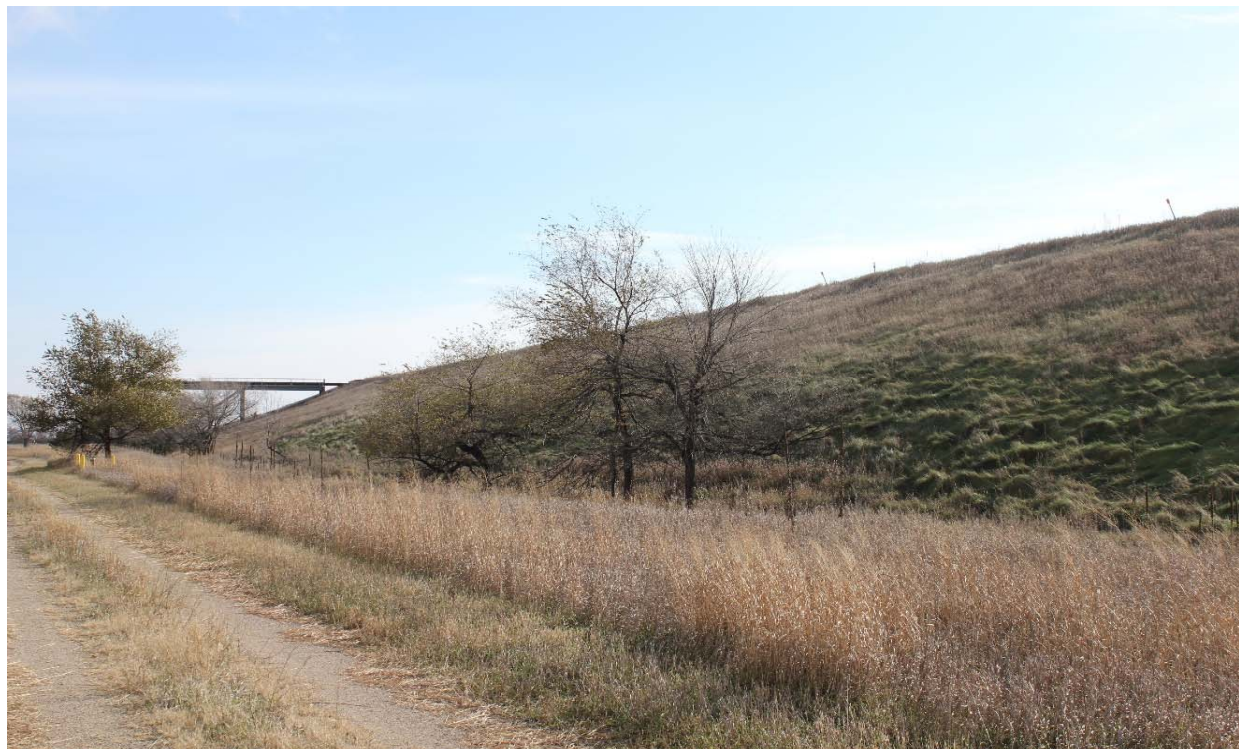
| Photo 4 | North embankment and riprap toe drain, looking east. |

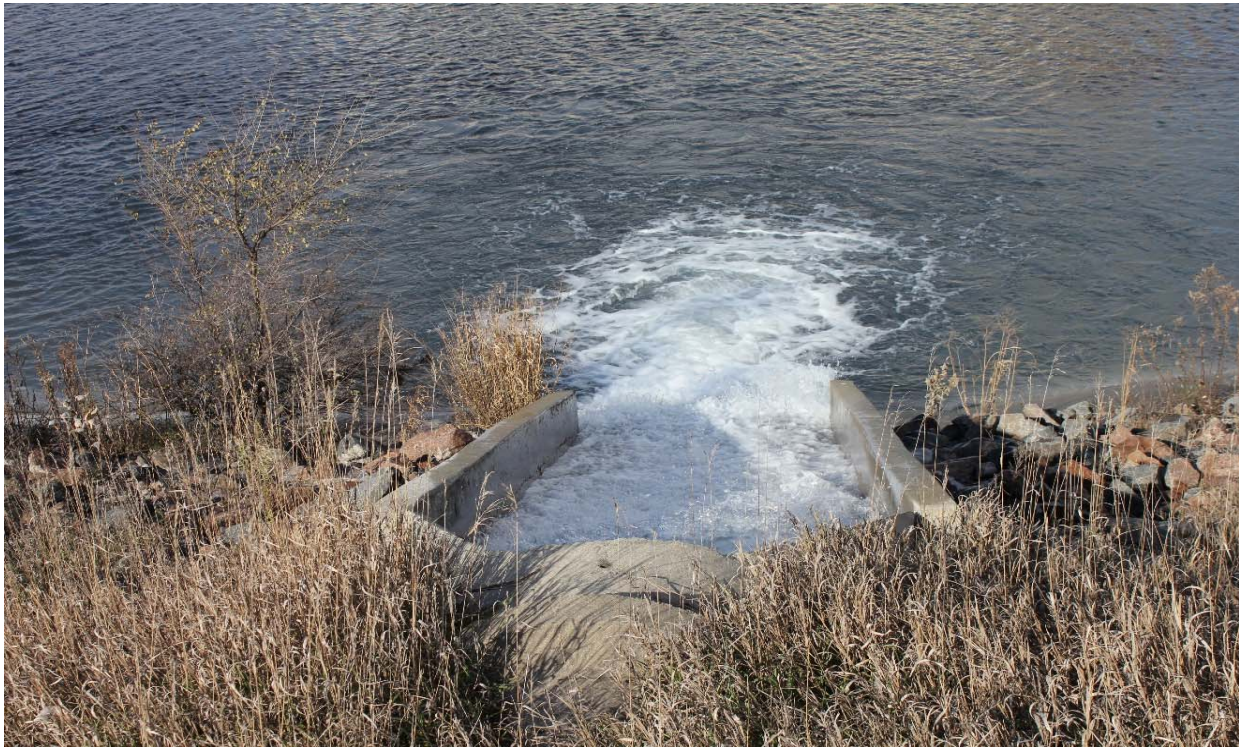
| Photo 5 | Bottom Ash Pond secondary outlet to Recycle Basin (Primary outlet is below the water level of the Recycle Basin). |

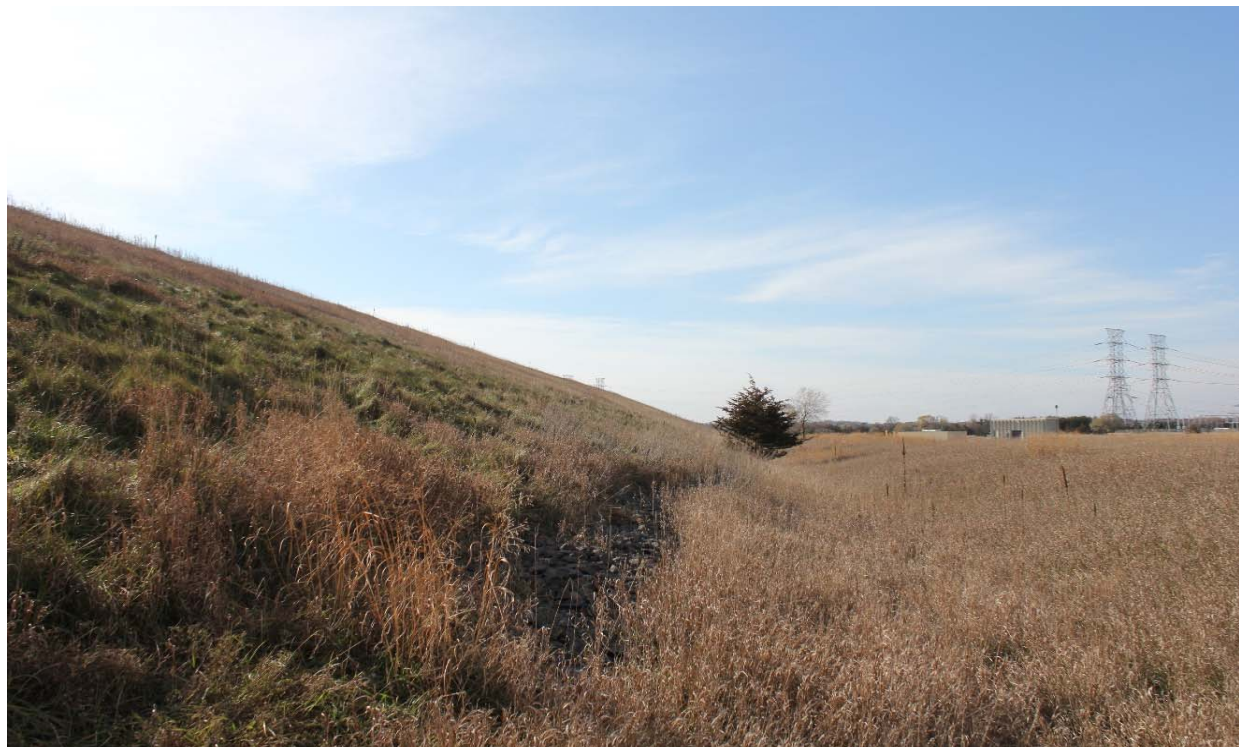
| Photo 6 | Northwest embankment riprap toe drain, looking southwest. |

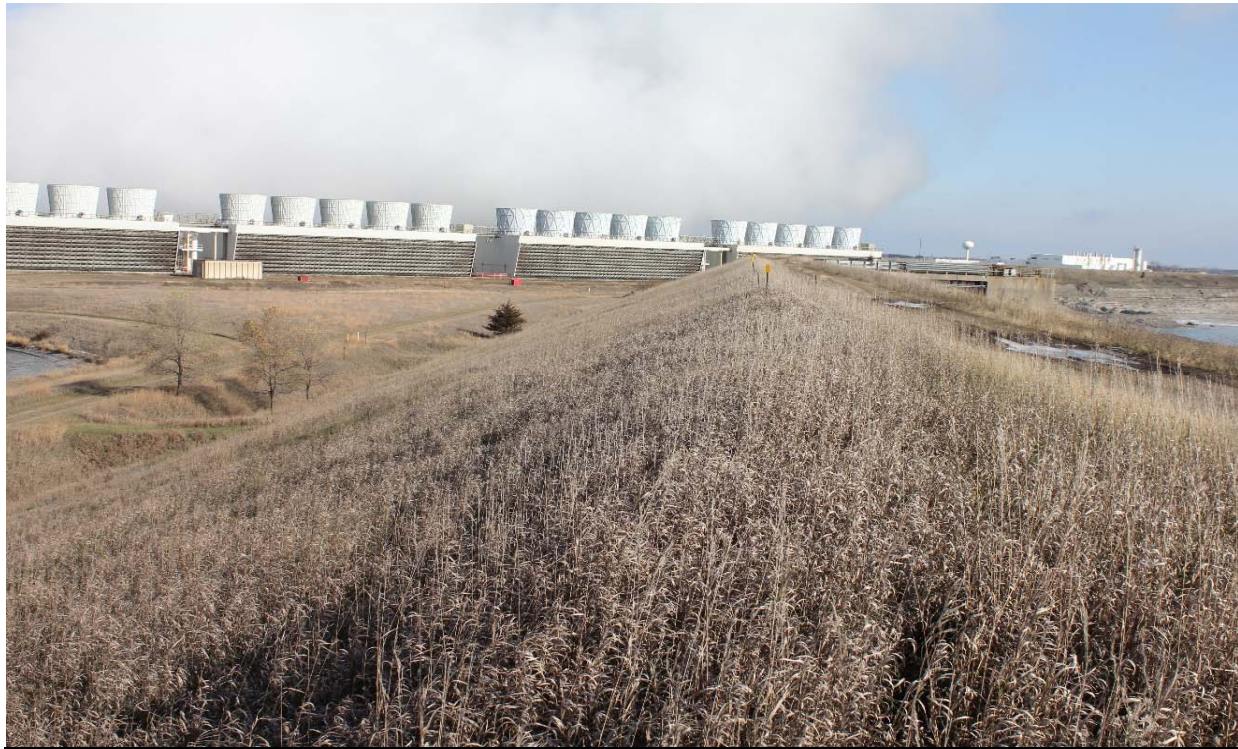
| Photo 7 | Northwest embankment, looking northeast. |

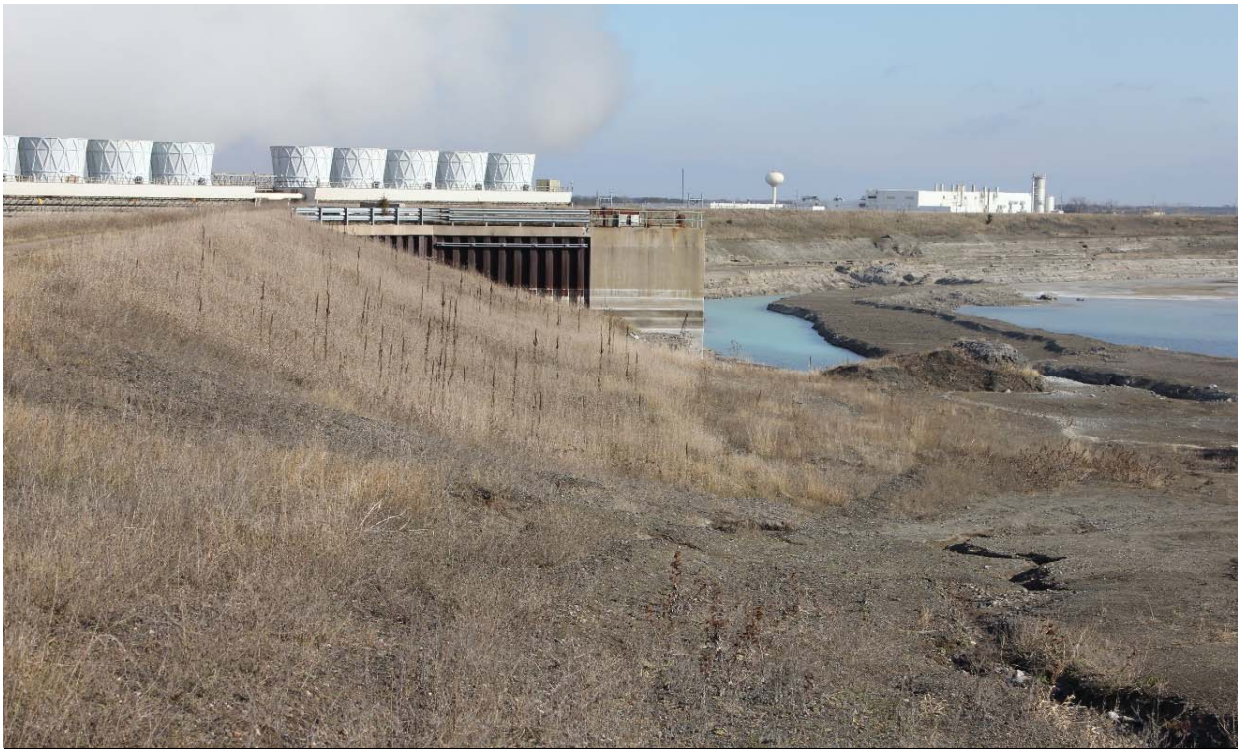
| Photo 8 | Pond interior, looking northeast. |

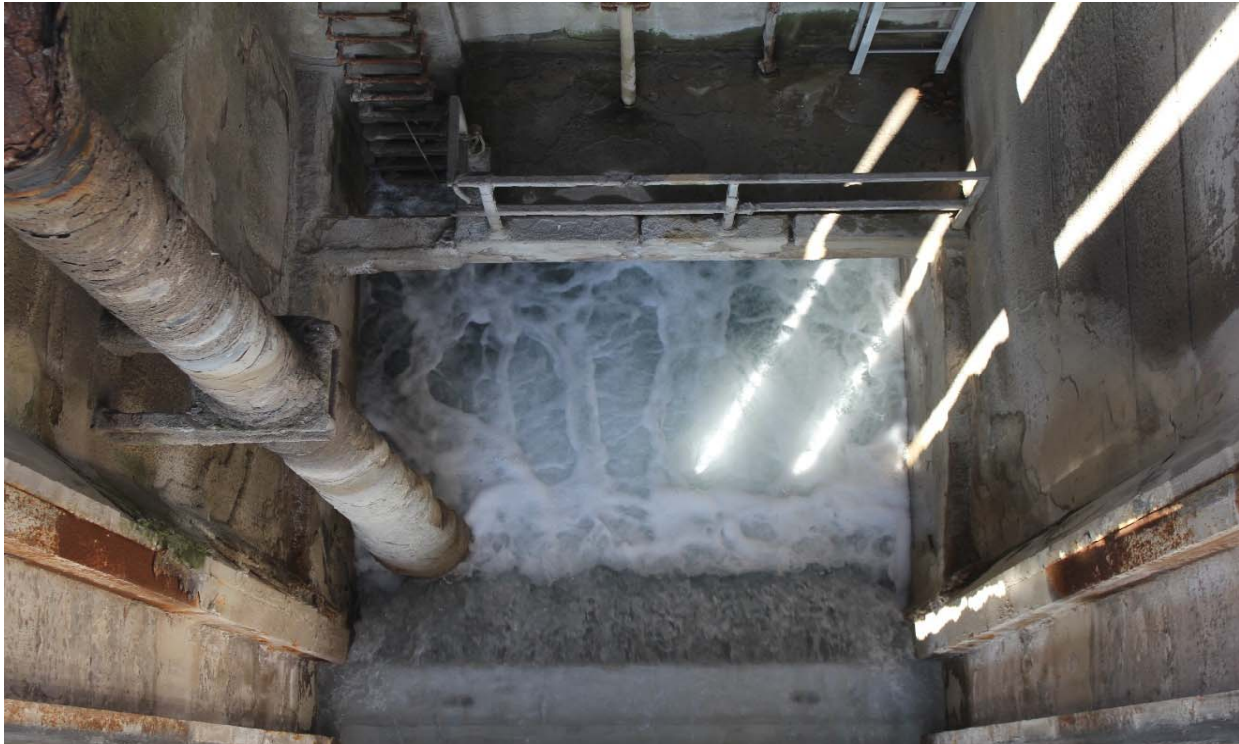
The water level in the BAP is controlled by concrete stop-logs in the discharge. All decreases in water level are attributed to the removal of stop logs.

| Photo 9 | Photo from inside the discharge structure. Shows stop-log metal channels and water flowing over concrete stop-log at the bottom of the channel. |

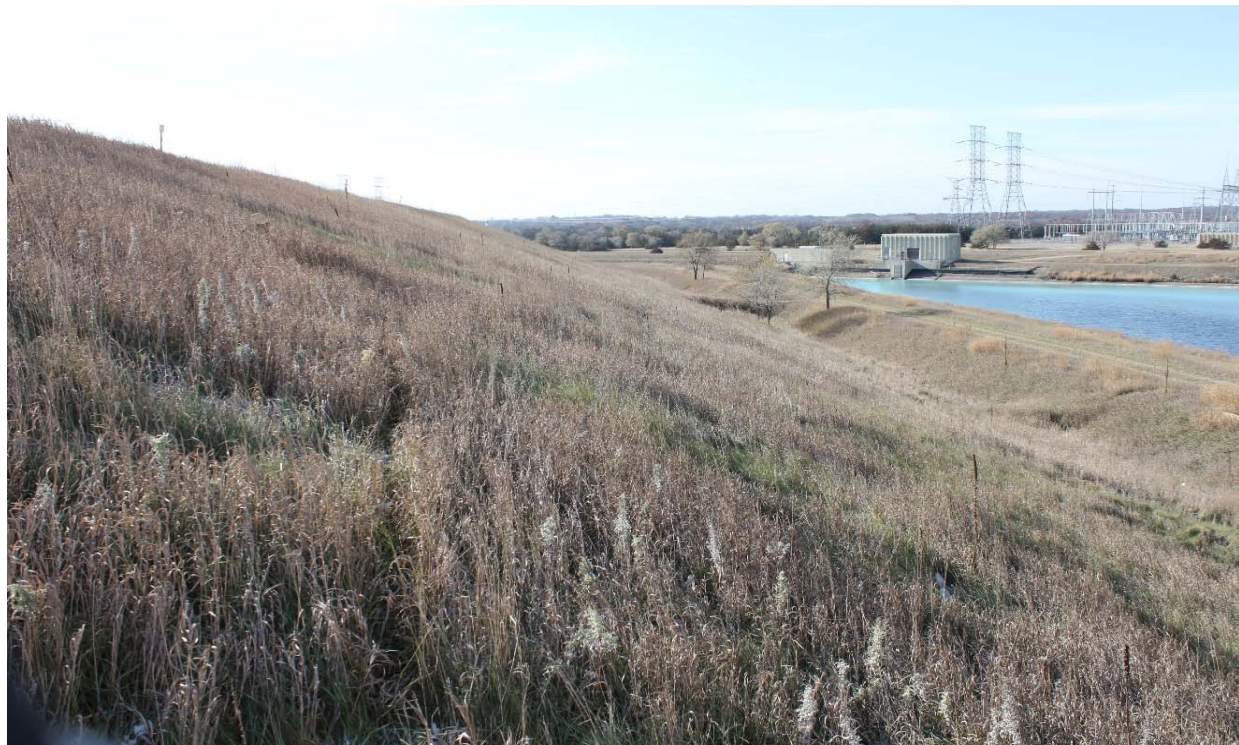
| Photo 10 | Mid slope of northwest embankment, looking southwest. |

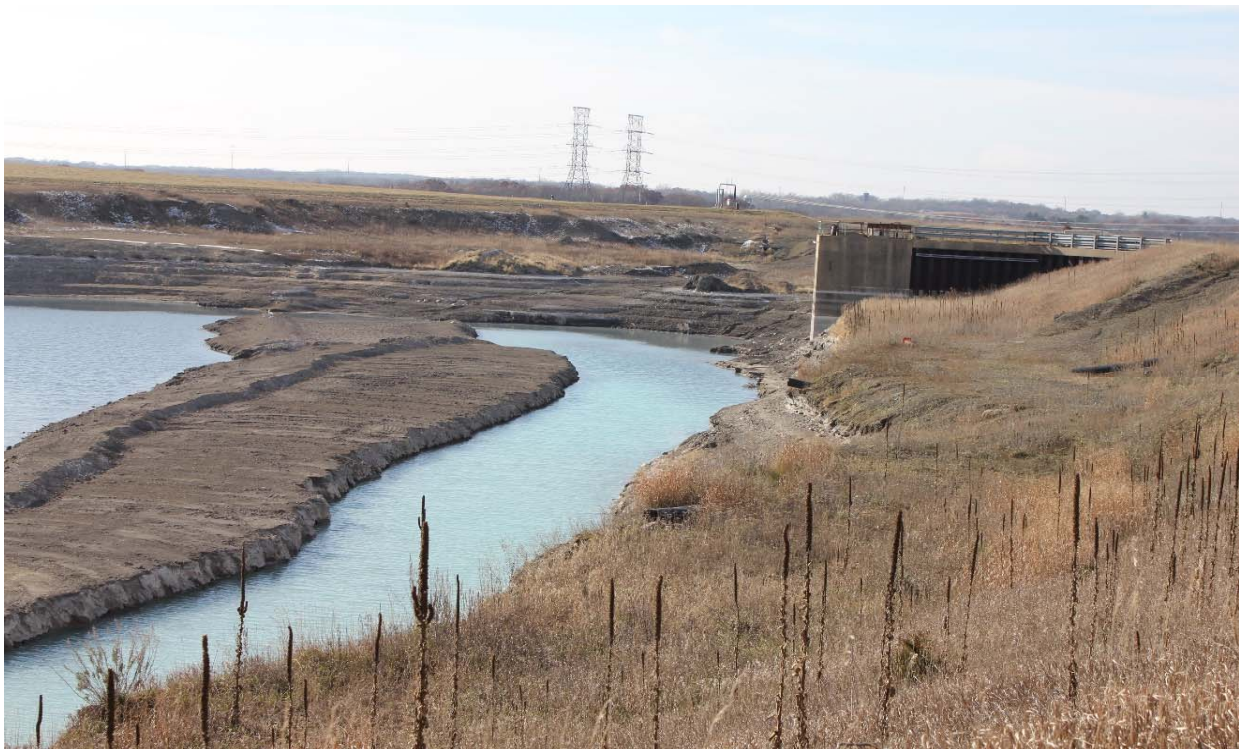
| Photo 11 | Pond interior, looking southwest. |

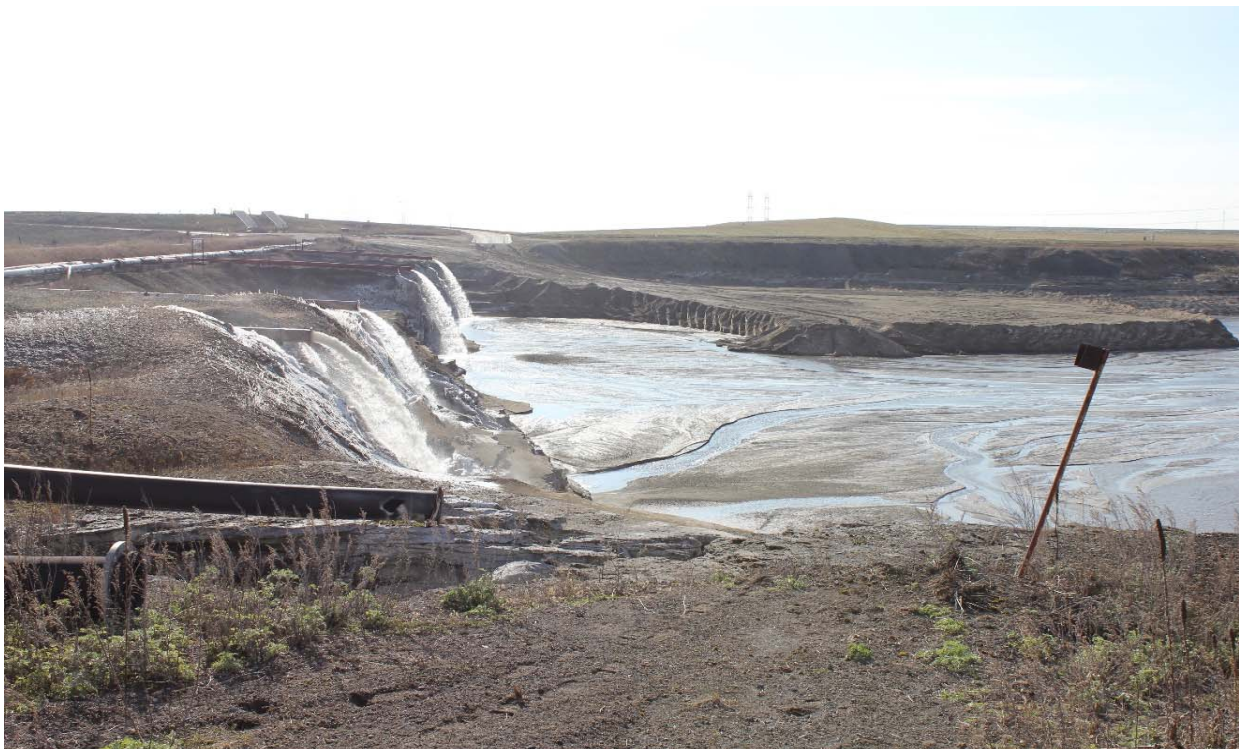
| Photo 12 | Pond interior, looking southeast. |

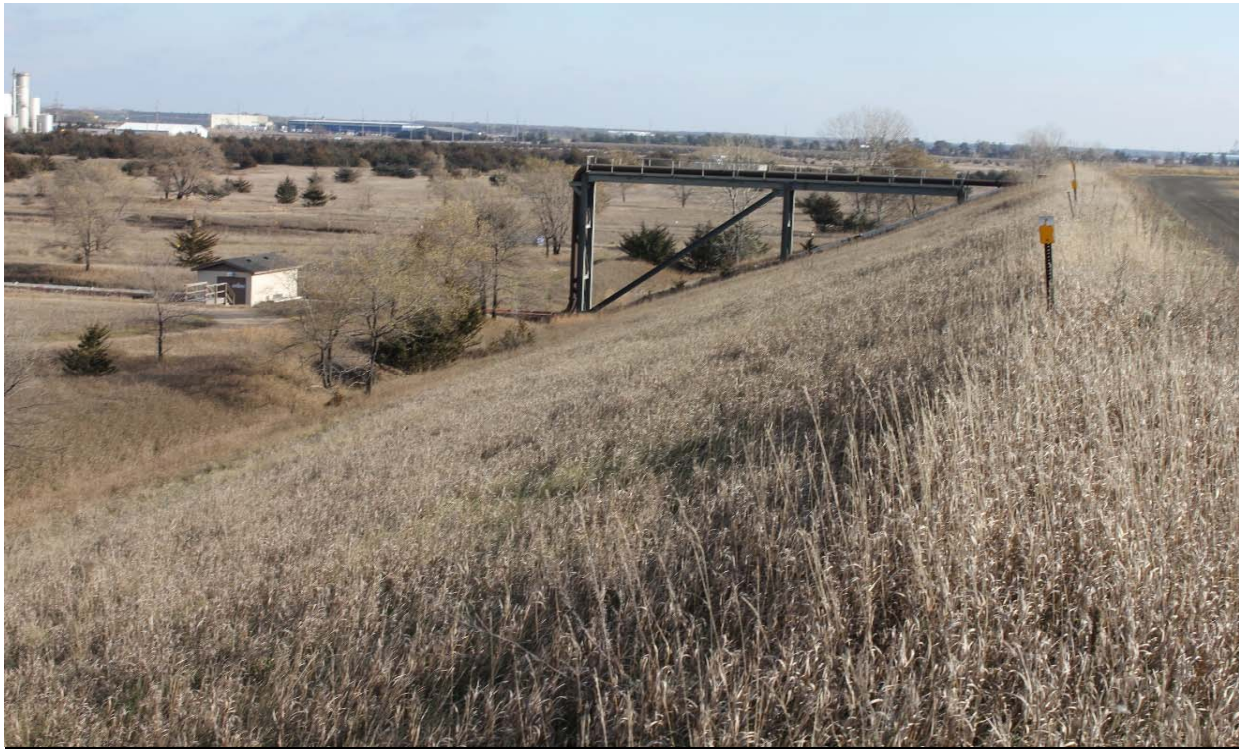
| Photo 13 | Upper slope of north embankment, looking east. |

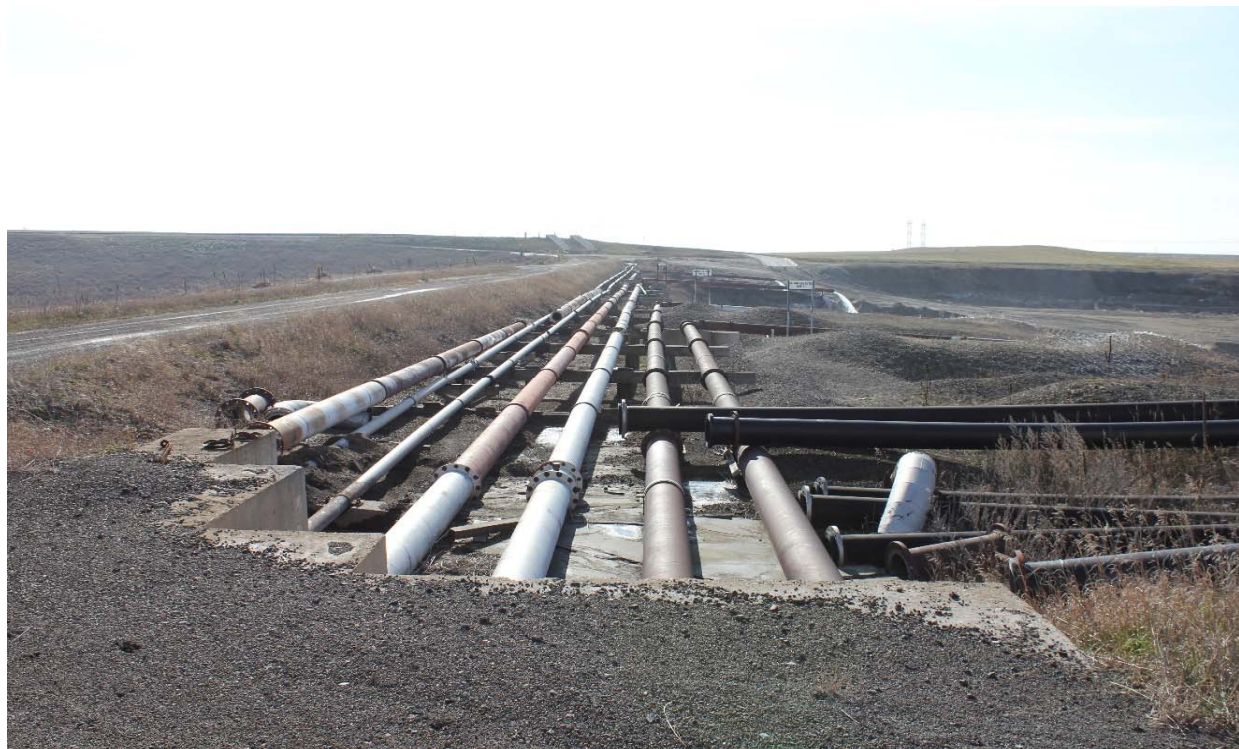
| Photo 14 | Interior of east embankment, looking south. |

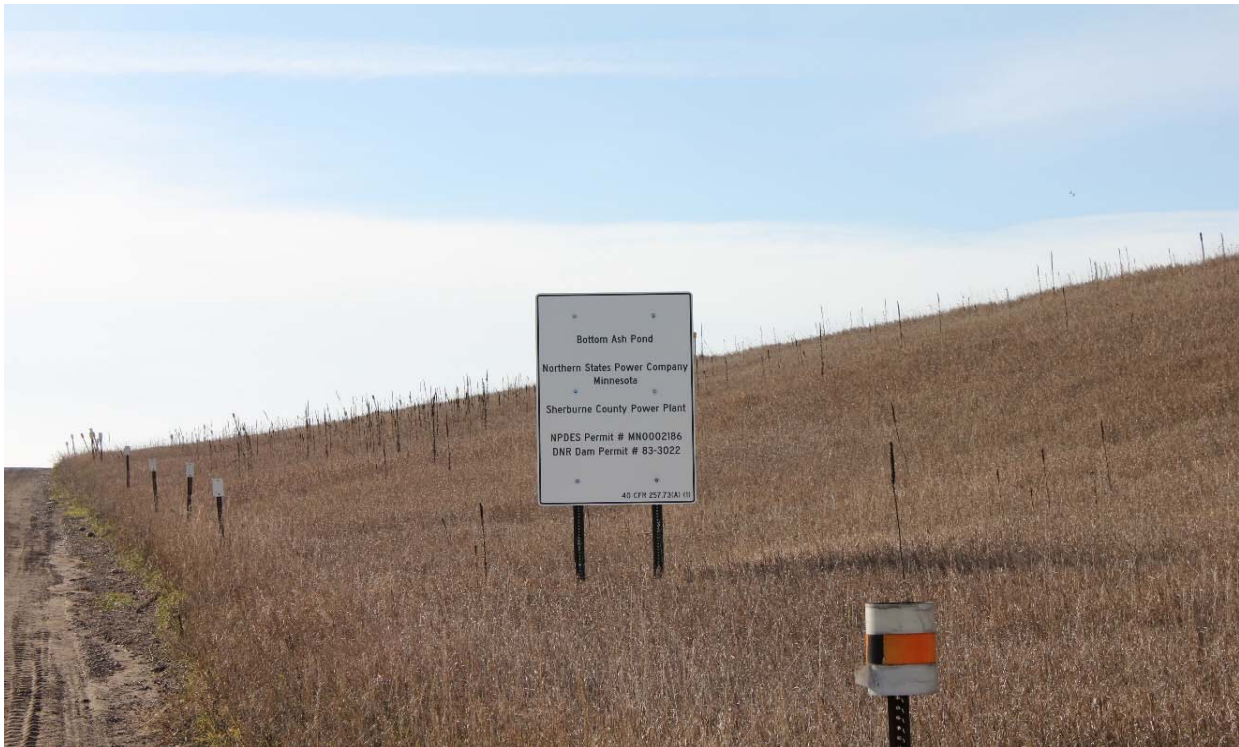
| Photo 16 | CCR Unit identification marker placed in accordance with Section 257.73. |
