# 2015 Initial Annual Inspection Report

for Compliance with the Coal  
Combustion Residuals Rule  
(40 CFR Part 257)

## **Comanche Station**

**January 18, 2016**

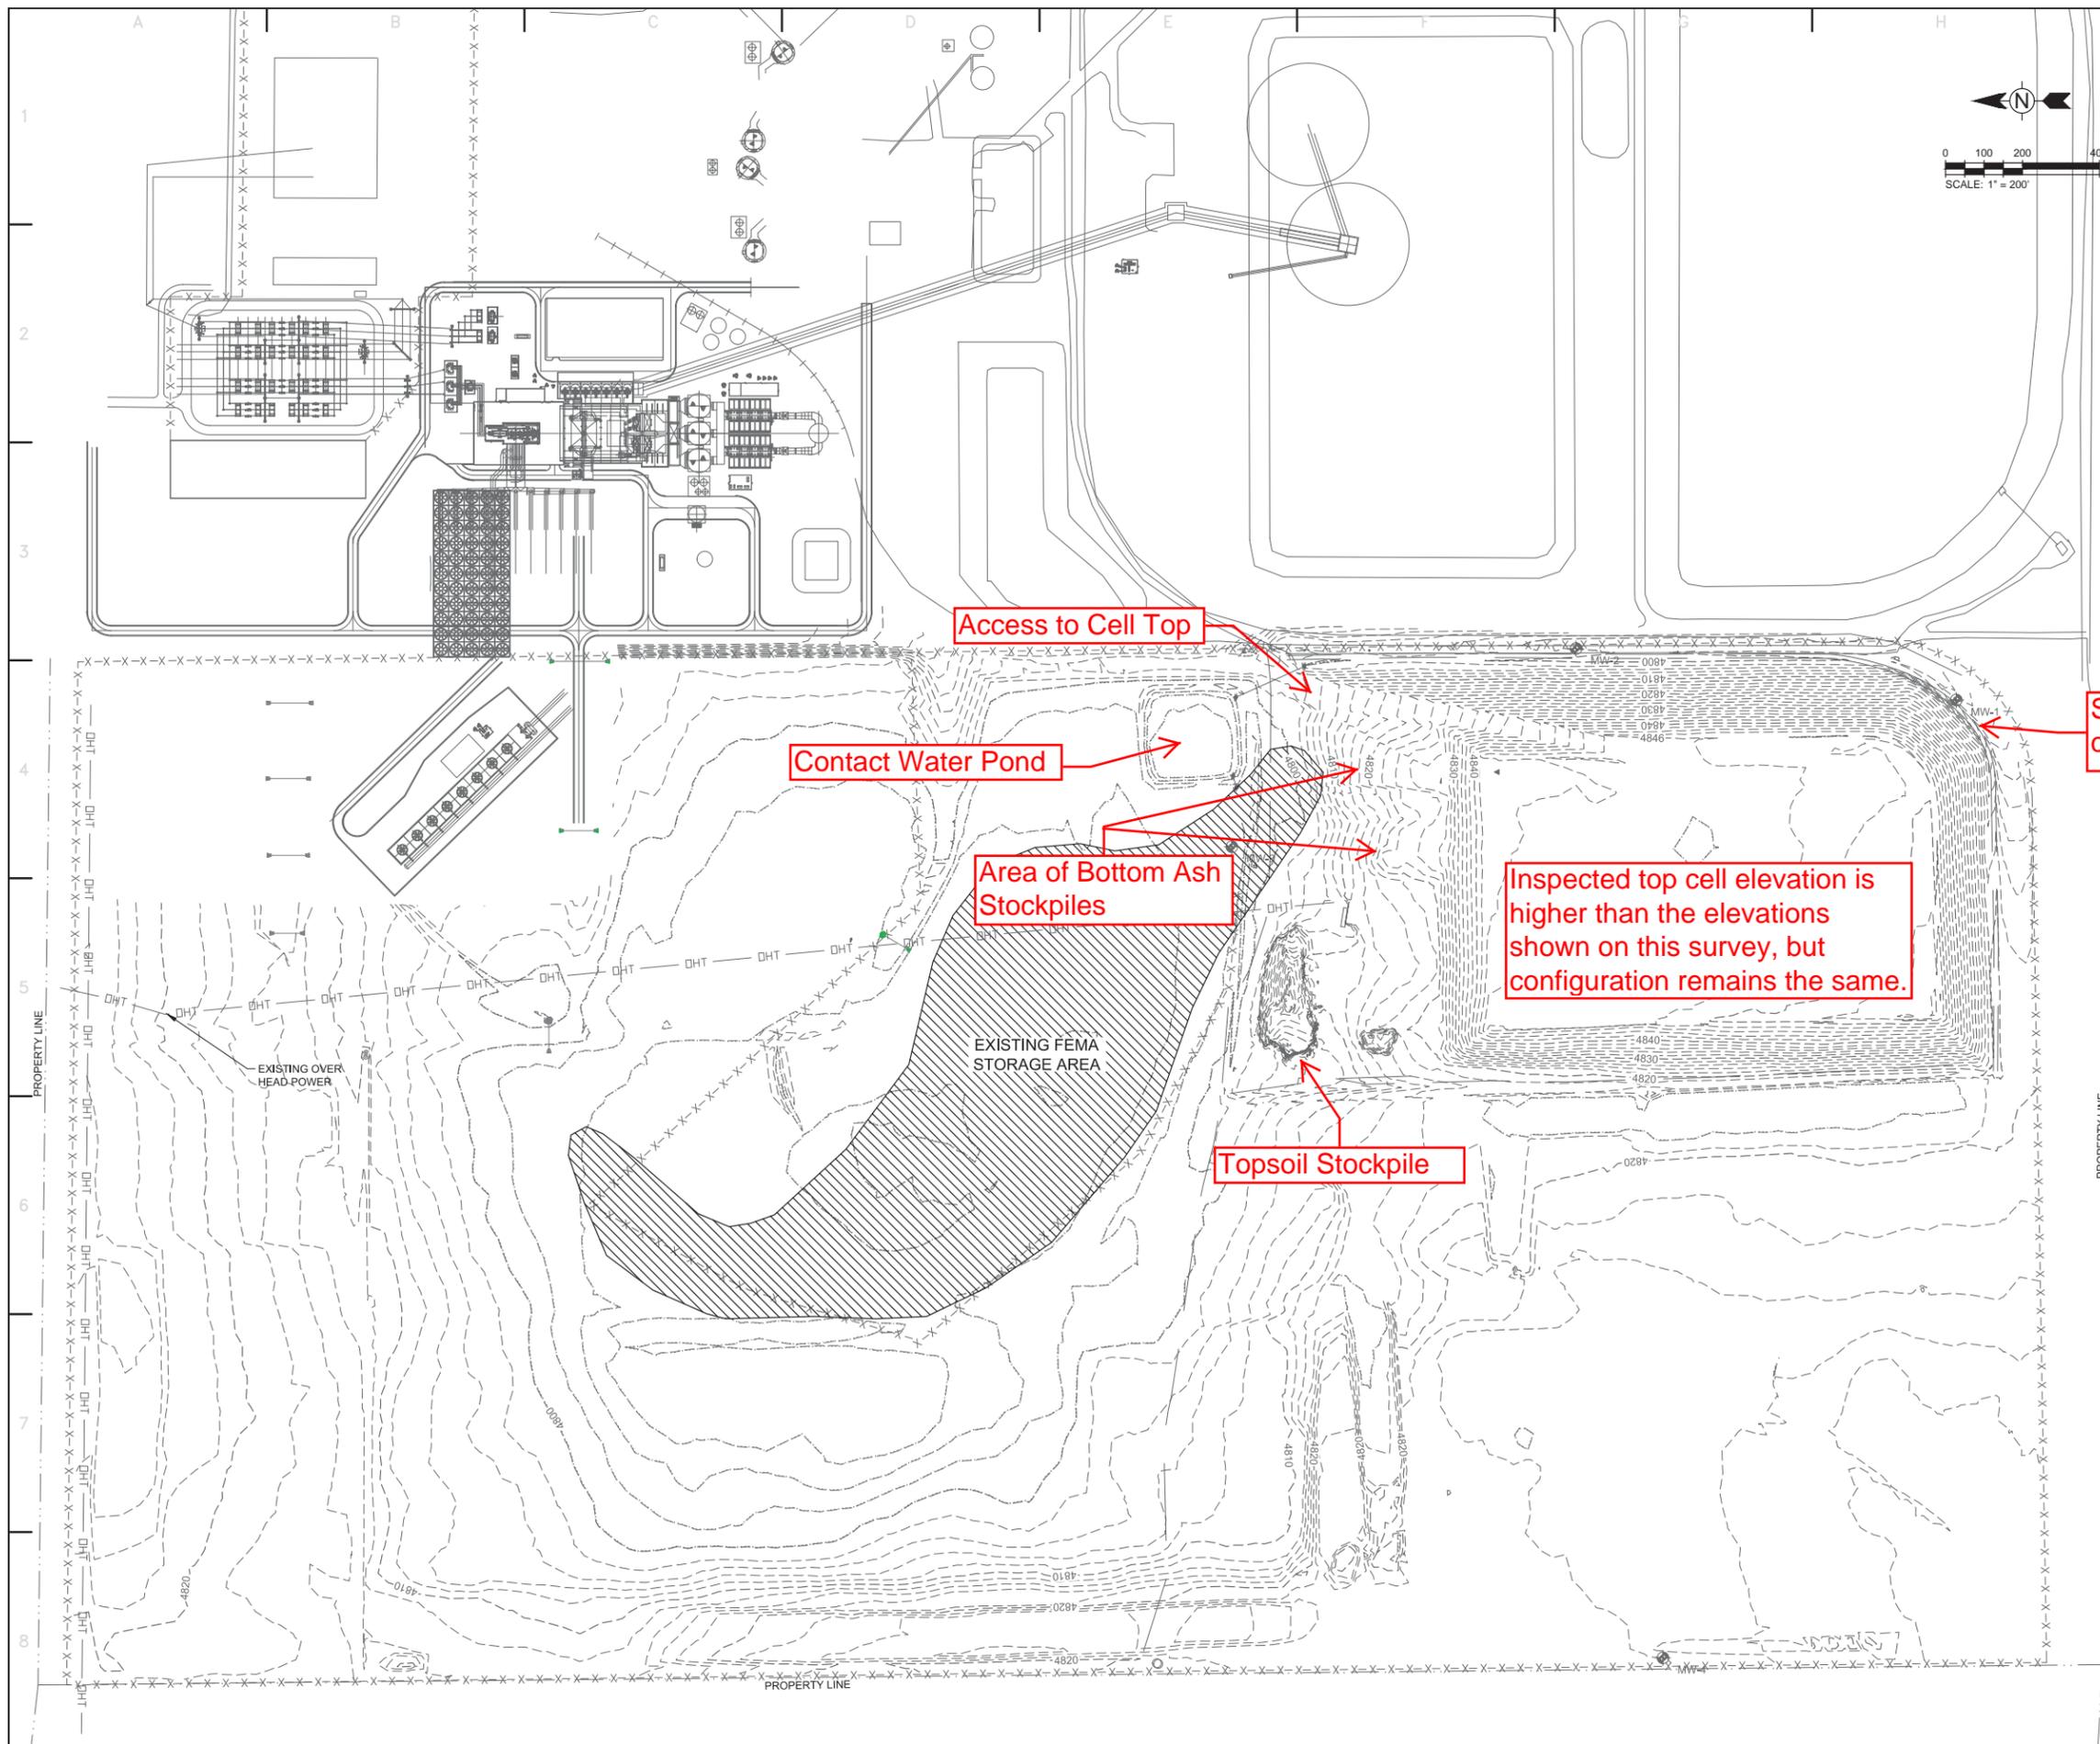
## Appendix A – Landfill Site Map

- The southeast corner of the landfill does not have a uniform grade. The perimeter access road cuts into the southeast landfill side slope and forms a very steep grade near the toe of slope. This steep grade area showed no signs of sloughing or movement, but this area should be closely monitored. This slope is shown on the Existing Conditions Plan and Proposed Final Grades Plan in the EDOP. Xcel Energy reported that a March 4, 2014 Design Report for construction of a new cell (Cell 2 East) contains plans to reconstruct this corner with a rip rap downslope structure.

- There are stockpiles of bottom ash north of the north landfill side slope that should be reviewed for handling per the EDOP. These stockpiles are within the landfill footprint and up-gradient of the contact water pond.

Area of Bottom Ash Stockpiles

Inspected top cell elevation is higher than the elevations shown on this survey, but configuration remains the same.

SE Embankment corner with Cut Toe
