January 16, 2017

Xcel Energy, Inc.  
Sherburne County Generating Station  
13999 Industrial Blvd.  
Becker, MN, 55308

**Re: 2016 Annual Inspection of Bottom Ash Pond**

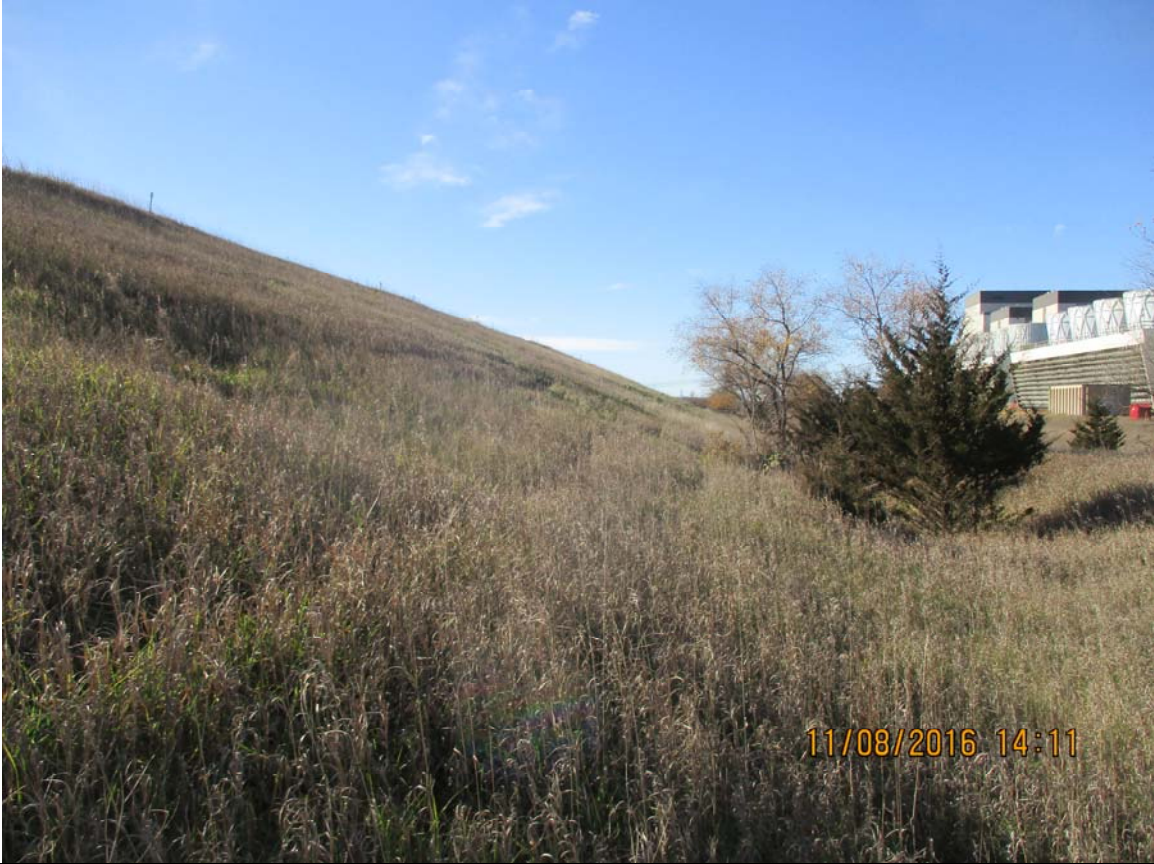
| Photo 2 | North embankment and perimeter ditch, looking west |

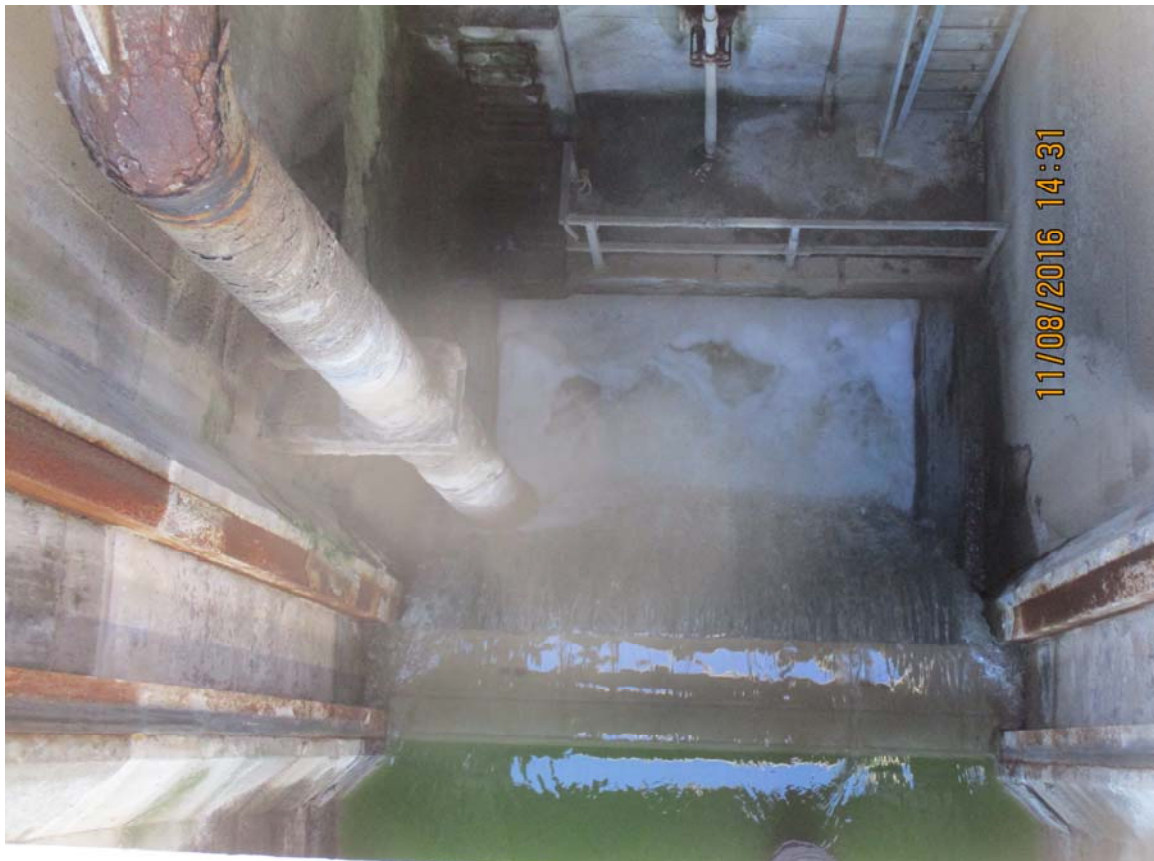
The water level in the BAP is controlled by concrete stop-logs in the discharge. All decreases in water level are attributed to the removal of stop logs.

| Photo 9 | Photo from inside of discharge structure. Bottom of photo depicts stop-log metal channels and water flowing over concrete stop-log at the bottom of the channel. |

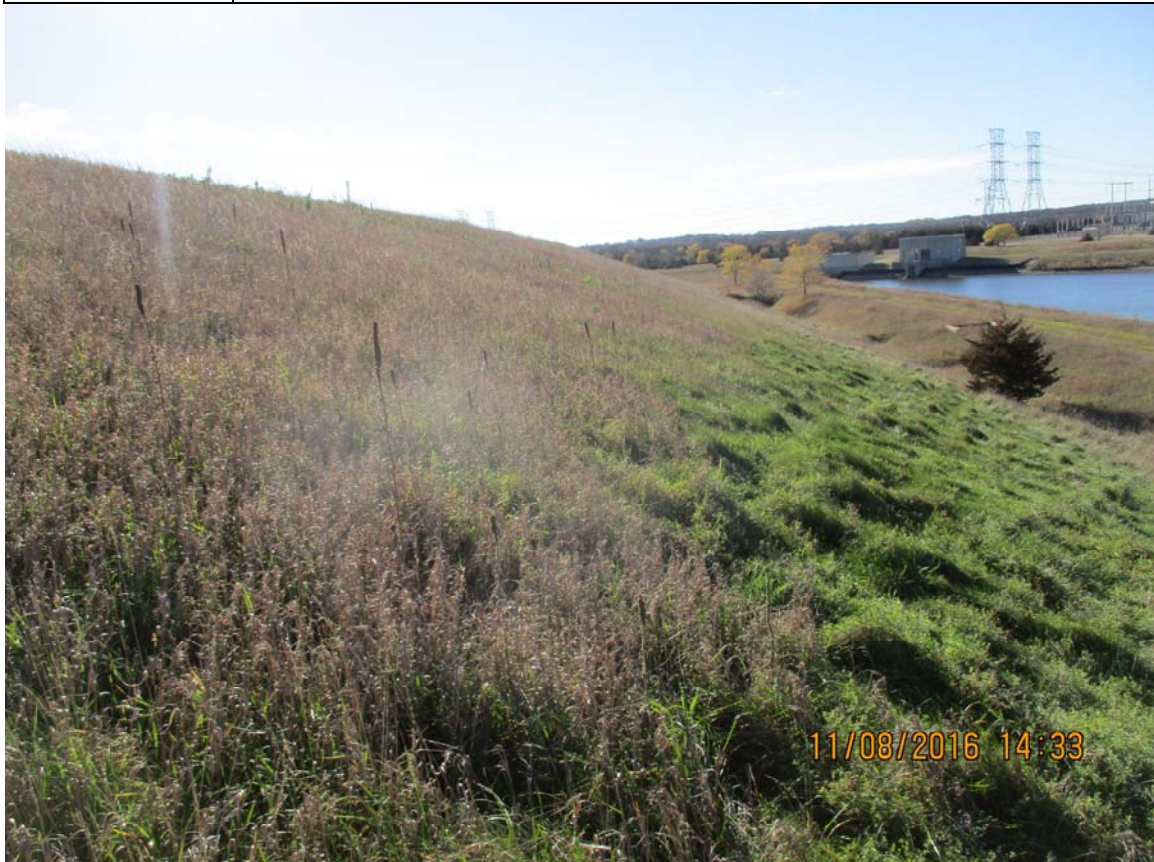
| Photo 10 | Mid slope of northwest embankment, looking southwest |

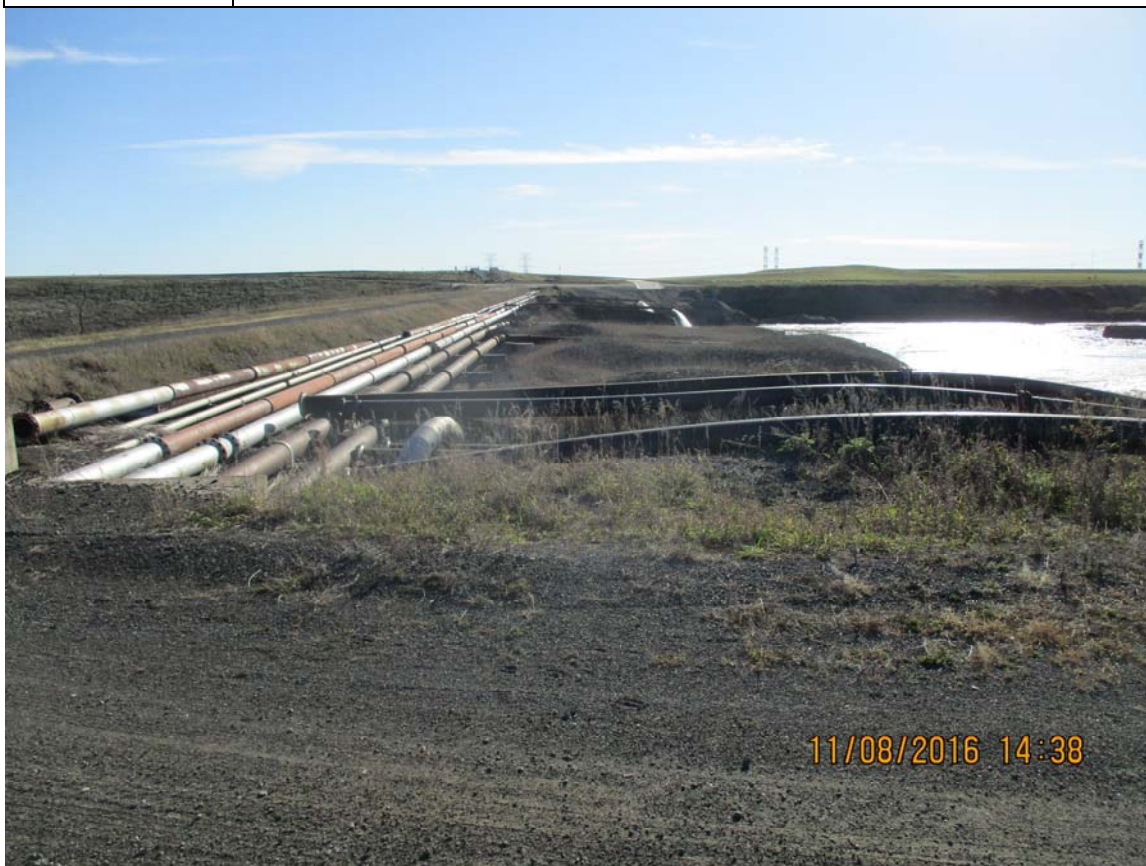
| Photo 14 | Interior of east embankment, looking south |

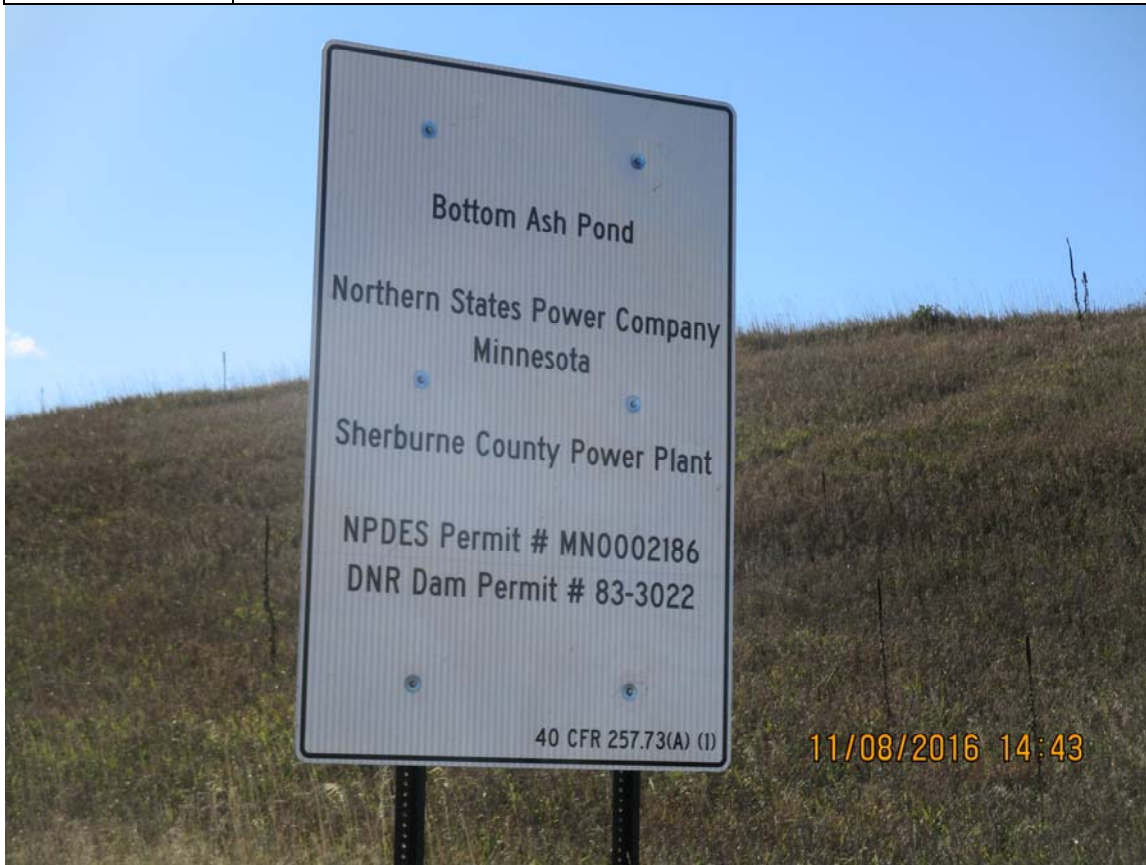
| Photo 16 | CCR Unit identification marker placed in accordance with Section 257.73 |
