Xcel Energy, Inc.
Sherburne County Generating Station
13999 Industrial Blvd.
Becker, MN, 55308

Re: 2016 Annual Inspection of Scrubber Solids Pond No. 3

Pond 3 Annual Inspection – November 2016

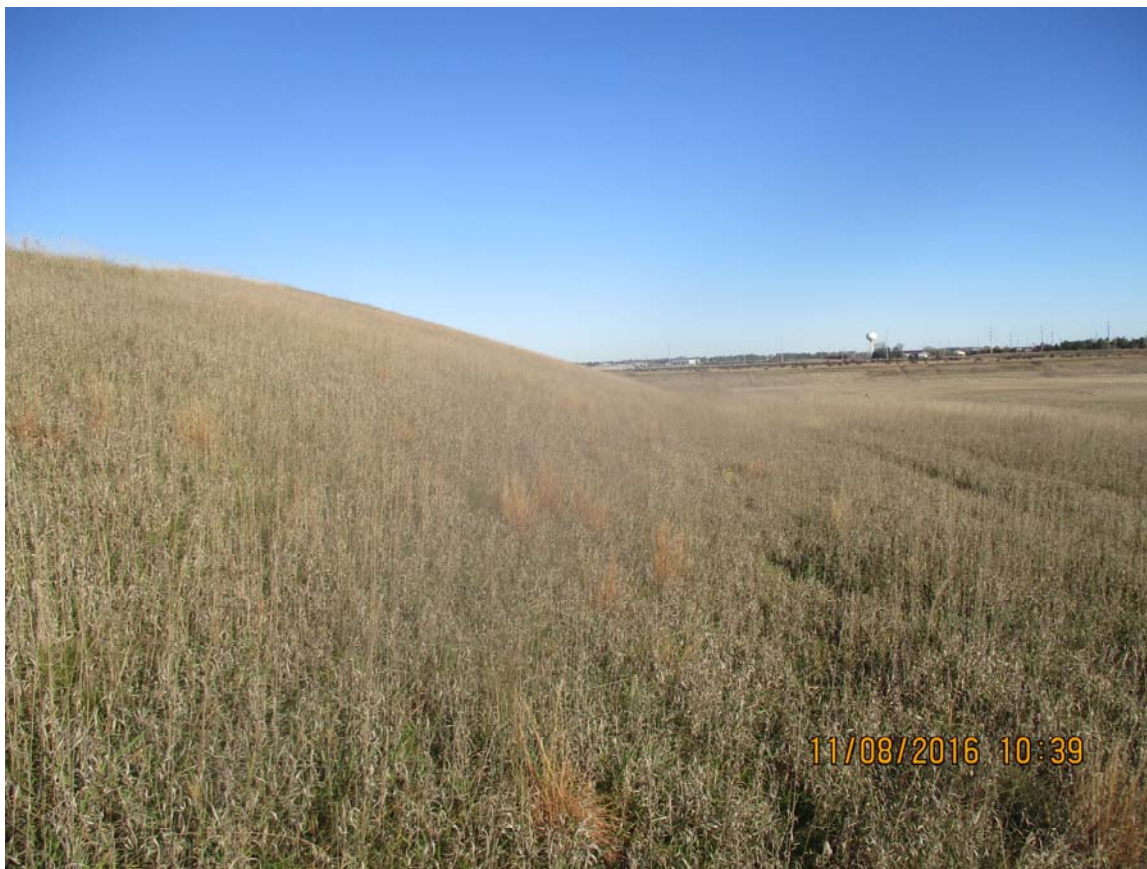
Photo 1	Outer east slope of north embankment, looking north
11/8

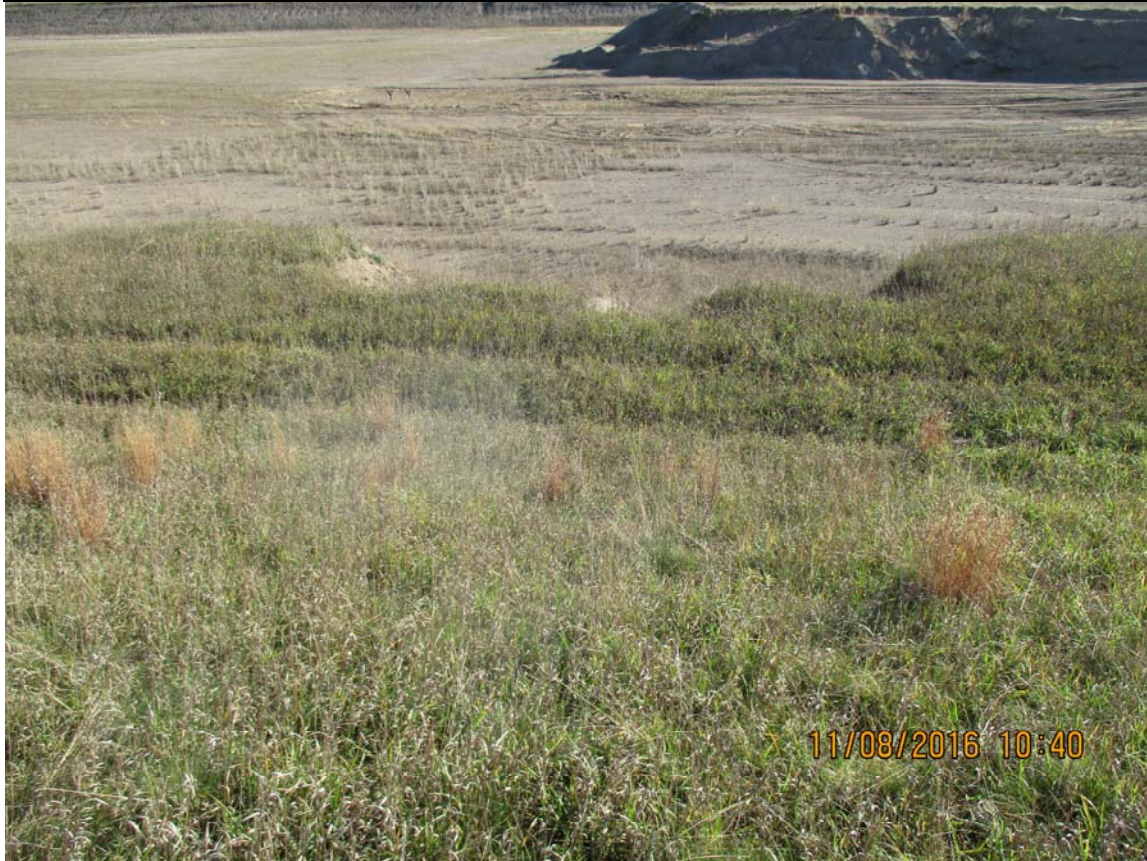
Photo 2	Small eroded channel near pond east embankment.

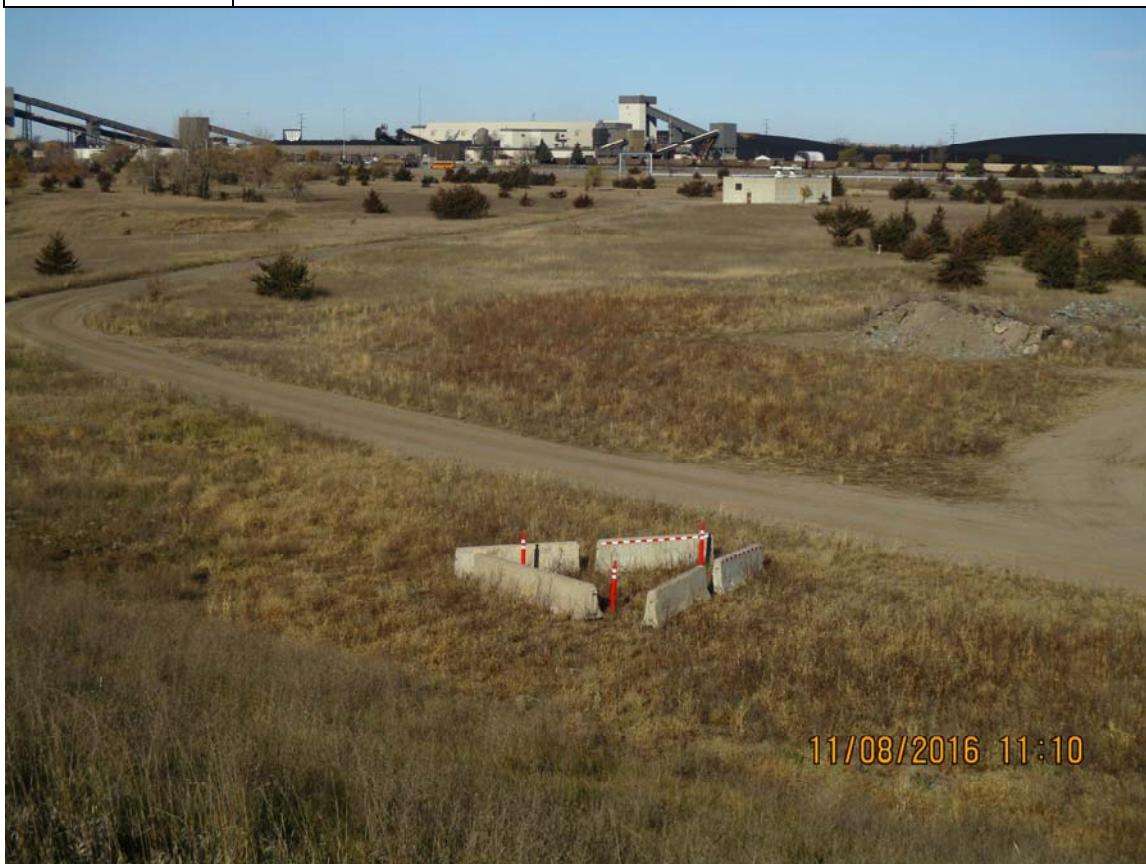
The discharge pipe corridor was inspected for signs of a leakage, such as saturated areas or sinkholes. No signs of leakage were observed along the pipe corridor or in the vault located north of Pond 3.

Photo 8	Underground discharge pipe corridor, looking northwest
---------	--------------------------------------------------------

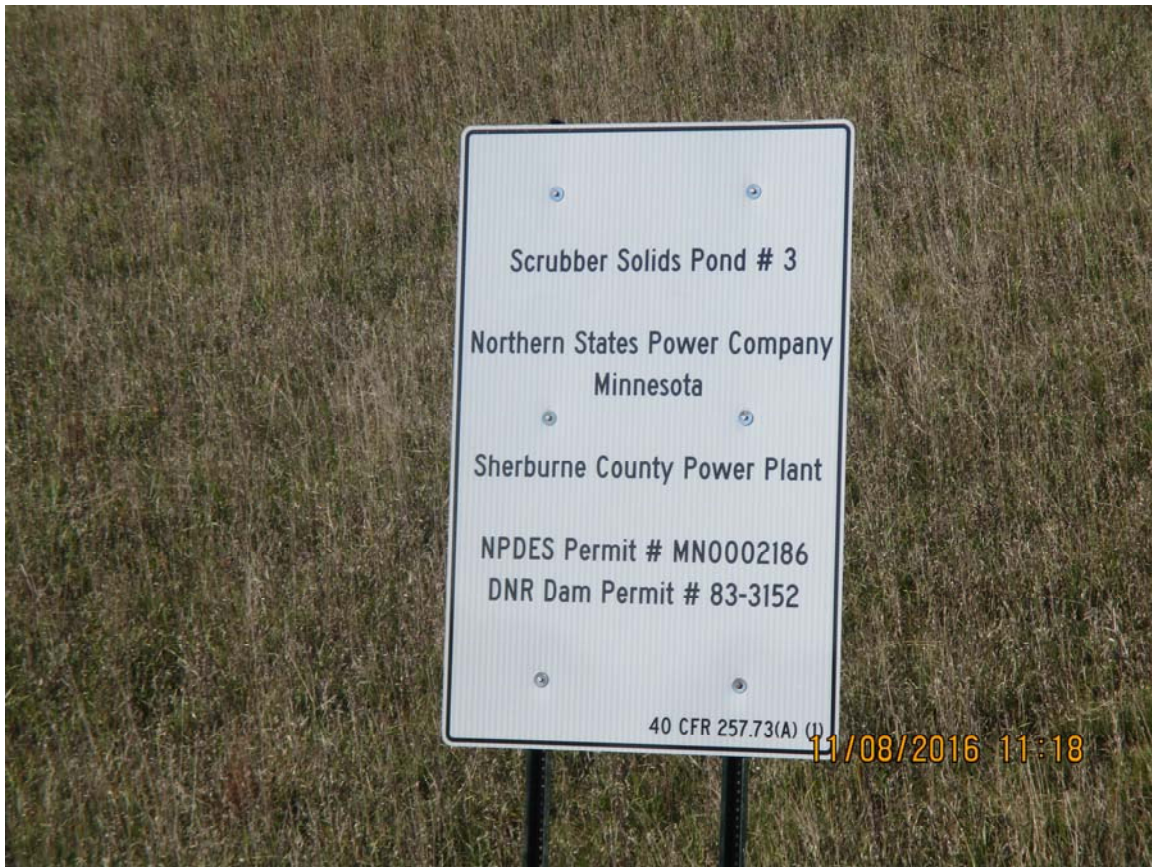
Photo 11	CCR Unit identification marker placed in accordance with Section 257.73

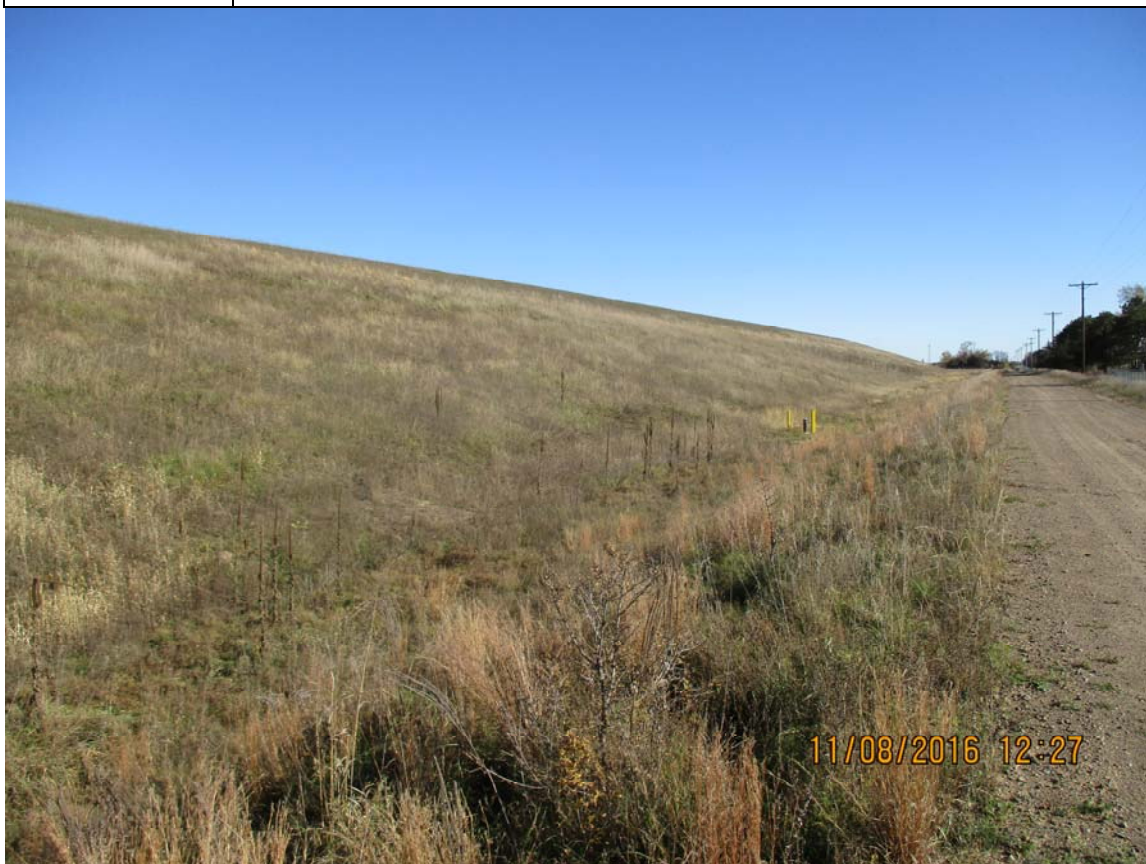
Photo 18	Pond south embankment, looking east. Middle right: Newly installed Pond 3 CCR monitoring well (between yellow bollards)
----------	-------------------------------------------------------------------------------------------------------------------------

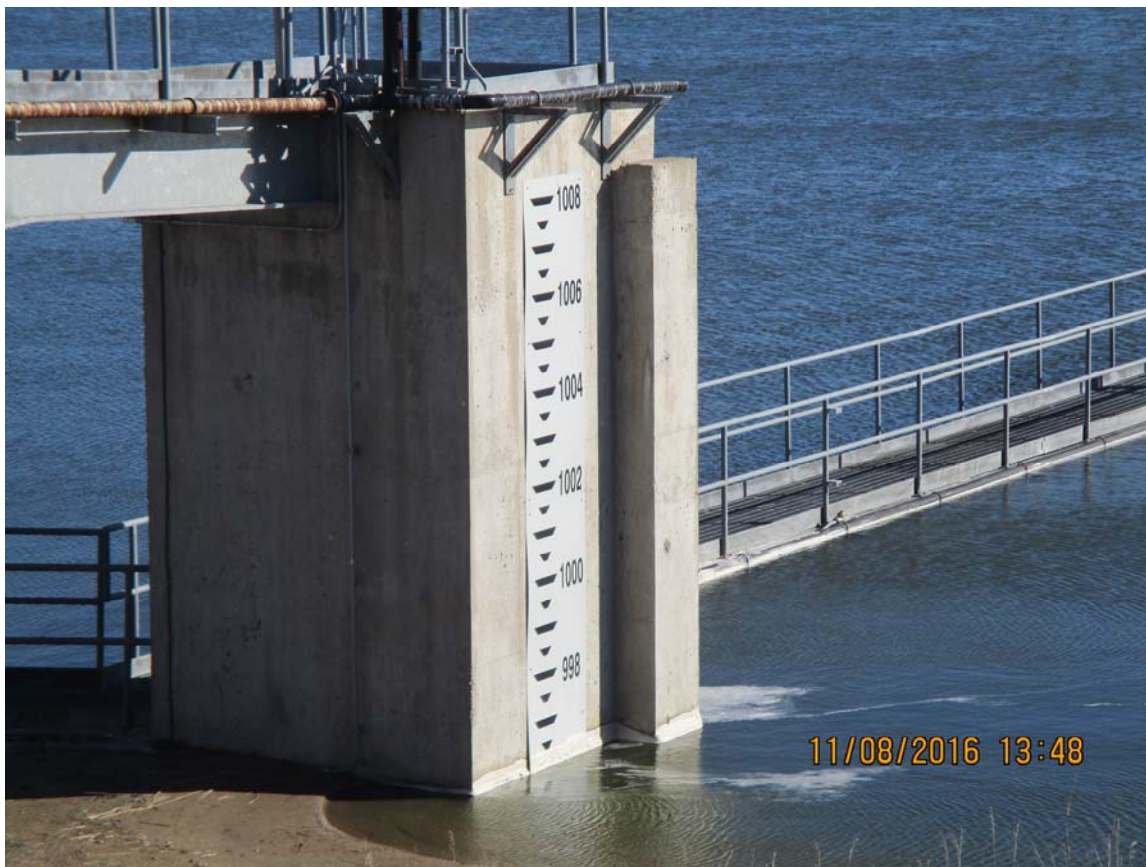
The only instrumentation on Pond 3 is a staff gauge used to determine water surface elevation, located on the west side of the discharge structures. The minimum elevation measured since the last inspection was 993.2 mean sea level (MSL), the maximum elevation was 996 MSL. The top of clay liner elevation is 1004 MSL. No instrumentation is needed for dike stability.

Photo 27	Pond water level staff gauge (shown at approximately 996 feet of elevation mean sea level)

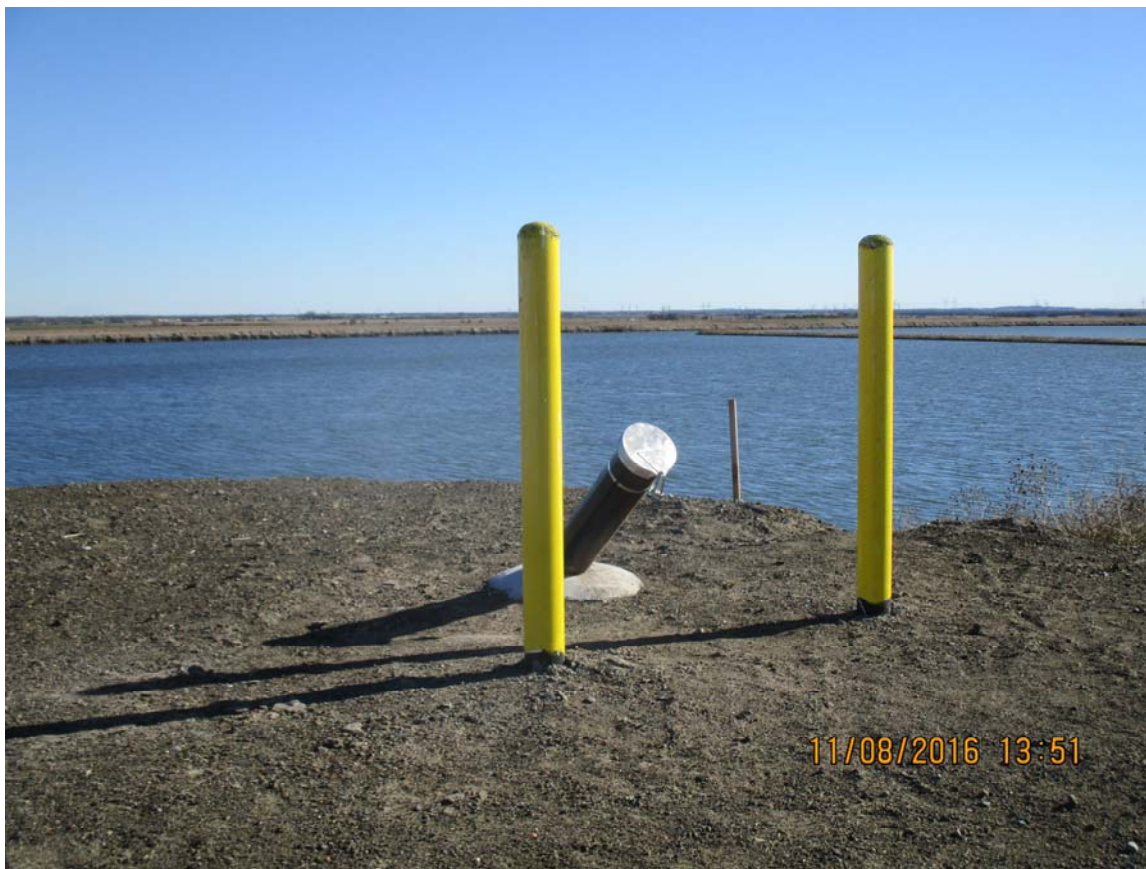
Photo 29	Newly installed pond CCR angled well, looking east
----------	----------------------------------------------------

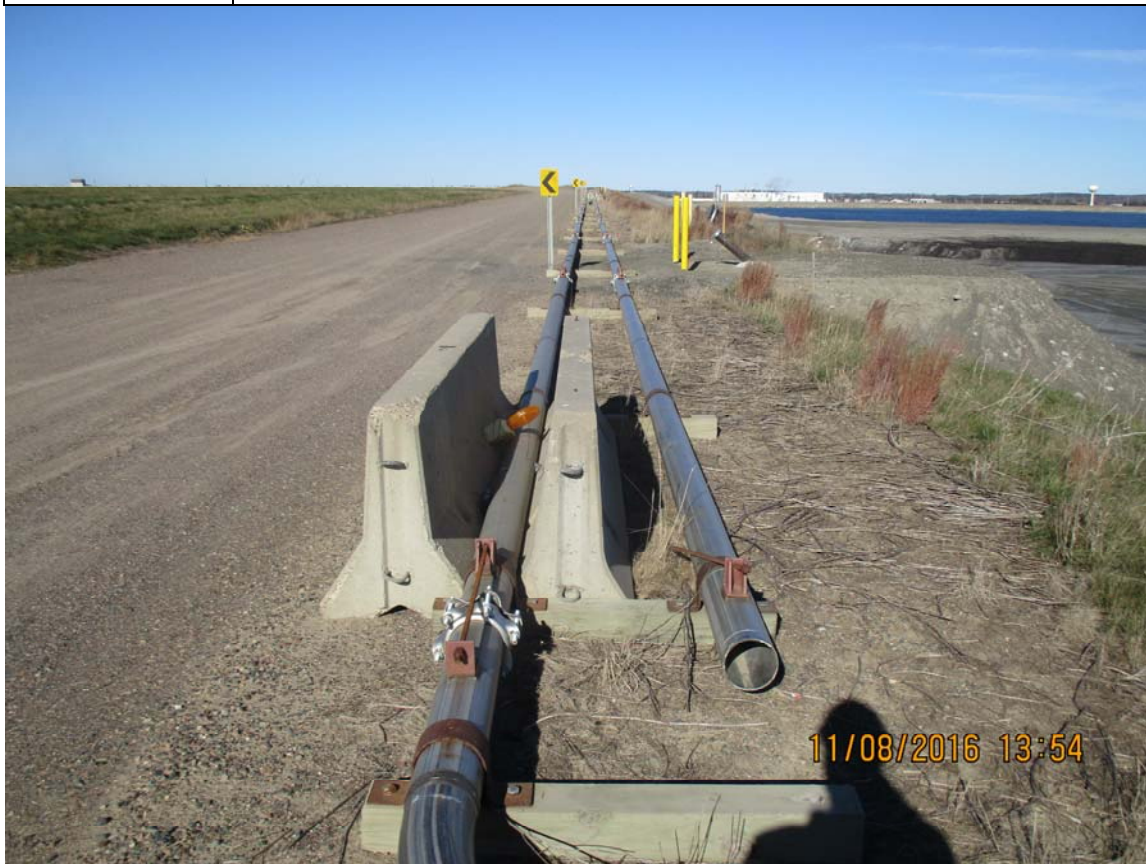
Photo 30	Foreground: Pond stainless steel scrubber solid pipes. Middle-right: newly installed CCR angled well
----------	------------------------------------------------------------------------------------------------------
