January 16, 2017

Xcel Energy, Inc.
Sherburne County Generating Station
13999 Industrial Blvd.
Becker, MN, 55308

Re: 2016 Annual Inspection of Unit 3 Landfill

Unit 3 Landfill Annual Inspection – November 2016

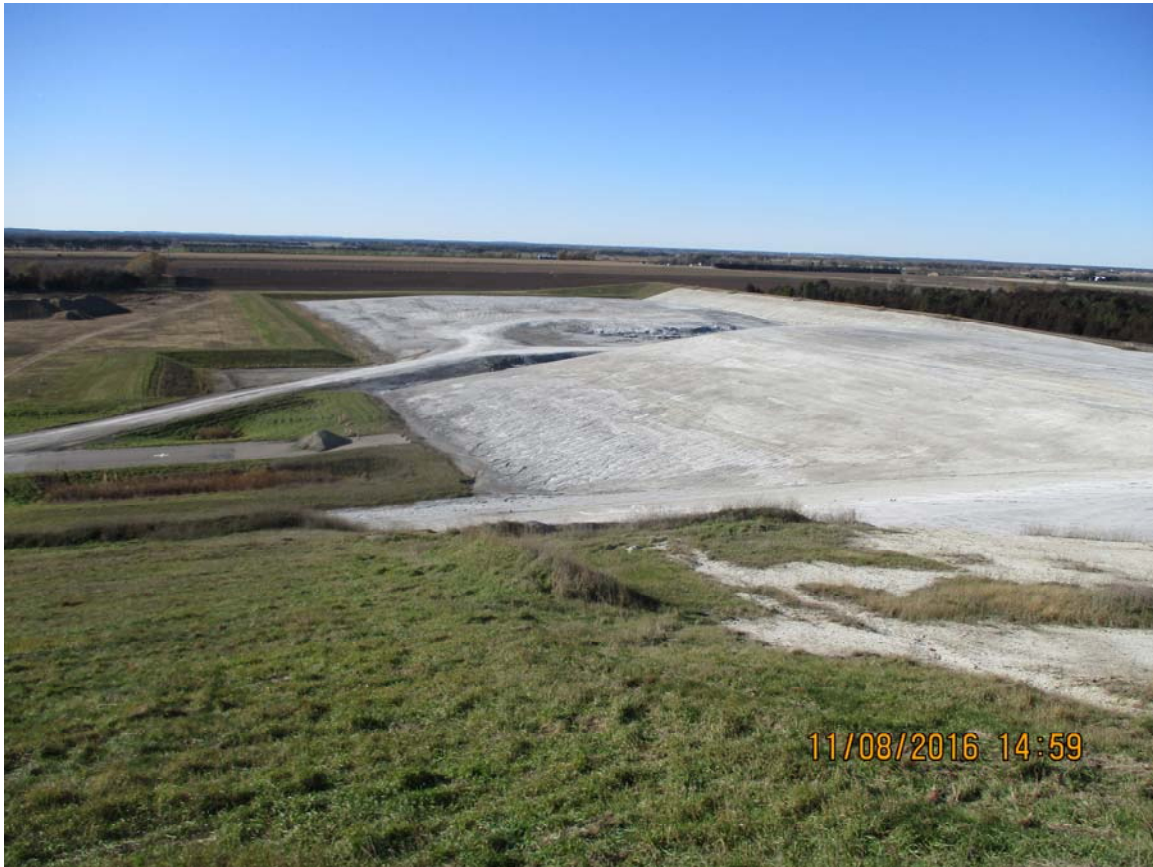
Photo 1	Open portion of landfill, looking northwest

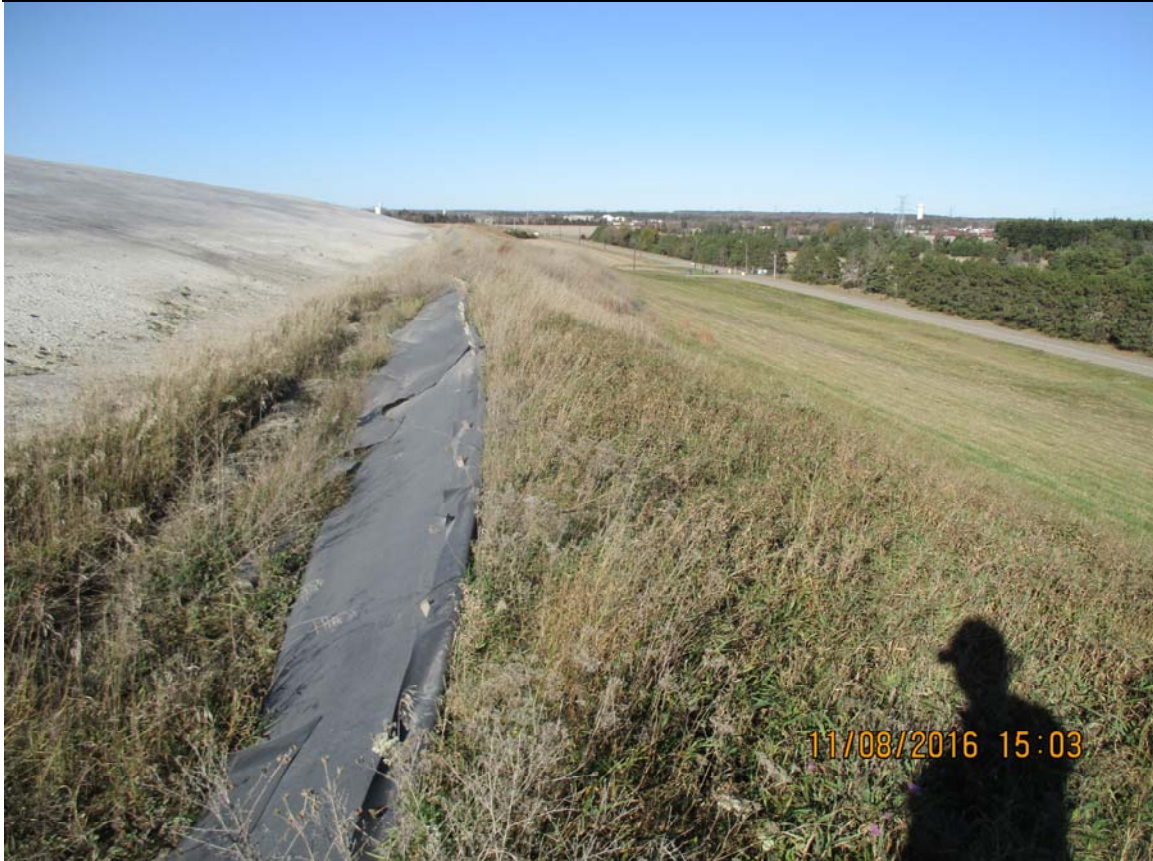
Photo 2	Final cover along east side of landfill. Leachate run-off containment flap can be seen in the foreground. Looking north

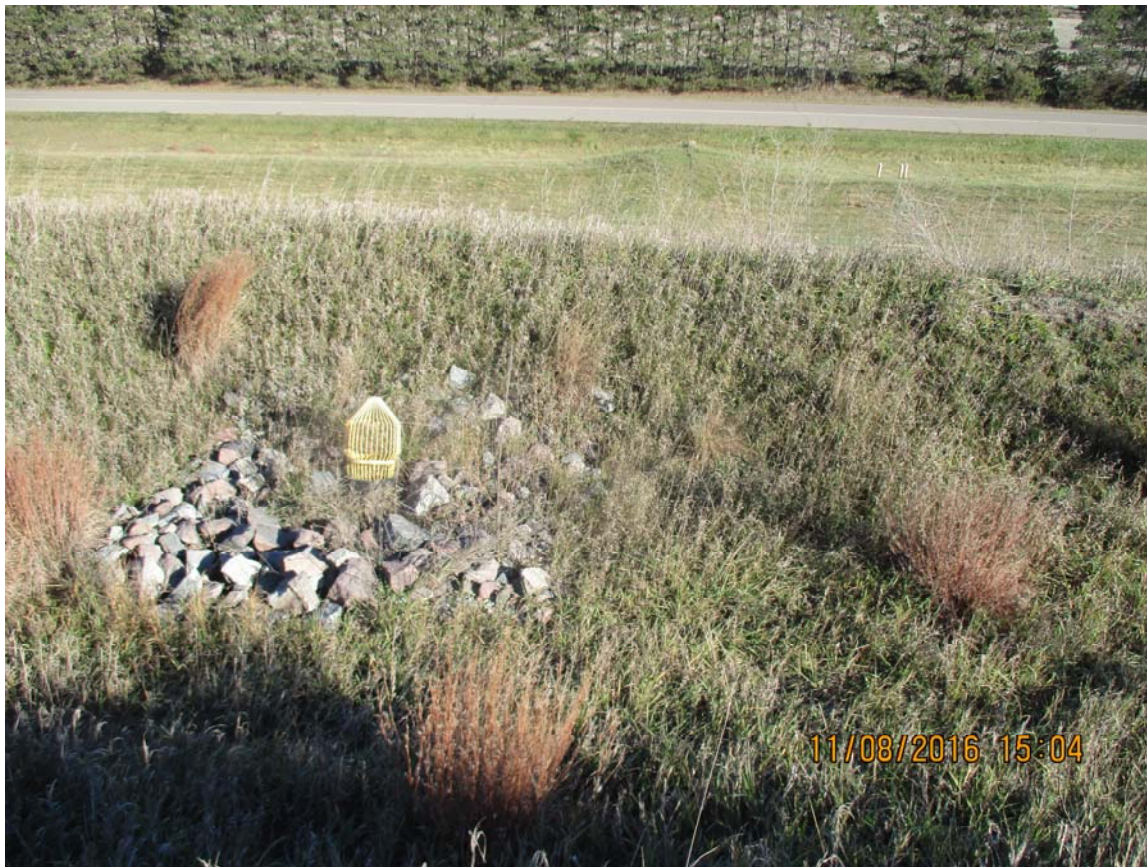
Photo 3	Stormwater control system inlet along east side of final cover, looking east.

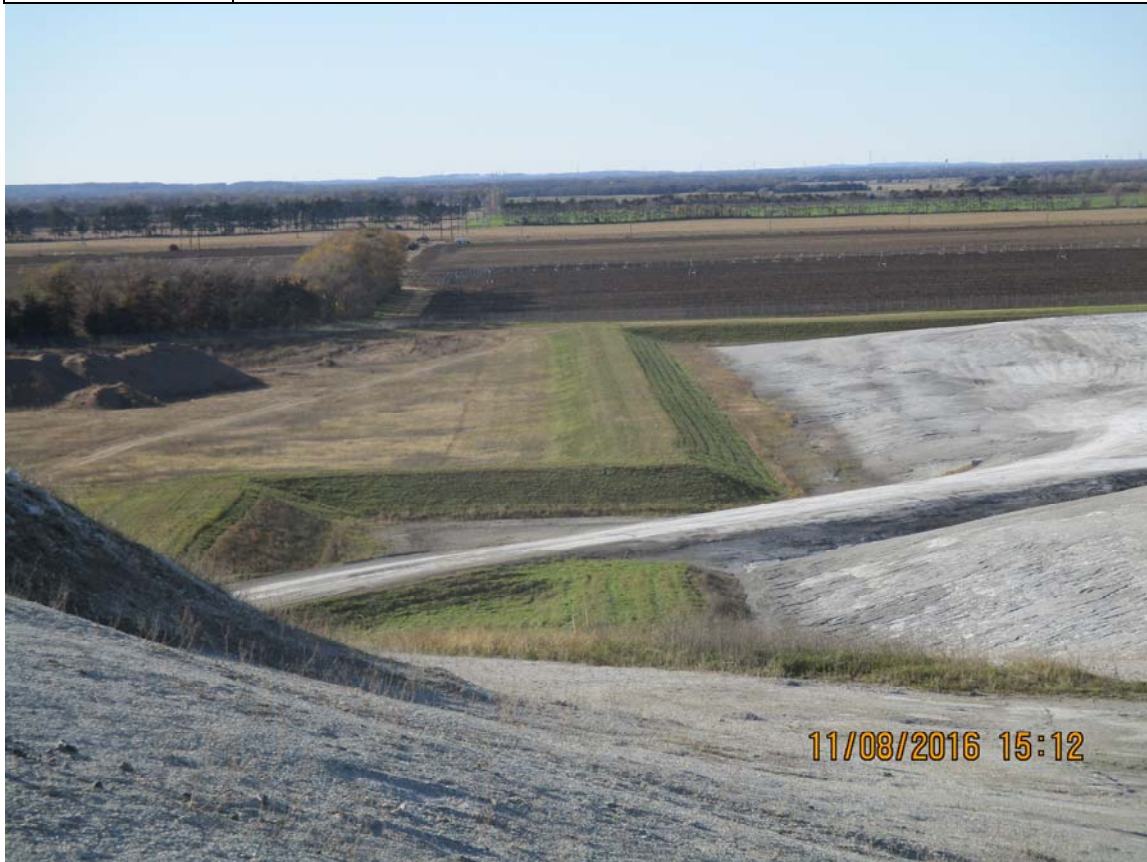
Photo 4	Run-on/run-off containment berm along south side of open area
10/19/2015

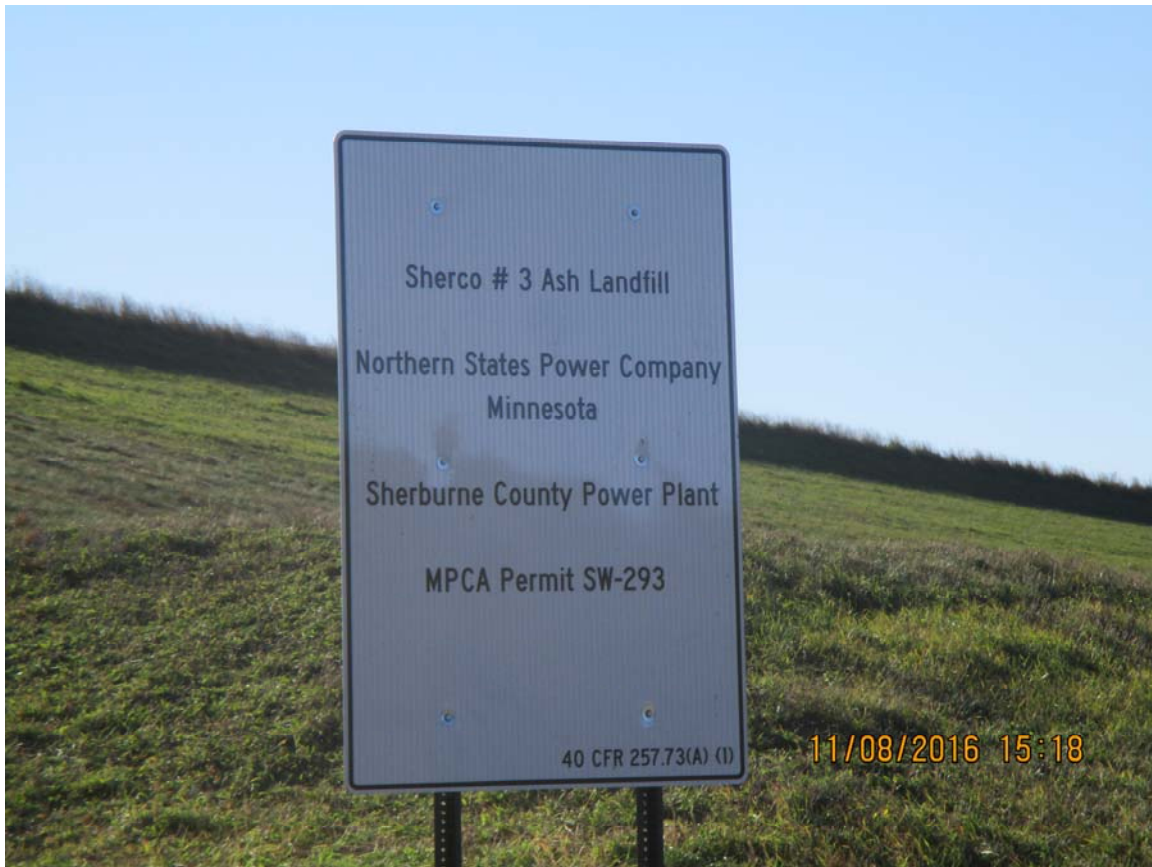
Photo 5	CCR Unit identification marked placed in accordance with Section 257.73

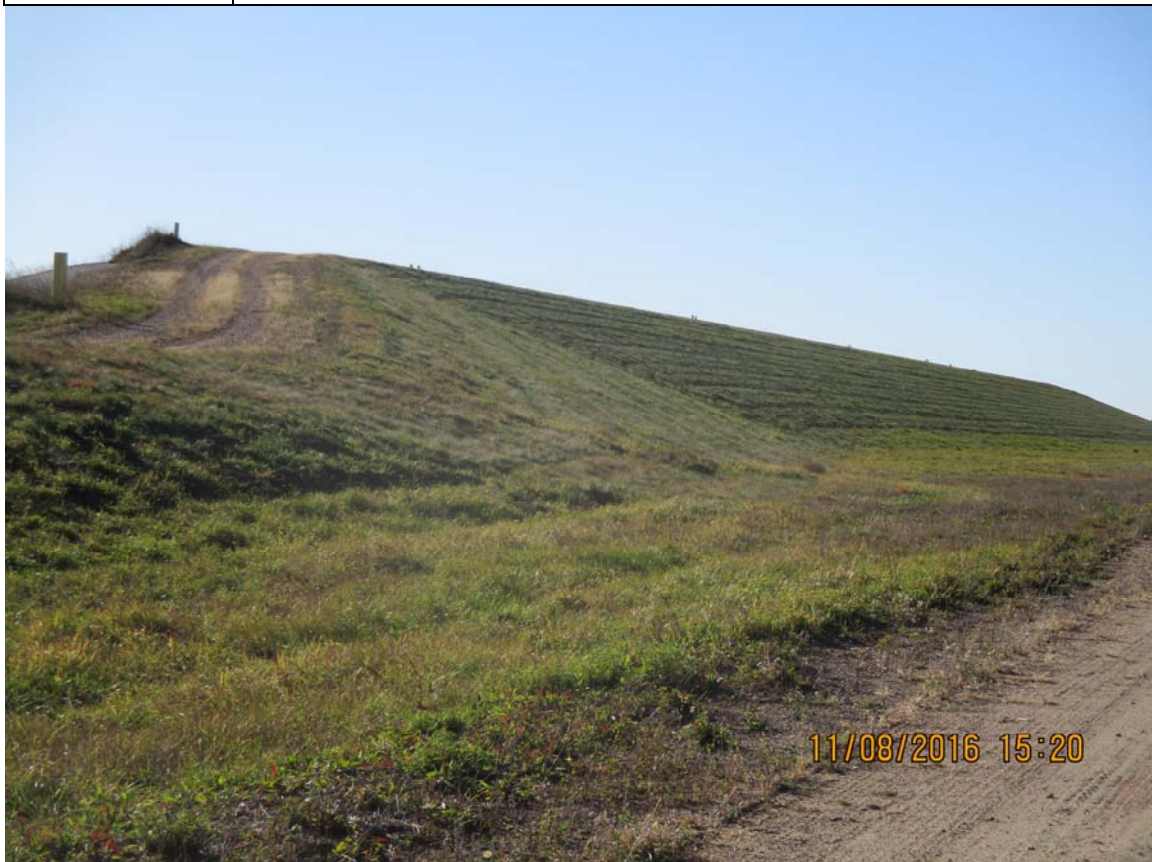
The landfill was inspected for structural weakness by walking a traverse at the base and top of the embankment. There were no signs that structural weakness had previously or is presently occurring on the landfill.

Photo 6	Exterior of north embankment, looking southwest

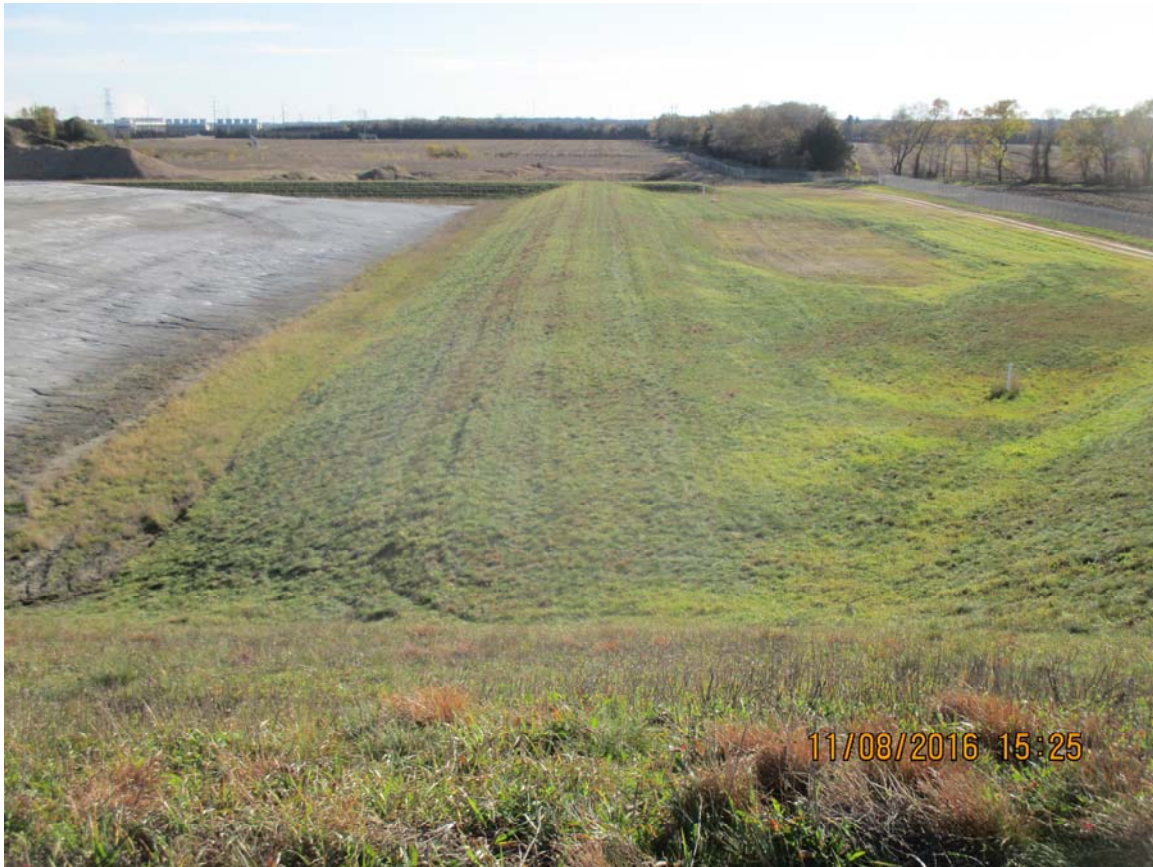
Photo 7	Run-on/run-off containment berm along west side of landfill, looking south
---------	----------------------------------------------------------------------------

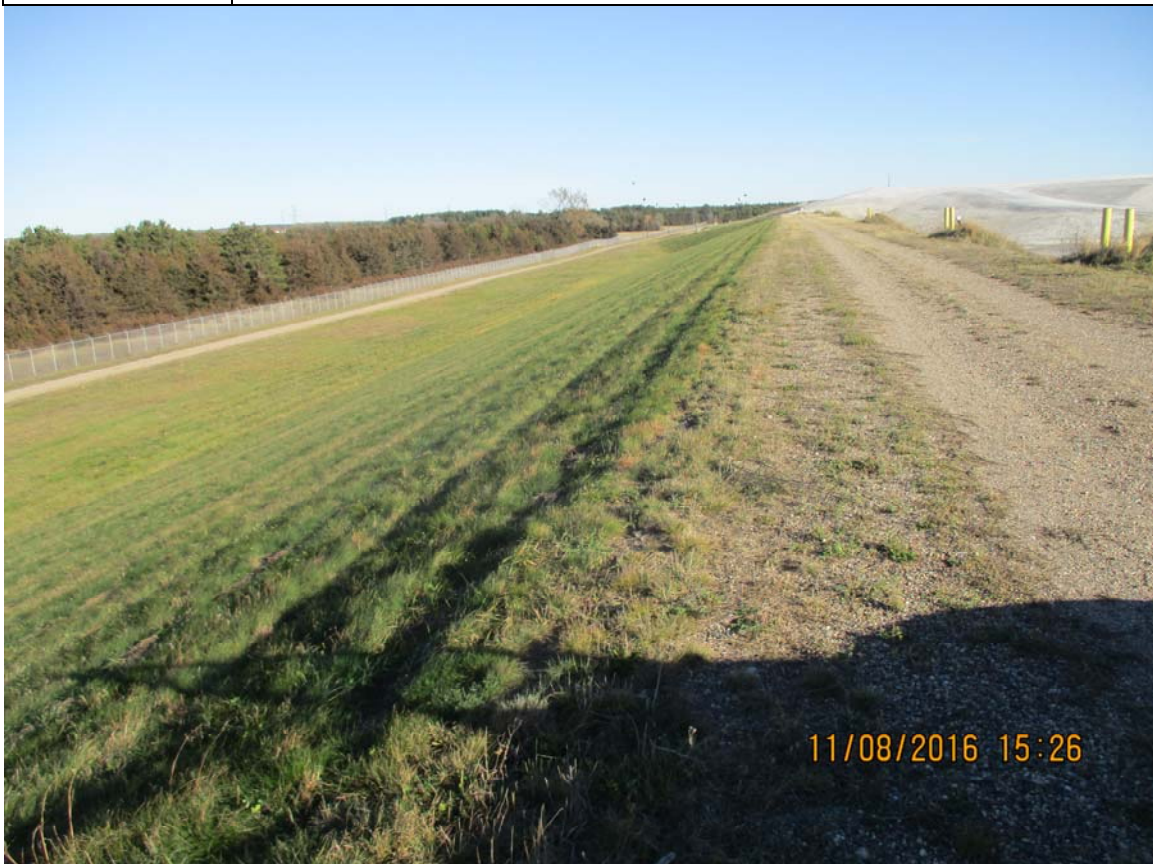
Photo 8	Access road on top of north embankment, looking east
---------	------------------------------------------------------

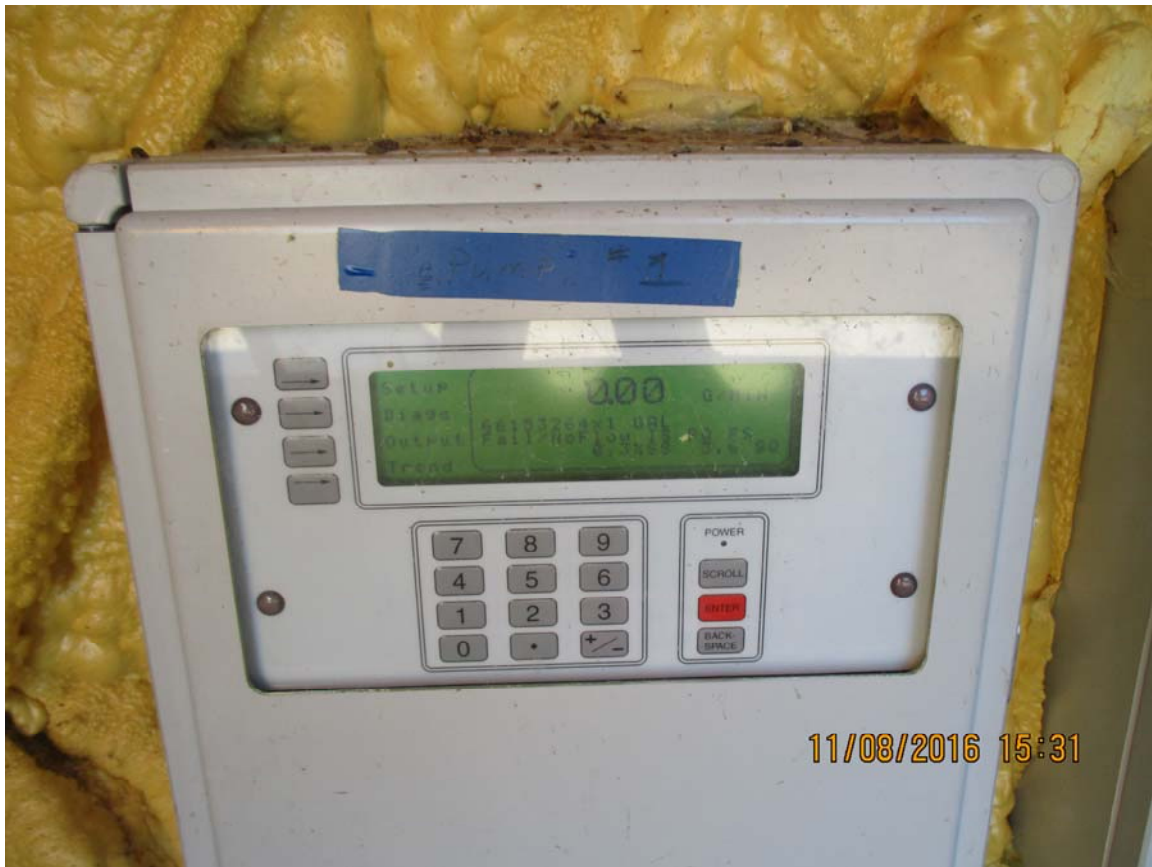
The active area sump panel controls and riser access panels were opened to verify that the leachate management system is functioning properly. There are no conditions disrupting the operation or safety of the CCR unit.

Photo 9	Display screen on properly function Pump No. 1
---------	------------------------------------------------

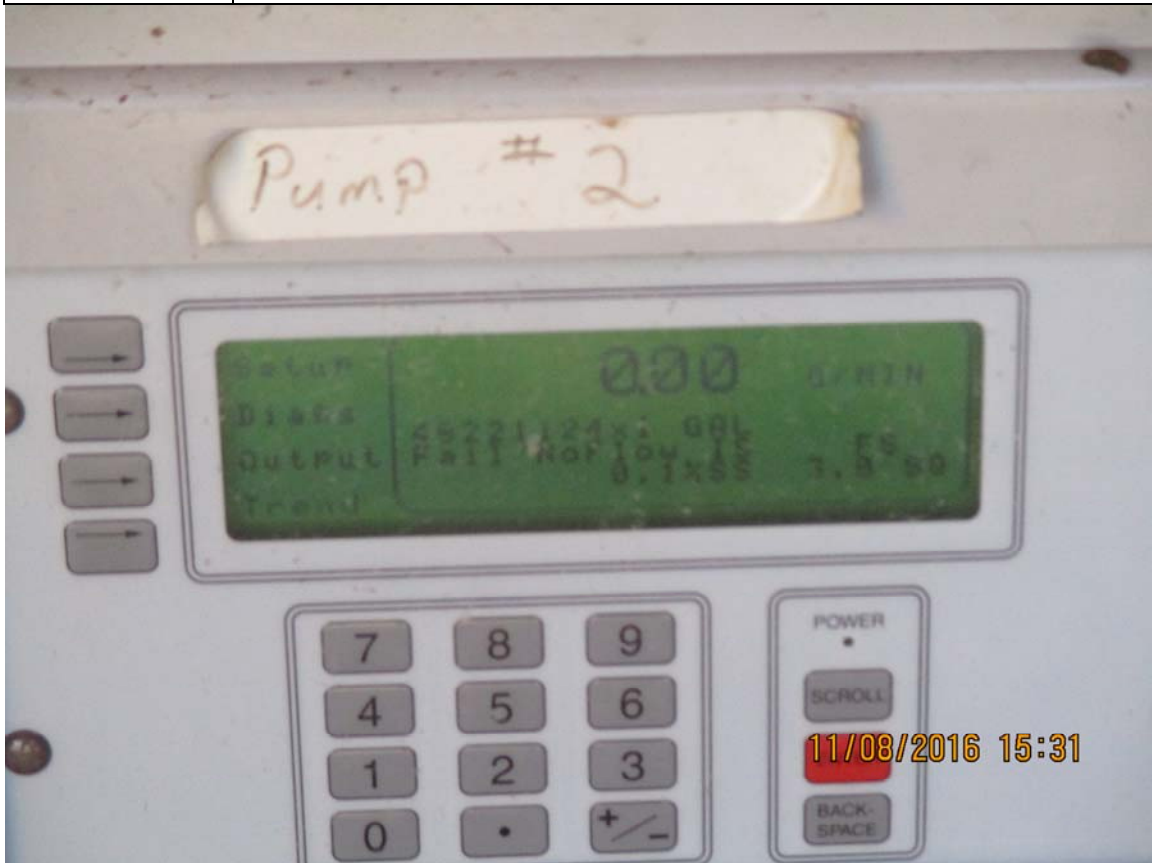
Photo 10	Display screen on properly function Pump No. 2
----------	------------------------------------------------
