# 2016 Annual Inspection Report

for Compliance with the Coal  
Combustion Residuals Rule  
(40 CFR Part 257)

## **Valmont Station**

**January 18, 2017**

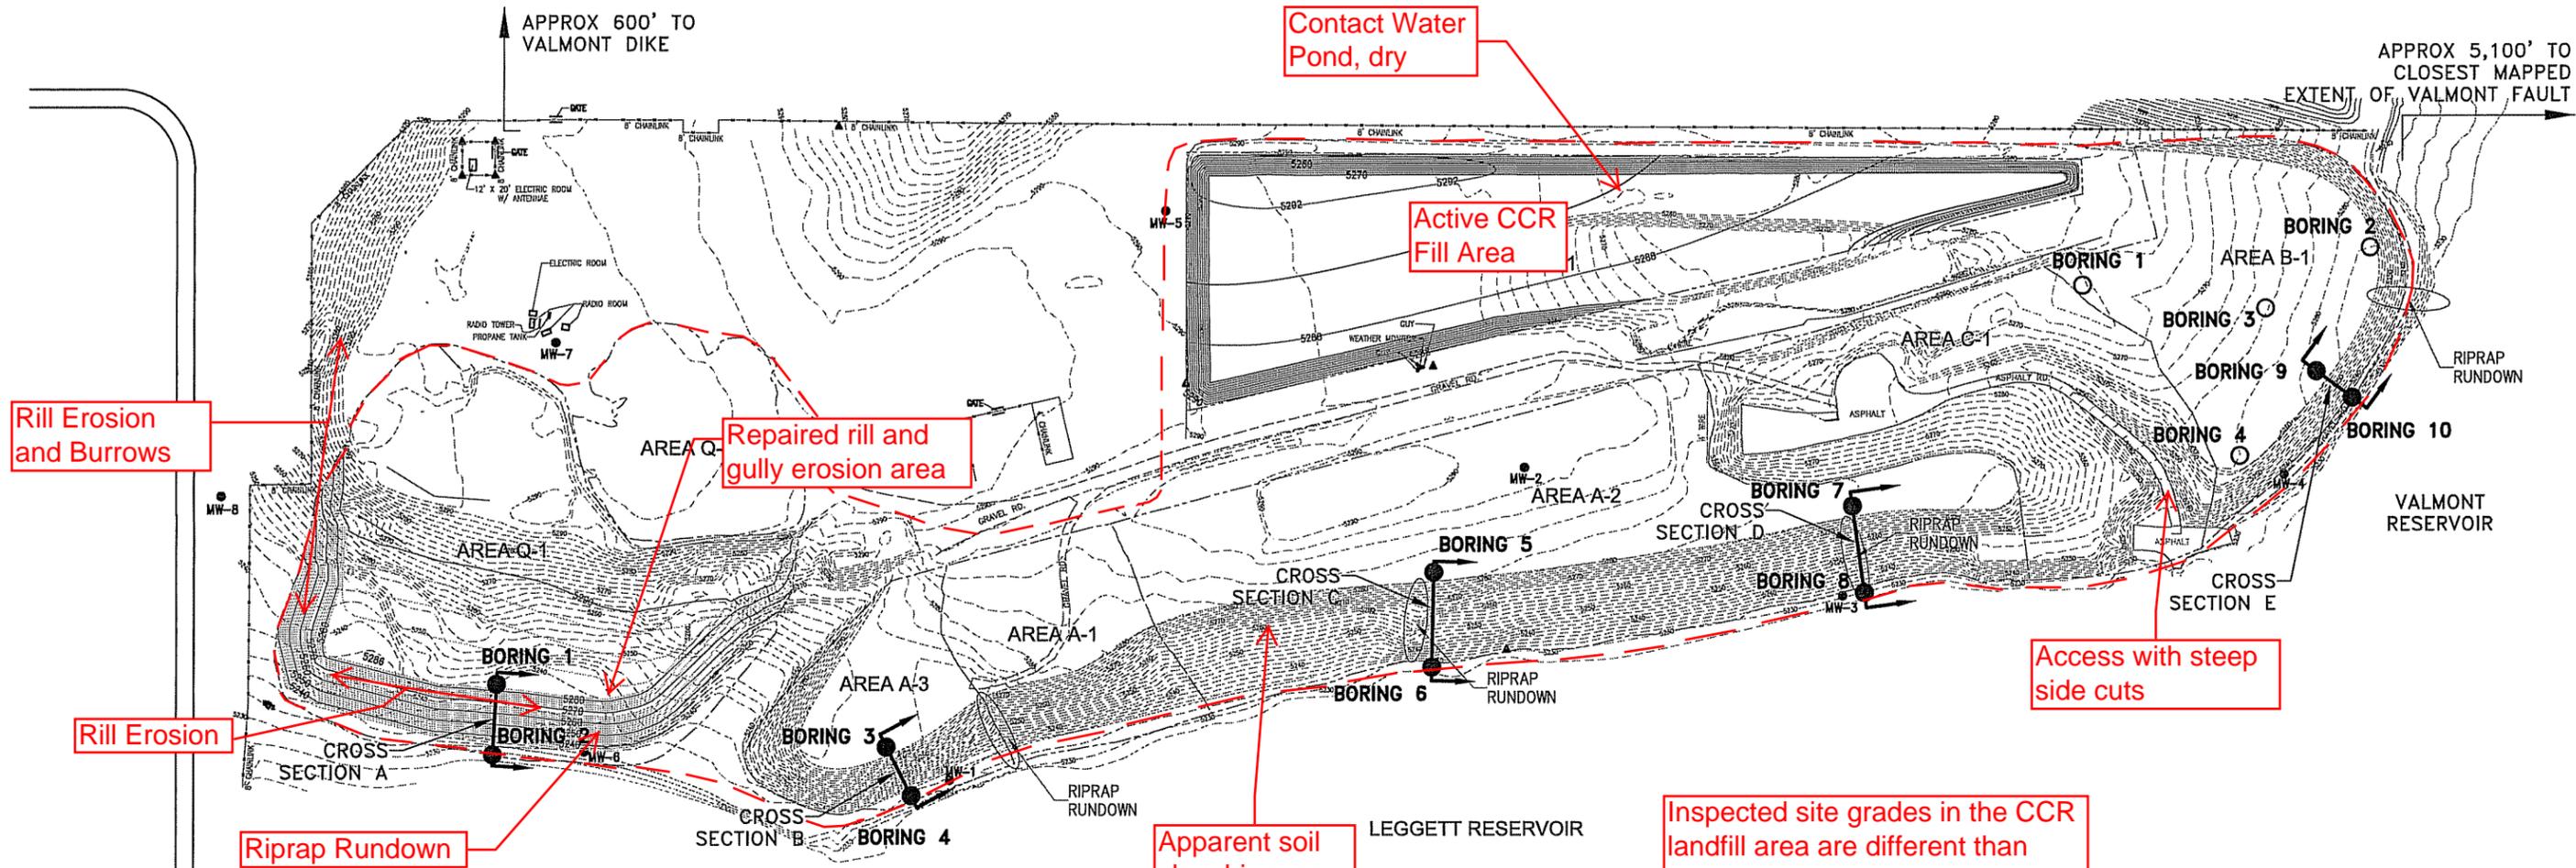
## Appendix A – Landfill Site Map

- The landfill side slopes along the southwest and west side of Area Q-1 have minimal vegetation cover. Despite the presence of regular benches to slow the stormwater flow, these areas show signs of rill and some gully erosion. These areas require continued monitoring and may require additional topsoil cover and revegetation to minimize future rill erosion.

- The riprap downchute on the southwestern slope (Area Q-1) was reconstructed to eliminate gully erosion on the sides of the riprap run down. No further erosion in the area was noted and the area has been covered with an erosion control blanket.

- There is a riprap run down on the east slope (Area B-1) with no visible erosion or stability concerns.
  - The south slope is an area where sloughing and localized instability is visible about one quarter down from the top plateau (against a degraded line of straw bales). This area is heavily vegetated but should be monitored for future sloughing or movement. The straw bales may be channeling surface water toward the impacted area; further analysis is warranted to determine the cause of the sloughing. No additional movement or sloughing was observed since the prior annual inspection.

- The active fill area (Area D-1) was observed to have minimal areas of exposed ash. The recently soil covered CCR landfill work areas on the western side of Area D-1 appeared to have adequate soil cover. The transition between the soil covered western side of D-1 and the eastern fill of Area D-1 had a limited amount of exposed ash. Side slopes for the cell excavation between the two fill areas were steep but showed no signs of instability or erosion.
- No ash disposal or compaction was observed during the site visit.
- There was no standing water observed in the active ash fill area.
