2019 Annual Inspection Report

for Compliance with the Coal
Combustion Residuals Rule
(40 CFR Part 257)

Comanche Station

January 18, 2020

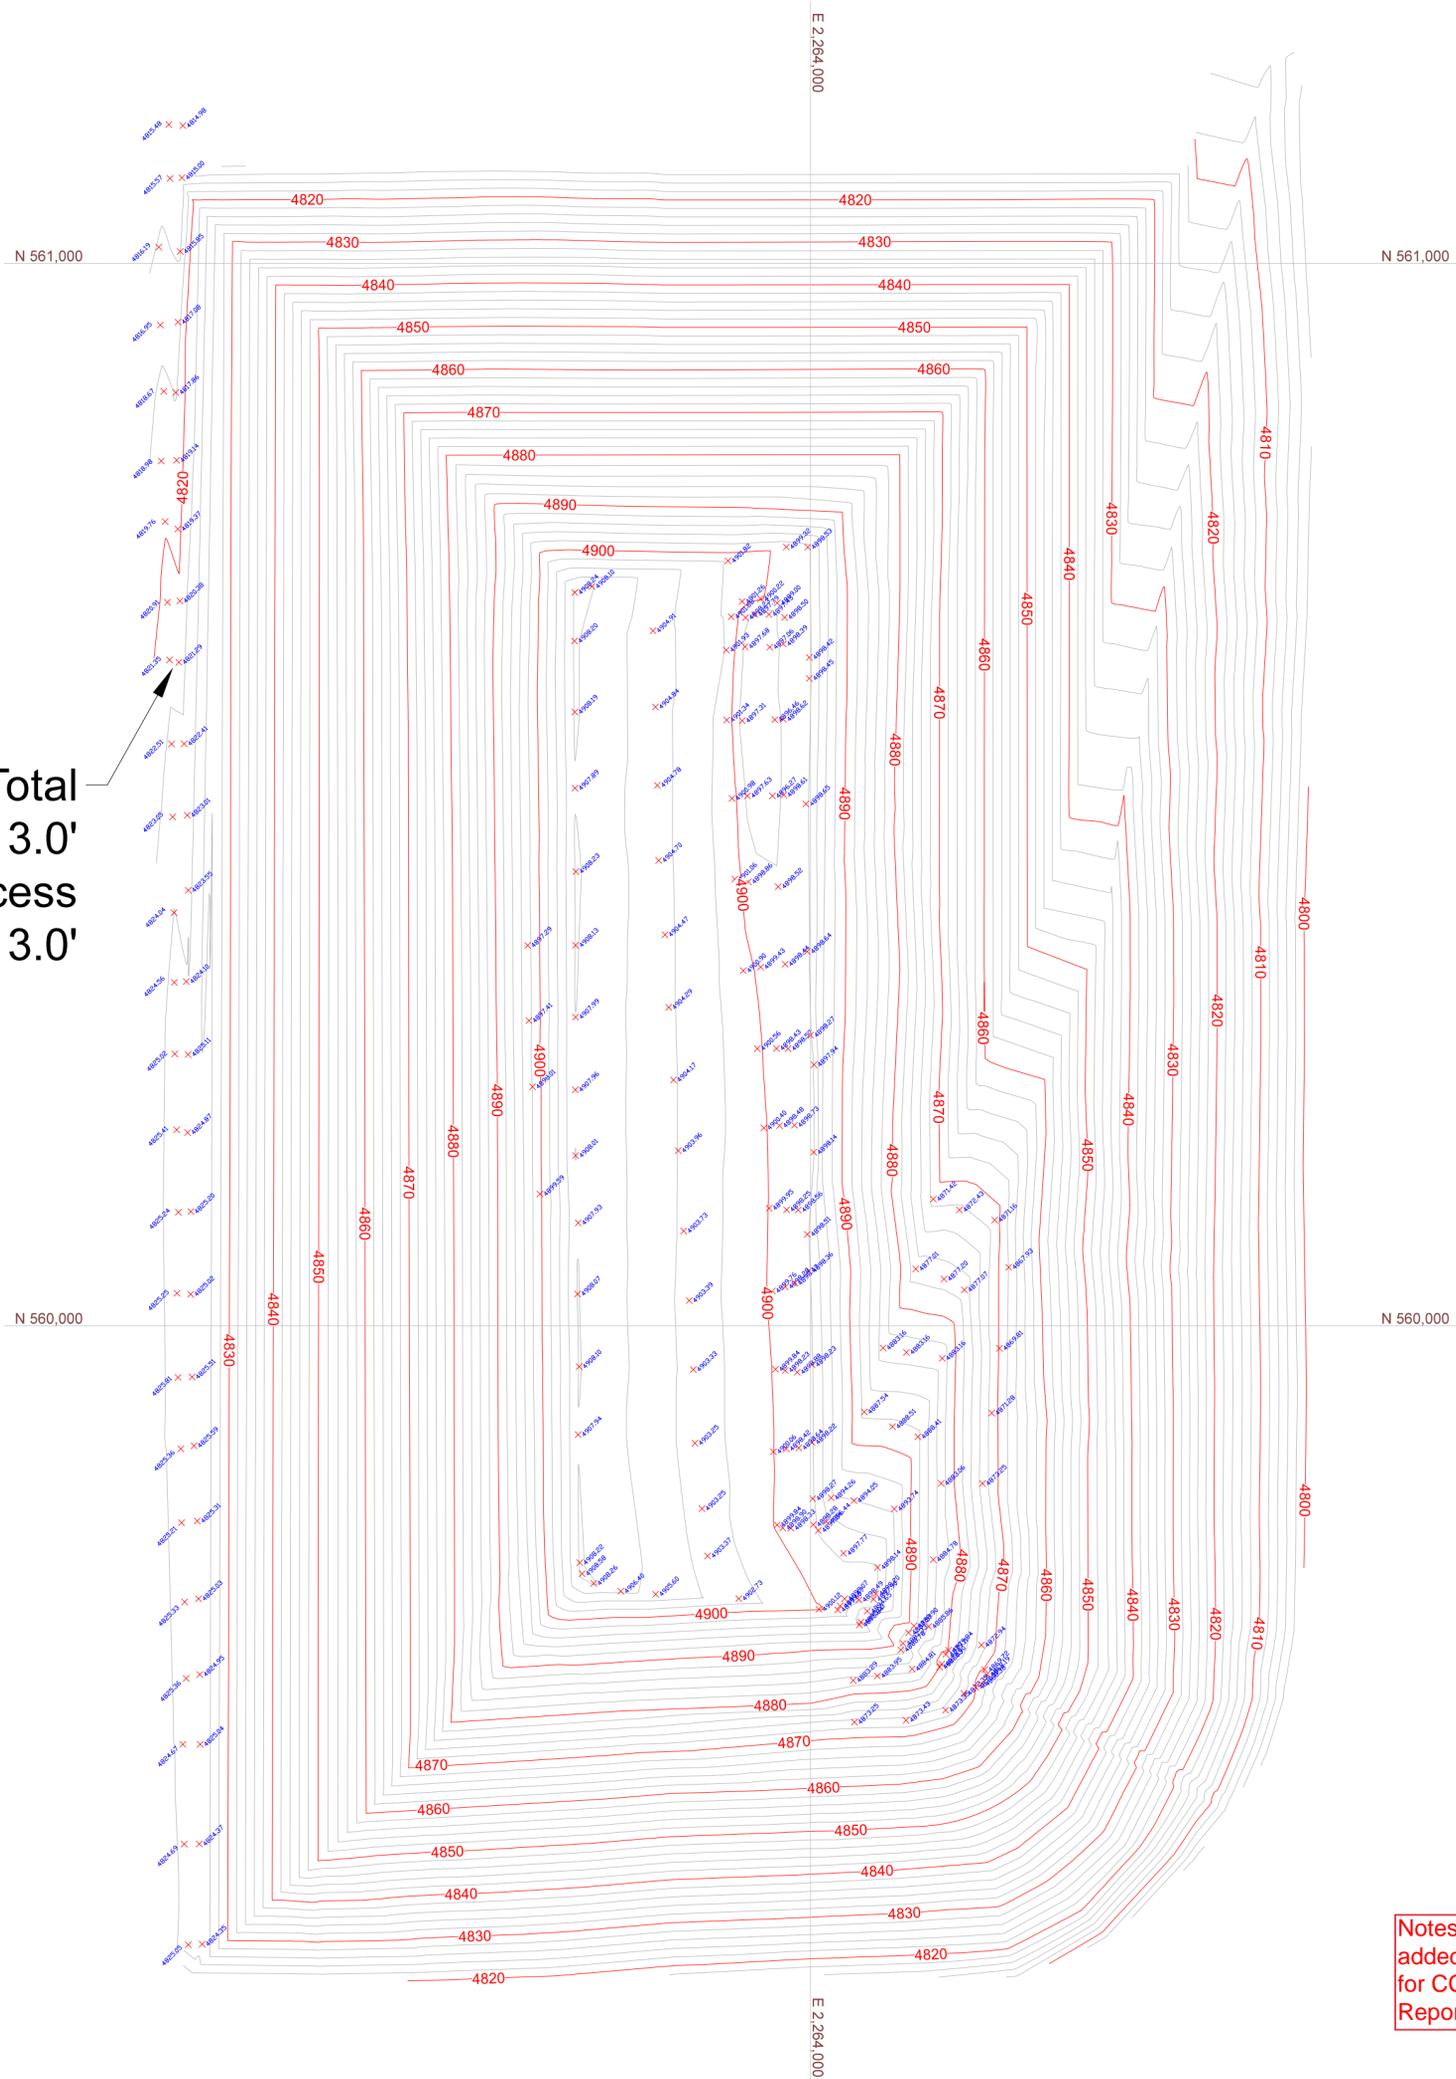
Appendix A – Cell 1 Topographic Survey

Volume Placed Dec. 2018 - Nov. 2019 - 90,735 CY
Current elevation of top of landfill - 4908'
Final elevation of landfill - 4910'

Volume shown
is for Cell 1 only.

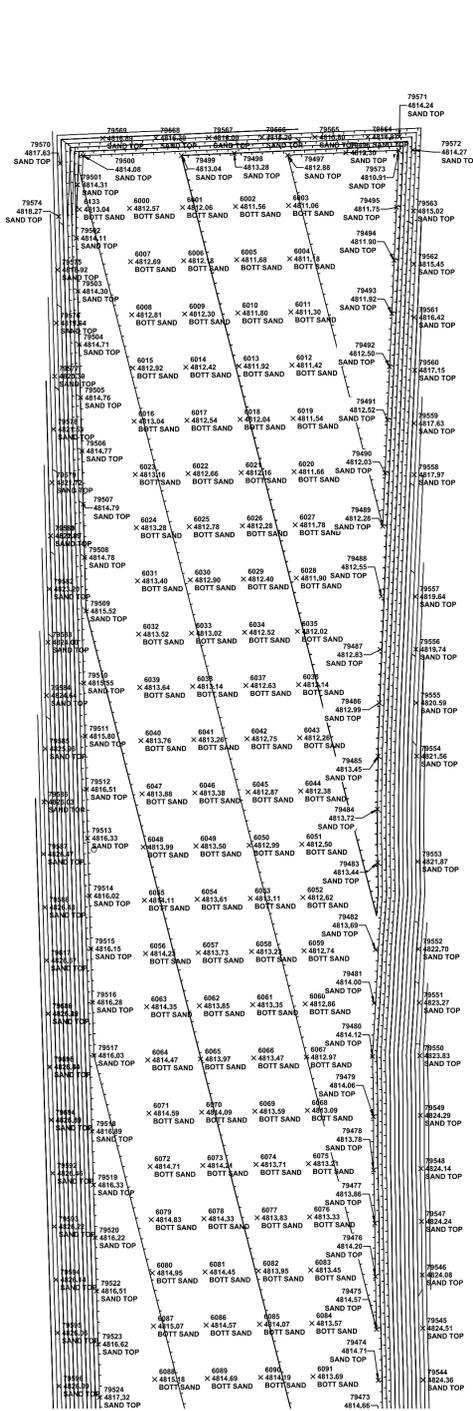
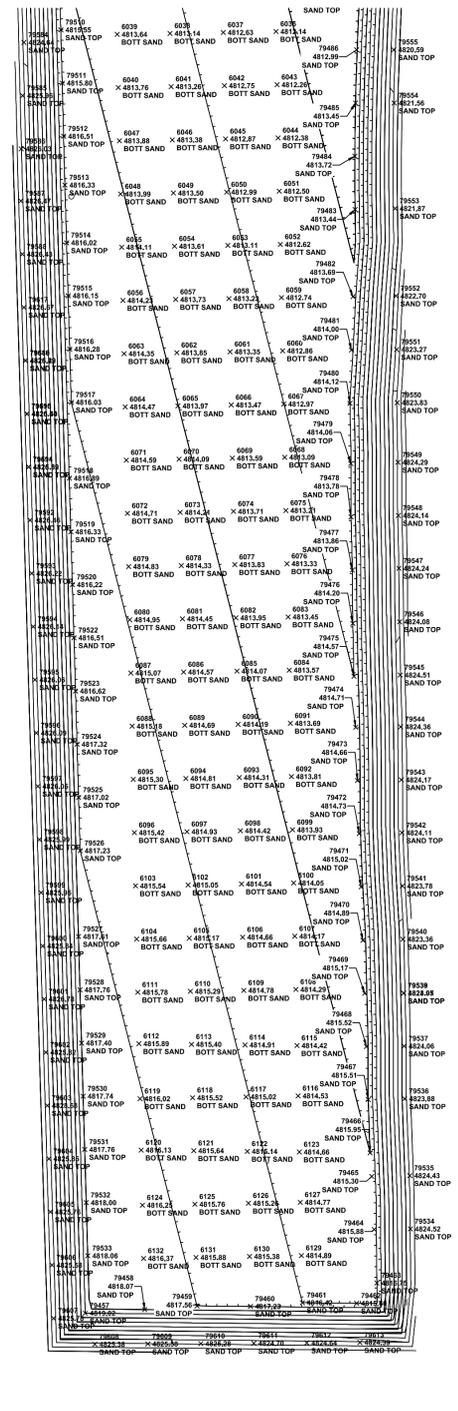
Appendix B – Cell 2E As-Built Survey

Approximately five feet of CCR placed above as-built grades - November 2019.
