2017 Annual Inspection Report

for Compliance with the Coal
Combustion Residuals Rule
(40 CFR Part 257)

Comanche Station

January 18, 2018

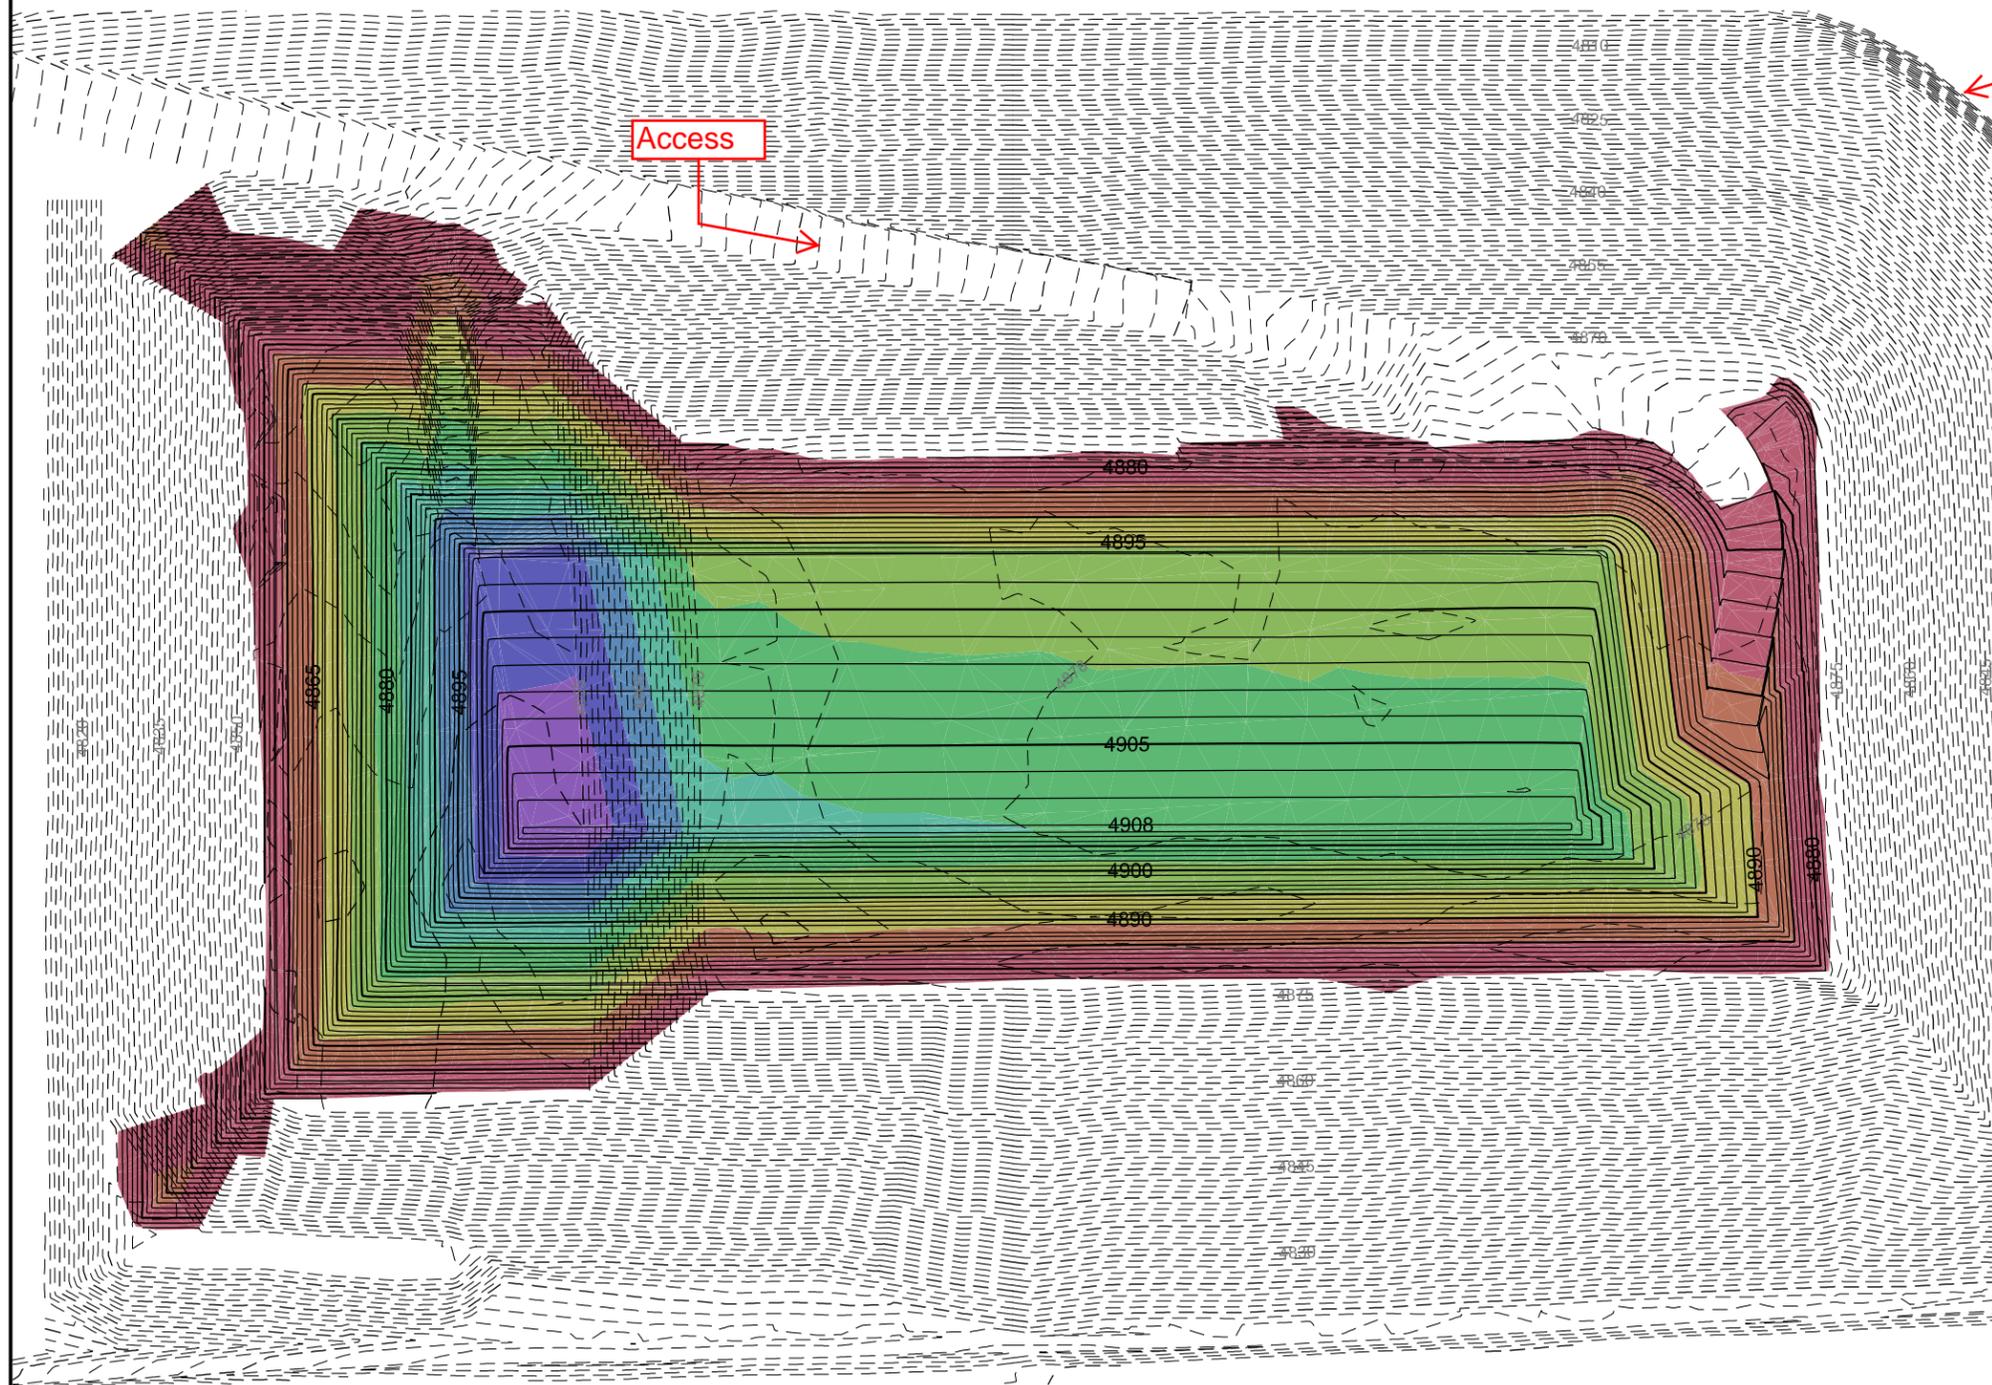
Appendix A – Landfill Site Map

- The southeast corner of the landfill does not have a uniform grade. The perimeter access road cuts into the southeast landfill side slope and forms a very steep grade near the toe of slope. This steep grade area showed no signs of sloughing or movement, but this area should be closely monitored as it is also susceptible to rill erosion. This slope is shown on the Existing Conditions Plan and Proposed Final Grades Plan in the EDOP. As part of the Cell 2 East construction Xcel Energy included plans to reconstruct this corner with a rip rap downslope structure in early 2018. As of this inspection, this plan remains unchanged and the installation of the downslope structure had not begun.

Based on the site inspection and review of available materials, excepting the southeast toe of slope discussed above in Section 4, the site showed no signs of operational and structural concern. Xcel intends to reconstruct the southeast corner in early 2018 with a rip rap downslope structure to minimize slope instability potential and reduce the occurrence of rill erosion in this steeply sloped area.

SE embankment corner with cut toe.
