2018 Annual Inspection Report

for Compliance with the Coal
Combustion Residuals Rule
(40 CFR Part 257)

Comanche Station

January 18, 2019

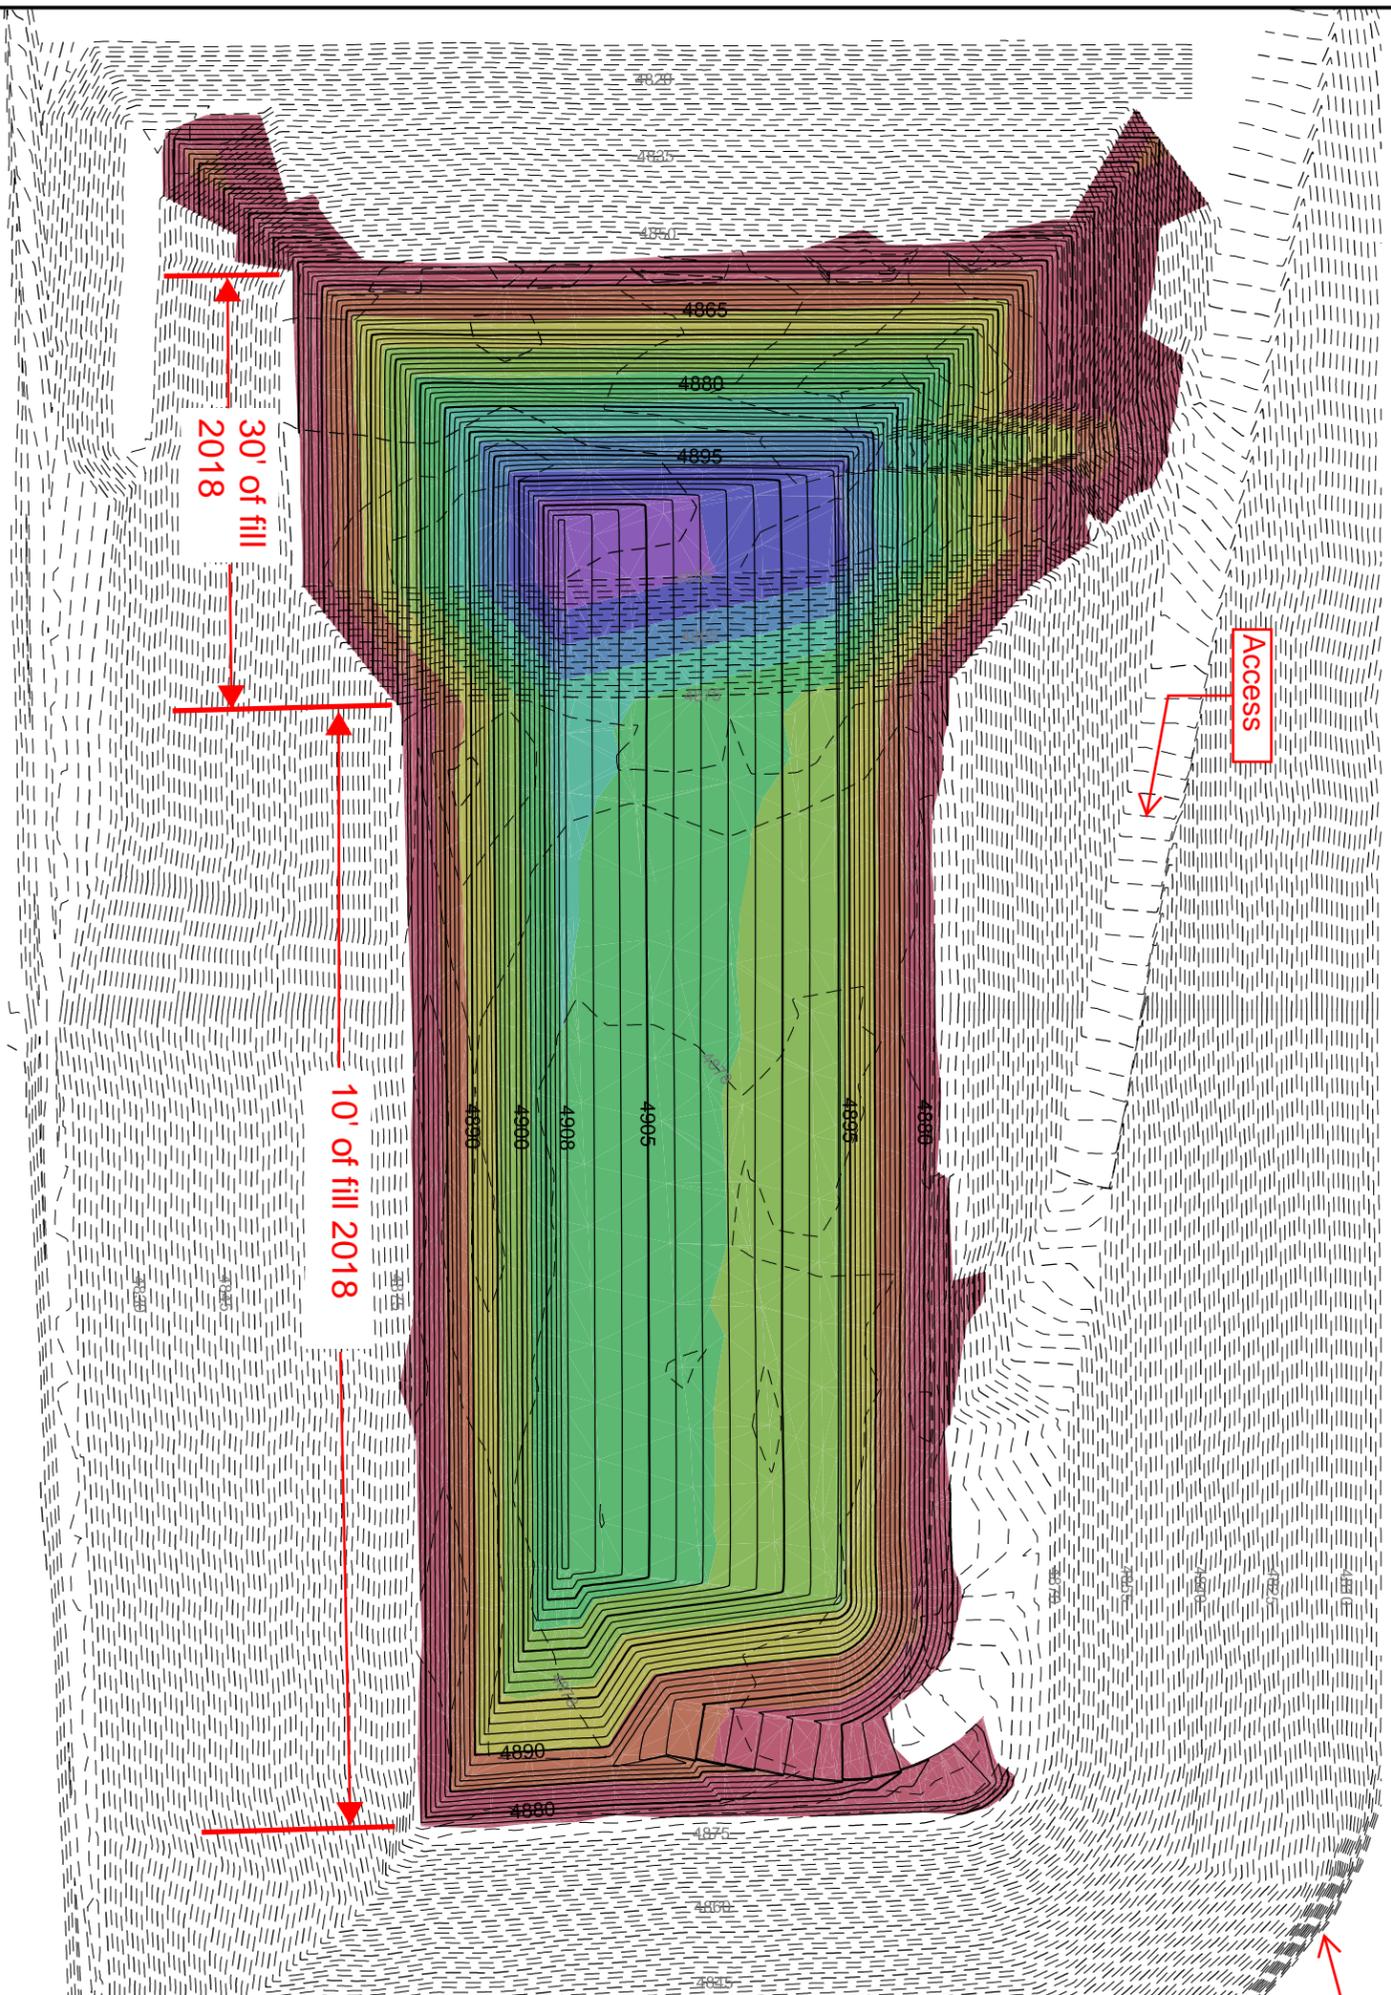
Appendix A – Landfill Site Map

SE embankment corner with toe cut modified in 2018. Slope reworked to match surrounding grades. Topography shown does not reflect new grades.
