2019 Annual Inspection Report

Pawnee Station – East Landfill

January 18, 2020

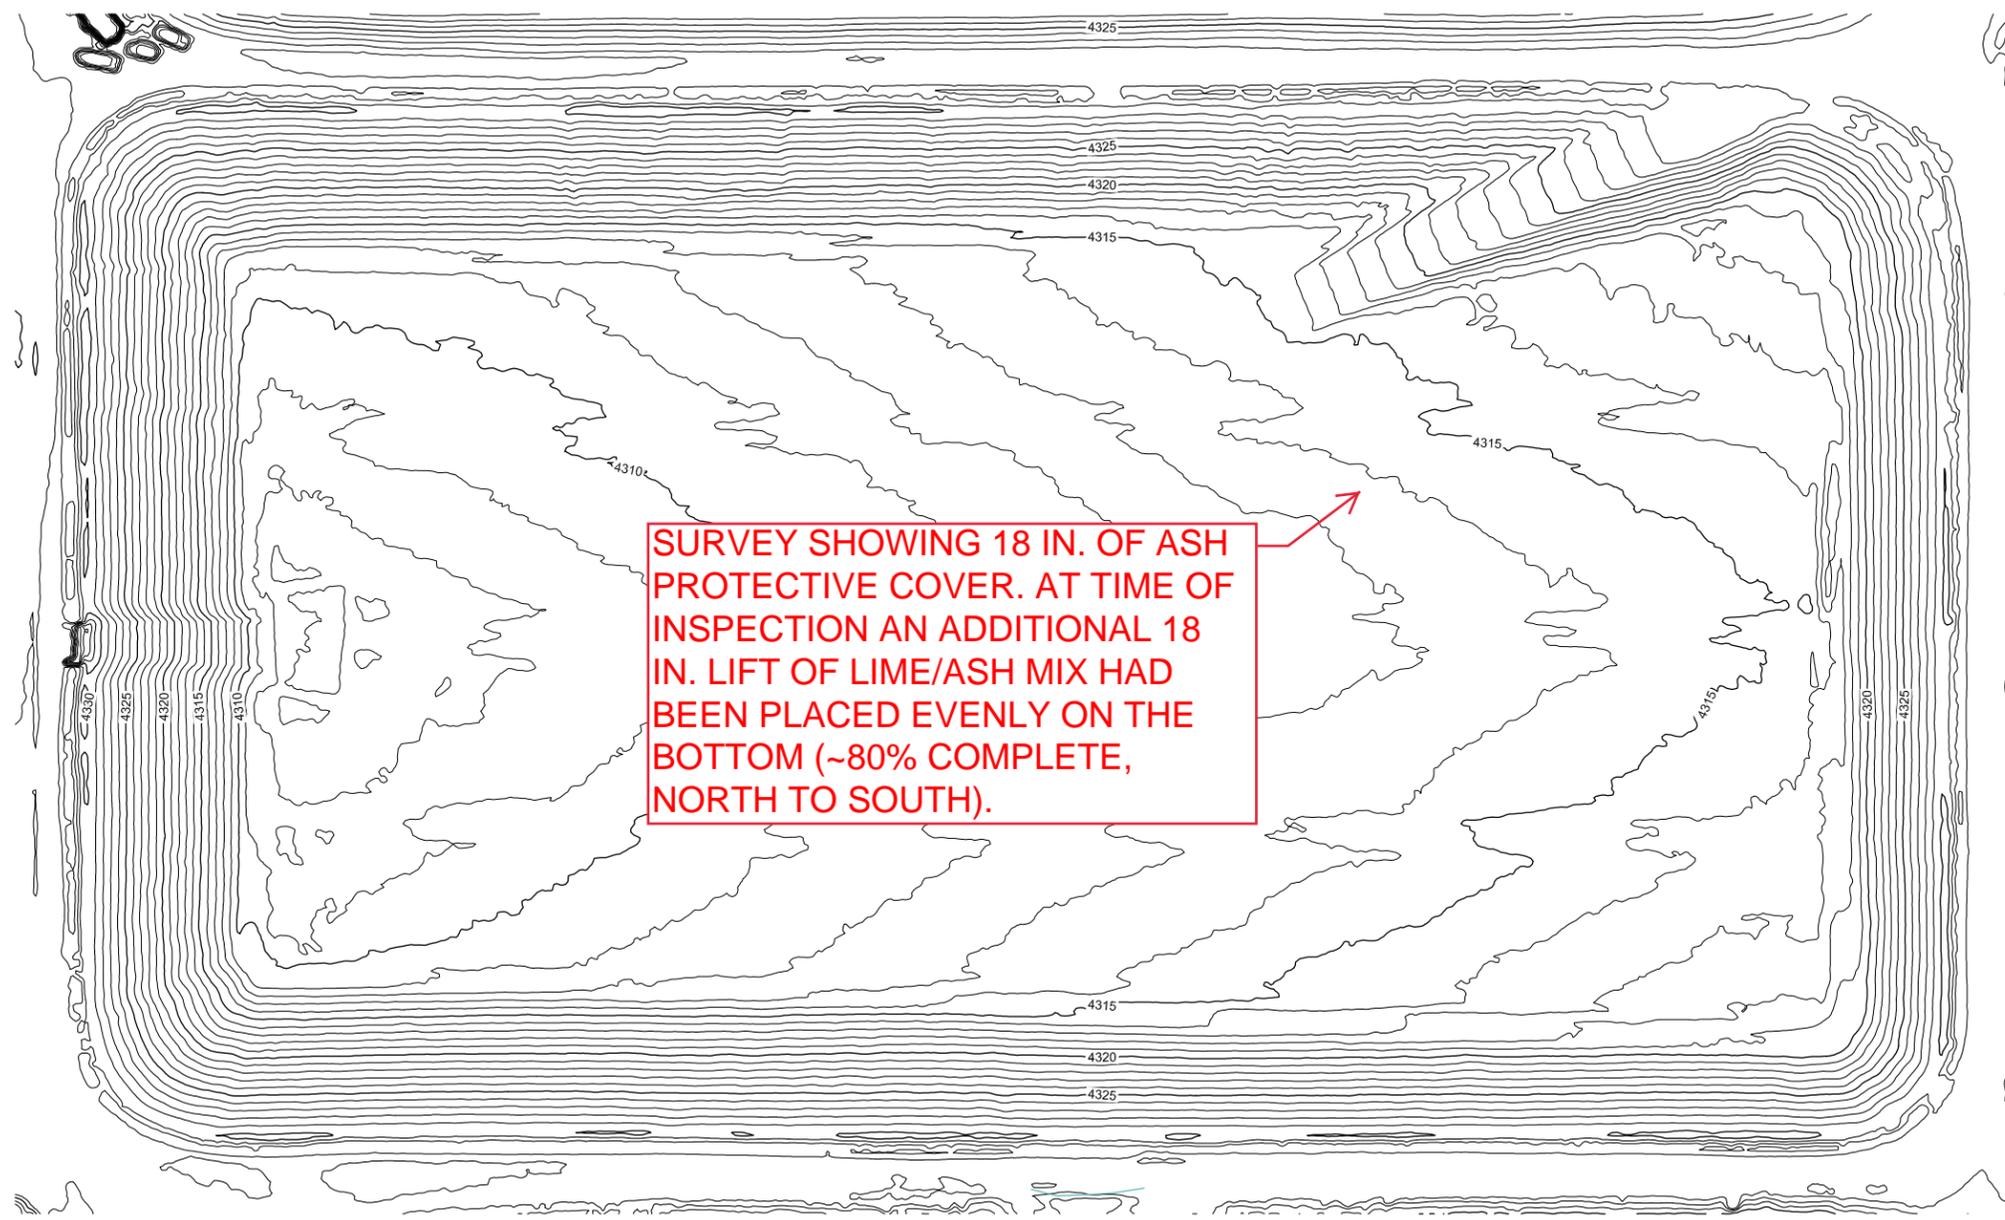
FIGURE
1

The Federal CCR Rule requires that site geometry changes be identified since the last inspection. Since the final construction survey, a protective layer of fly ash (18 inches) has been placed across the bottom and side slopes of the landfill. Additionally, a single 18 inch lift of ash-lime mix has been placed on the bottom of the landfill. This lift was approximately 80% complete at the time of the inspection with the southern-most segment remaining.

**PAWNEE EAST LANDFILL
ASH PROTECTIVE COVER**
