2018 Annual Inspection Report

for Compliance with the Coal Combustion Residuals Rule (40 CFR Part 257)

Pawnee Station

January 18, 2019

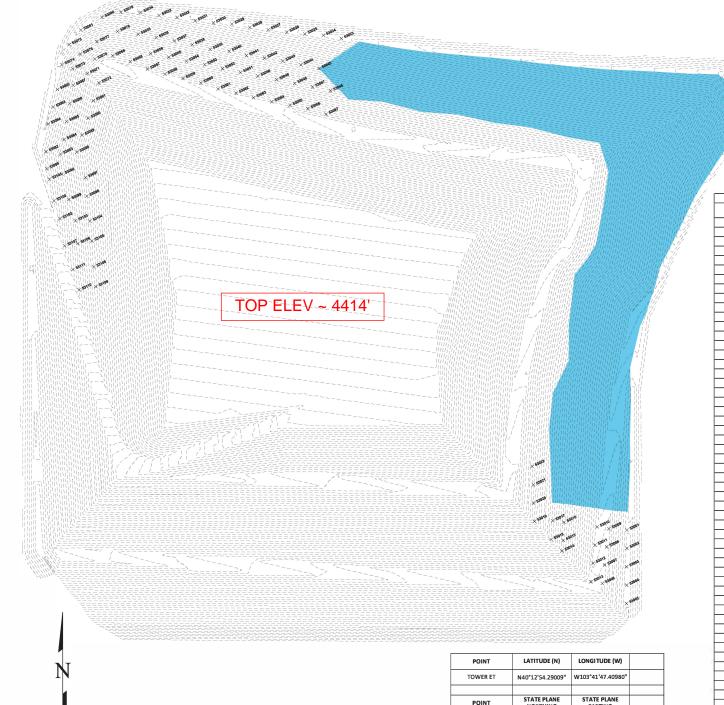
NORTH CCR LANDFILL TOP OF CCR VERIFICATION

SURVEY PROVIDED TO SUPPORT TOPOGRAPHIC CHANGES FOR CCR ANNUAL INSPECTION REPORT. RED TEXT BOXED NOTES BY HDR FOR JANUARY, 2019 SUBMITTAL
