Xcel Energy, Inc.
Sherburne County Generating Station
13999 Industrial Blvd.
Becker, MN, 55308

Re: 2018 Annual Inspection of Scrubber Solids Pond No. 3

Pond 3 Annual Inspection - October 2018

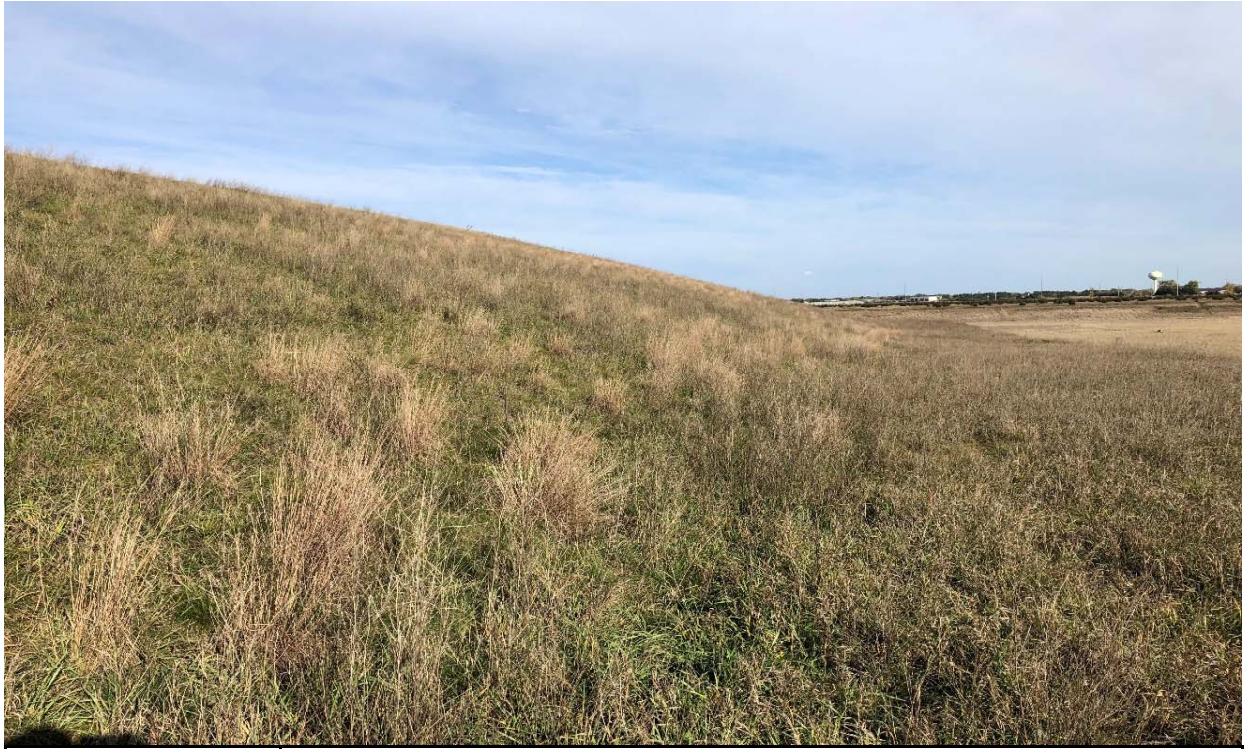
Photo 1	Outer east slope of east embankment, looking north.
10/22/2018

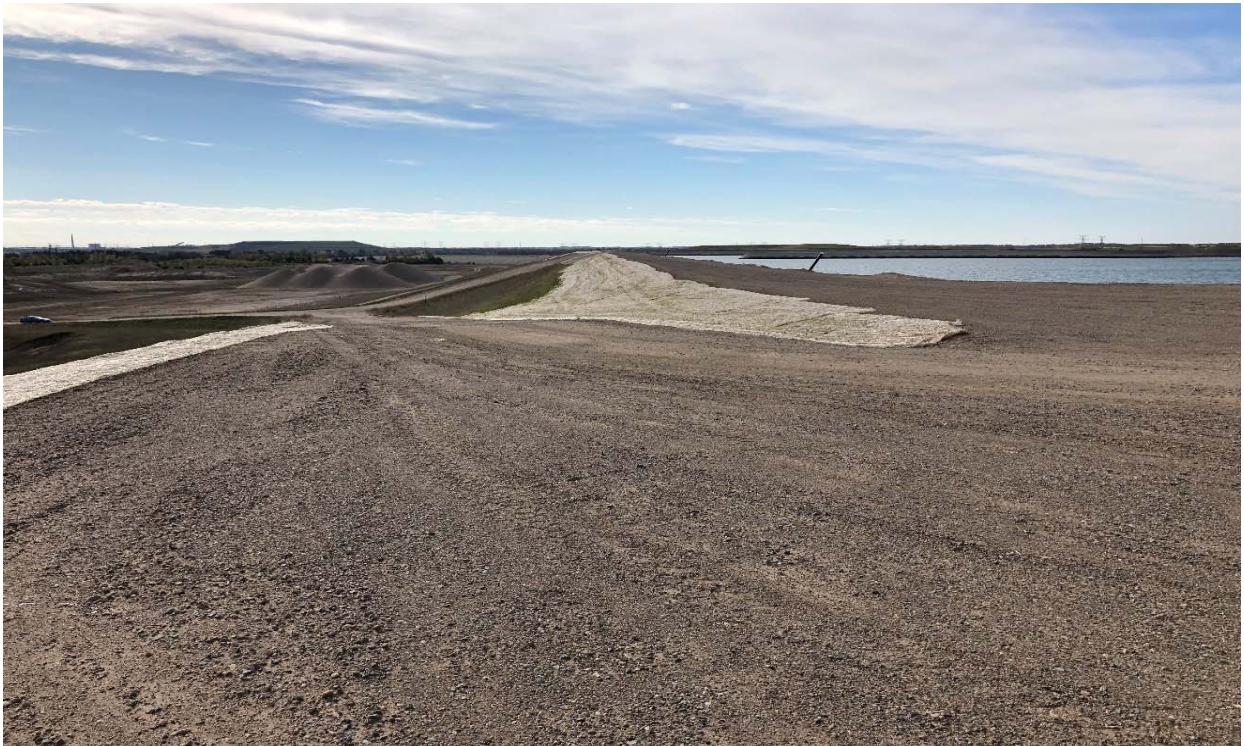
Photo 2	Northeast corner top of embankment, looking south.
10/22/2018

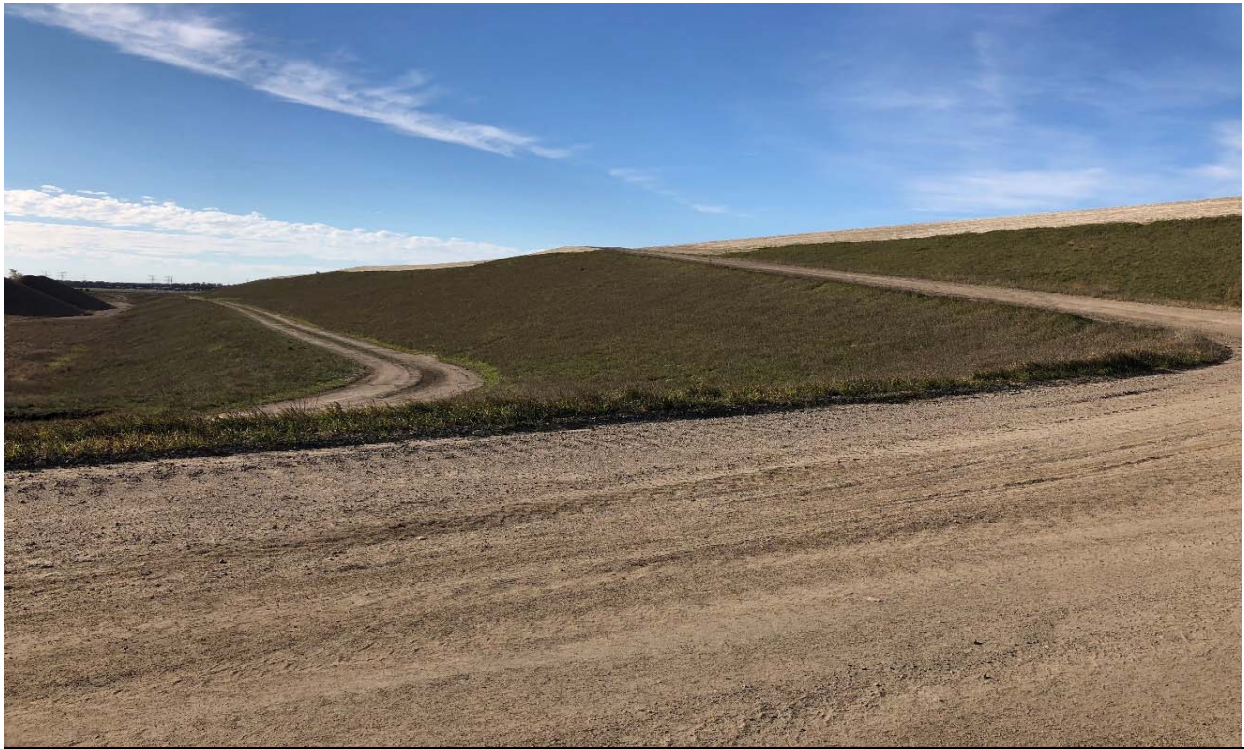
Photo 3	East embankment, looking southwest.
10/22/2018

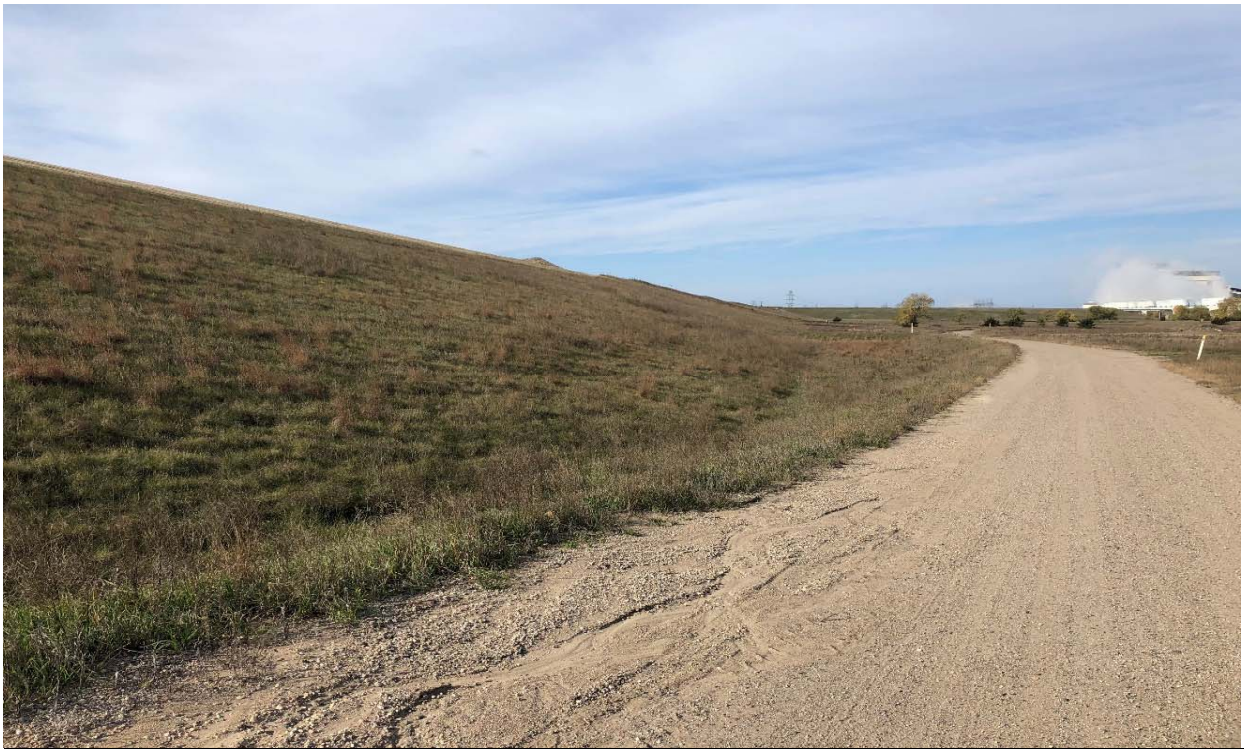
Photo 4	Outer slope of north embankment, looking west.
10/22/2018

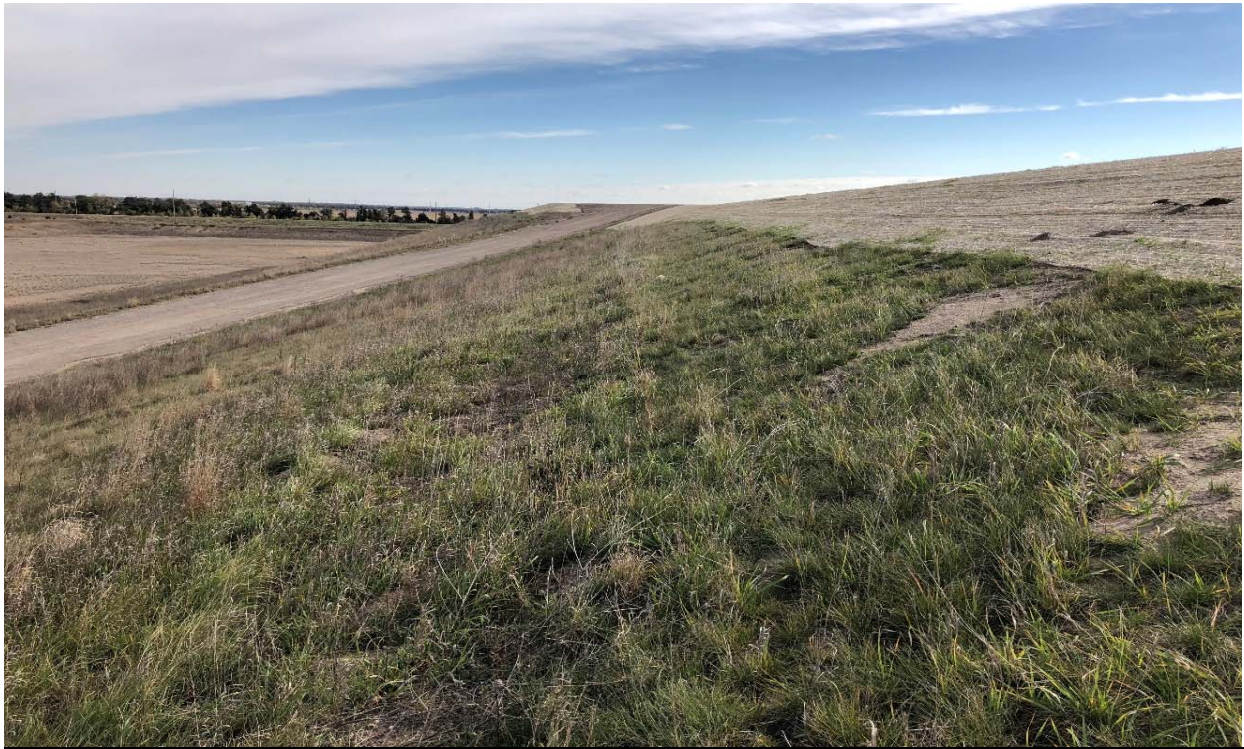
Photo 5	North embankment ramp, looking east.
10/22/2018

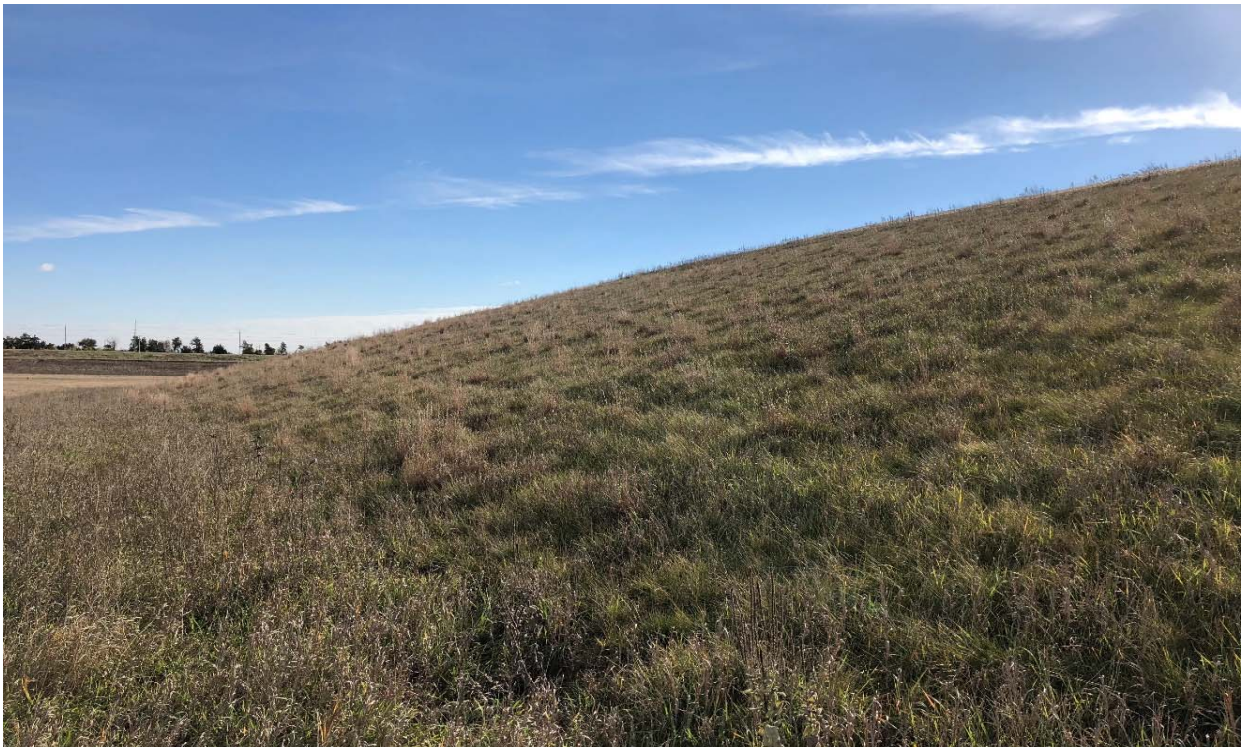
Photo 6	North embankment, looking east.
10/22/2018

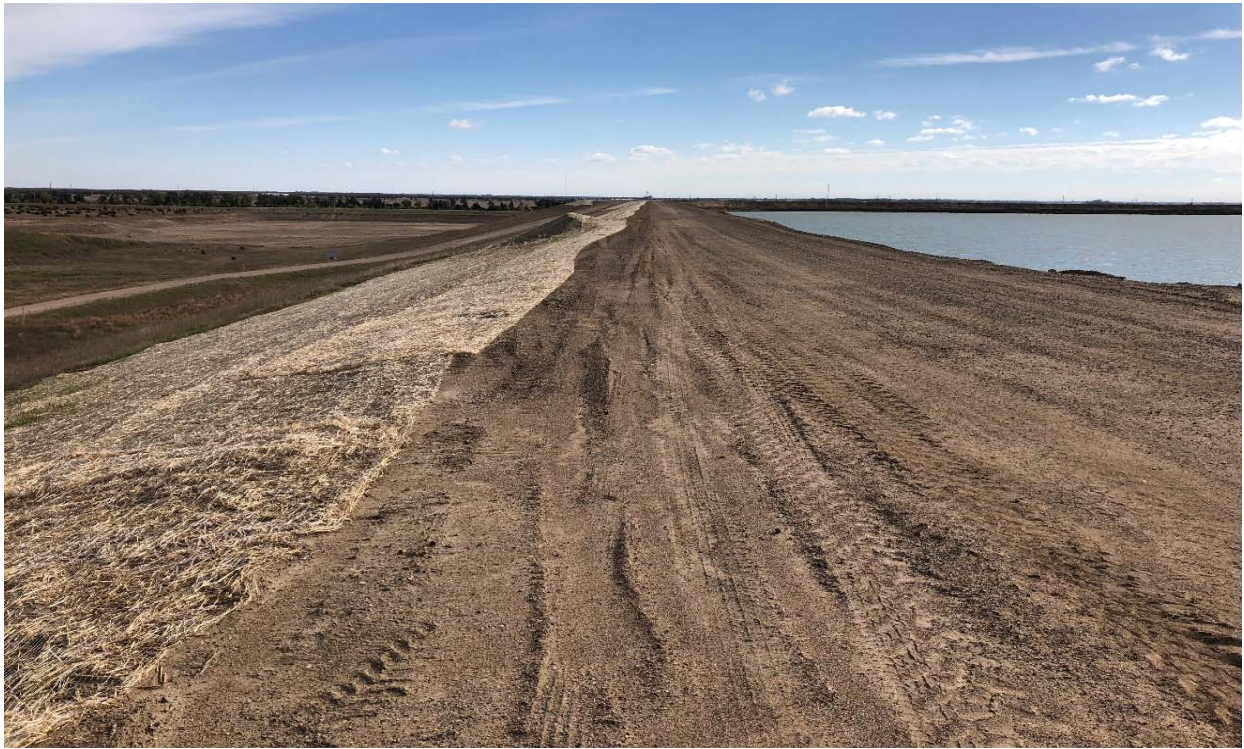
Photo 7	Top of north embankment, looking east.
10/22/2018

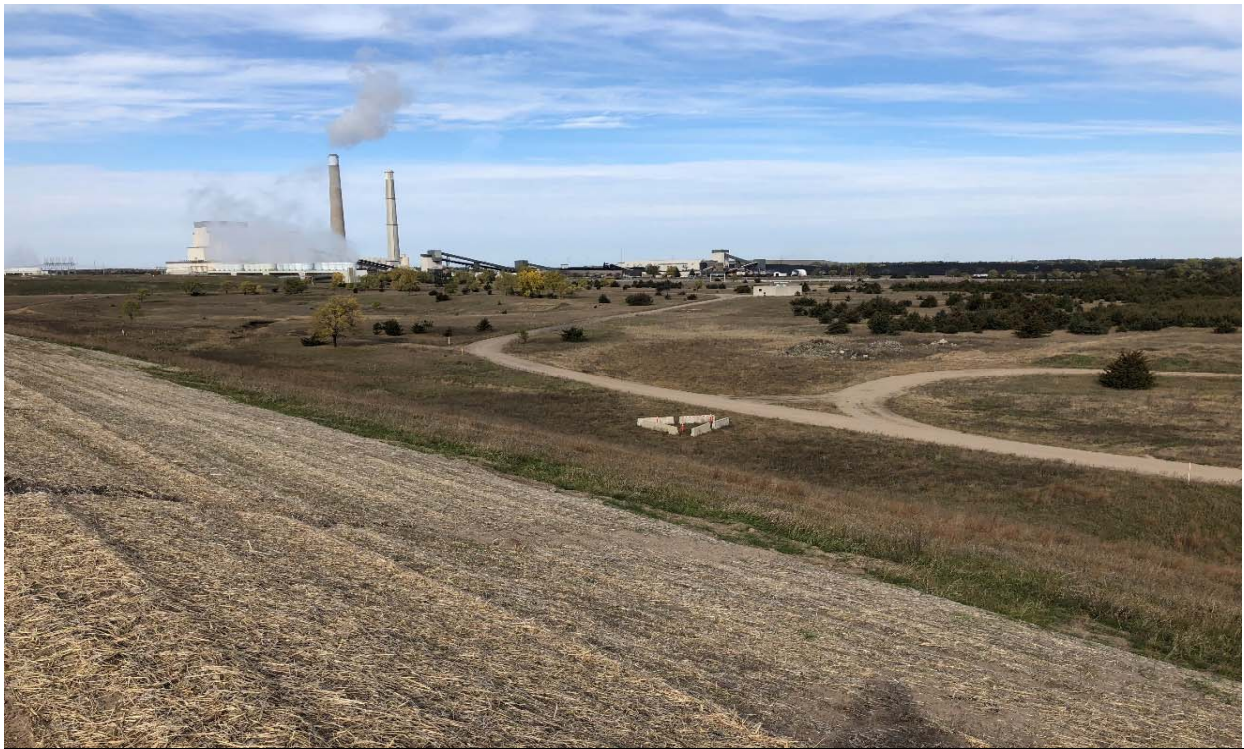
The discharge pipe corridor was inspected for signs of a leakage, such as saturated areas or sinkholes. No signs of leakage were observed along the pipe corridor or in the vault located north of Pond 3.

Photo 8	Underground discharge pipe corridor, looking northwest.
10/22/2018

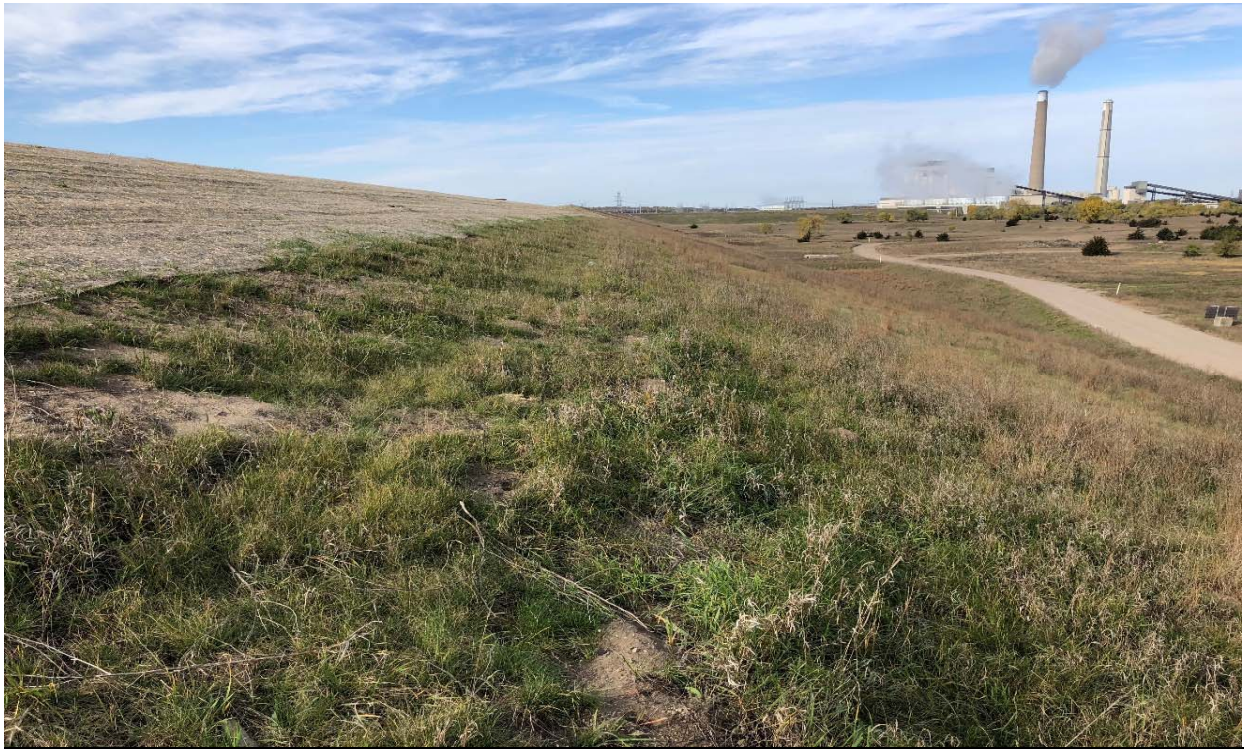
Photo 9	Pond north embankment mid-slope, looking west.
10/22/2018

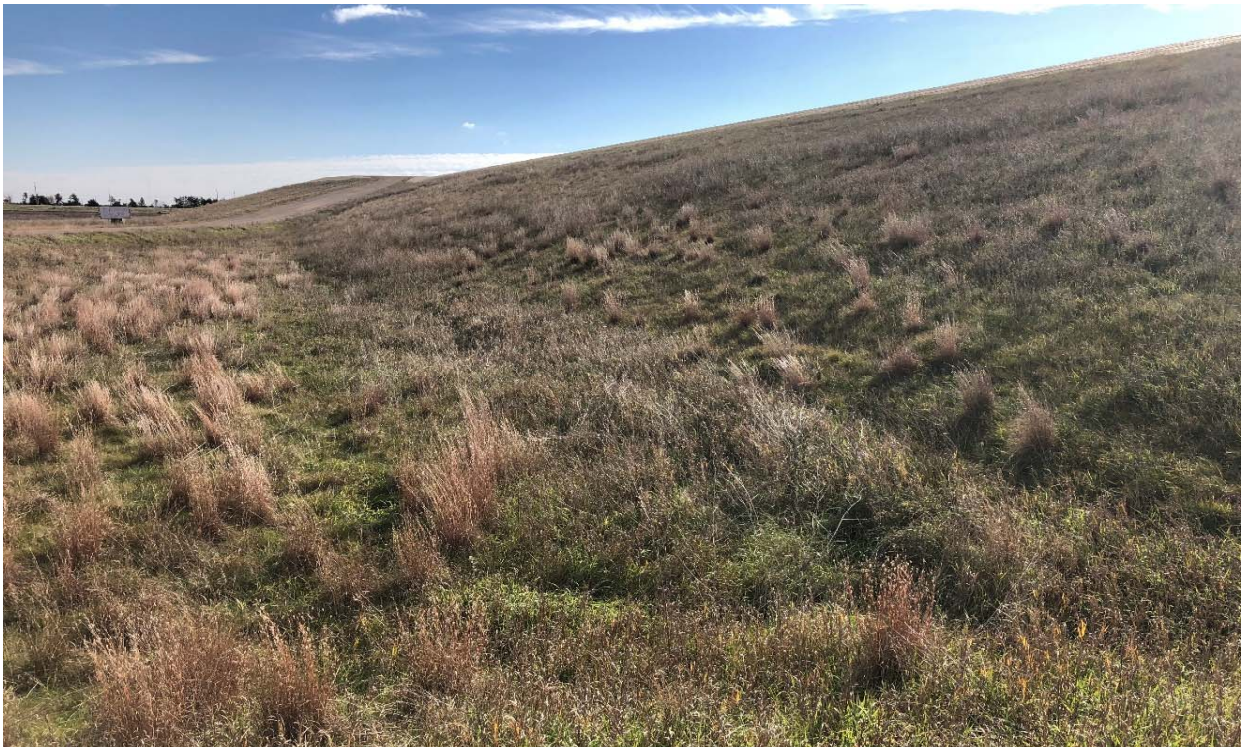
Photo 10	Pond north embankment and infiltration pond, looking east.
10/22/2018

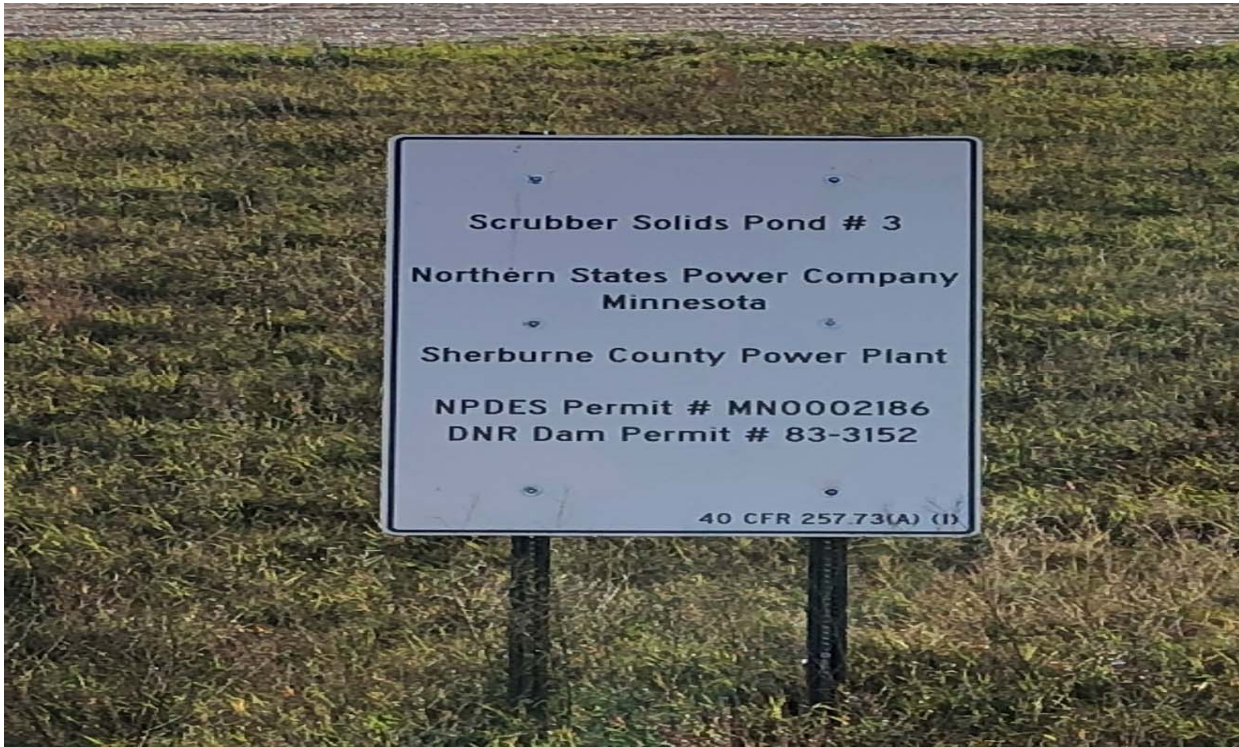
Photo 11	CCR Unit identification marker placed in accordance with Section 257.73
10/22/2018

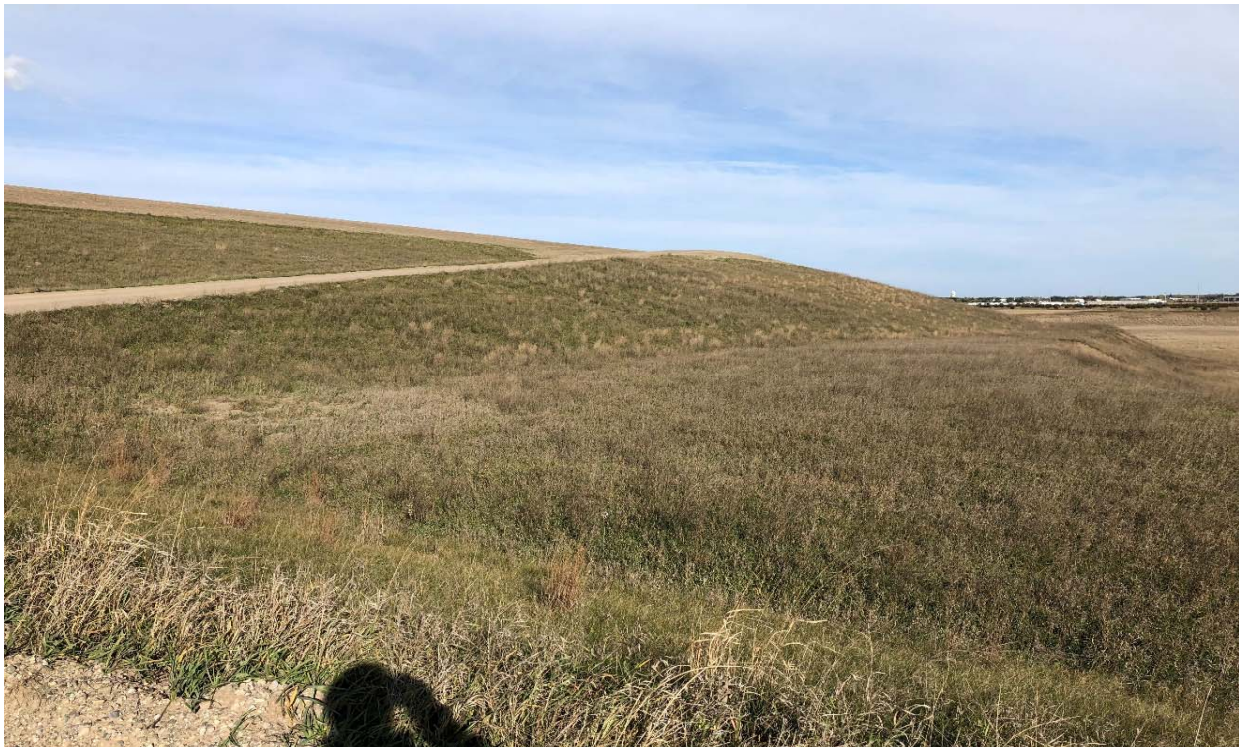
Photo 12	North end of pond east embankment, looking northwest.
10/22/2018

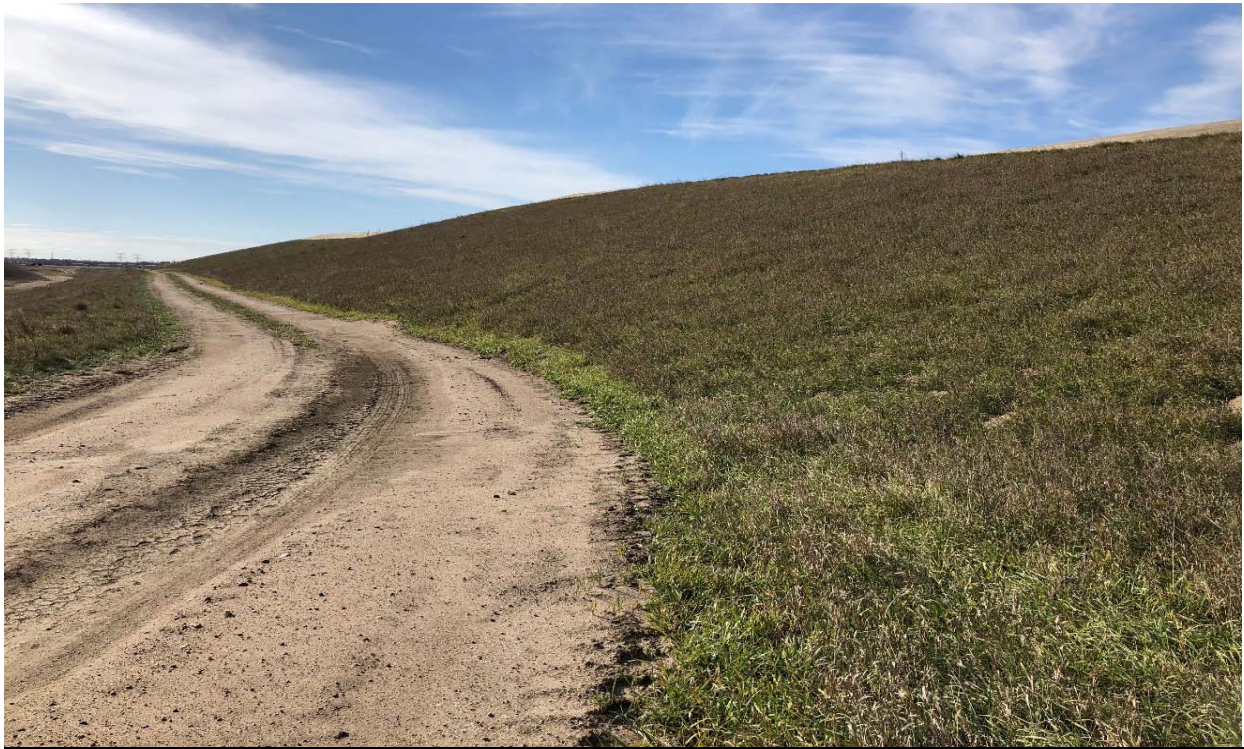
Photo 13	Pond east embankment, looking southwest.
10/22/2018

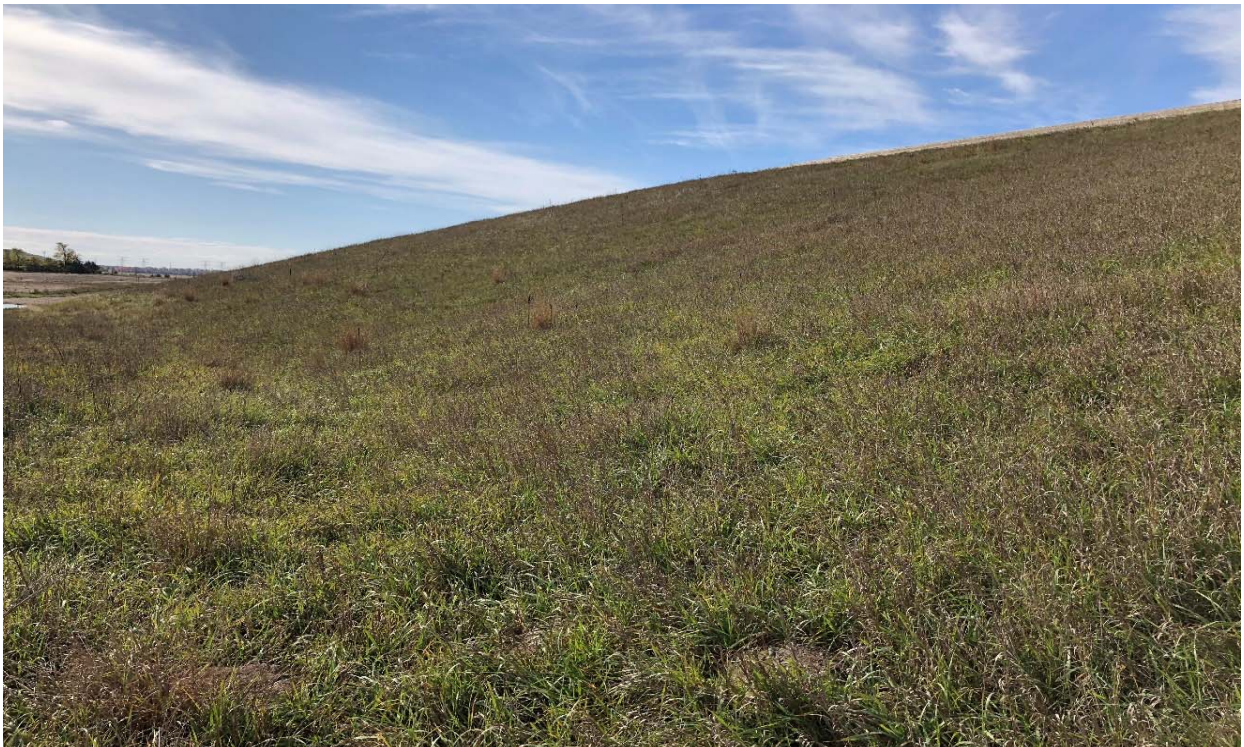
Photo 14	Pond east embankment, looking south.
10/22/2018

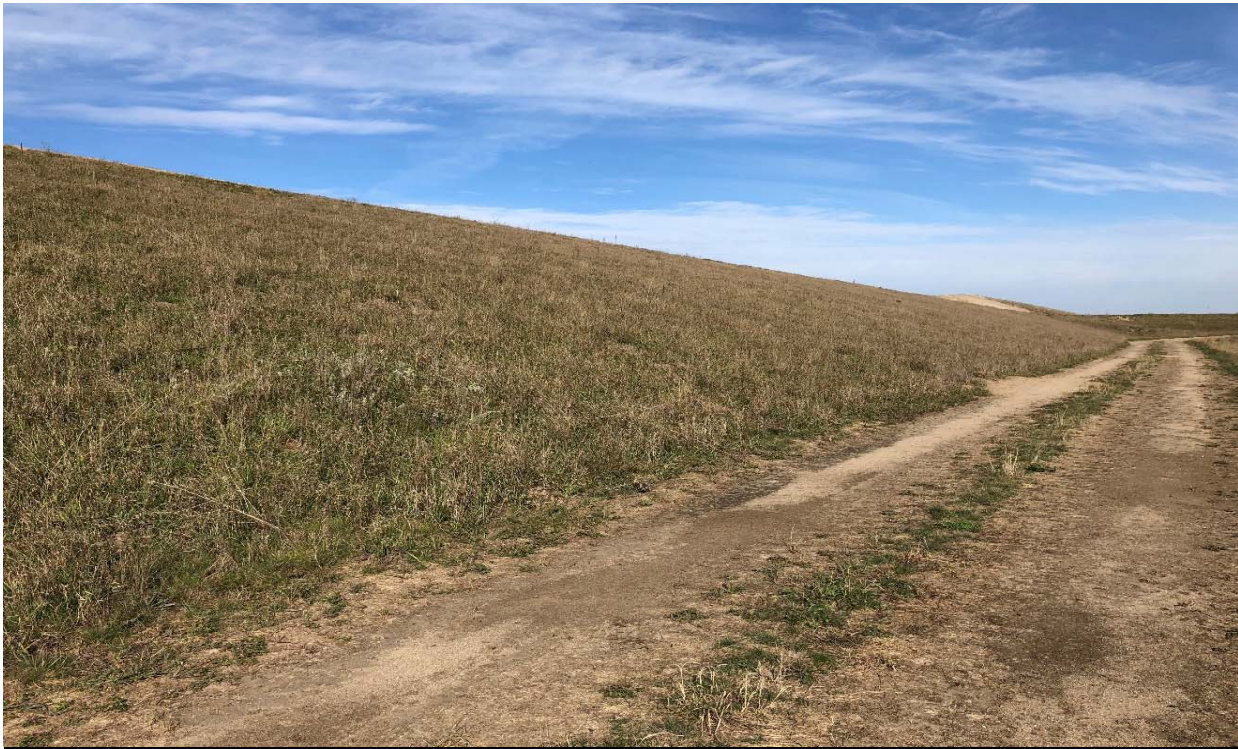
Photo 15	Pond east embankment, looking north.
10/22/2018

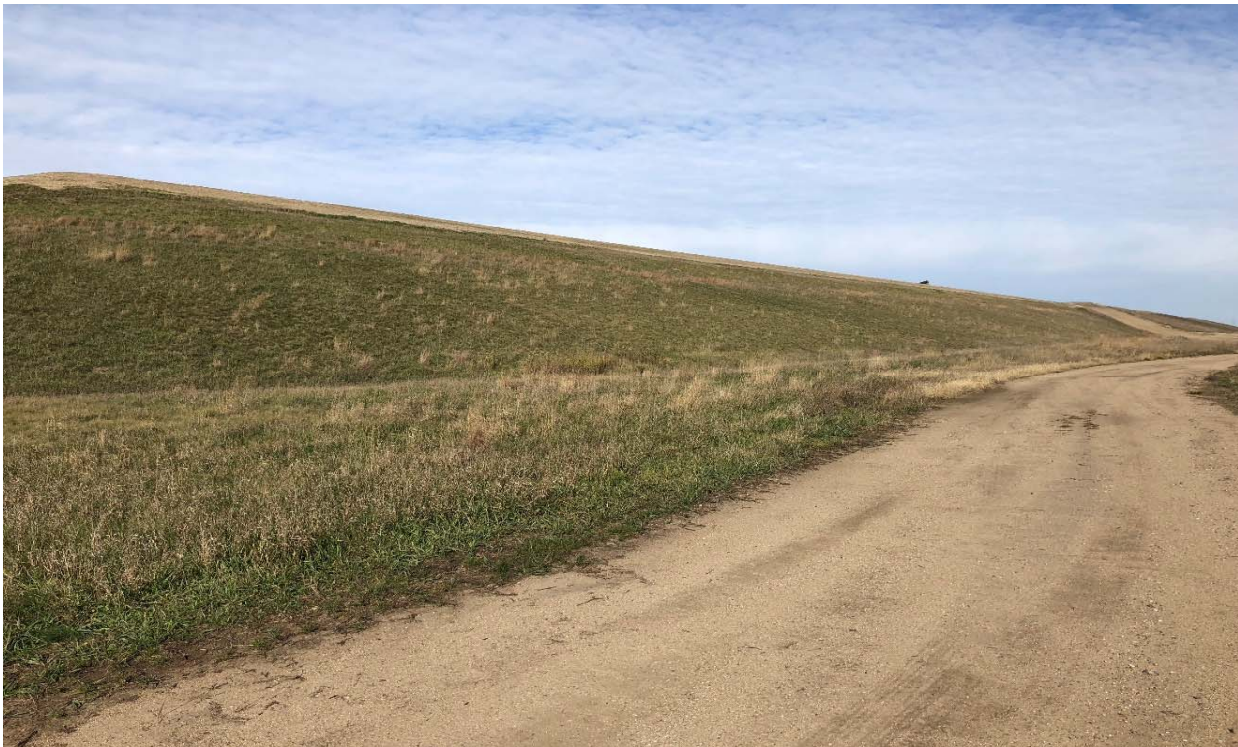
Photo 16	Southeast corner of outer embankment, looking north.
10/22/2018

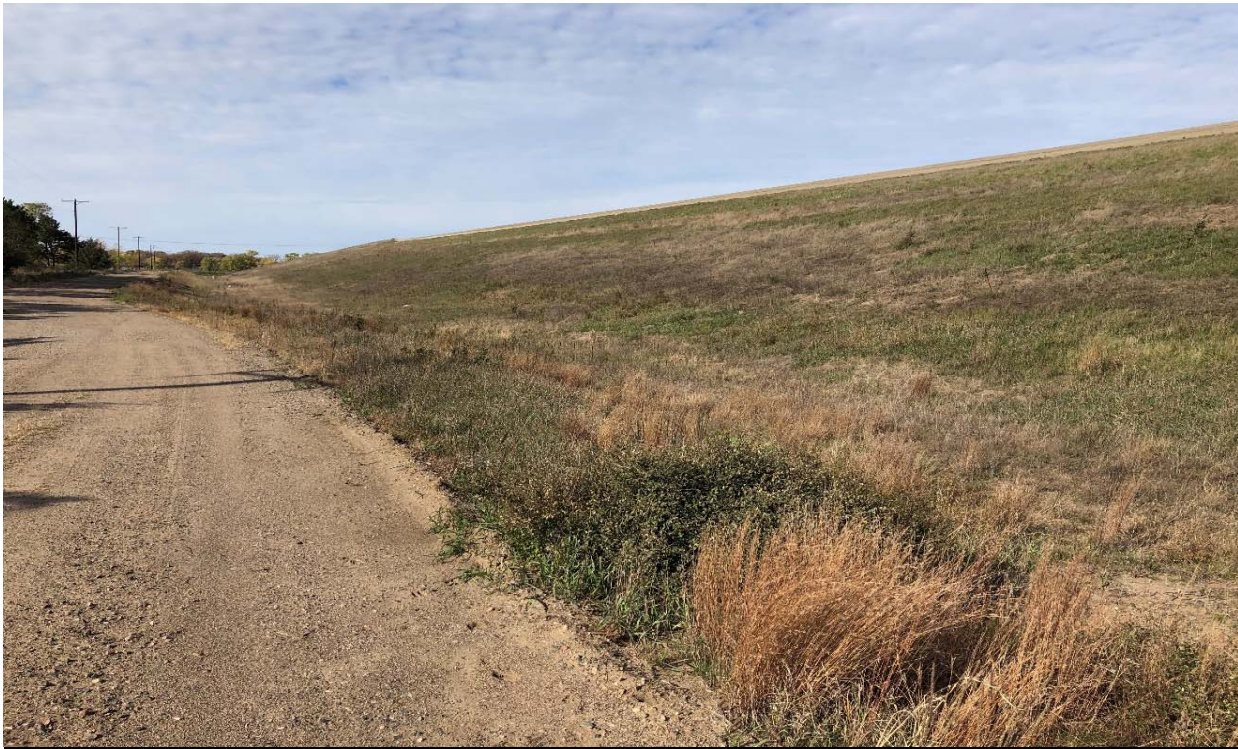
Photo 17	Pond south embankment, looking west.
10/22/2018

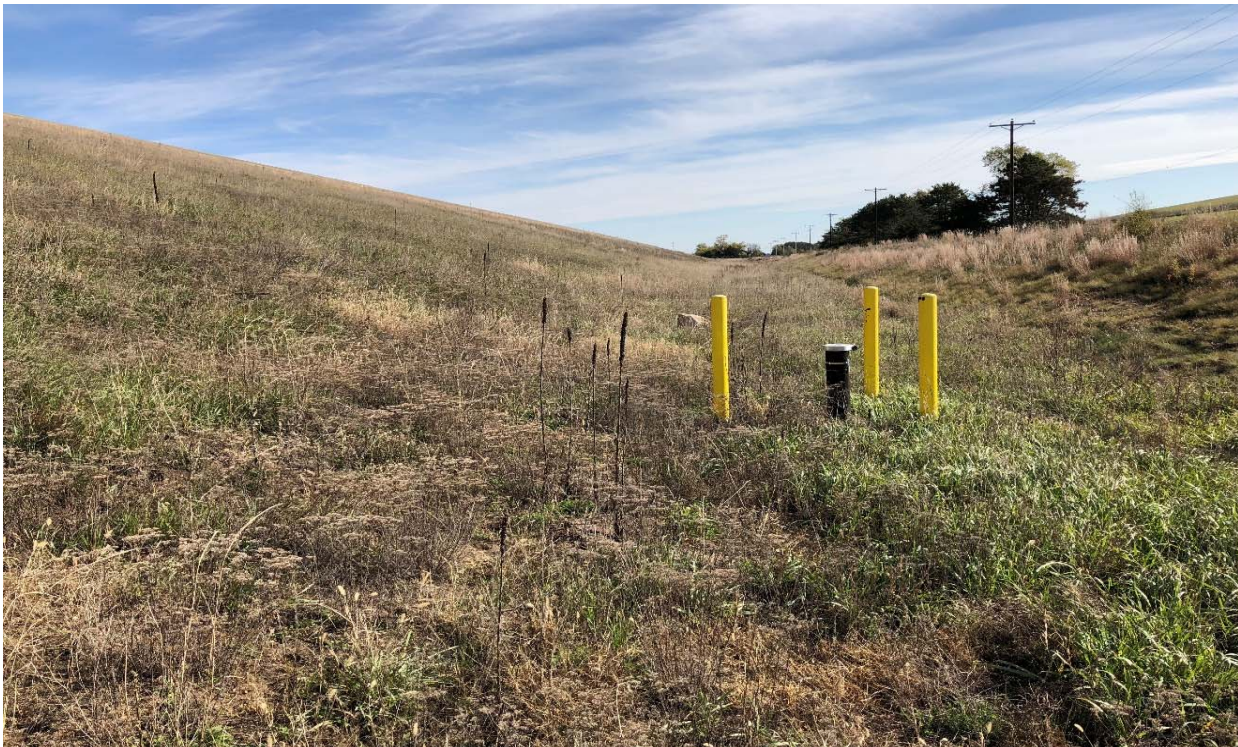
Photo 18	Pond south embankment, looking east. Middle right: Pond 3 CCR monitoring well (between yellow bollards).
10/22/2018

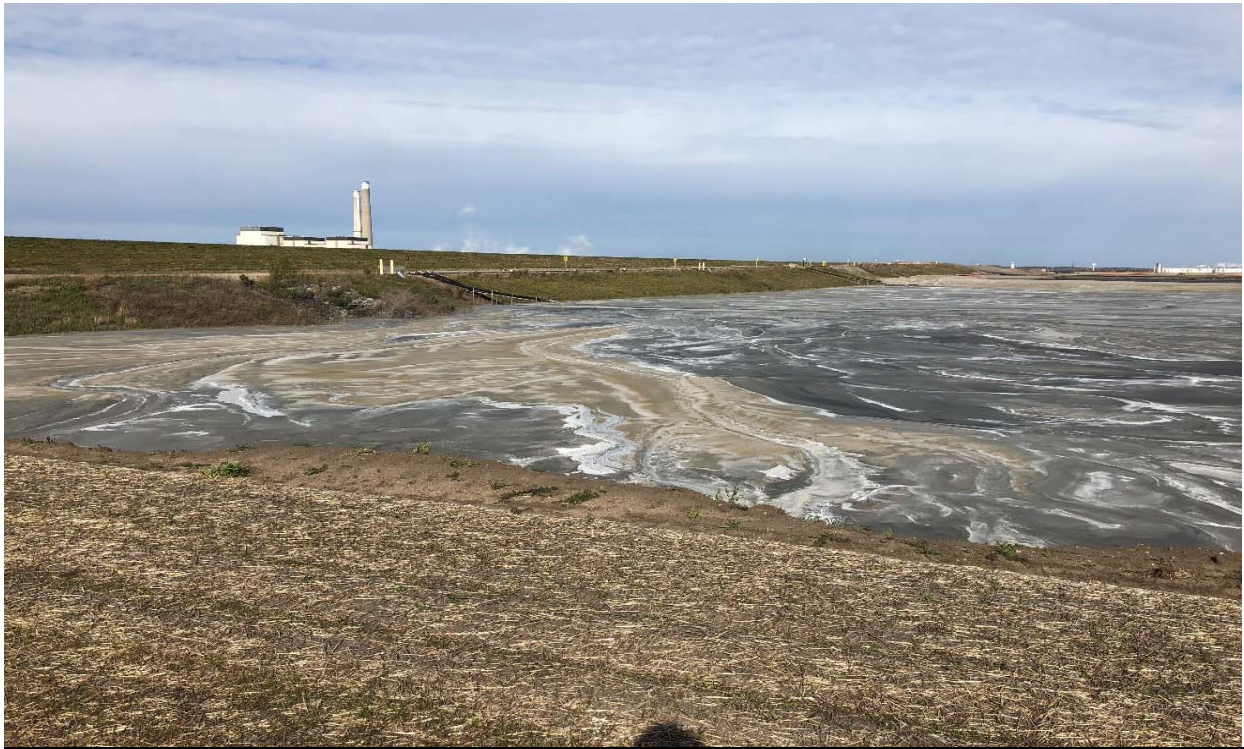
Photo 19	Pond interior west embankment, looking northwest.
10/22/2018

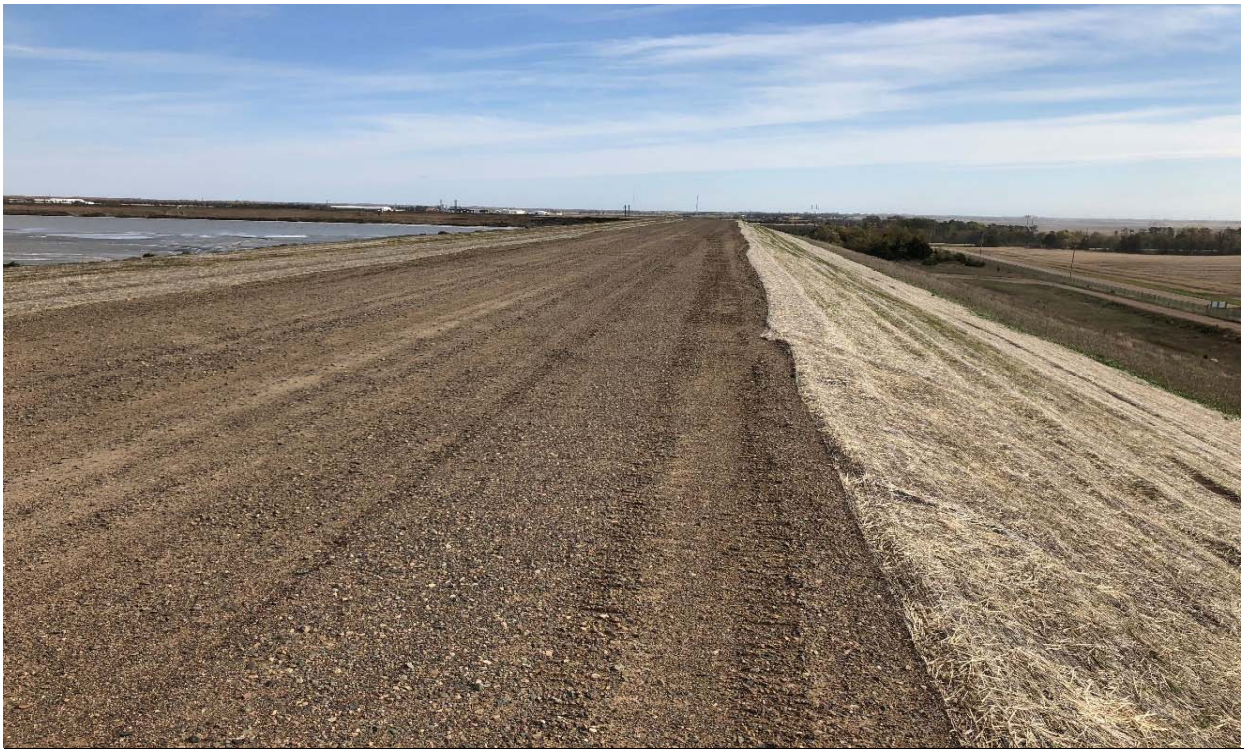
Photo 20	Top of pond south embankment, looking east
10/22/2018

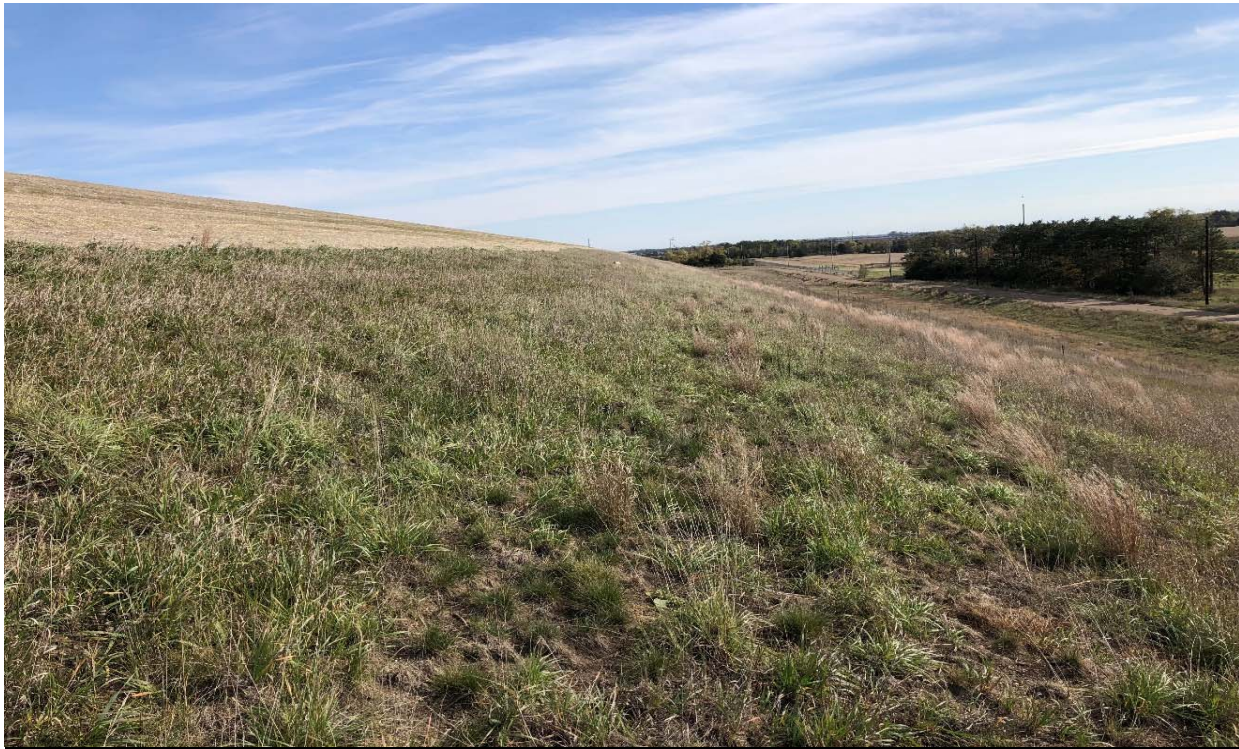
Photo 21	Mid-slope of south embankment, looking east.
10/22/2018

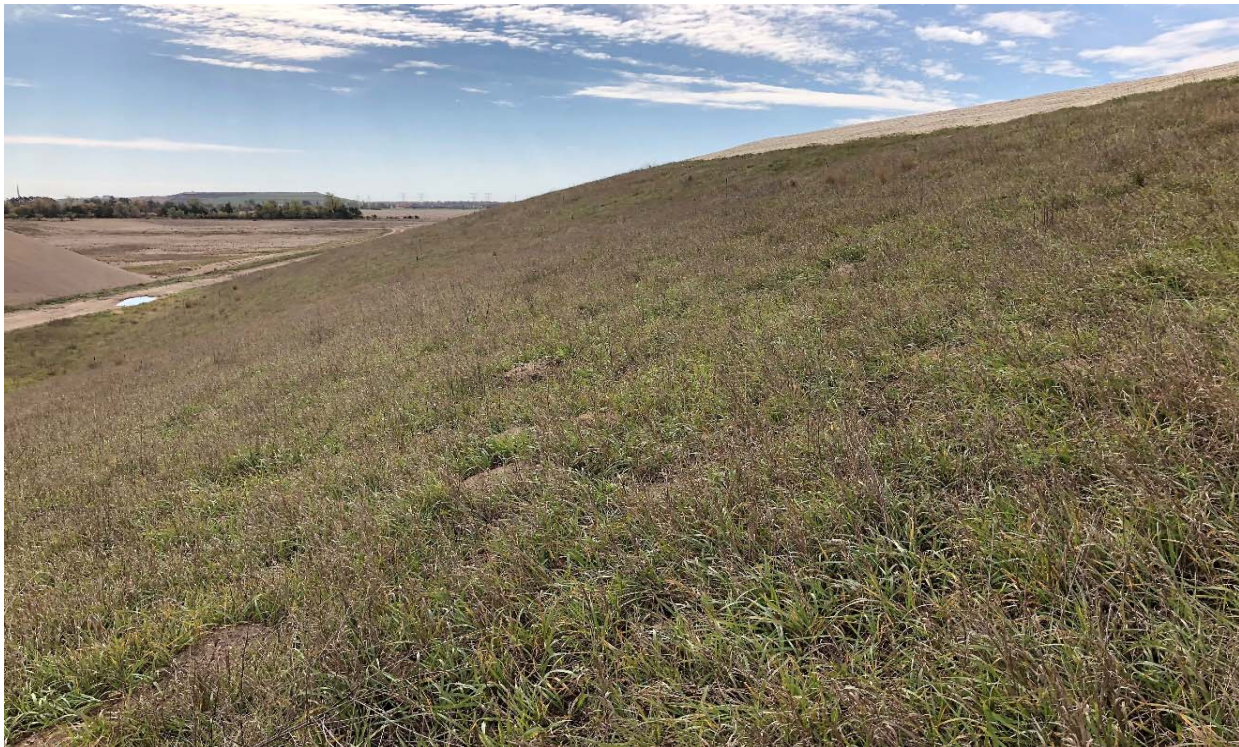
Photo 22	Pond east embankment mid-slope, looking south.
10/22/2018

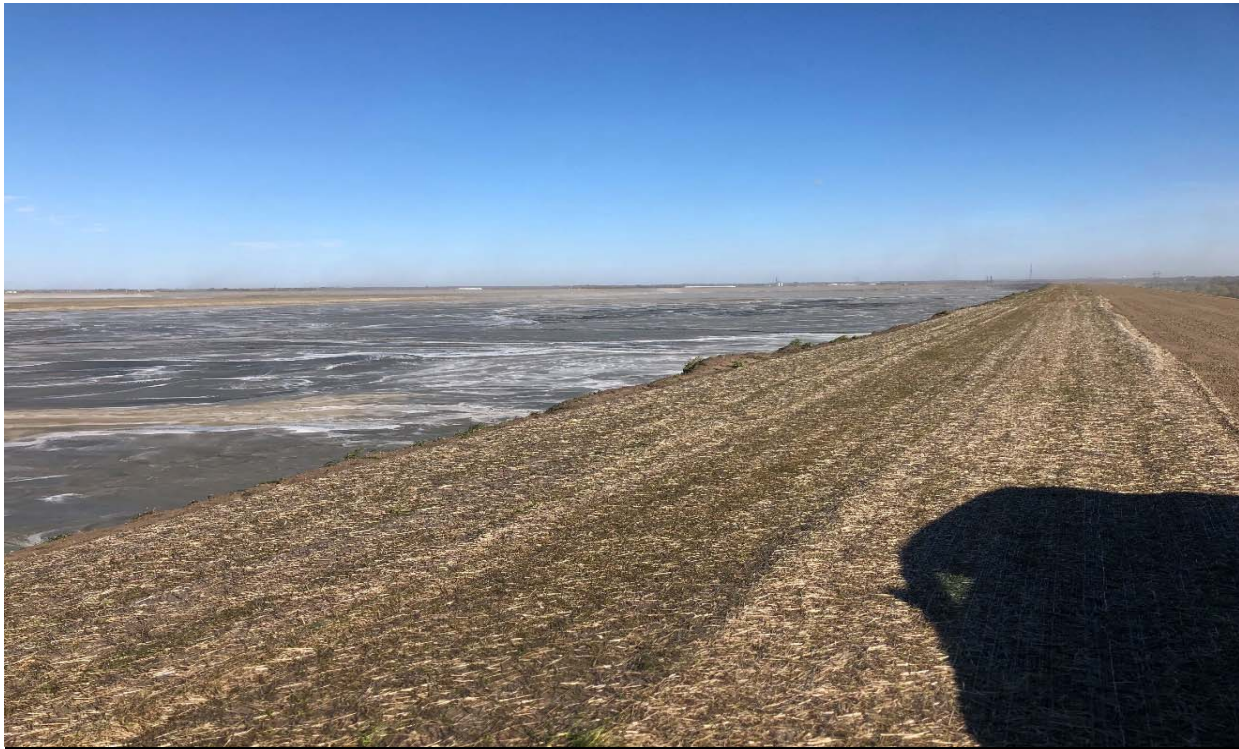
Photo 23	Top of south embankment, looking east.
10/22/2018

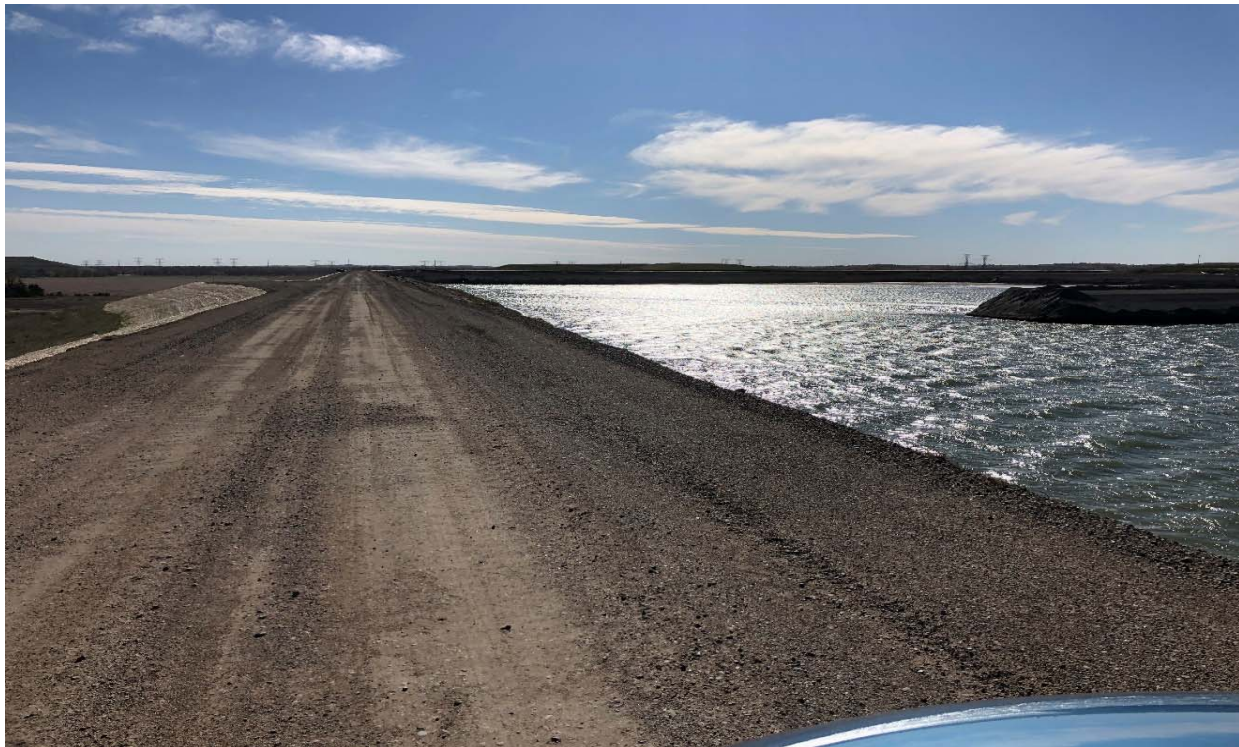
Photo 24	Top-center of east embankment, looking south.
10/22/2018
