Xcel Energy, Inc.
Sherburne County Generating Station
13999 Industrial Blvd.
Becker, MN, 55308

Re: 2018 Annual Inspection of Scrubber Solids Pond No. 3

Pond 3 Annual Inspection - October 2018

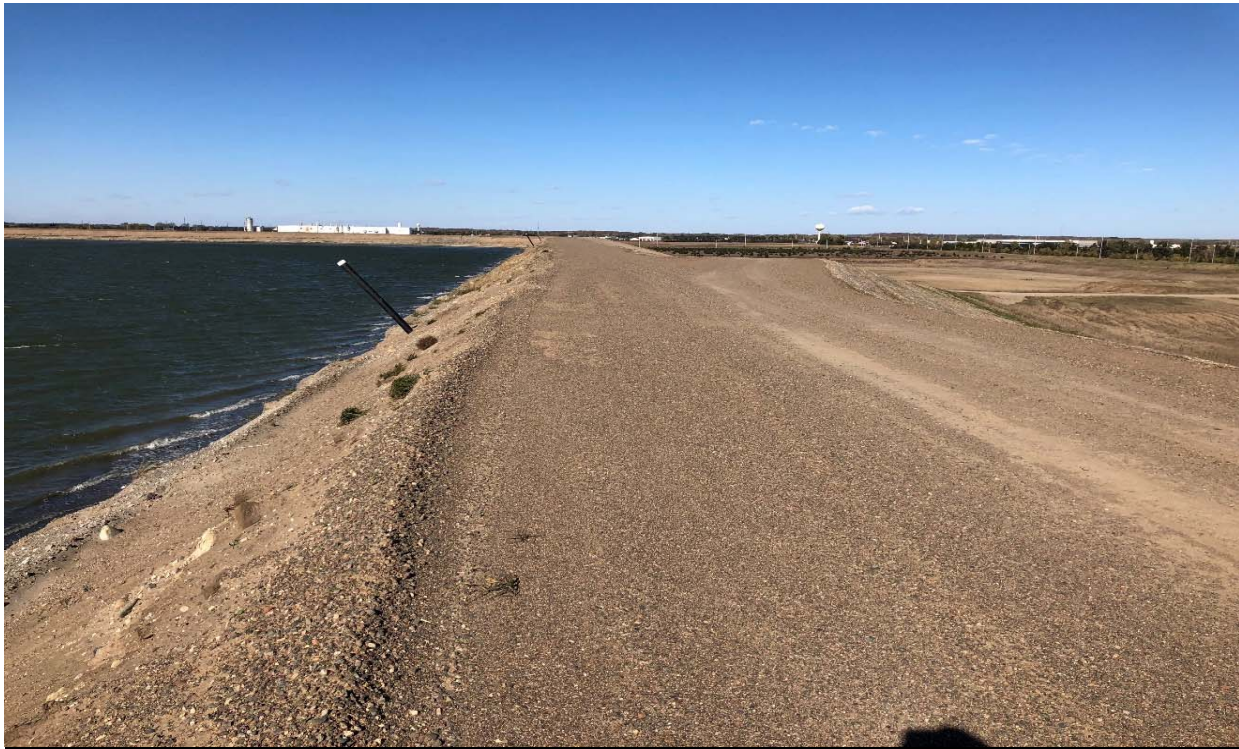
Photo 25	Top-center of east embankment, looking north.
10/22/2018

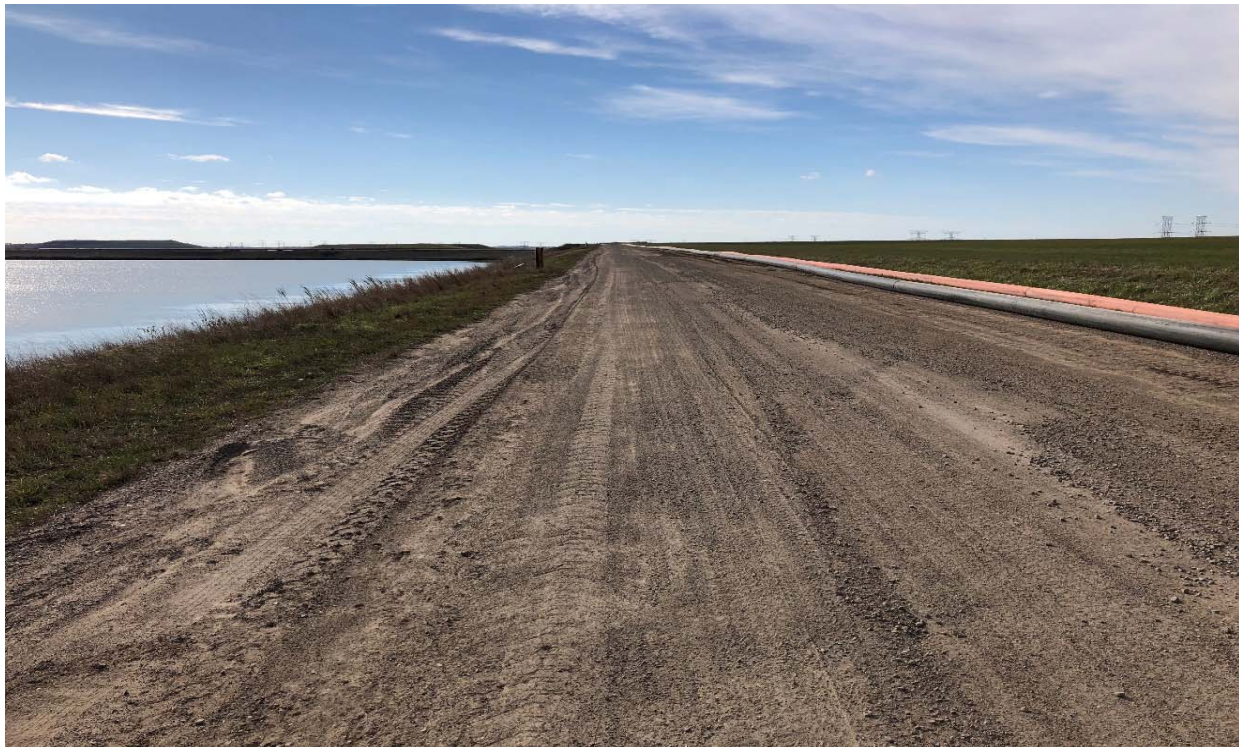
Photo 26	Top of west embankment, looking south. Right: pipes from a hydraulic dredging project.
10/22/2018

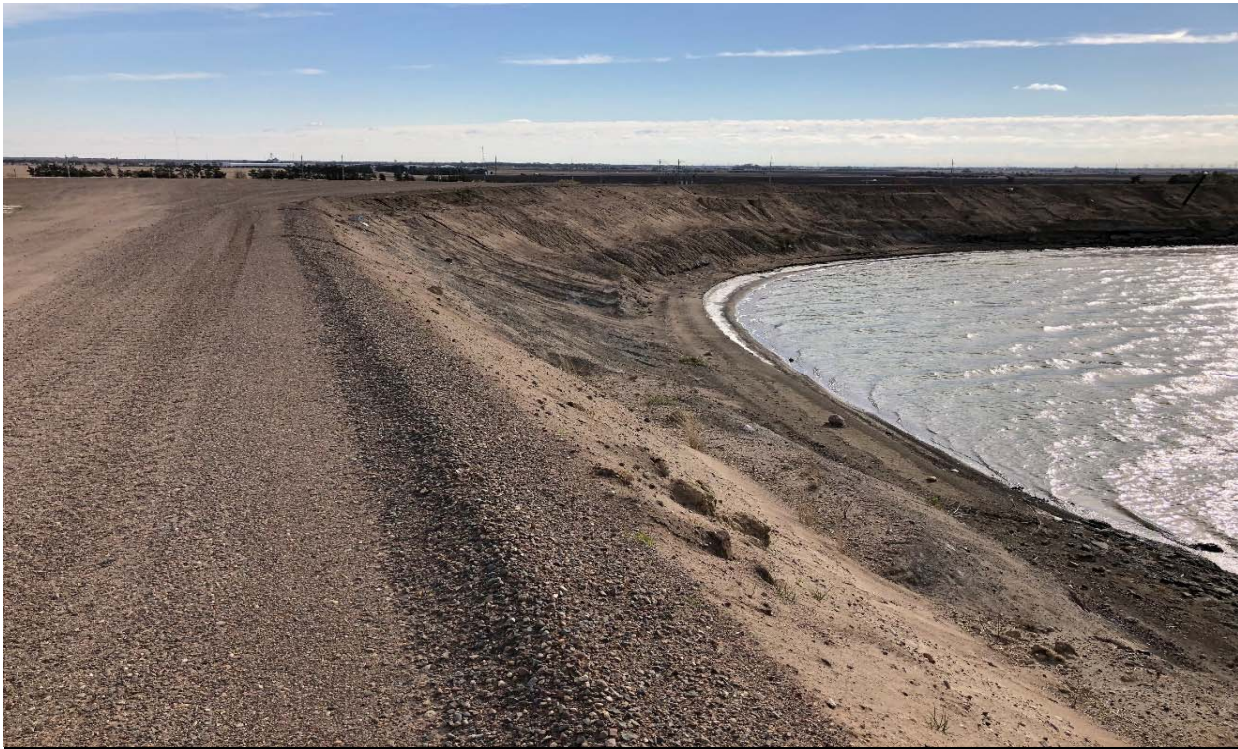
Photo 27	Top of north embankment, looking east at the northeast corner.
10/22/2018

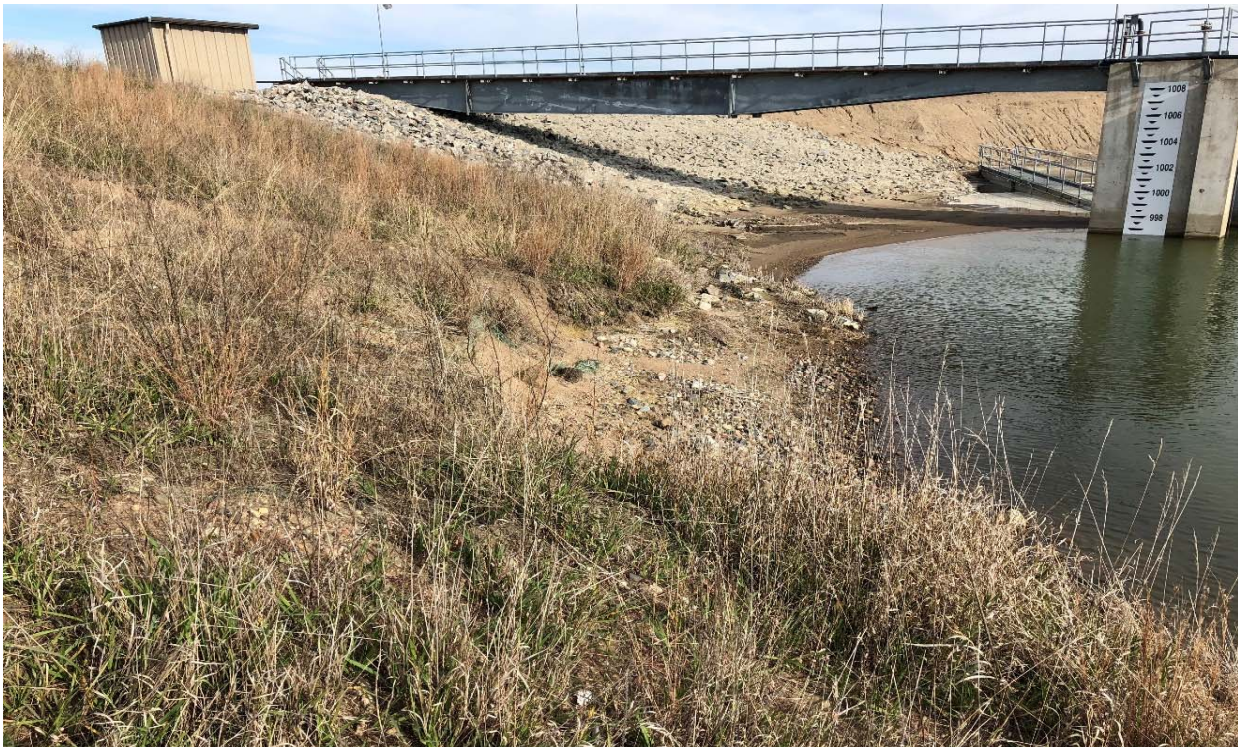
The only instrumentation on Pond 3 is a staff gauge used to determine water surface elevation, located on the west side of the discharge structure. The Pond water level was 997.1 feet mean sea level (MSL) during the 2017 CCR inspection. In 2018 the water level rose to a maximum of 998.2 feet MSL at the end of May, dropped to 996.4 feet MSL during the inspection, and continued to drop to a minimum elevation of 995.6 feet MSL at the end of 2018 (present). The top of clay liner elevation is 1010 MSL. No instrumentation is needed for dike stability.

Photo 28	Interior embankment of northwest corner, looking northeast. Pond water level staff gauge (shown at approx. 996.5 feet of elevation mean sea)
10/22/2018

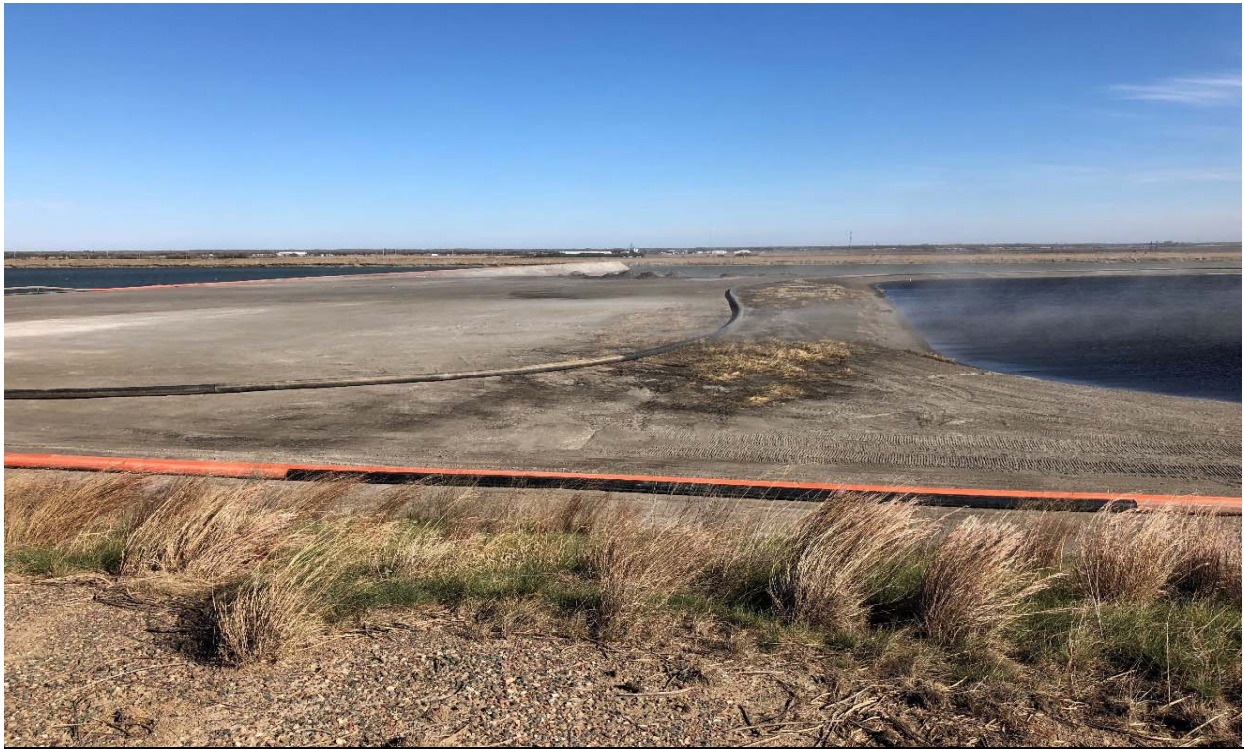
Photo 29	Top of west embankment, looking east at pond interior diking and
10/22/2018	hydraulic dredging pipes.

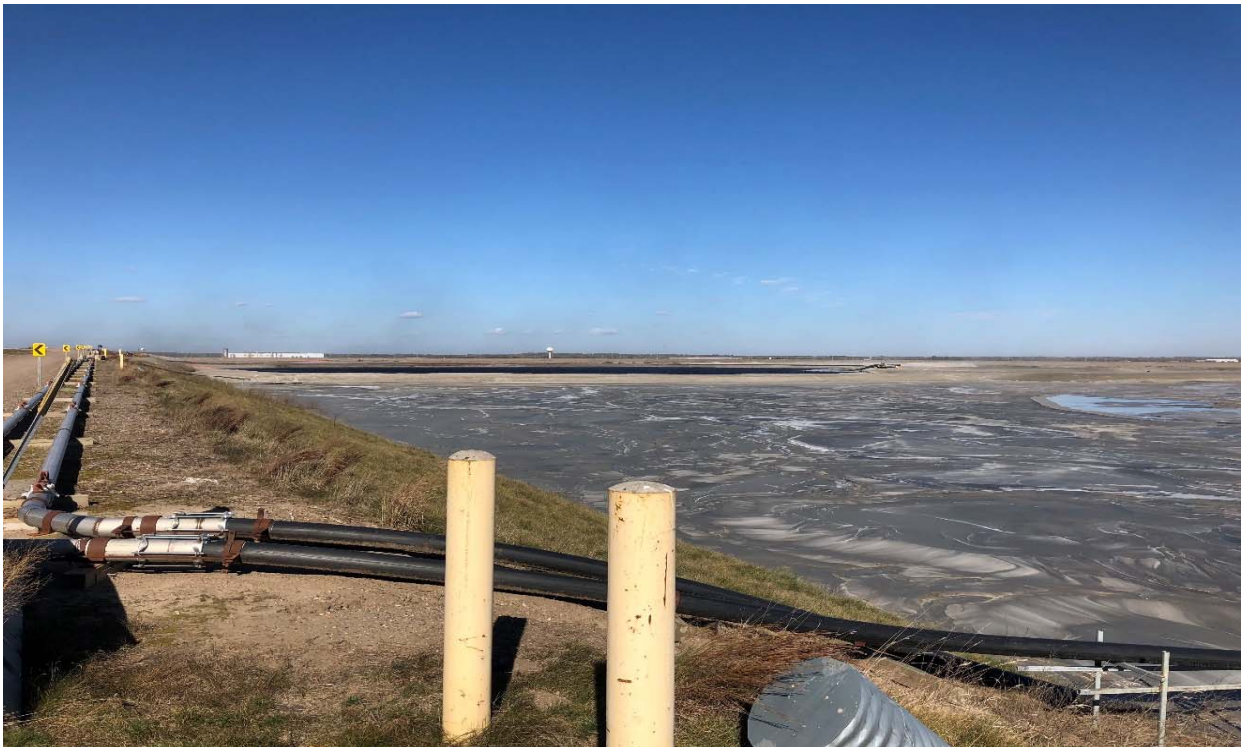
Photo 30	Pond west embankment interior, looking northeast. Left: Pond stainless
10/22/2018	steel scrubber solid pipes. Bottom: dewatering pipe clean-out.

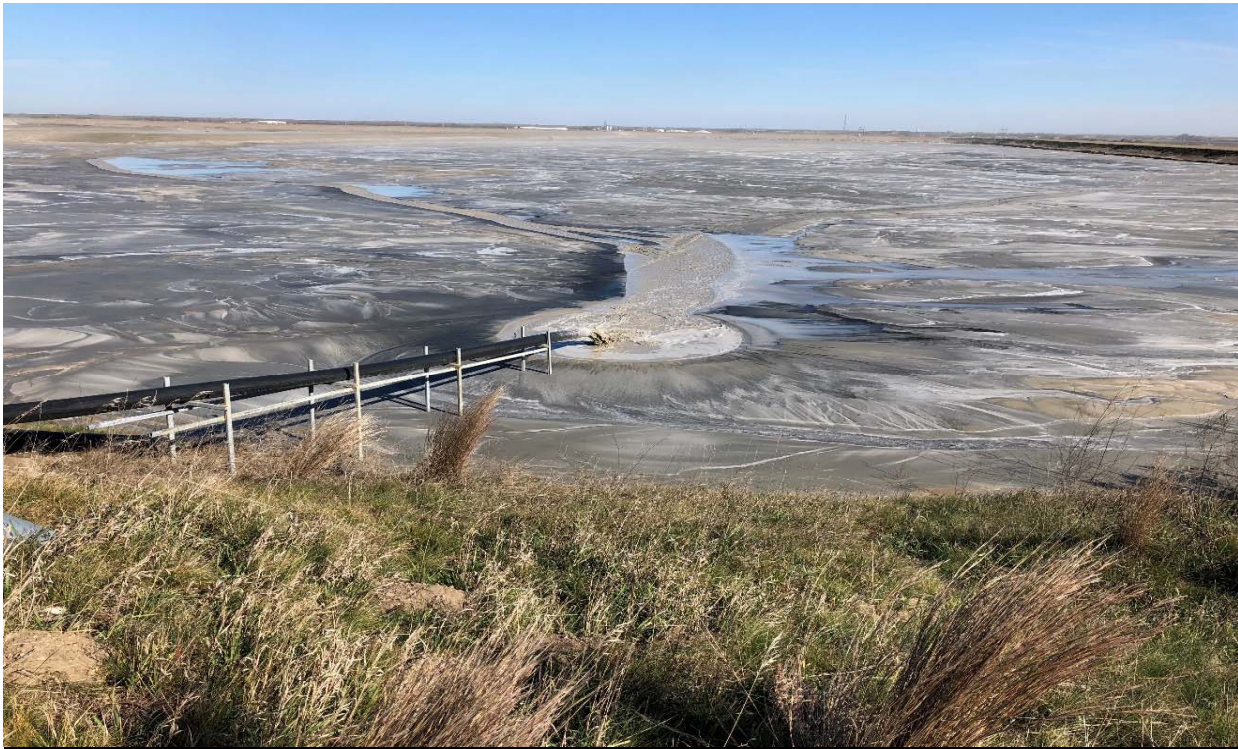
Photo 31	Pond interior from west embankment, looking east. Foreground: scrubber pipe discharge.
10/22/2018

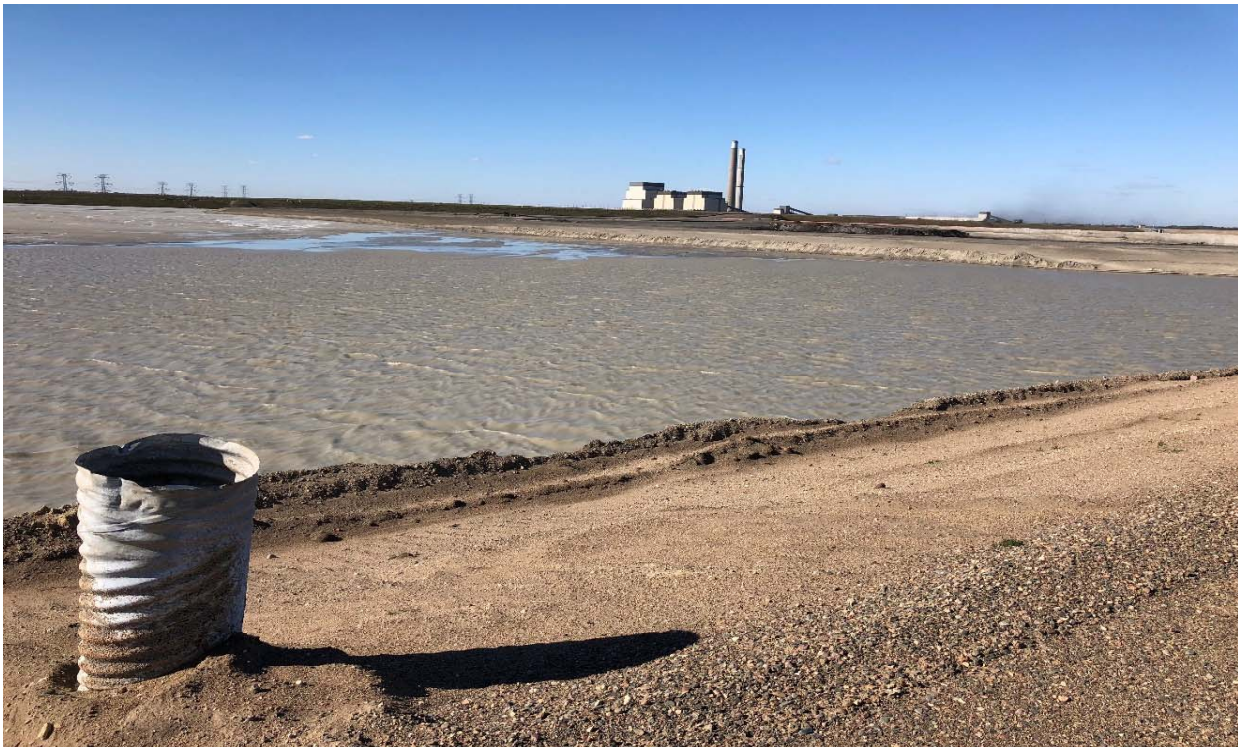
Photo 32	Top of east embankment and interior diking, looking northwest.
10/22/2018
