January 10, 2018

Xcel Energy, Inc.  
Sherburne County Generating Station  
13999 Industrial Blvd.  
Becker, MN, 55308

**Re: 2017 Annual Inspection of Scrubber Solids Pond No. 3**

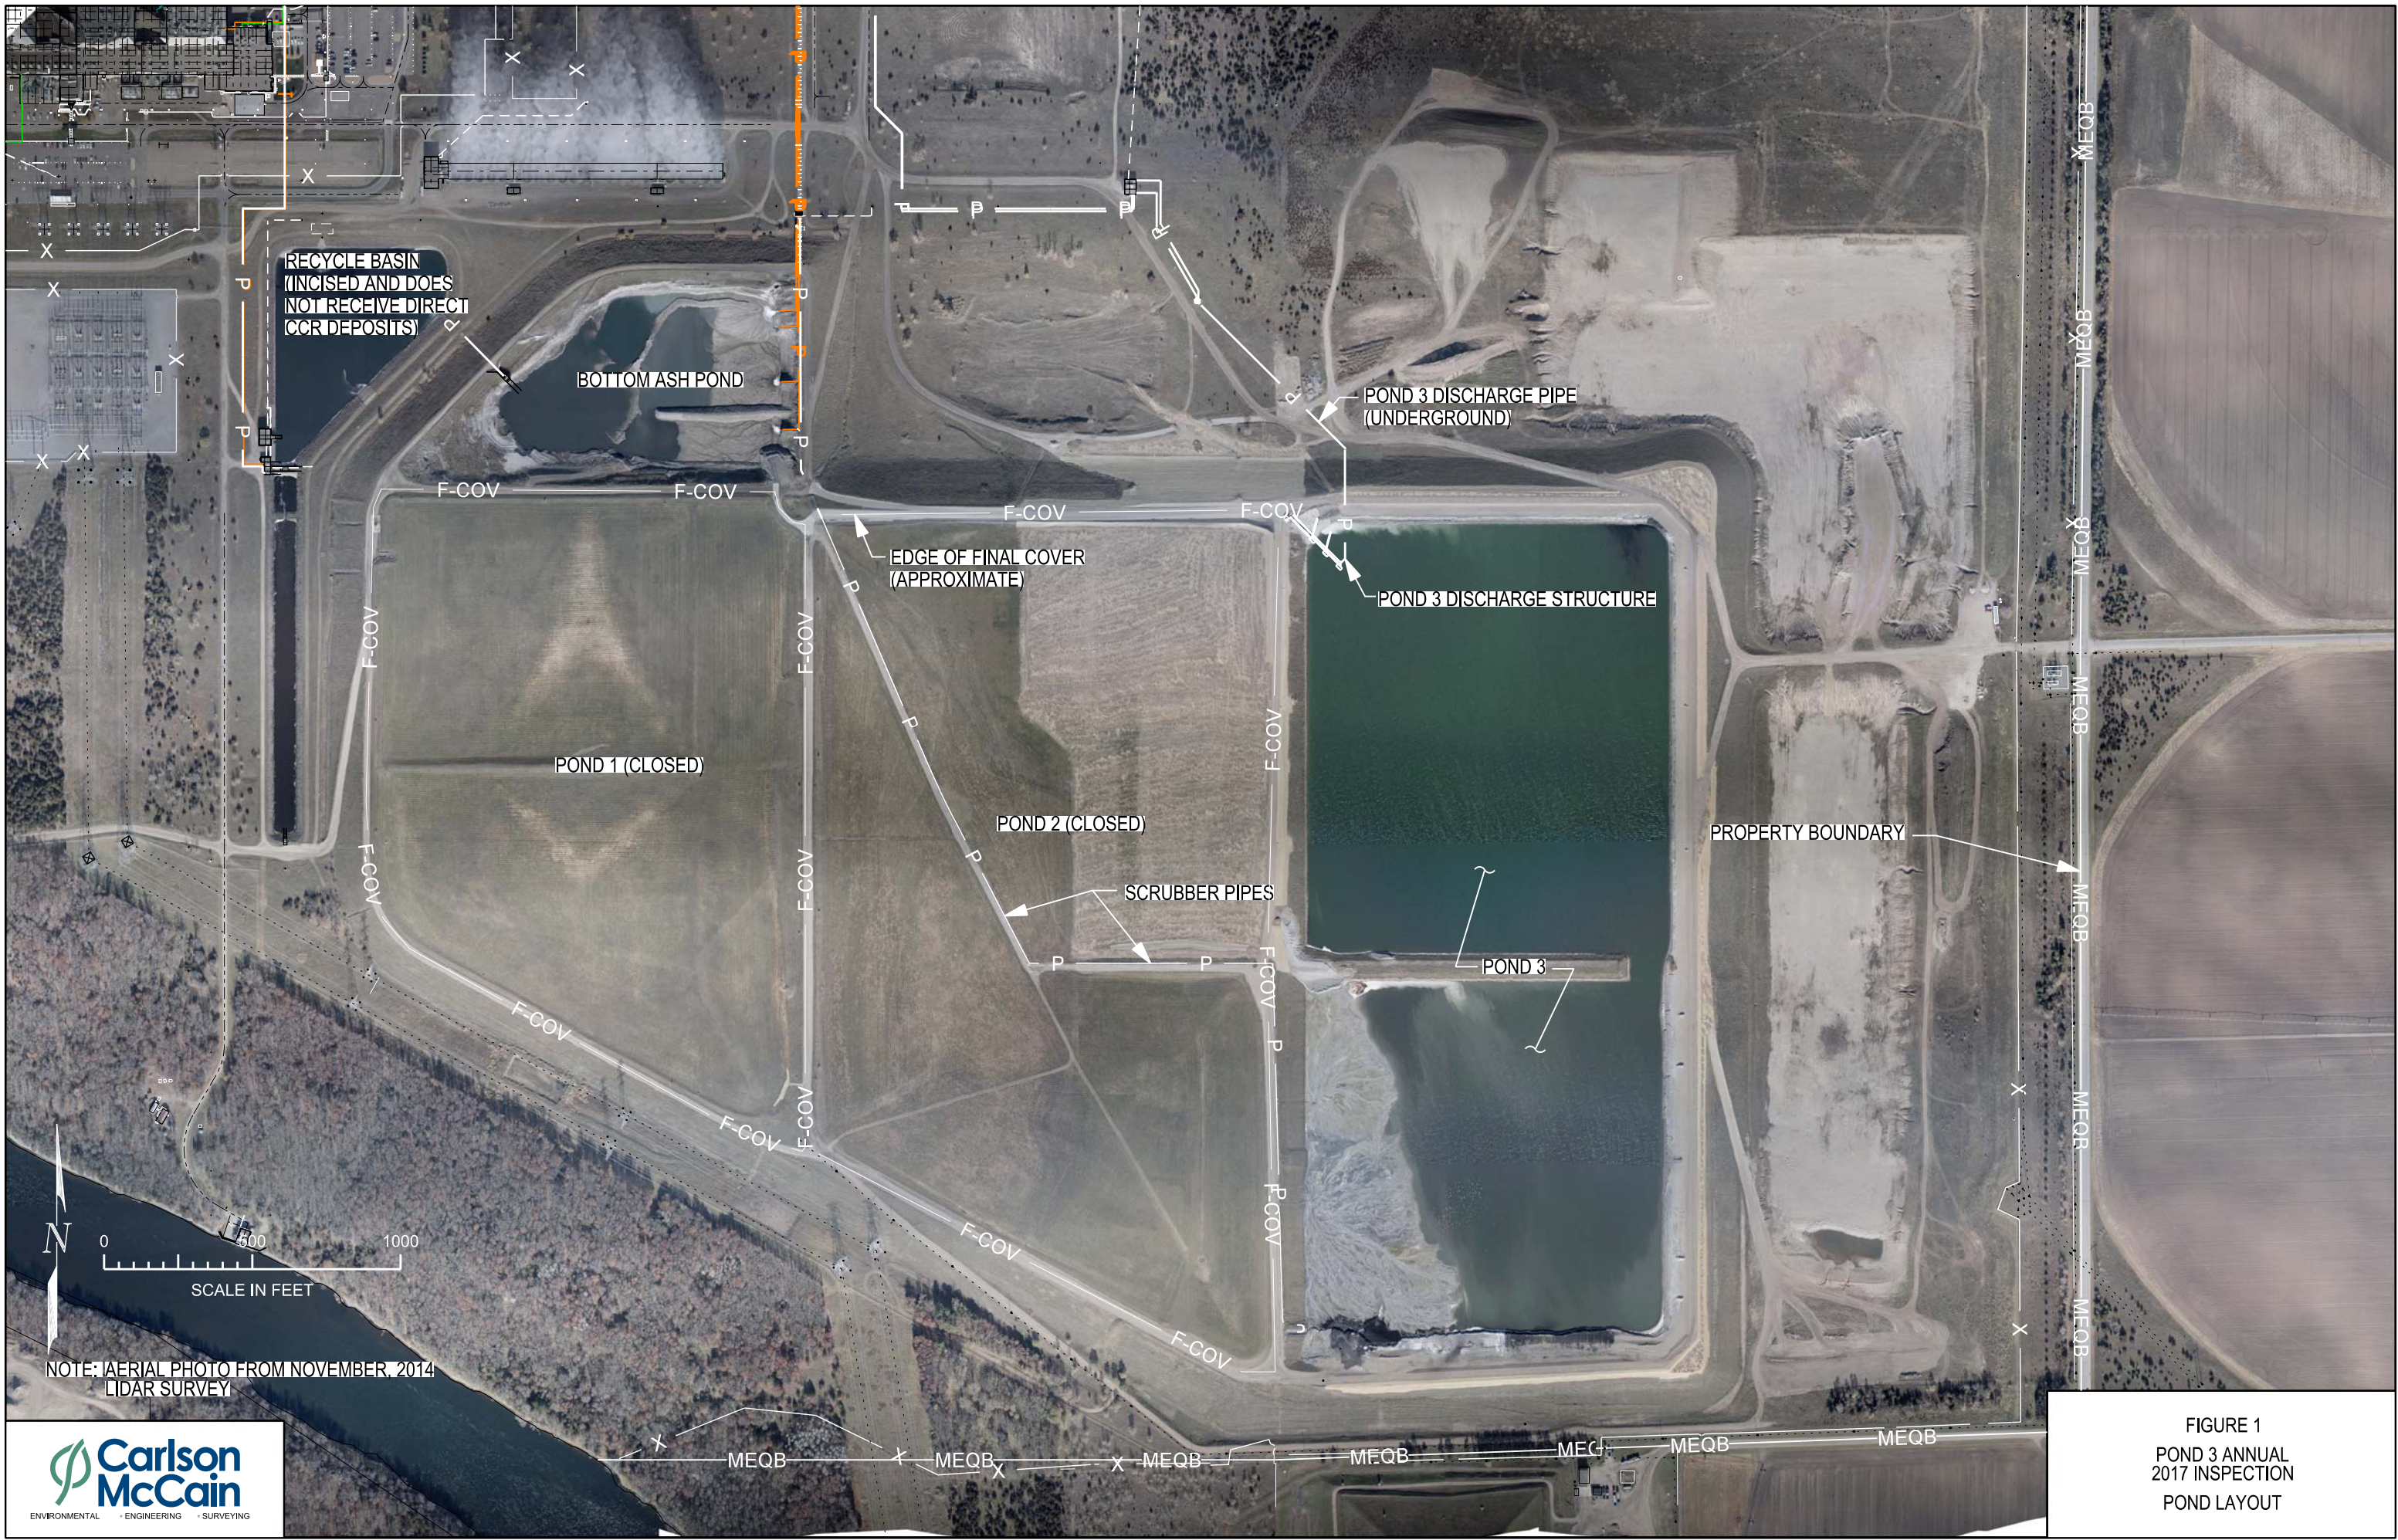
FIGURE 1  
POND 3 ANNUAL  
2017 INSPECTION  
POND LAYOUT

Two forms of CCR are deposited or placed in Pond 3. Solid bottom ash is excavated and hauled from the Bottom Ash Pond (see figure 1) and used above the water level in Pond 3 and compacted as a structural fill, or deposited in the pond, and not compacted. The highest elevation of bottom ash diked

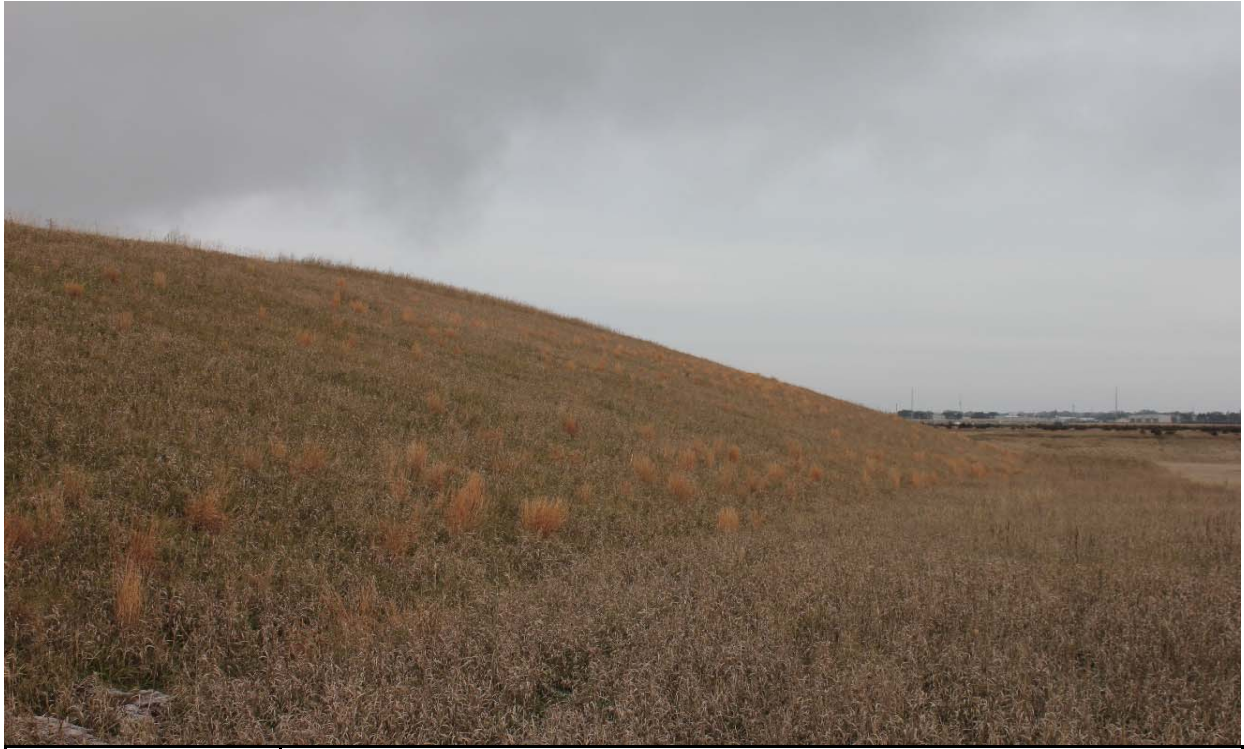
The exterior of the Pond was inspected for structural weakness in the form of seepage by walking a traverse at the base, mid-slope, and top of the embankment. Signs of seepage would include saturated areas, patches of grass more lush than the surrounding area or flowing "springs". There were no signs that seepage had previously or is presently occurring on Pond 3.

| Photo 1 | Outer east slope of north embankment, looking north. |

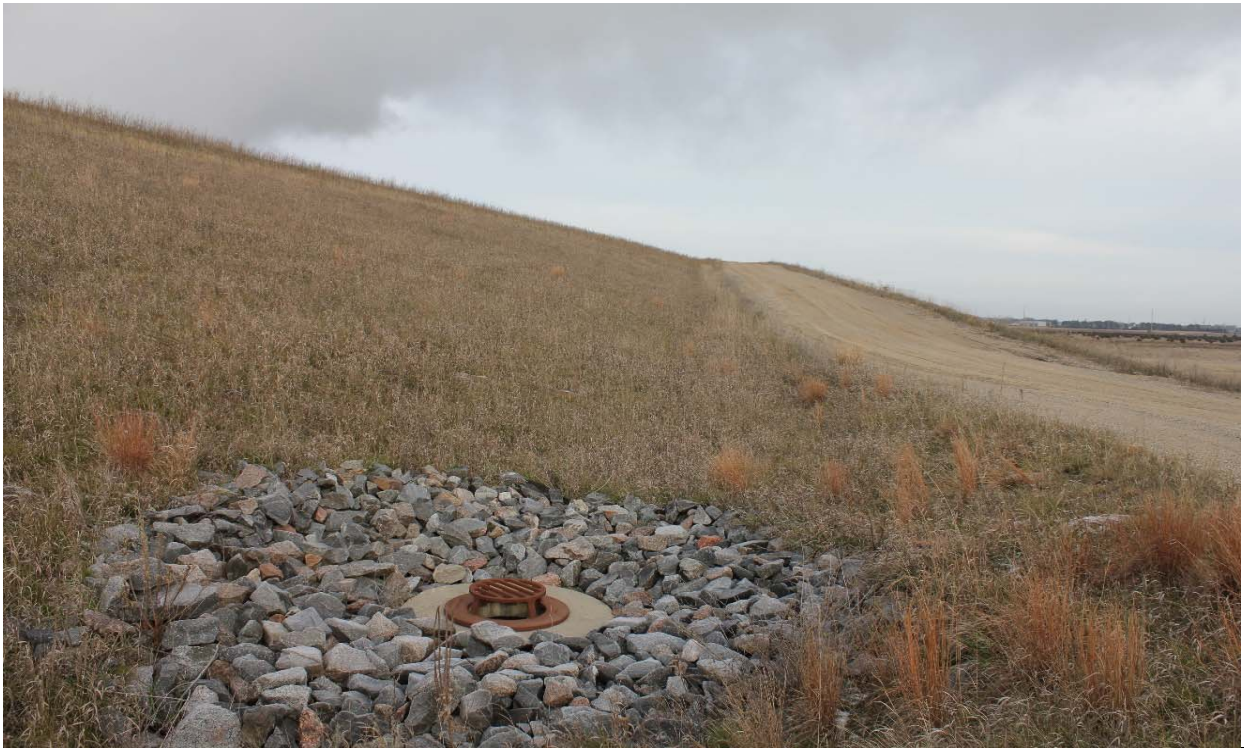
| Photo 2 | East embankment north ramp and stormwater inlet, looking north. |

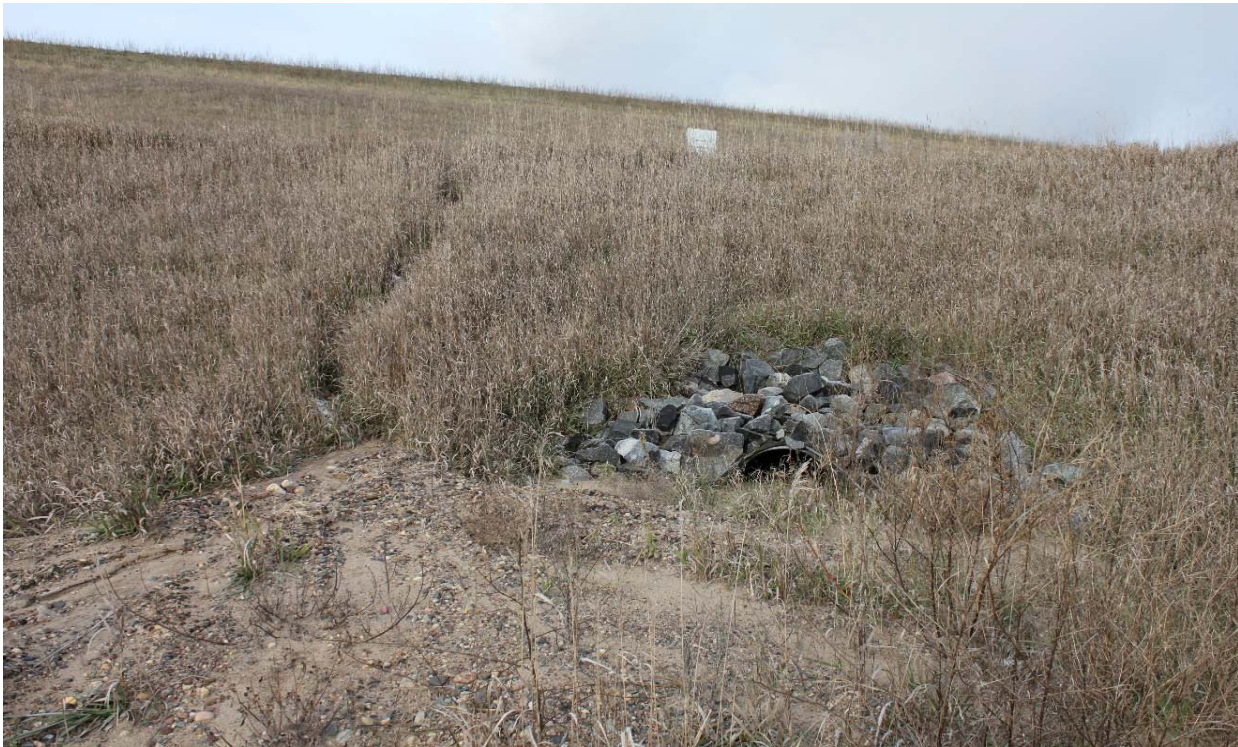
| Photo 3 | Stormwater outlet and small eroded channel on outer east slope of south embankment, looking northwest. |

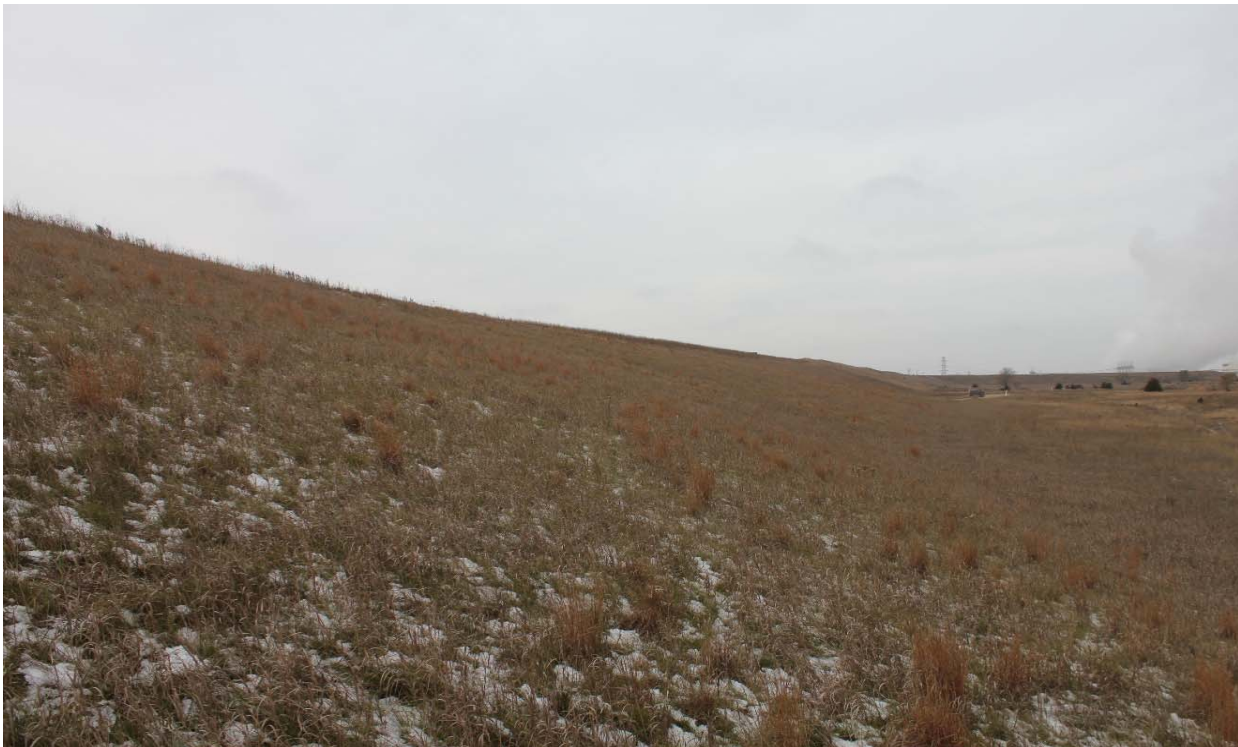
| Photo 4 | Outer slope of north embankment, looking west. |

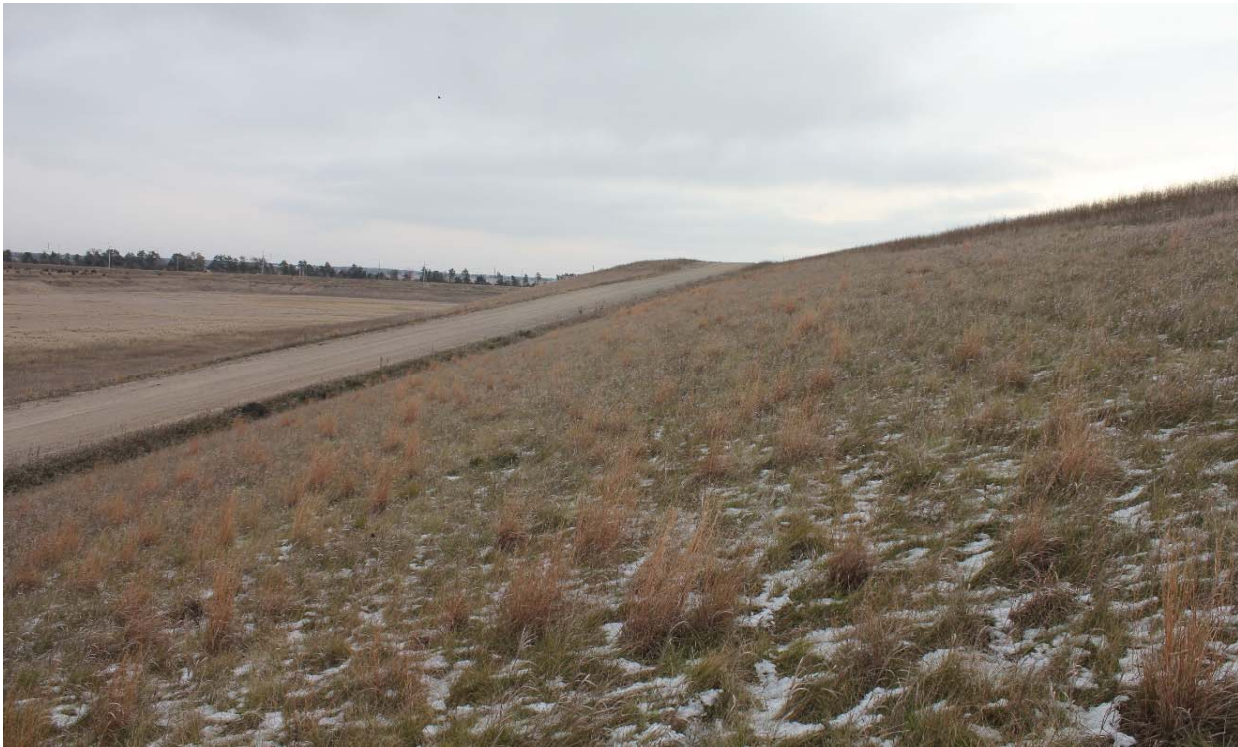
| Photo 5 | North embankment ramp, looking east. |

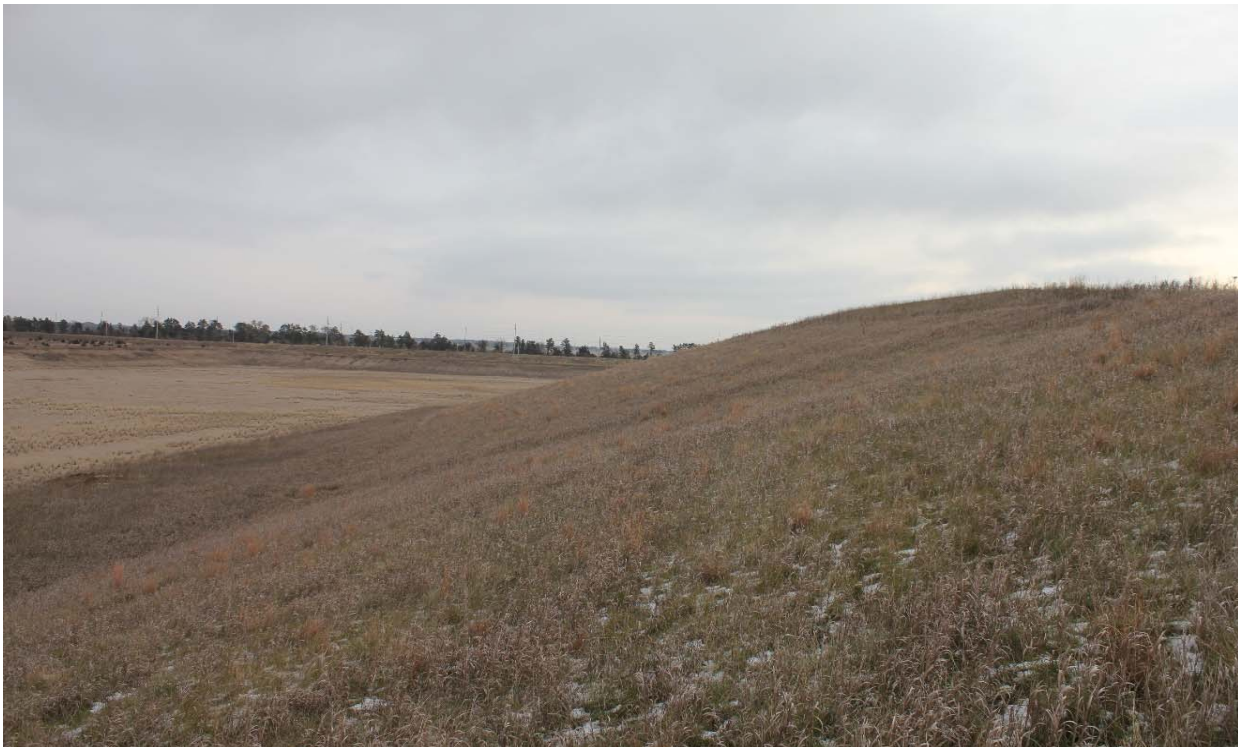
| Photo 6 | Pond north embankment mid-slope, looking east. |

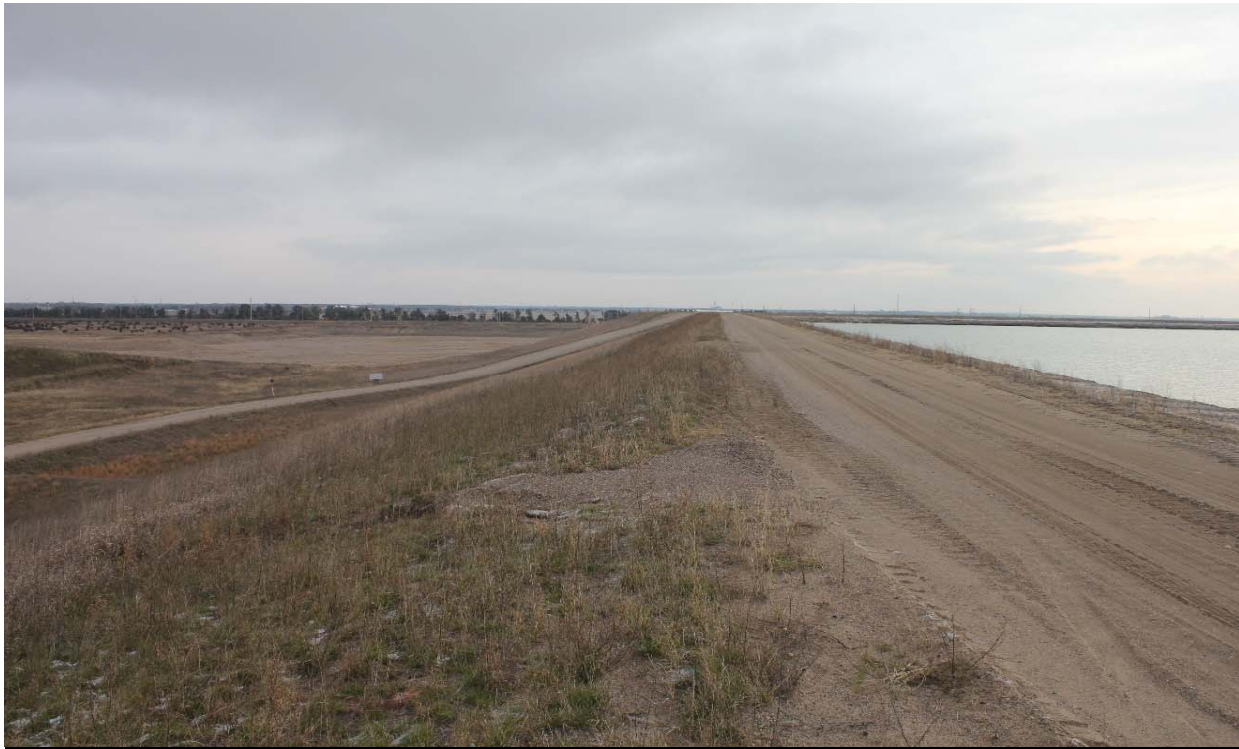
| Photo 7 | Top of pond north embankment, looking east. |

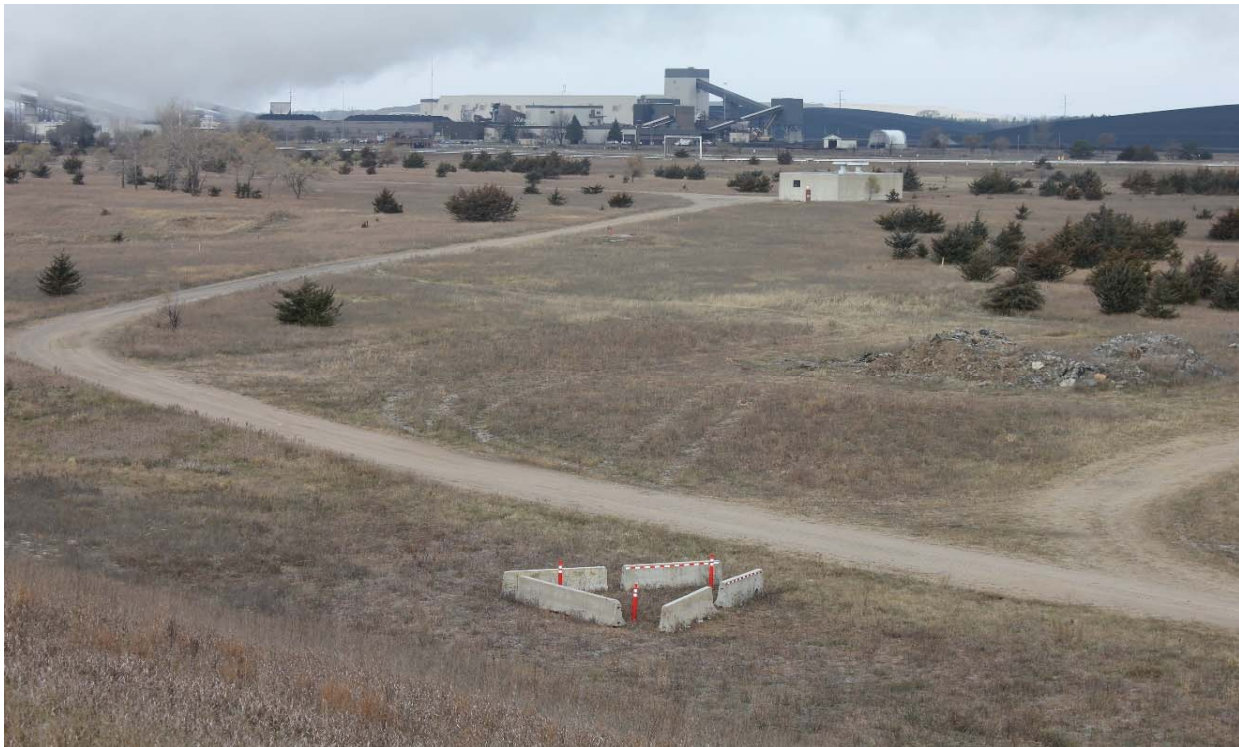
The discharge pipe corridor was inspected for signs of a leakage, such as saturated areas or sinkholes. No signs of leakage were observed along the pipe corridor or in the vault located north of Pond 3.

| Photo 8 | Underground discharge pipe corridor, looking northwest. |

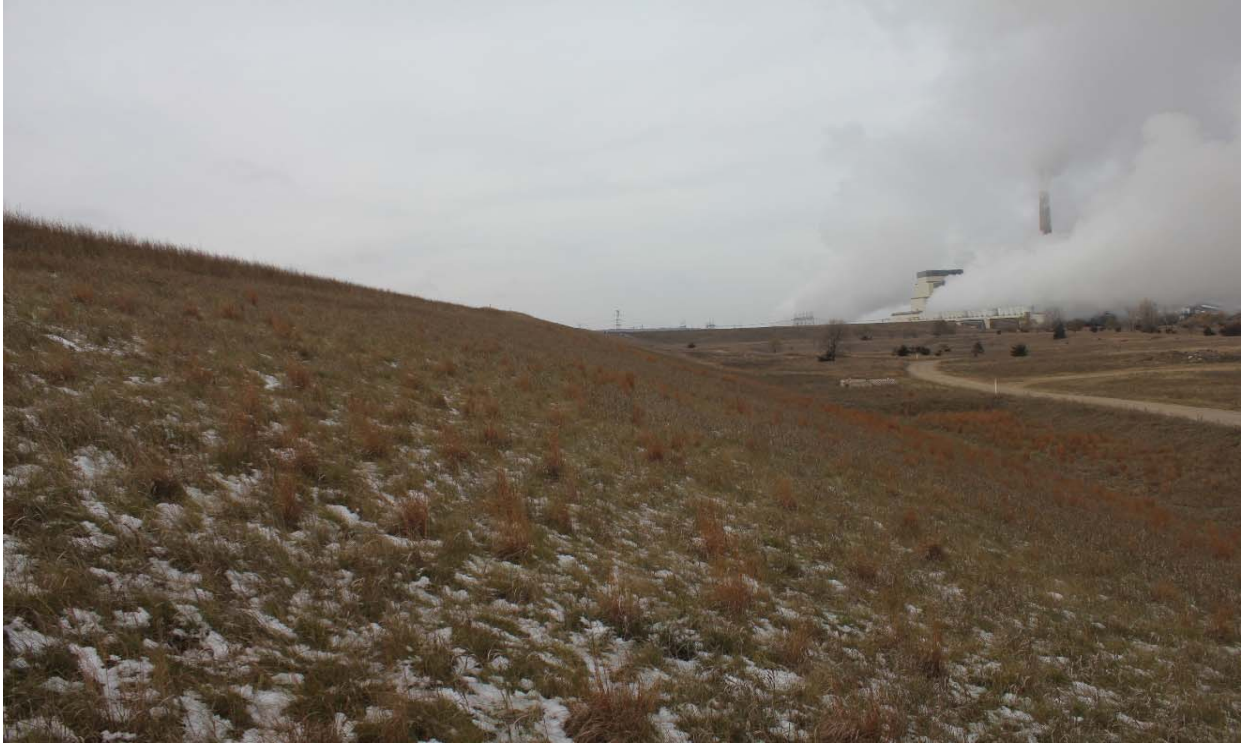
| Photo 9 | Pond north embankment mid-slope, looking west. |

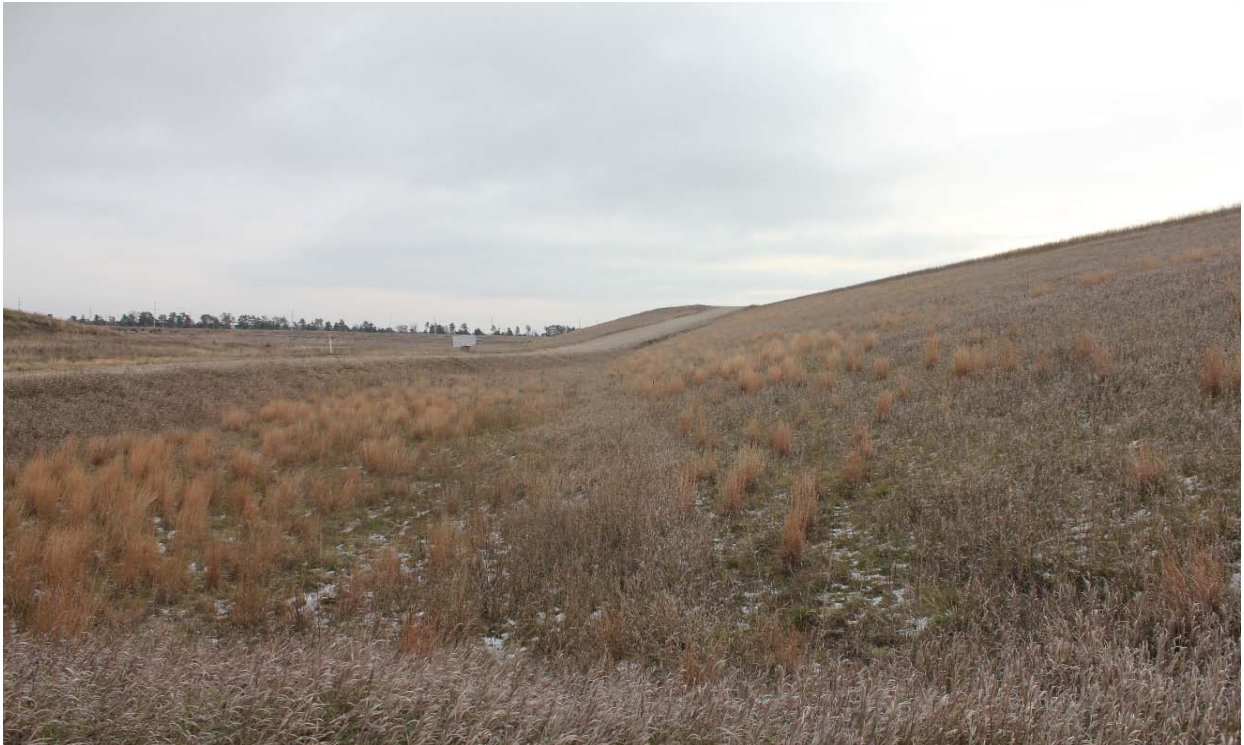
| Photo 10 | Pond north embankment and infiltration pond, looking east. |

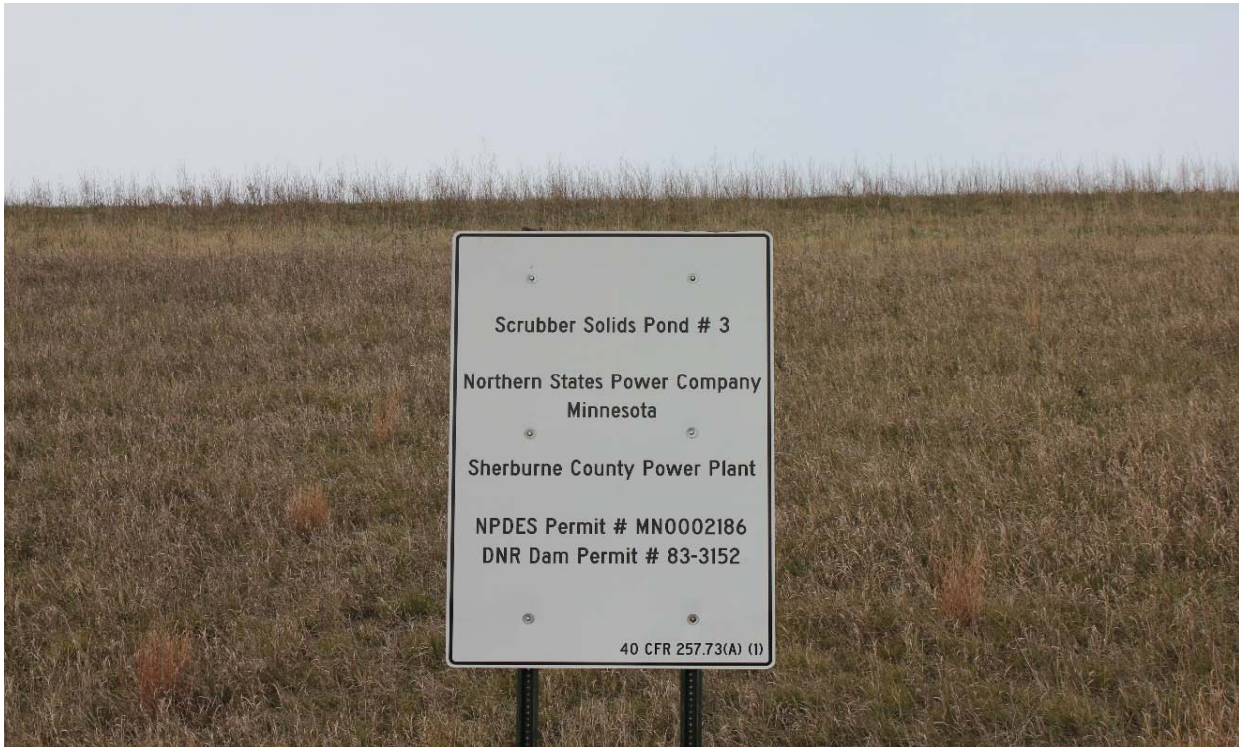
| Photo 11 | CCR Unit identification marker placed in accordance with Section 257.73 |

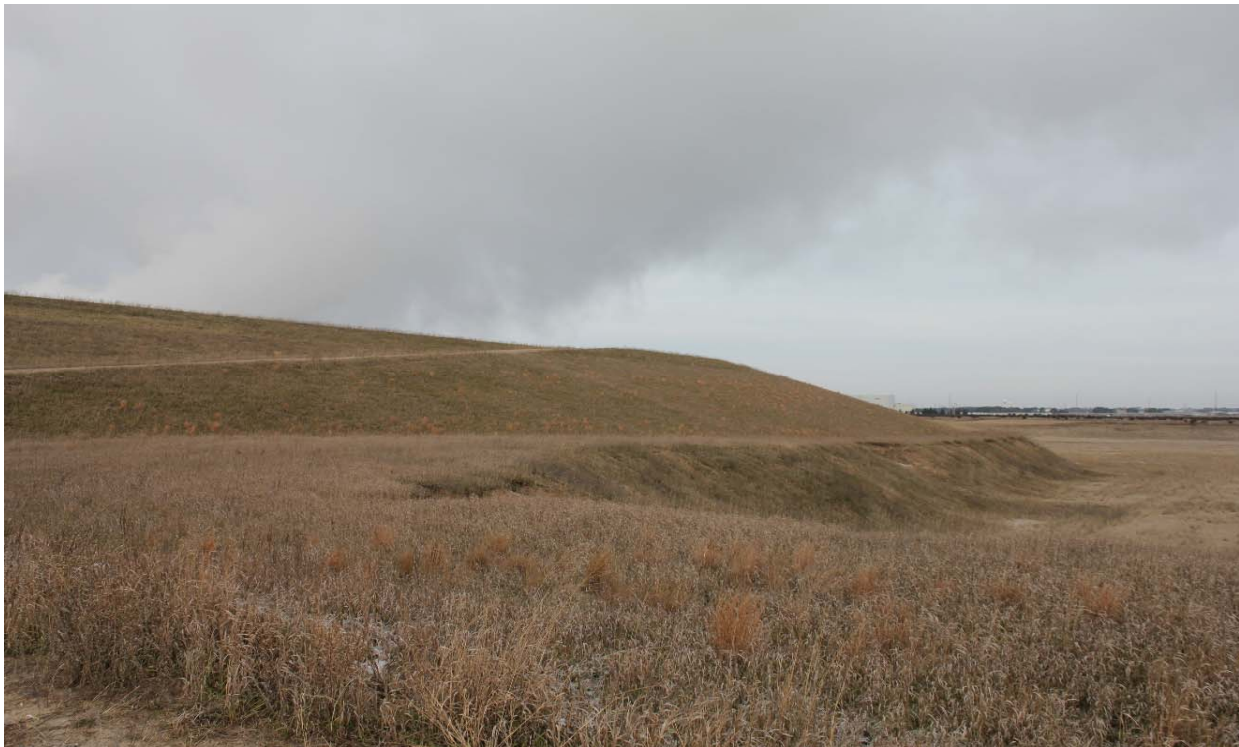
| Photo 12 | North end of pond east embankment, looking northwest. |

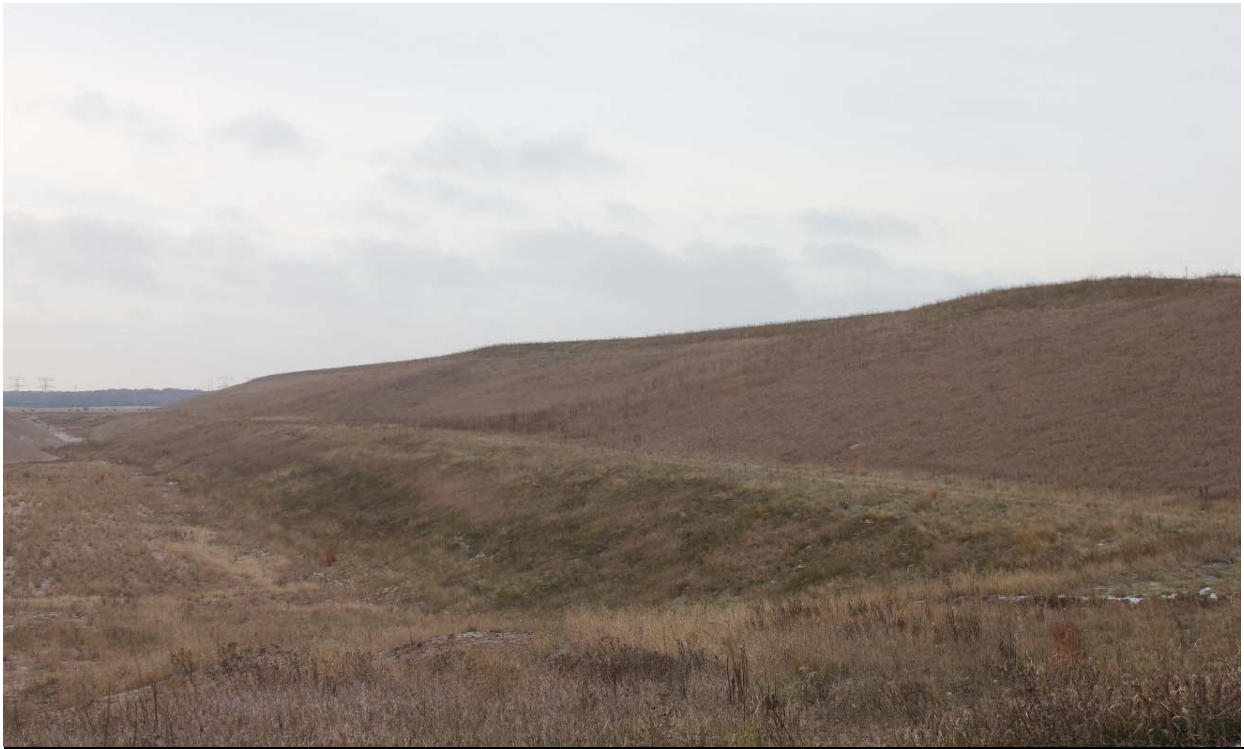
| Photo 13 | South end of pond east embankment, looking southwest. |

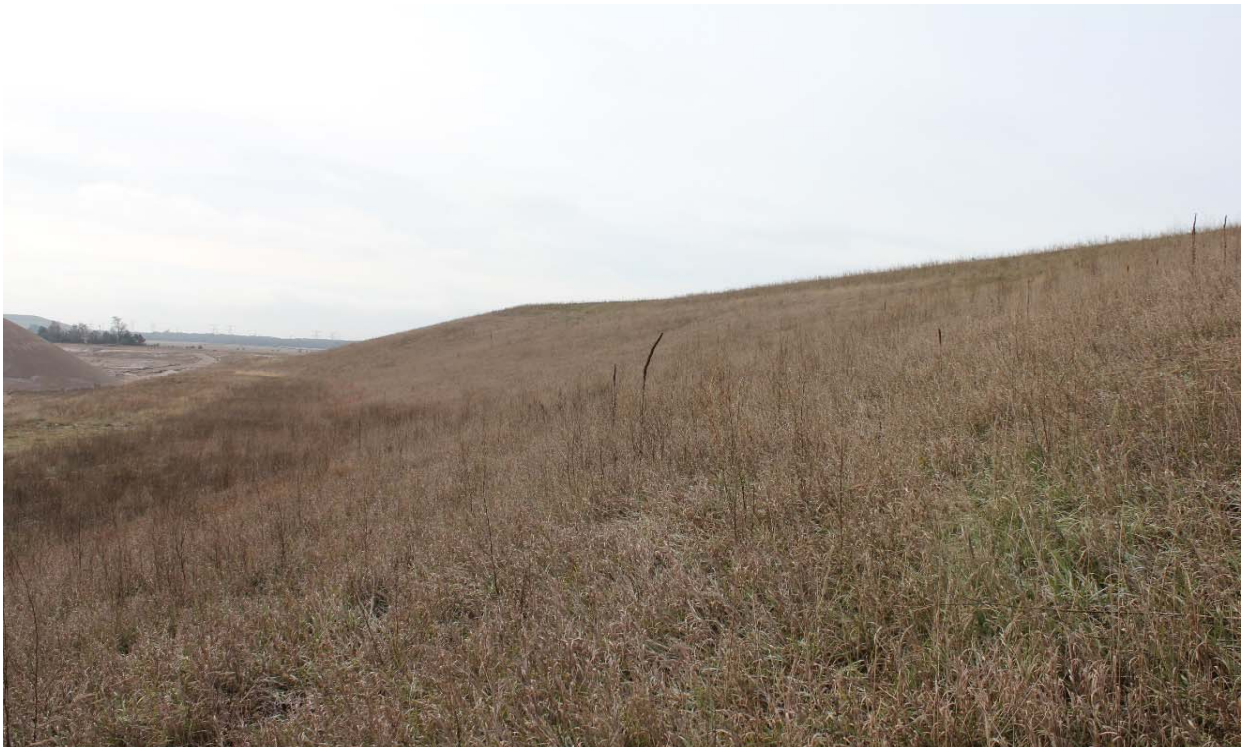
| Photo 14 | Pond east embankment mid-slope, looking south. |

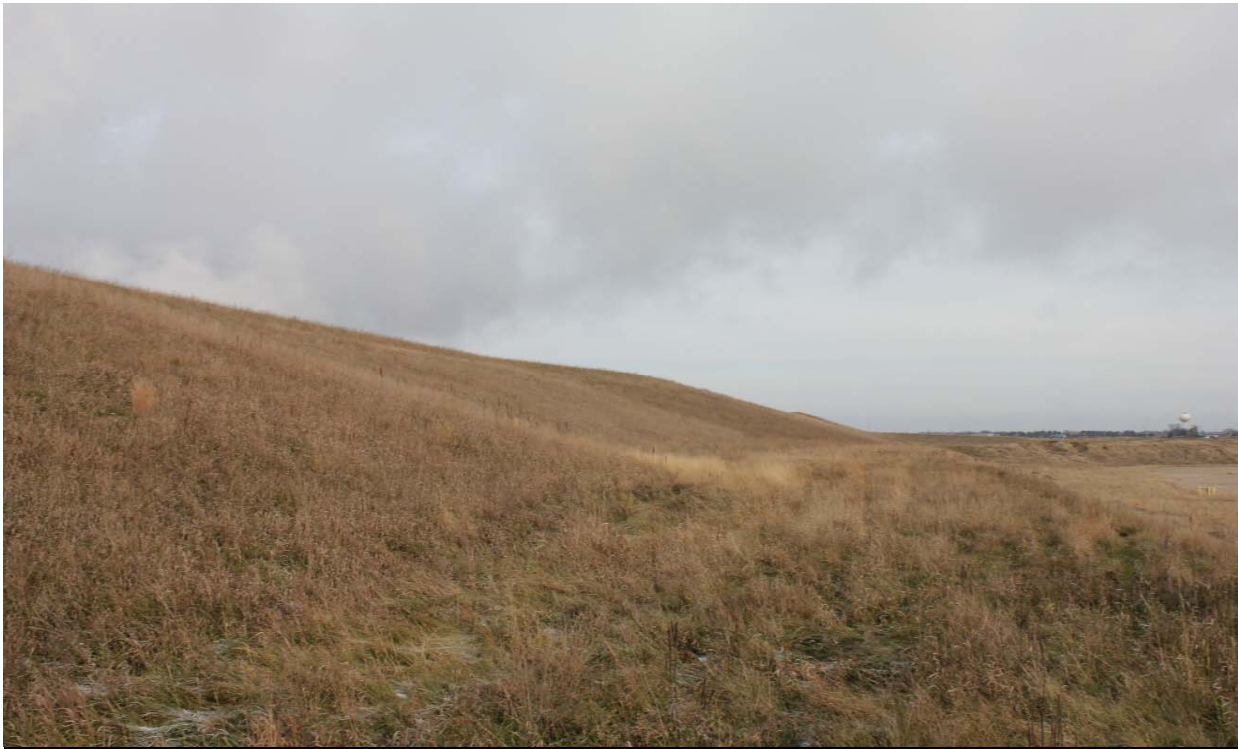
| Photo 15 | Pond east embankment, looking north. |

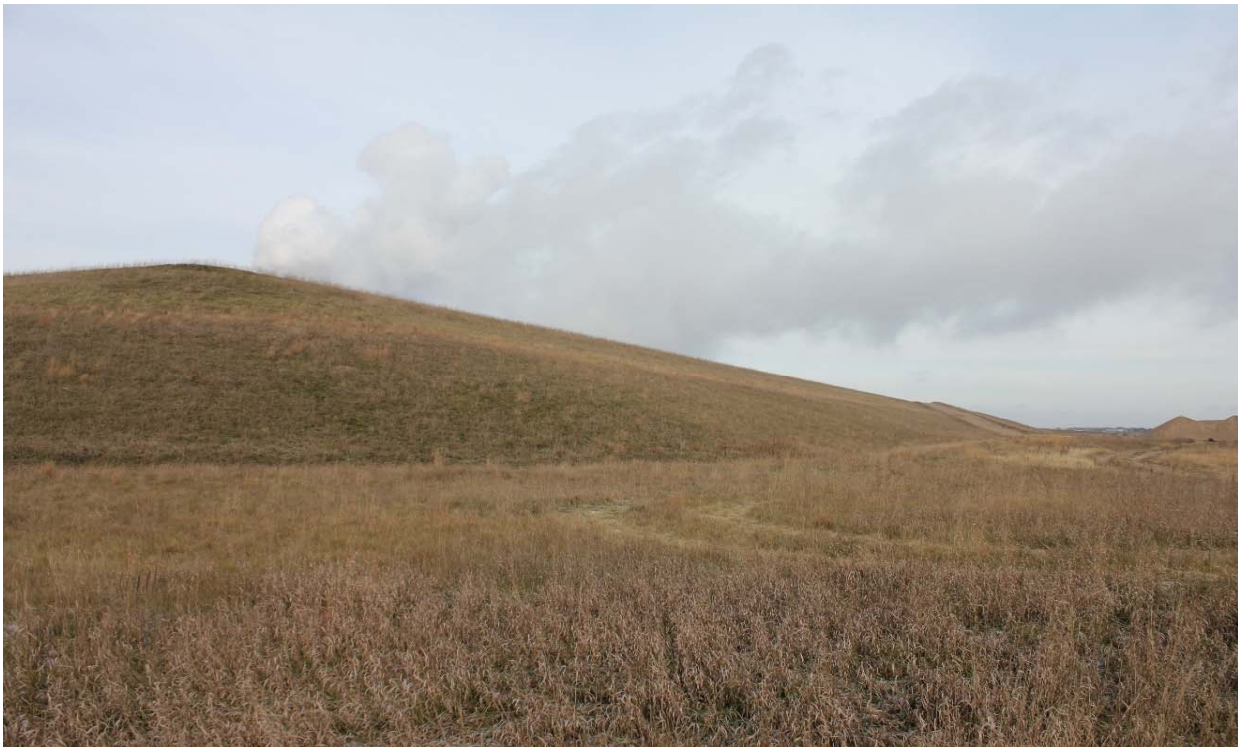
| Photo 16 | Southeast corner of outer embankment, looking north. |

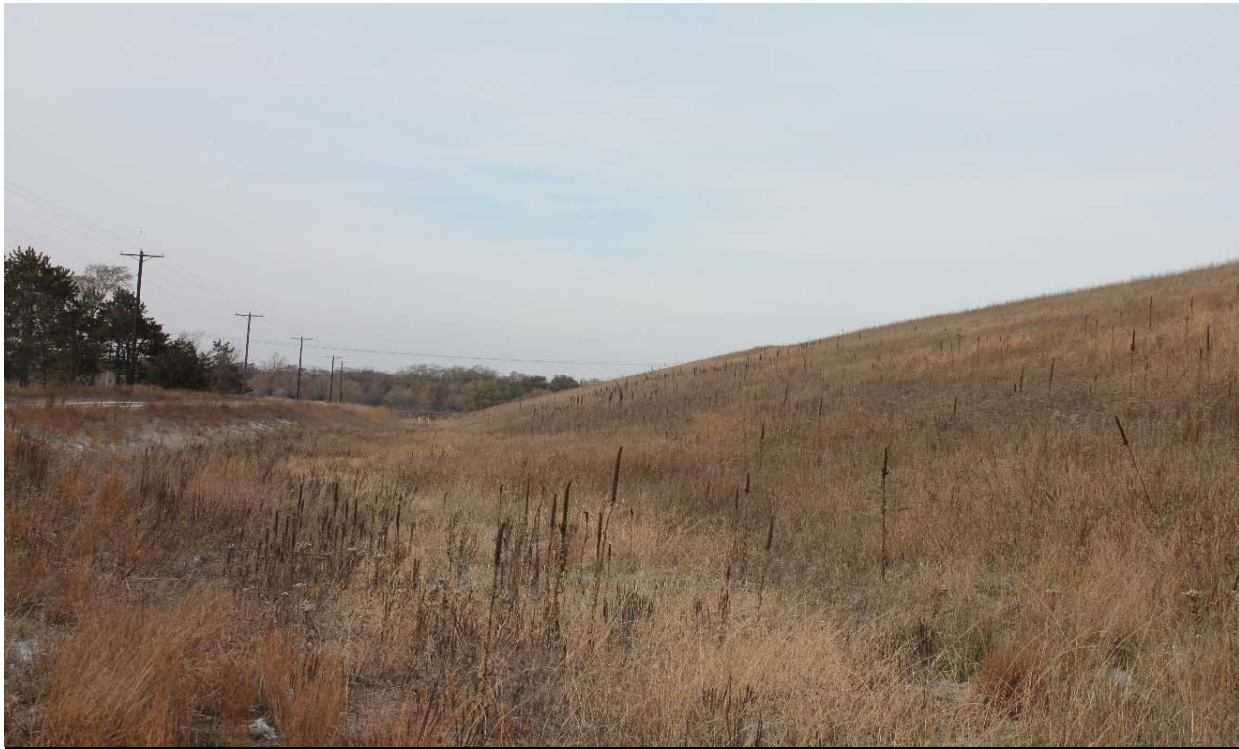
| Photo 17 | Pond south embankment, looking west. |

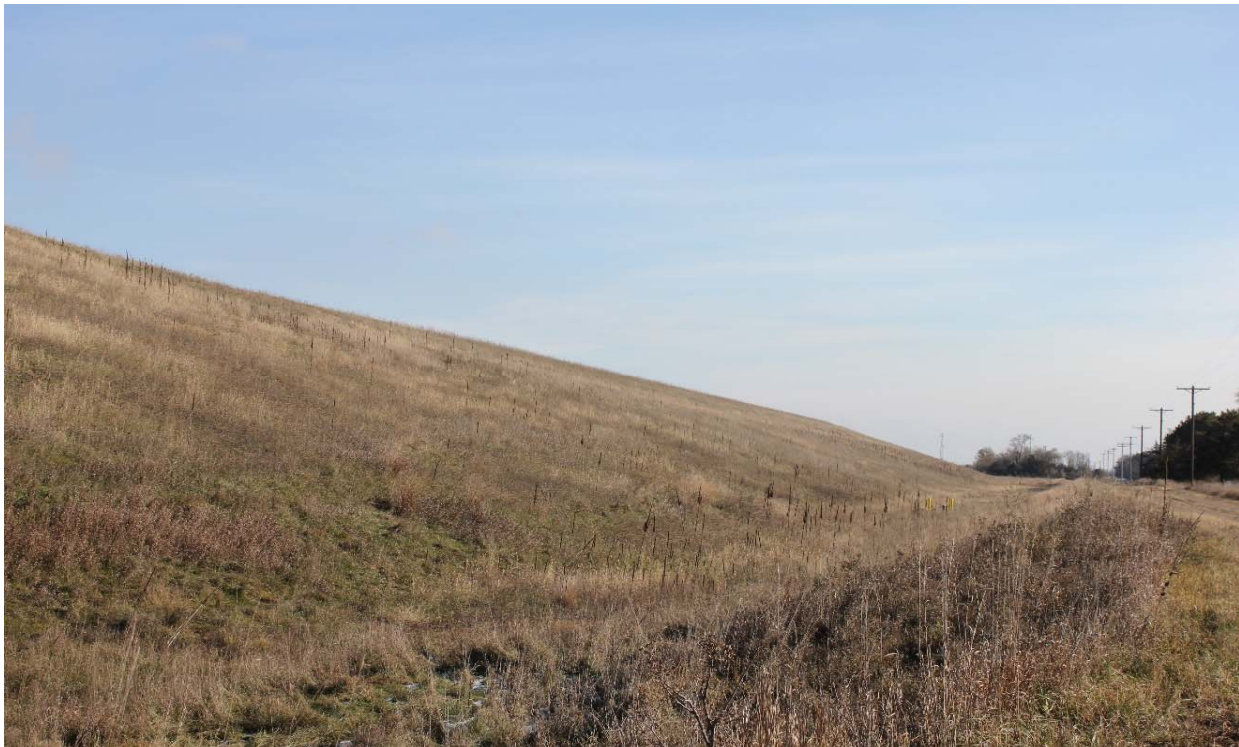
| Photo 18 | Pond south embankment, looking east. Middle right: Pond 3 CCR monitoring well (between yellow bollards). |

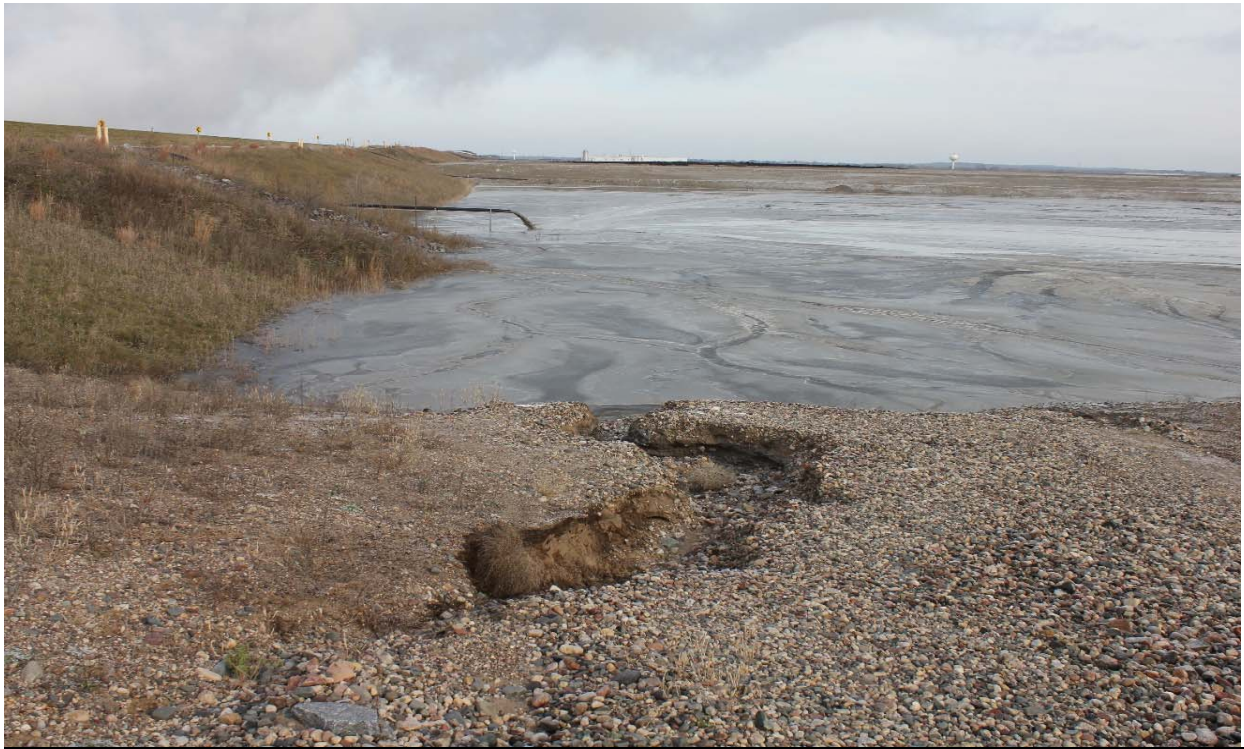
| Photo 19 | Pond interior west embankment, looking north. |

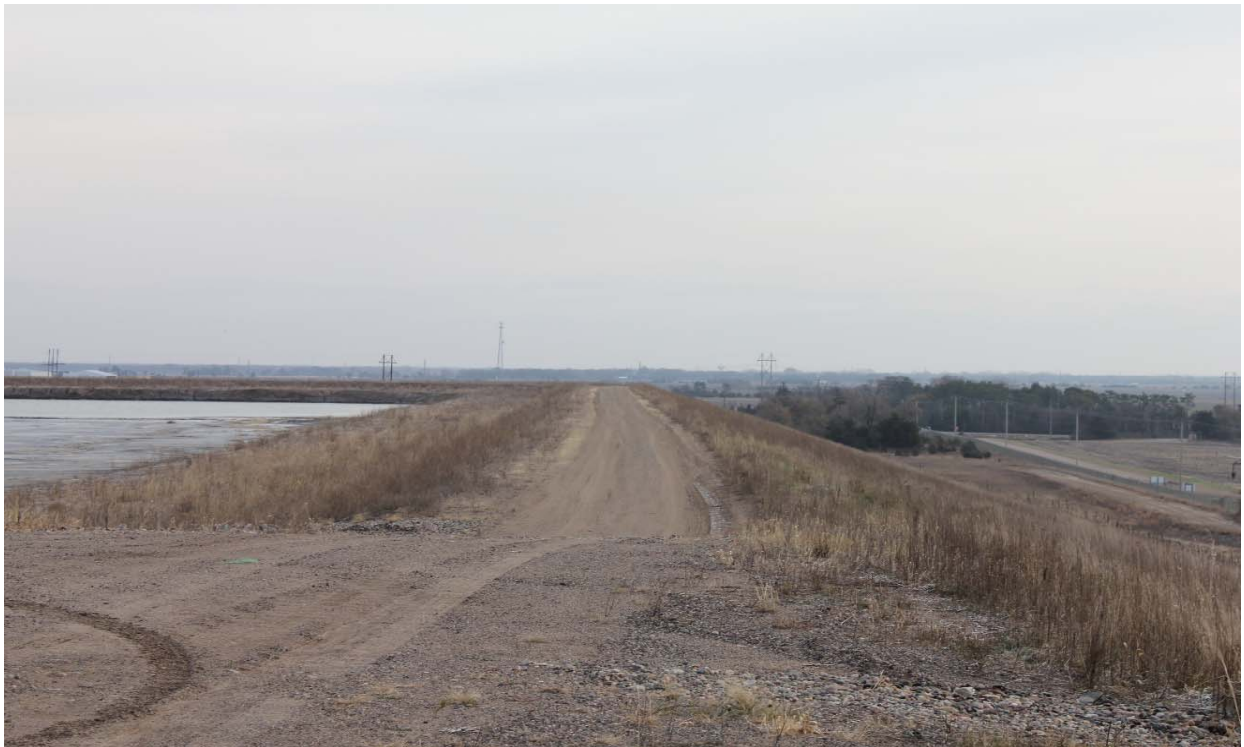
| Photo 20 | Top of pond south embankment, looking east |
