January 10, 2018

Xcel Energy, Inc.  
Sherburne County Generating Station  
13999 Industrial Blvd.  
Becker, MN, 55308

**Re: 2017 Annual Inspection of Scrubber Solids Pond No. 3**

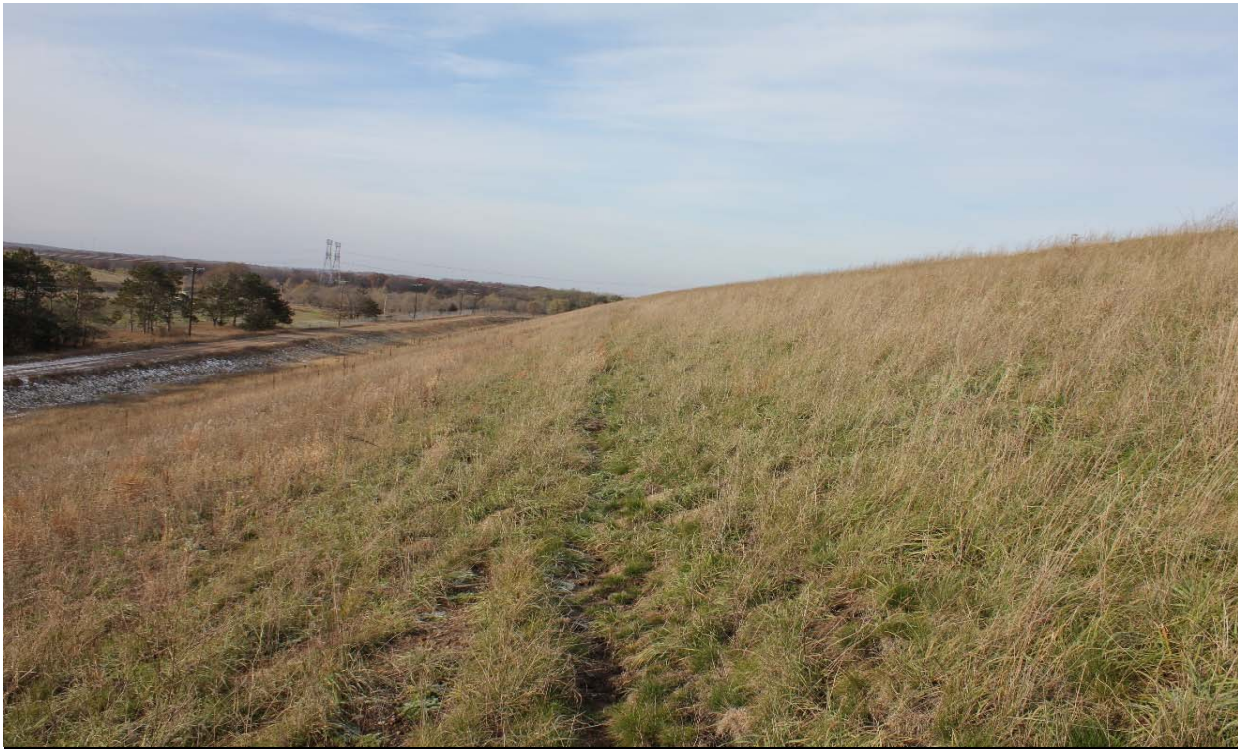
| Photo 21 | Mid-slope of south embankment, looking west. |

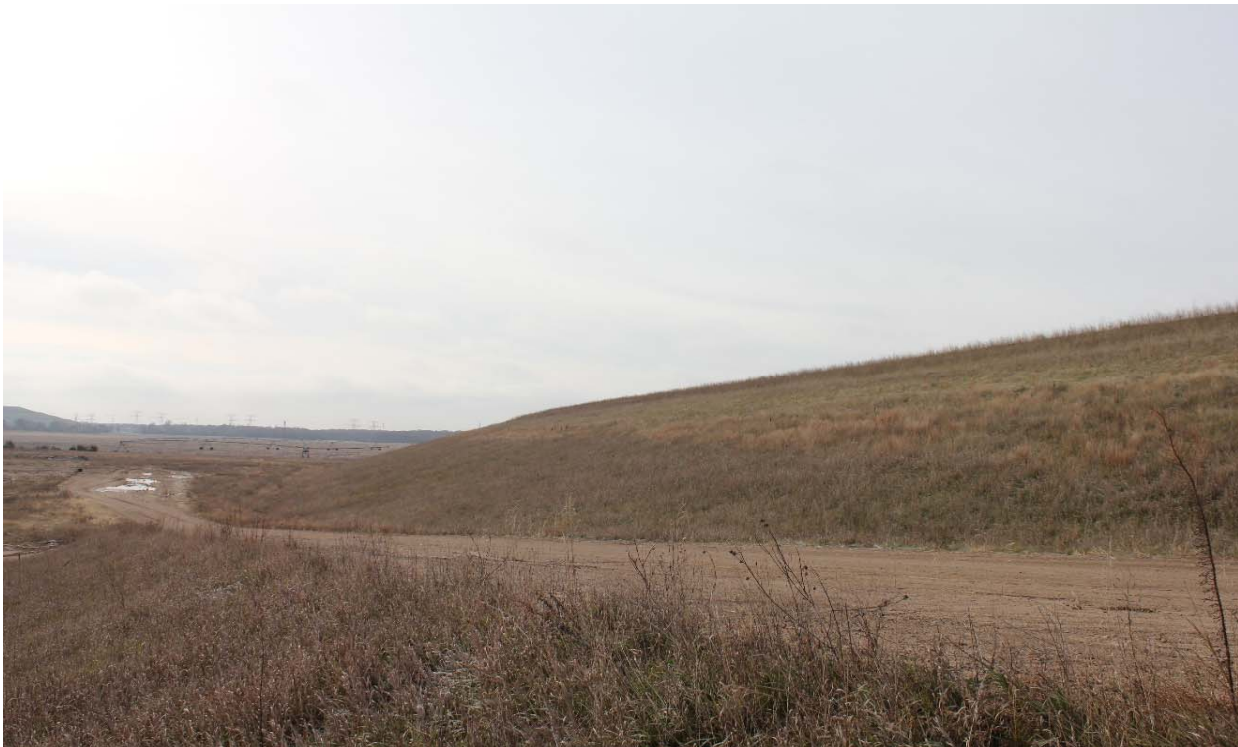
| Photo 22 | Pond southeast ramp and embankment, looking south. |

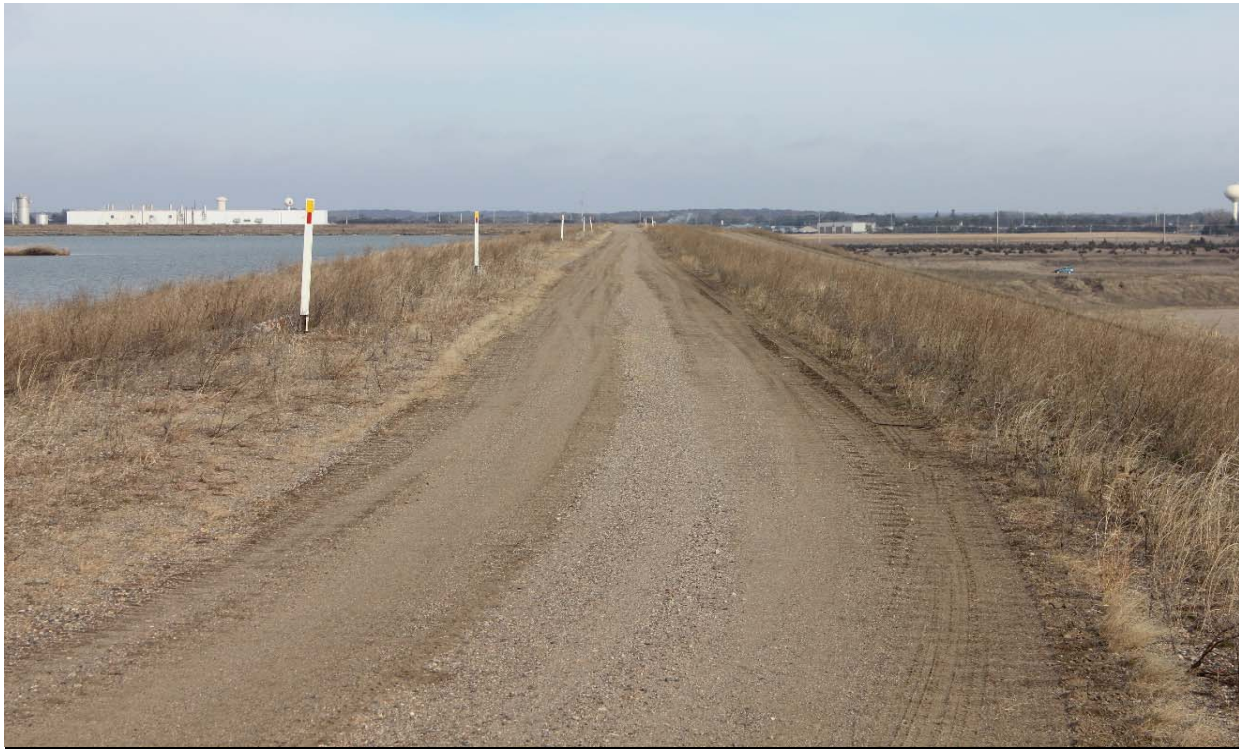
| Photo 23 | Top southeast corner of east embankment, looking north. |

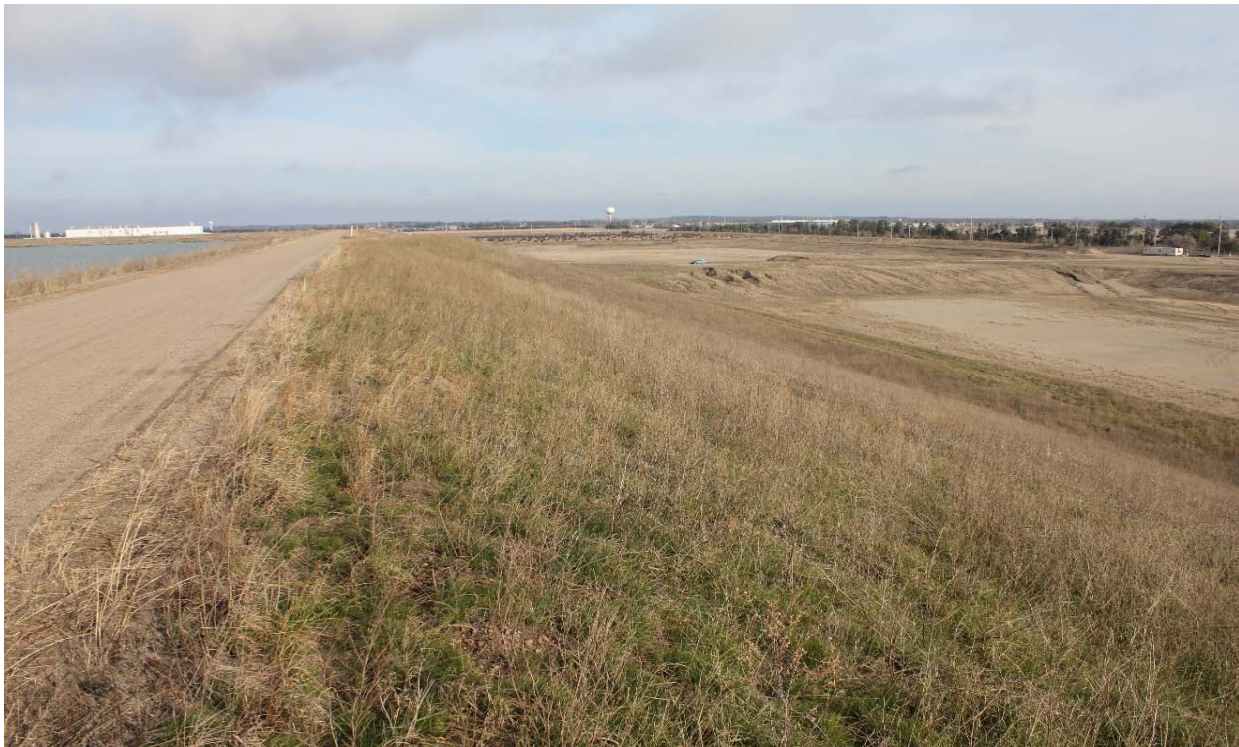
| Photo 24 | Top-center of east embankment, looking north. |

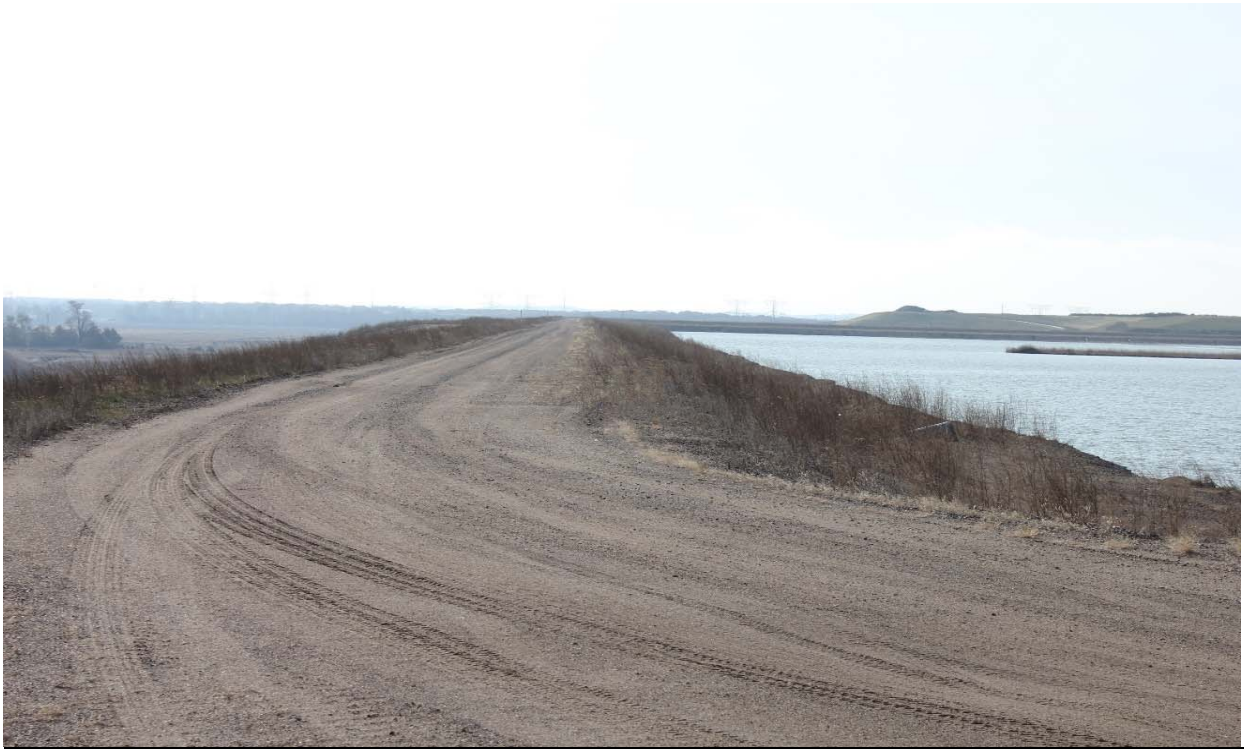
| Photo 25 | Top northeast corner of east embankment, looking south. |

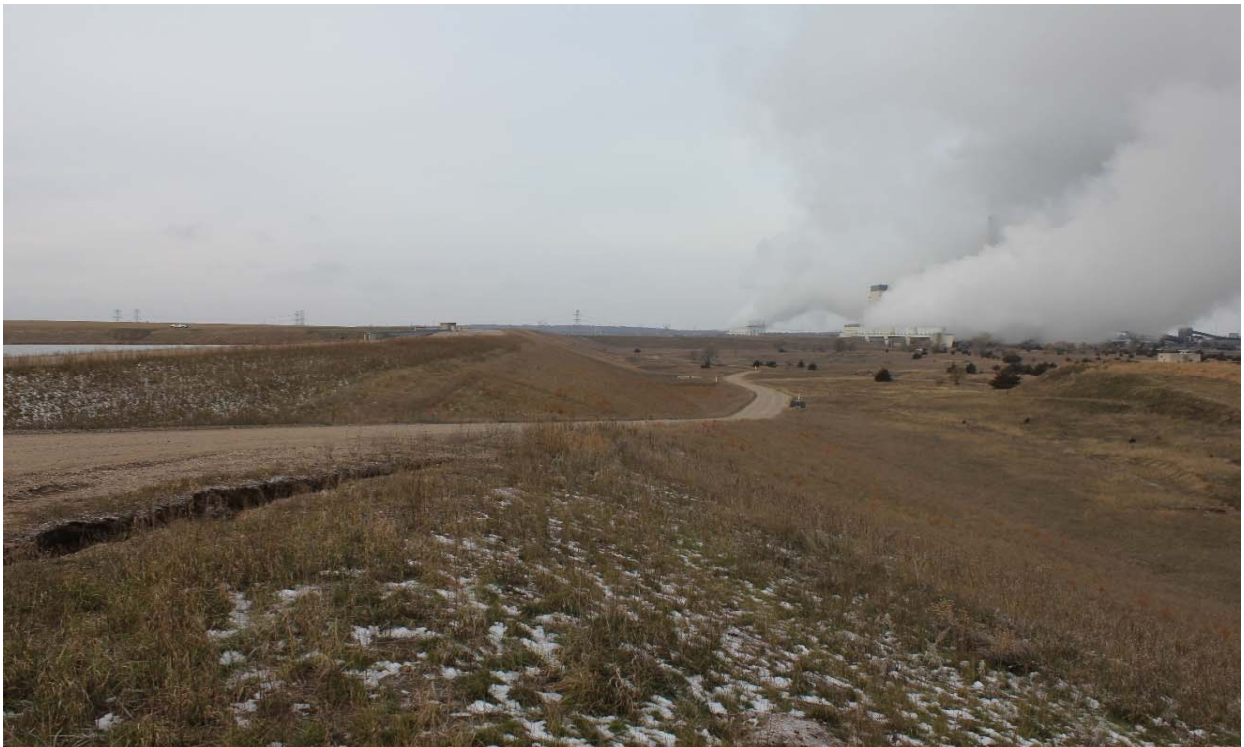
| Photo 26 | Top northeast corner of north embankment and small eroded channel, looking west. |

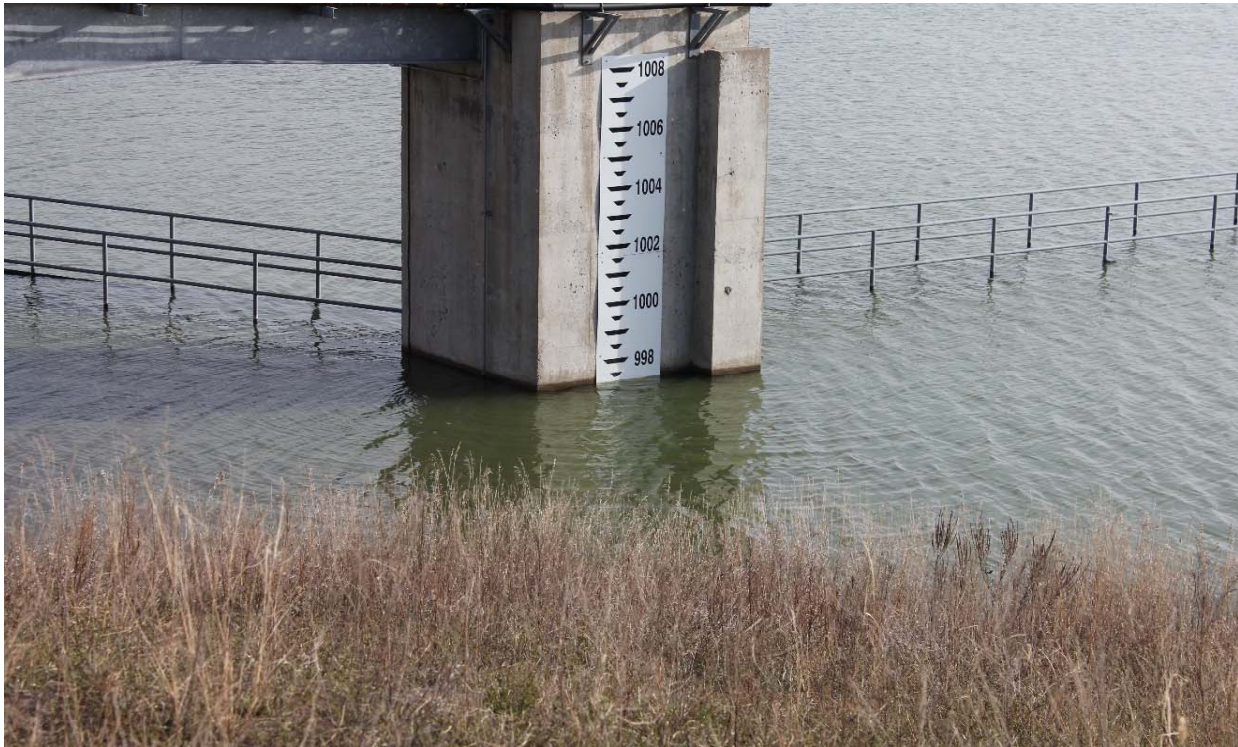
The only instrumentation on Pond 3 is a staff gauge used to determine water surface elevation, located on the west side of the discharge structure. The minimum elevation measured since the last inspection was 996.0 Mean Sea Level (MSL), the maximum elevation was 997.1 MSL. The top of clay liner elevation is 1004 MSL. No instrumentation is needed for dike stability.

| Photo 27 | Pond water level staff gauge (shown at approximately 997.1 feet of elevation mean sea level). |

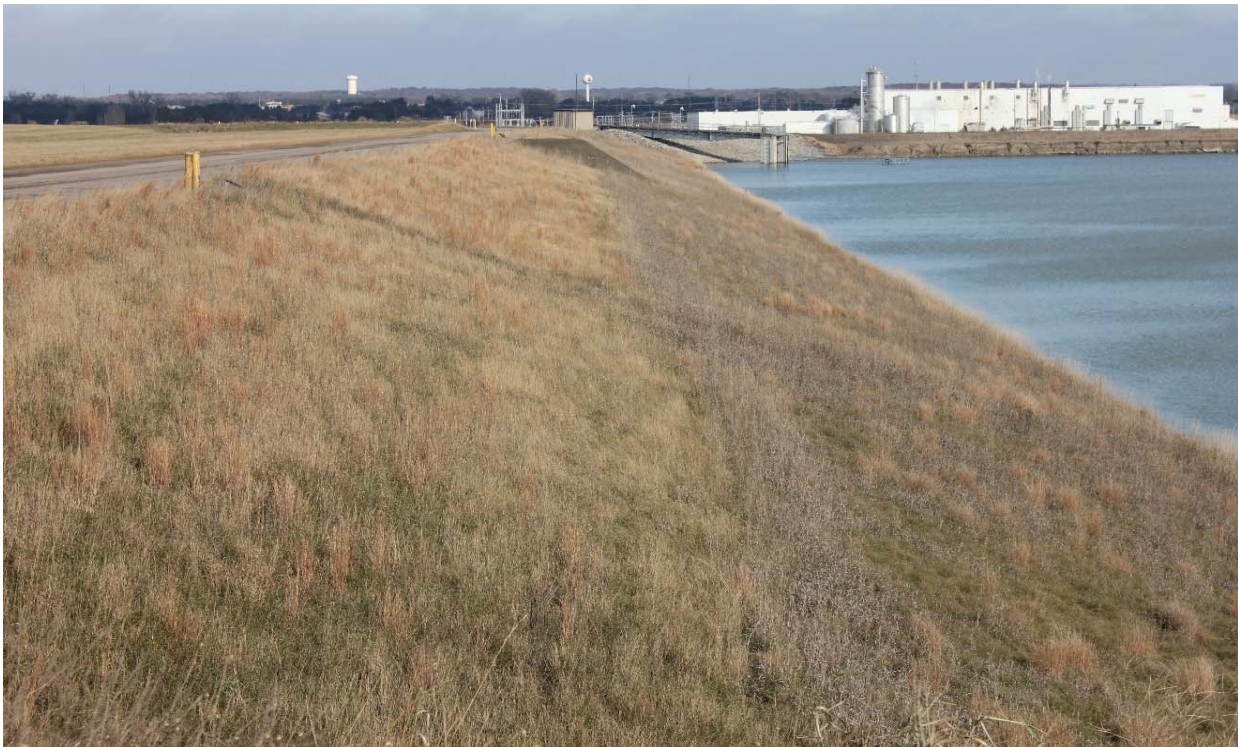
| Photo 28 | Pond interior west slope, looking north. |

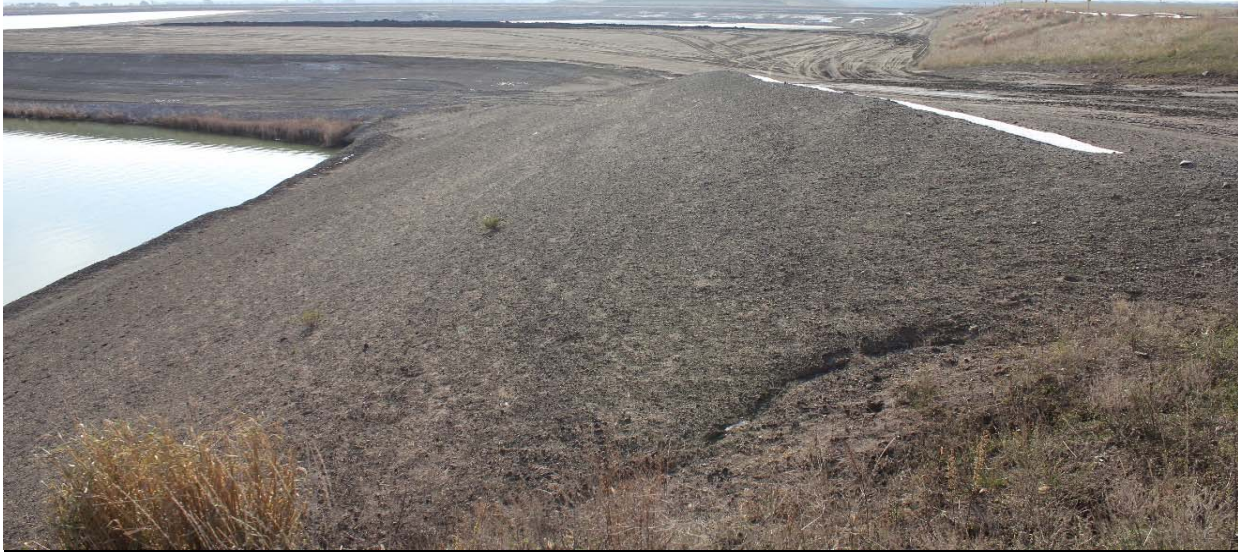
| Photo 29 | Pond interior west slope and bottom ash diking, looking south. |

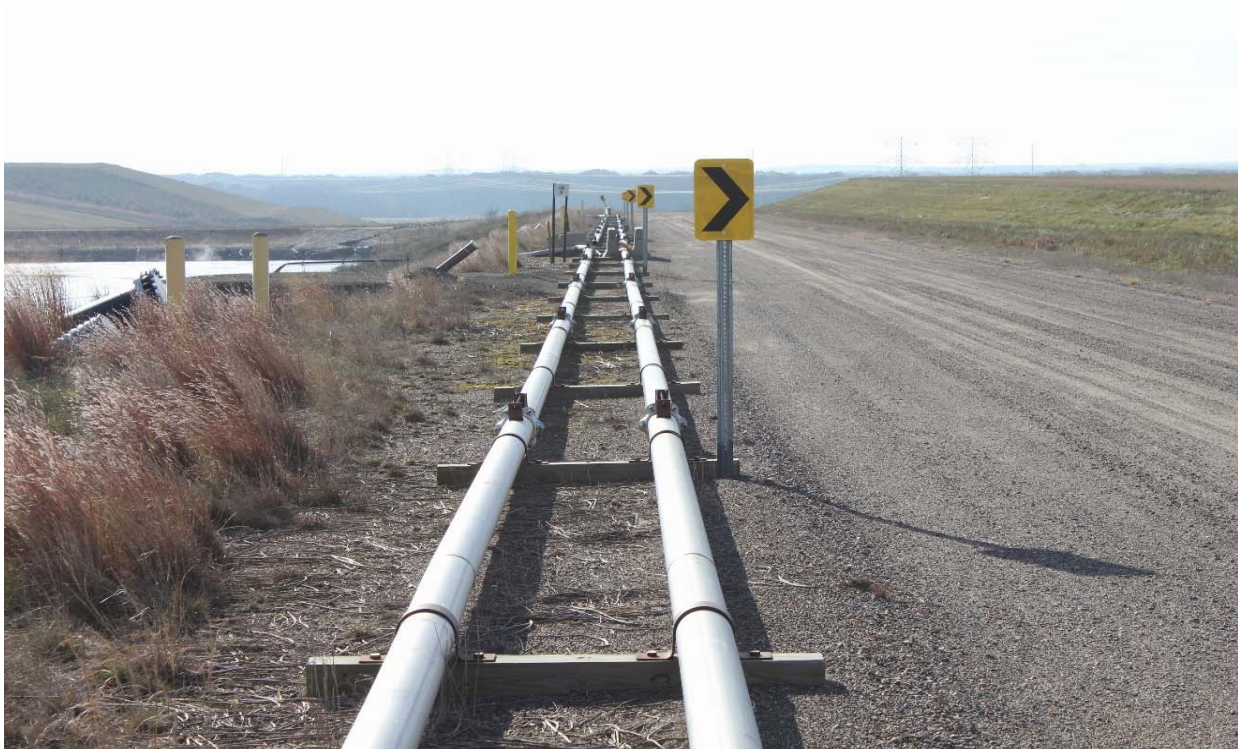
| Photo 30 | Foreground: Pond stainless steel scrubber solid pipes. Middle-left: CCR angled well. |

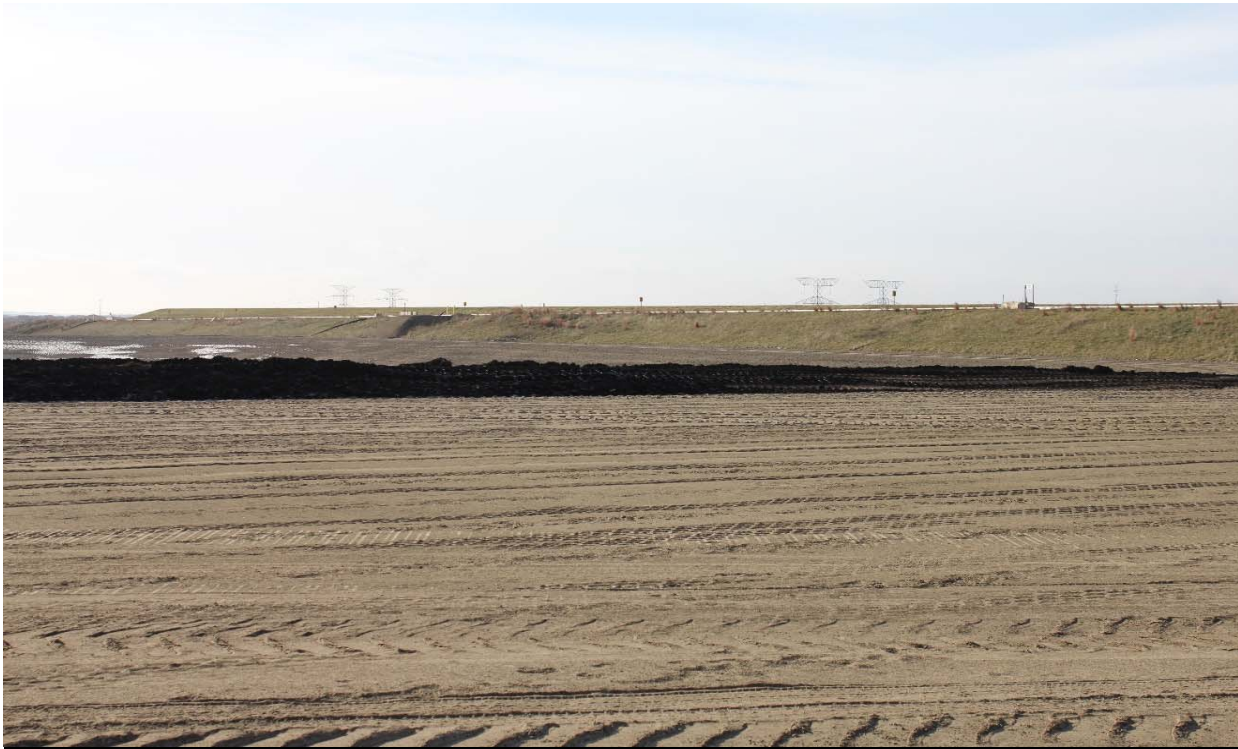
| Photo 31 | Pond west embankment south end, looking southwest. |

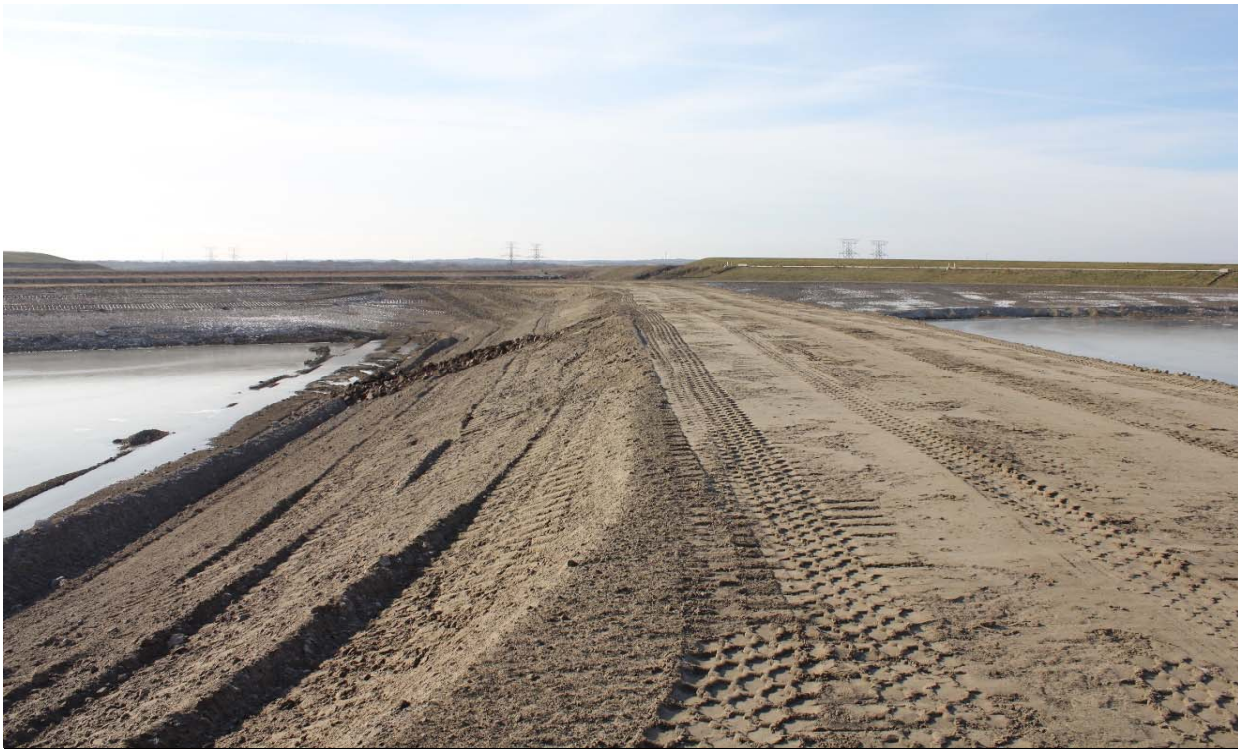
| Photo 32 | Bottom ash diking, looking southwest. |
