## **Initial Safety Factor Assessment**

### **Bottom Ash Pond**

### **Sherburne County Generating Plant**

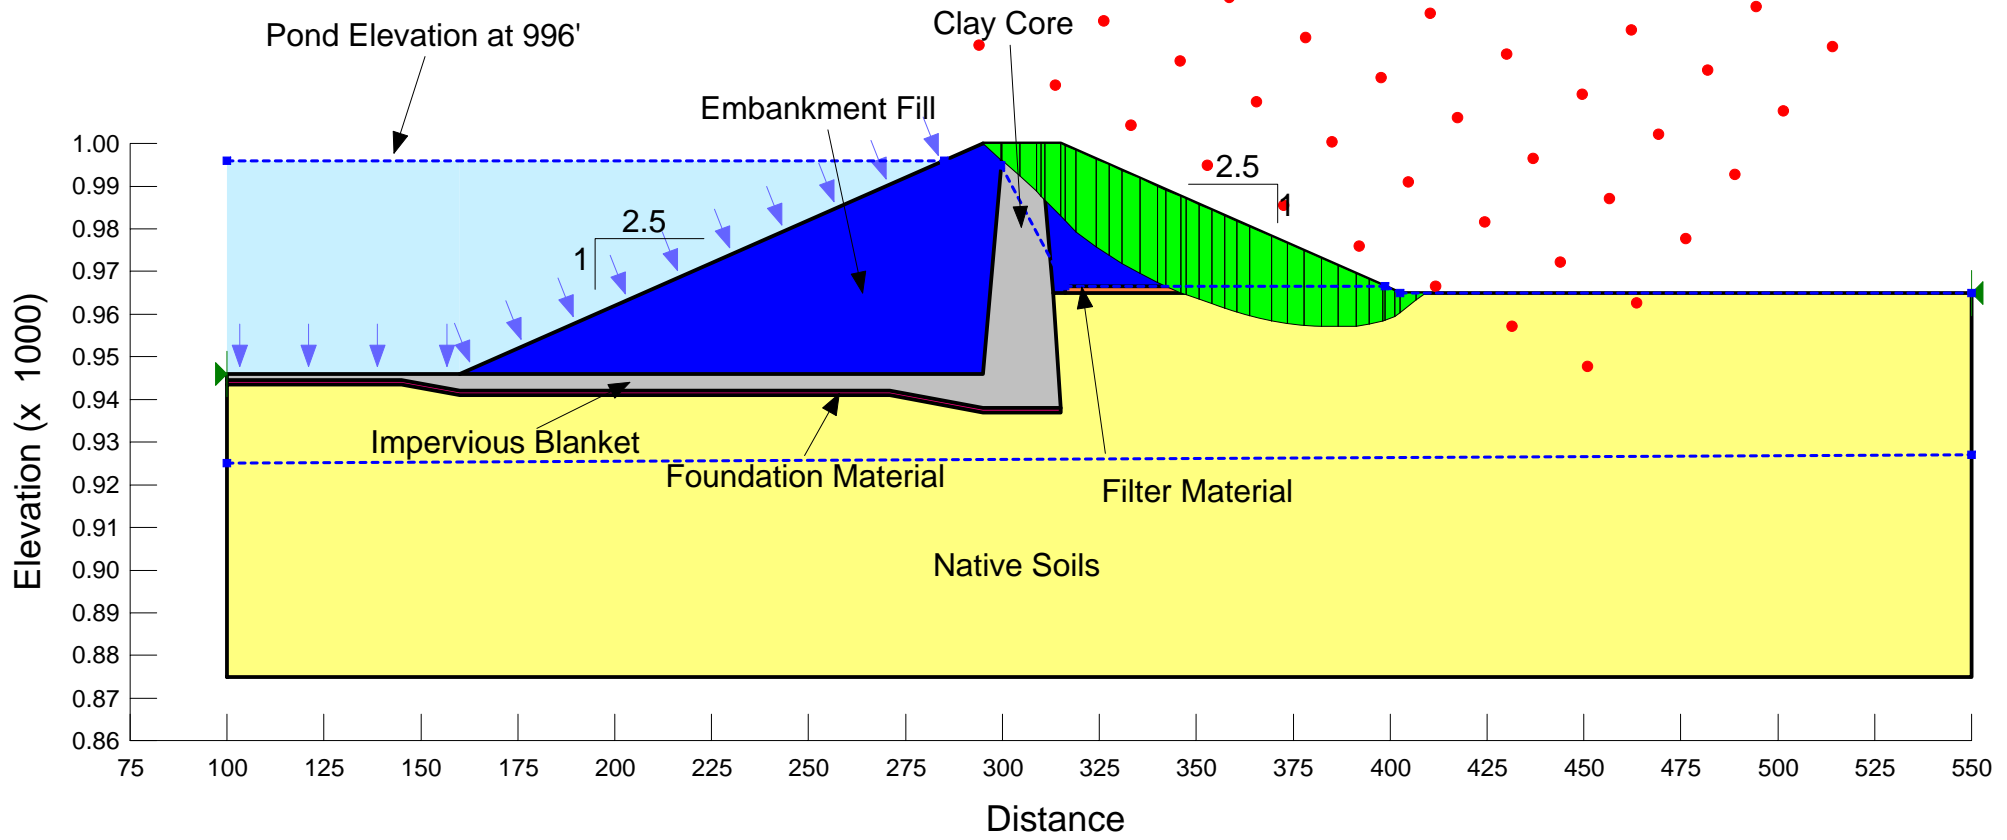
Condition 1: Maximum Storage Loading  
Pond Elevation at 996'  
Xcel Sherco Bottom Ash Pond  
Deep Circular Failure

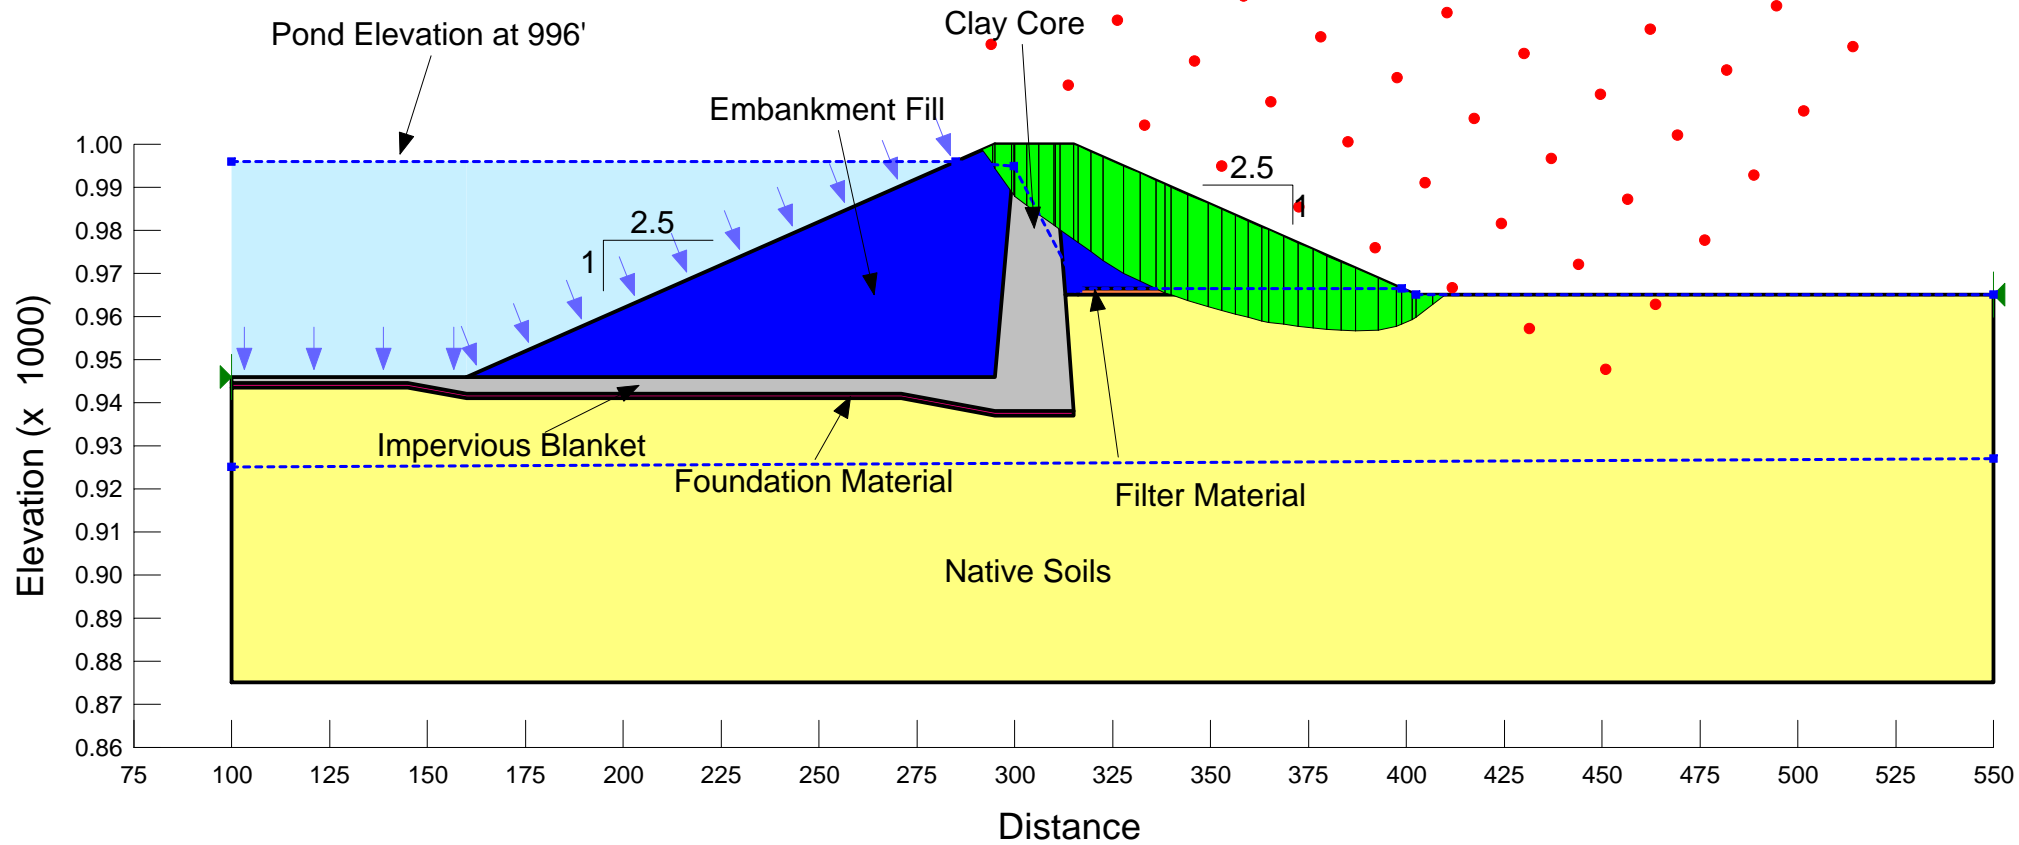
Condition 1: Maximum Storage Loading  
 Pond Elevation at 996'  
 Xcel Sherco Bottom Ash Pond  
 Deep Circular Failure  
 Seismic Analysis

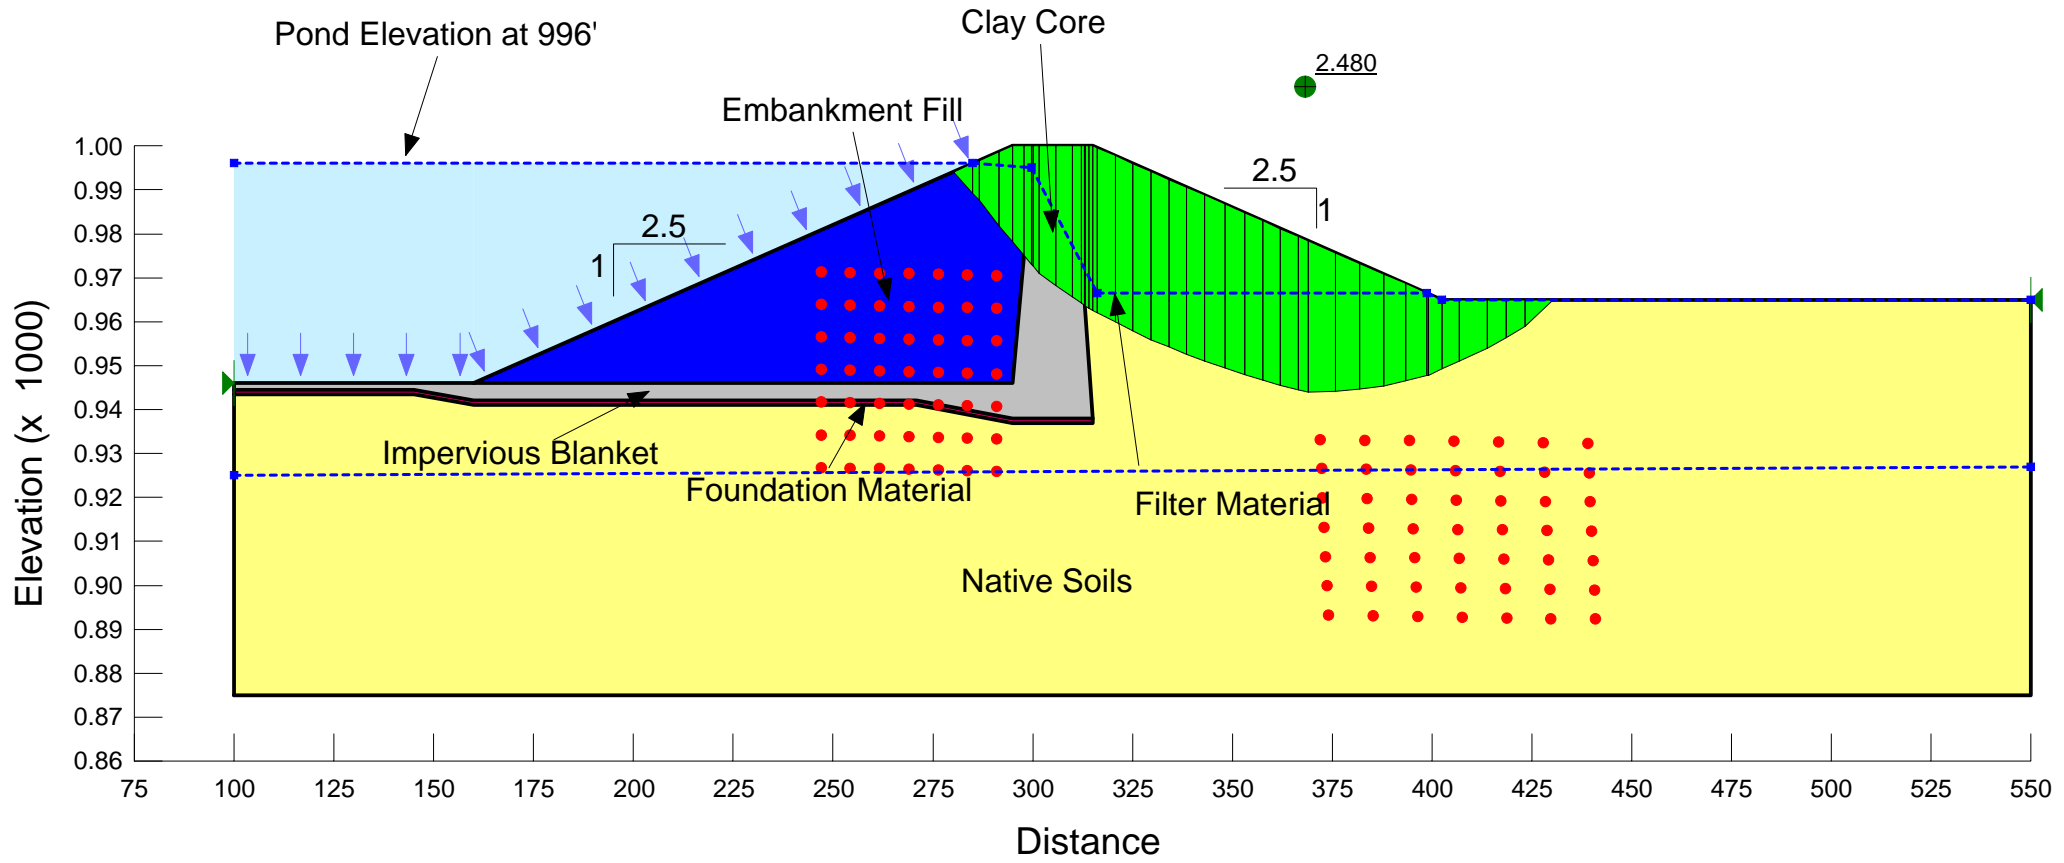
Condition 1: Maximum Storage Loading  
Pond Elevation at 996'  
Xcel Sherco Bottom Ash Pond  
Block Failure

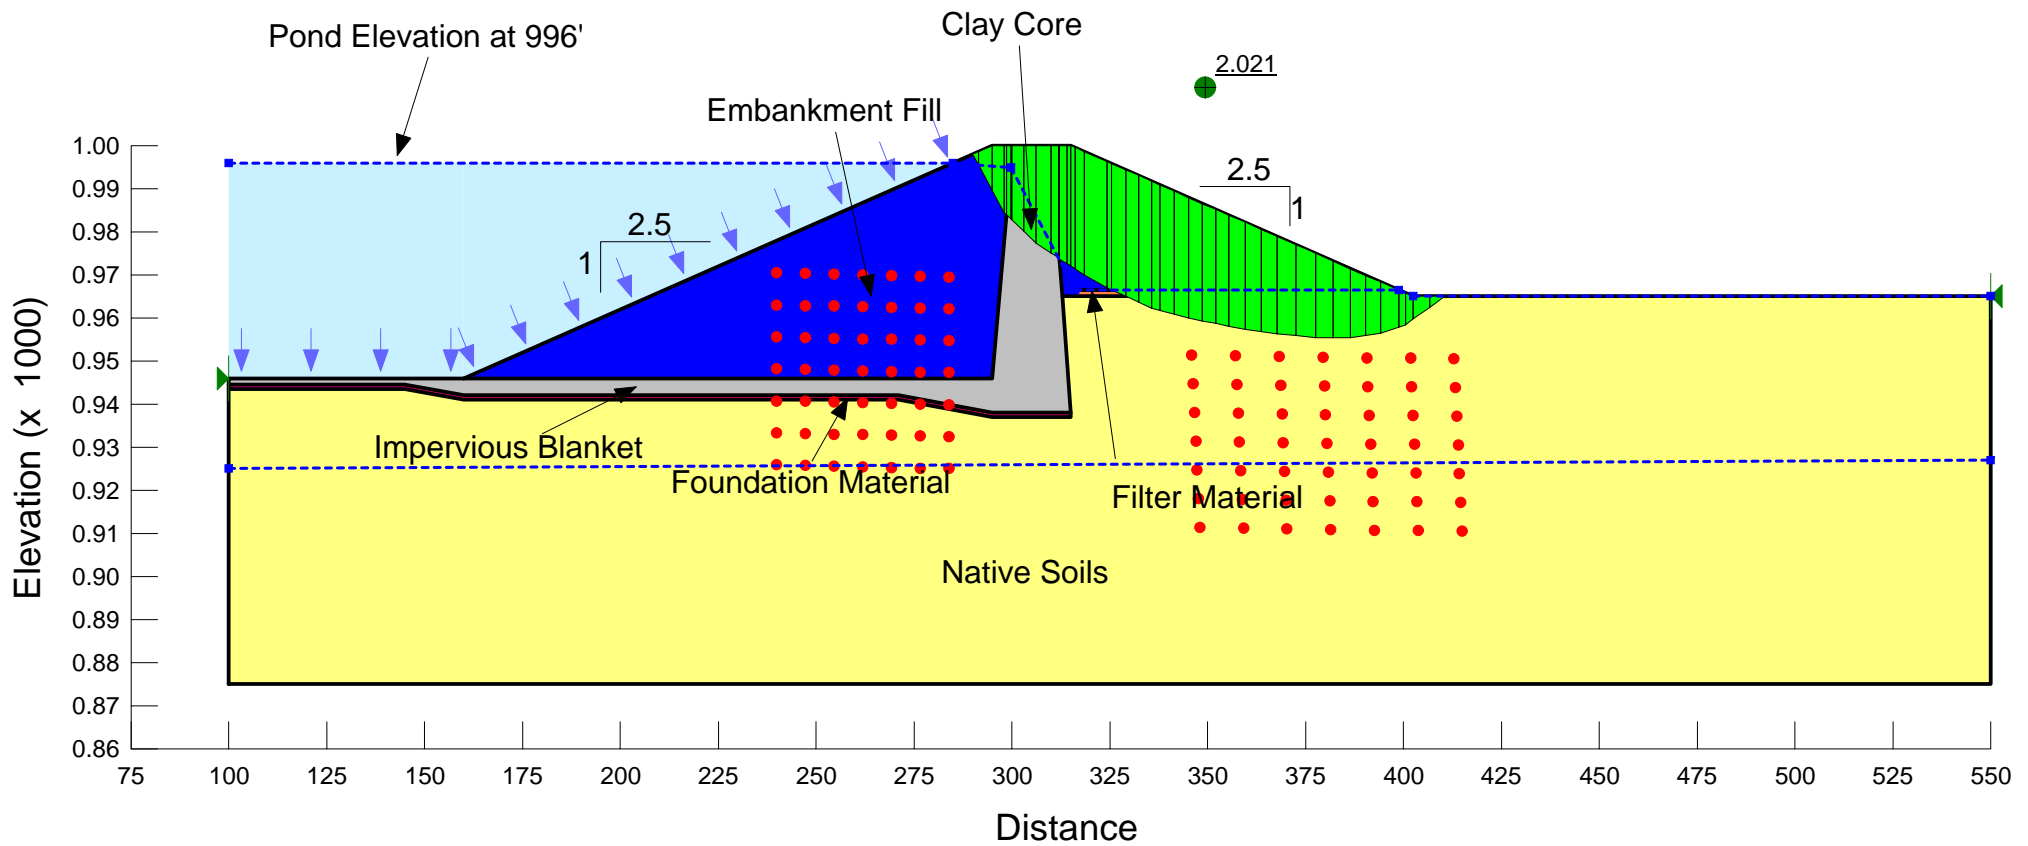
Condition 1: Maximum Storage Loading  
Pond Elevation at 996'  
Xcel Sherco Bottom Ash Pond  
Block Failure  
Seismic Analysis

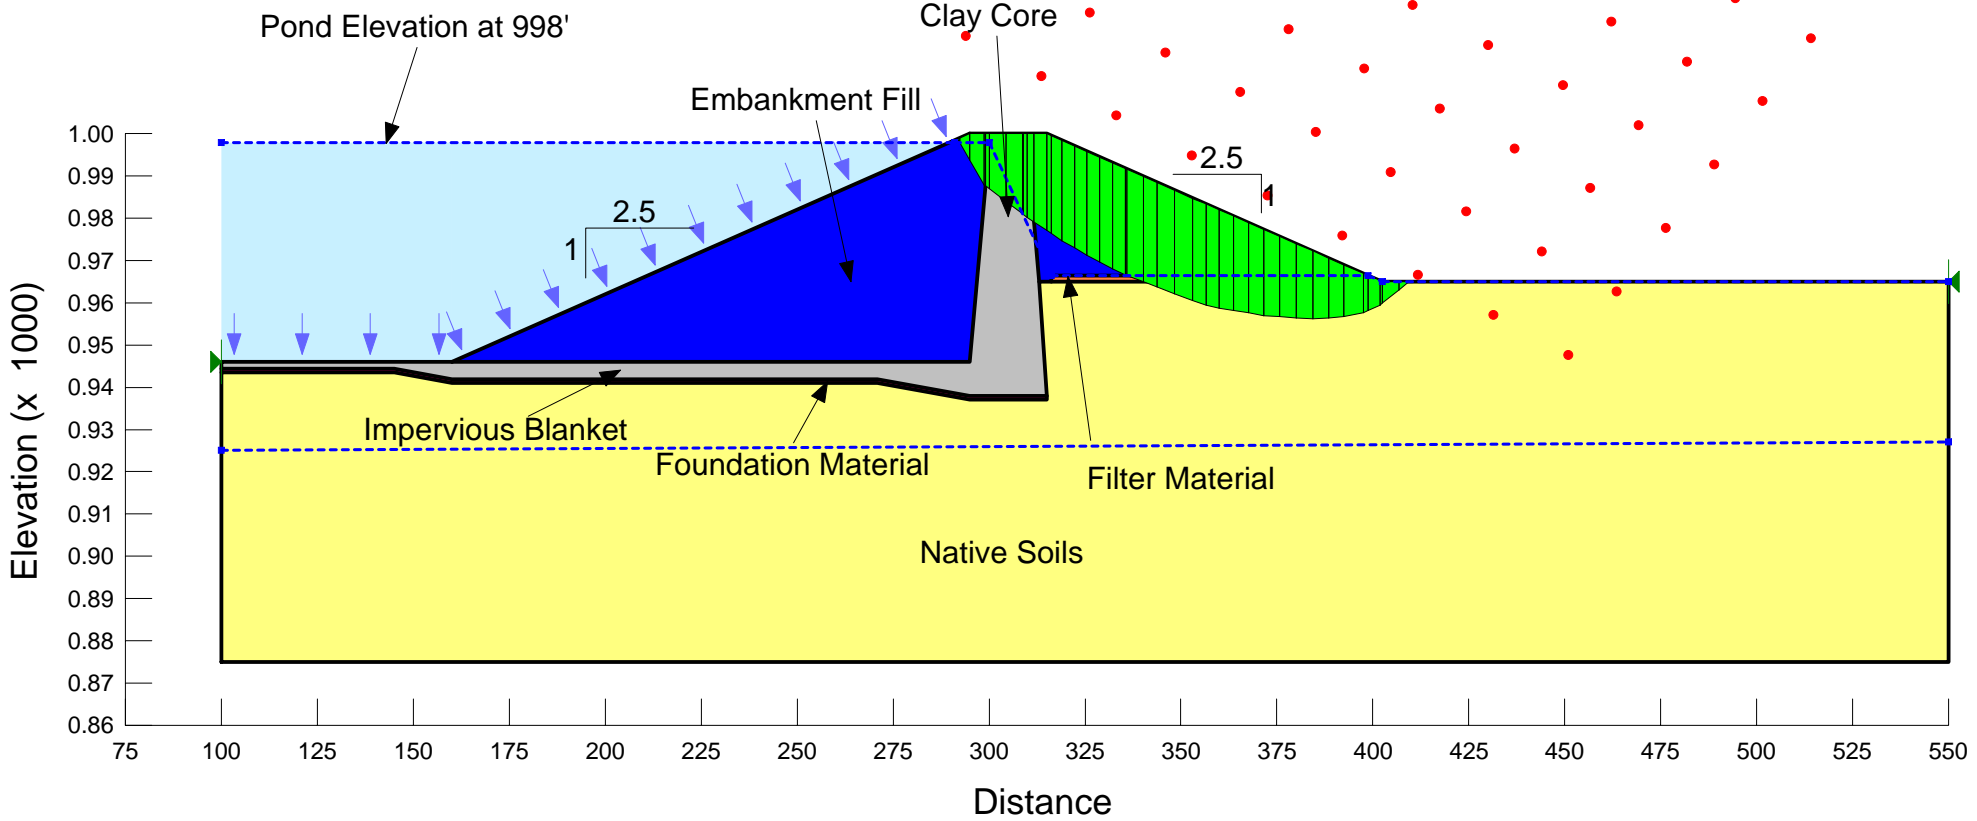
Condition 2: Maximum Surcharge Loading  
Pond Elevation at 998'  
Xcel Sherco Bottom Ash Pond  
Deep Circular Failure

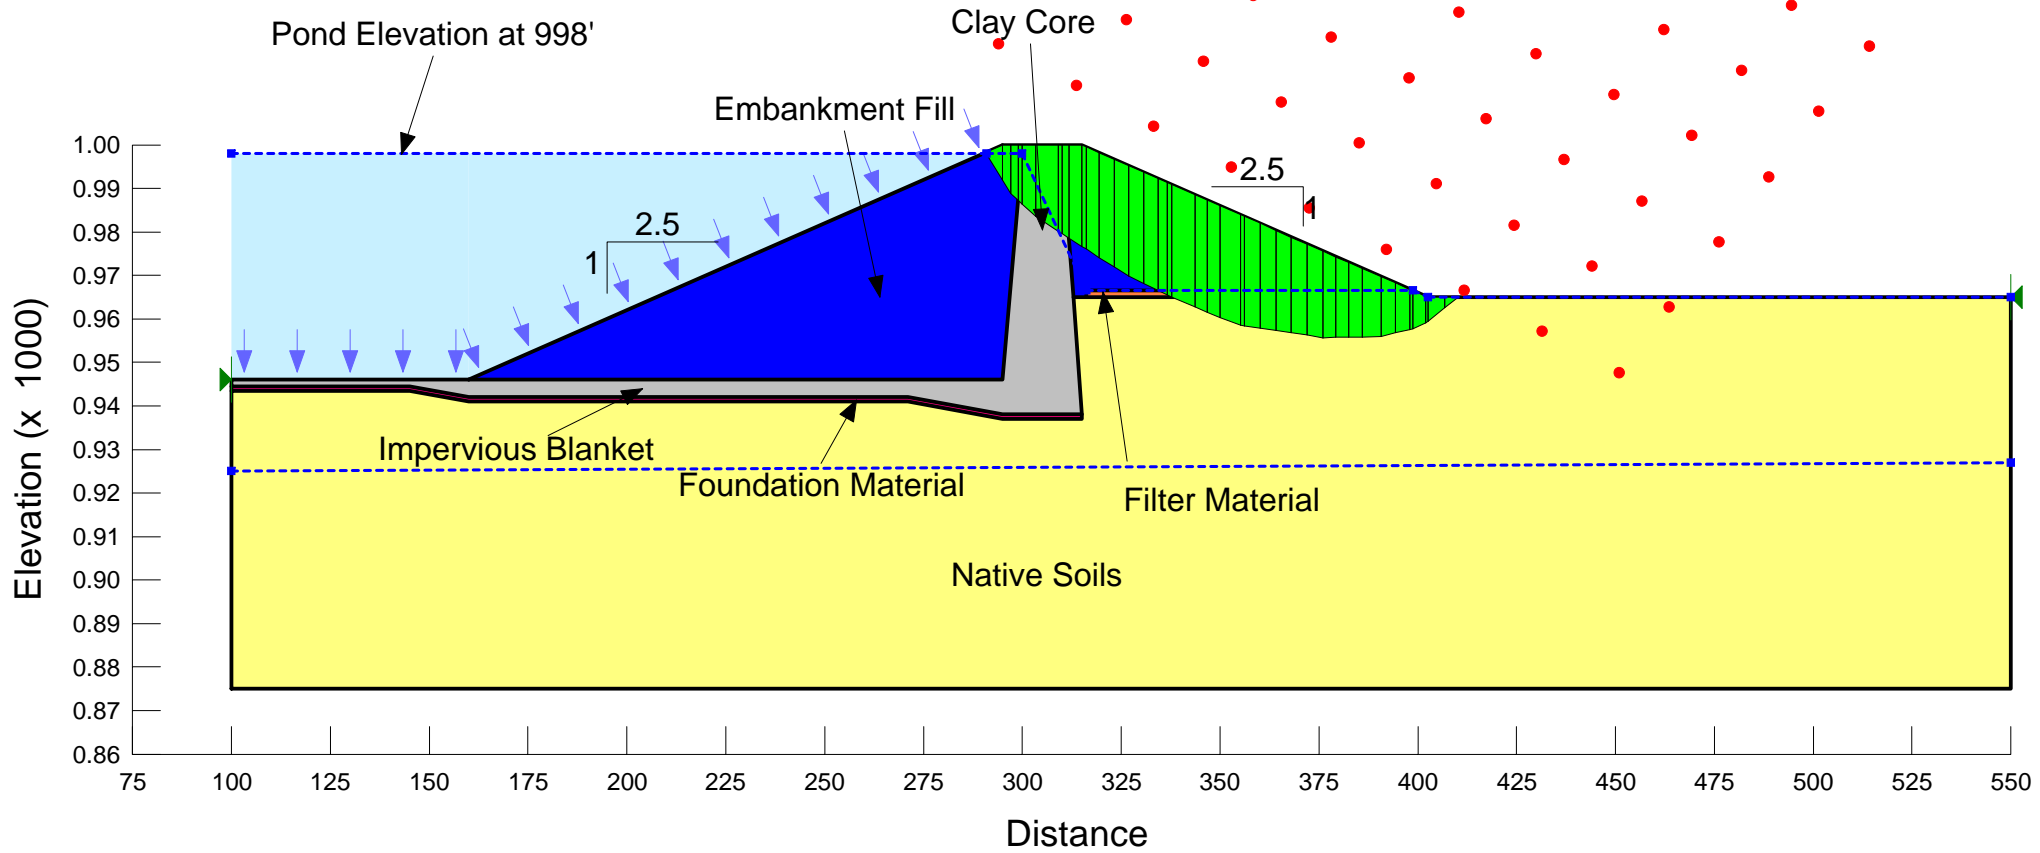
Condition 2: Maximum Surcharge Loading  
Pond Elevation at 998'  
Xcel Sherco Bottom Ash Pond  
Deep Circular Failure  
Seismic Analysis

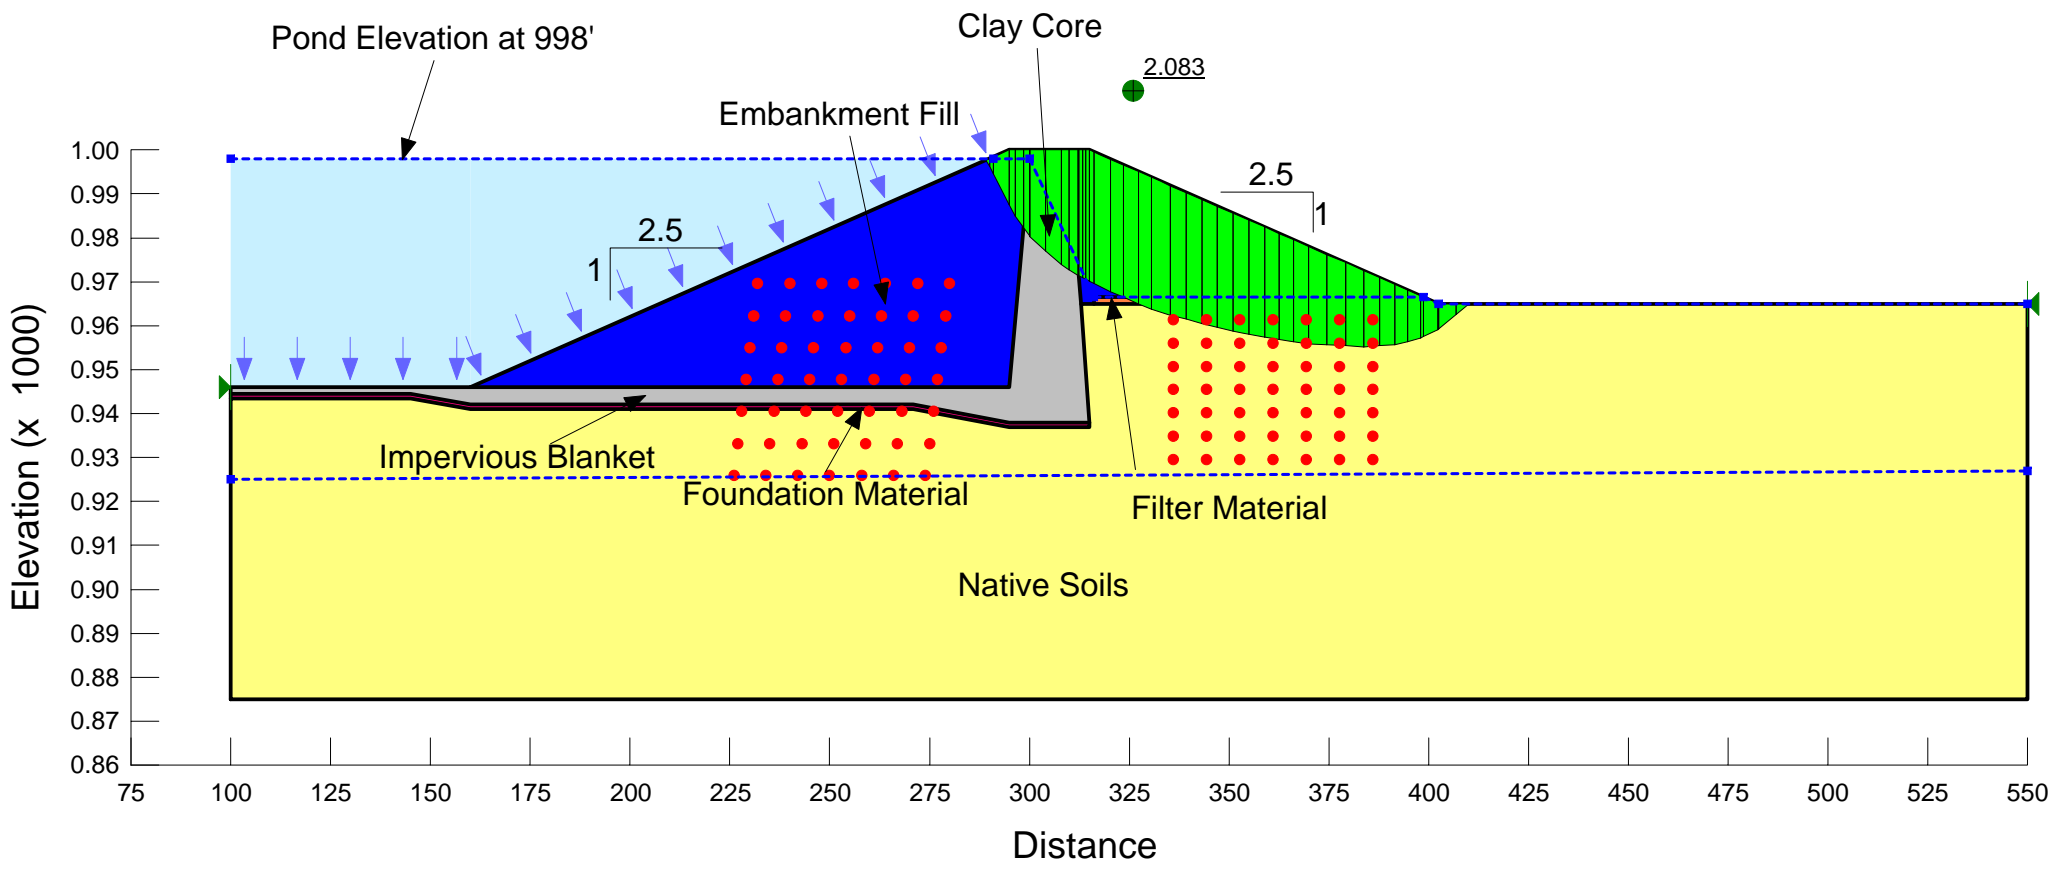
Condition 2: Maximum Surcharge Loading  
Pond Elevation at 998'  
Xcel Sherco Bottom Ash Pond  
Block Failure

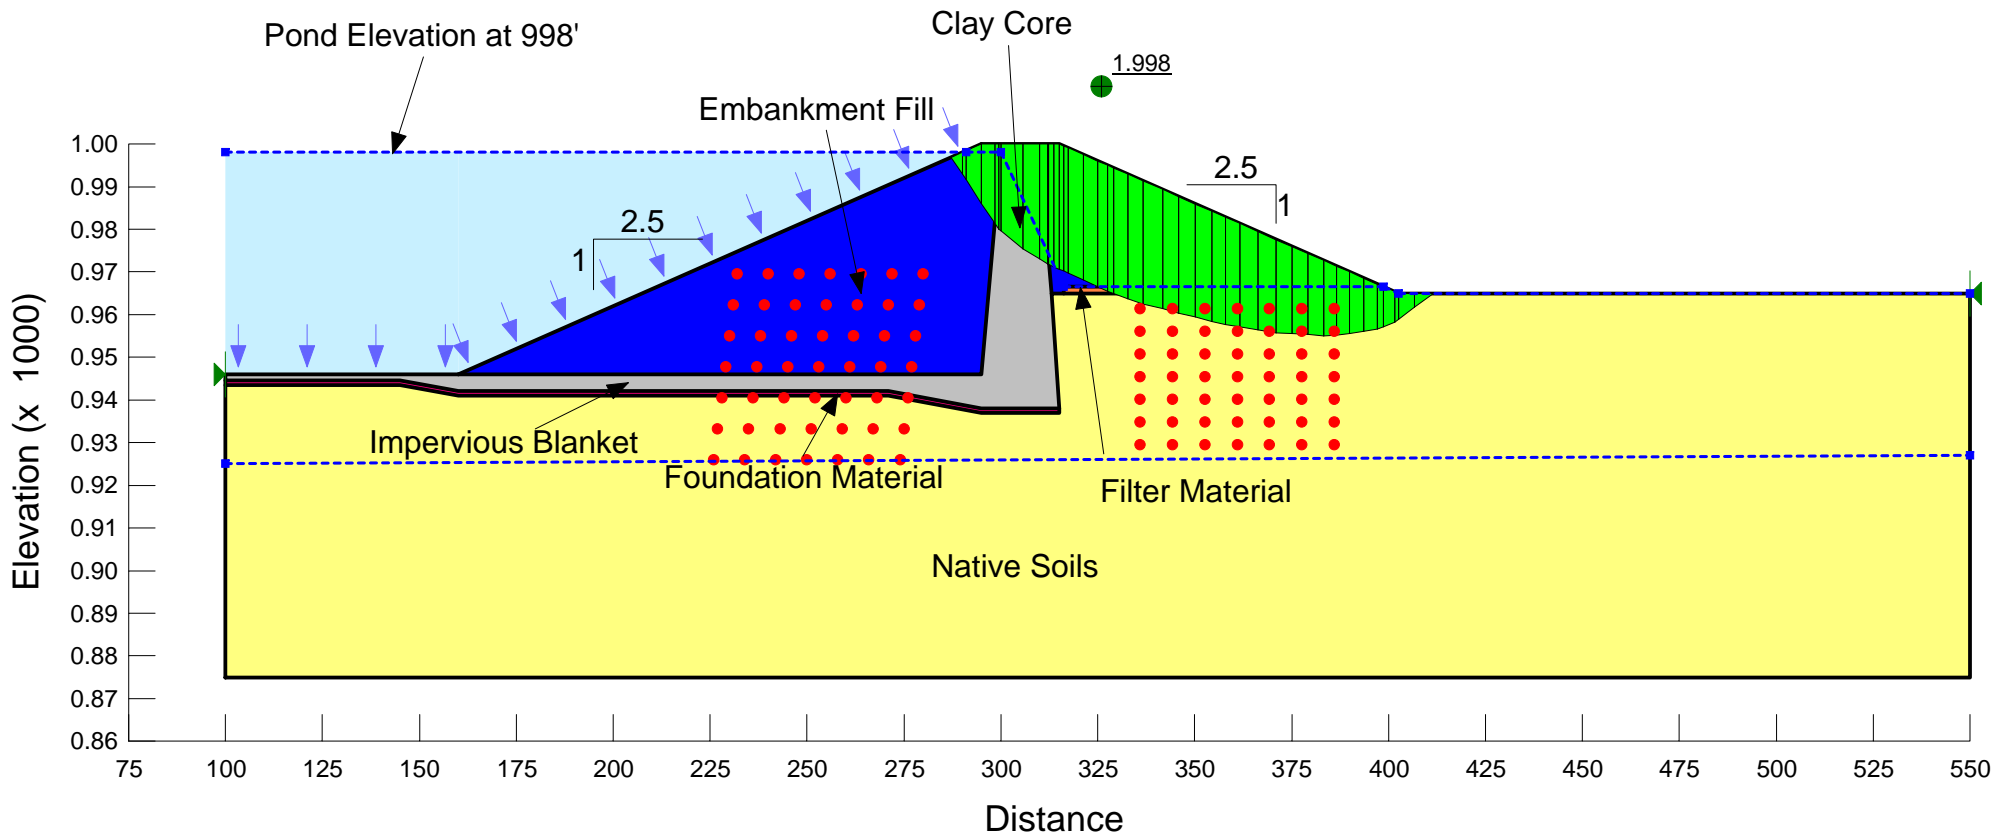
Condition 2: Maximum Surcharge Loading  
Pond Elevation at 998'  
Xcel Sherco Bottom Ash Pond  
Block Failure  
Seismic Analysis
