Xcel Energy, Inc.
Sherburne County Generating Station
13999 Industrial Blvd.
Becker, MN, 55308

Re: 2016 Annual Inspection of Bottom Ash Pond

Bottom Ash Pond Annual Inspection – November 2016

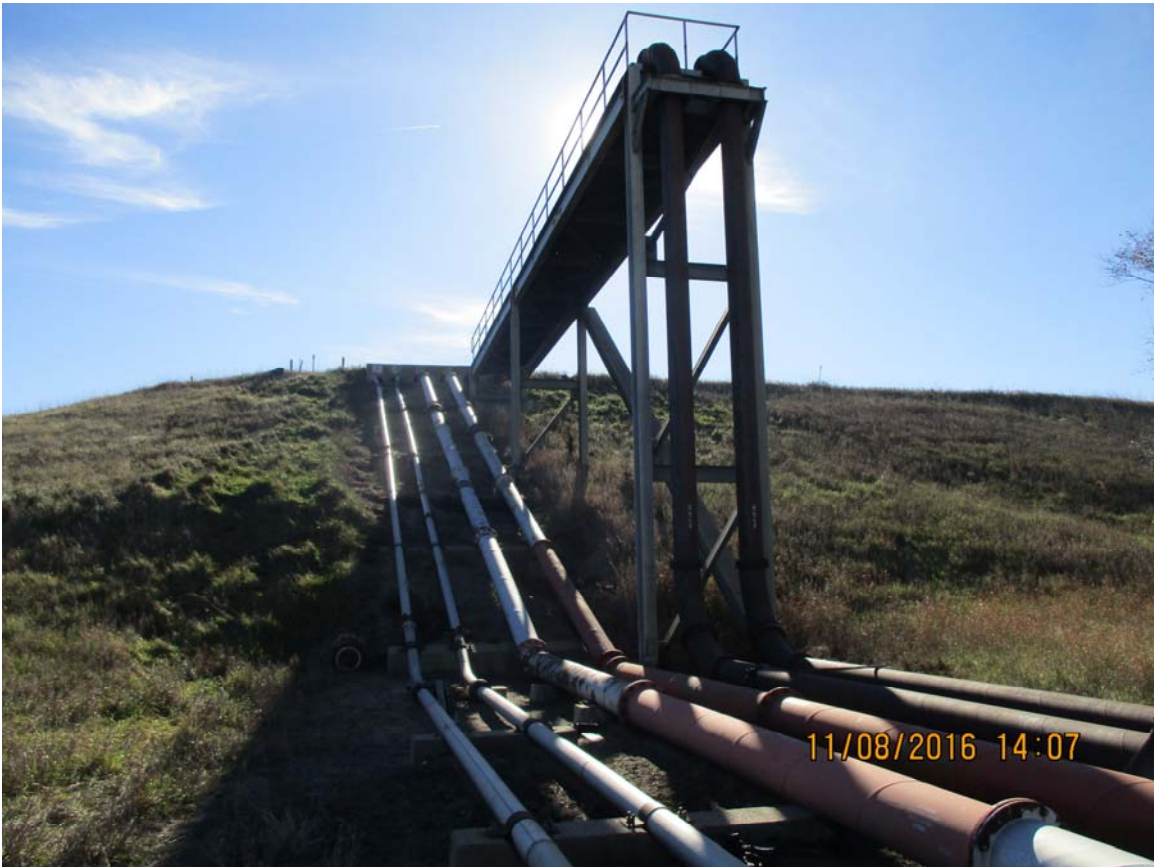
Photo 1	Bottom ash and scrubber pipes, looking south
11/8

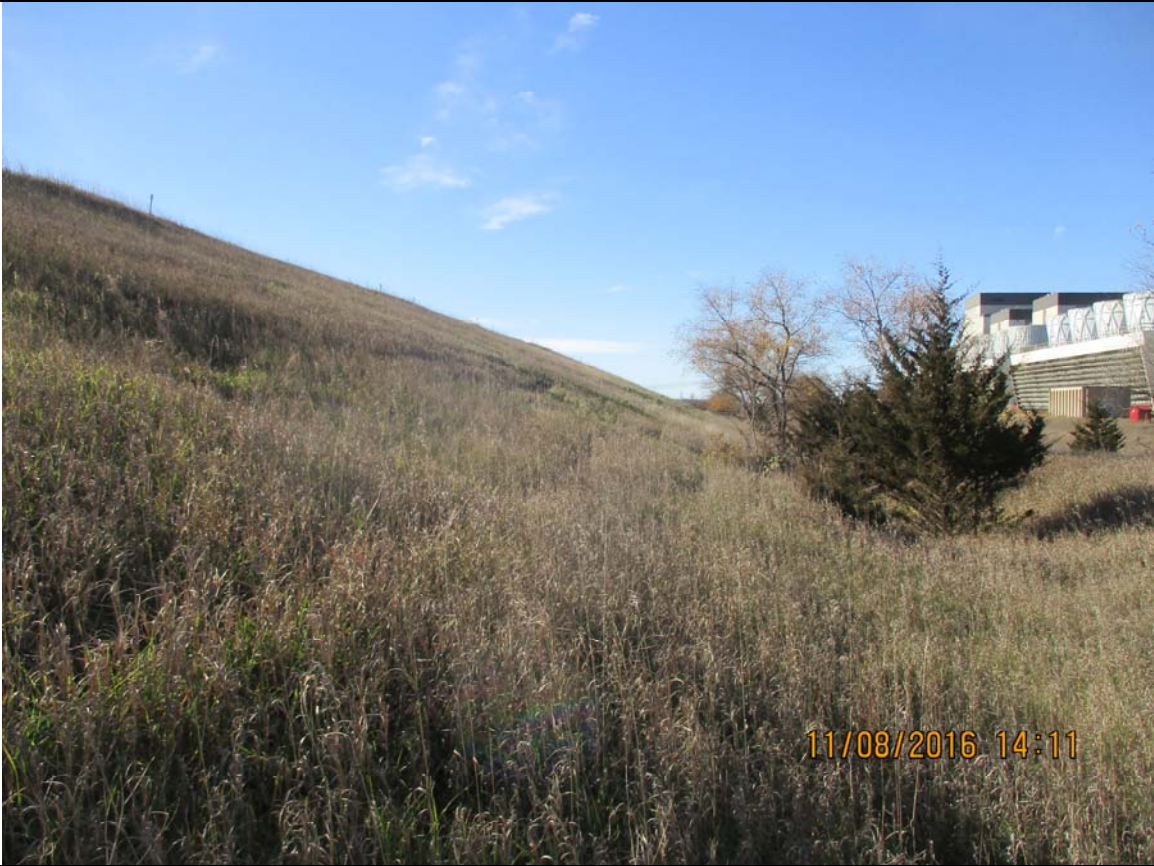
Photo 2	North embankment and perimeter ditch, looking west

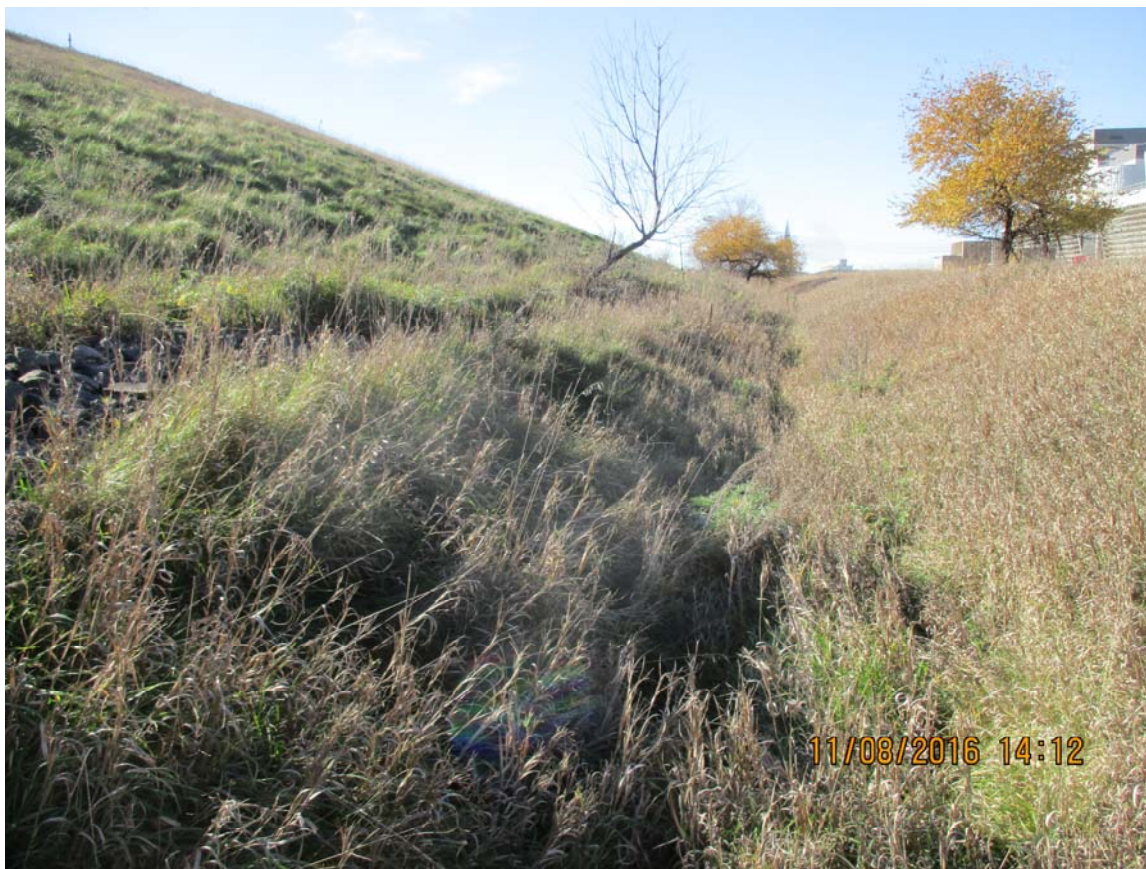
Photo 3	North embankment and riprap toe drain, looking west.
---------	--

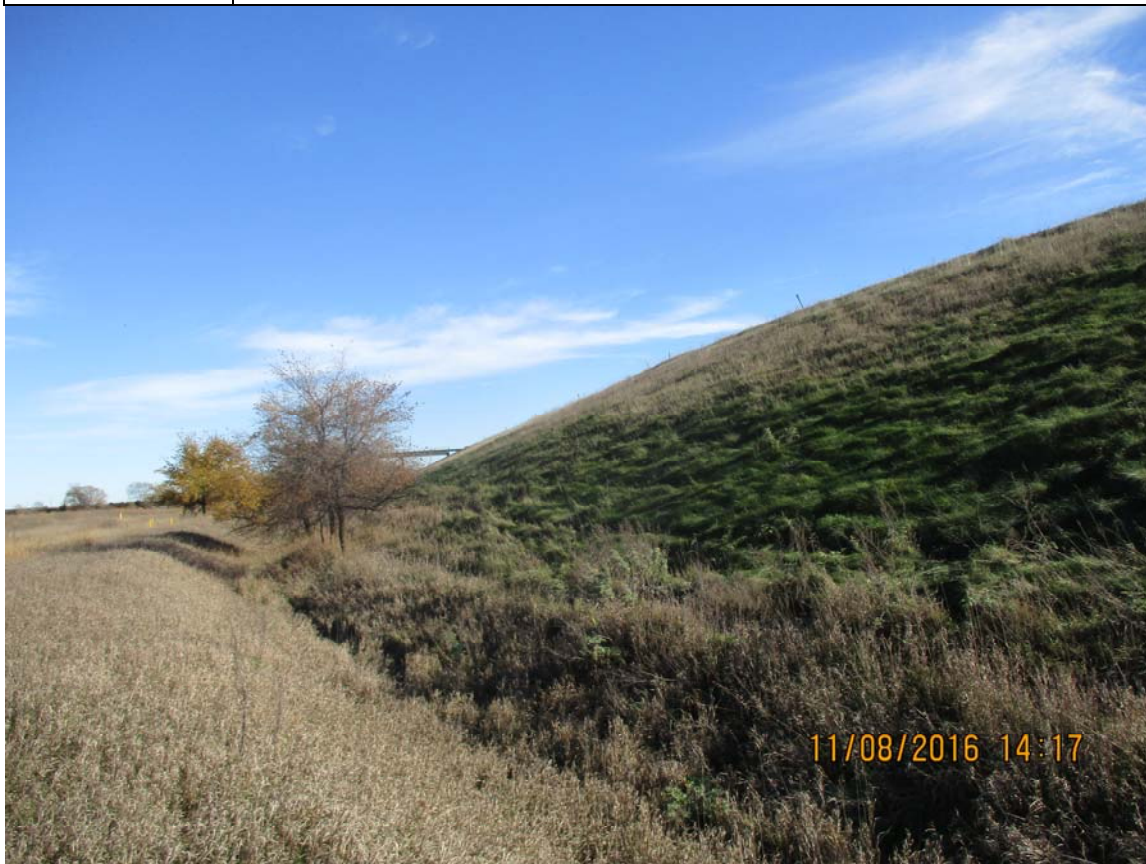
Photo 4	North embankment and toe drain, looking east.
---------	---

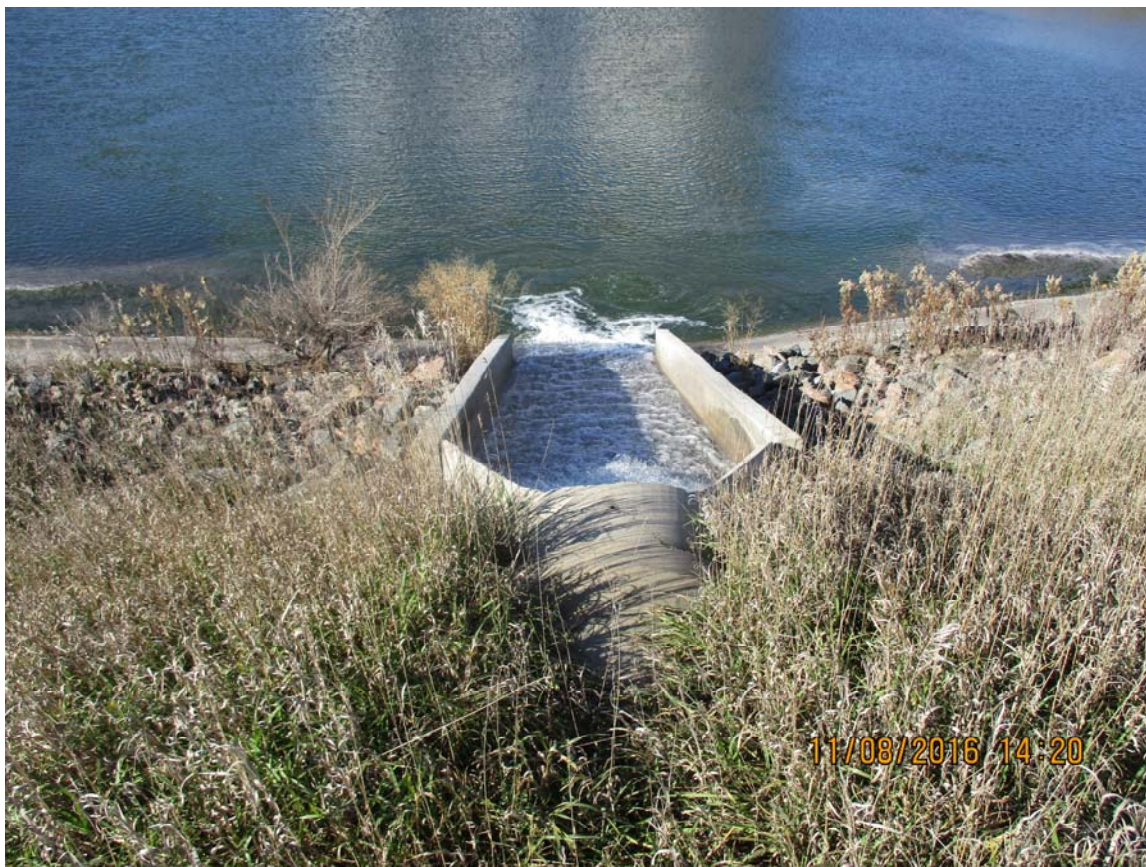
Photo 5	Bottom Ash Pond secondary outlet to Recycle Basin (Primary outlet is below the water level of the Recycle Basin).
---------	---

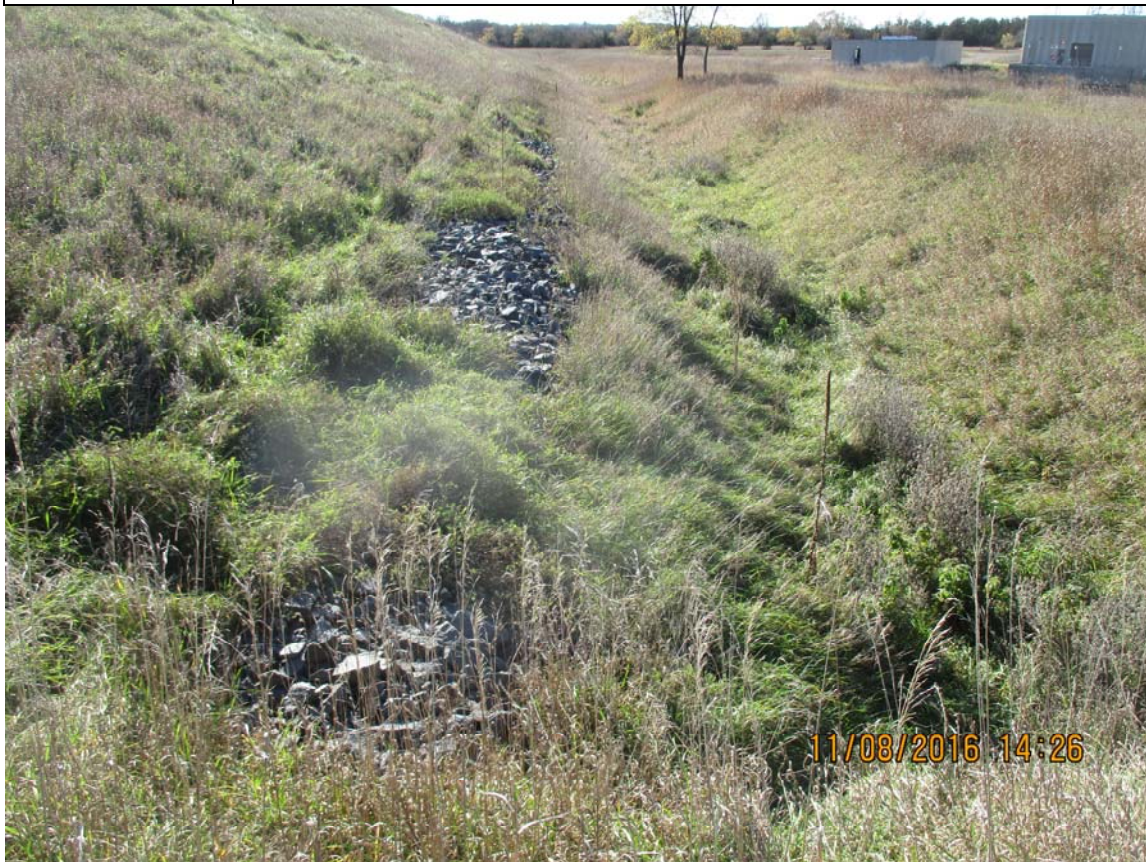
Photo 6	Northwest embankment riprap toe drain, looking southwest.
---------	---

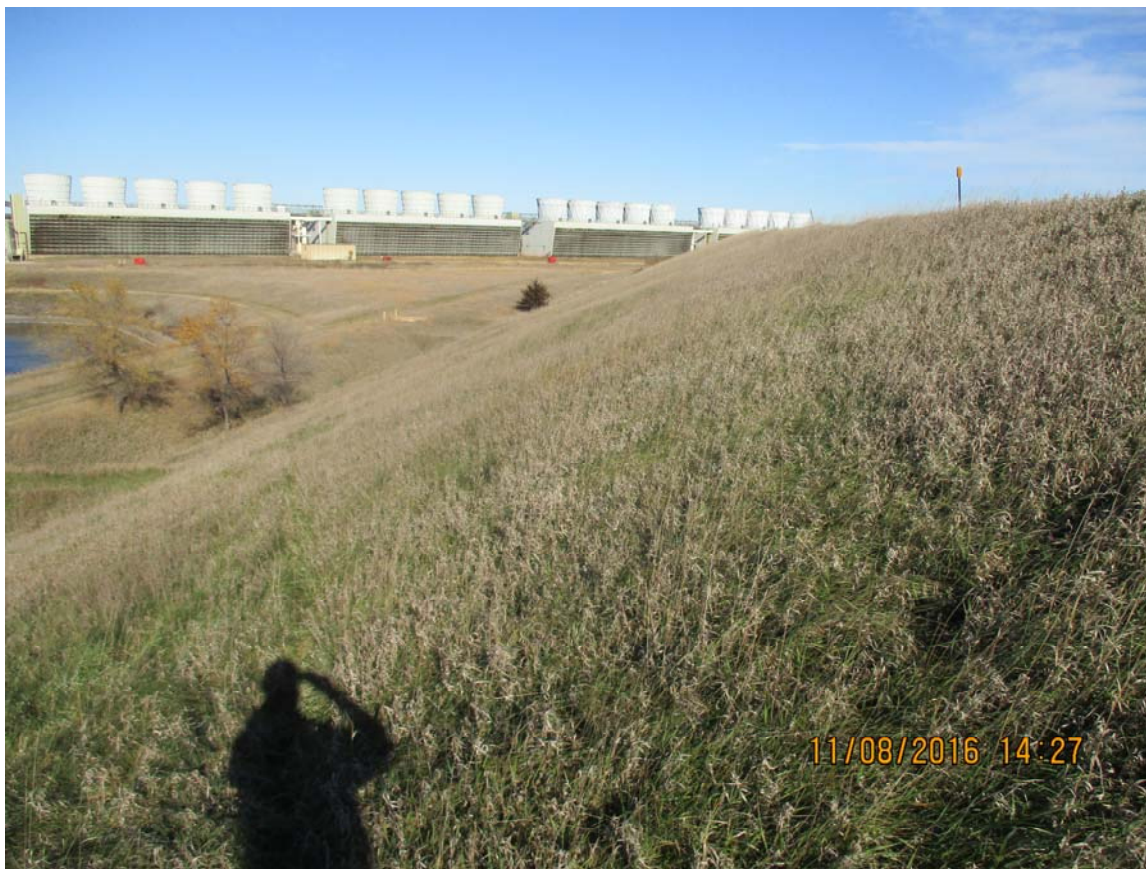
Photo 7	Northwest embankment, looking northeast.
---------	--

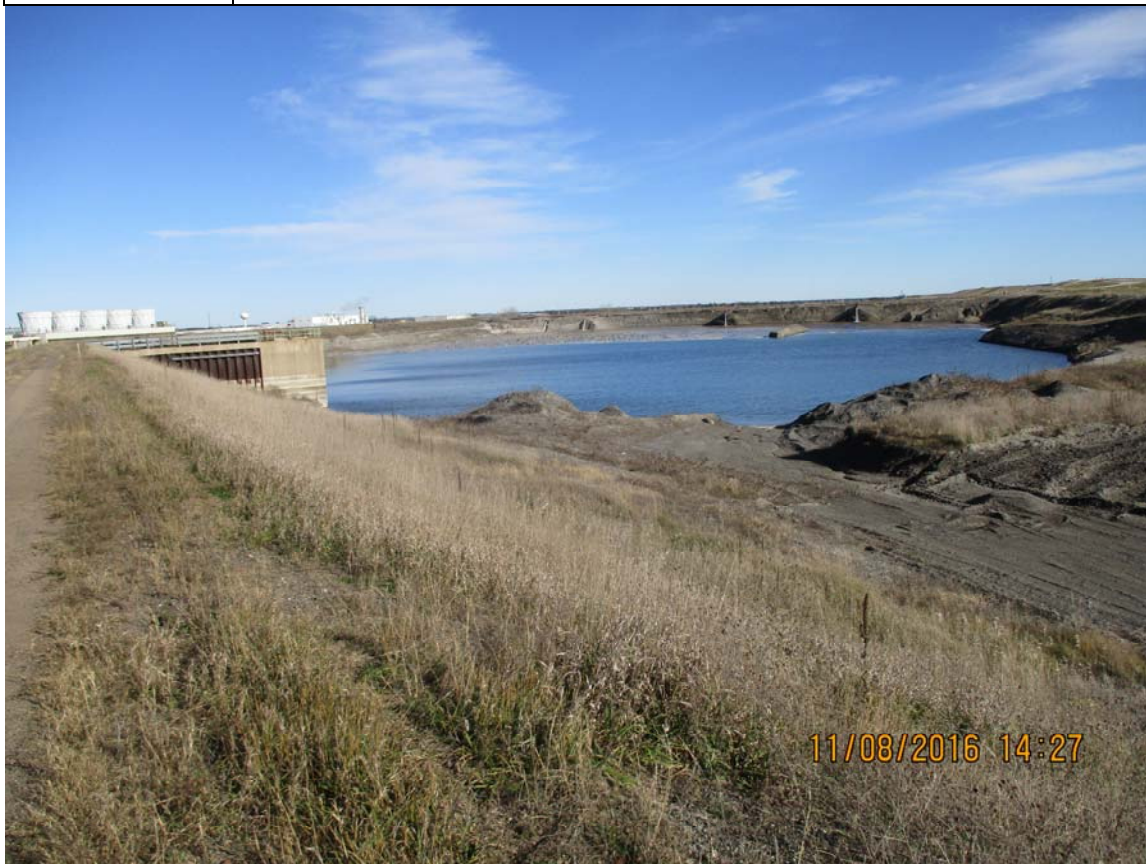
Photo 8	Pond interior, looking north
---------	------------------------------

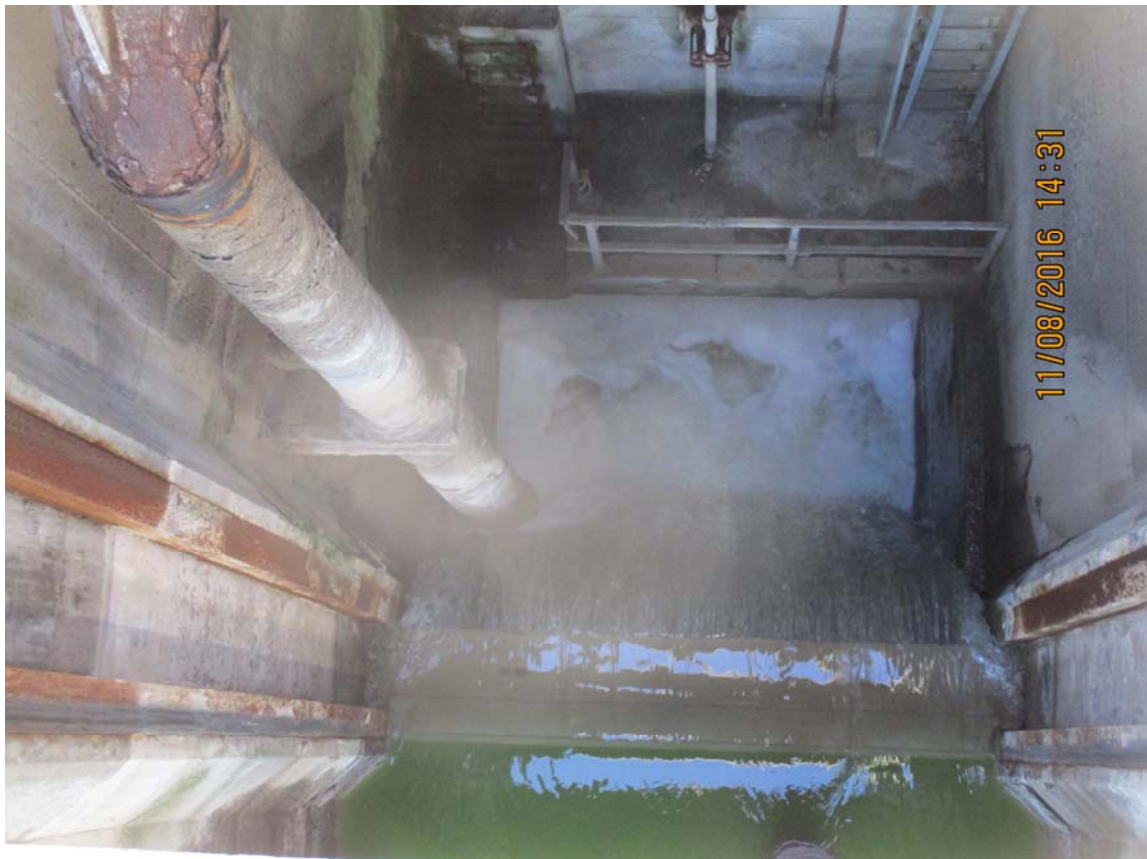
The water level in the BAP is controlled by concrete stop-logs in the discharge. All decreases in water level are attributed to the removal of stop logs.

Photo 9	Photo from inside of discharge structure. Bottom of photo depicts stop-log metal channels and water flowing over concrete stop-log at the bottom of the channel.
---------	--

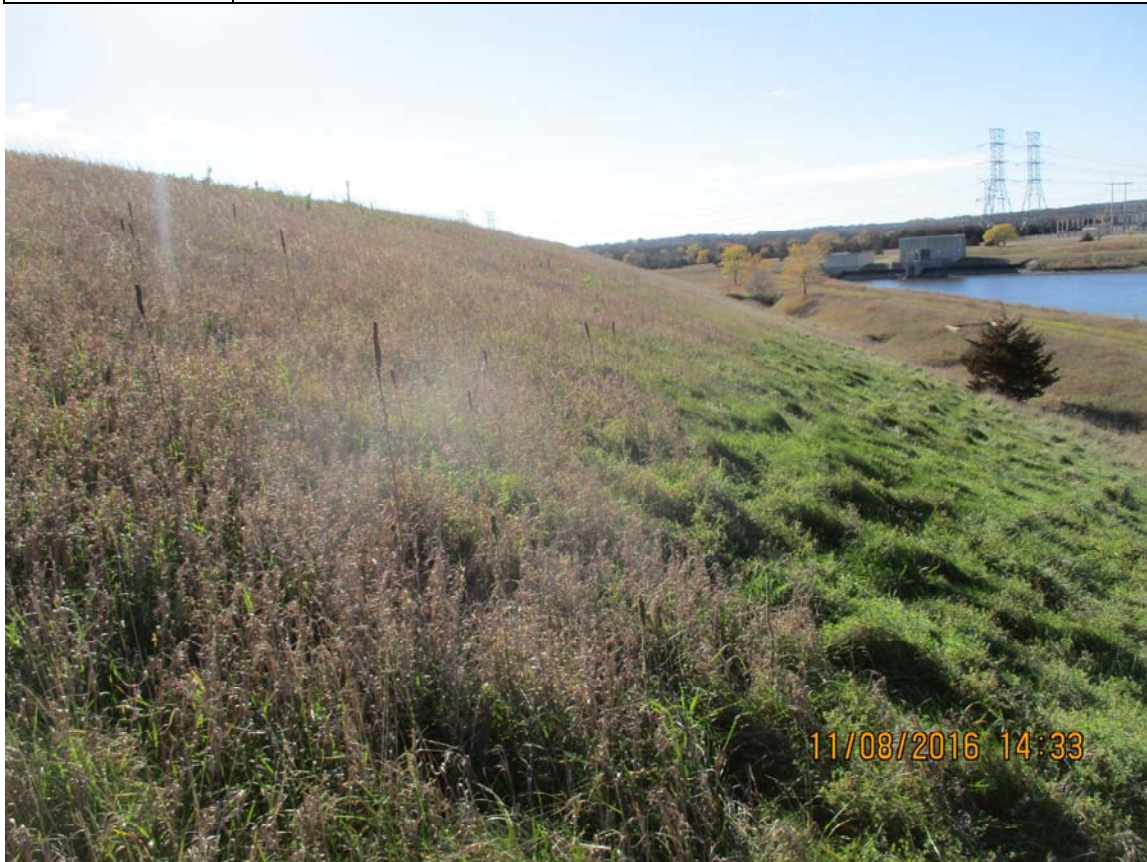
Photo 10	Mid slope of northwest embankment, looking southwest
----------	--

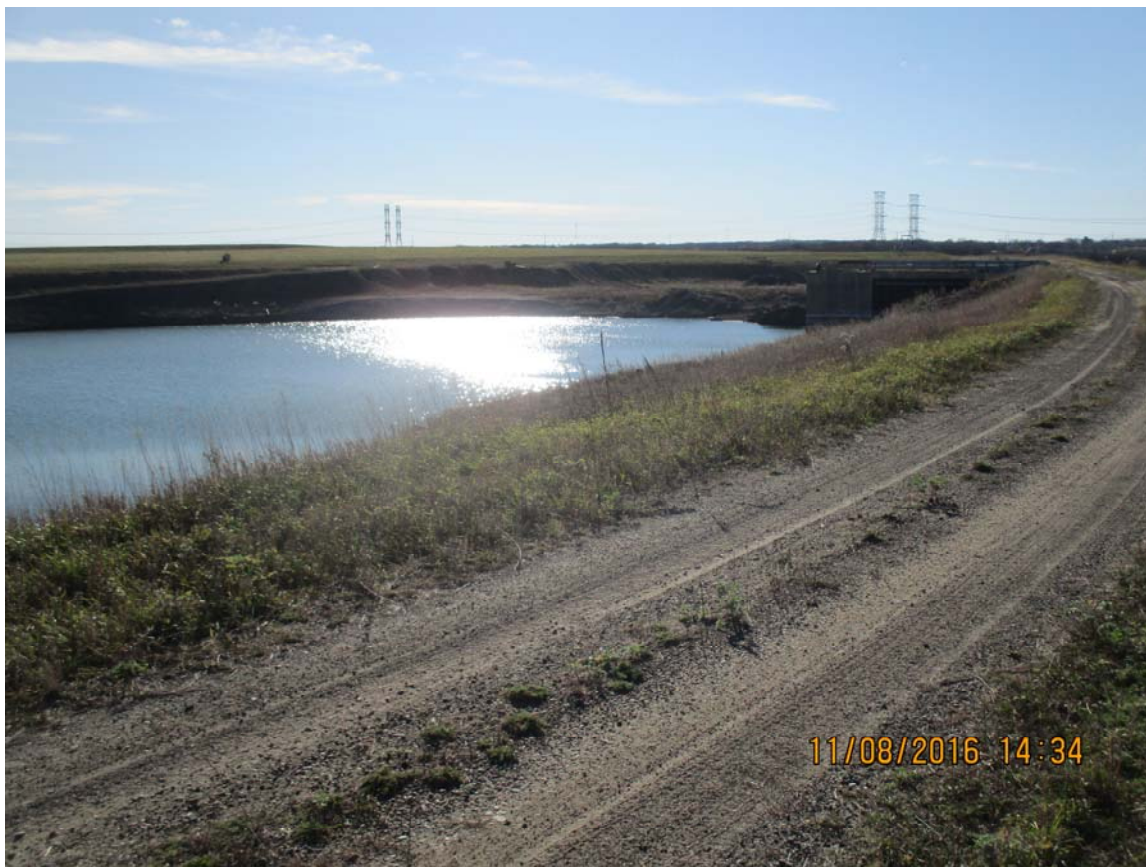
Photo 11	Pond interior, looking southwest

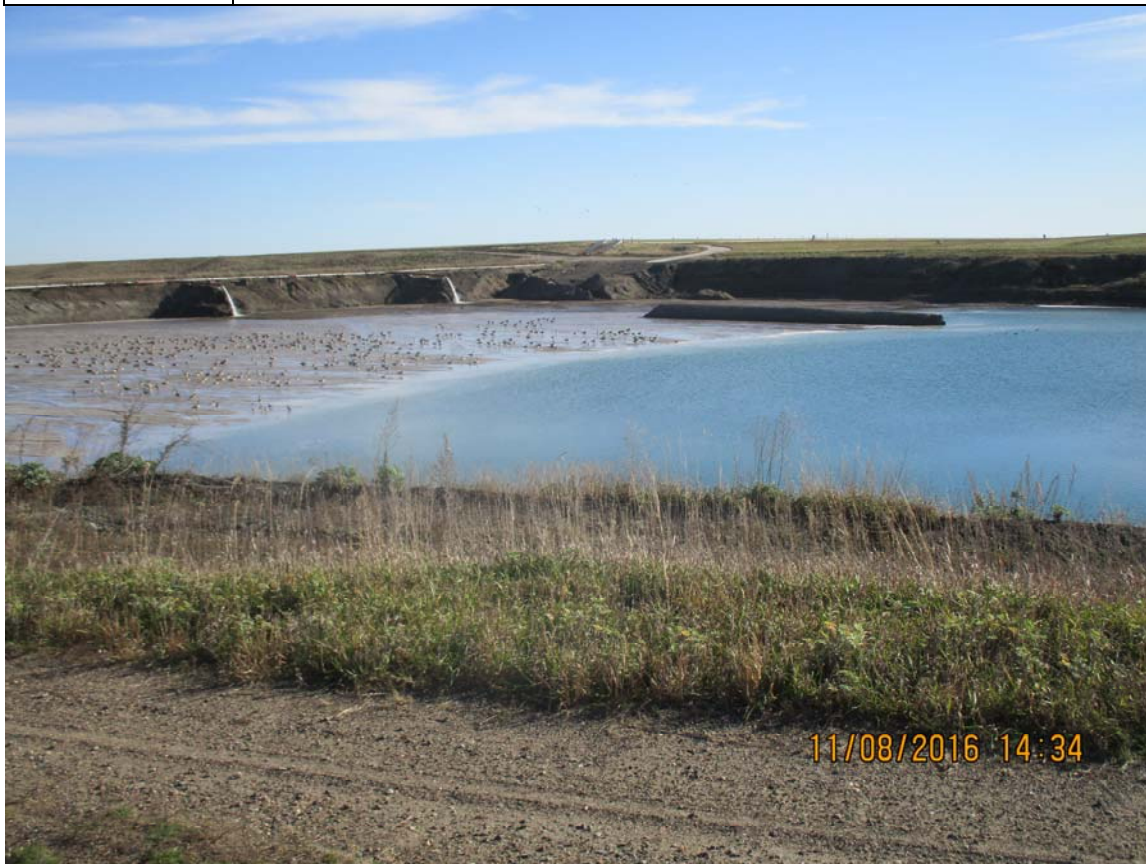
Photo 12	Pond interior, looking southeast

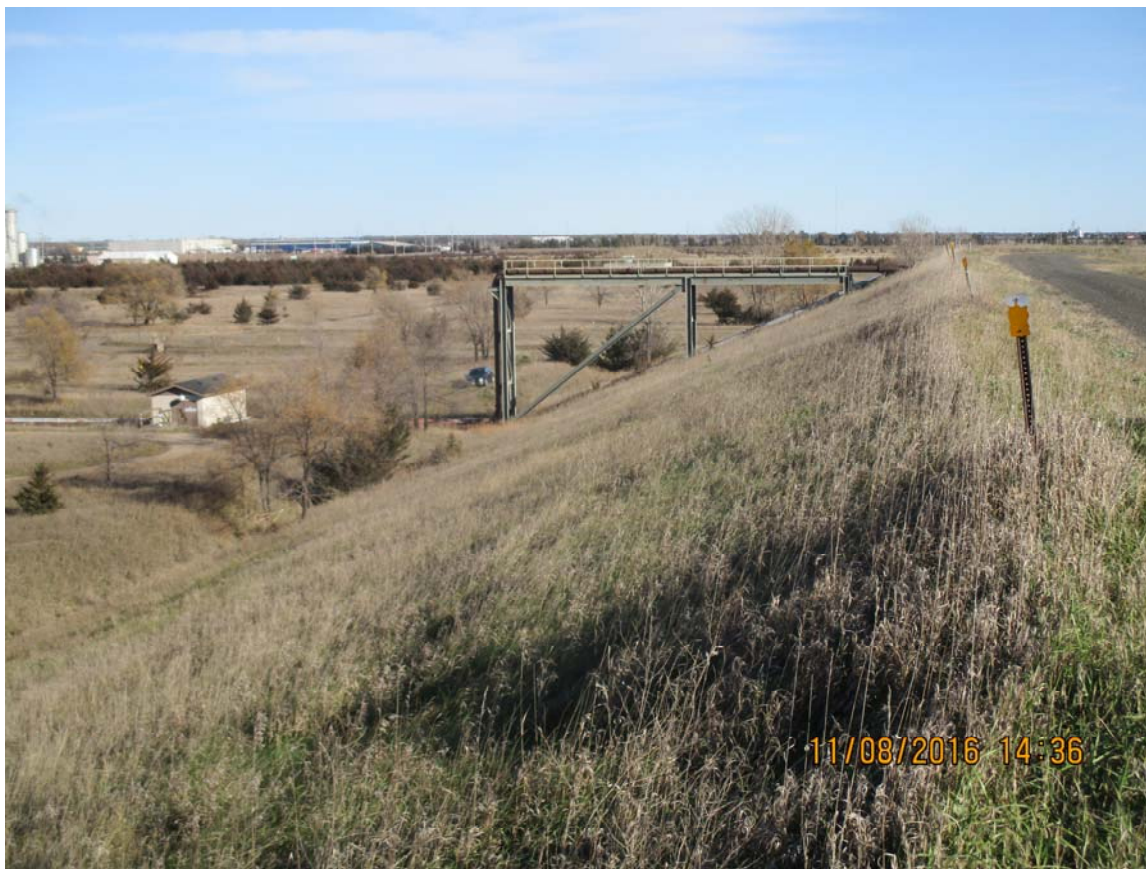
Photo 13	Upper slope of north embankment, looking east
----------	---

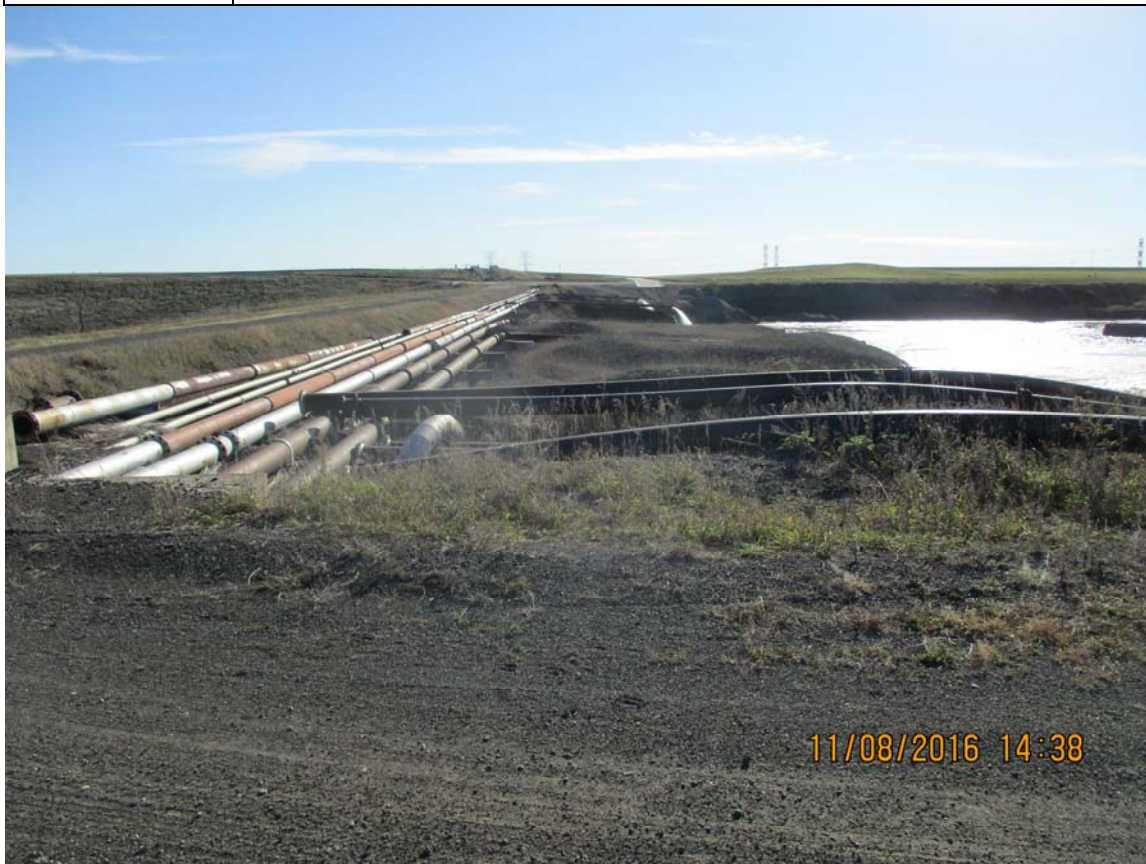
Photo 14	Interior of east embankment, looking south
----------	--

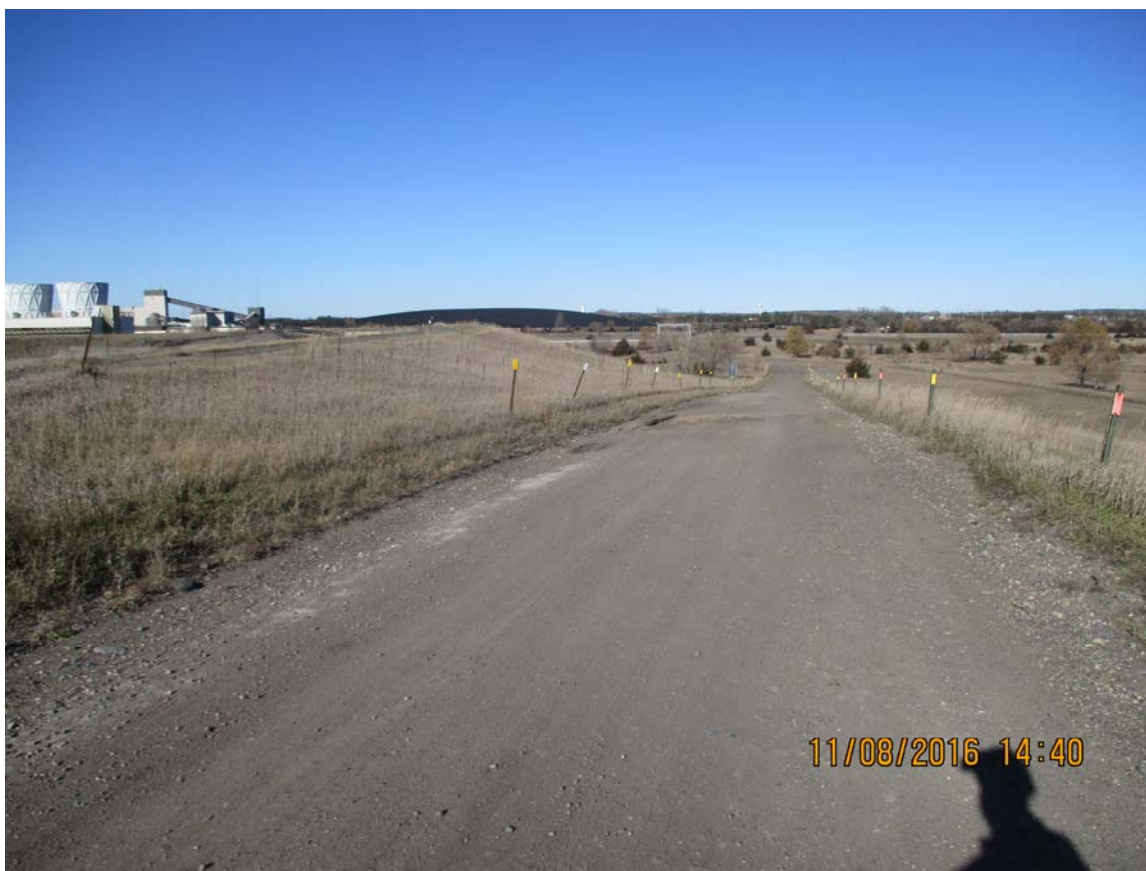
Photo 15	East embankment, looking north

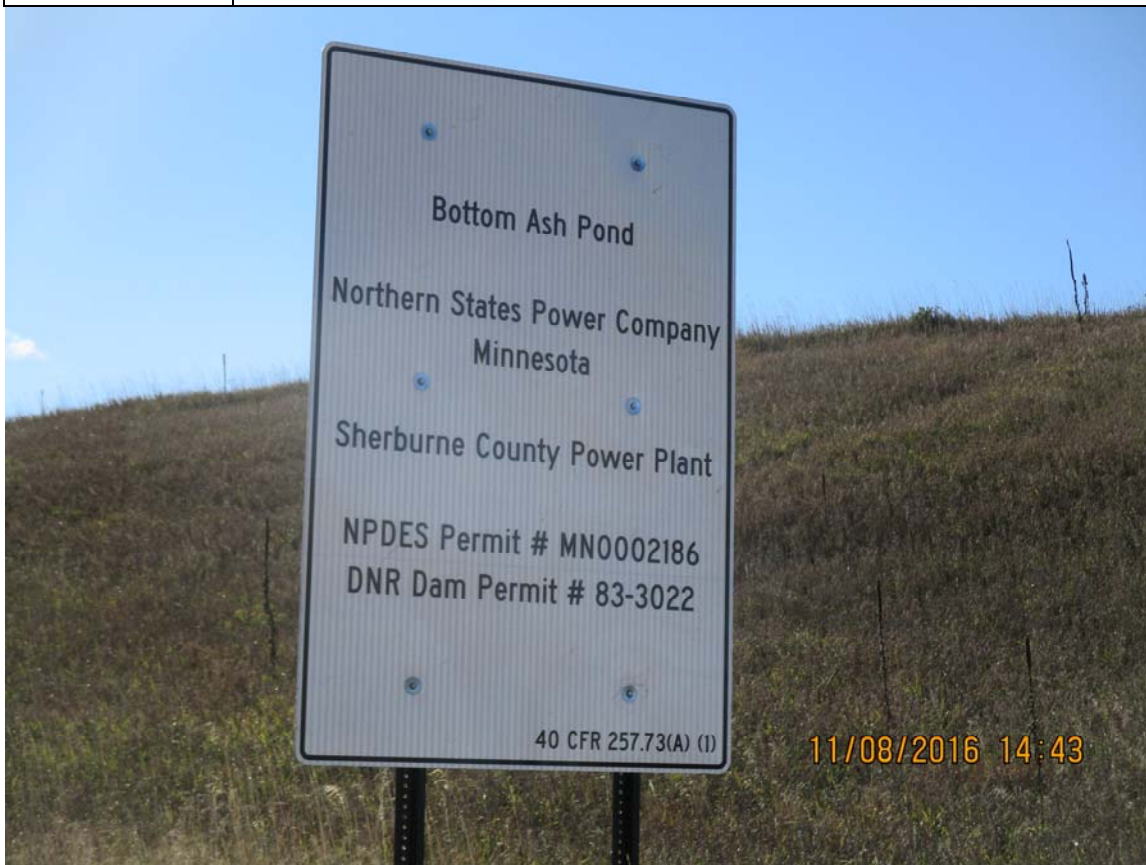
Photo 16	CCR Unit identification marker placed in accordance with Section 257.73
