Xcel Energy, Inc.
Sherburne County Generating Station
13999 Industrial Blvd.
Becker, MN, 55308

Re: 2017 Annual Inspection of Bottom Ash Pond

Bottom Ash Pond Annual Inspection - November 2017

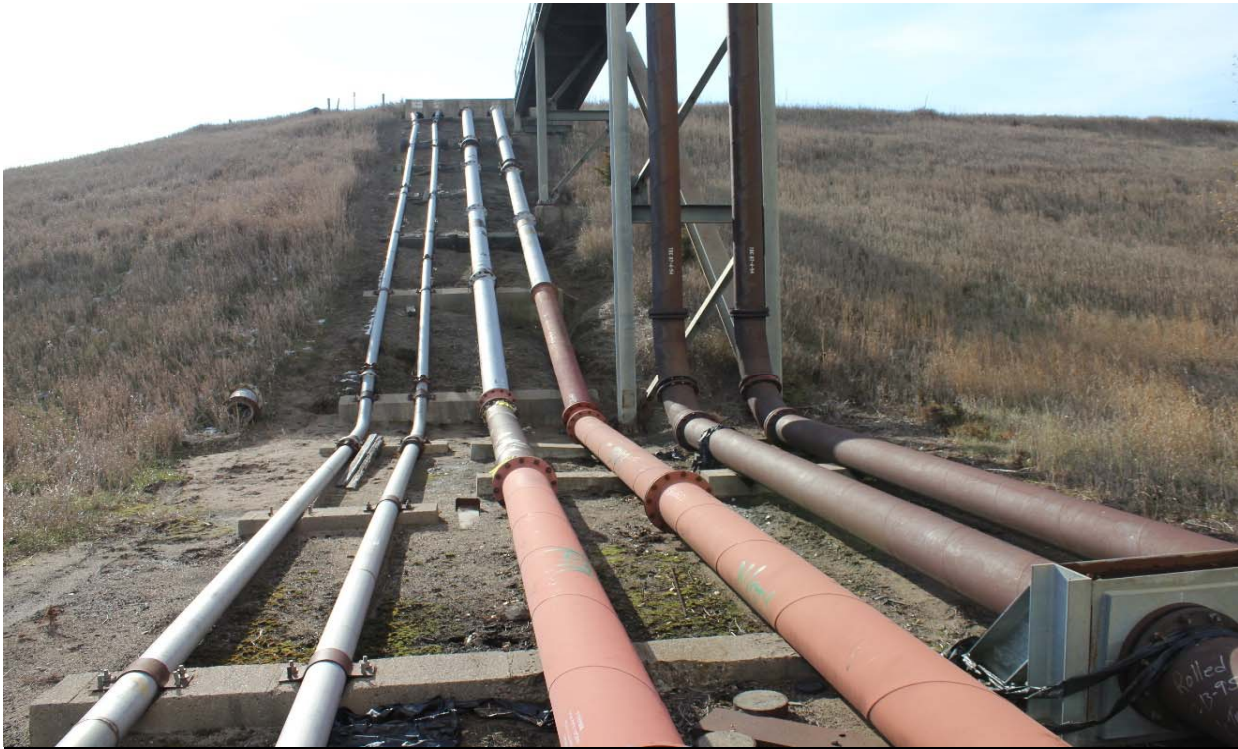
Photo 1	Bottom ash and scrubber pipes, looking south.
11/8/2017

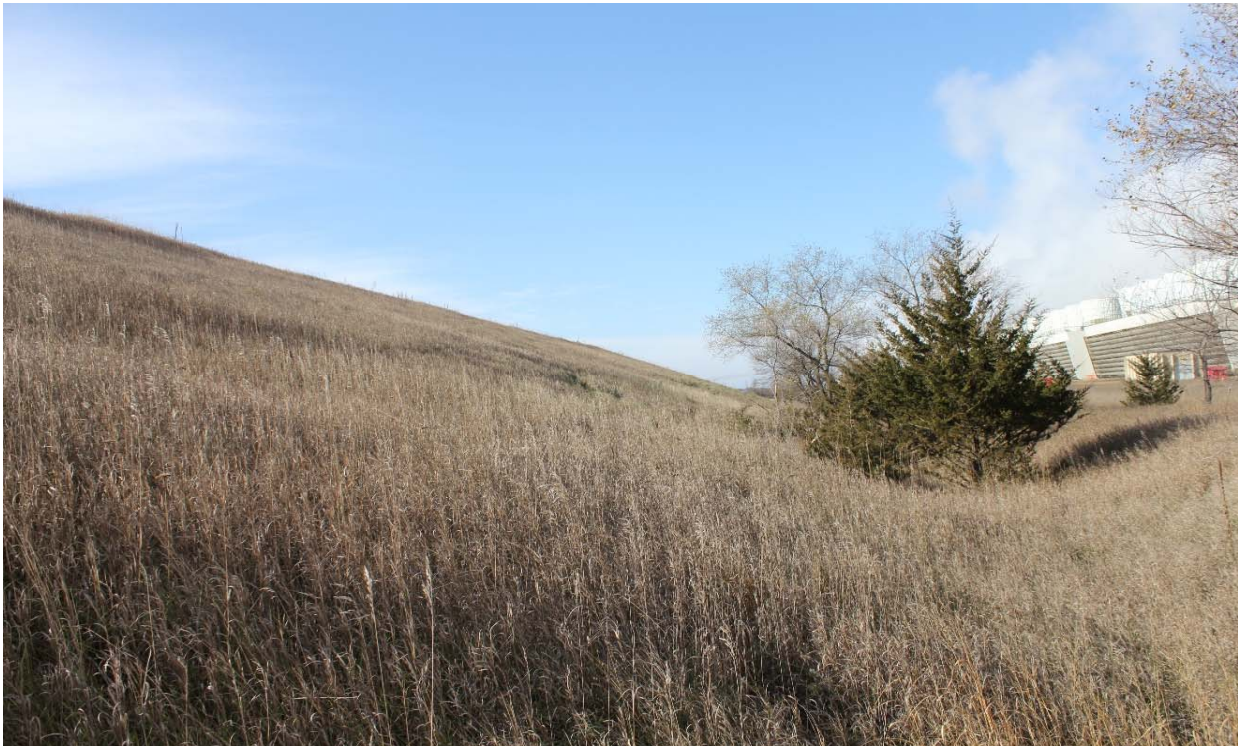
Photo 2	North embankment and perimeter ditch, looking west.
11/8/2017

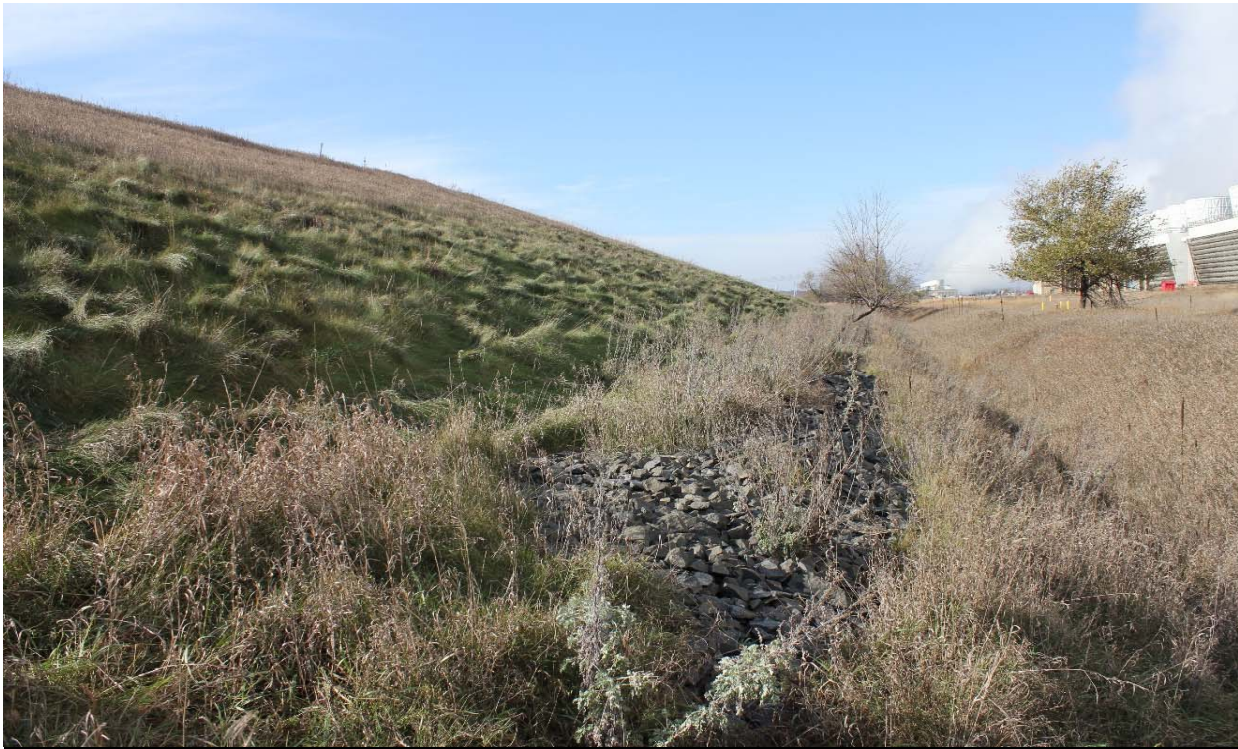
Photo 3	North embankment and riprap toe drain, looking west.
11/8/2017

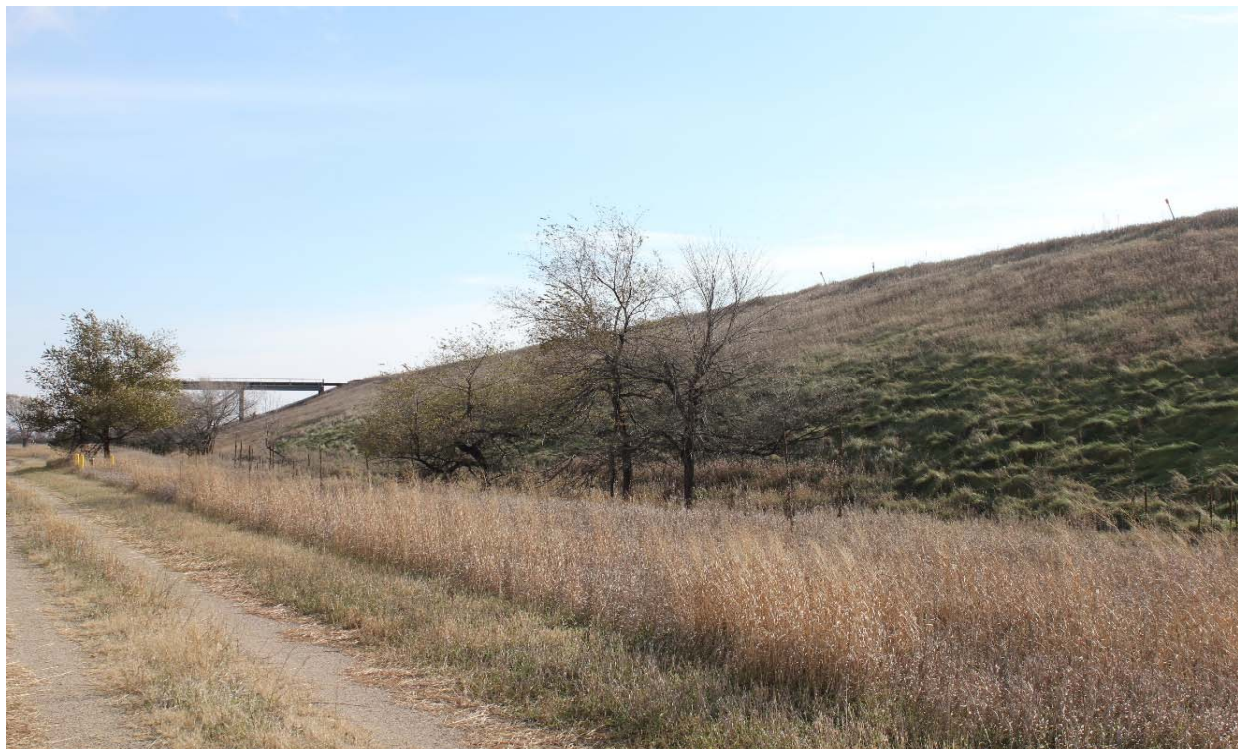
Photo 4	North embankment and riprap toe drain, looking east.
11/8/2017

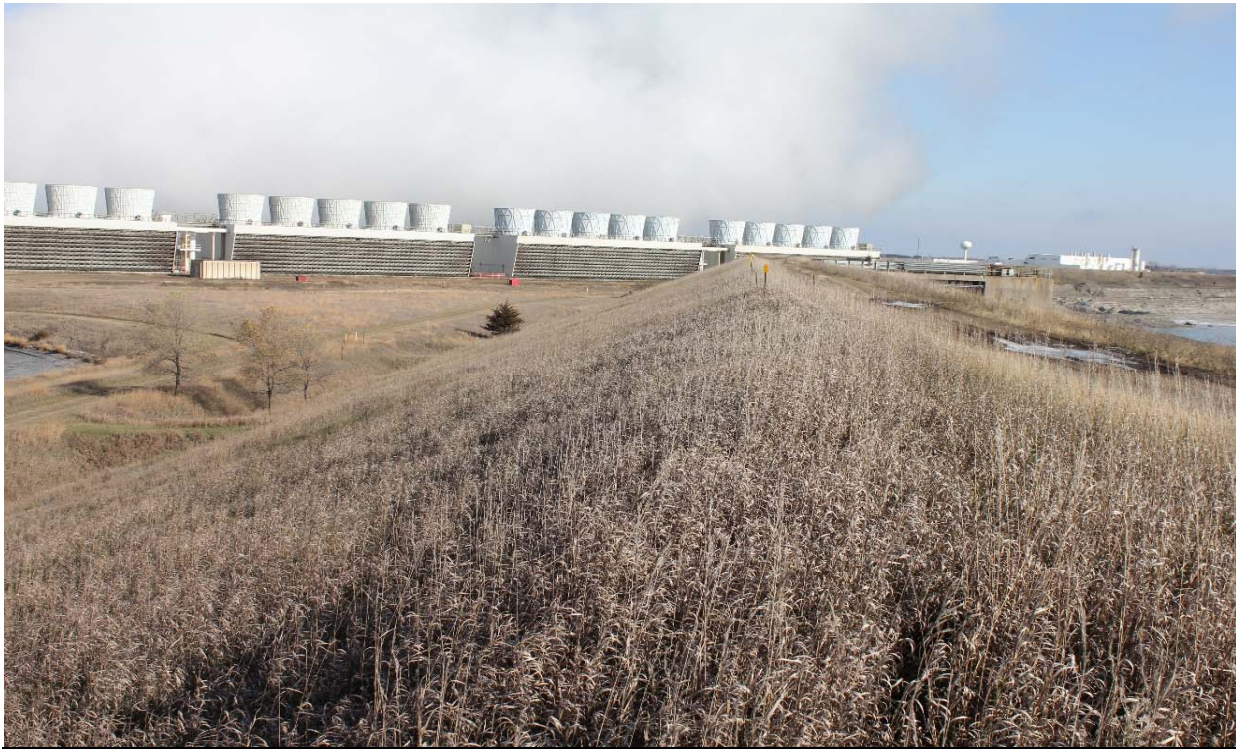
Photo 7	Northwest embankment, looking northeast.
11/8/2017

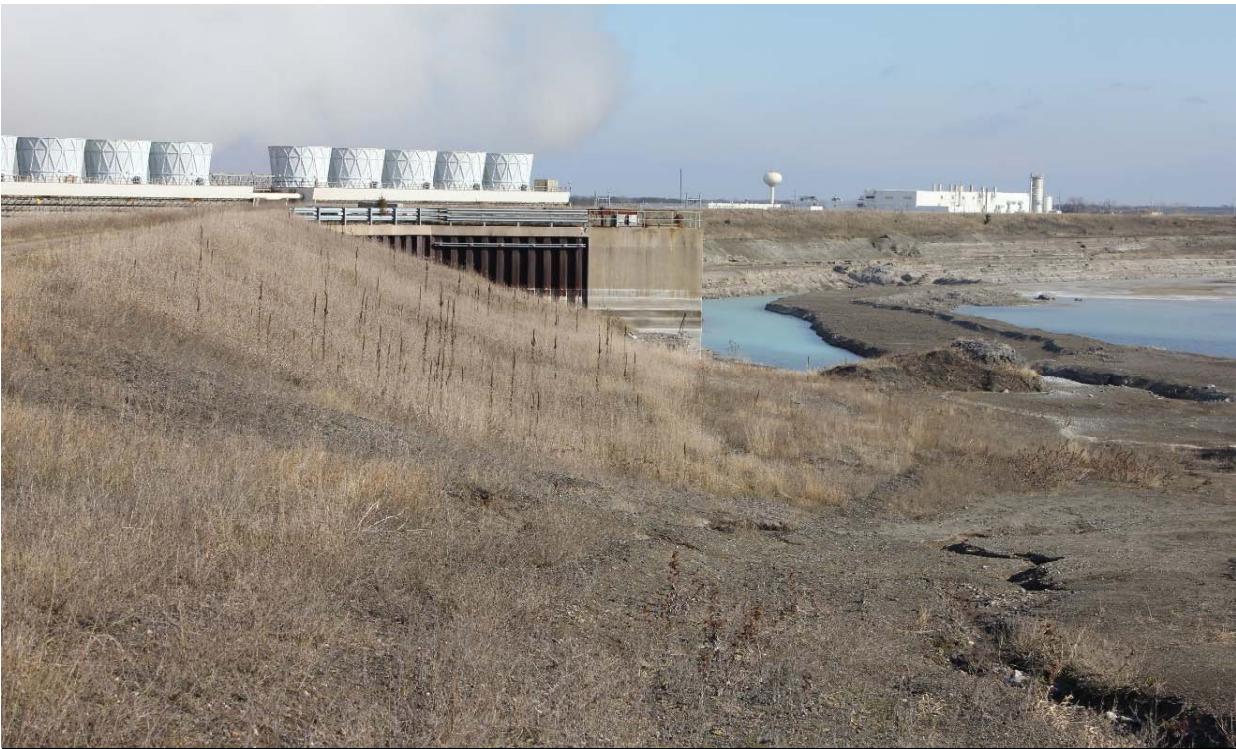
Photo 8	Pond interior, looking northeast.
11/8/2017

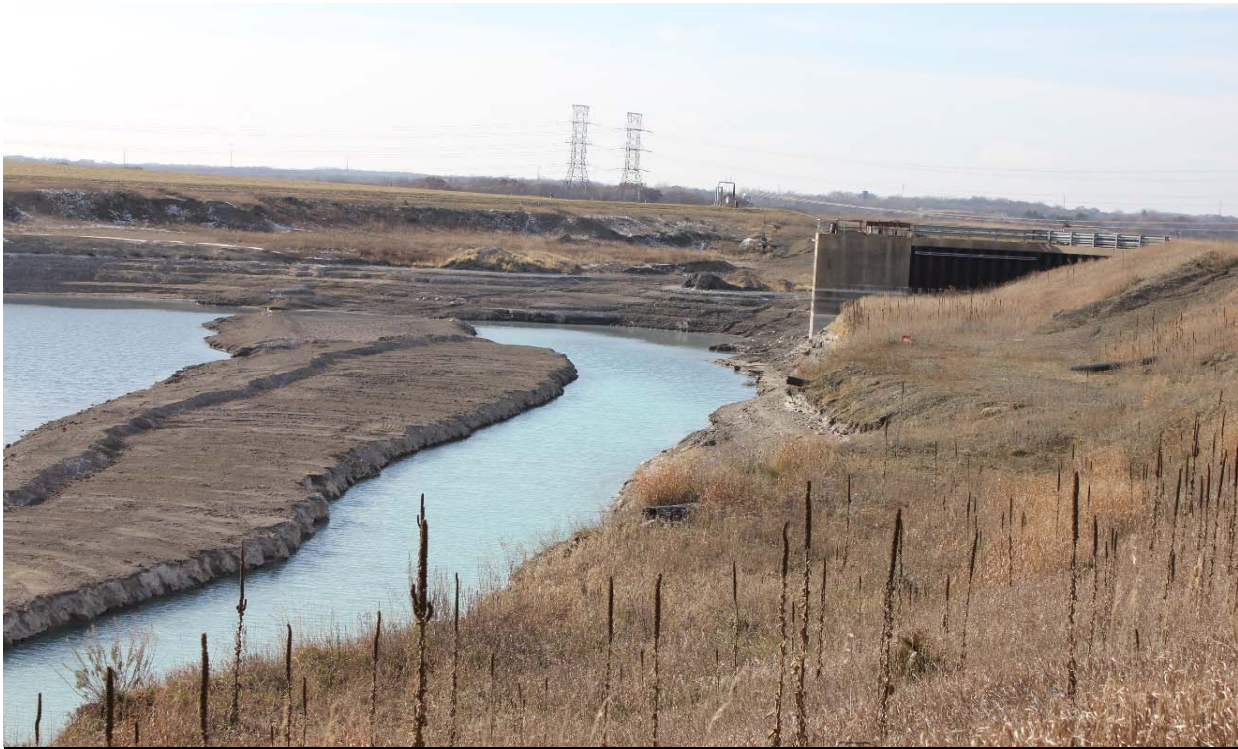
Photo 11	Pond interior, looking southwest.
11/8/2017

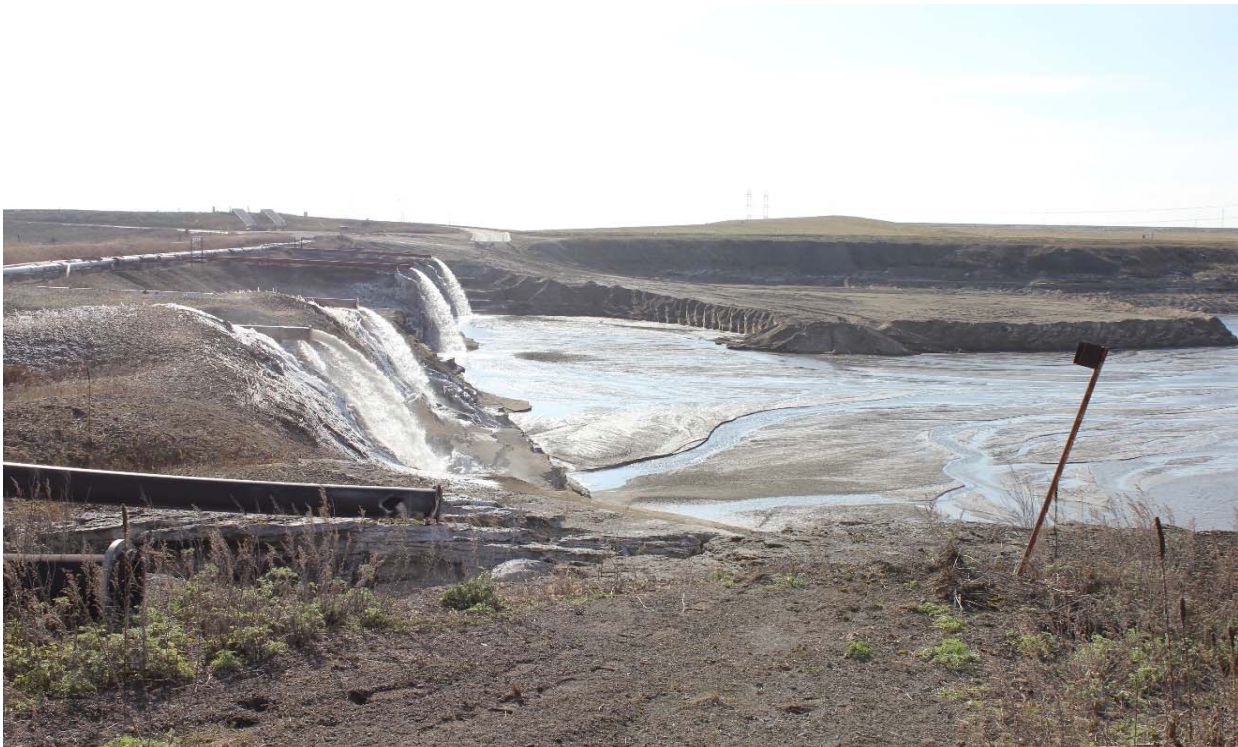
Photo 12	Pond interior, looking southeast.
11/8/2017

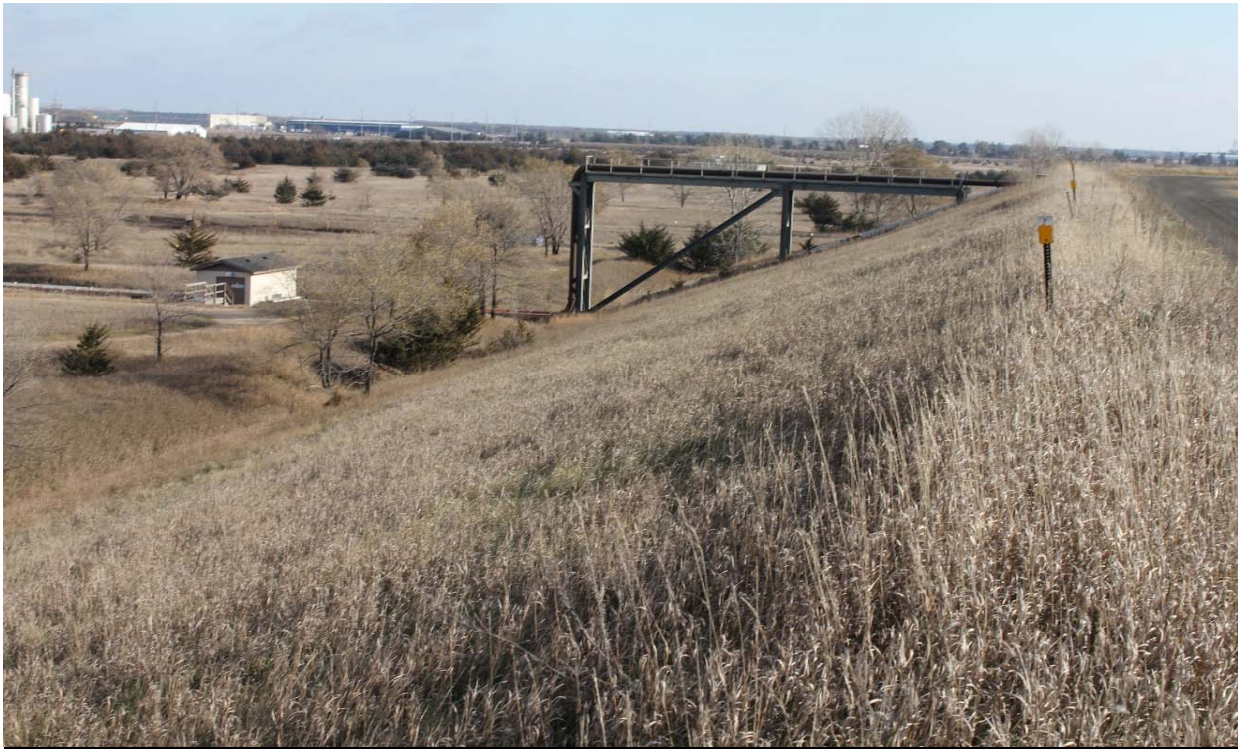
Photo 13	Upper slope of north embankment, looking east.
11/8/2017

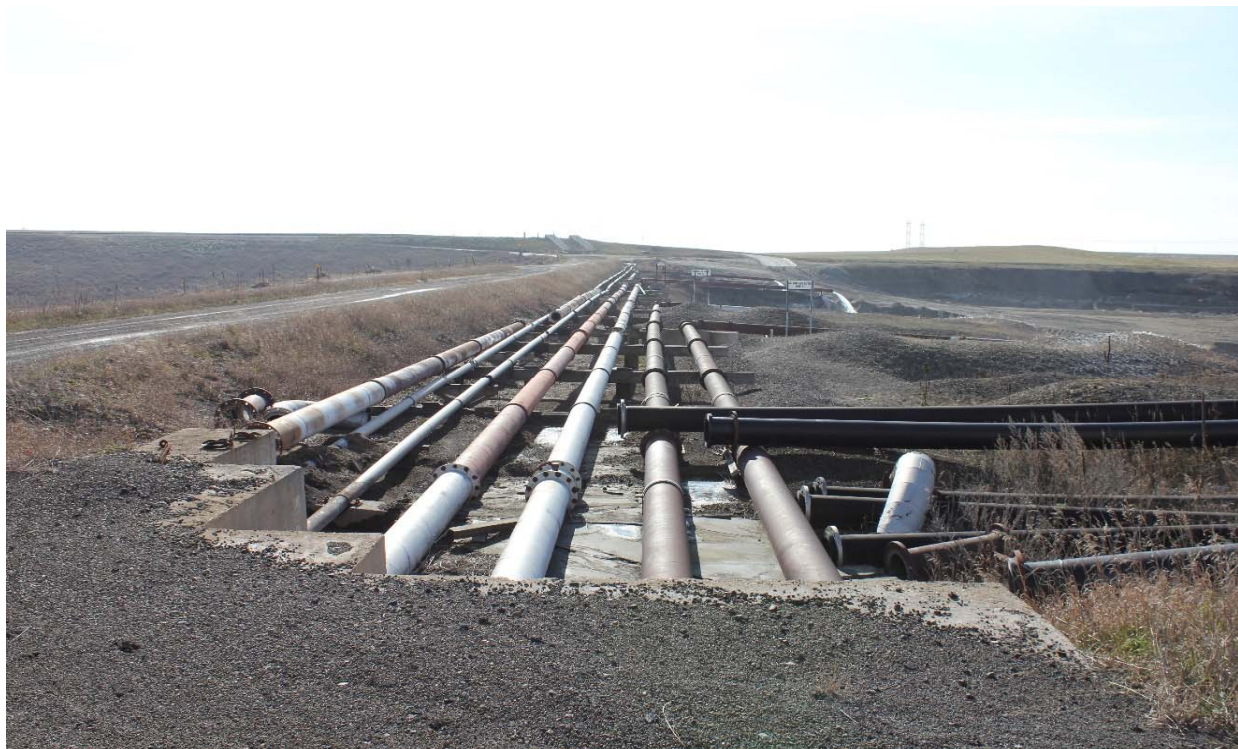
Photo 14	Interior of east embankment, looking south.
11/8/2017

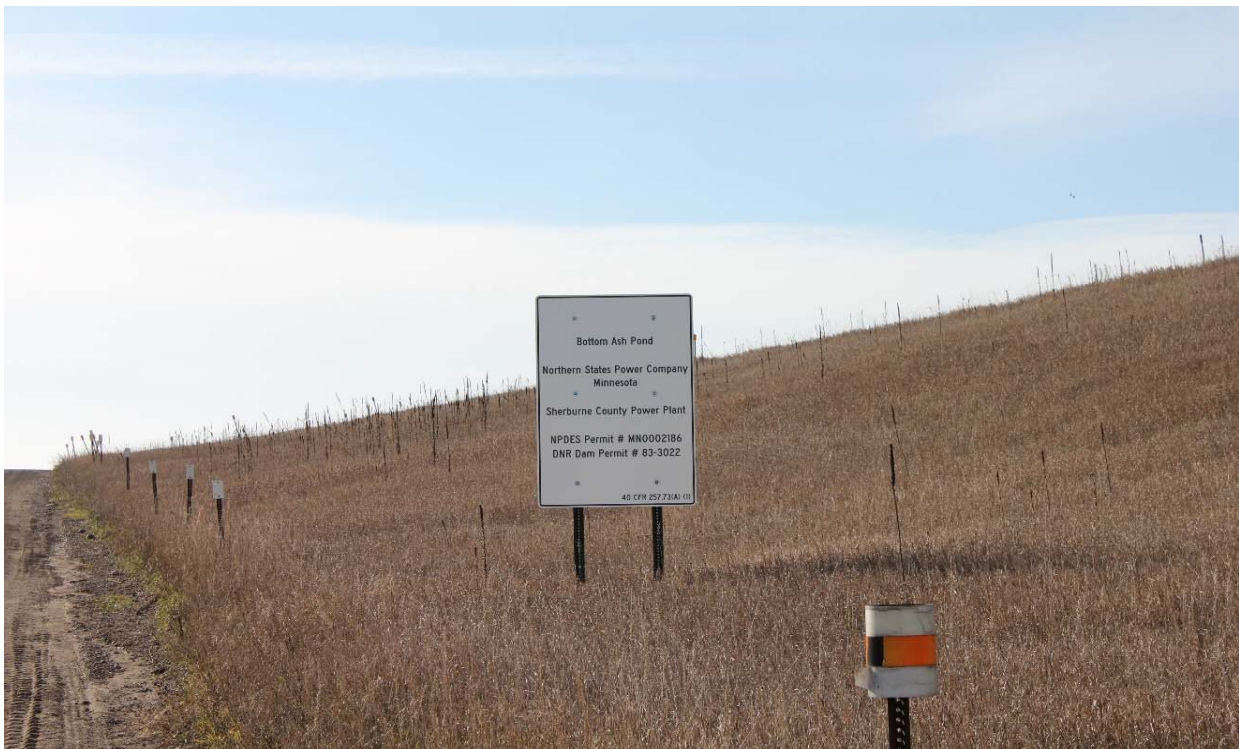
Photo 16	CCR Unit identification marker placed in accordance with Section 257.73.
11/8/2017
