January 4, 2020

Xcel Energy, Inc.  
Sherburne County Generating Station  
13999 Industrial Blvd.  
Becker, MN, 55308

**Re: 2019 Annual Inspection of Bottom Ash Pond**

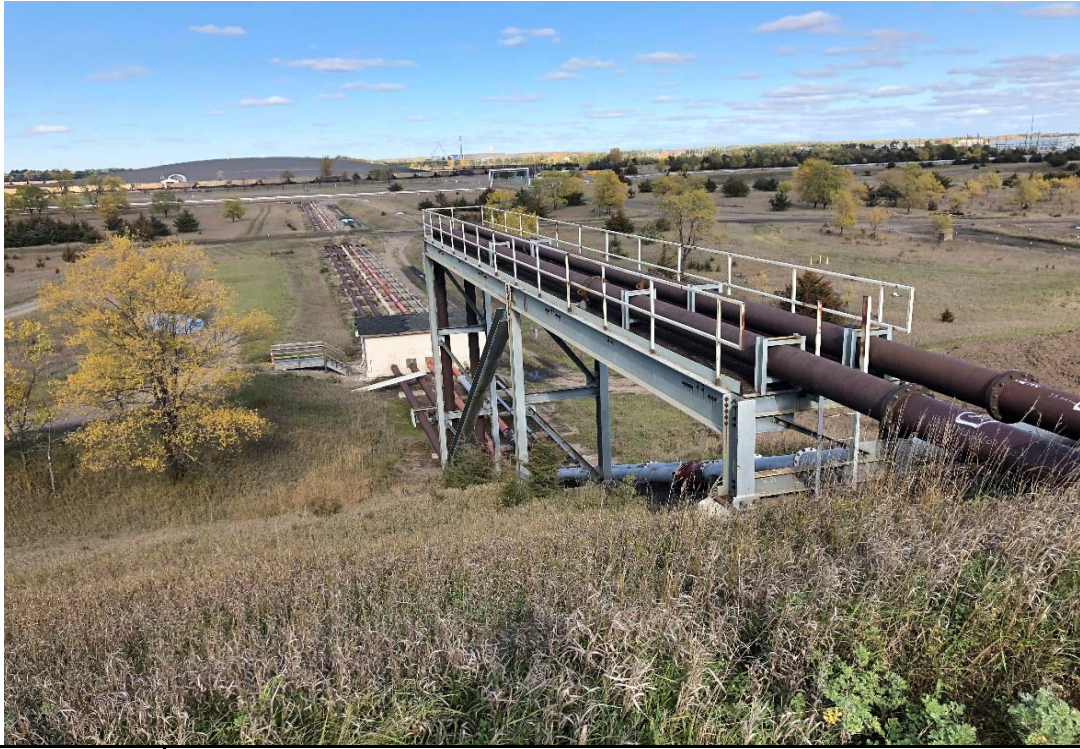
Photo 1	Bottom ash and scrubber pipes, looking northeast.
10/24/2019

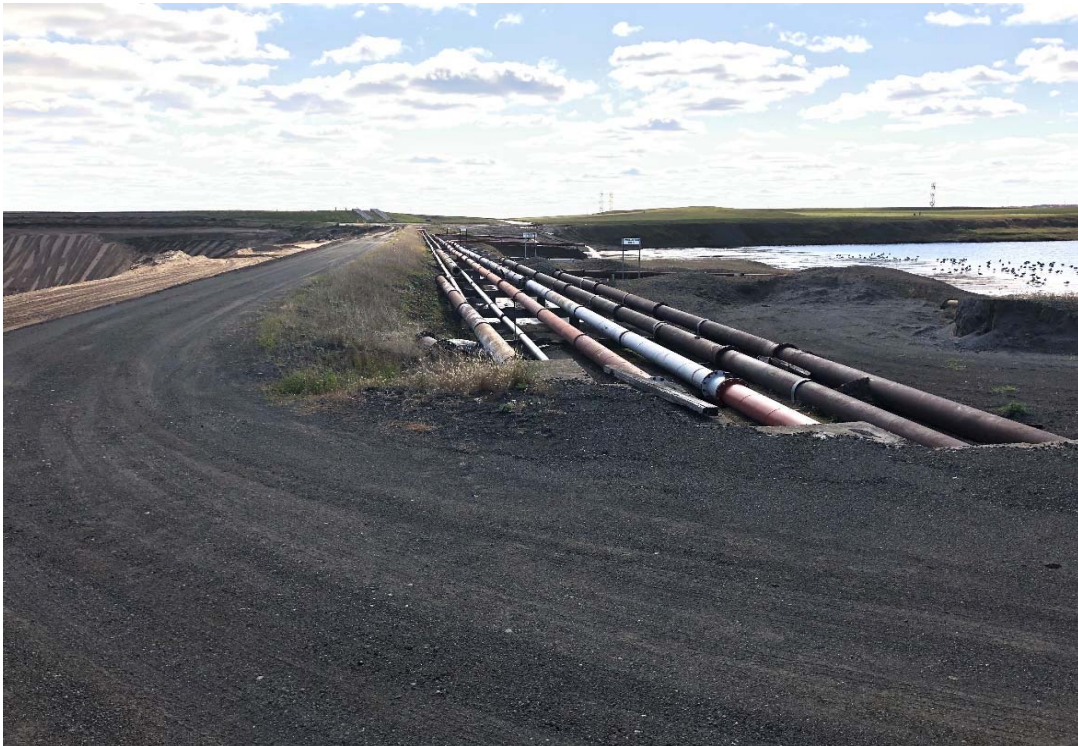
Photo 2	Interior of east embankment, looking south.
10/24/2019

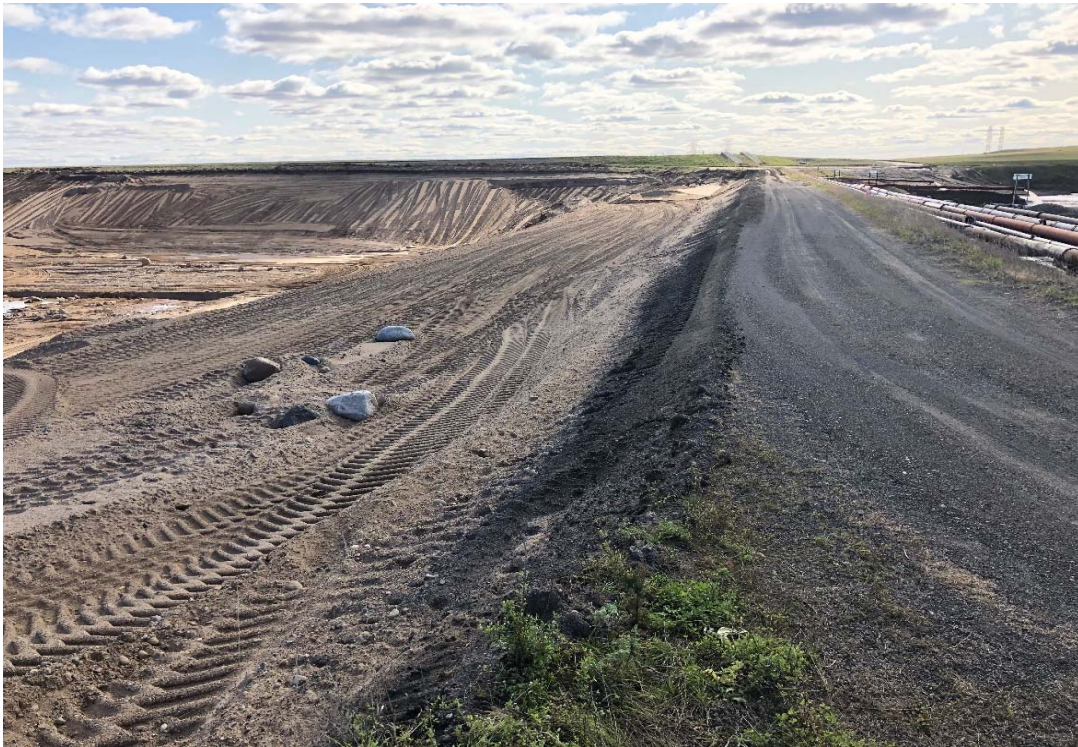
Photo 3	Exterior of east embankment (also shown: New Bottom Ash Pond under construction), looking south.
10/24/2019

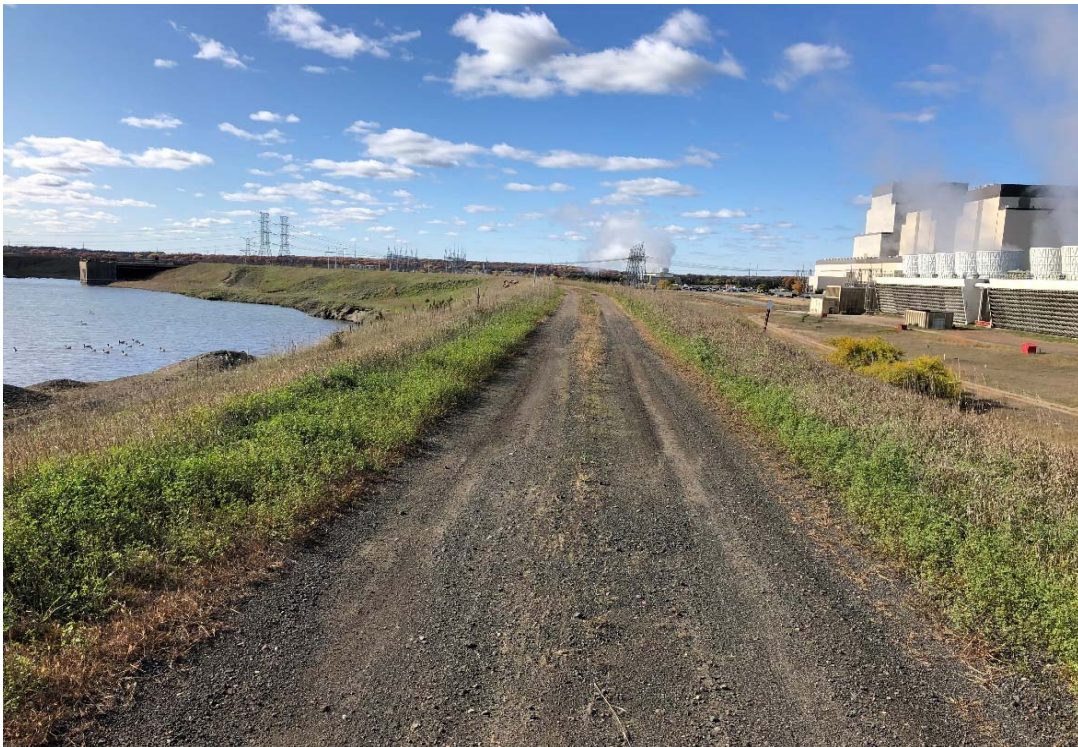
Photo 4	Top of north embankment, looking west.
10/24/2019

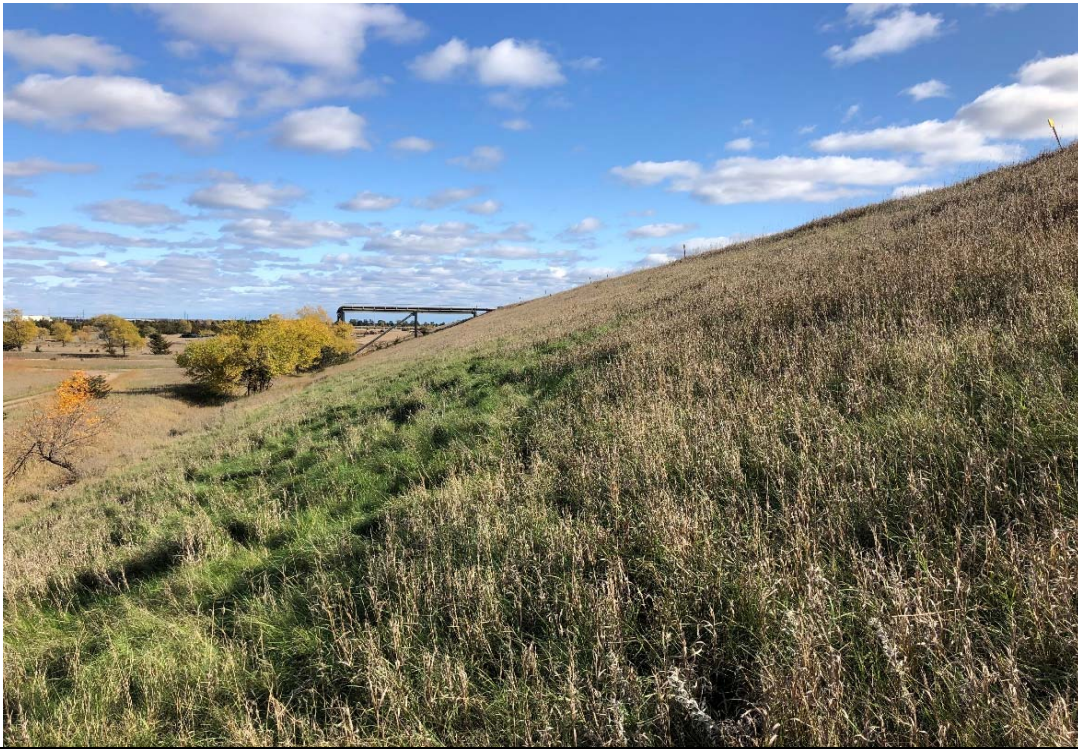
Photo 5	Exterior of north embankment, looking east.
10/24/2019

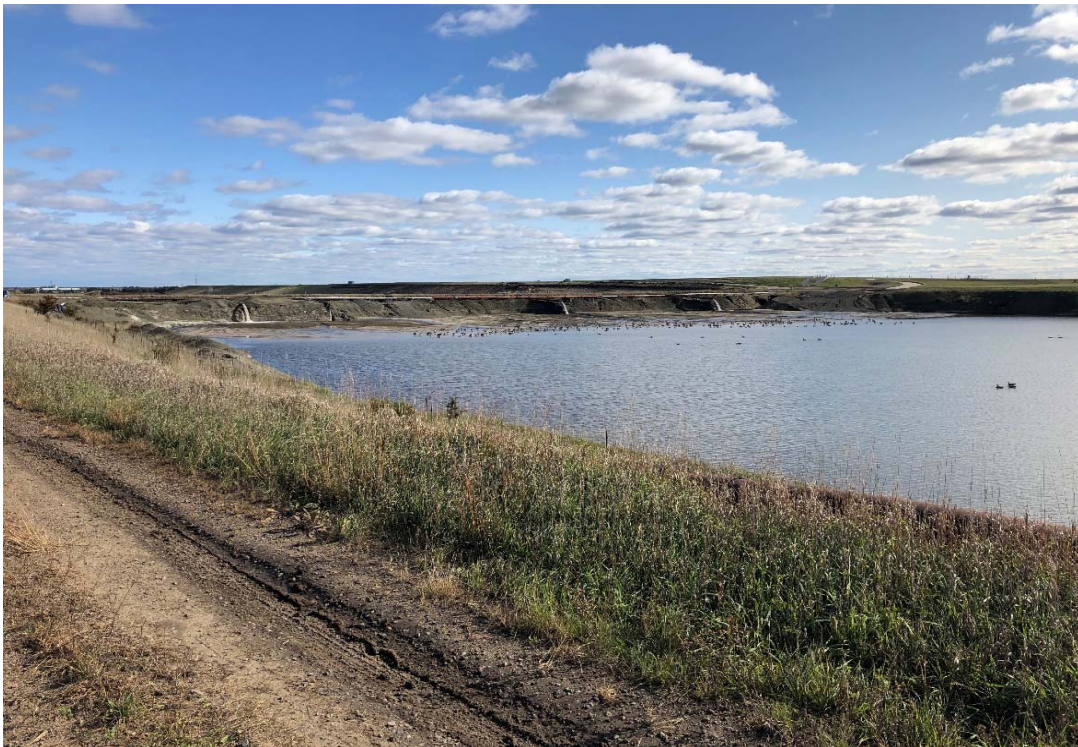
Photo 6	Interior of pond, looking southeast.
10/24/2019

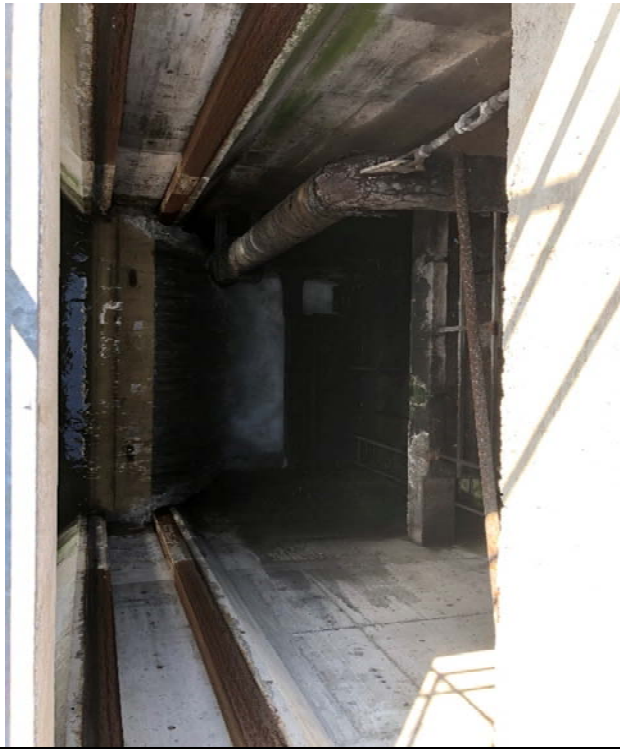
Photo 7	Interior of discharge structure.
10/24/2019

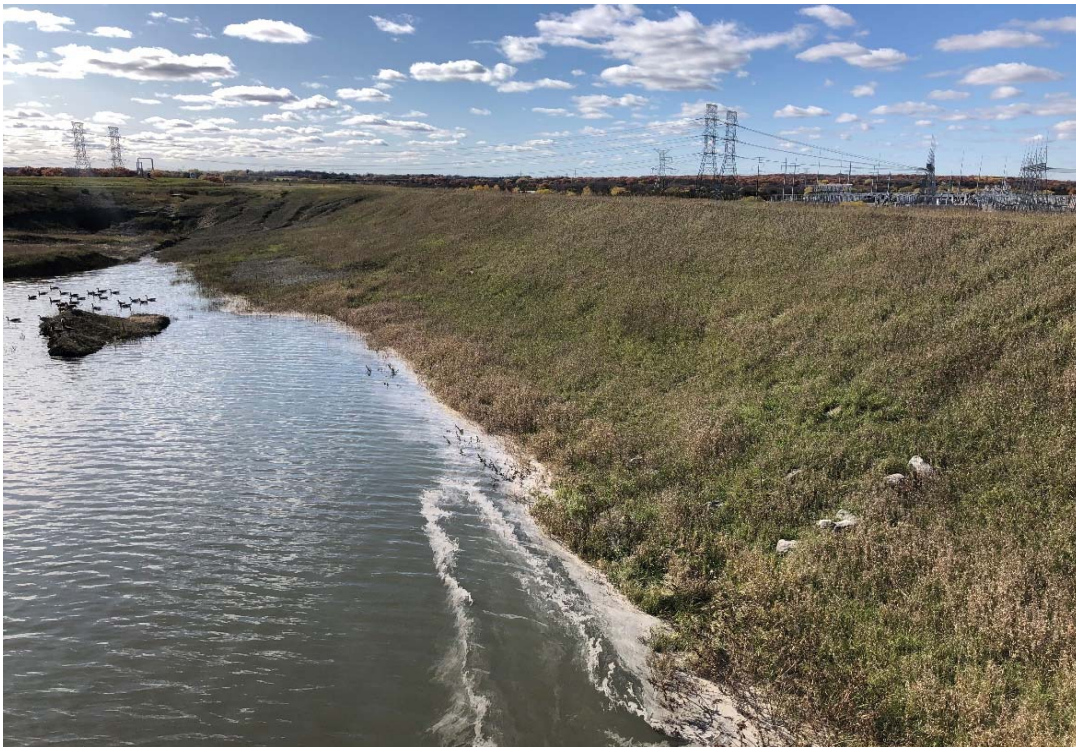
Photo 8	Pond interior, looking southwest.
10/24/2019

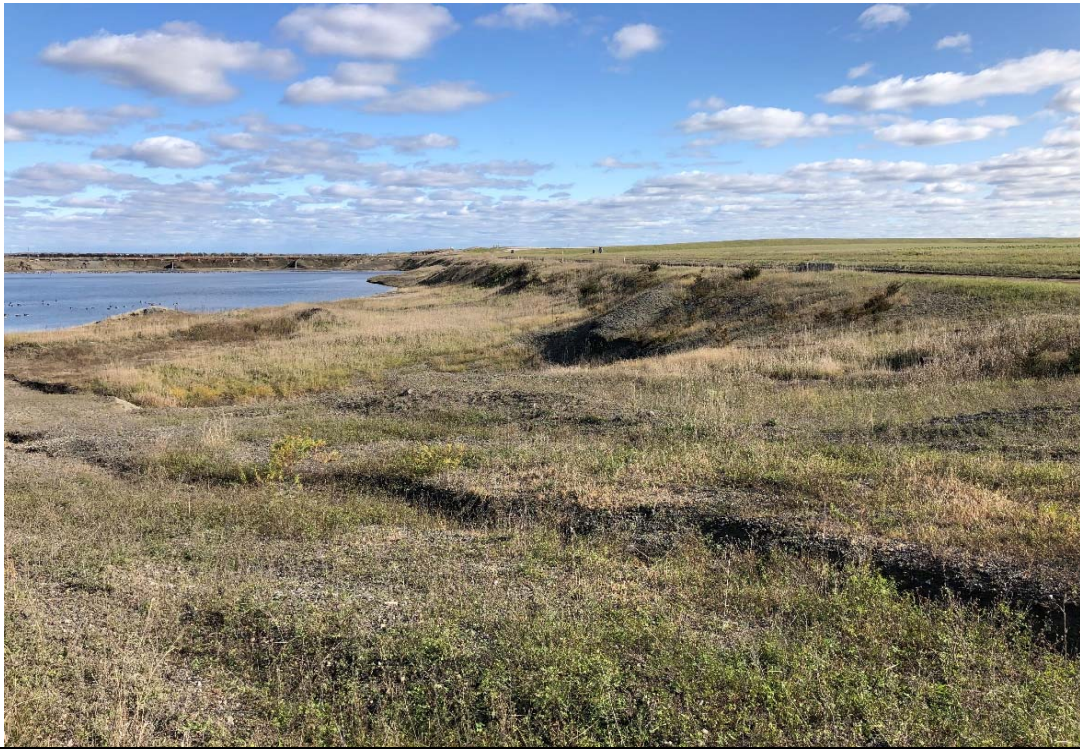
Photo 9	Interior of south embankment, looking east.
10/24/2019

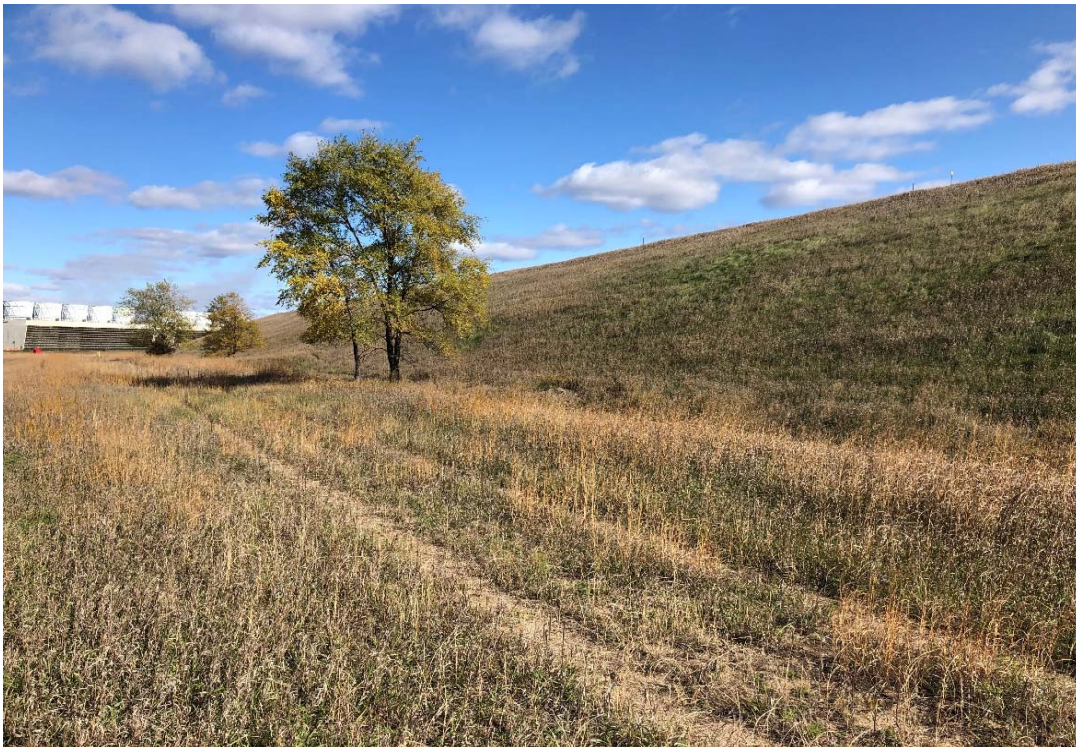
Photo 10	Exterior of northwest embankment, looking northwest.
10/24/2019

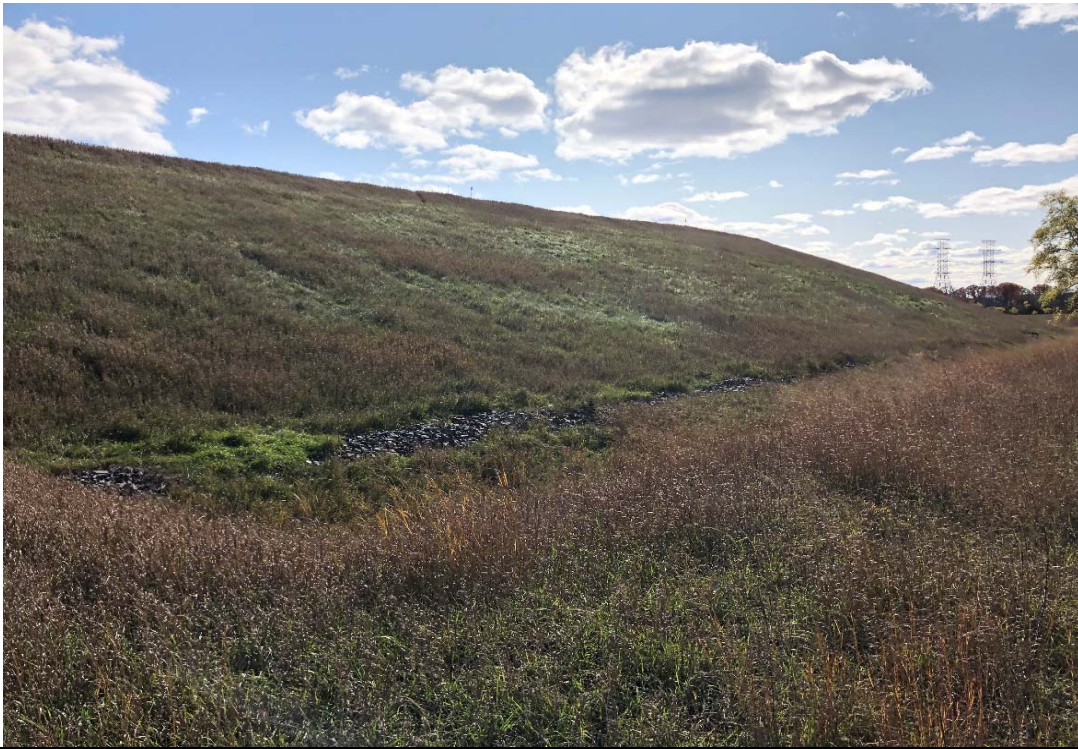
Photo 11	Exterior of northwest embankment, looking southwest.
10/24/2019

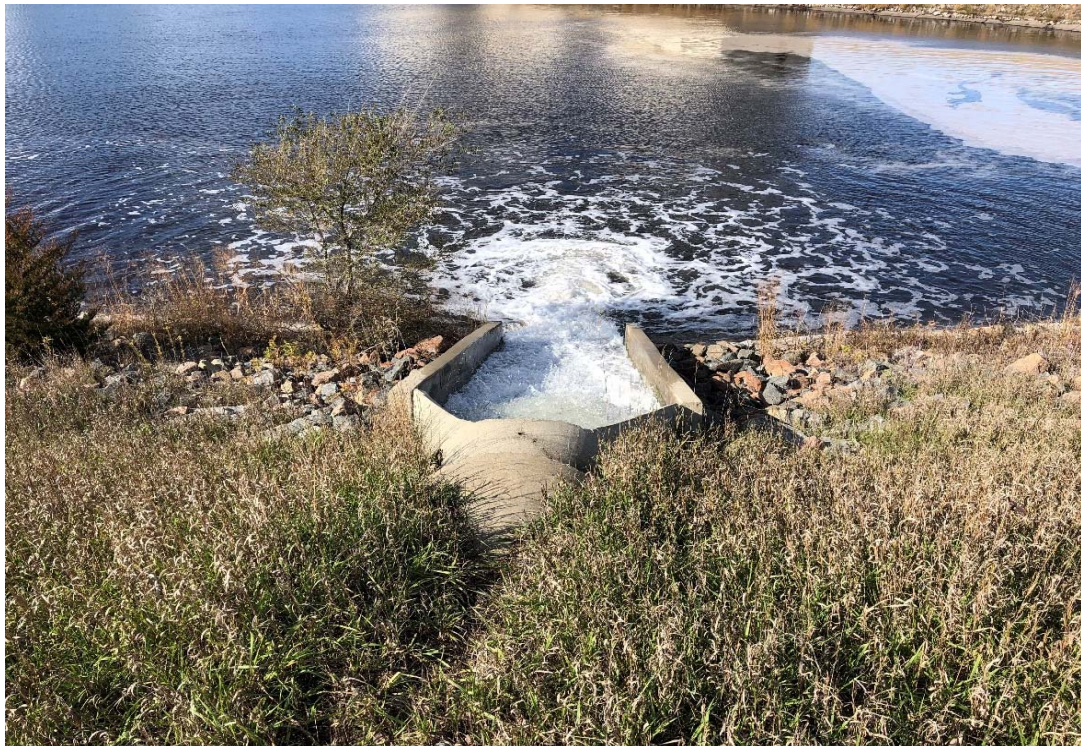
Photo 12	Bottom Ash Pond outlet.
10/24/2019

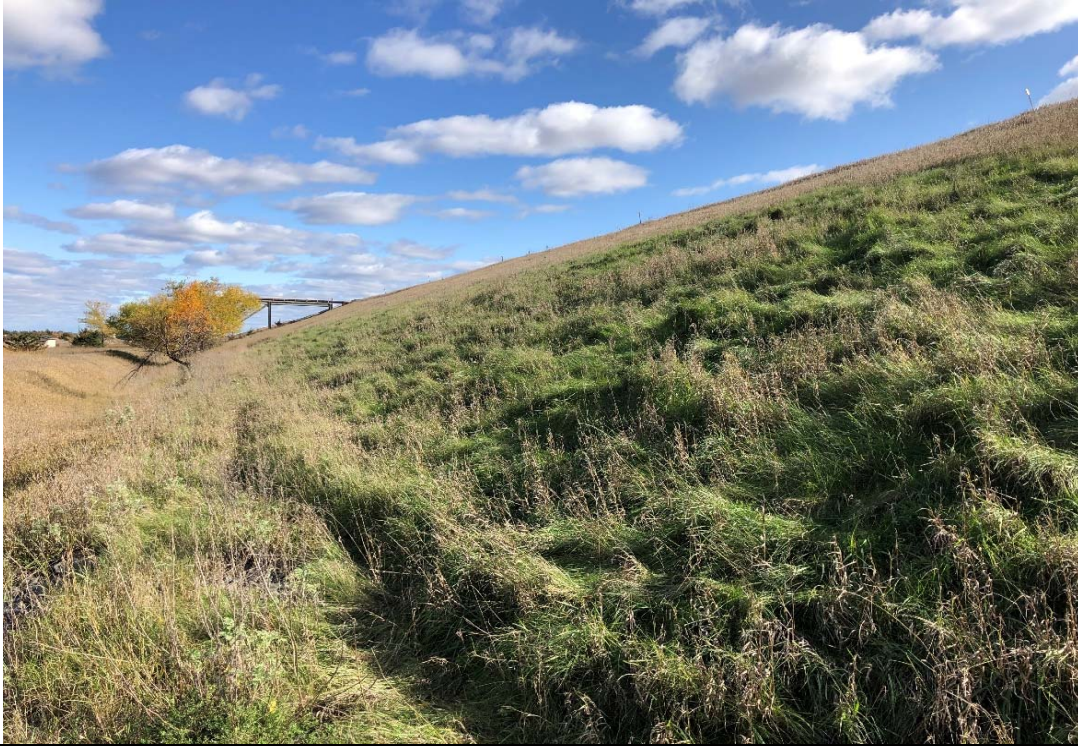
Photo 13	Mid-slope of north embankment, looking east.
10/24/2019

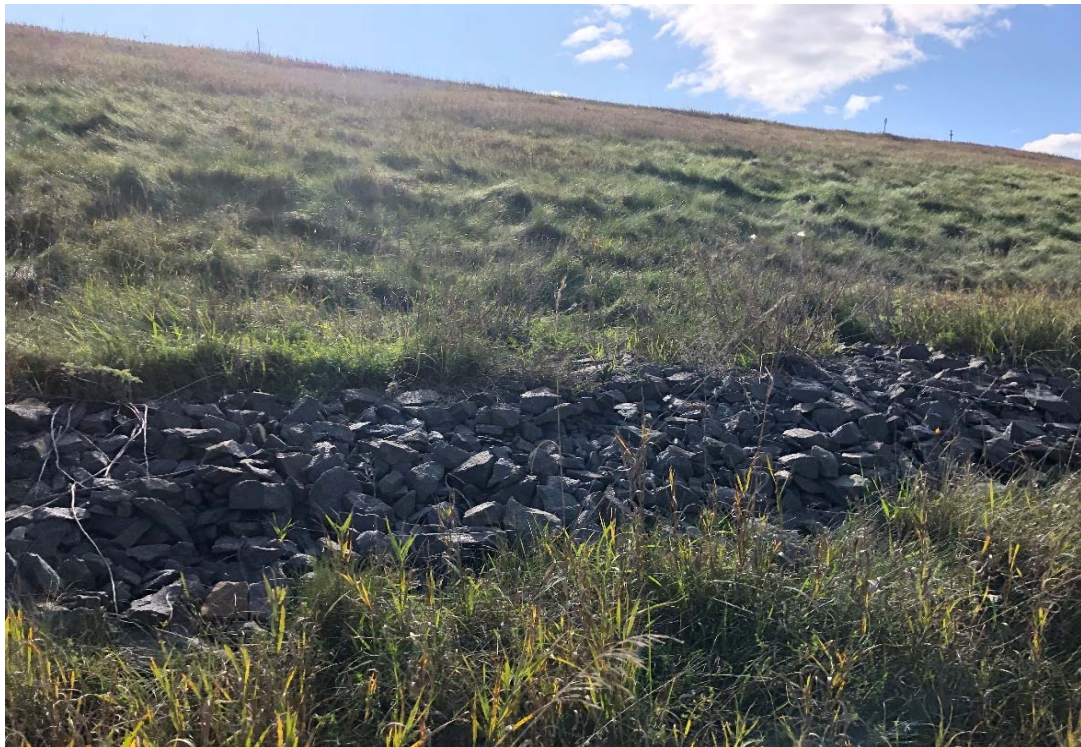
Photo 14	Toe drain of north slope, looking south.
10/24/2019

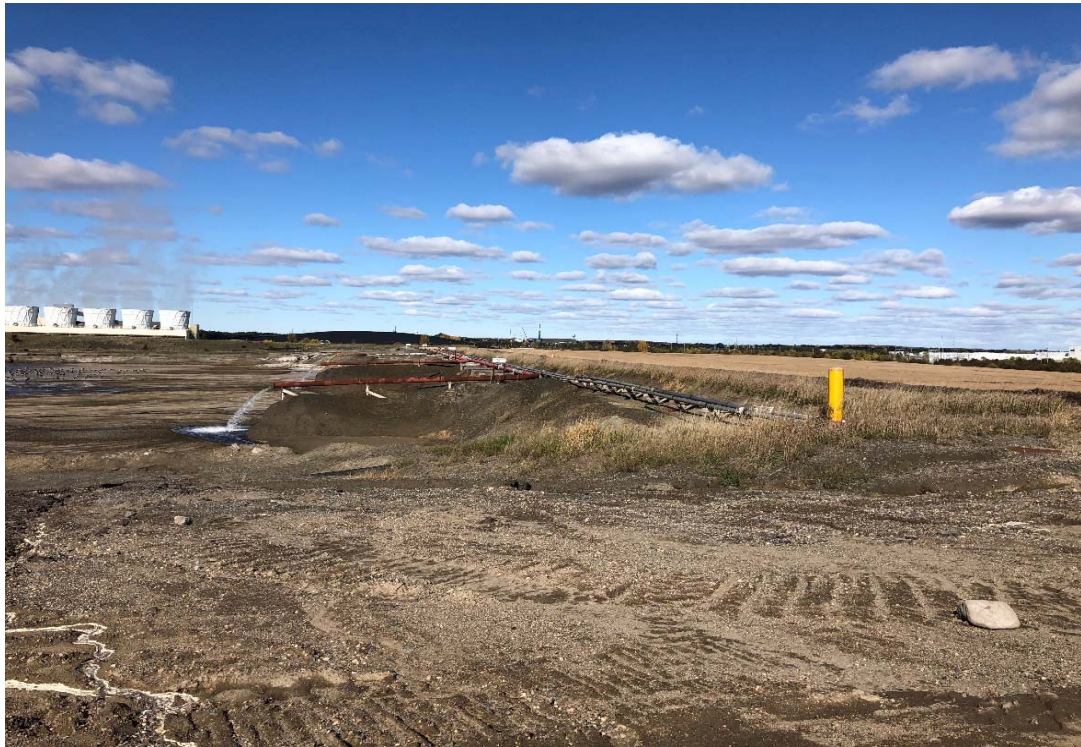
Photo 15	Bottom ash sluice pipes, looking north.
10/24/2019

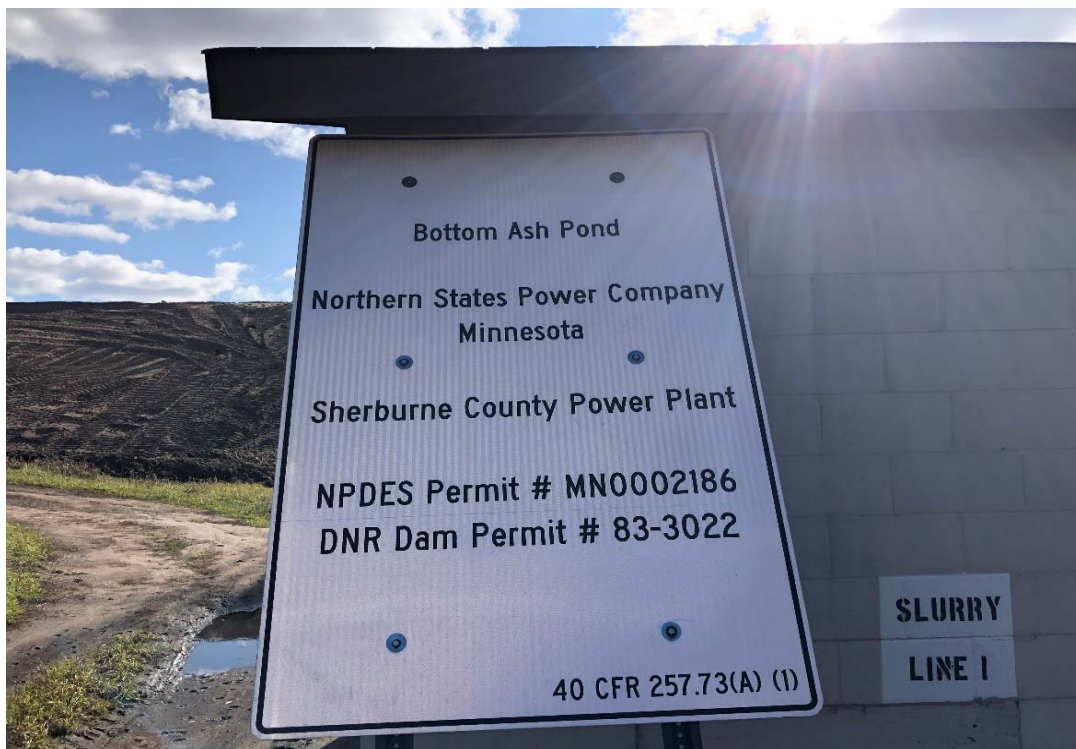
Photo 16	CCR Unit identification marker placed in accordance with Section 257.73 (temporary location during construction)
10/24/2019
