January 4, 2020

Xcel Energy, Inc.
Sherburne County Generating Station
13999 Industrial Blvd.
Becker, MN, 55308

Re: 2019 Annual Inspection of Scrubber Solids Pond No. 3

Pond 3 Annual Inspection - October 2019

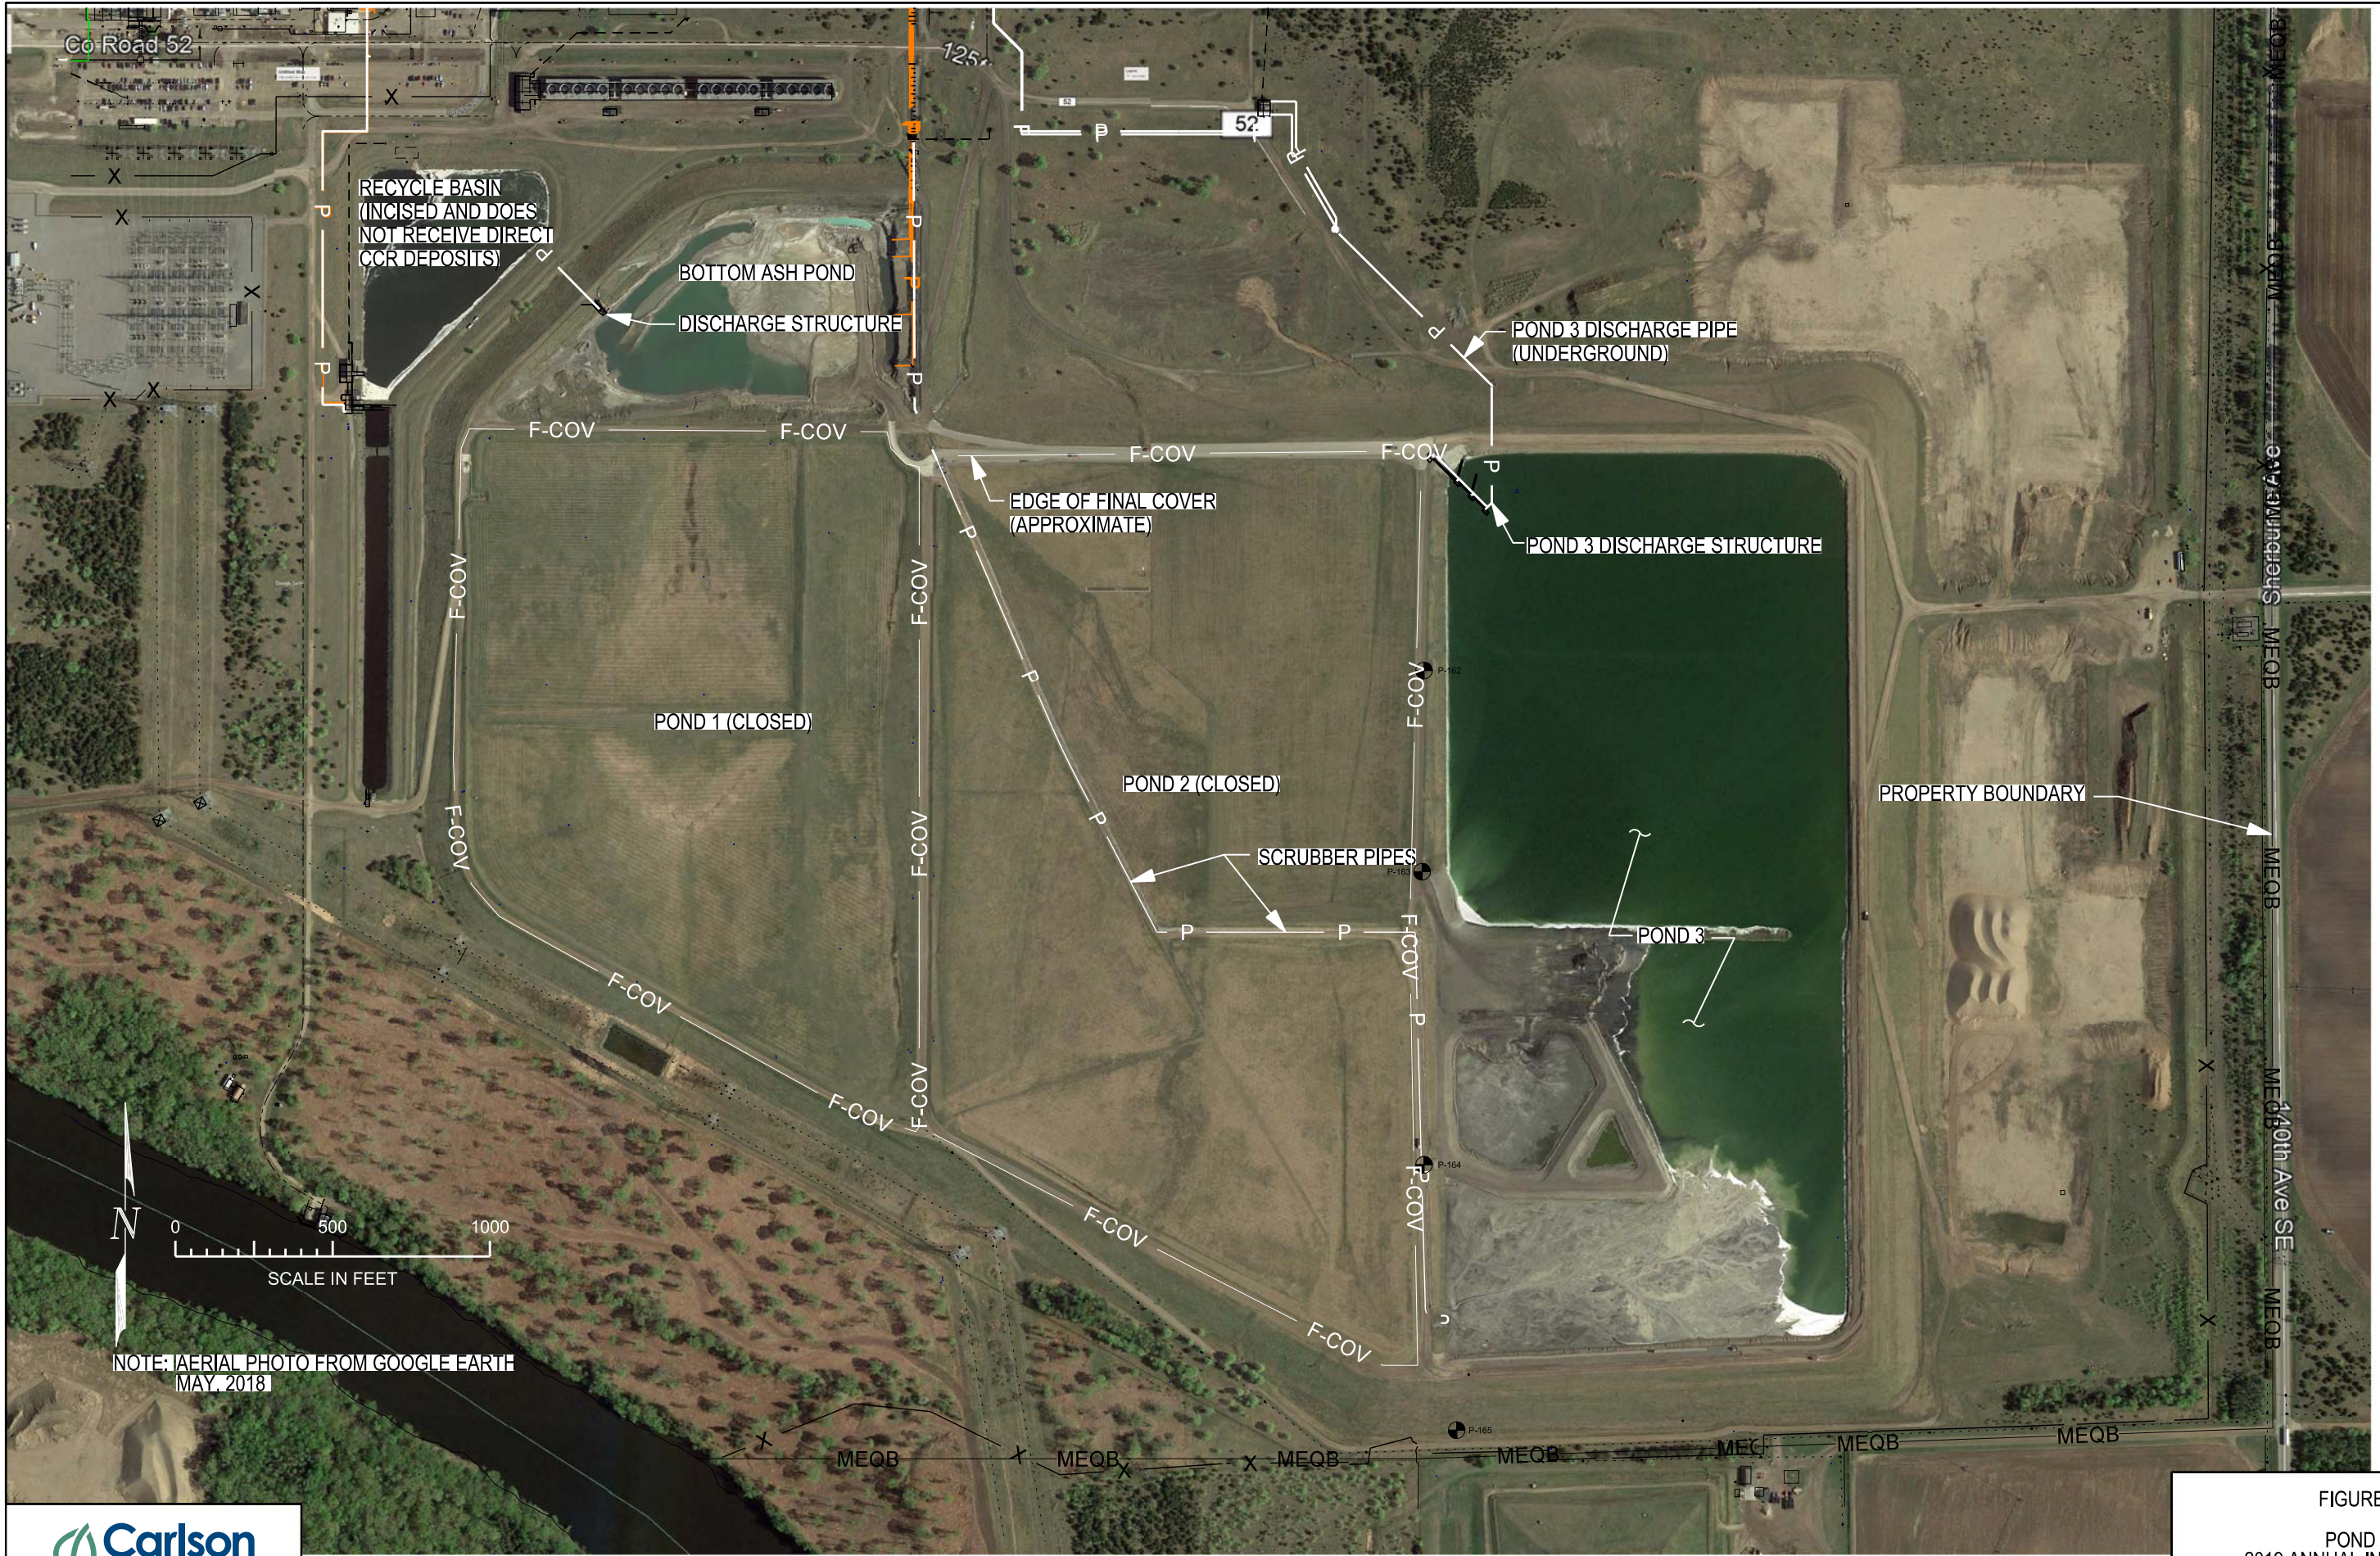
FIGURE 1
POND 3
2019 ANNUAL INSPECTION
POND LAYOUT

Two forms of CCR are deposited or placed in Pond 3. Solid bottom ash is excavated and hauled from the Bottom Ash Pond (see figure 1) and used above the water level in Pond 3 and compacted as a structural fill, or deposited in the pond, and not compacted. The highest elevation of bottom ash diked

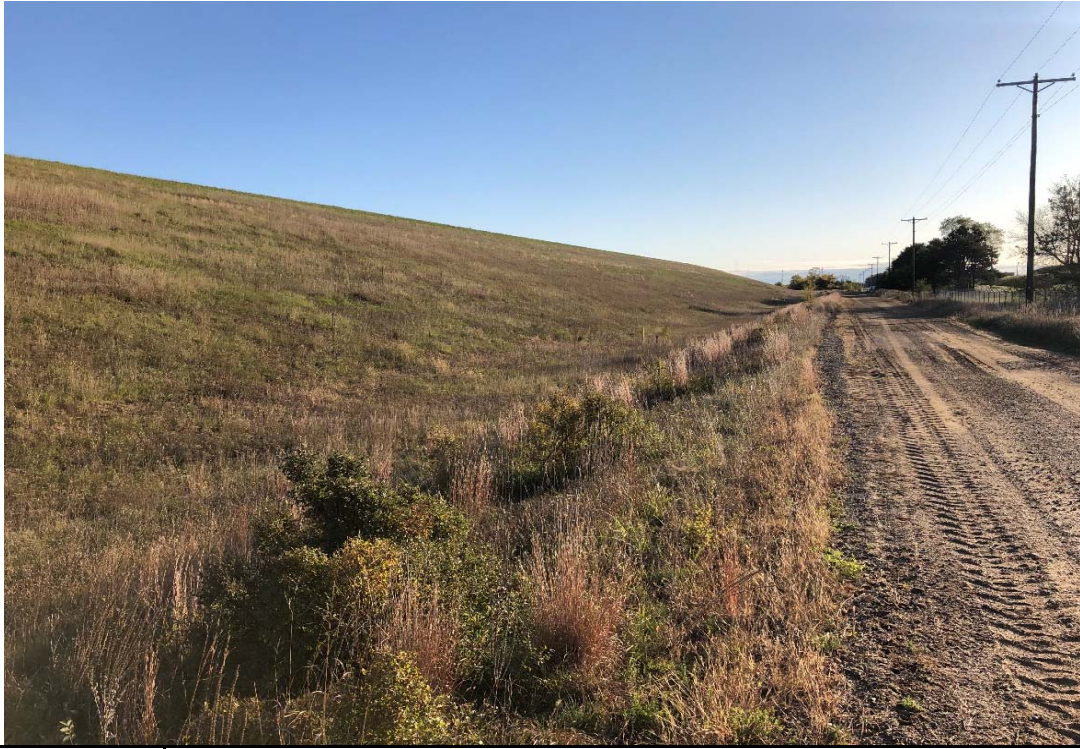
Photo 1	Outer slope of south embankment, looking east
10/24/2019

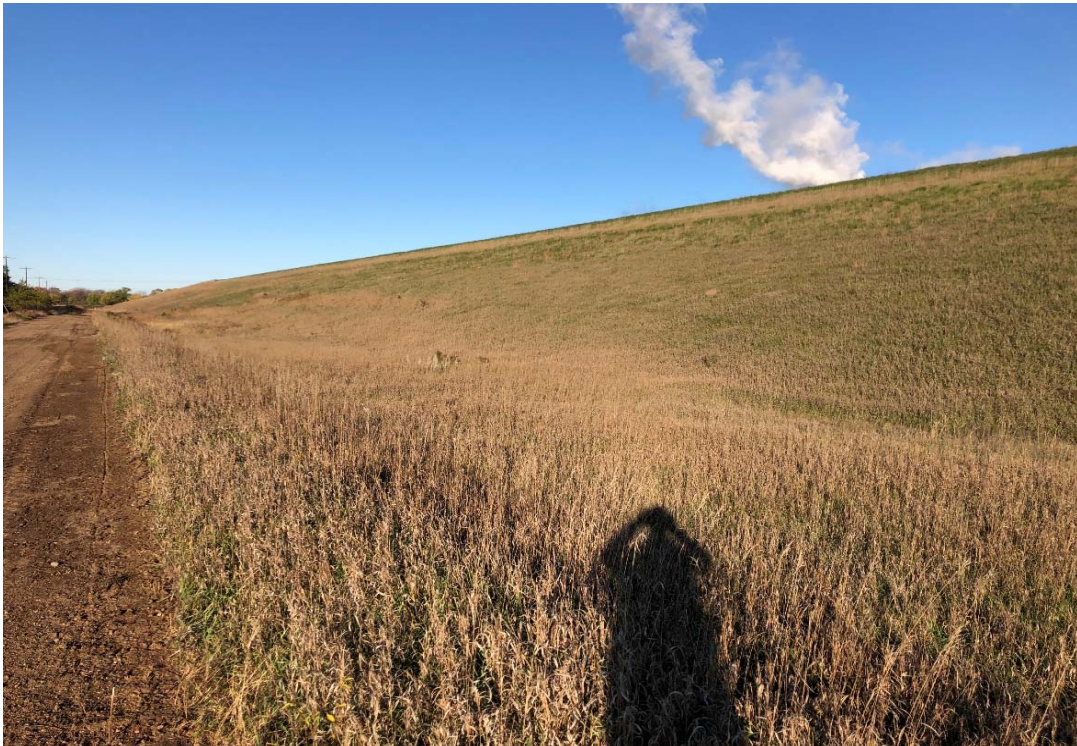
Photo 2	Outer slope of south embankment, looking west
10/24/2019

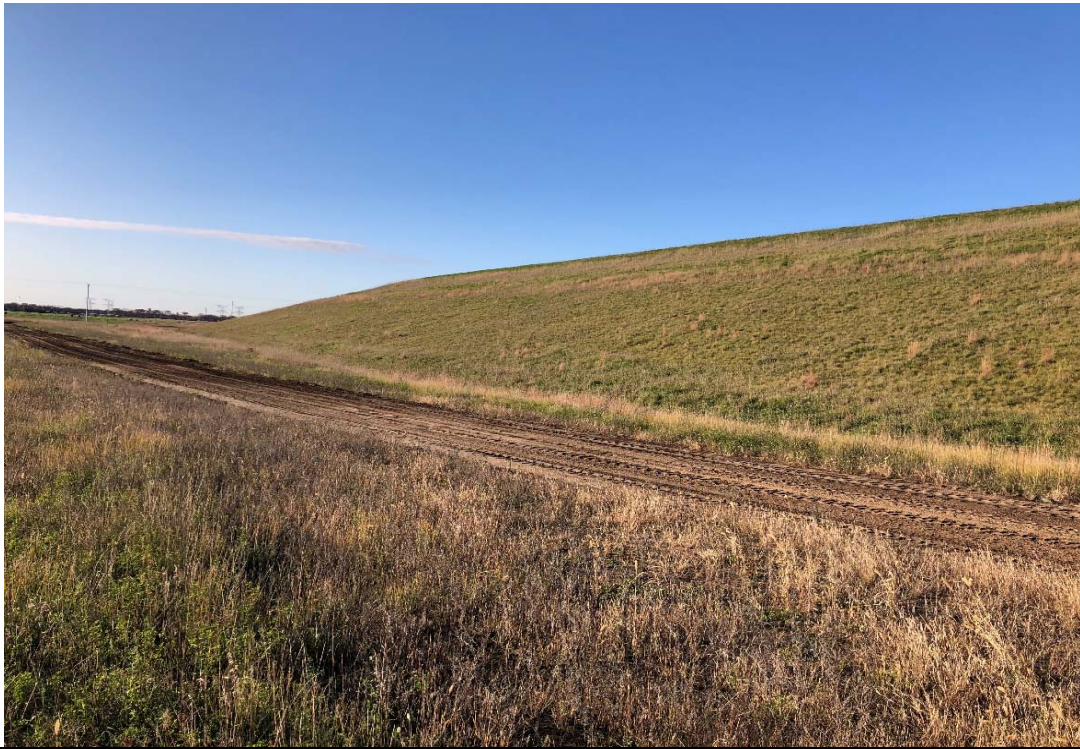
Photo 3	South end of east embankment, looking southwest.
10/24/2019

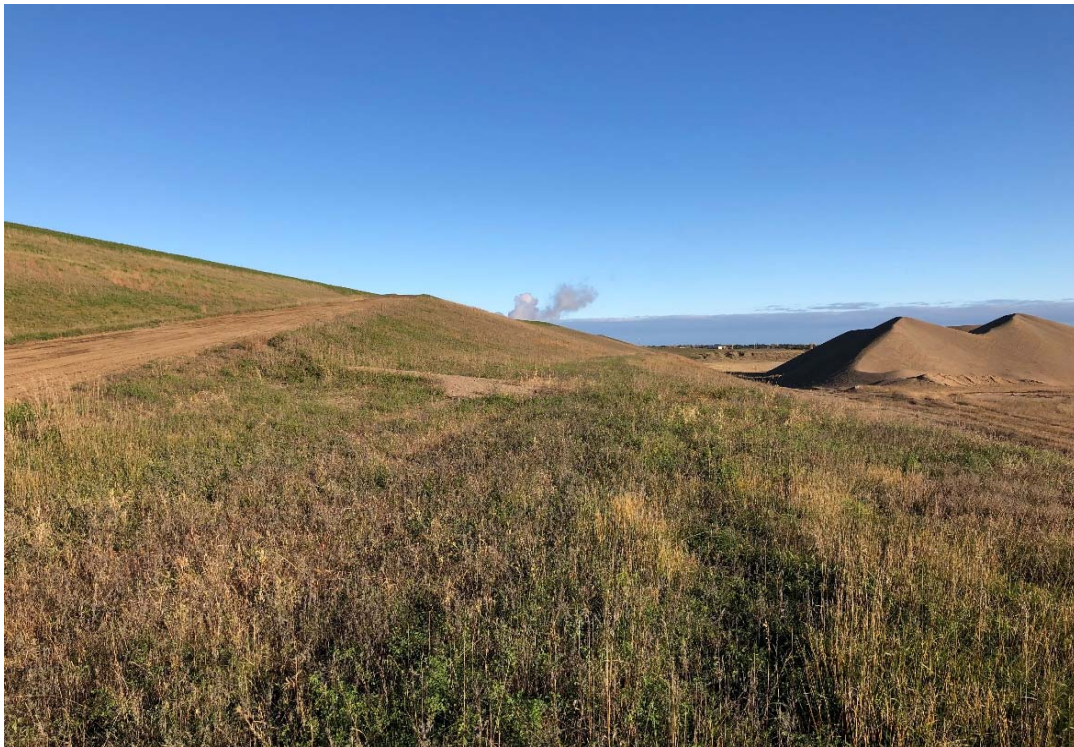
Photo 4	South end of east embankment, looking north.
10/24/2019

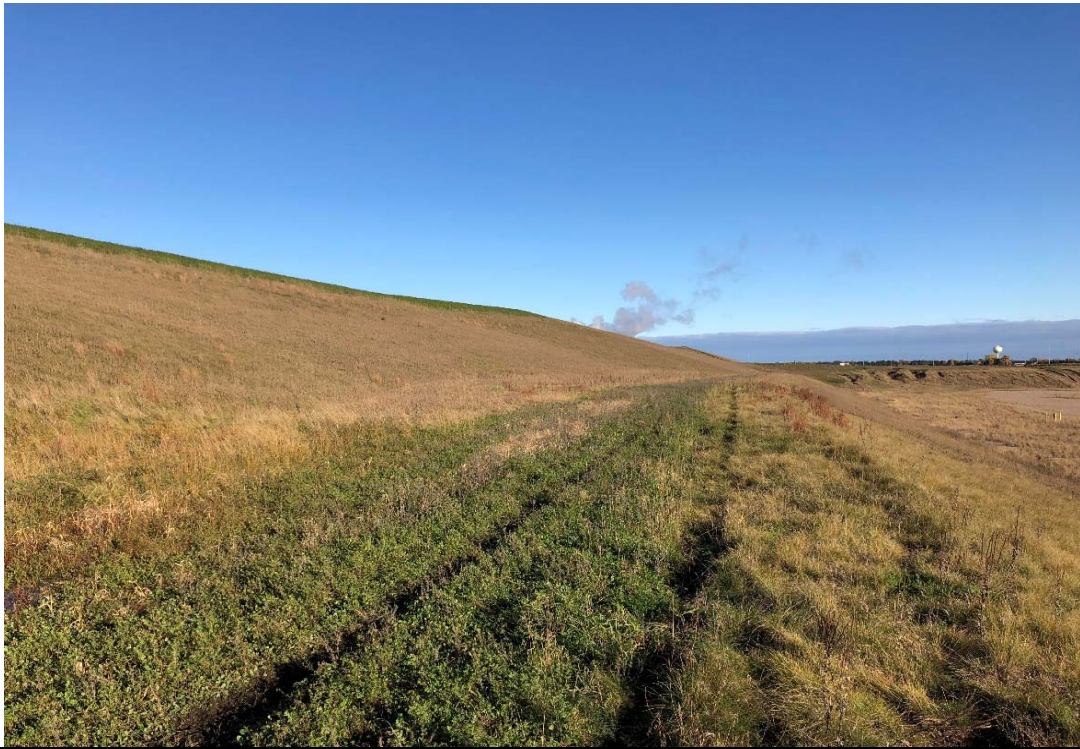
Photo 5	East embankment, looking north
10/24/2019

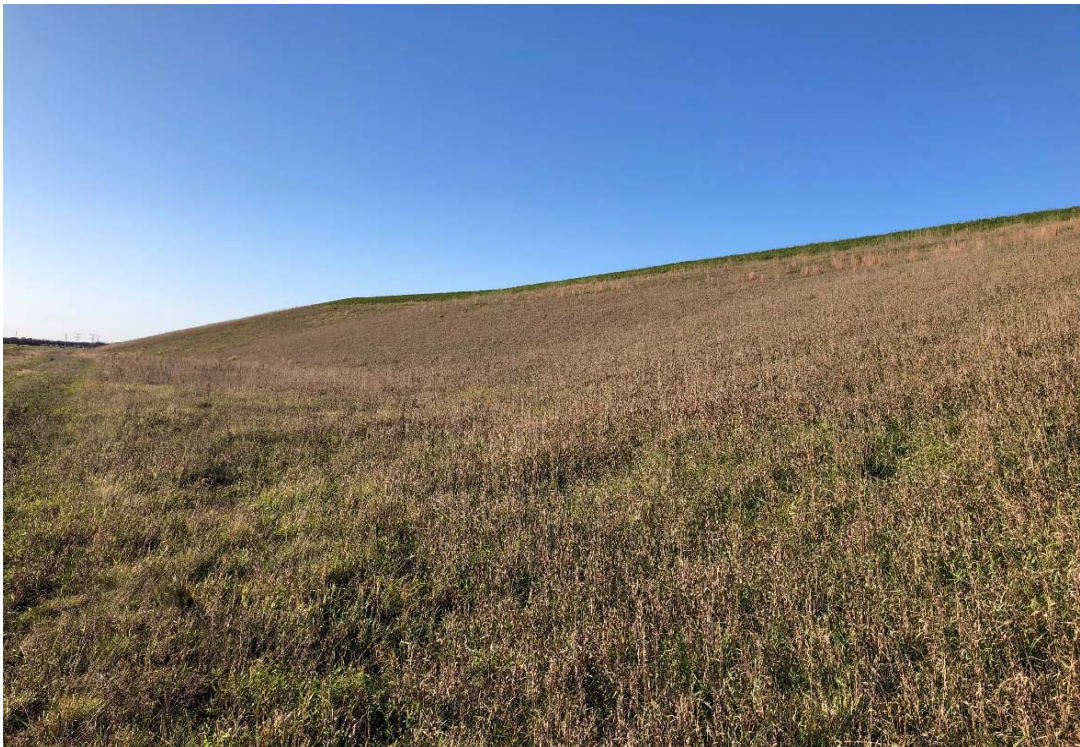
Photo 6	East embankment, looking south
10/24/2019

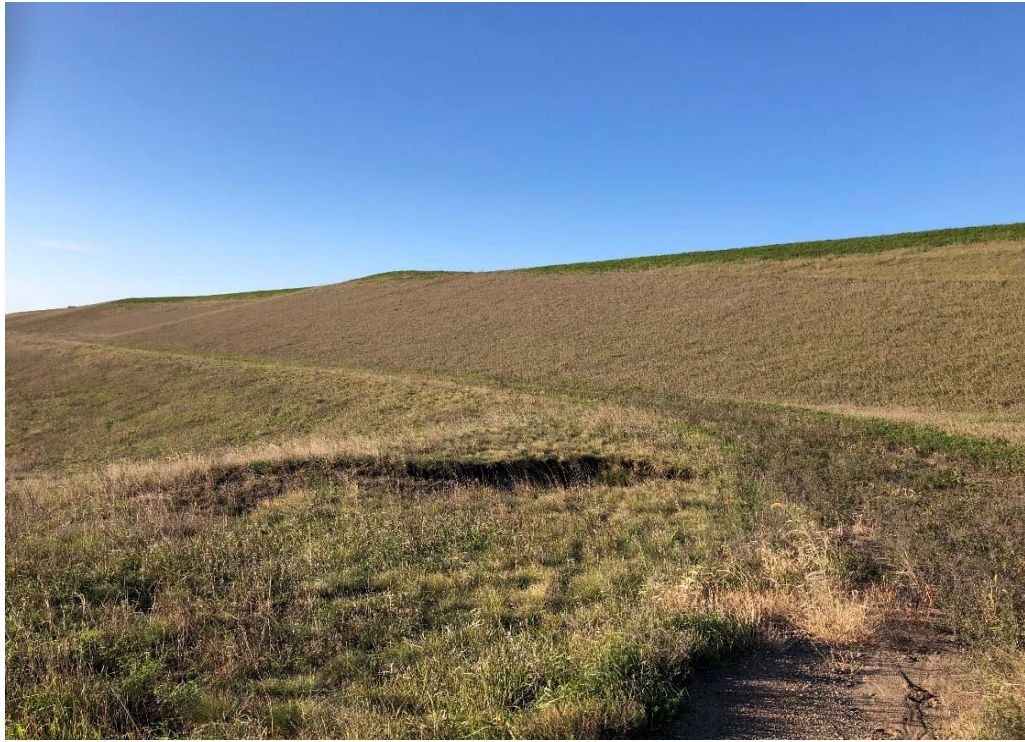
Photo 7	East embankment, looking southwest.
10/24/2019

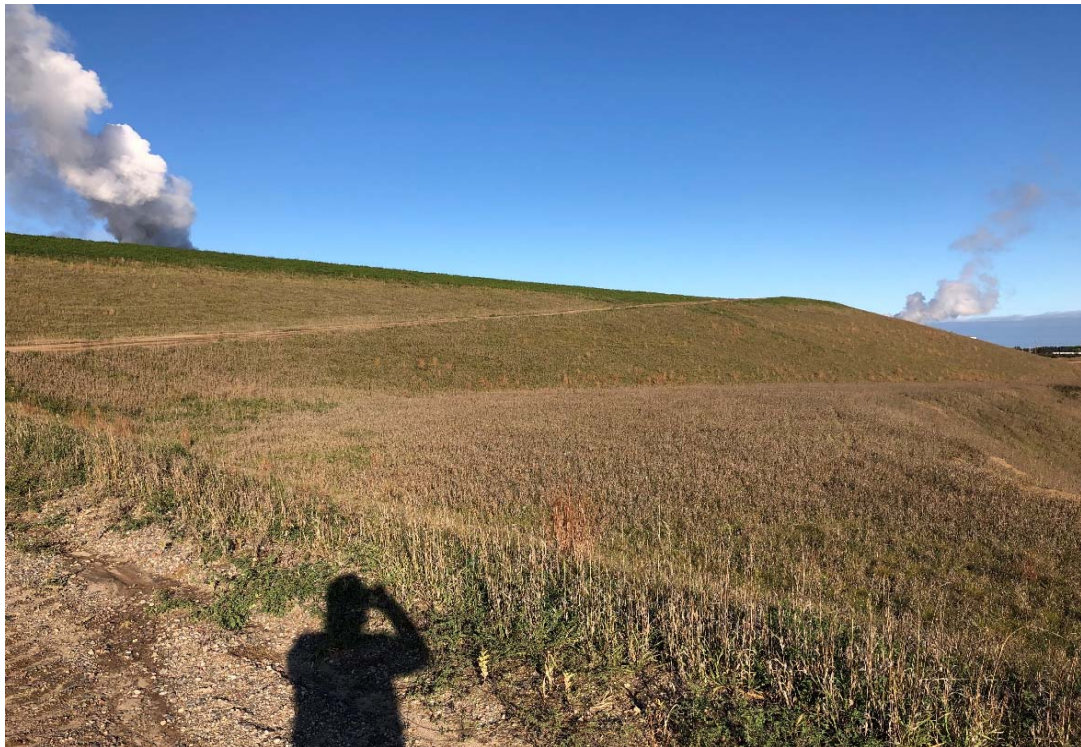
Photo 8	North end of east embankment, looking northwest.
10/24/2019

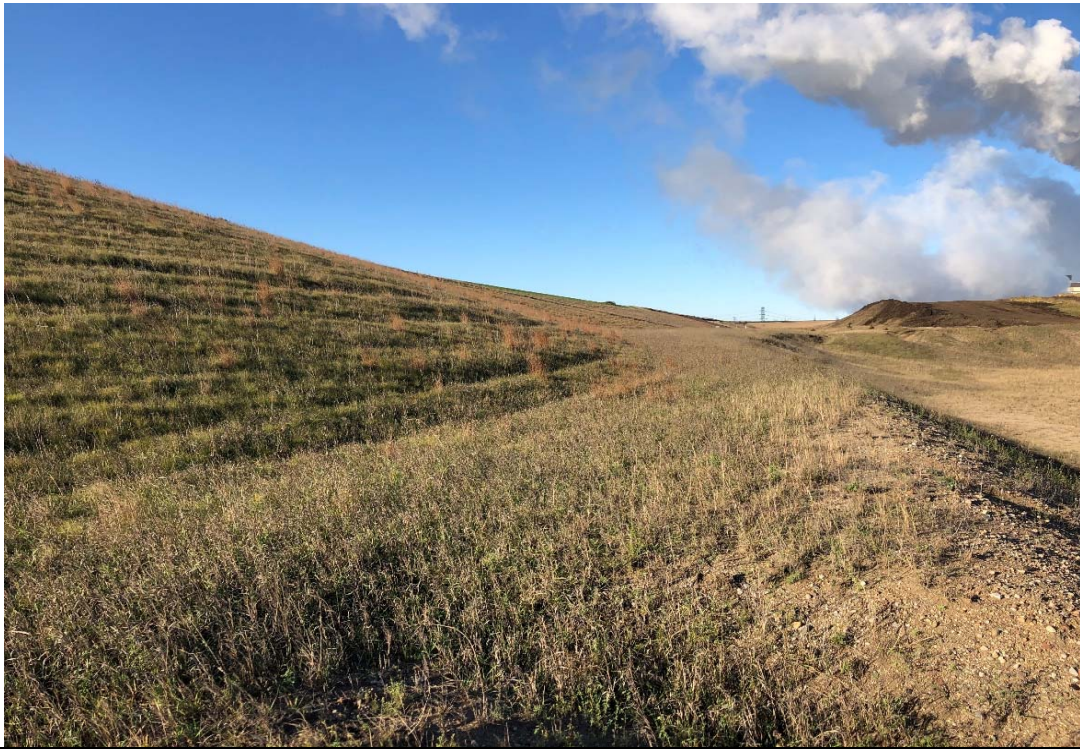
Photo 9	North embankment, looking west.
10/24/2019

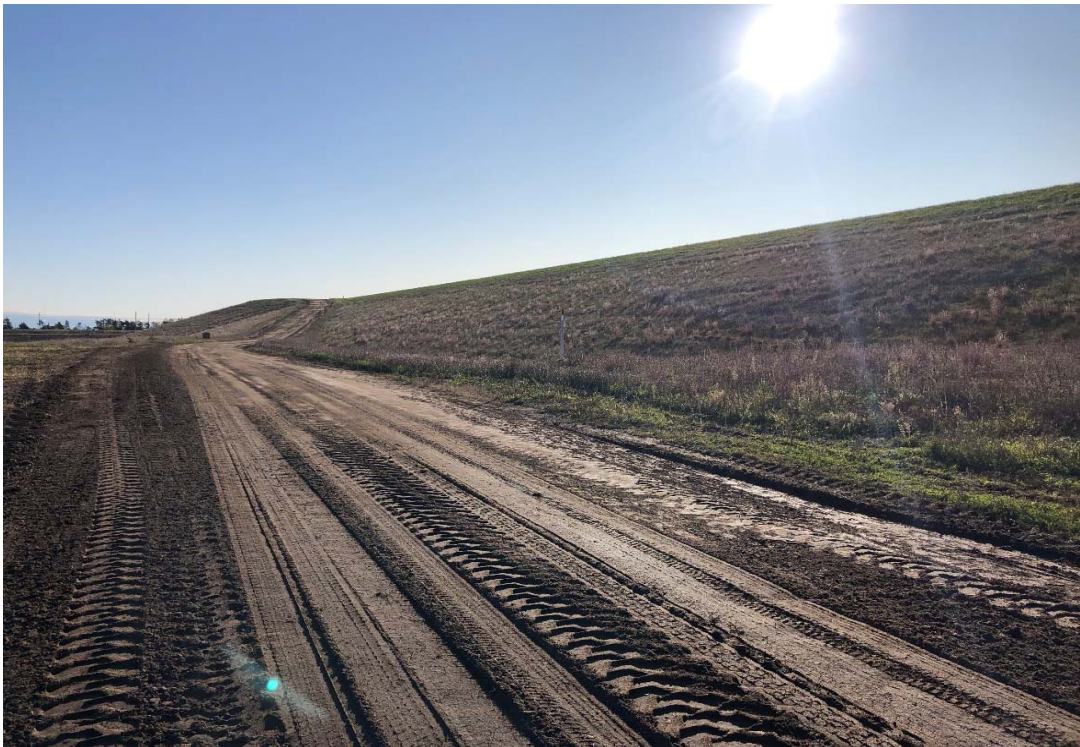
Photo 10	North embankment, looking east
10/24/2019

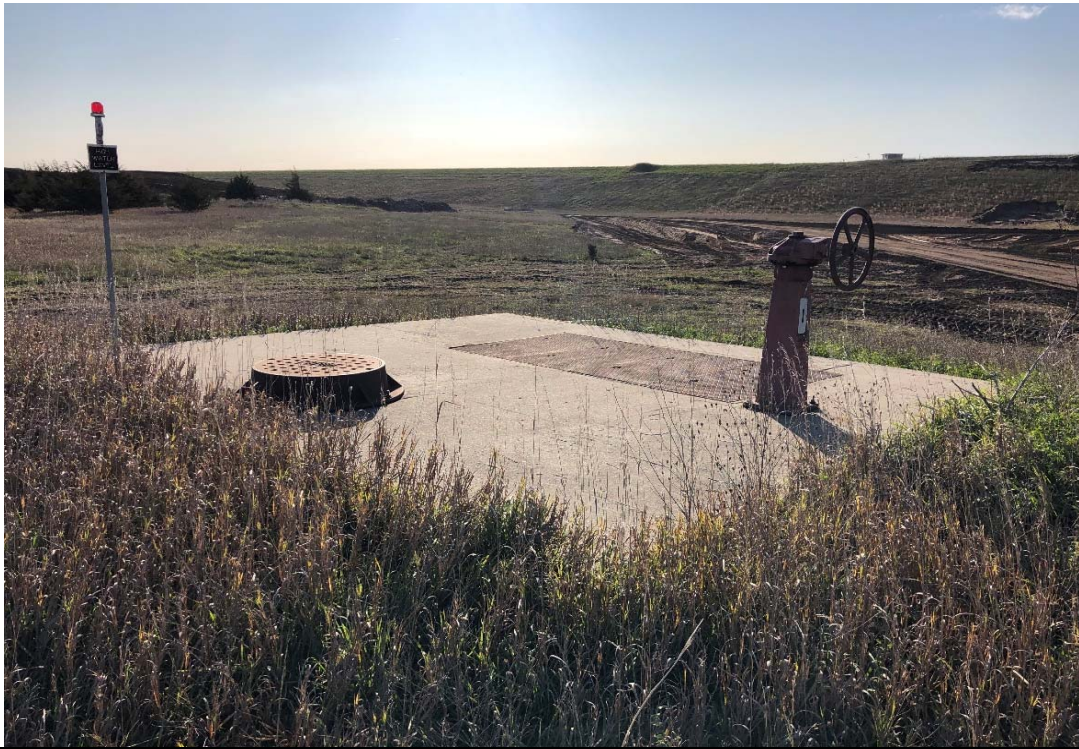
The discharge pipe corridor was inspected for signs of a leakage, such as saturated areas or sinkholes. No signs of leakage were observed along the pipe corridor or in the vault located north of Pond 3.

Photo 11	Pond 3 discharge pipe vault and pipeline corridor, looking southeast.
10/24/2019

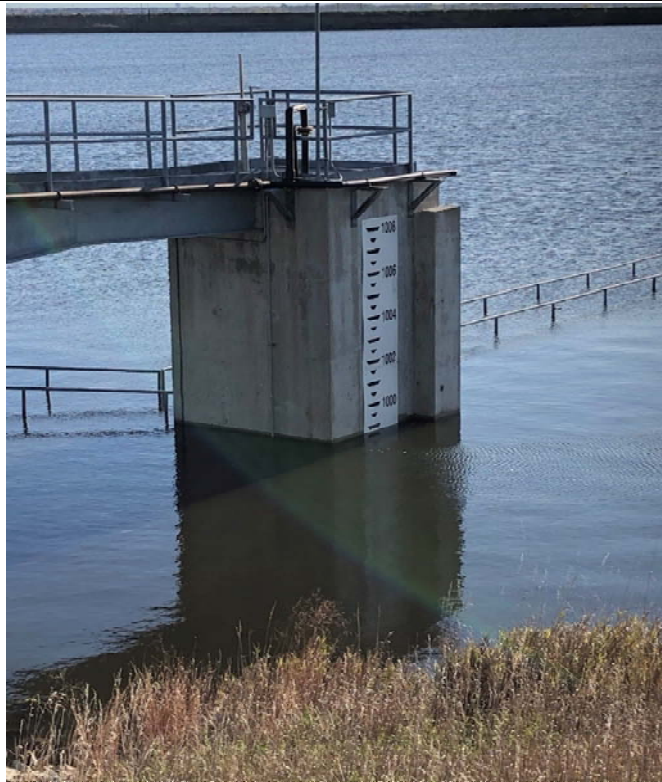
The only instrumentation on Pond 3 is a staff gauge used to determine water surface elevation, located on the west side of the discharge structure. The Pond water level was 996.4 feet above mean sea level (MSL) during the 2018 CCR inspection and rose to 998.8 feet MSL during the 2019 inspection. The top of clay liner elevation is 1010 feet MSL. No instrumentation is needed for dike stability.

Photo 12	Pond 3 staff gauge, reading an elevation of 998.75 feet (mean sea level).
10/24/2019

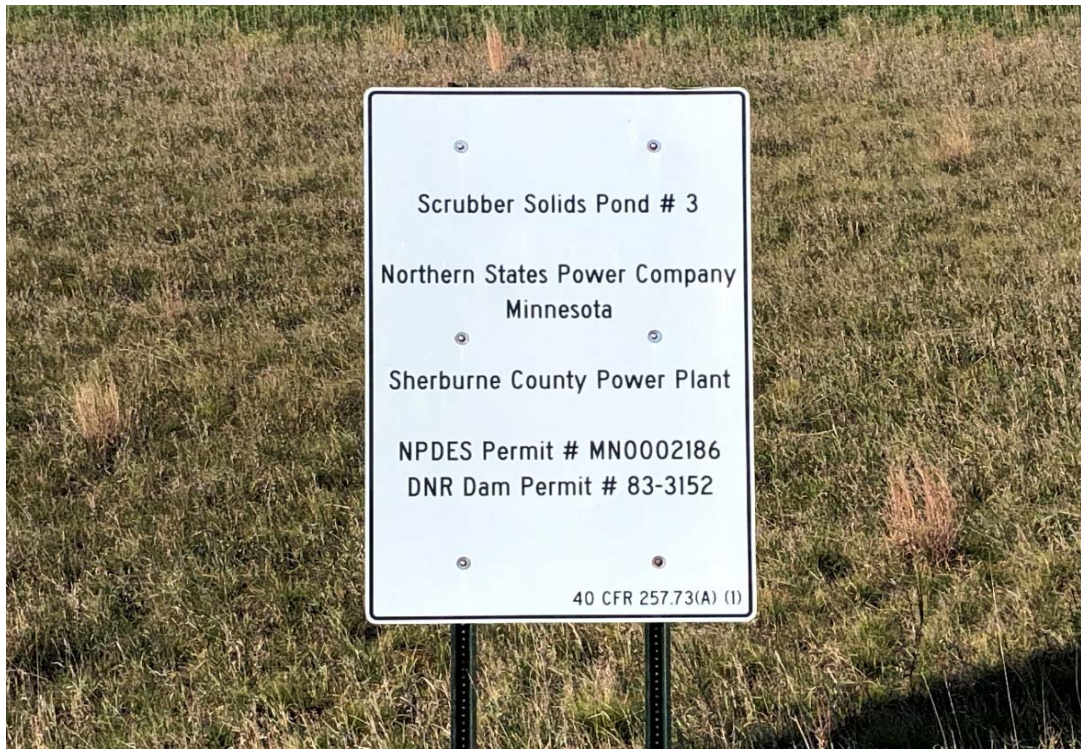
Photo 17	Pond 3 Unit Marker installed in accordance with 257.73(A)(1).
10/24/2019

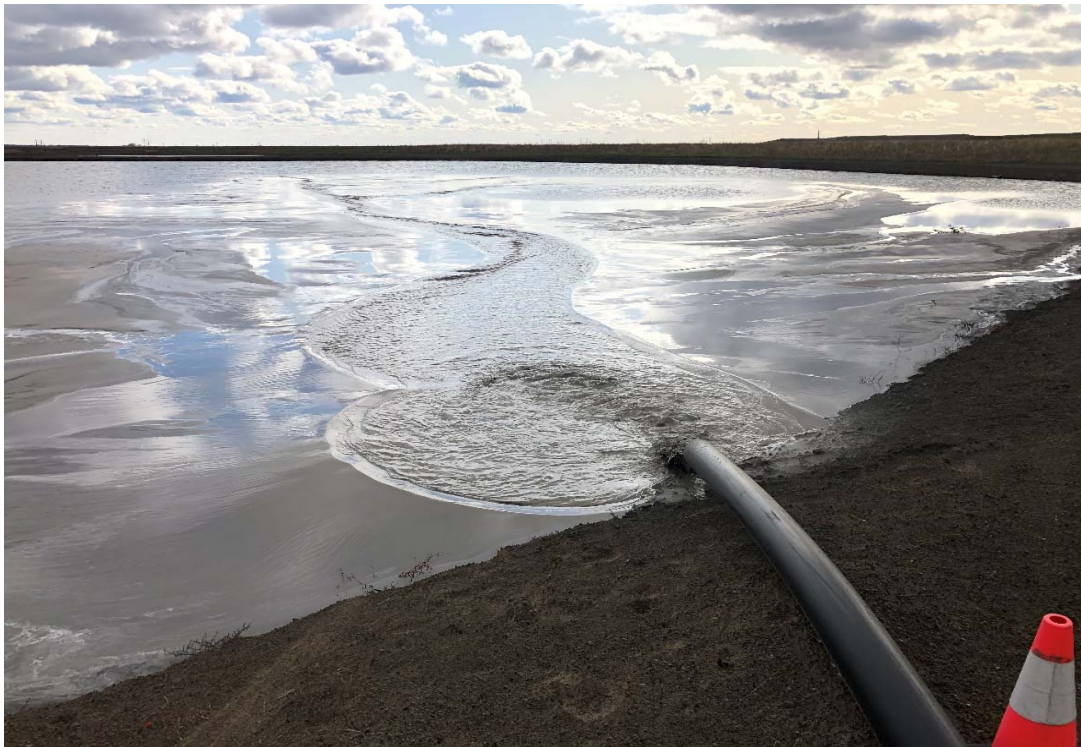
Photo 22	Scrubber solids discharge pipe, looking east.
10/24/2019
