Xcel Energy, Inc.  
Sherburne County Generating Station  
13999 Industrial Blvd.  
Becker, MN 55308

**Re: 2019 Annual Inspection of Unit 3 Landfill**

## Unit 3 Landfill Annual Inspection - 2019

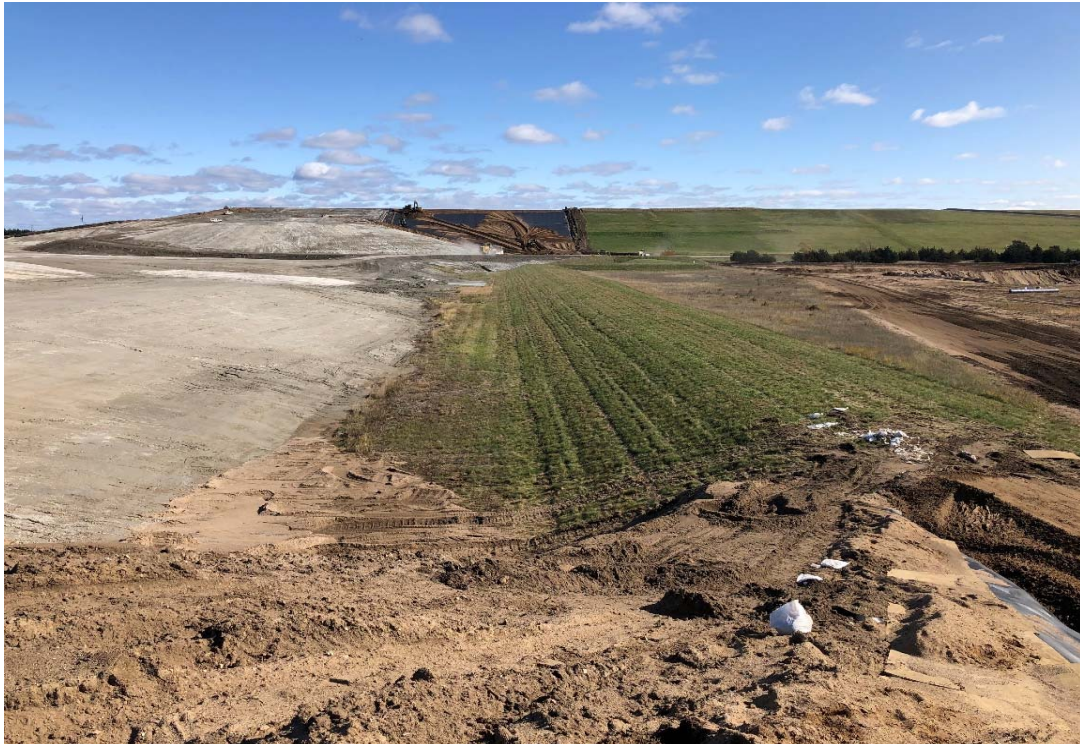
| Photo 2 | Run-on/run-off control berm, looking east. |

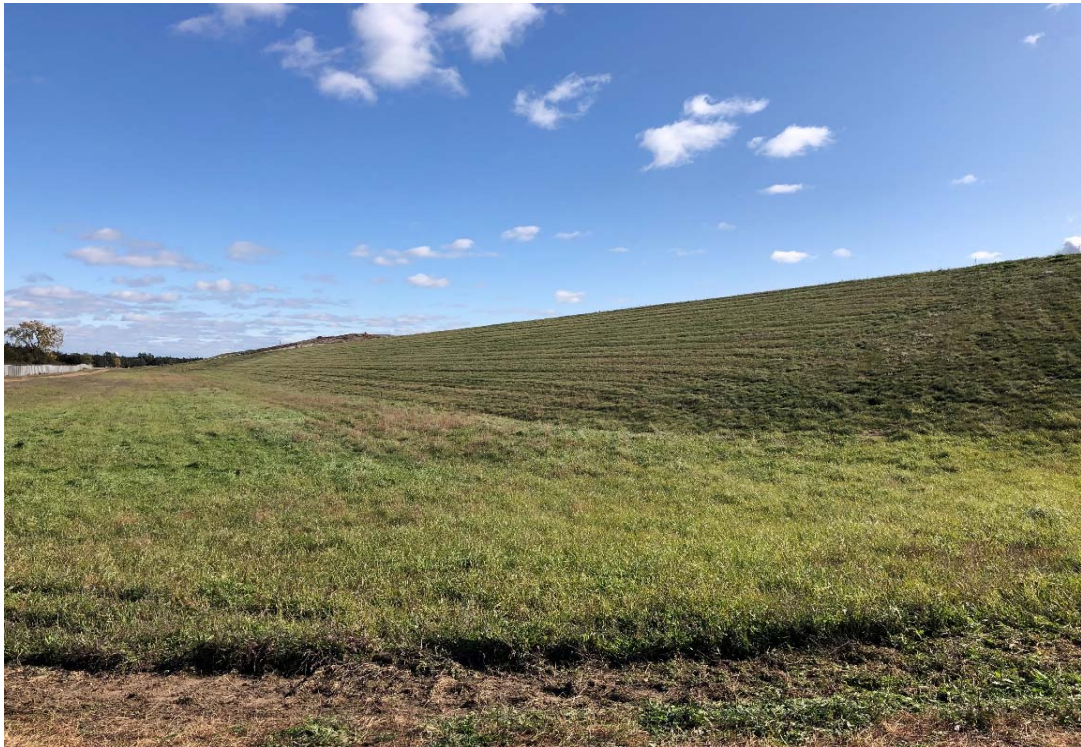
| Photo 5 | Exterior of north berm, looking east. |

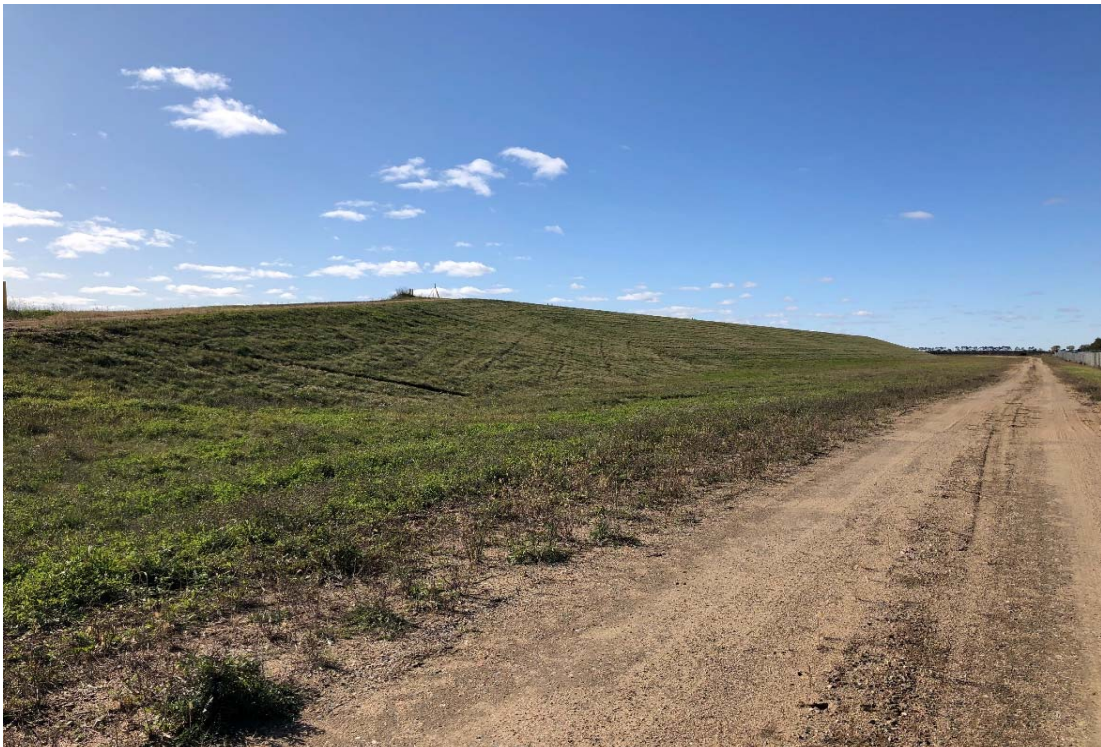
| Photo 6 | Exterior of north berm, looking west. |

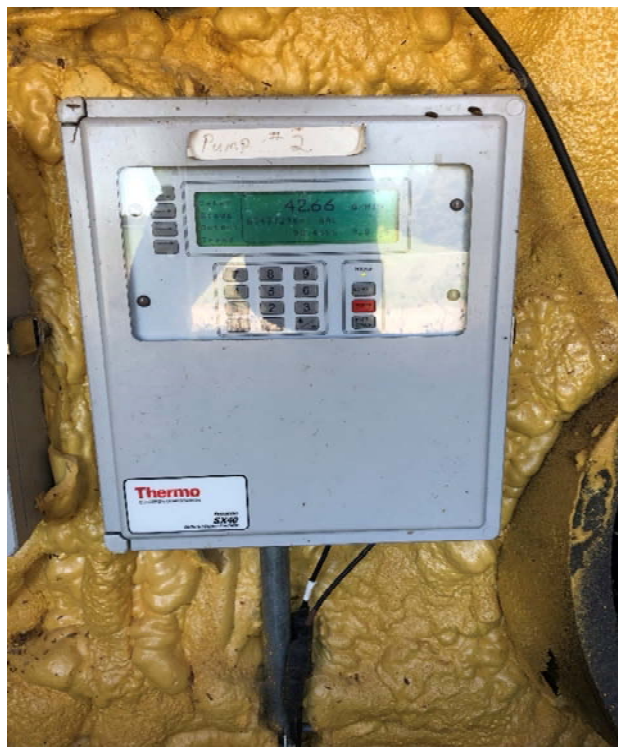
| Photo 10 | Display screen on properly functioning Pump No. 2. |
