Xcel Energy, Inc.  
Sherburne County Generating Station  
13999 Industrial Blvd.  
Becker, MN, 55308

**Re: 2017 Annual Inspection of Scrubber Solids Pond No. 3**

The Scrubber Solids Pond No. 3 (Pond 3) inspection was conducted on November 8<sup>th</sup>, 2017 by Daniel J. Riggs, a professional engineer licensed in the State of Minnesota. This was the third inspection done in accordance with the EPA's published Coal Combustion Residual (CCR) Rules under section 257.83. Prior inspections were conducted in 2008, 2009, 2013 by the Minnesota Department of Natural Resources (DNR); in August 2009 by the EPA; annually from 2010 to 2014 by Qualified Professional Engineers in accordance with the DNR and Minnesota Pollution Control Agency (MPCA) inspection requirements; and annually since 2015 by a Qualified Professional Engineer in accordance with EPA CCR Rules.

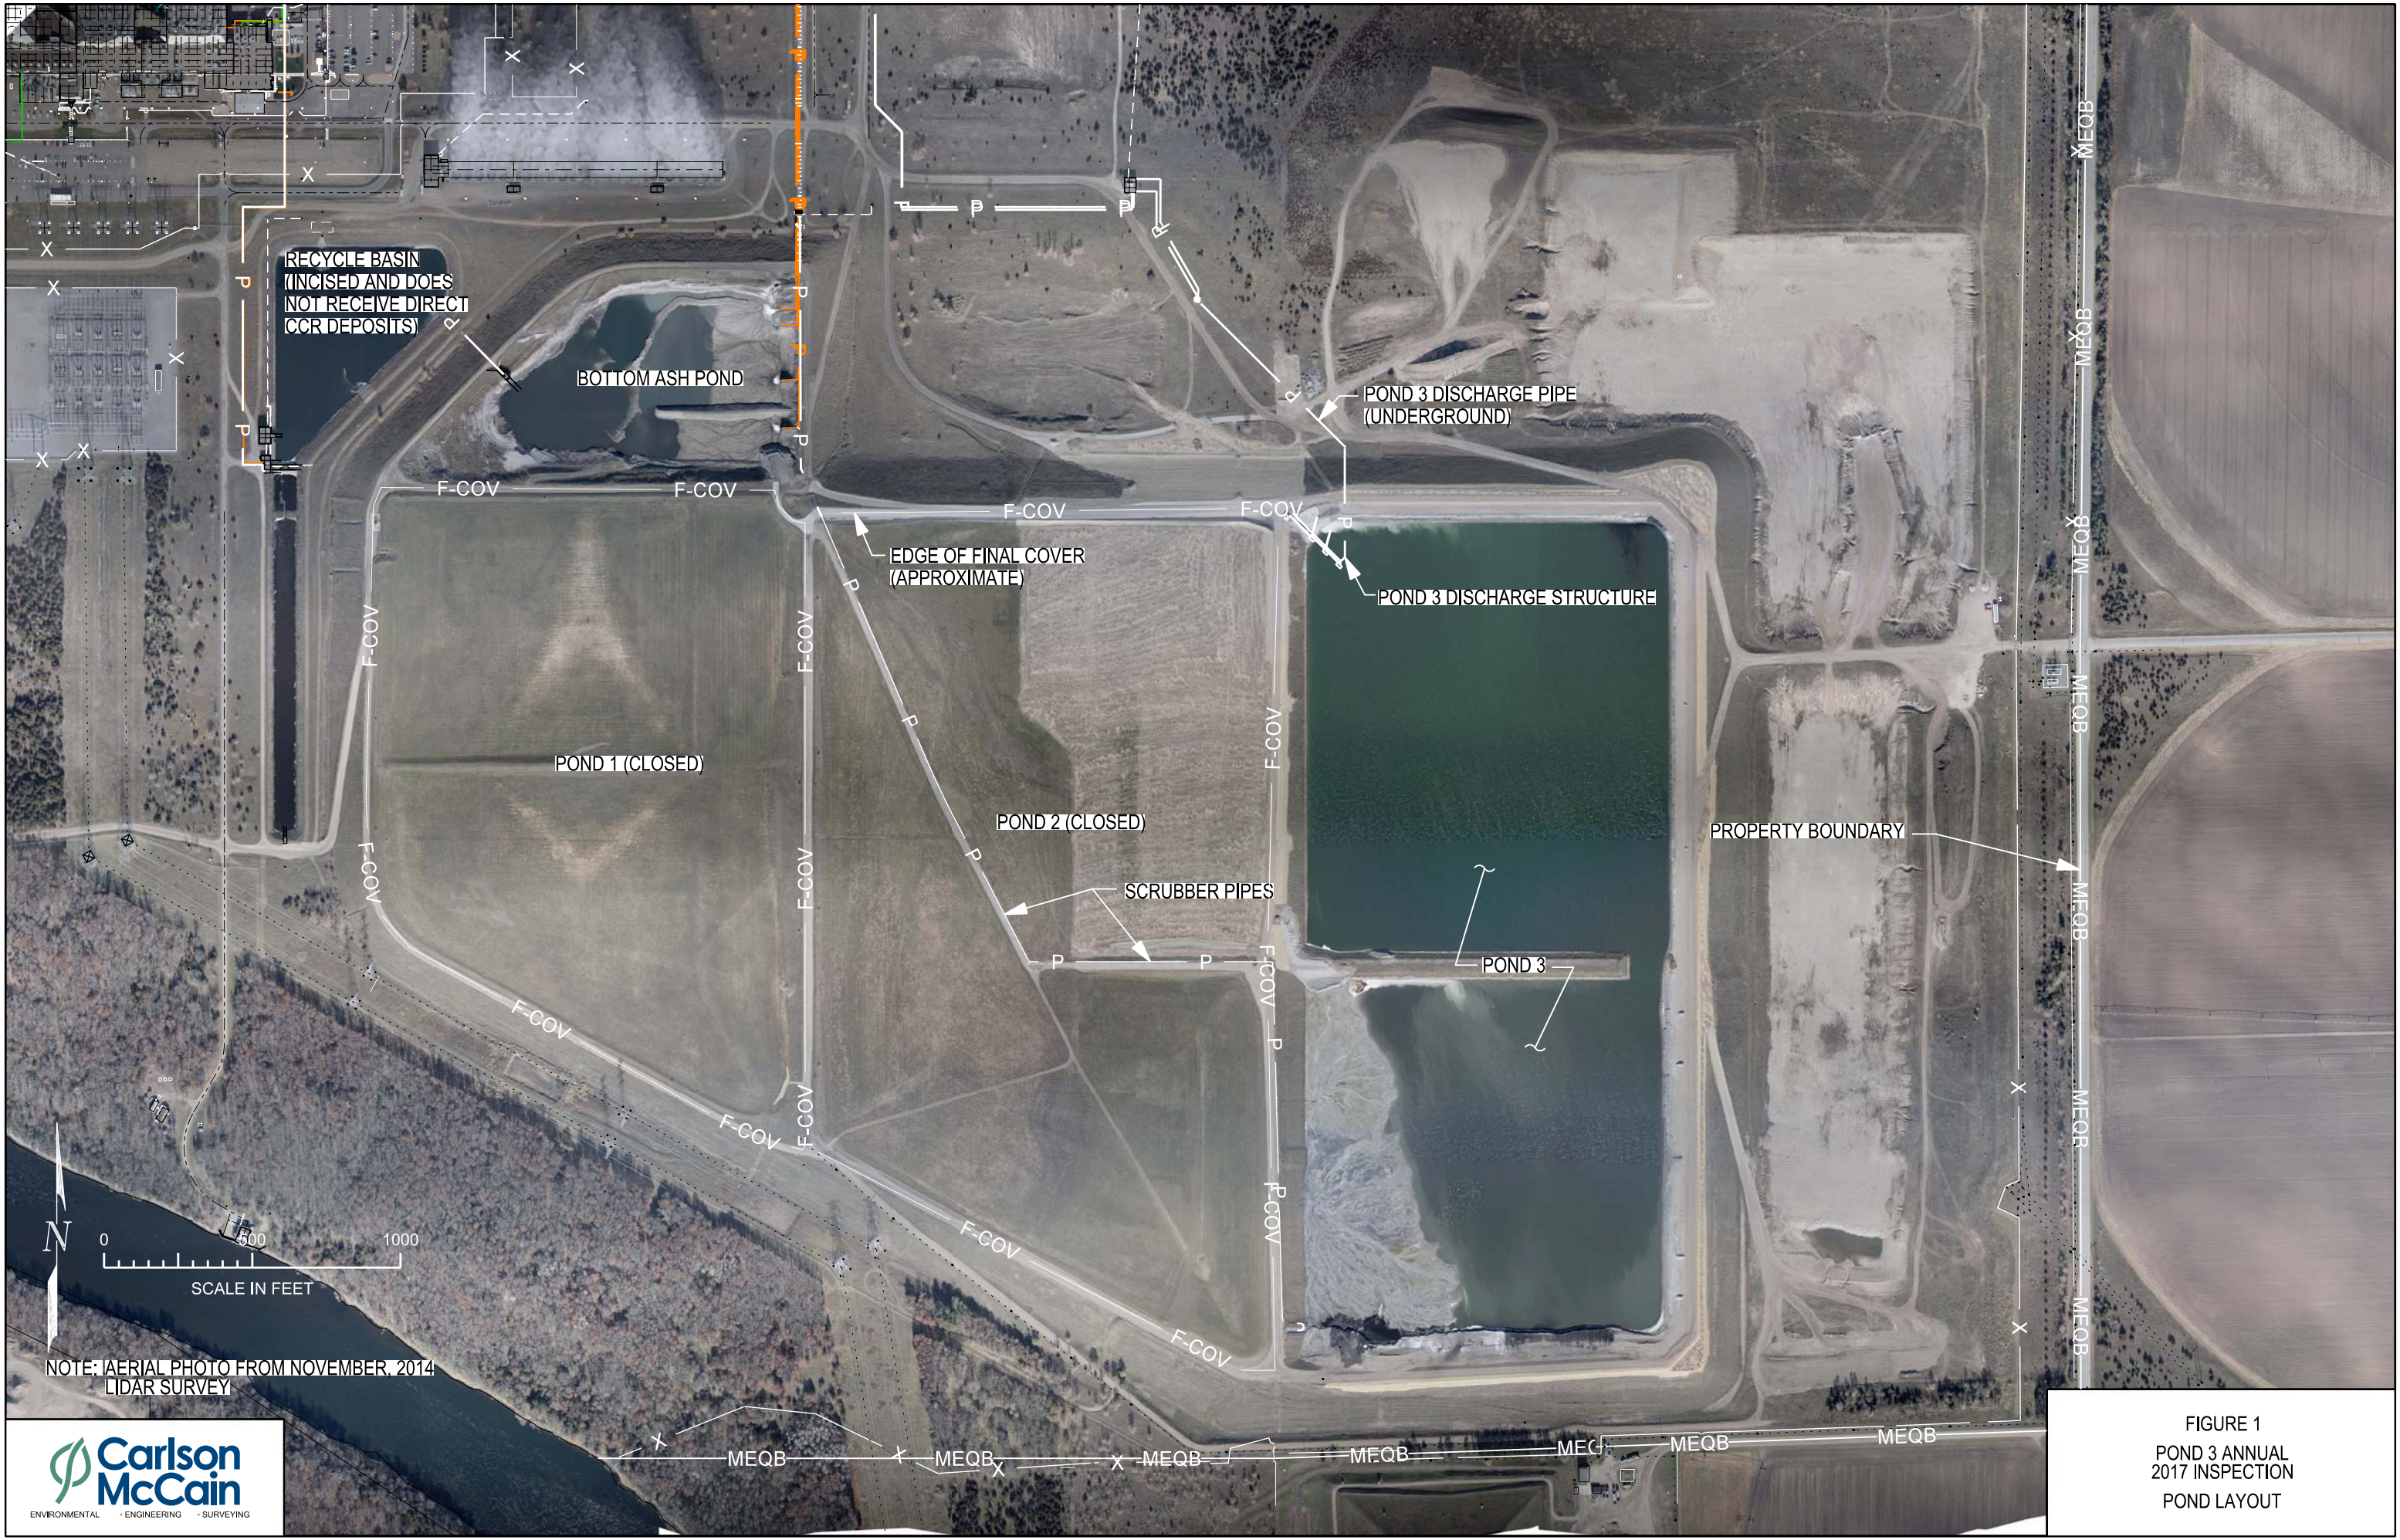
FIGURE 1  
POND 3 ANNUAL  
2017 INSPECTION  
POND LAYOUT

Two forms of CCR are deposited or placed in Pond 3. Solid bottom ash is excavated and hauled from the Bottom Ash Pond (see figure 1) and used above the water level in Pond 3 and compacted as a structural fill, or deposited in the pond, and not compacted. The highest elevation of bottom ash diked

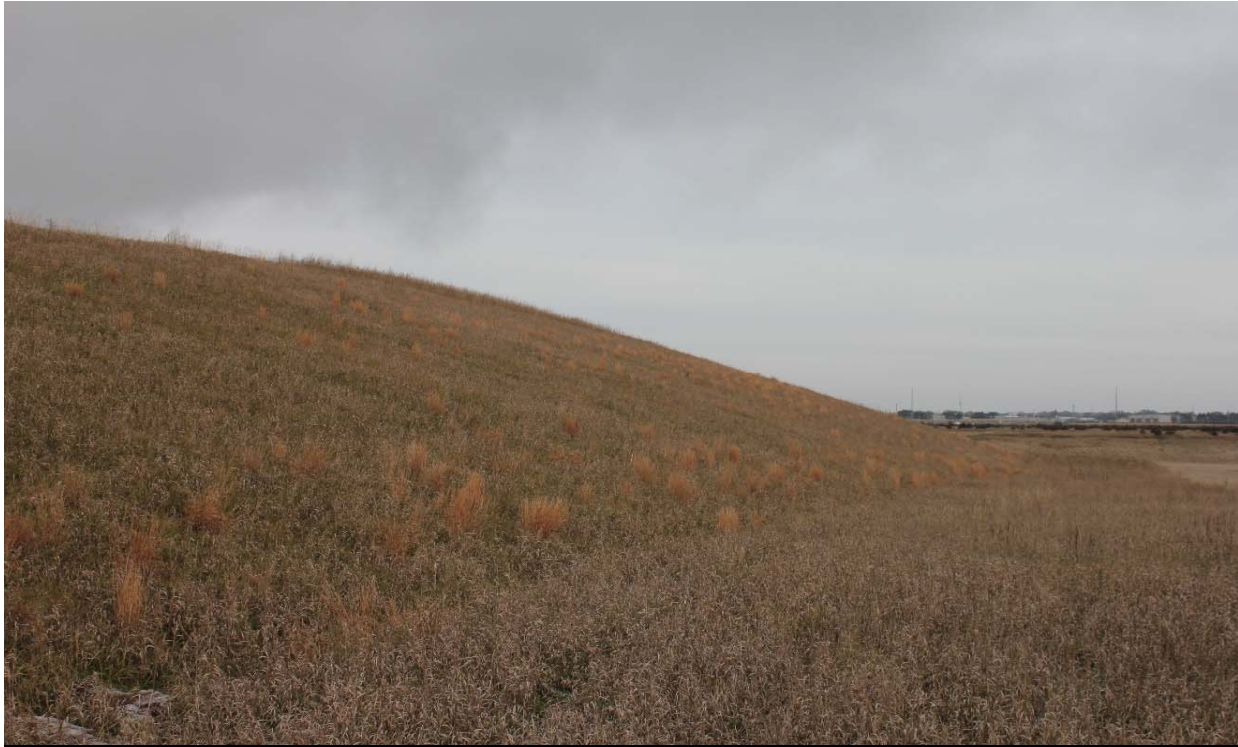
Photo 1	Outer east slope of north embankment, looking north.
11/8/2017

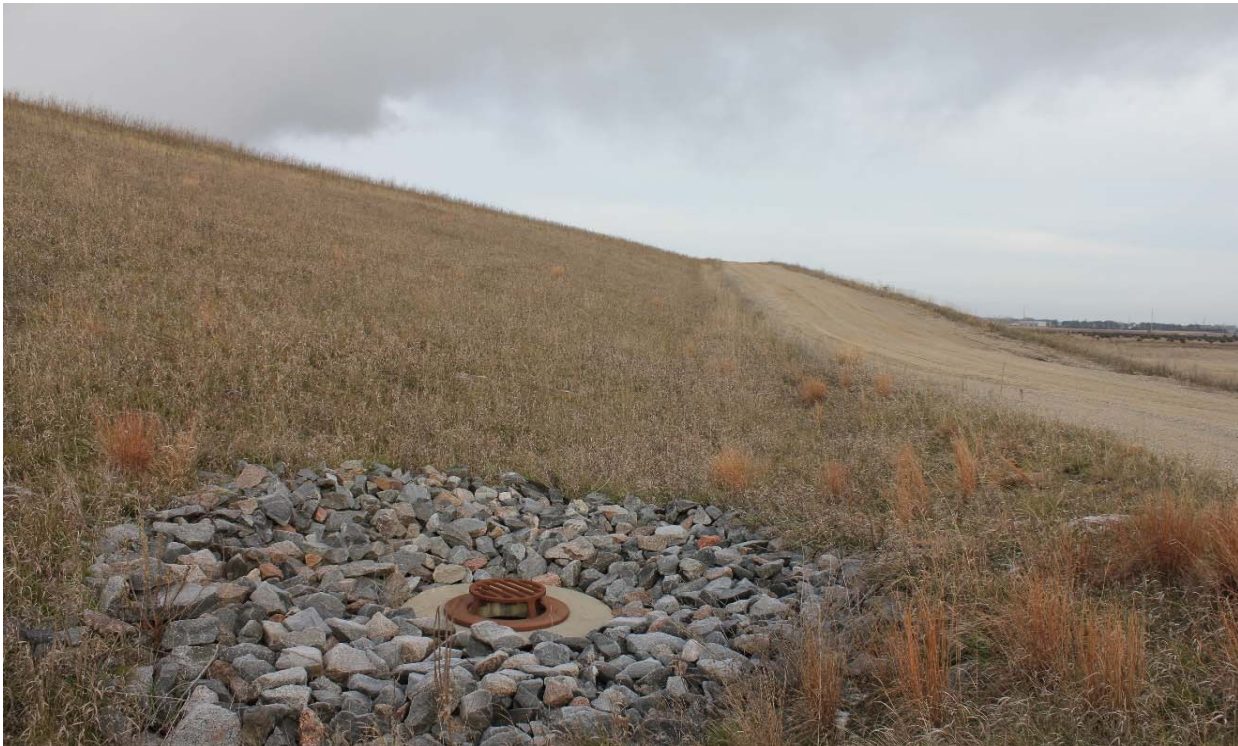
Photo 2	East embankment north ramp and stormwater inlet, looking north.
11/8/2017

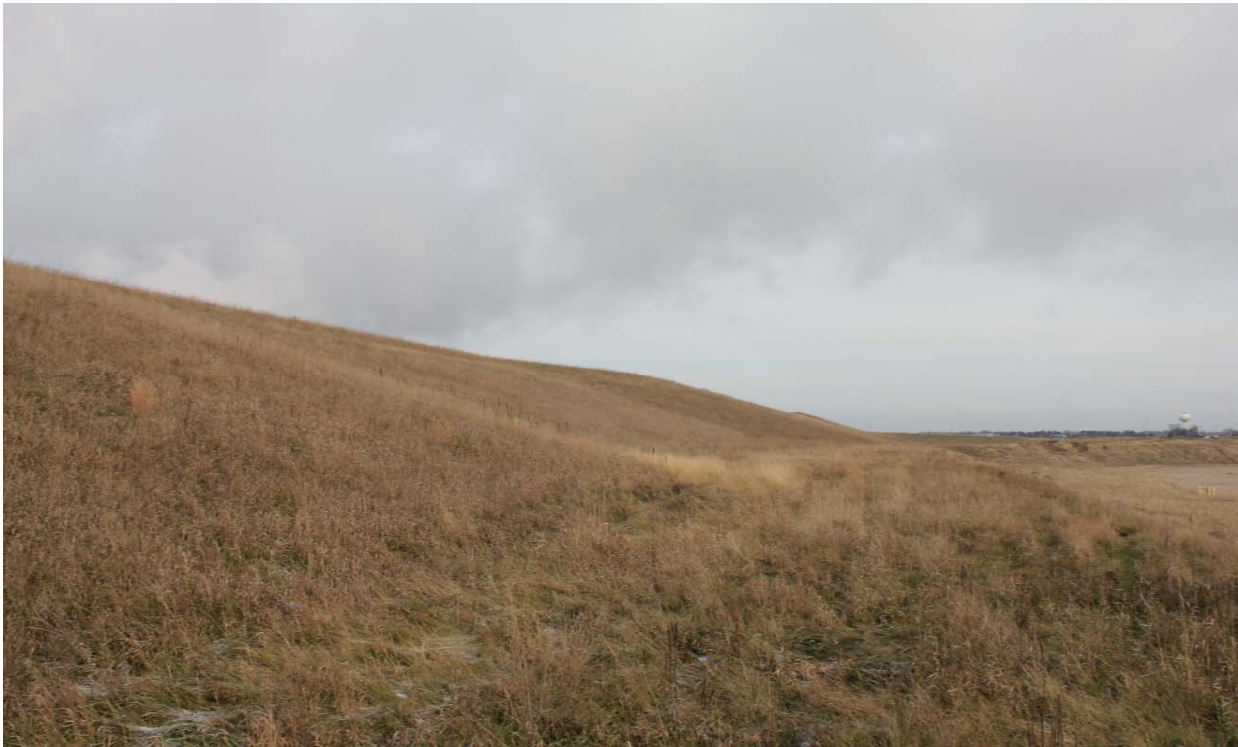
Photo 15	Pond east embankment, looking north.
11/8/2017

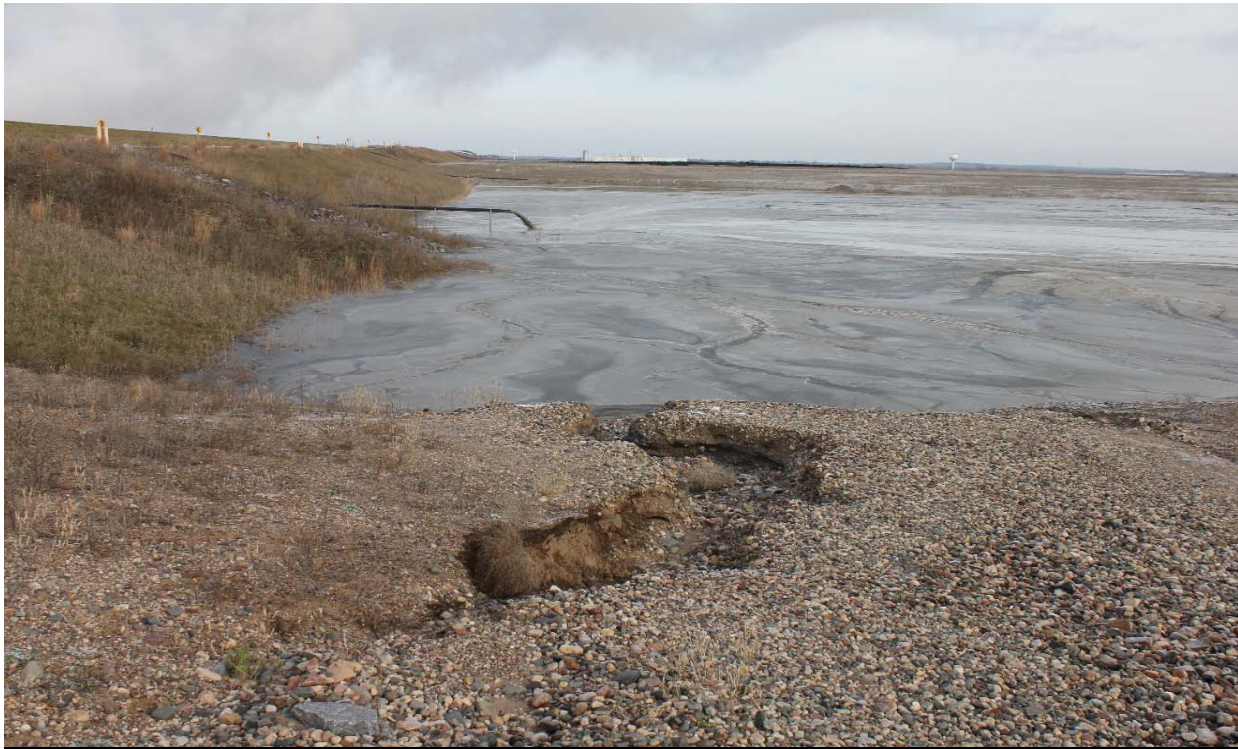
Photo 19	Pond interior west embankment, looking north.
11/8/2017

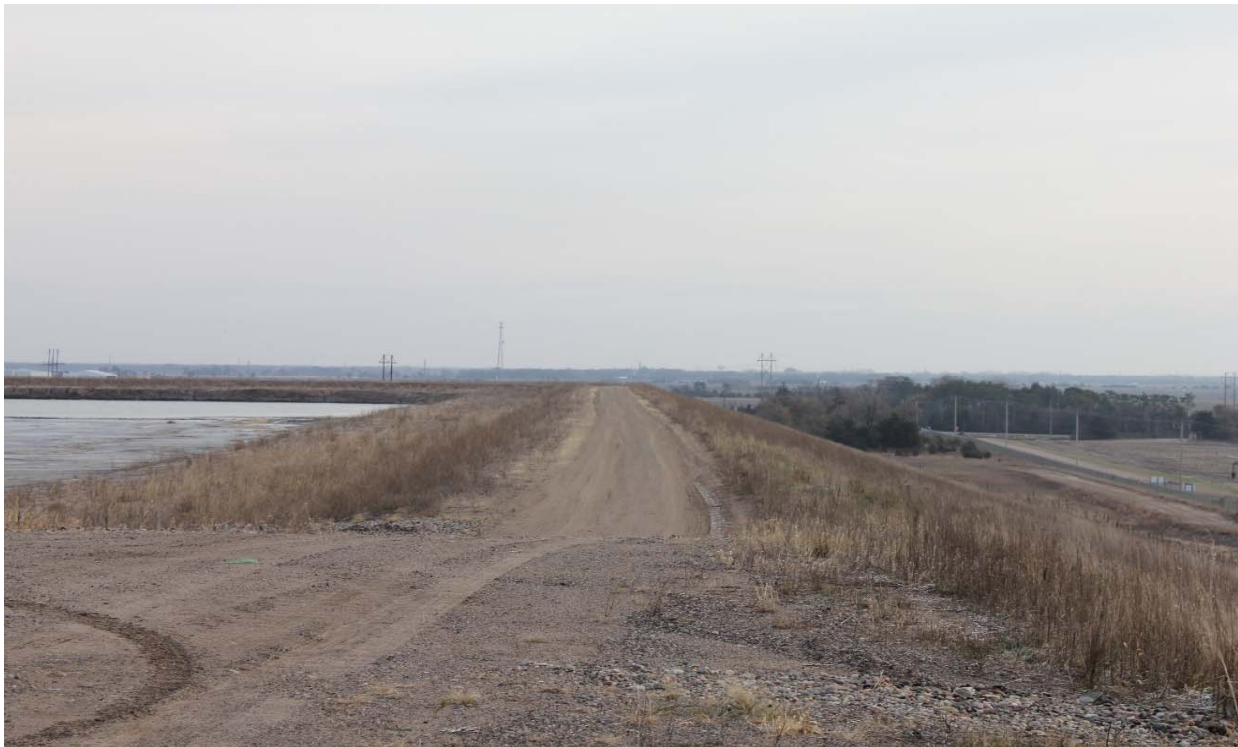
Photo 20	Top of pond south embankment, looking east
11/8/2017

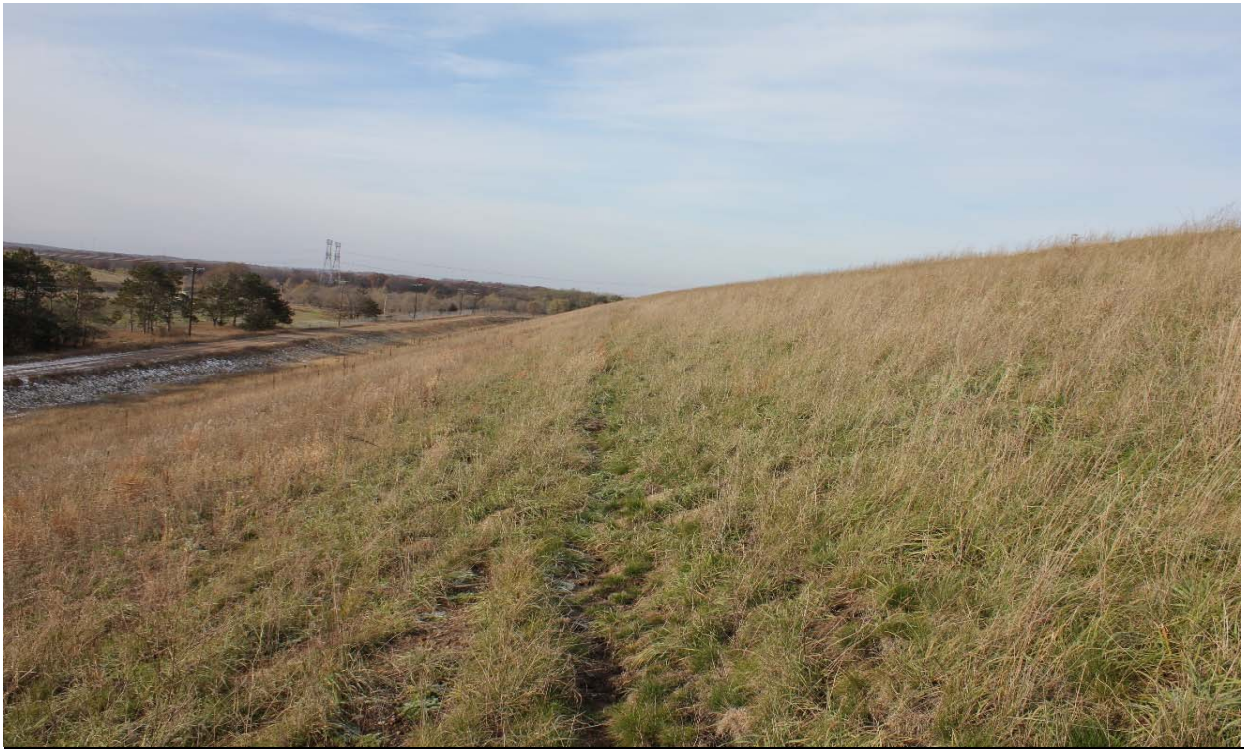
Photo 21	Mid-slope of south embankment, looking west.
11/8/2017

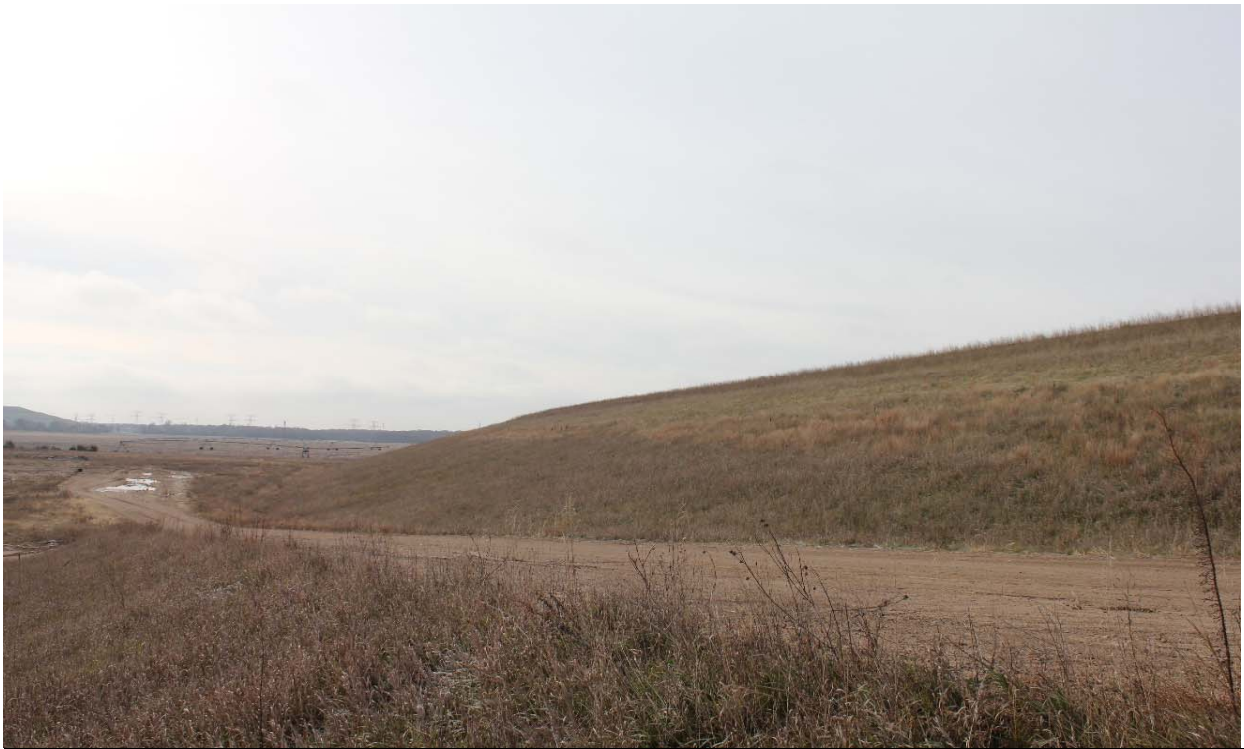
Photo 22	Pond southeast ramp and embankment, looking south.
11/8/2017

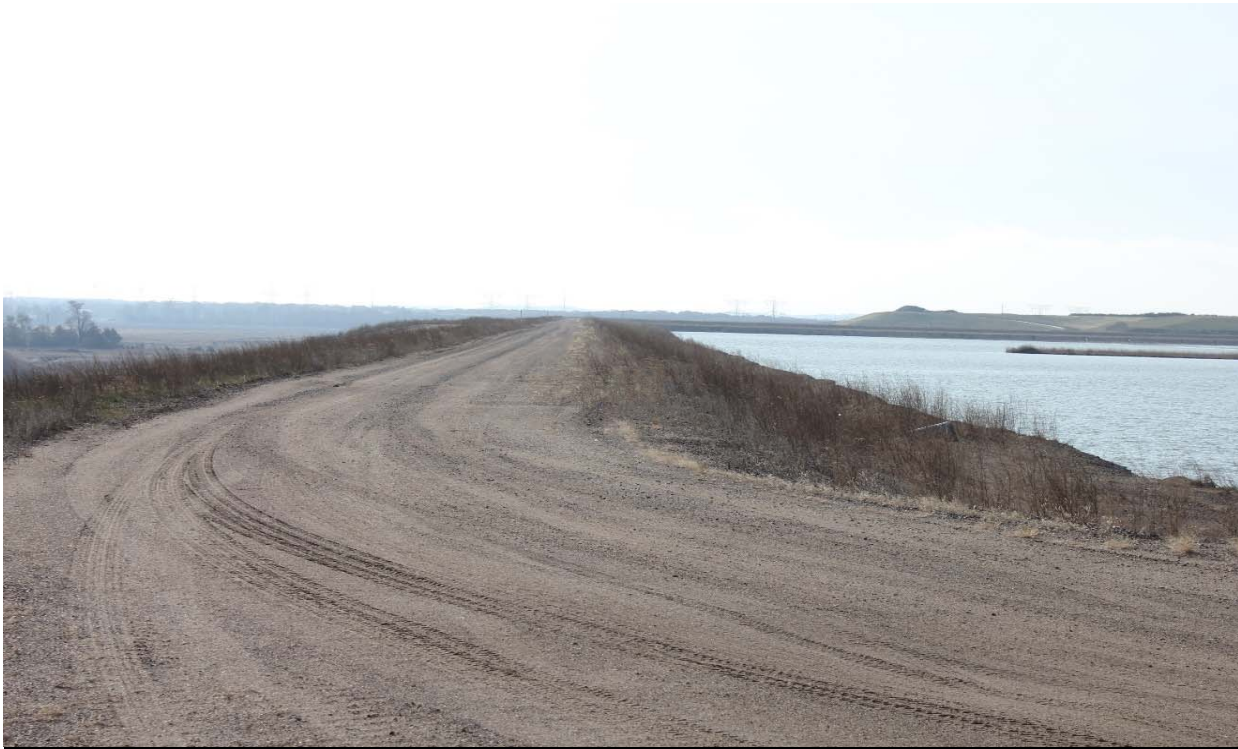
Photo 25	Top northeast corner of east embankment, looking south.
11/8/2017

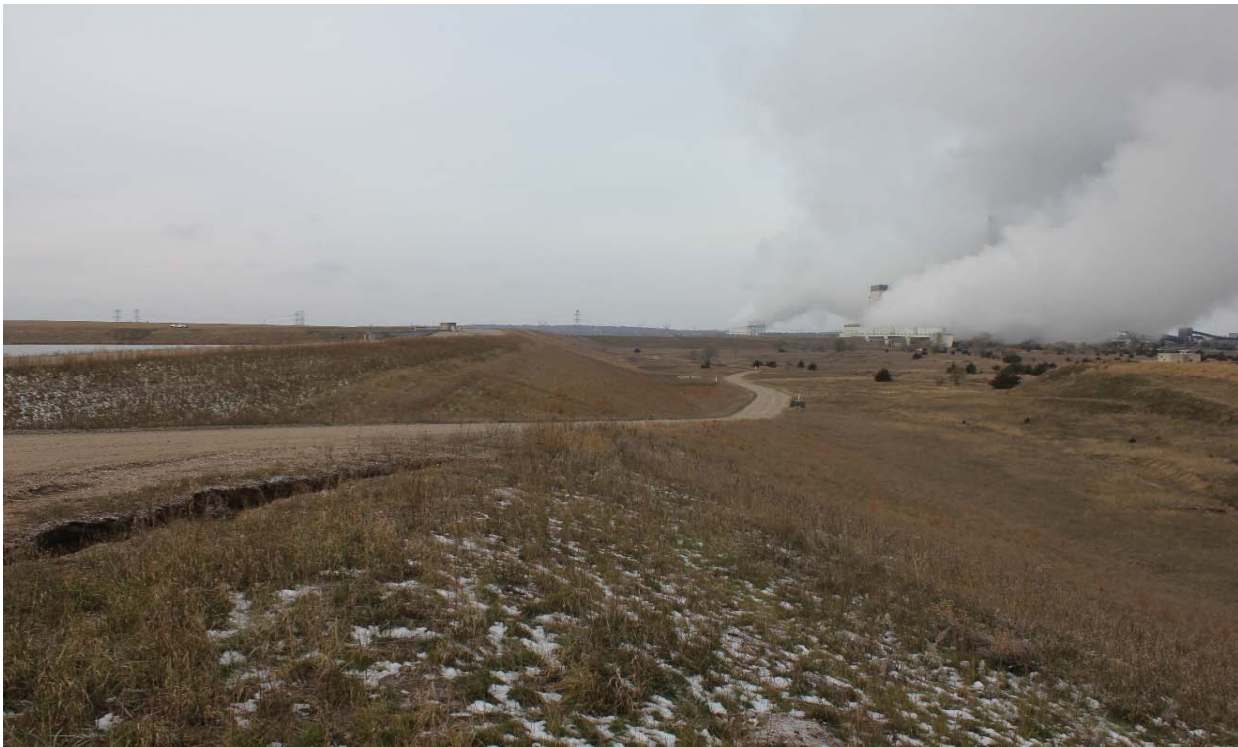
Photo 26	Top northeast corner of north embankment and small eroded channel, looking west.
11/8/2017

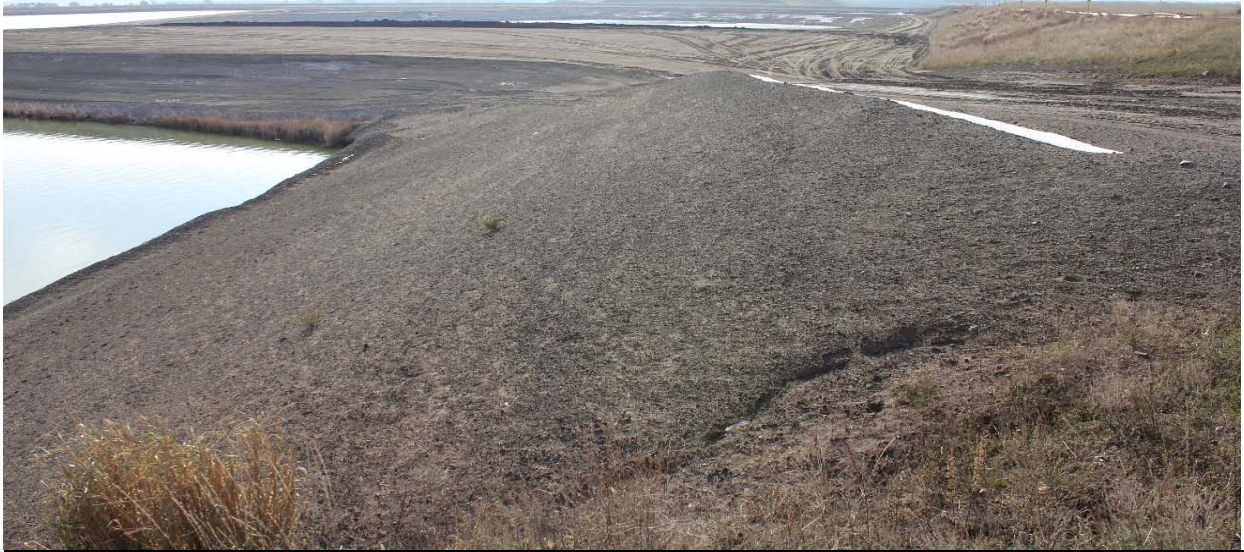
Photo 29	Pond interior west slope and bottom ash diking, looking south.
11/8/2017

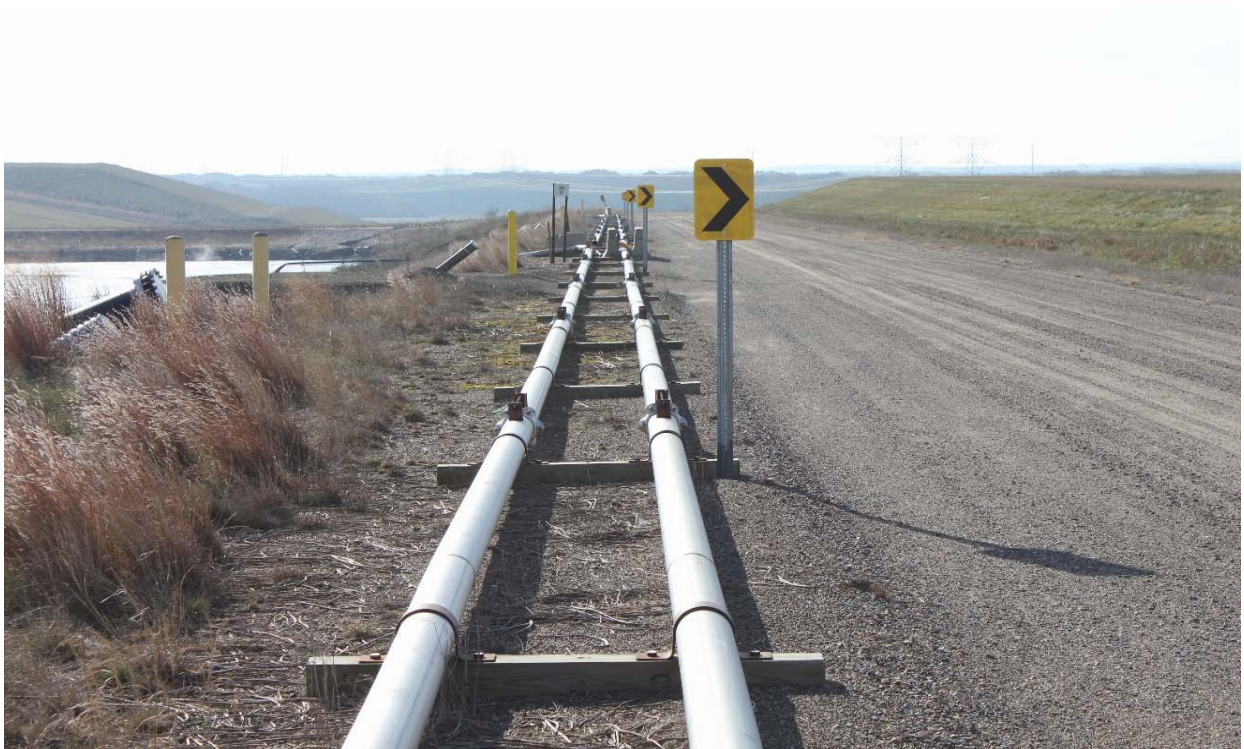
Photo 30	Foreground: Pond stainless steel scrubber solid pipes. Middle-left: CCR angled well.
11/8/2017
