Re: 2018 Annual Inspection of Unit 3 Landfill

FIGURE 1
UNIT 3 LANDFILL 2018
ANNUAL INSPECTION
PHOTO LOCATIONS

Unit 3 Landfill Annual Inspection - 2018

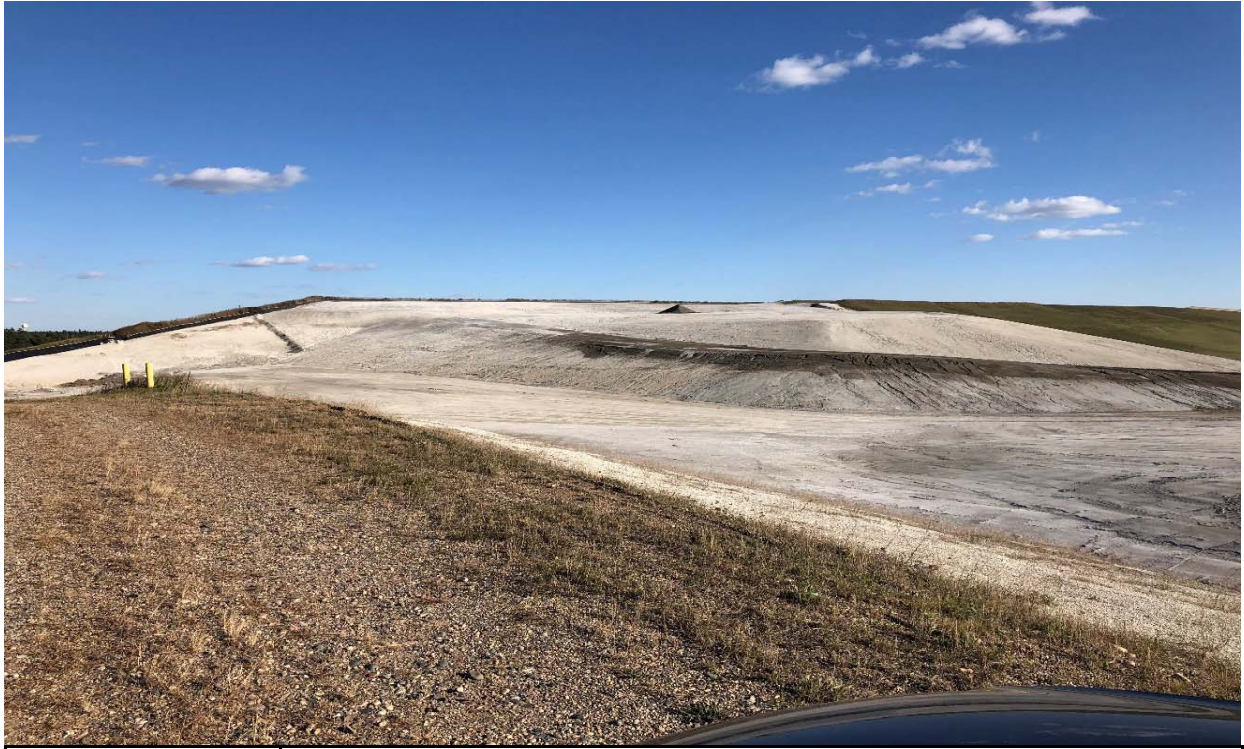
| Photo 1 | Open portion of the landfill, looking east. |

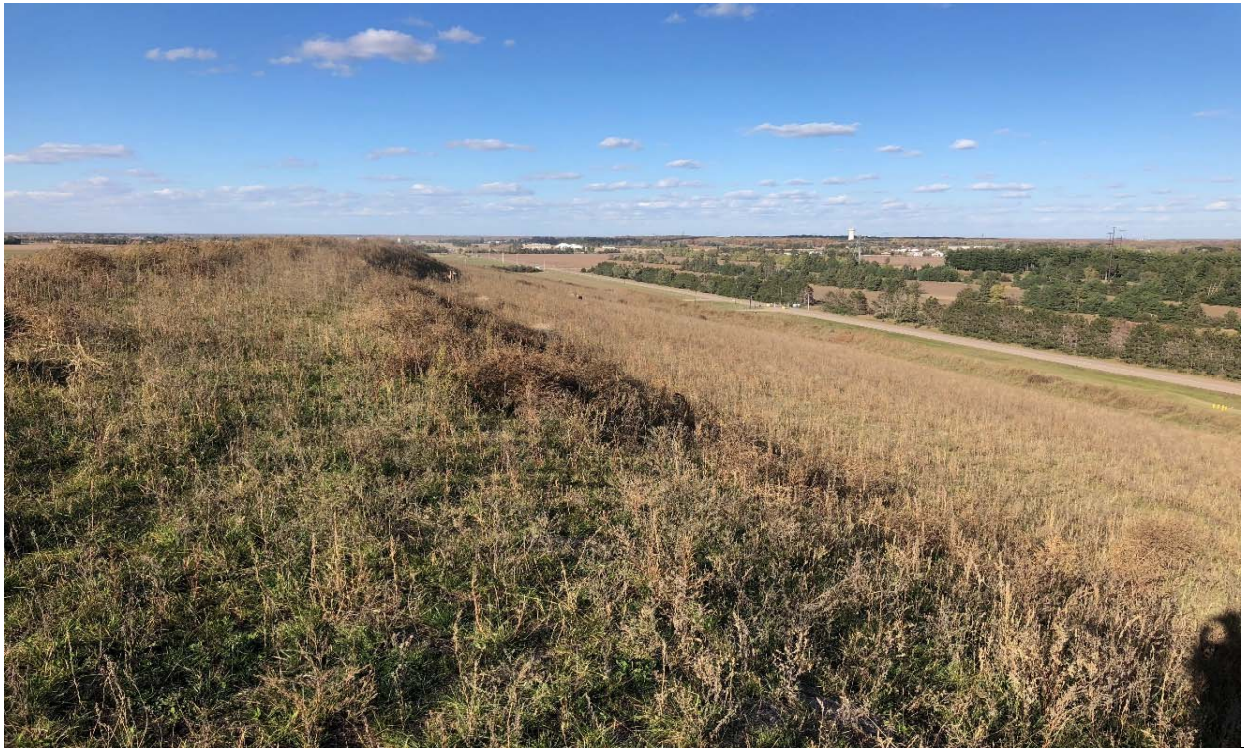
| Photo 2 | East side of the landfill embankment, looking north. |

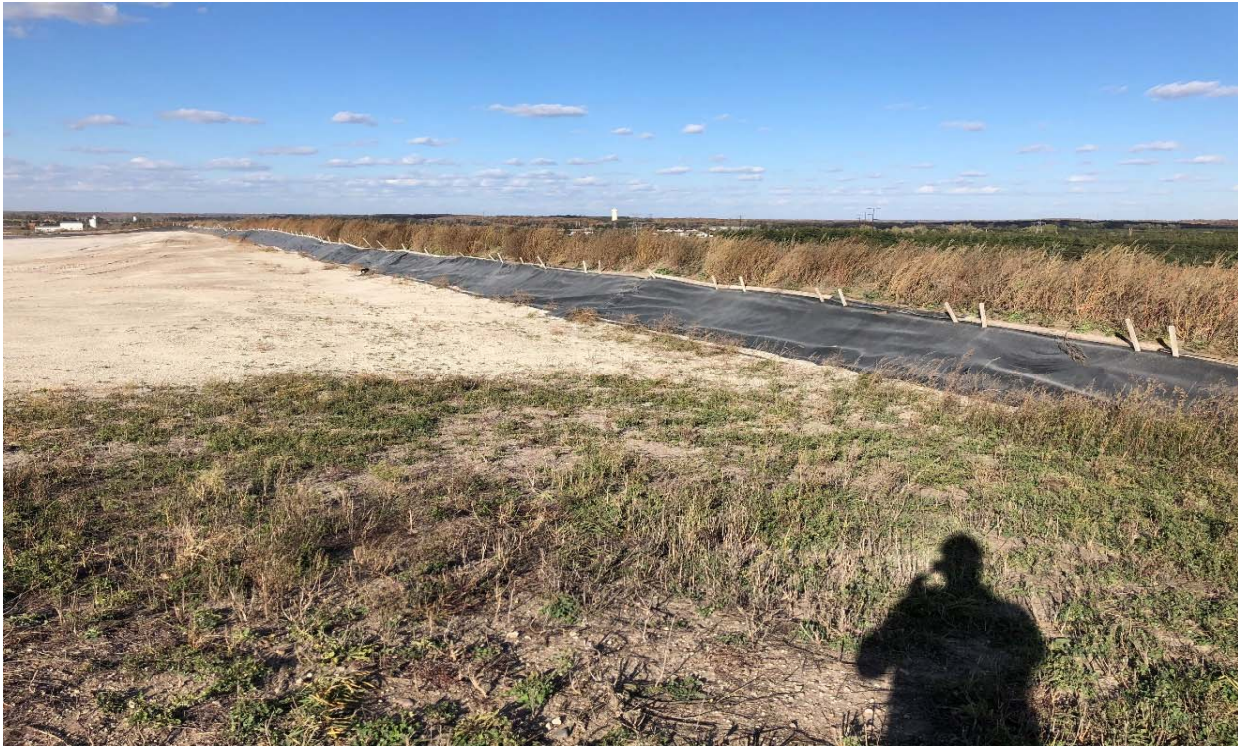
| Photo 3 | Leachate run-off containment flap along edge of final cover, looking northeast. |

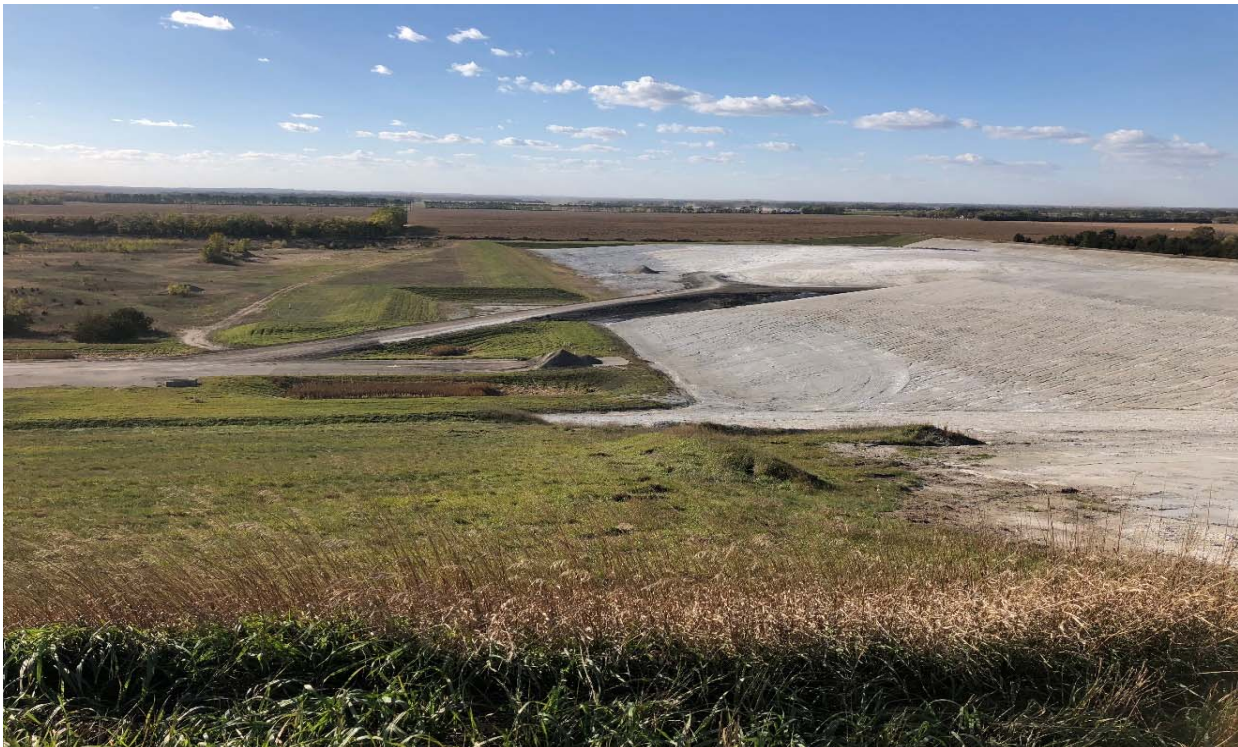
| Photo 4 | Run-on/run-off containment berm along south side of open area, looking west. |

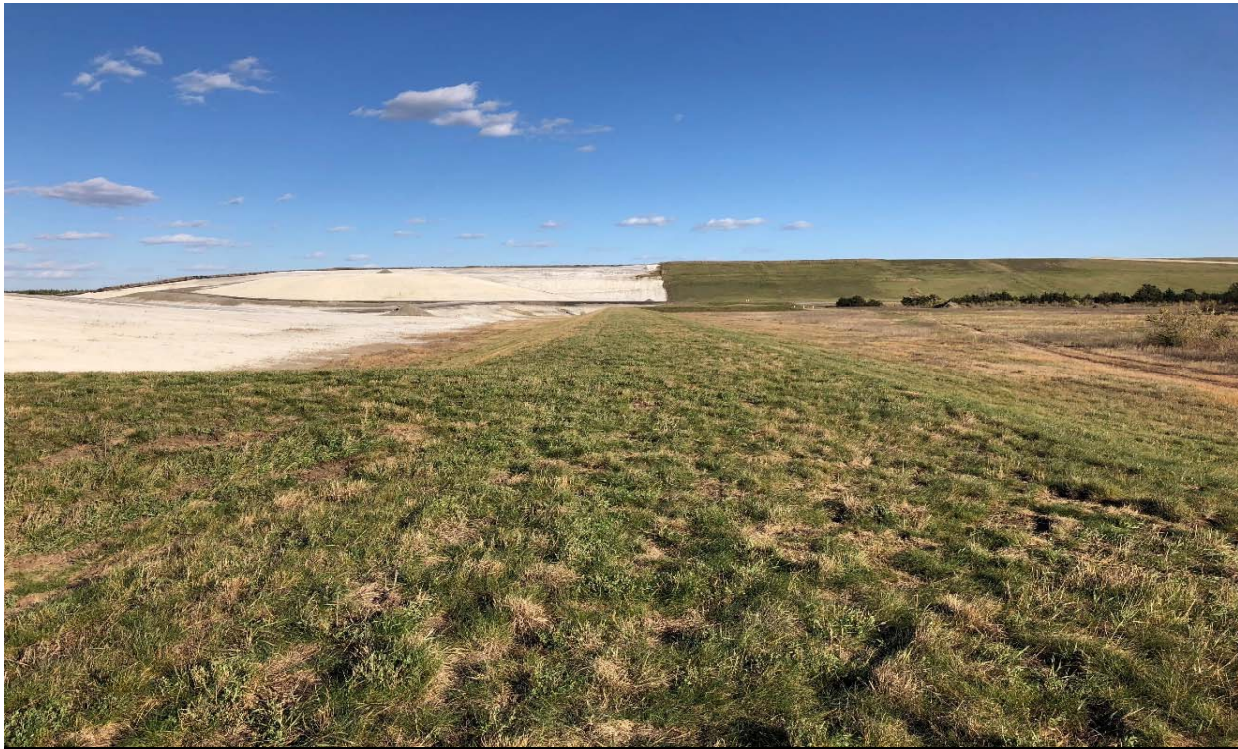
| Photo 5 | Run-on/run-off containment berm along south side of open area, looking east. |

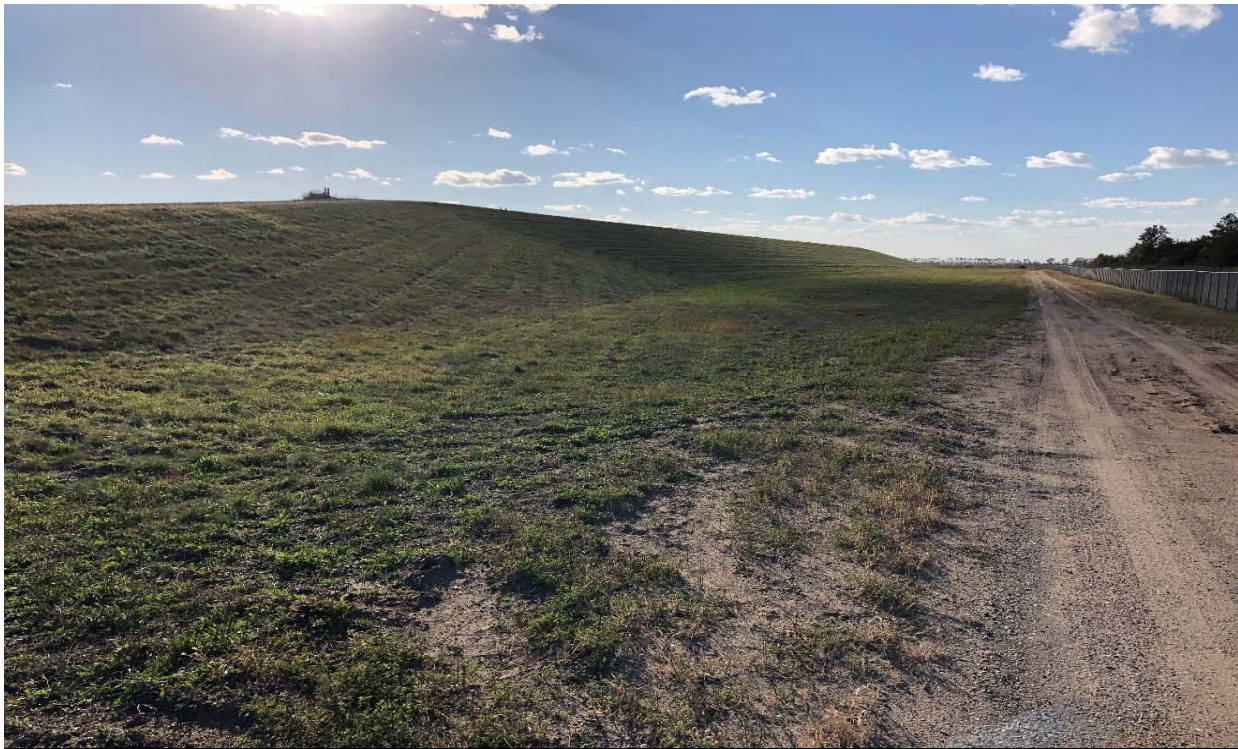
| Photo 6 | Exterior of north embankment, looking west. |

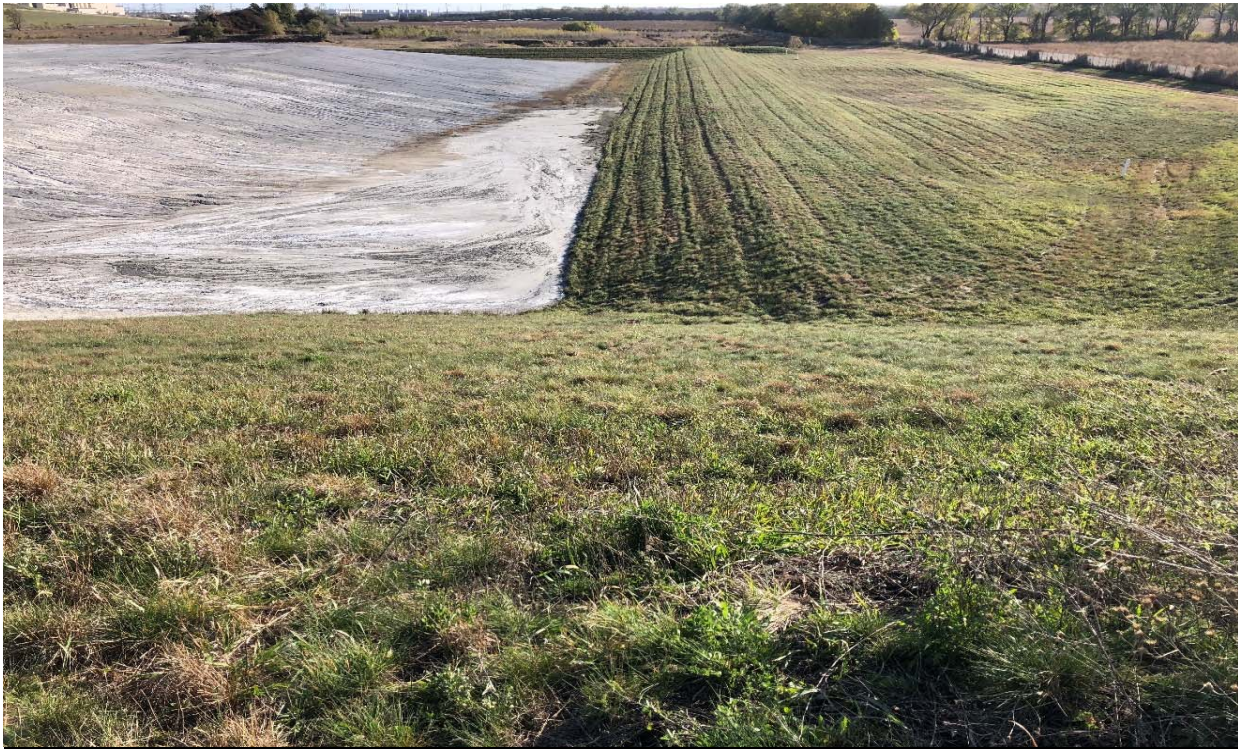
| Photo 7 | Run-on/run-off containment berm along west side of landfill, looking south. |

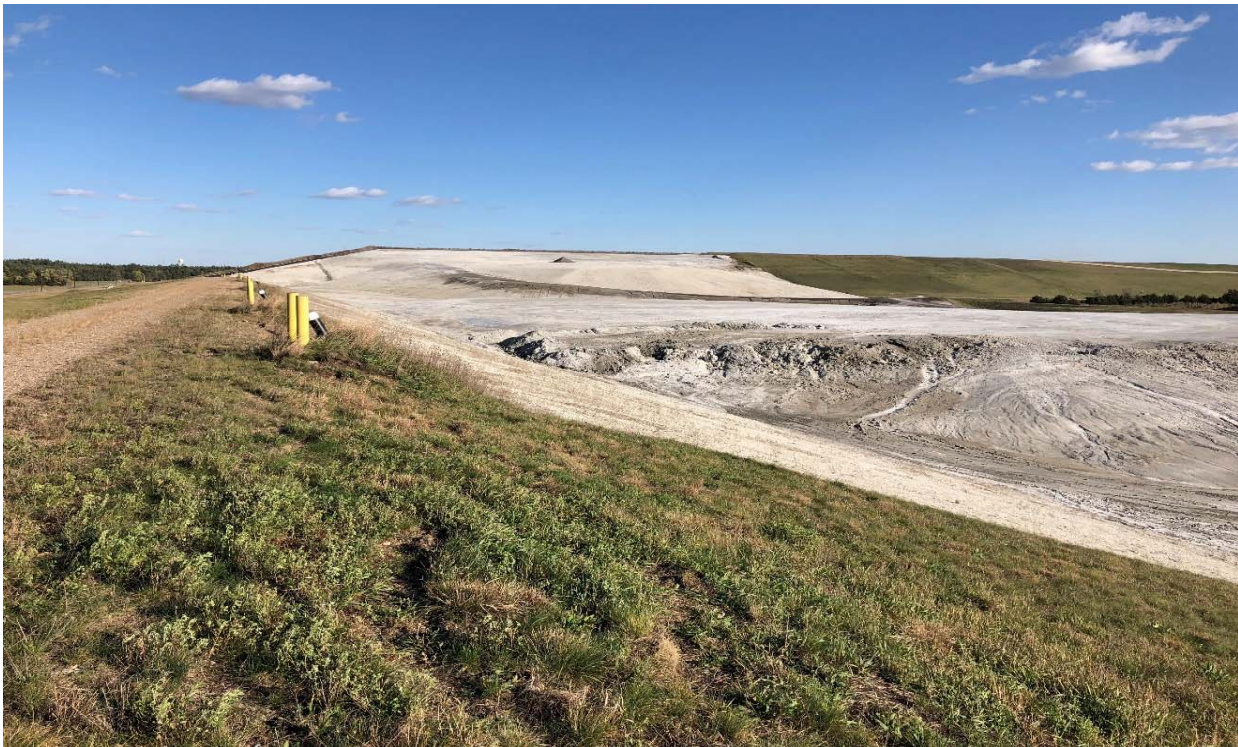
| Photo 8 | Edge of access road on top of north embankment, looking east. |

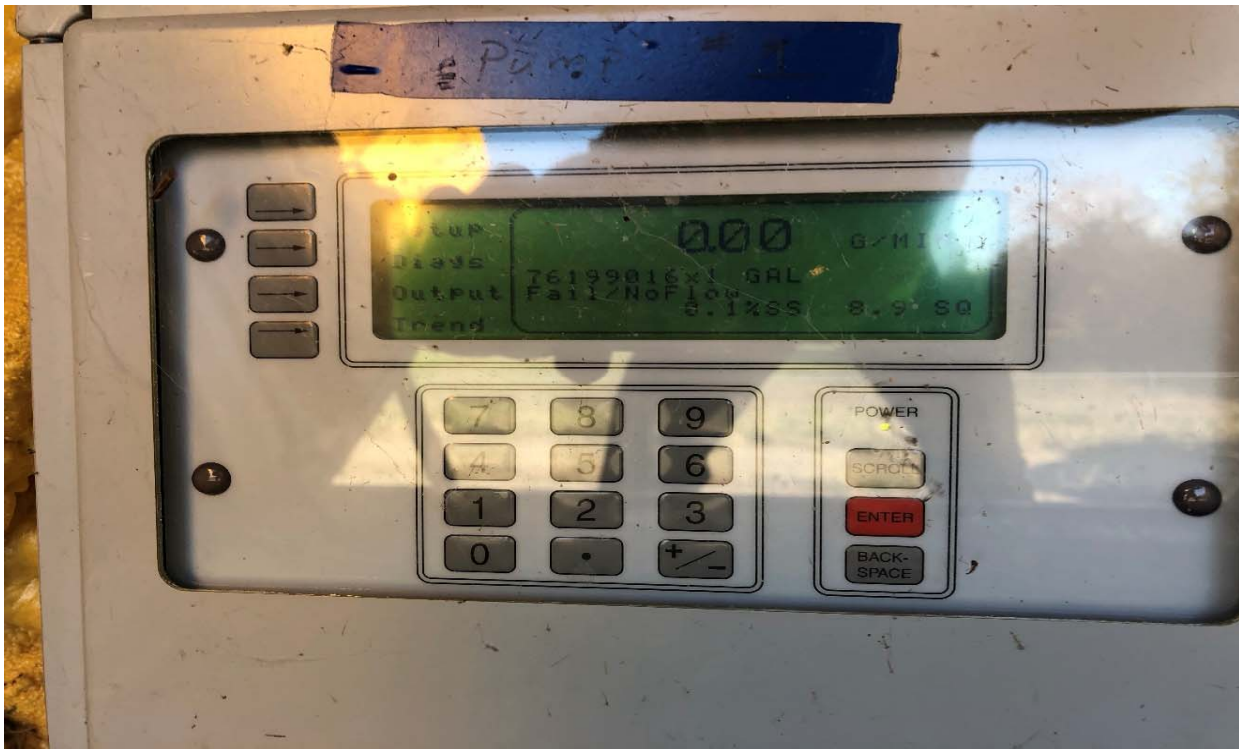
| Photo 9 | Display screen on properly function Pump No. 1. |

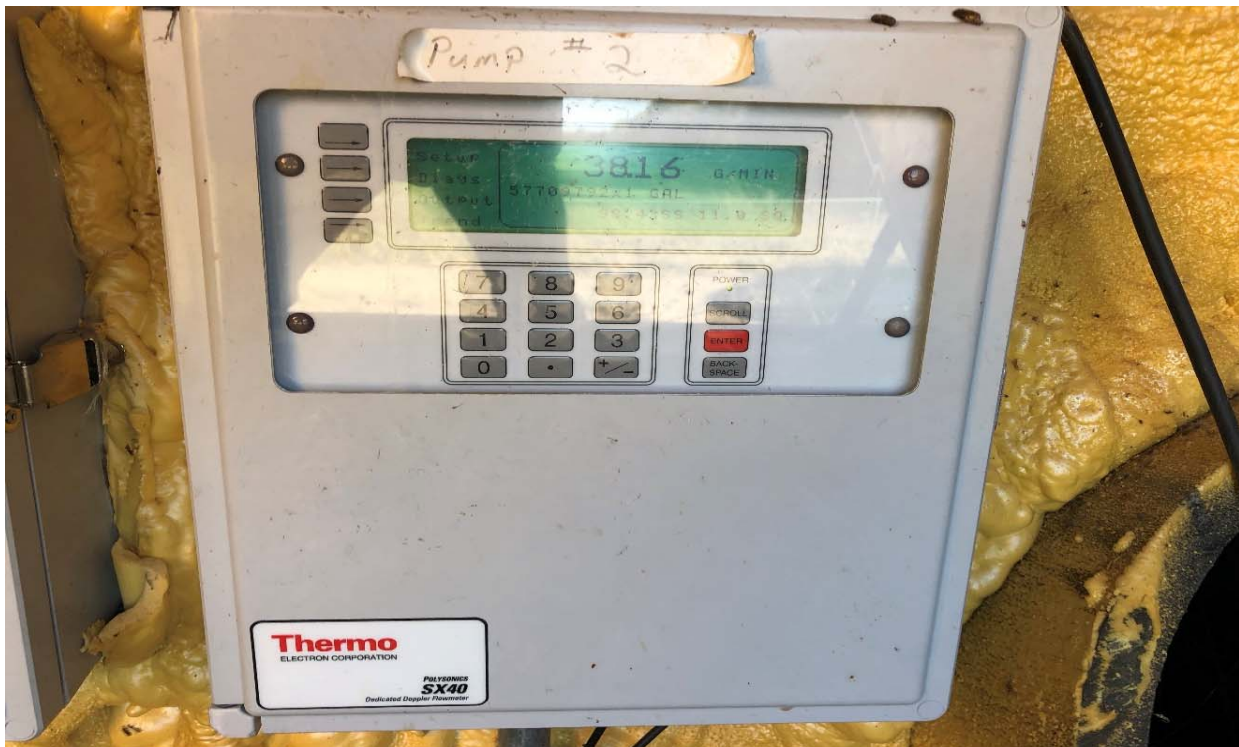
| Photo 10 | Display screen on properly function Pump No. 2. |

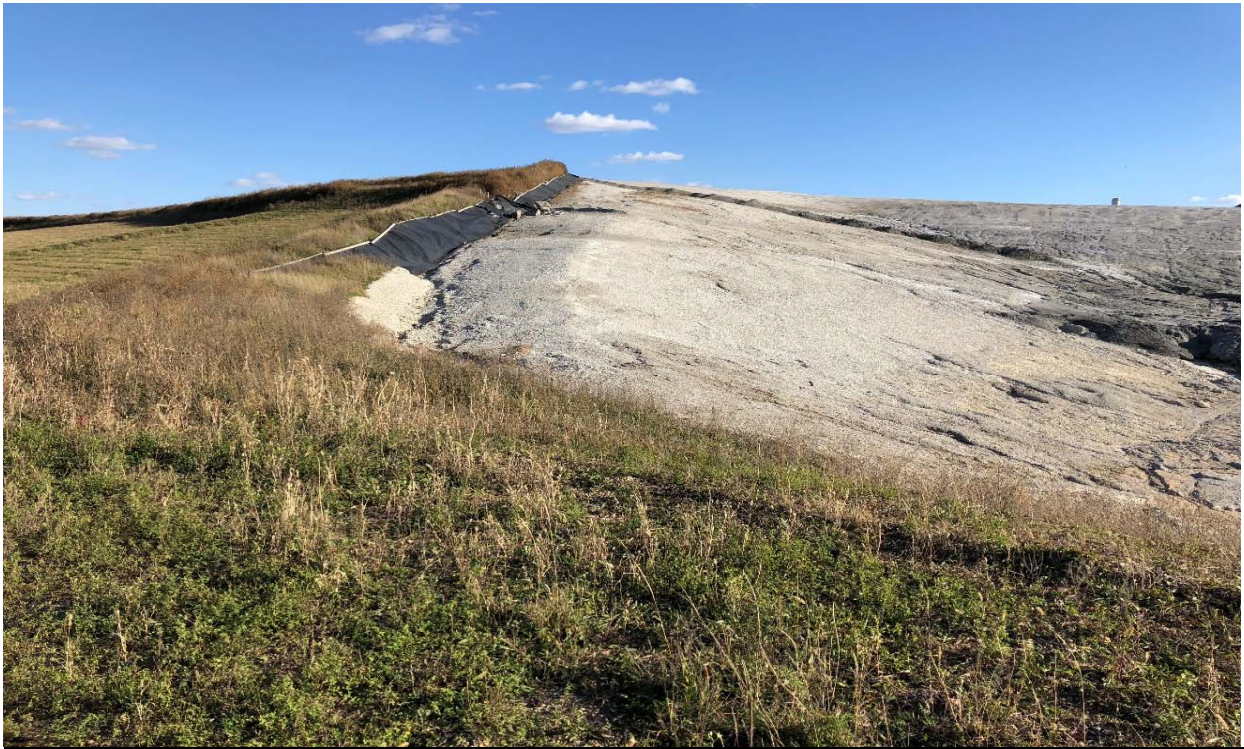
| Photo 11 | Containment berm along the north side of the landfill, looking southeast. |

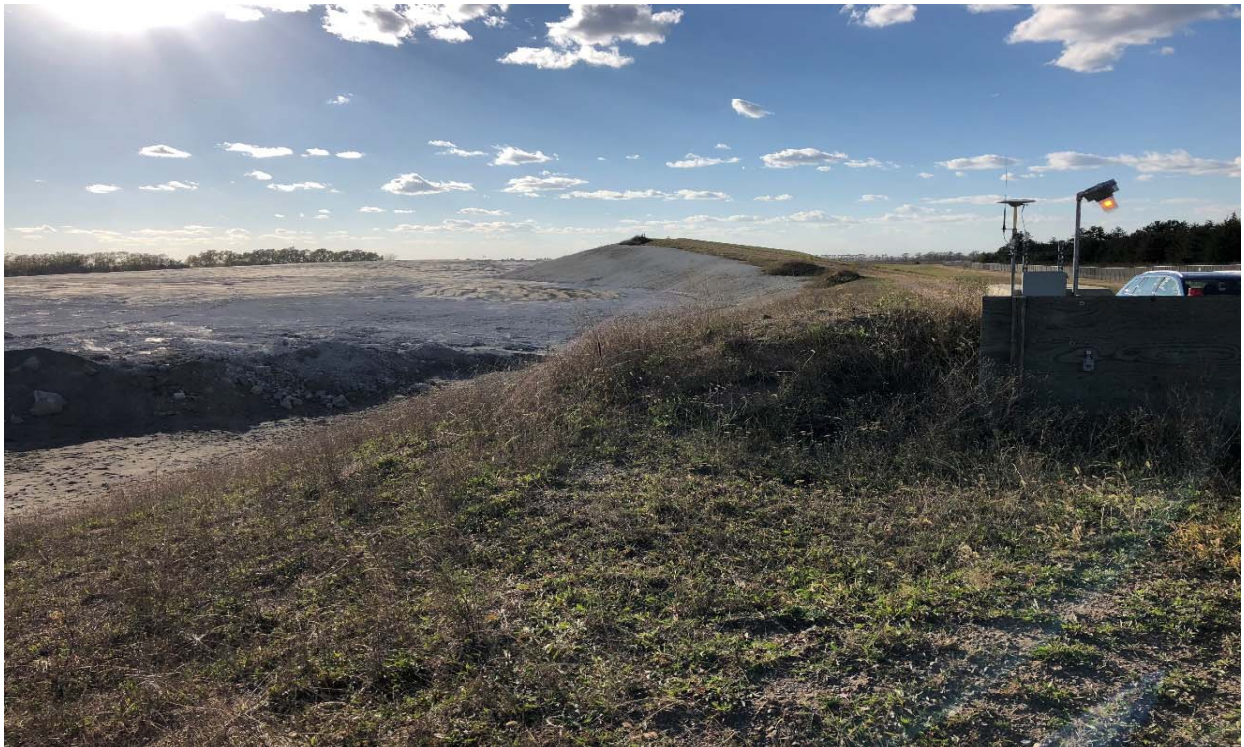
| Photo 12 | Open portion of landfill, looking west along interior of north slope. |
