Xcel Energy, Inc.  
Sherburne County Generating Station  
13999 Industrial Blvd.  
Becker, MN 55308

**Re: 2019 Annual Inspection of Unit 3 Landfill**

## Unit 3 Landfill Annual Inspection - 2019

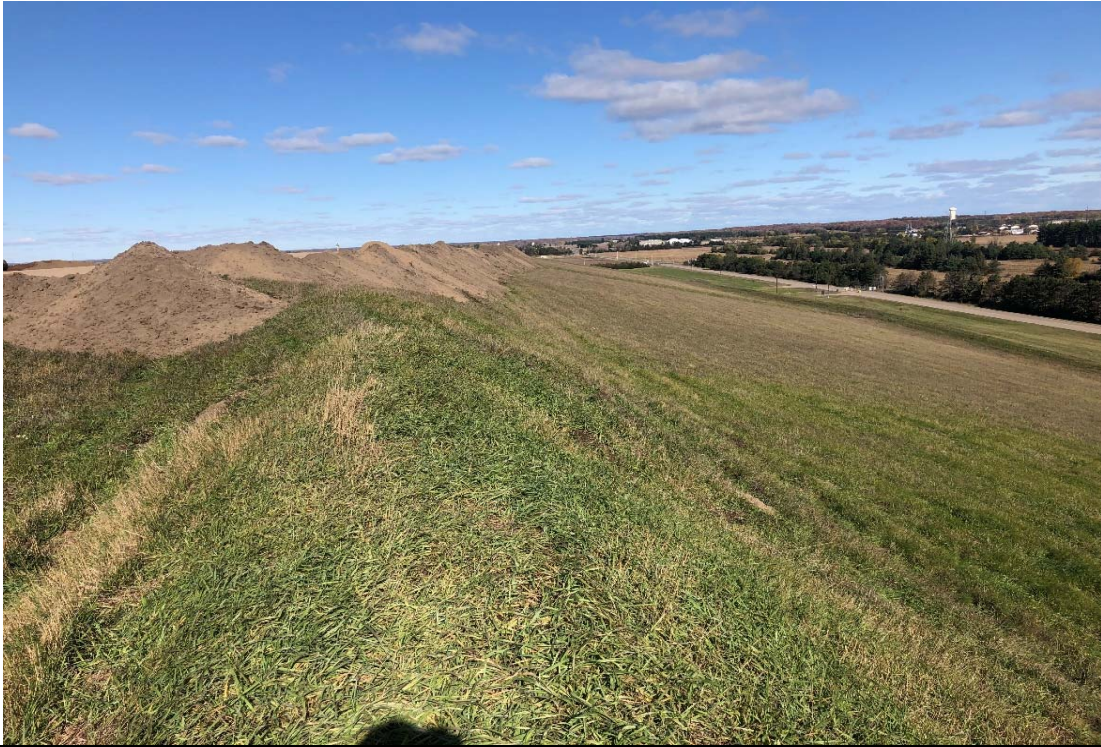
Photo 1	Left: construction of new final cover. Right: existing final cover
10/24/2019	(constructed in 2017), looking north.

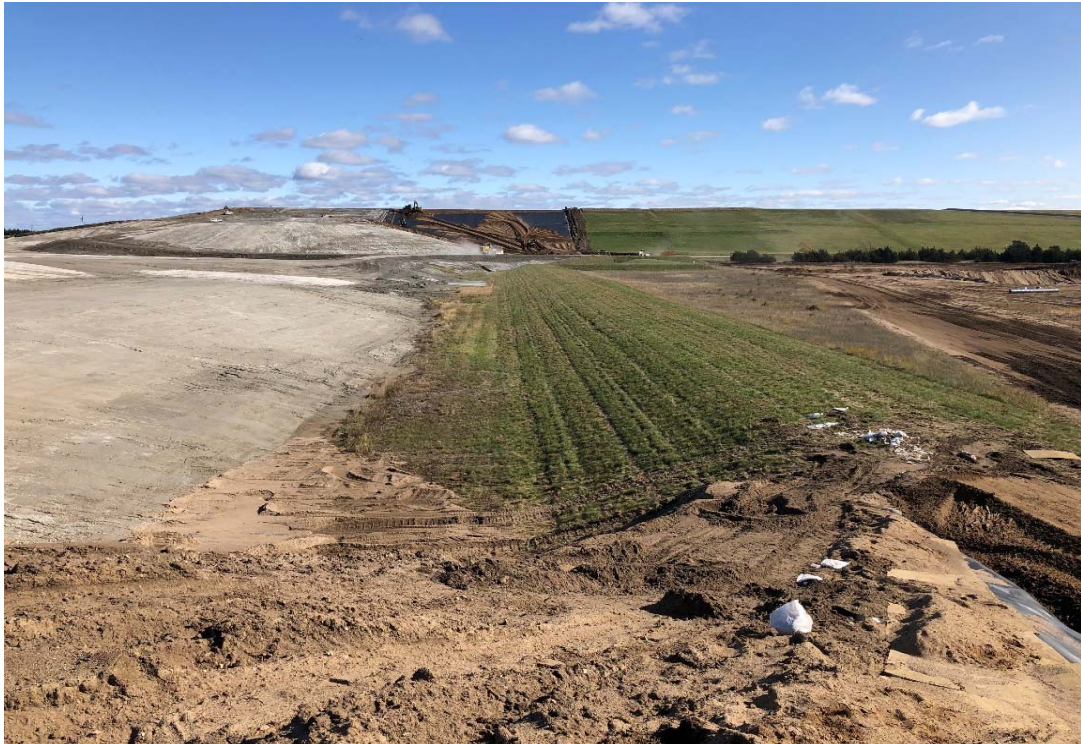
Photo 2	Run-on/run-off control berm, looking east.
10/24/2019

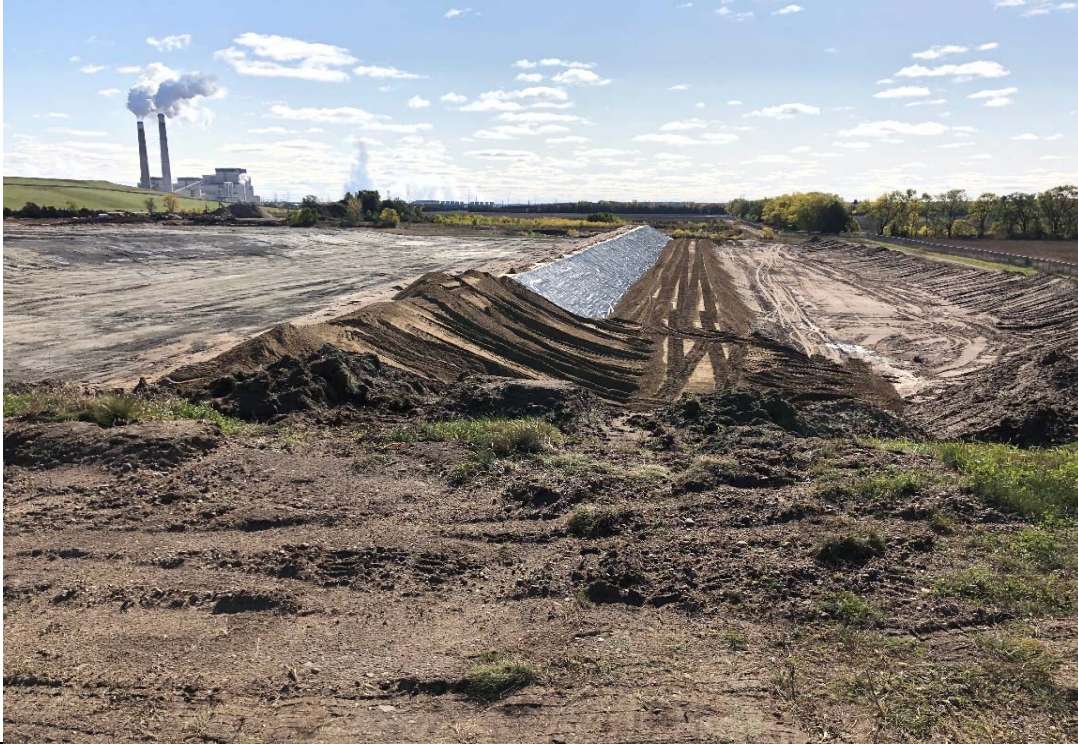
Photo 3	Left: active area of landfill. Center: final cover construction project, looking south.
10/24/2019

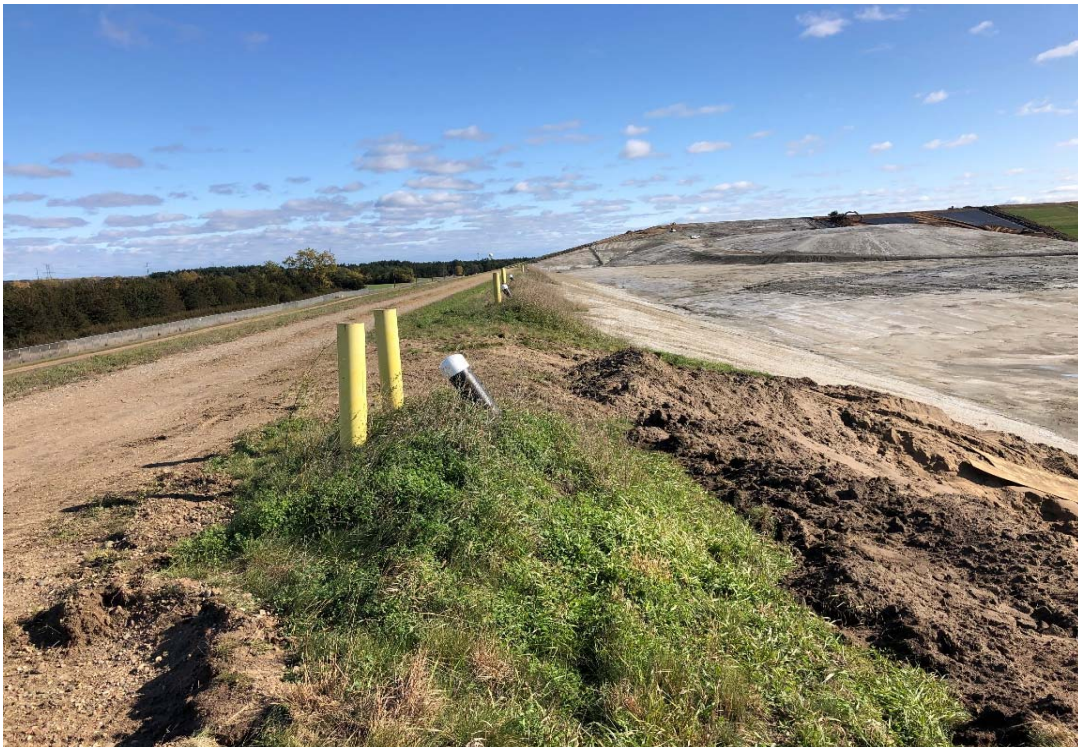
Photo 4	Interior of north berm, looking east.
10/24/2019

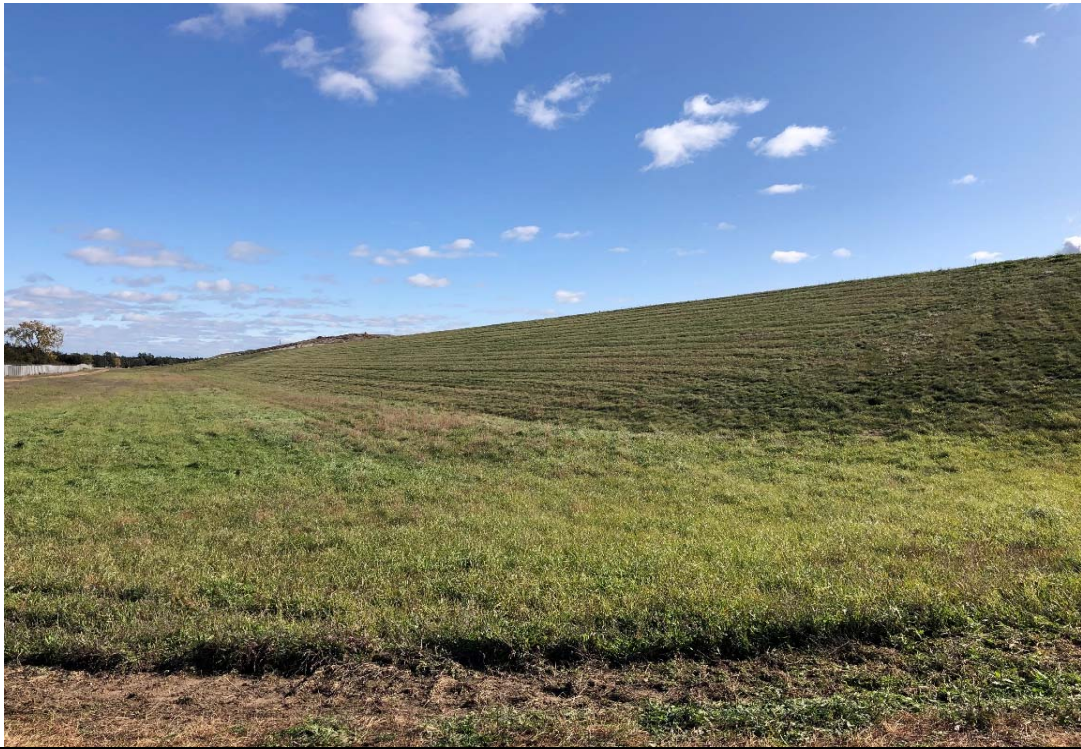
Photo 5	Exterior of north berm, looking east.
10/24/2019

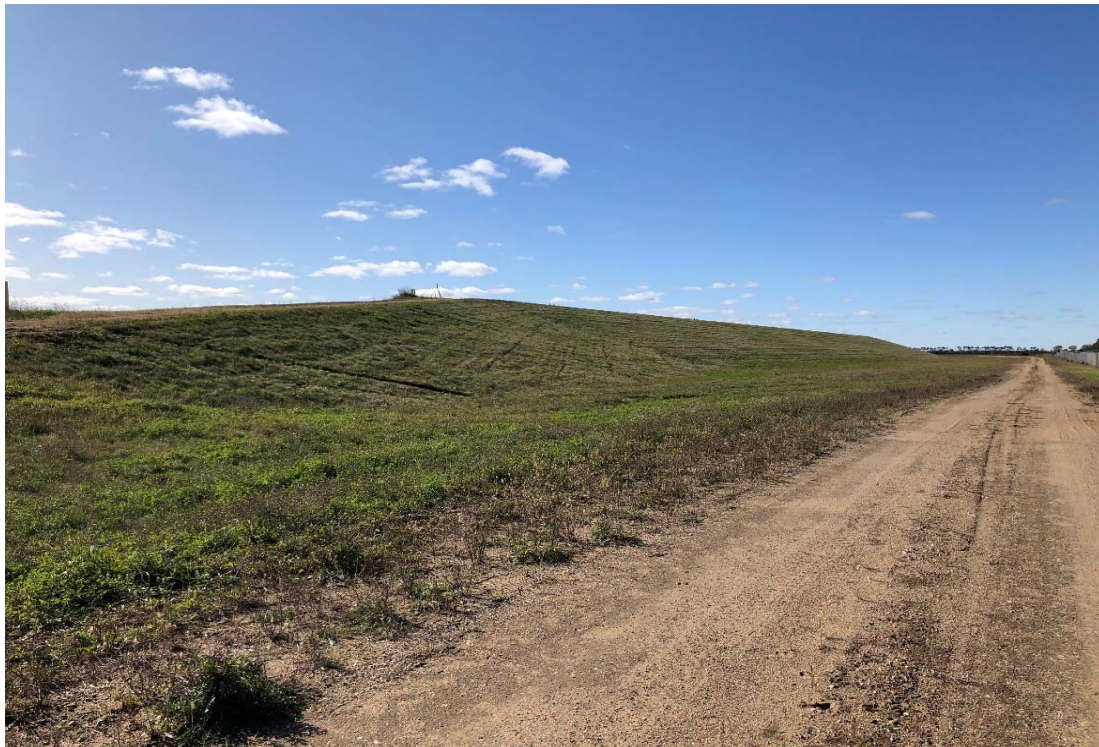
Photo 6	Exterior of north berm, looking west.
10/24/2019

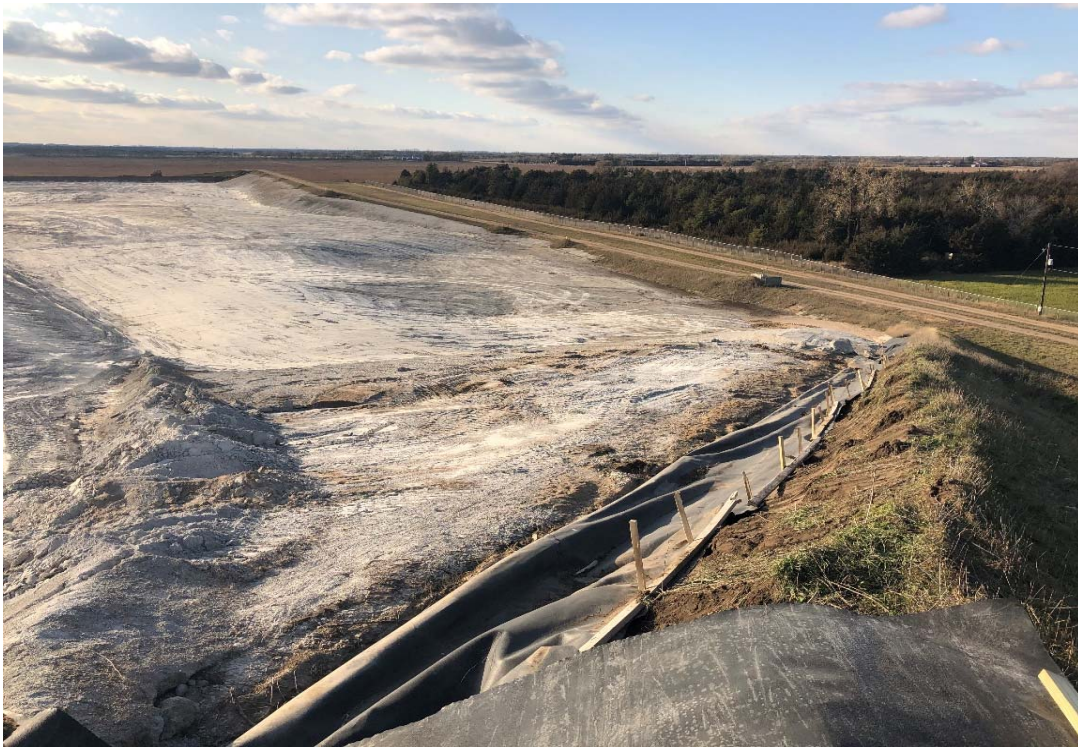
Photo 7	Run-on/run-off containment berm along east side of landfill, looking west.
10/24/2019

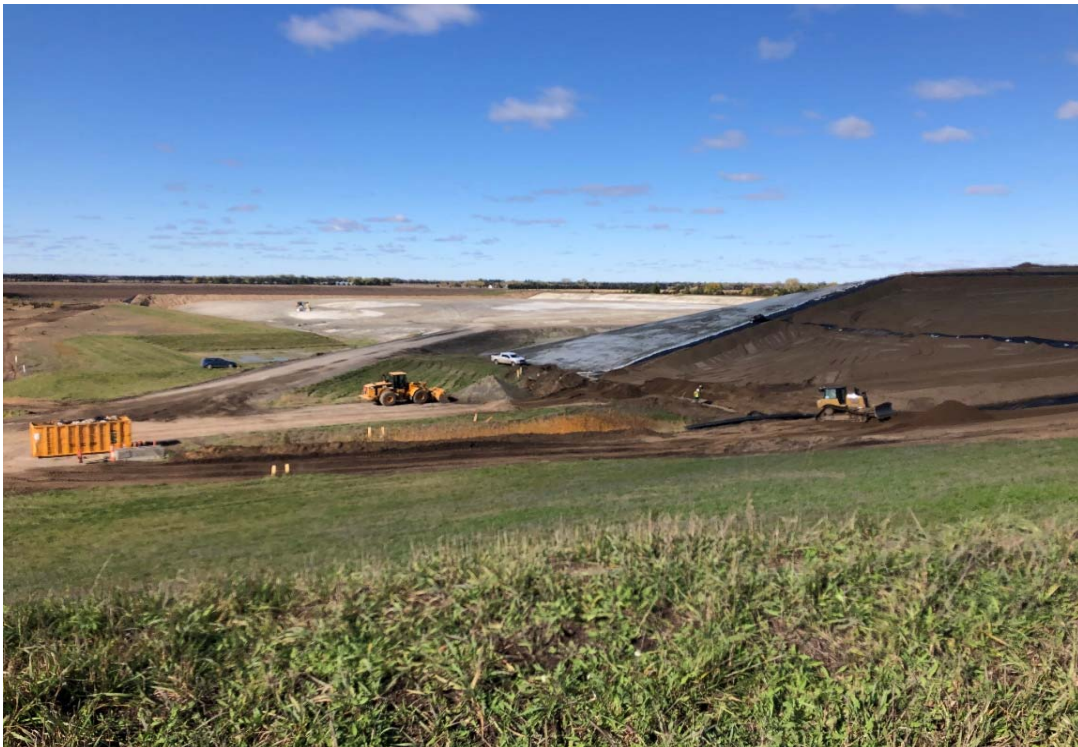
Photo 8	Foreground/right: final cover construction. Background/left: active area of landfill, looking west.
10/24/2019

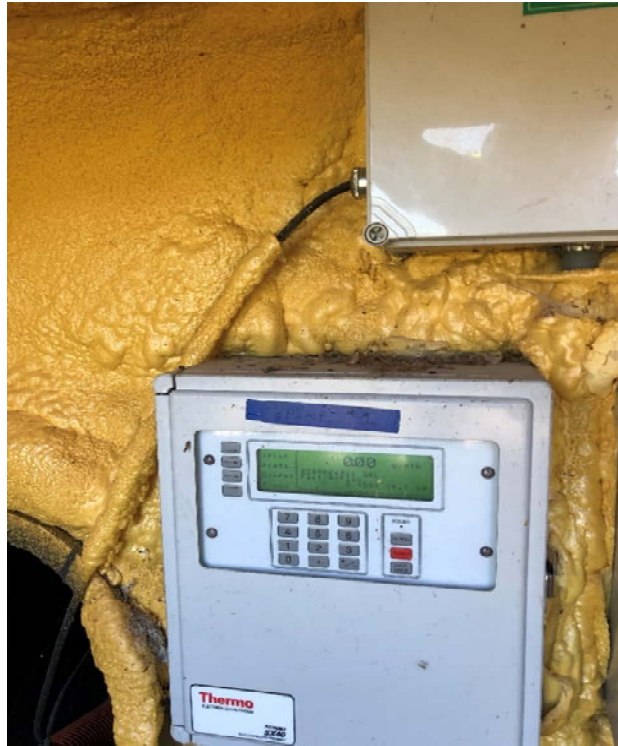
The active area sump panel controls and riser access panels were opened to verify that the leachate management system is functioning properly. There are no conditions disrupting the operation or safety of the CCR unit.

Photo 9	Display screen on properly functioning Pump No. 1.
10/24/2019
