Re: 2017 Annual Inspection of Unit 3 Landfill

Unit 3 Landfill Annual Inspection - 2017

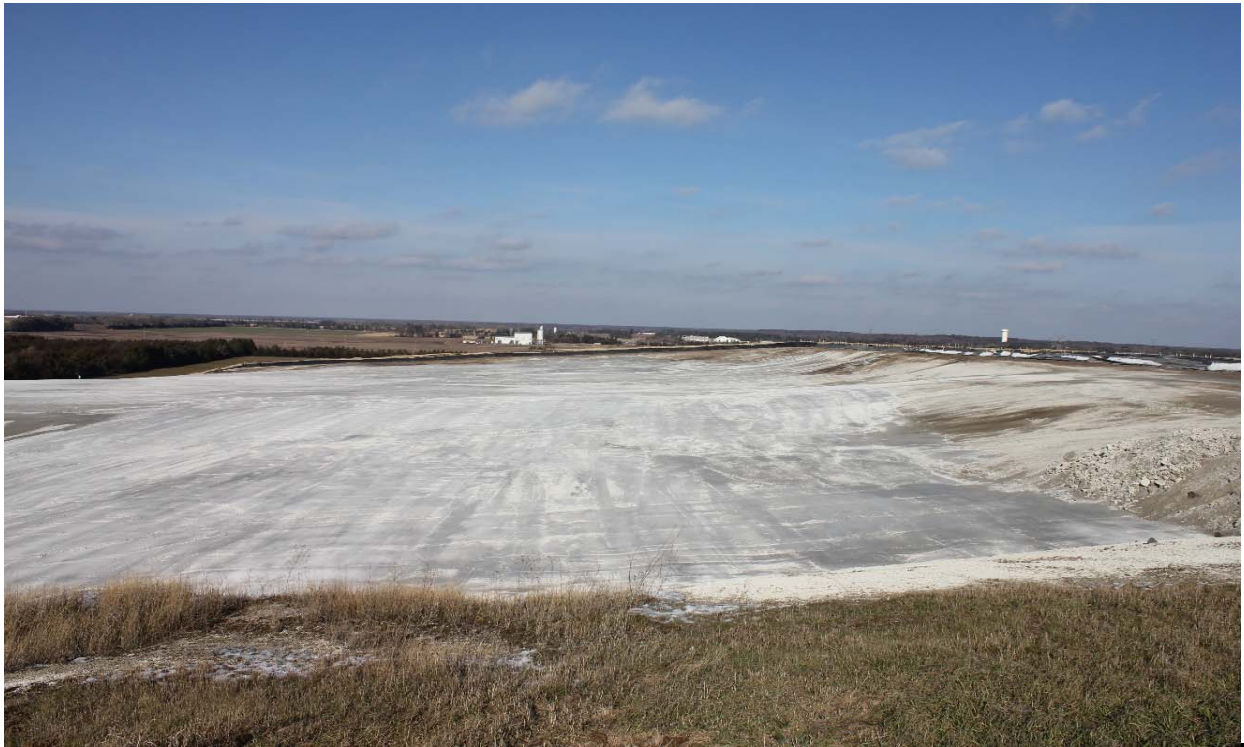
Photo 1	Open portion of the landfill, looking north.
11/8/2017

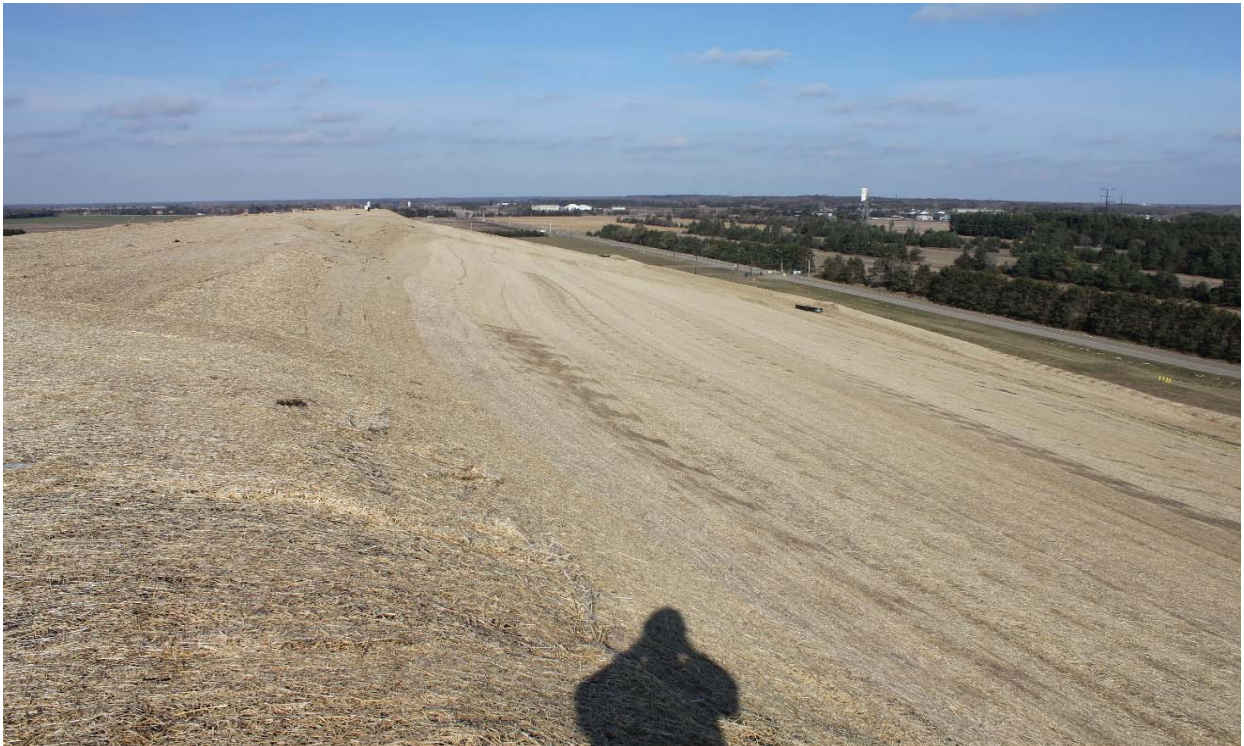
Photo 2	Newly installed final cover along the east side of the landfill, looking north.
11/8/2017

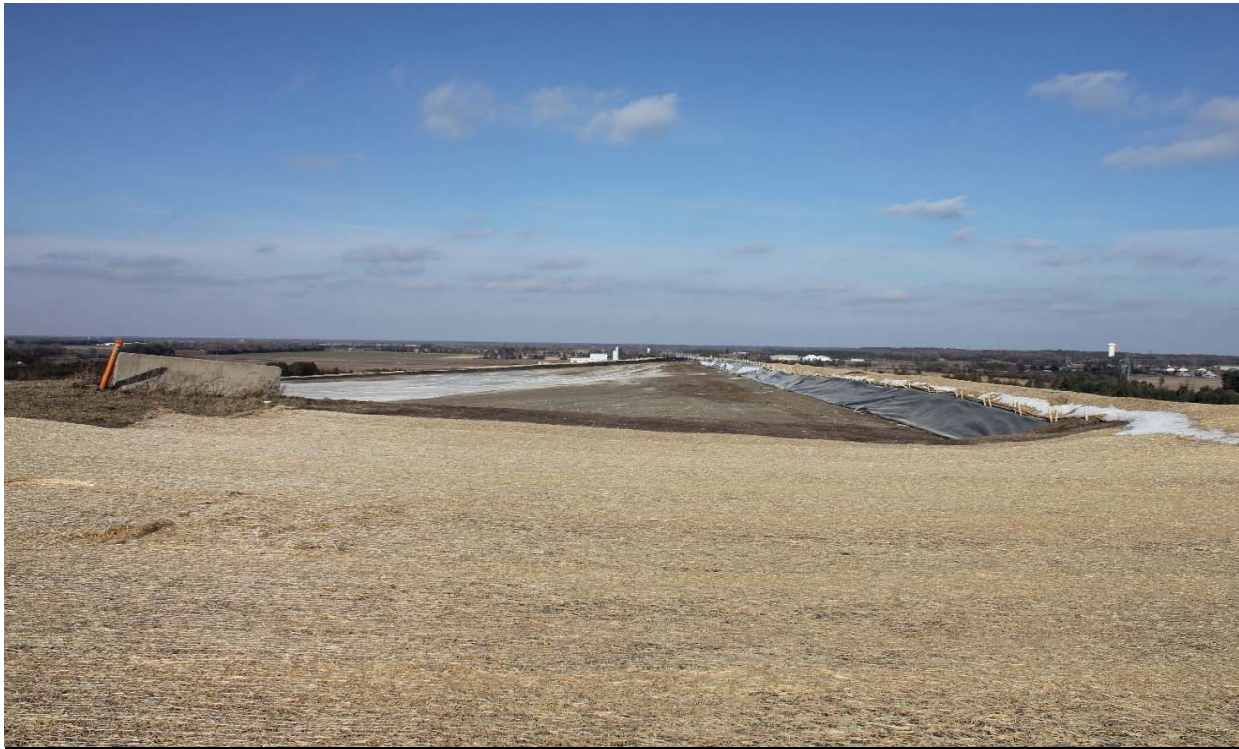
Photo 3	Leachate run-off containment flap along edge of final cover, looking north.
11/8/2017

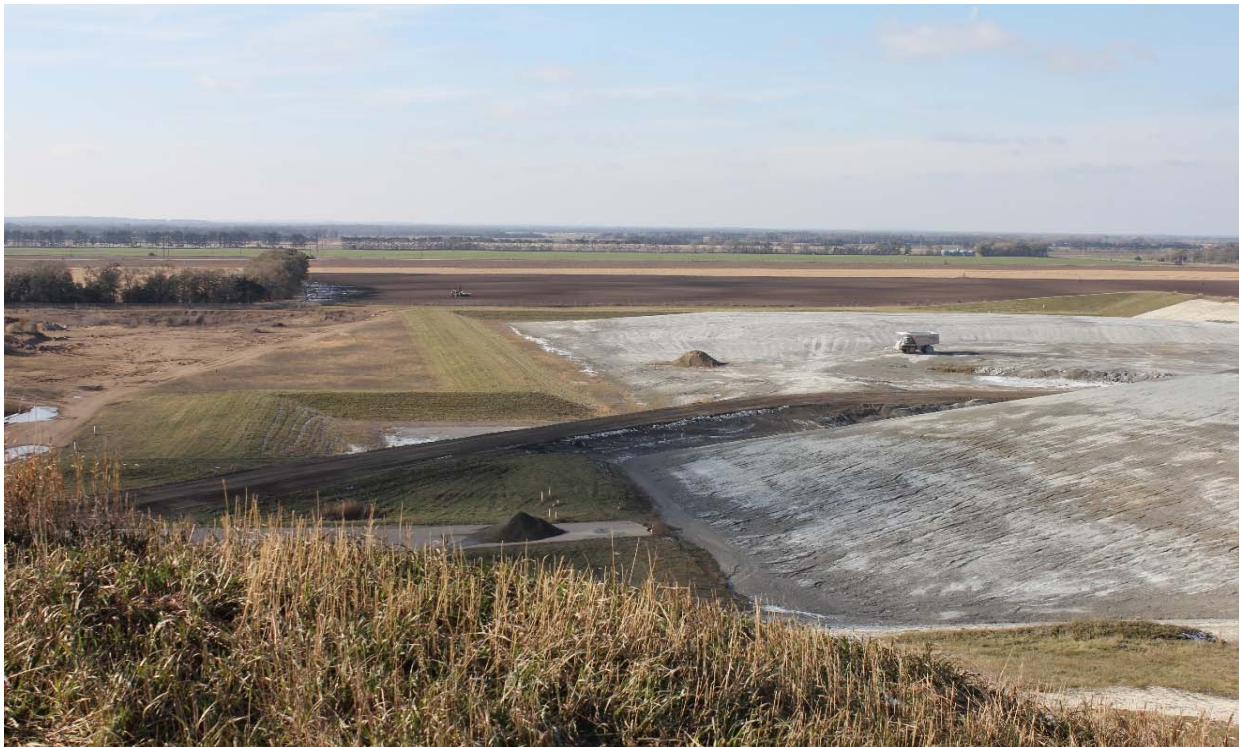
Photo 4	Run-on/run-off containment berm along south side of open area, looking west.
11/8/2017

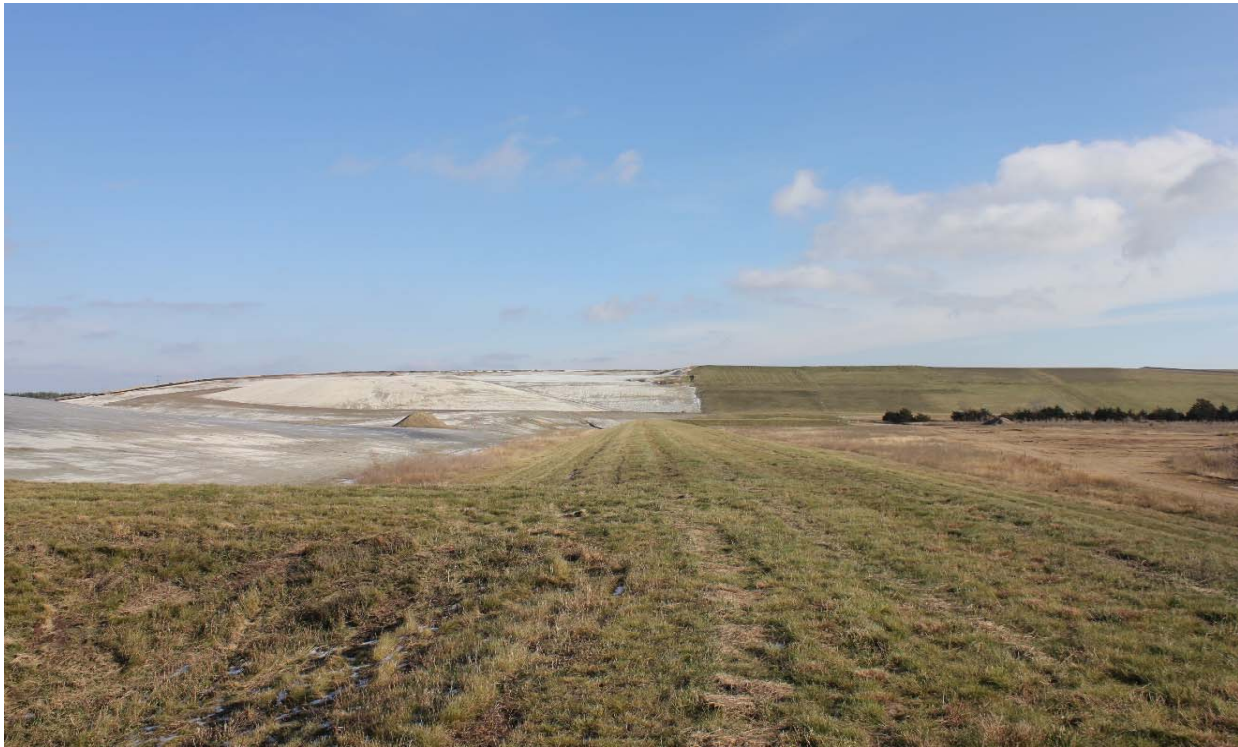
Photo 5	Run-on/run-off containment berm along south side of open area, looking east.
11/8/2017

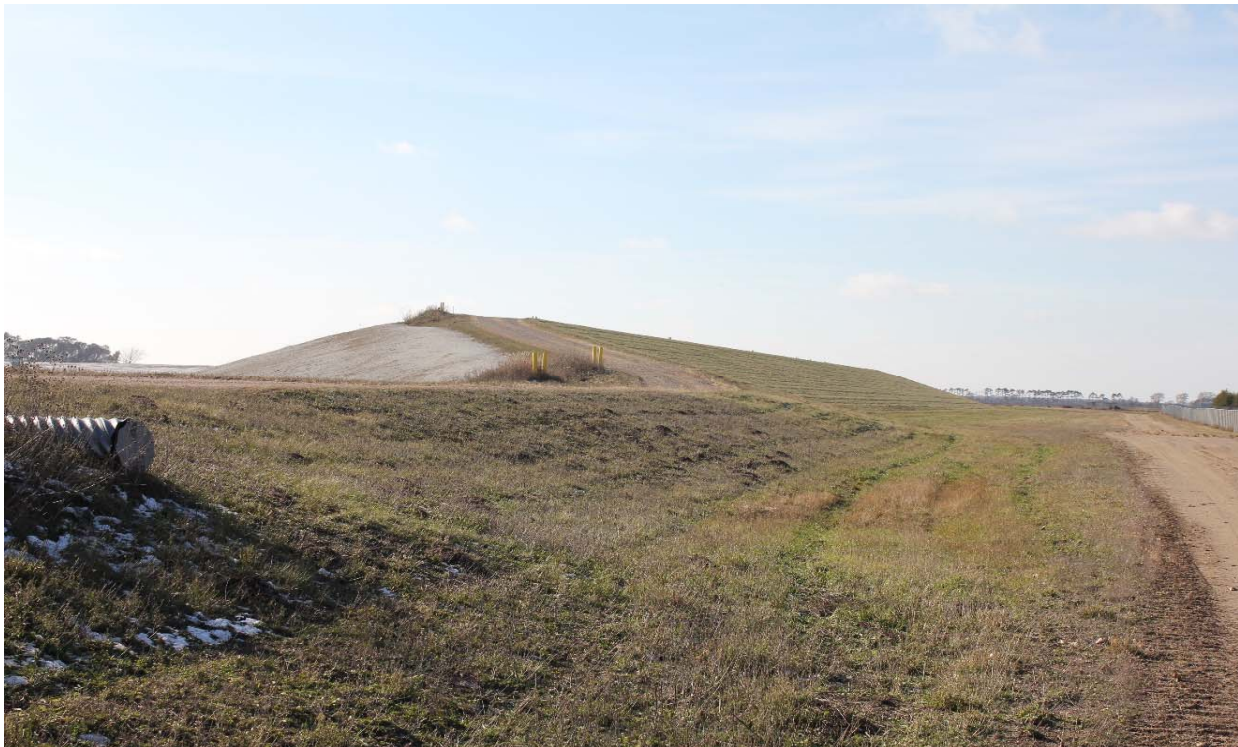
The landfill was inspected for structural weakness by walking a traverse at the base and top of the embankment. There were no signs that structural weakness had previously or is presently occurring on the landfill.

Photo 6	Exterior of north embankment, looking west.
11/8/2017

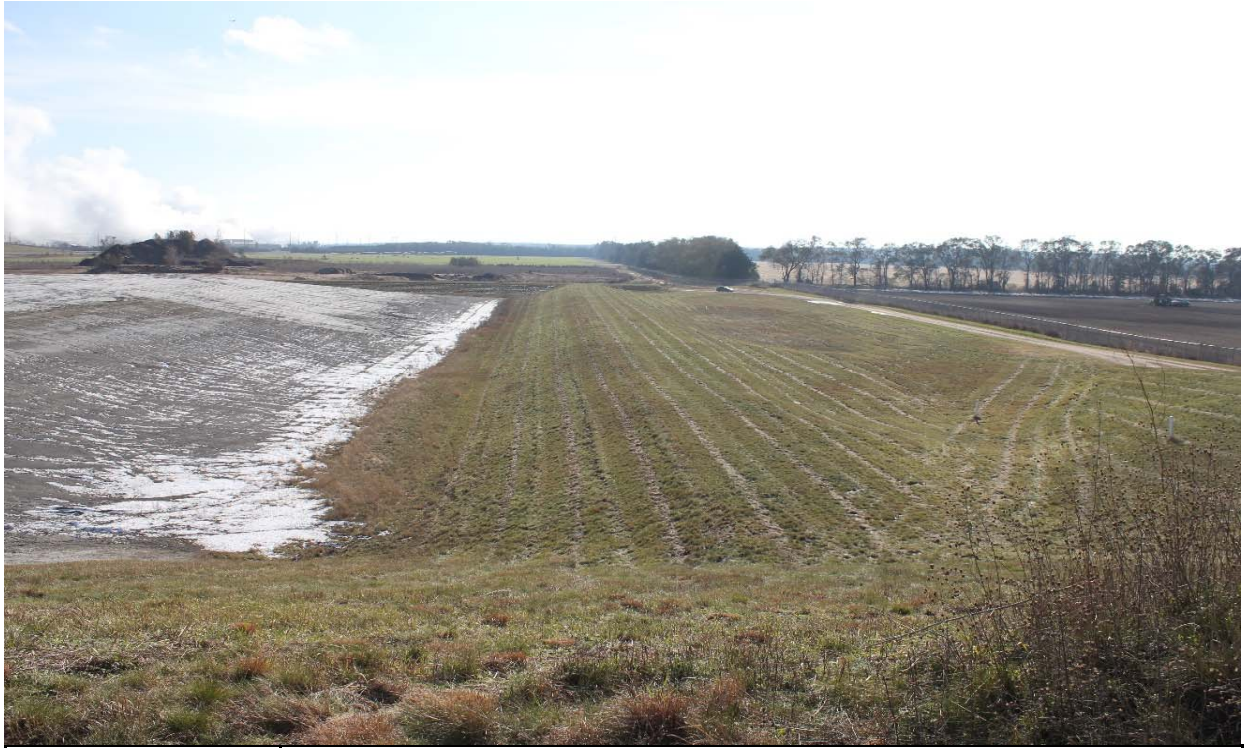
Photo 7	Run-on/run-off containment berm along west side of landfill, looking south.
11/8/2017

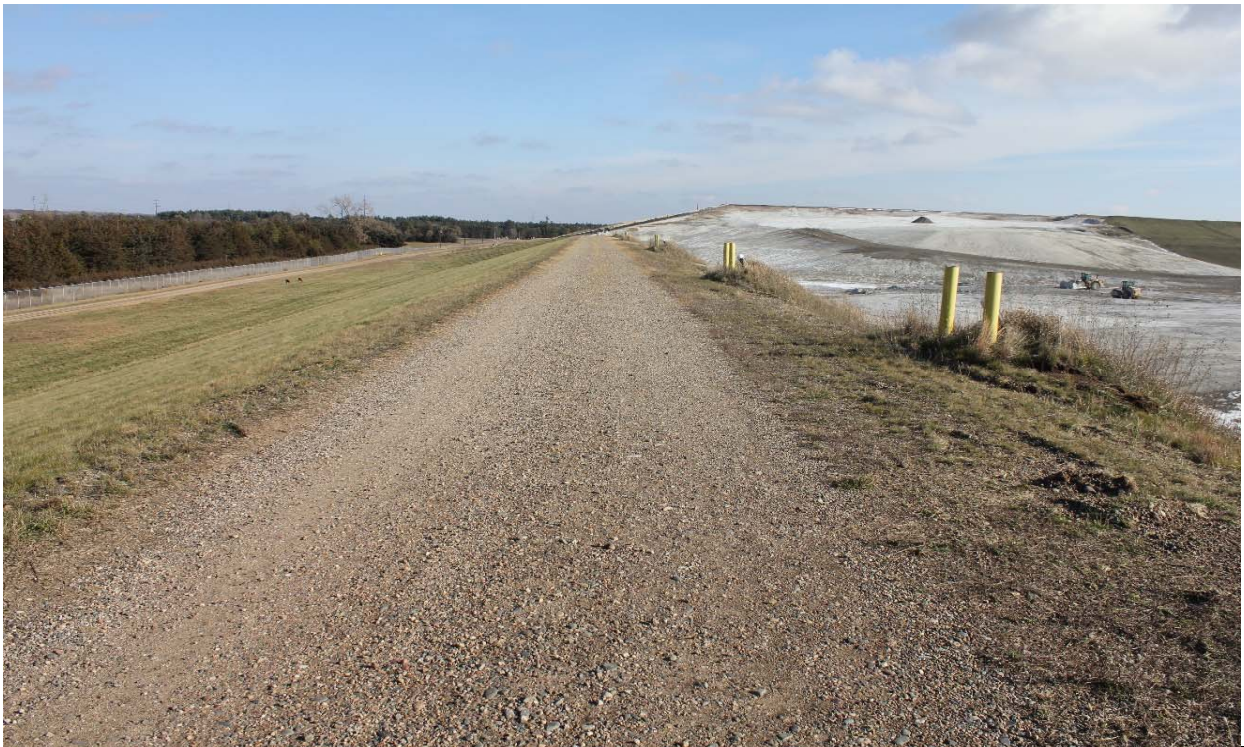
Photo 8	Access road on top of north embankment, looking east.
11/8/2017

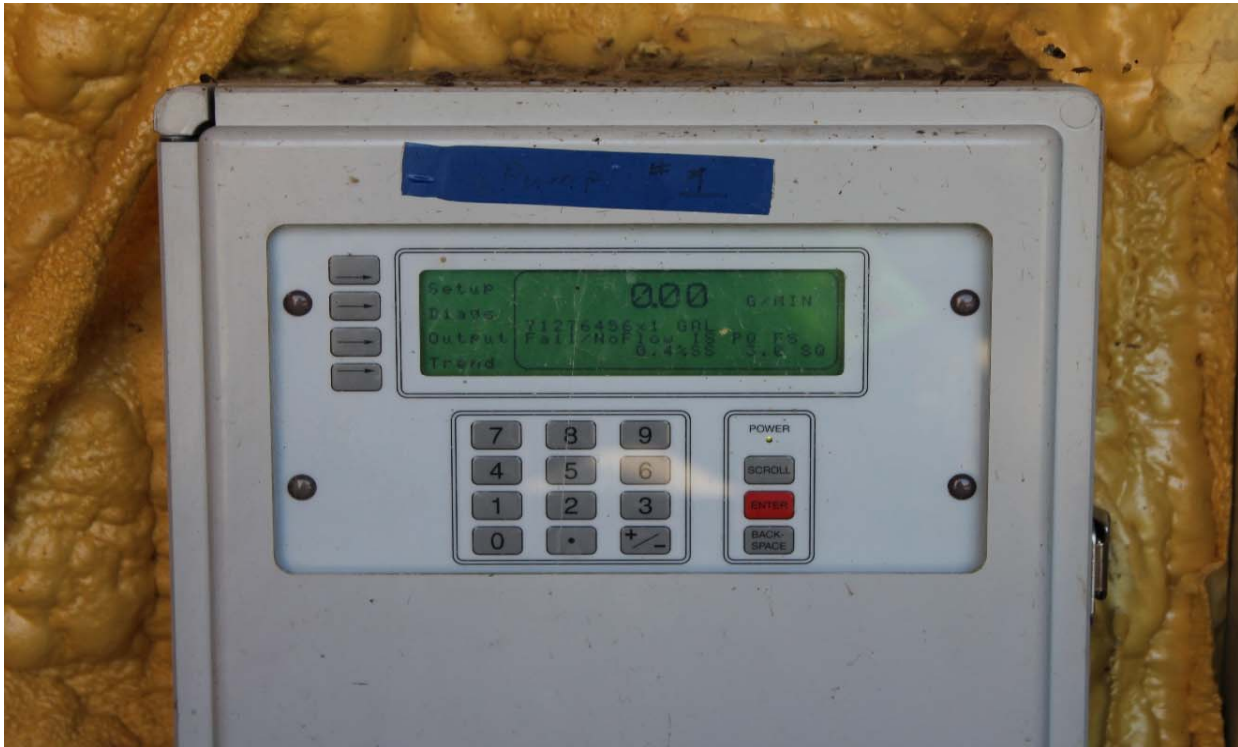
The active area sump panel controls and riser access panels were opened to verify that the leachate management system is functioning properly. There are no conditions disrupting the operation or safety of the CCR unit.

Photo 9	Display screen on properly function Pump No. 1.
11/8/2017

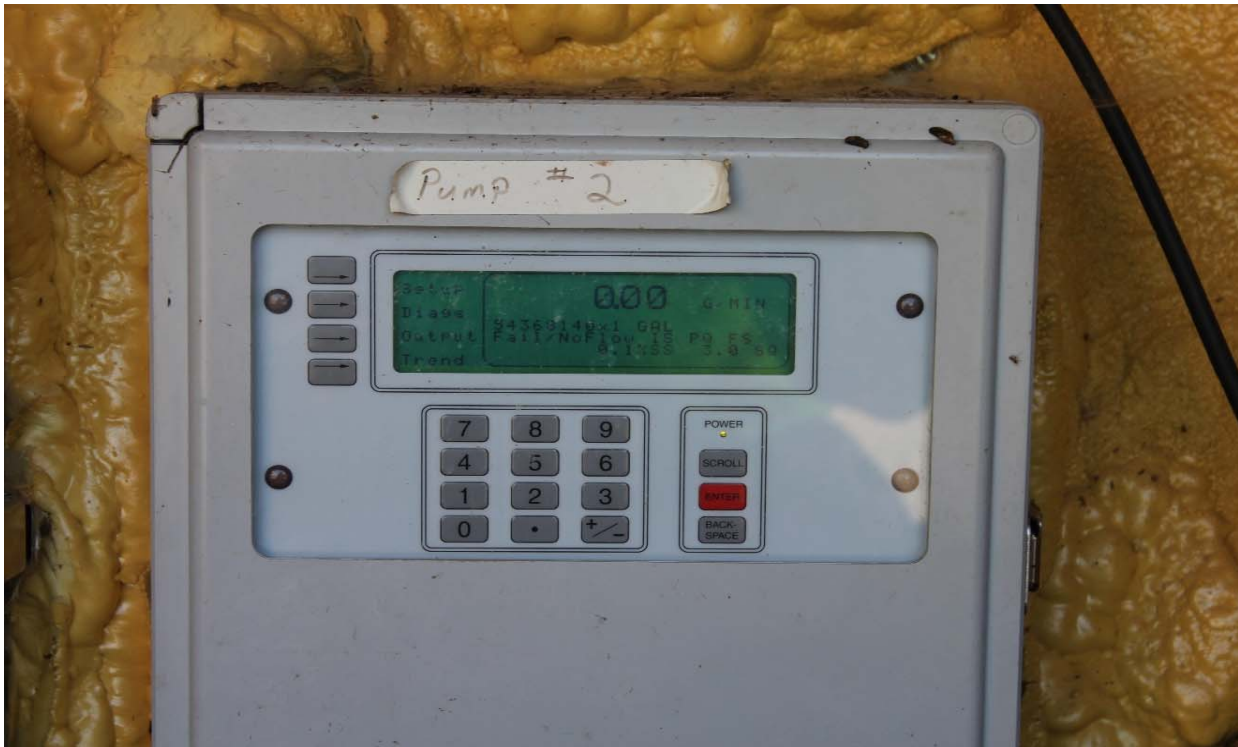
Photo 10	Display screen on properly function Pump No. 2.
11/8/2017

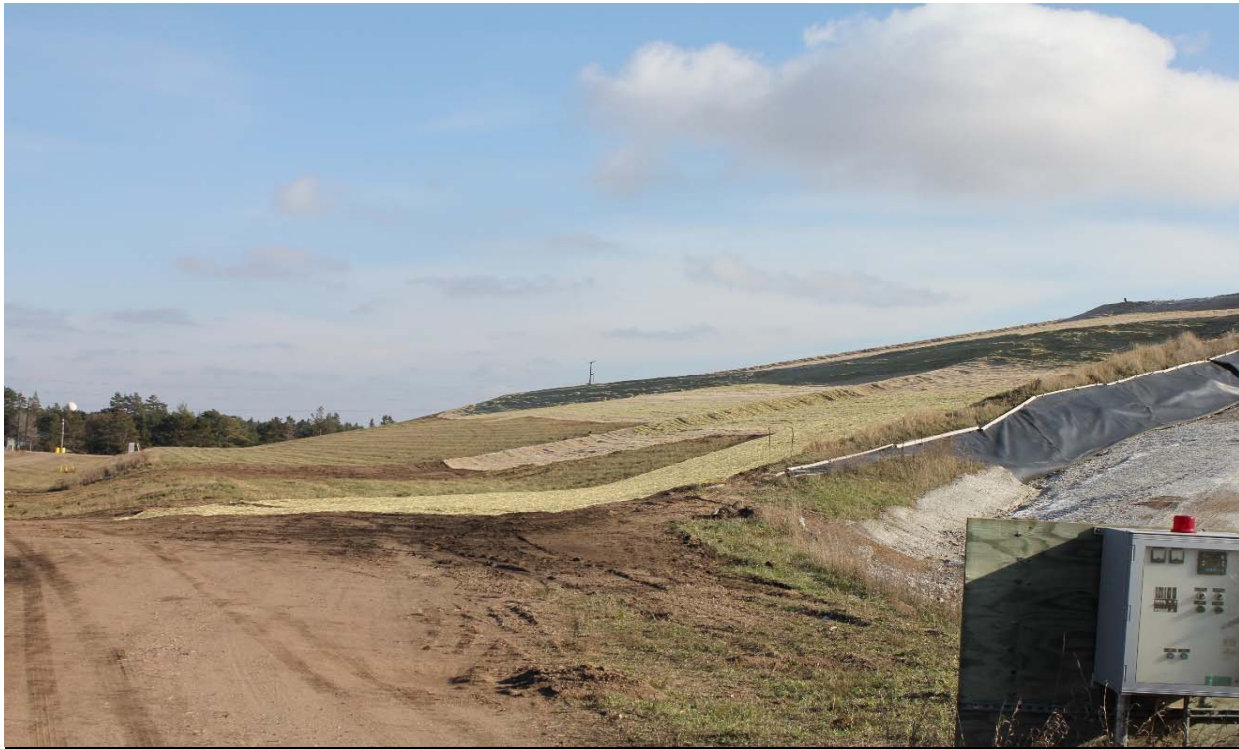
Photo 11	Newly installed final cover along the north side of the landfill, looking east.
11/8/2017

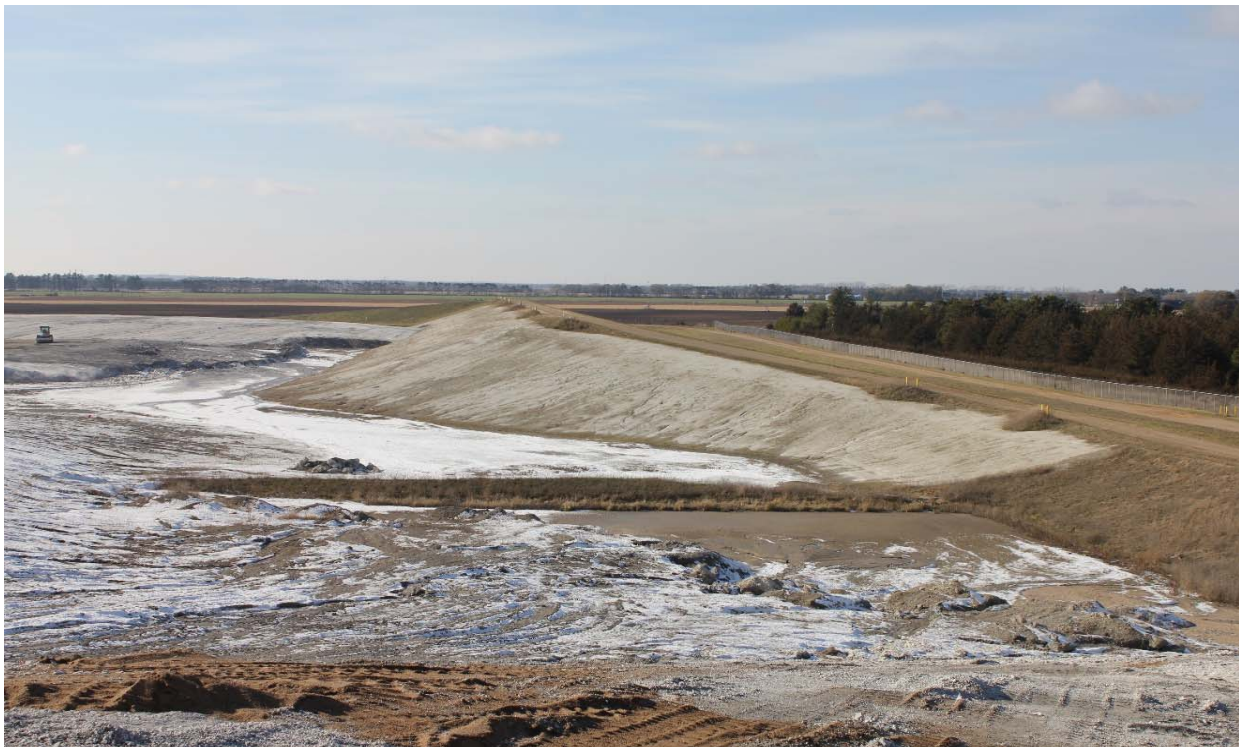
Photo 12	Open portion of landfill, looking west.
11/8/2017
