# 2015 Initial Annual Inspection Report

for Compliance with the Coal  
Combustion Residuals Rule  
(40 CFR Part 257)

## **Valmont Station**

**January 18, 2016**

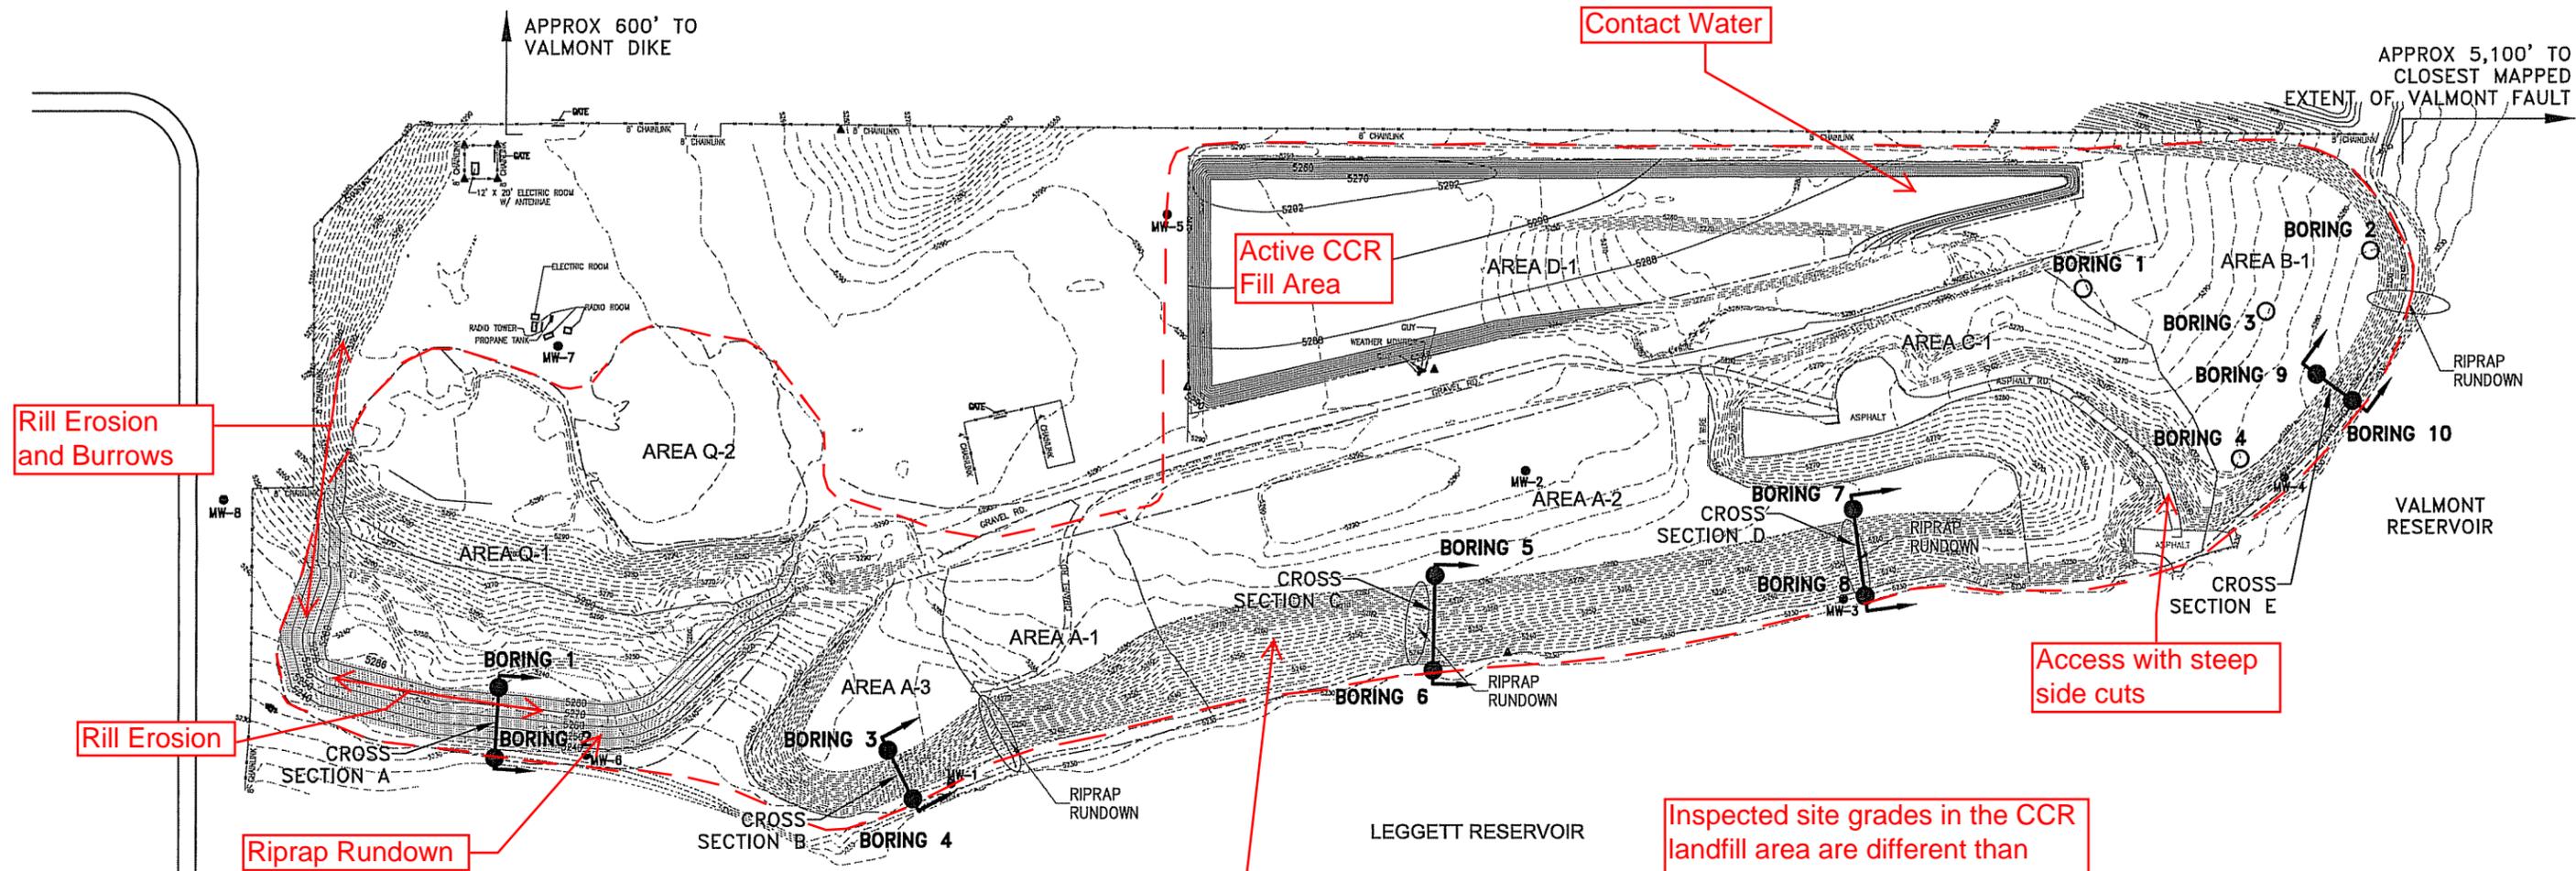
## Appendix A – Landfill Site Map

Notes in red added by HDR Engineering for CCR Annual Inspection Report, January 2016
