Xcel Energy, Inc.  
Sherburne County Generating Station  
13999 Industrial Blvd.  
Becker, MN, 55308

**Re: Initial Annual Inspection of Bottom Ash Pond**

## Bottom Ash Pond Annual Inspection – October 2015

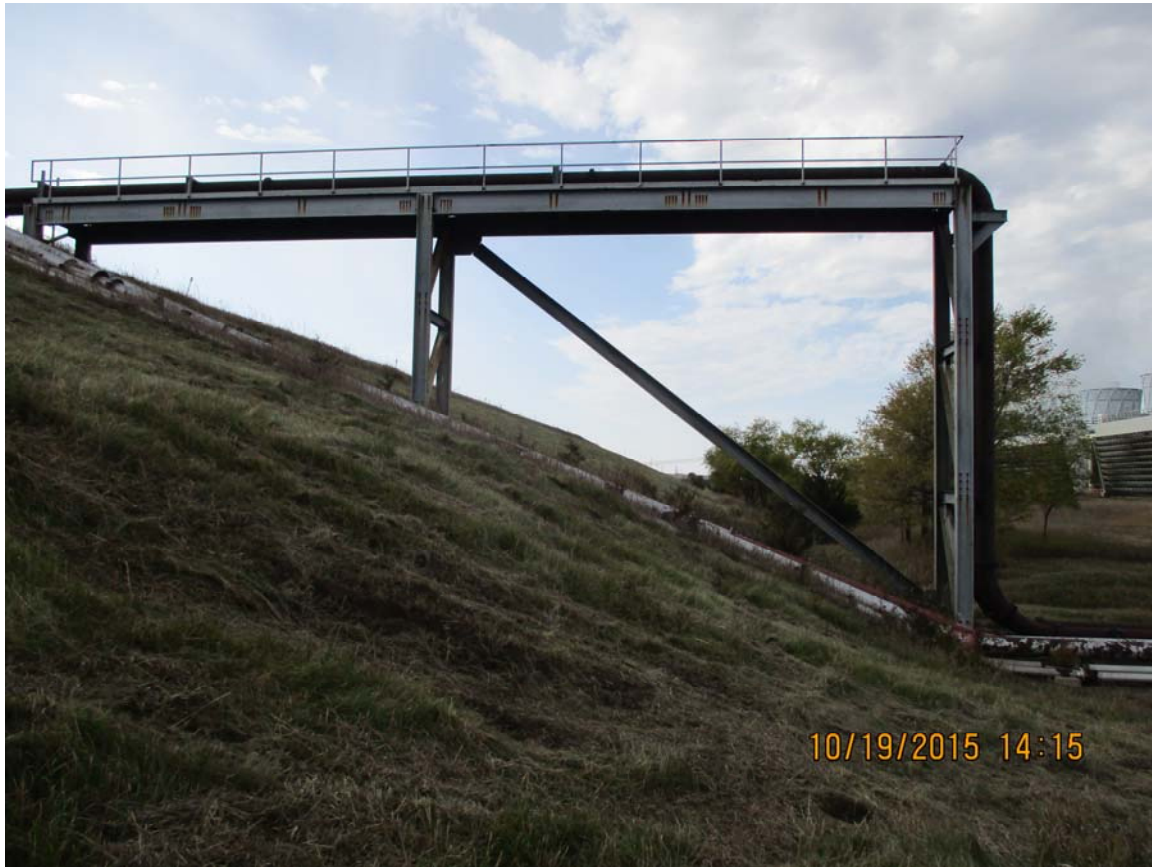
Photo 1	Bottom Ash and Scrubber pipes, looking west
10/19

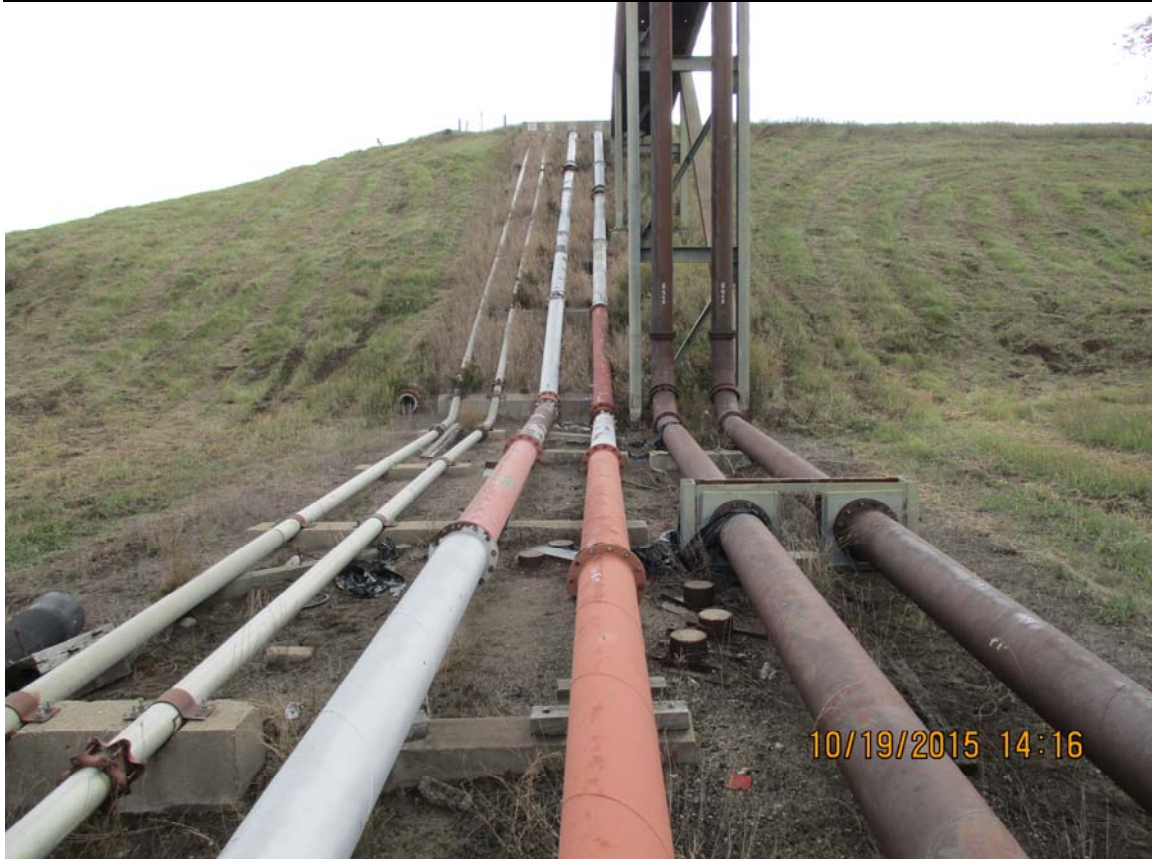
Photo 2	Left: Two 6 inch stainless steel scrubber solid pipes (to Pond 3). Middle/Right, Four 12 inch bottom ash pipes.

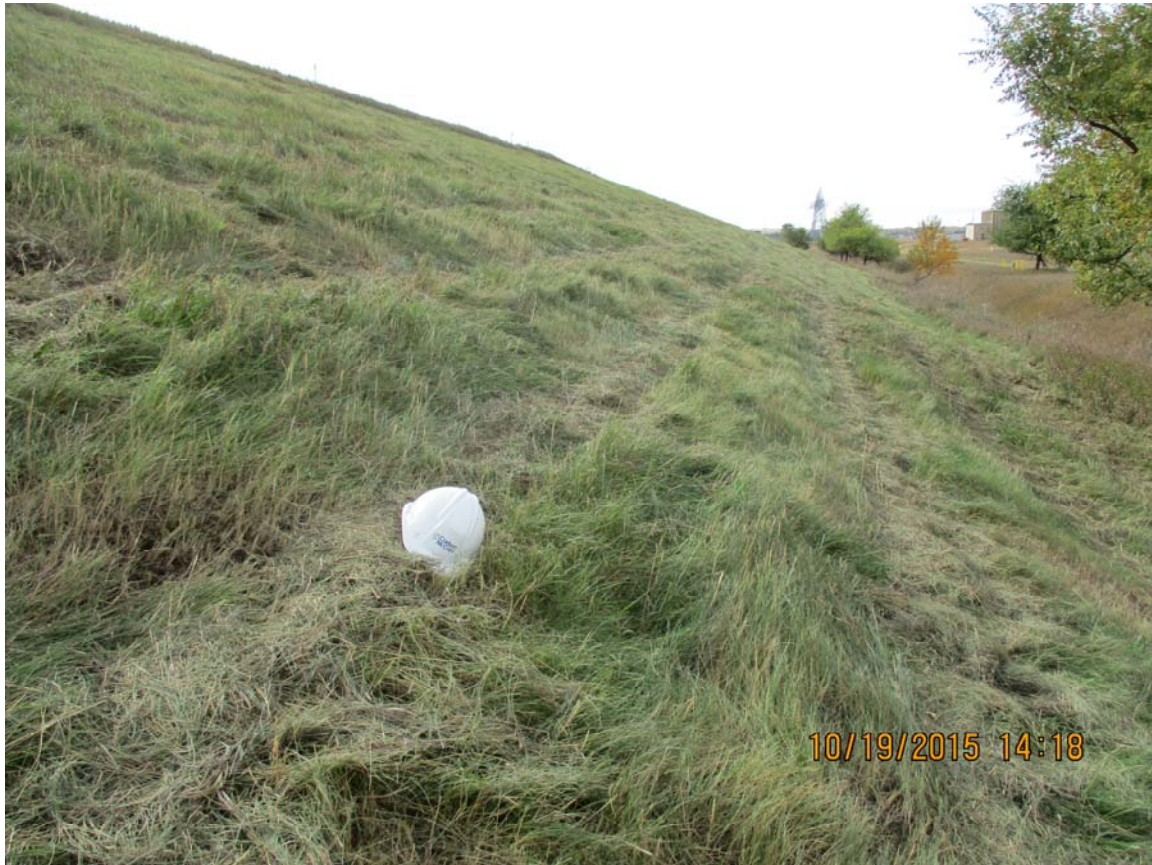
Photo 3	Northern slope, looking west. Hard hat used to shown length of grass (approximately 6 inches).
---------	--

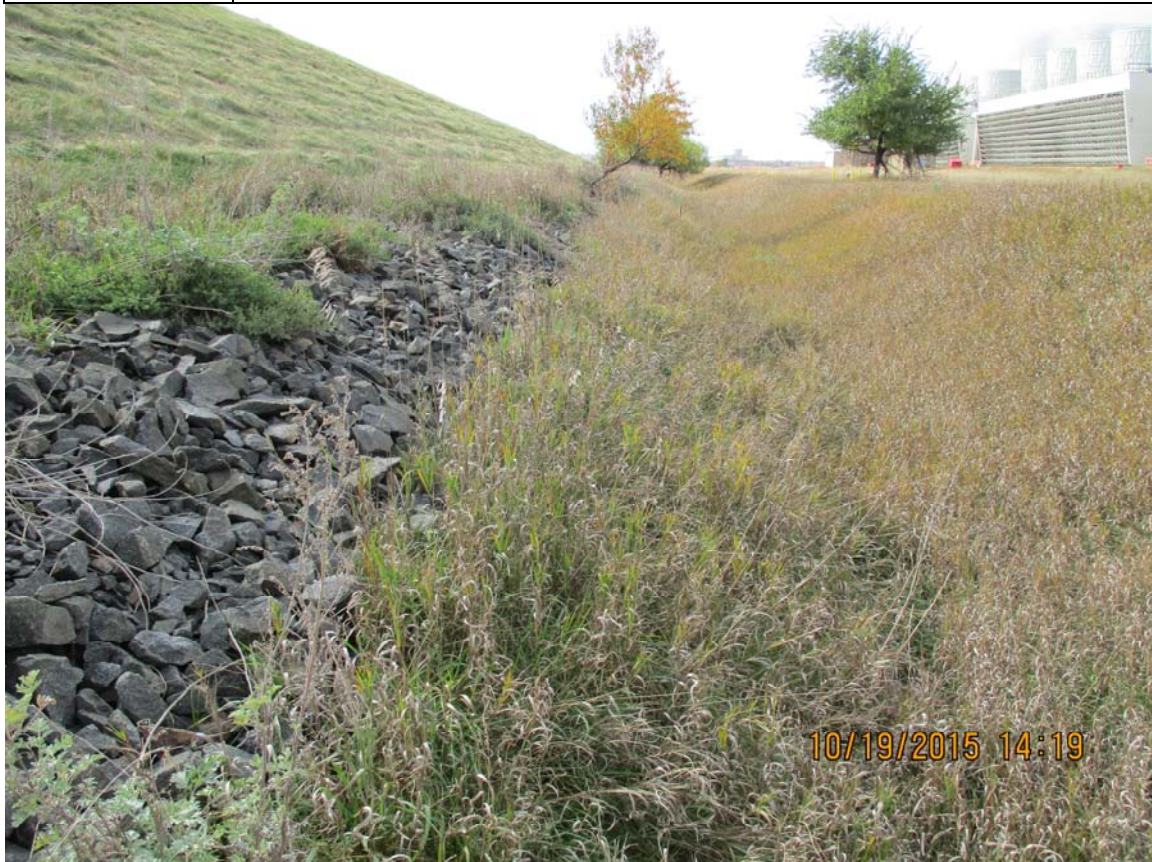
The exterior of the BAP was inspected for structural weakness in the form of seepage by walking a traverse at the base, mid-slope, and top of the embankment. Signs of seepage would include moss or marshy vegetation at the toe-drain along the base, soft or saturated areas, patches of grass more lush than the surrounding area, or flowing "springs". There were no signs that seepage had previously or is presently occurring on the BAP.

Photo 4	Left: Rirap outlet of embankment toe drain. Right, perimeter ditch, looking west.
---------	---

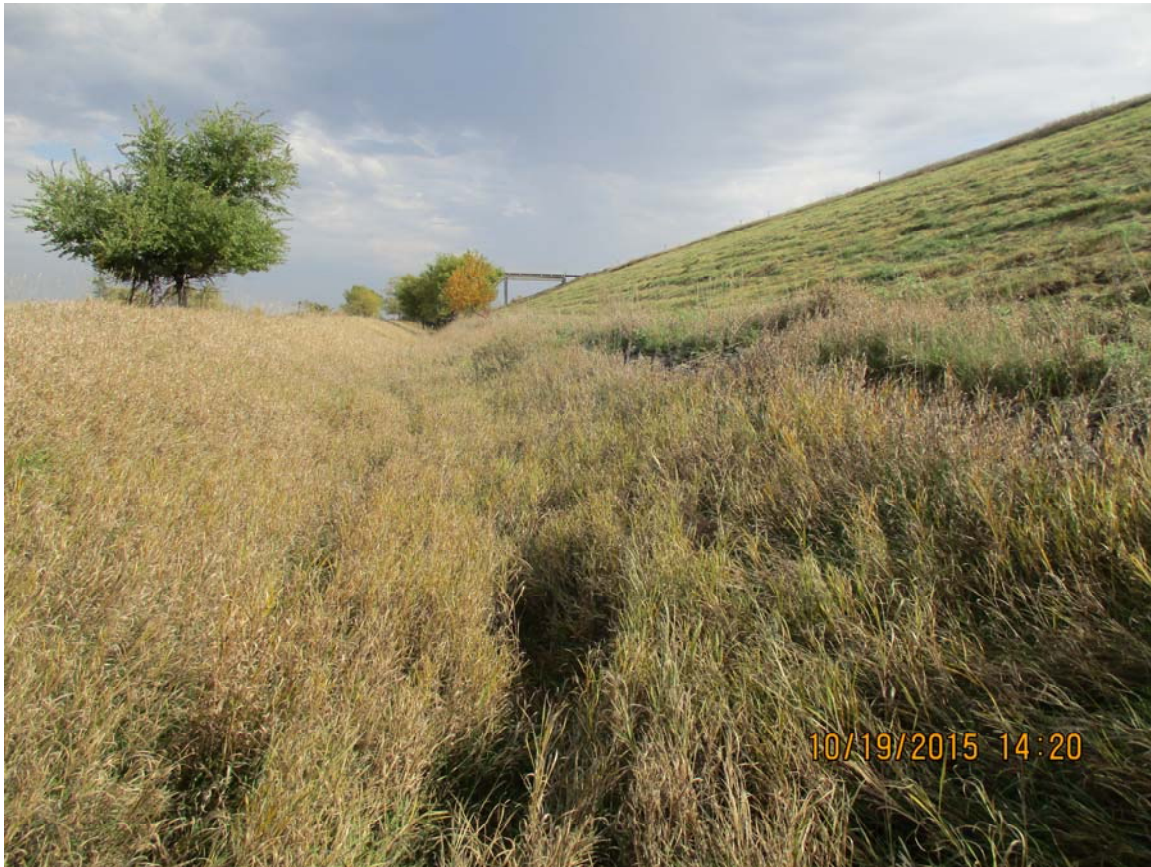
Photo 5	North embankment of pond at perimeter ditch, looking east

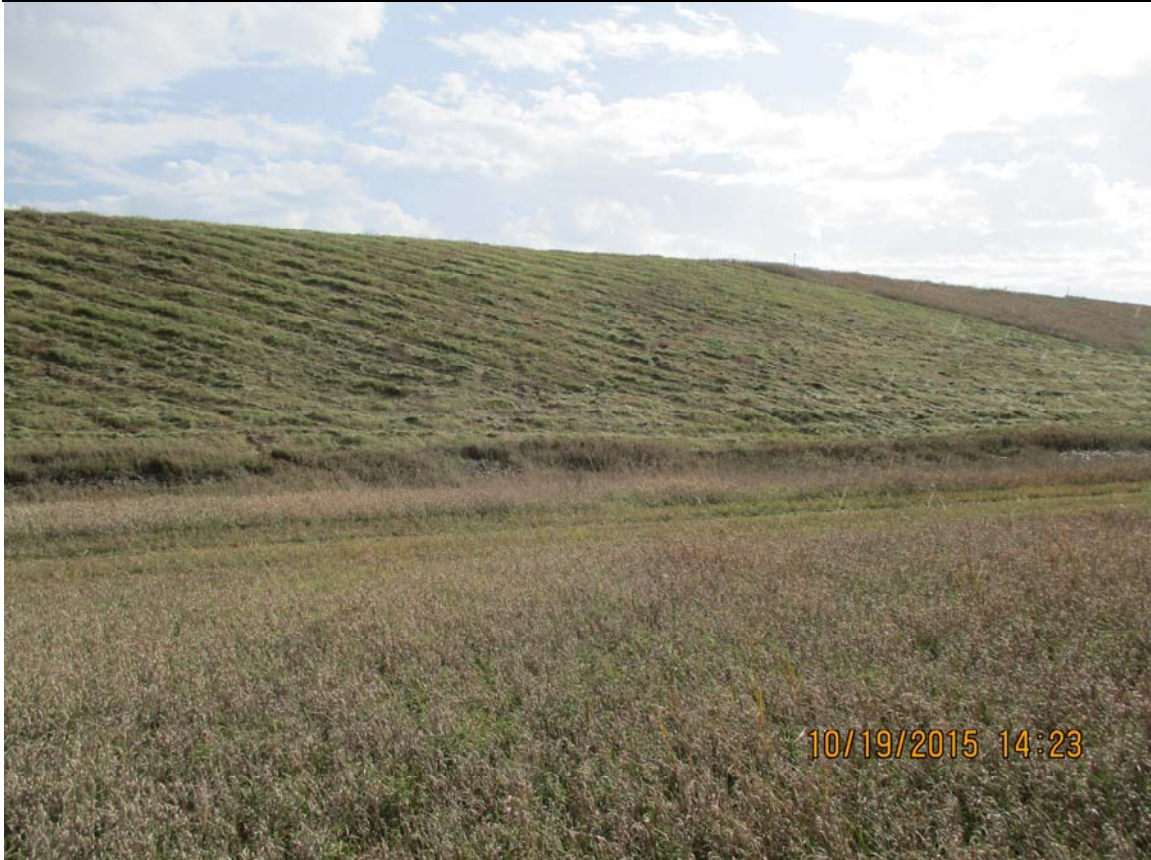
Photo 6	West embankment, looking south.

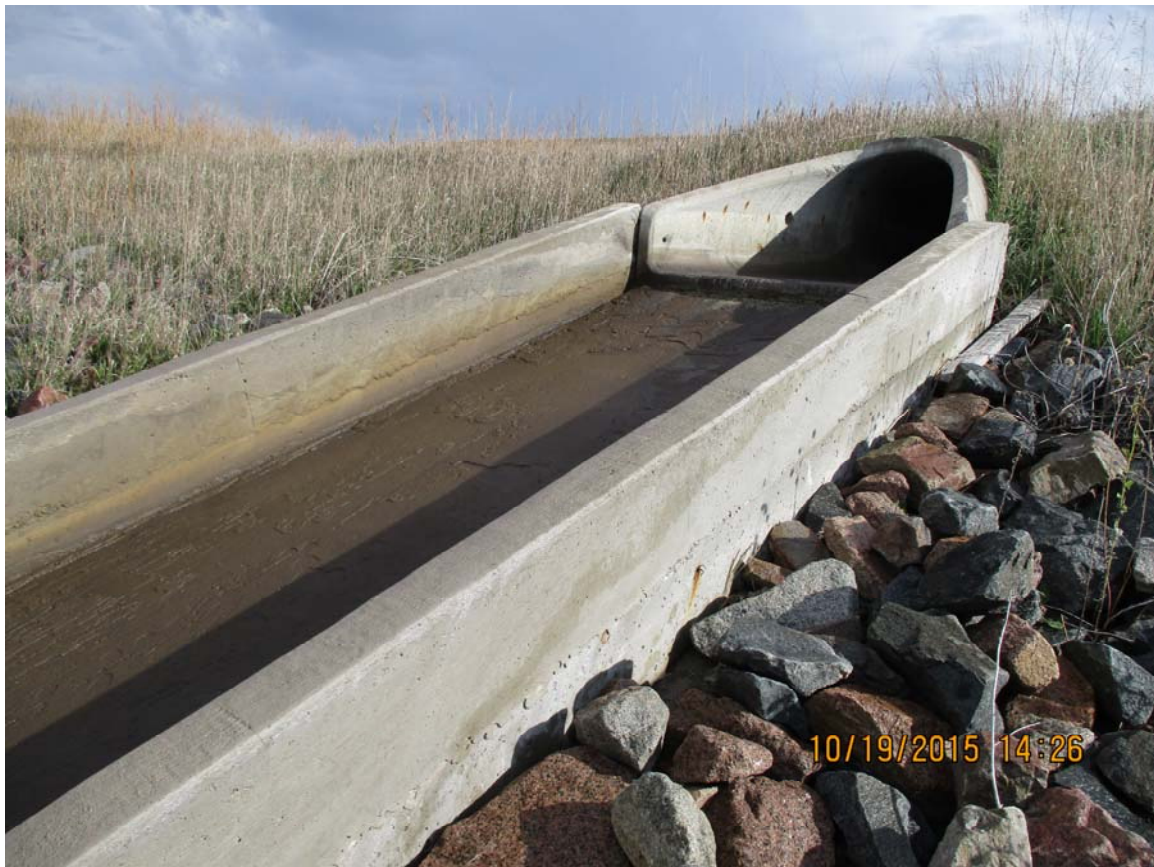
Photo 7	Bottom Ash Pond secondary outlet to Recycle Basin (Primary outlet is below the water level of the Recycle Basin).
---------	---

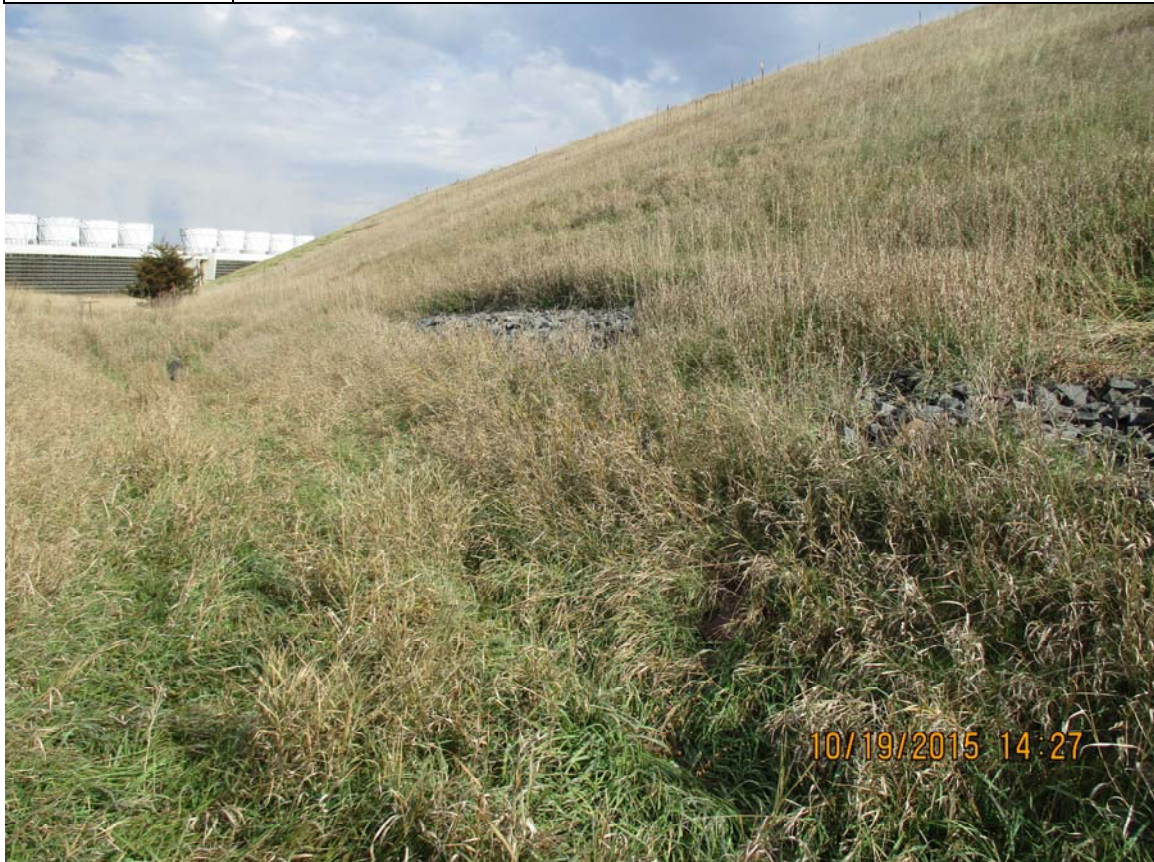
Photo 8	Perimeter ditch and toe-drain along west embankment, looking north
---------	--

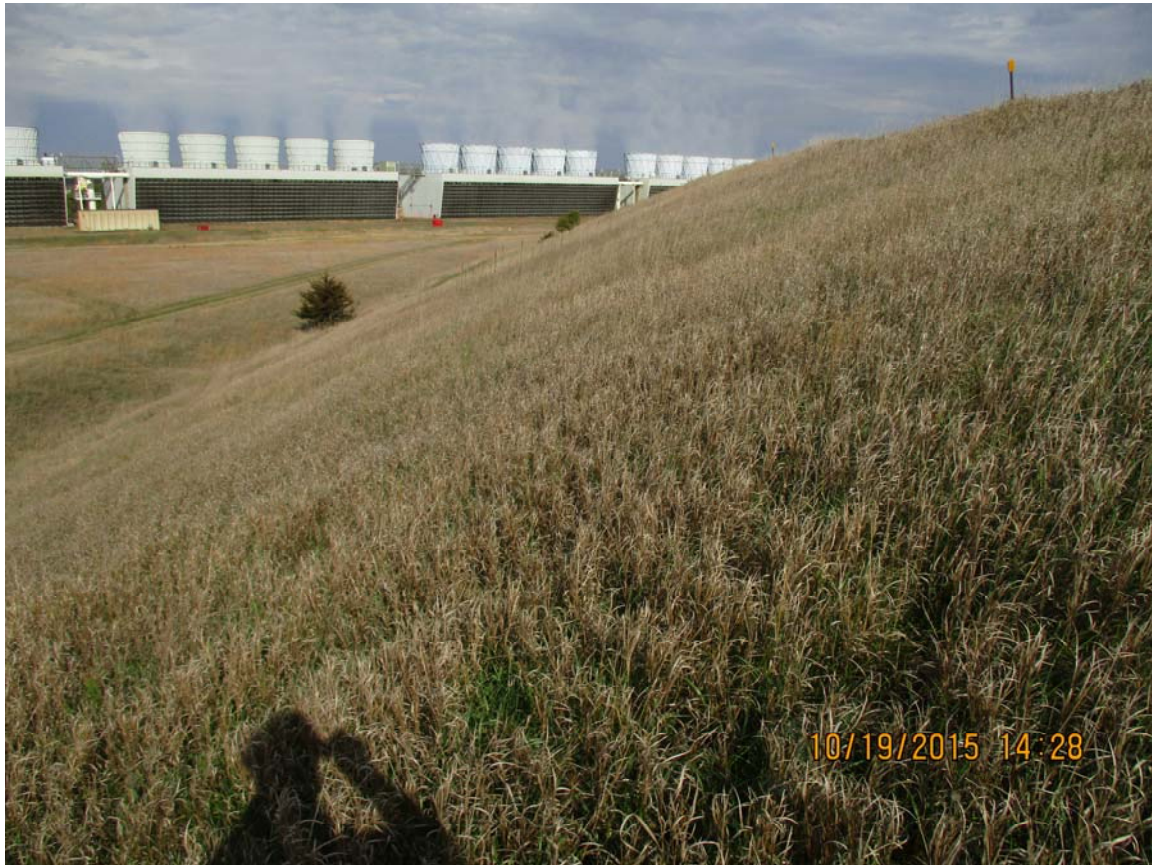
Photo 9	West embankment at mid-slope, looking northeast.
---------	--

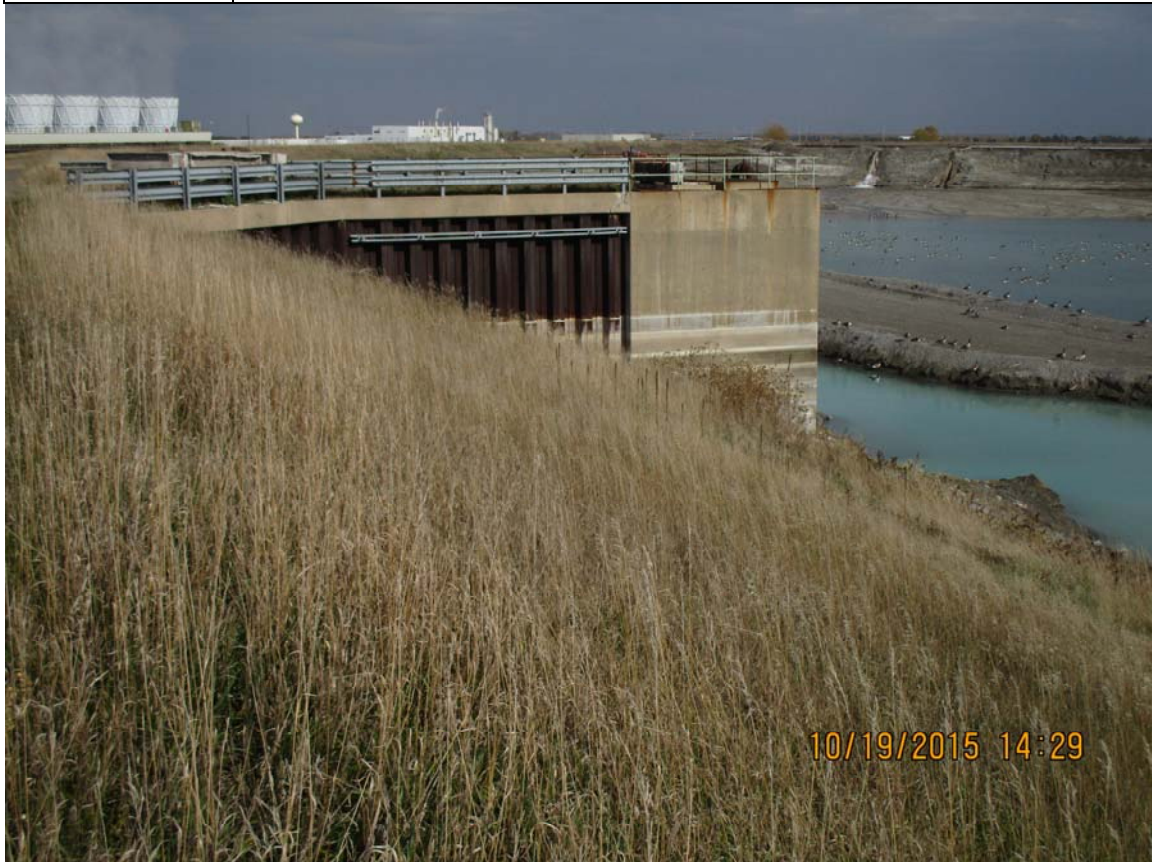
The BAP discharges to the Recycle Basin over concrete stop-logs located in the discharge structure. These stop-logs are added or removed to raise or lower the impounded water level in the BAP. In 2015, the maximum water level was maintained at an elevation of 974 (MSL) until late May to promote bottom ash material deposition, then lowered to a minimum elevation of 964 (MSL) allowing access to deposited material by excavation equipment. Stop-logs were added following excavation to a present elevation of 972 (MSL).

Photo 10	Discharge structure on interior slope of pond, looking northeast
----------	--

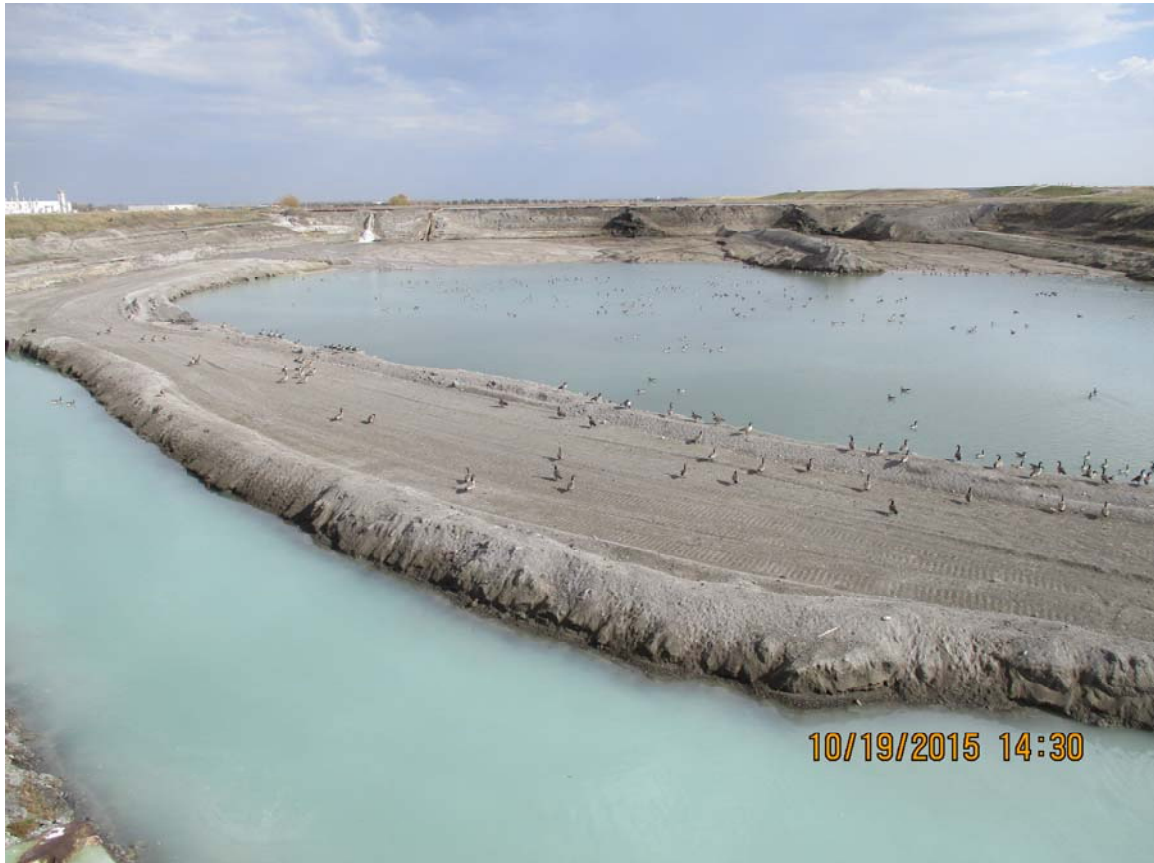
Photo 11	Interior of pond from top of discharge structure, looking east
----------	--

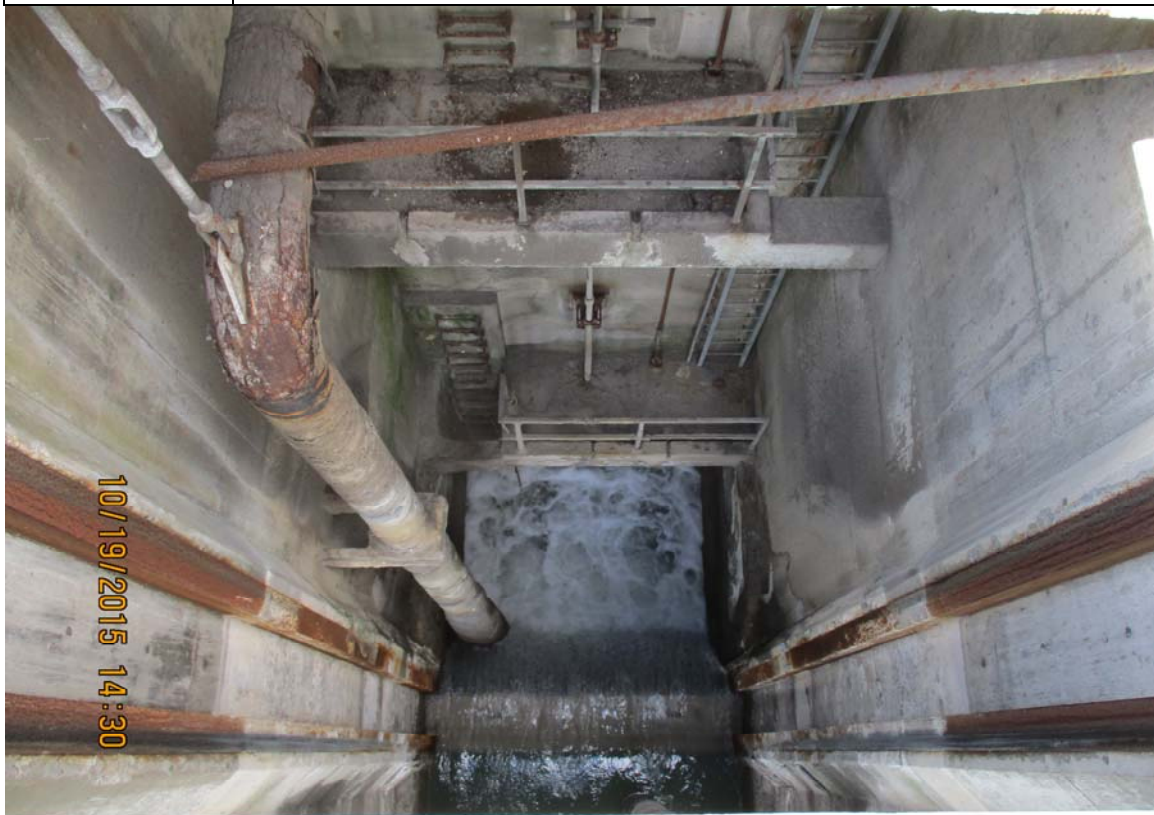
The water level in the BAP is controlled by concrete stop-logs in the discharge. All decreases in water level are attributed to the removal of stop logs.

Photo 12	Photo from inside of discharge structure. Bottom of photo depicts stop log metal channels and water flowing over concrete stop-log at the bottom of the channel.
----------	--

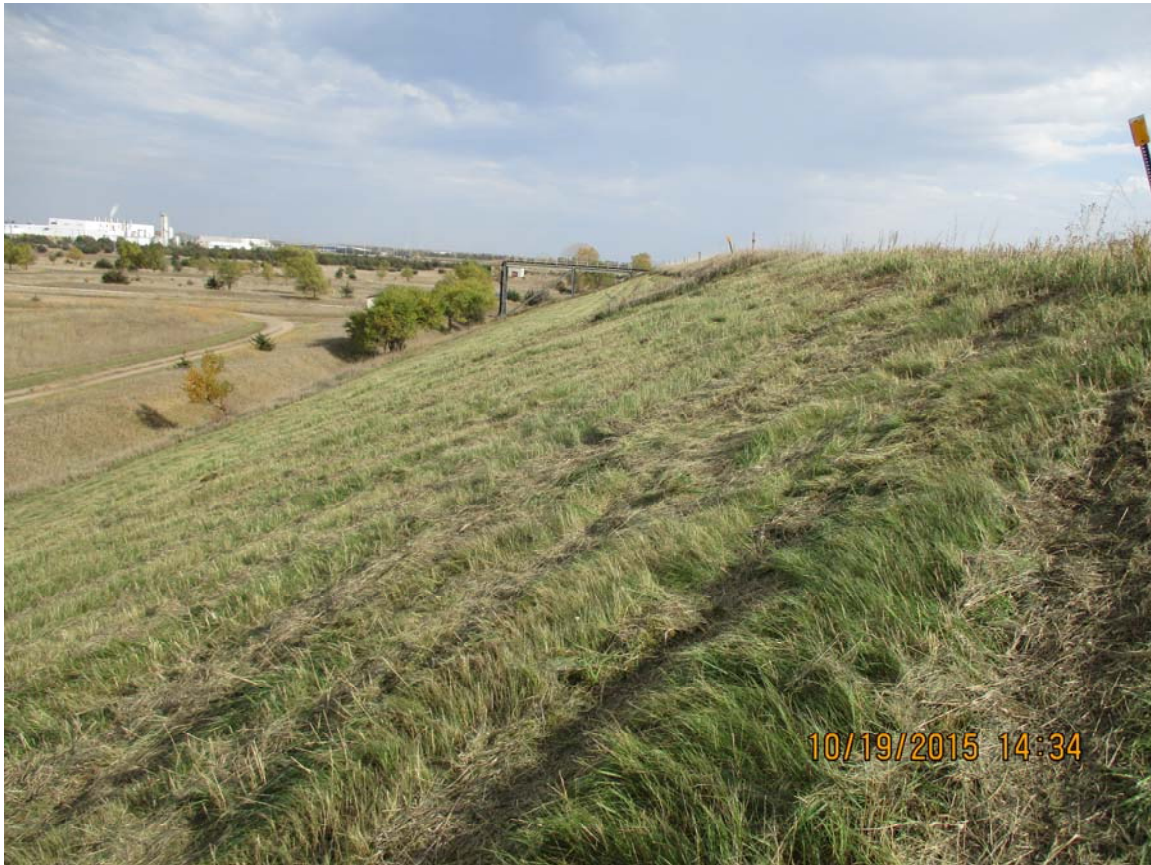
Photo 13	Mid/Upper slope of north embankment, looking east
----------	---

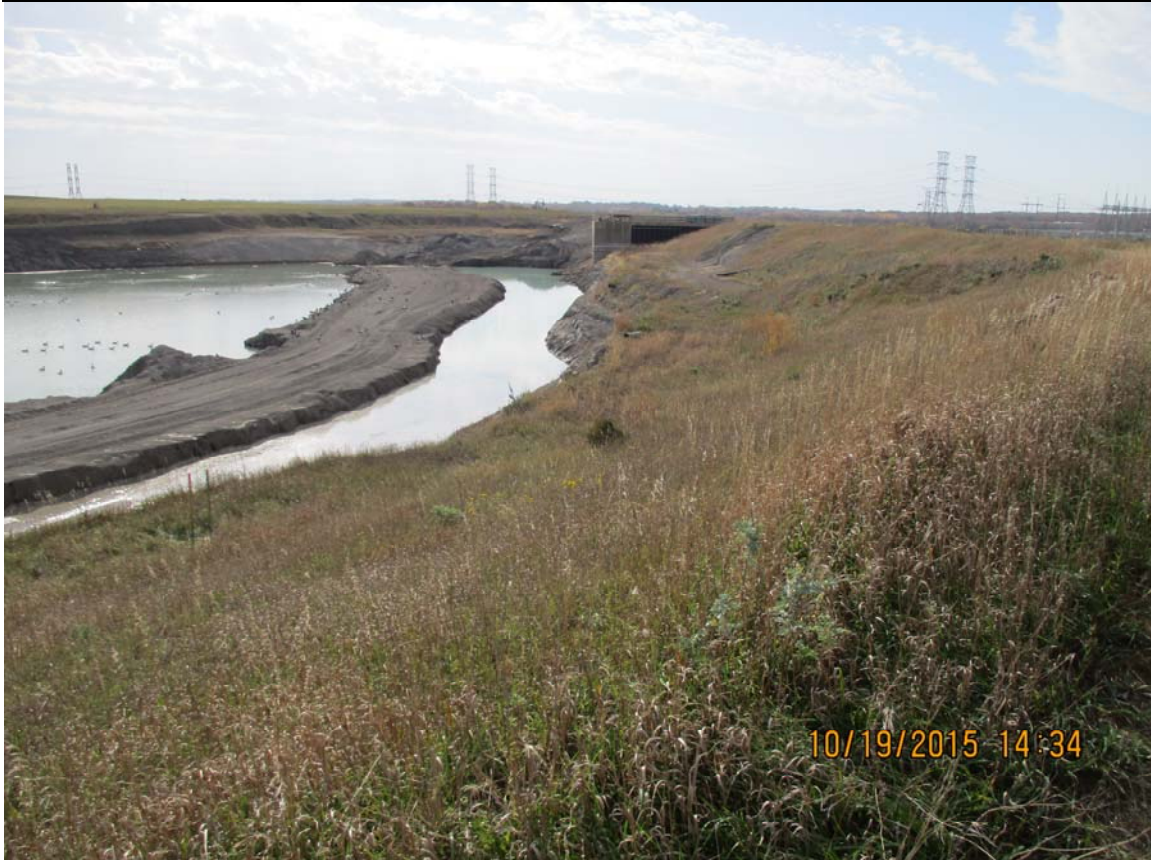
Photo 14	Interior of north embankment, looking west
----------	--

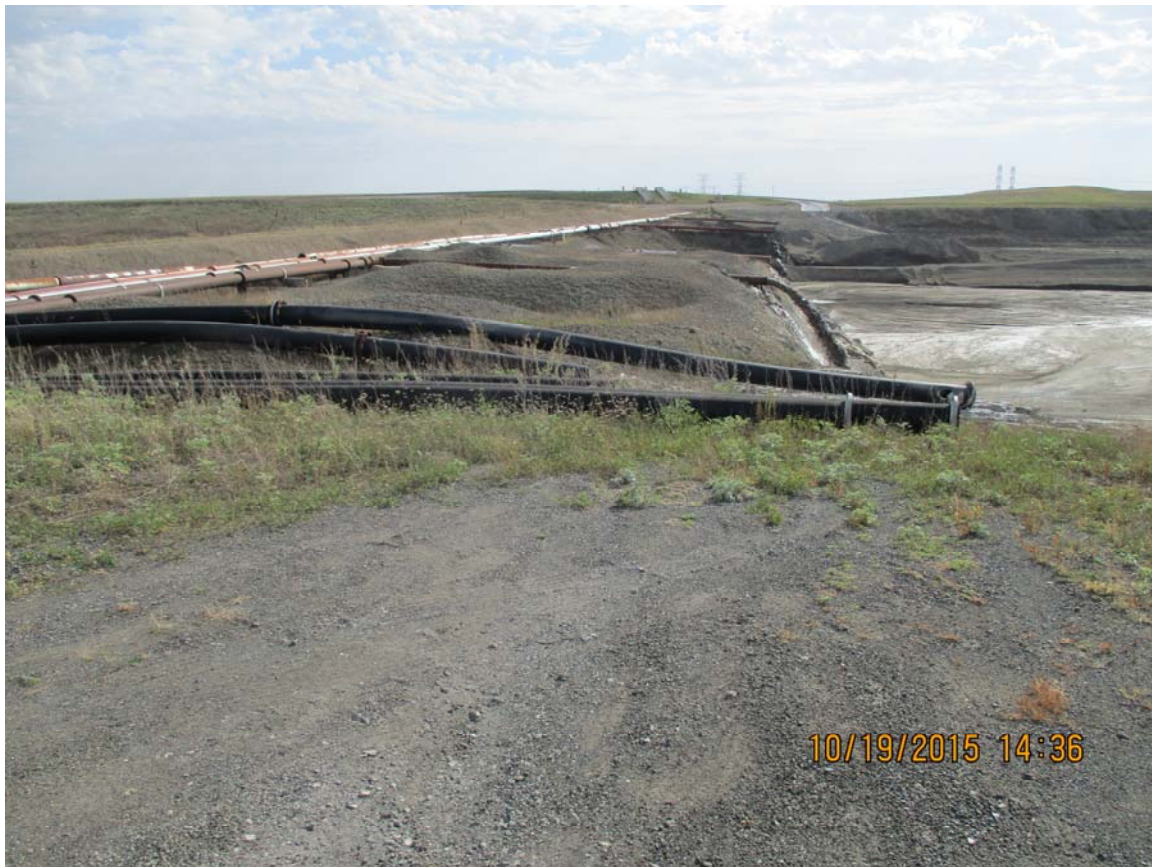
Photo 15	Interior of east embankment and discharge pipes, looking south.

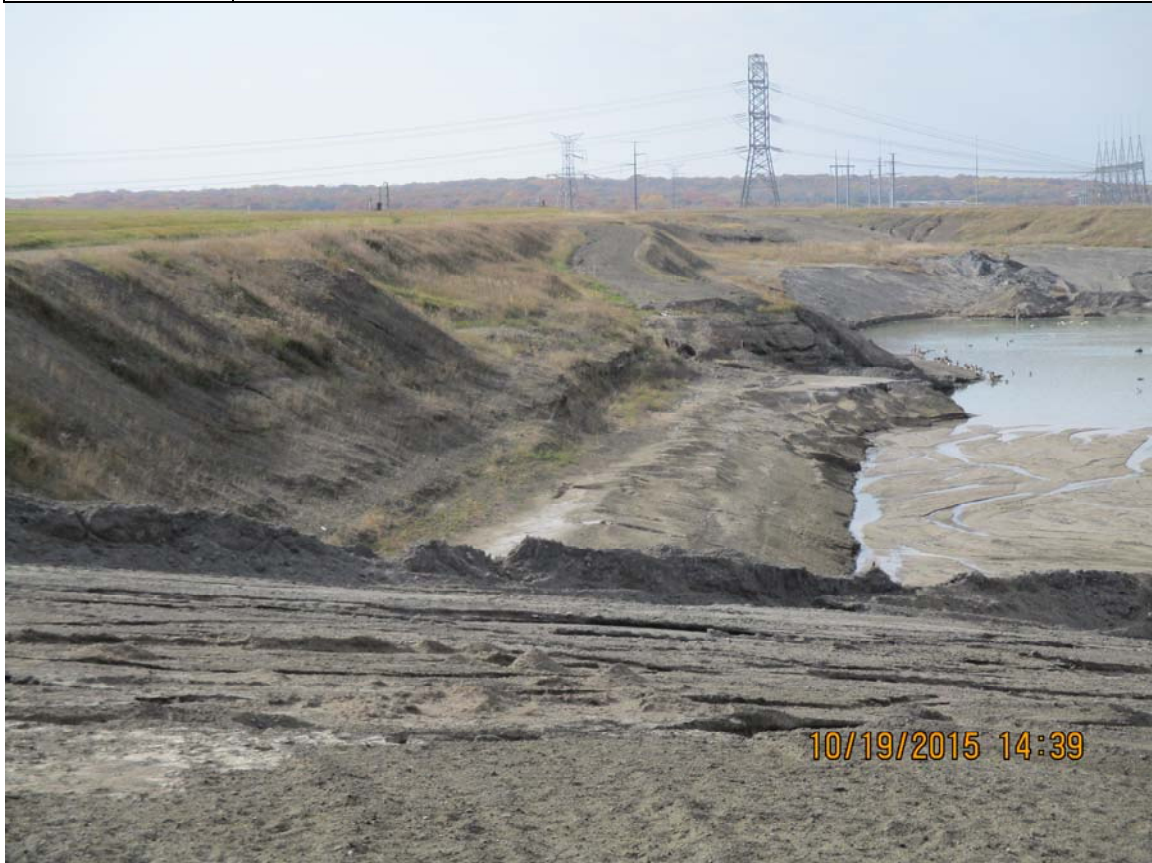
Photo 16	Interior of south embankment, looking west.

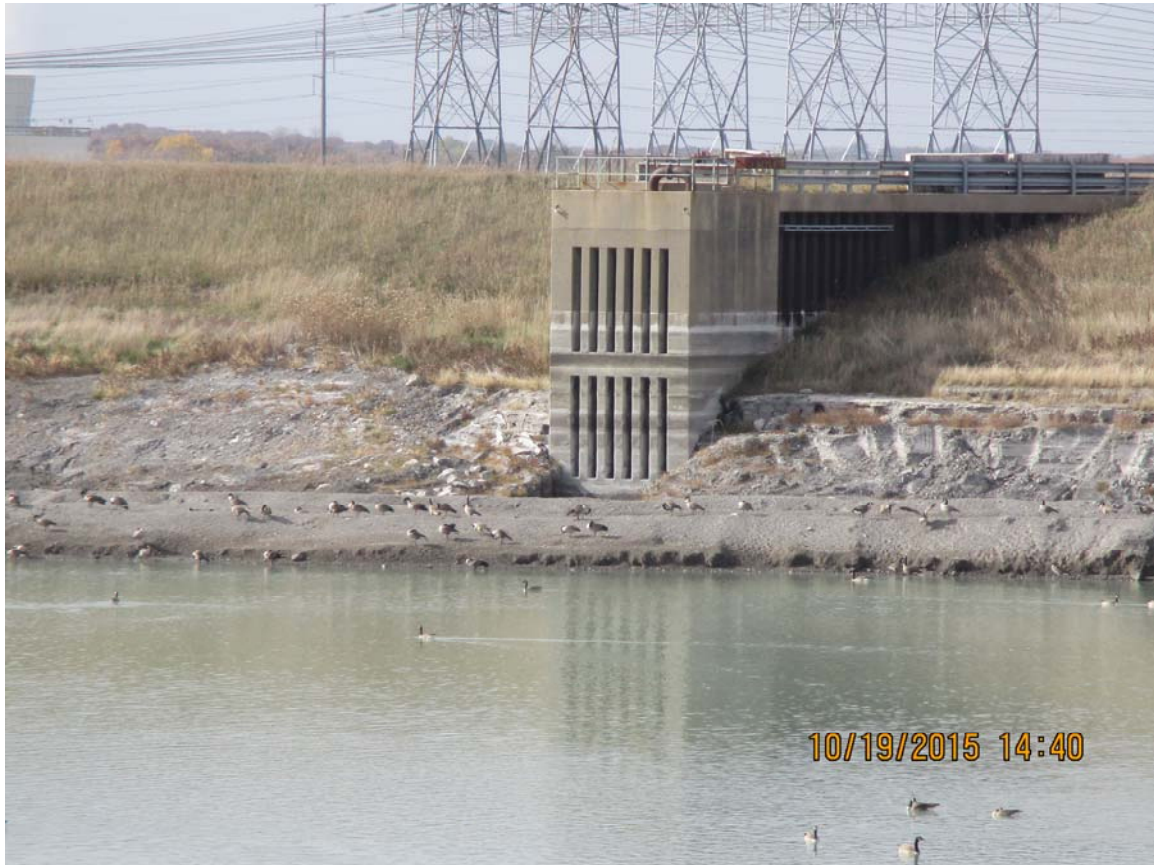
Photo 17	Inlet of discharge structure, looking west

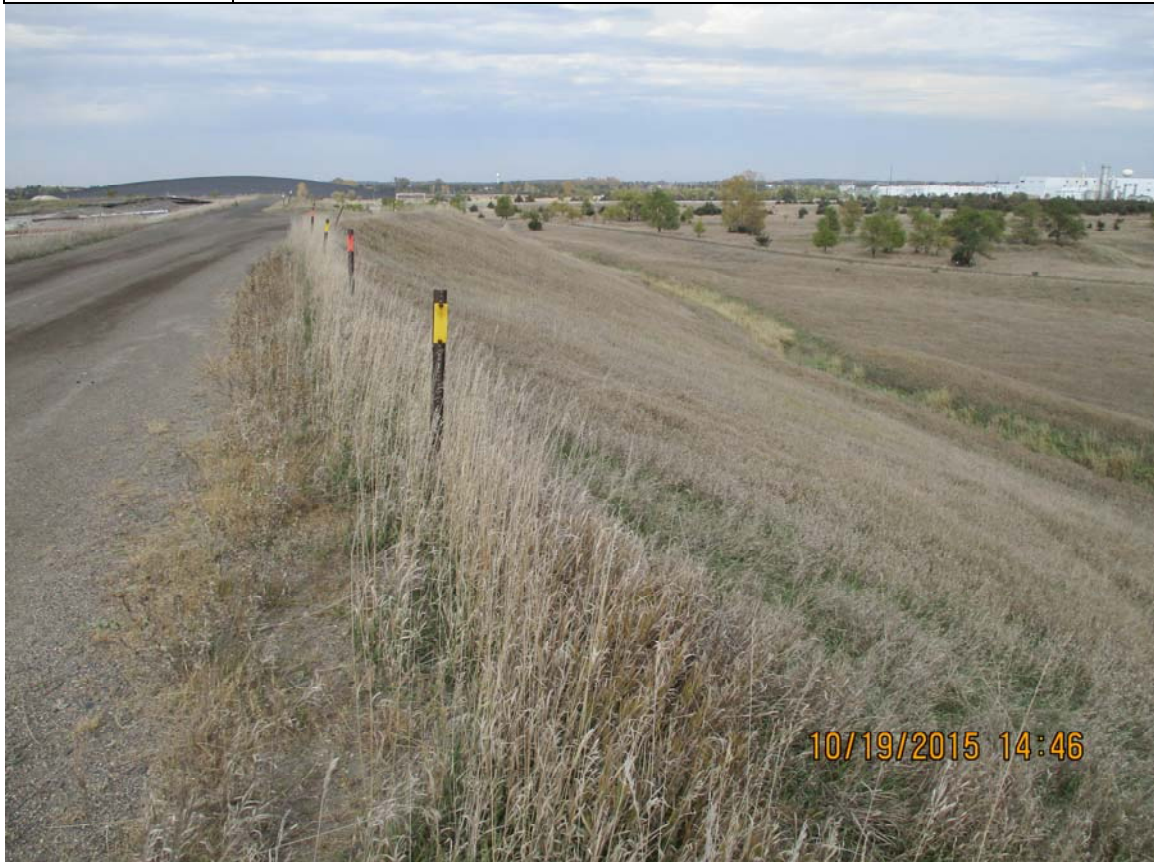
Photo 18	Outer slope of east embankment, looking north.
