Xcel Energy, Inc.
Sherburne County Generating Station
13999 Industrial Blvd.
Becker, MN, 55308

Re: Initial Annual Inspection of Scrubber Solids Pond No. 3

Pond 3 Annual Inspection – October 2015

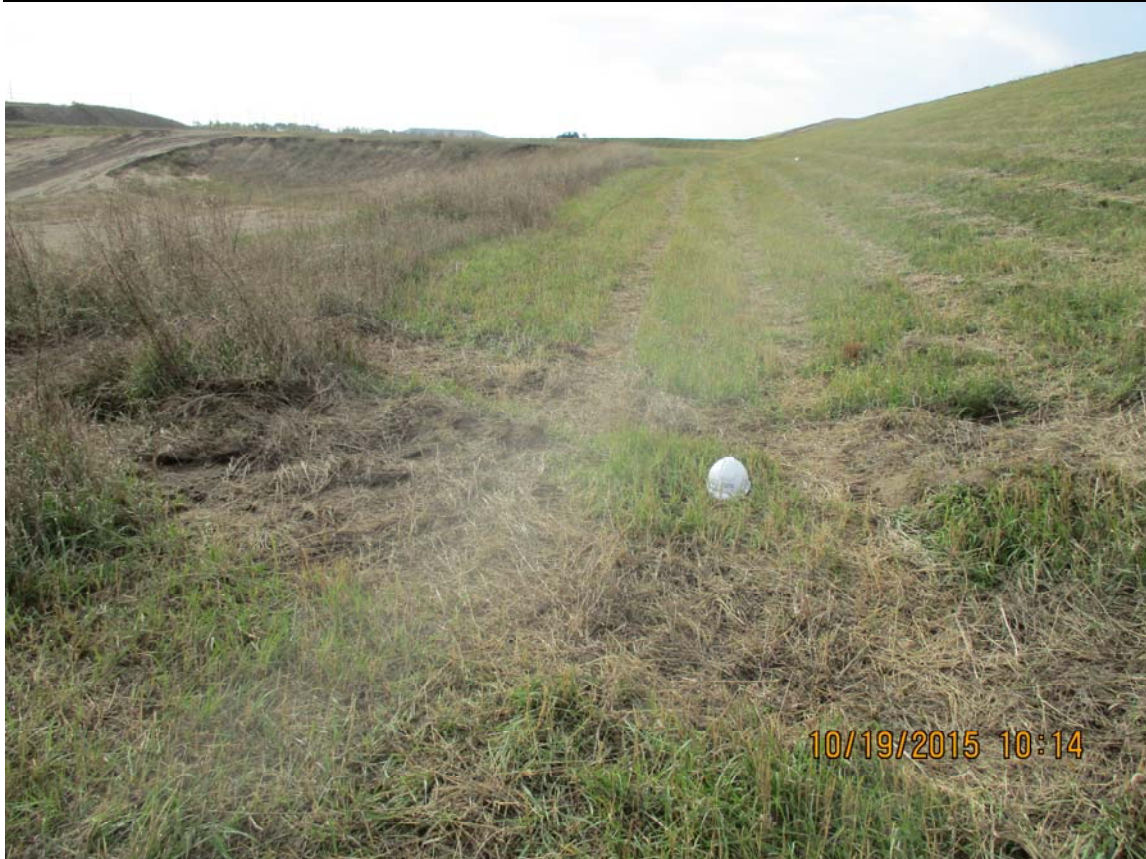
Photo 2	Outer east slope of north embankment, looking south (hard hat used to show length of grass, approximately 6 inches). Left, beginning of eroded channel.

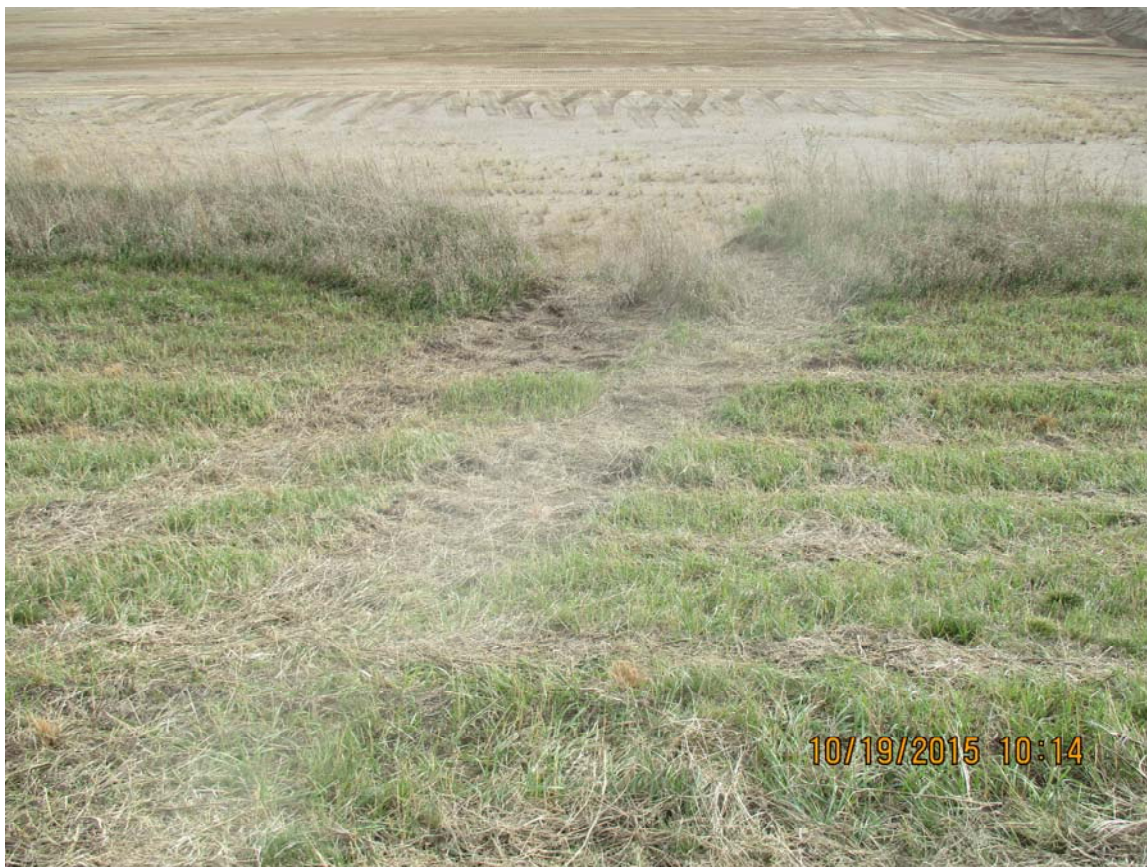
Photo 3	Erosion depicted on photo 2

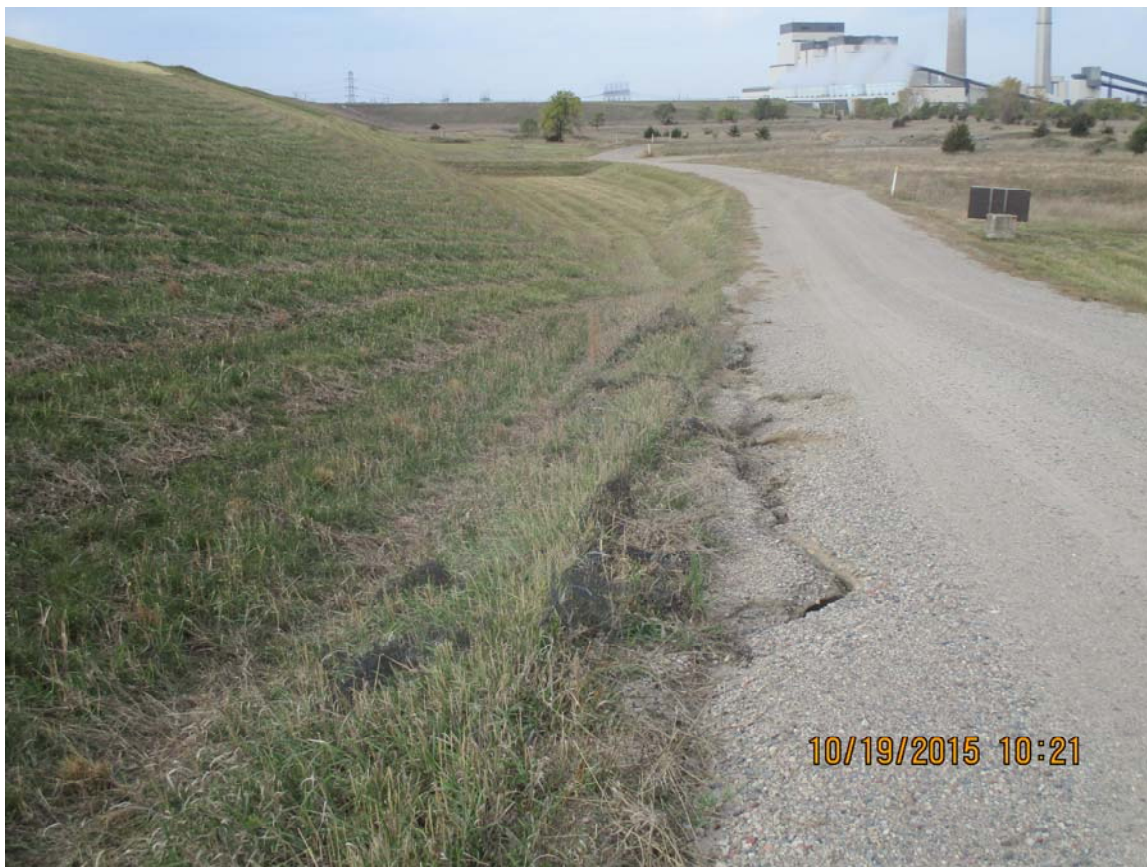
Photo 5	North embankment ramp, stormwater ditch and infiltration pond. Minor erosion on south side of class 5 road, looking west.

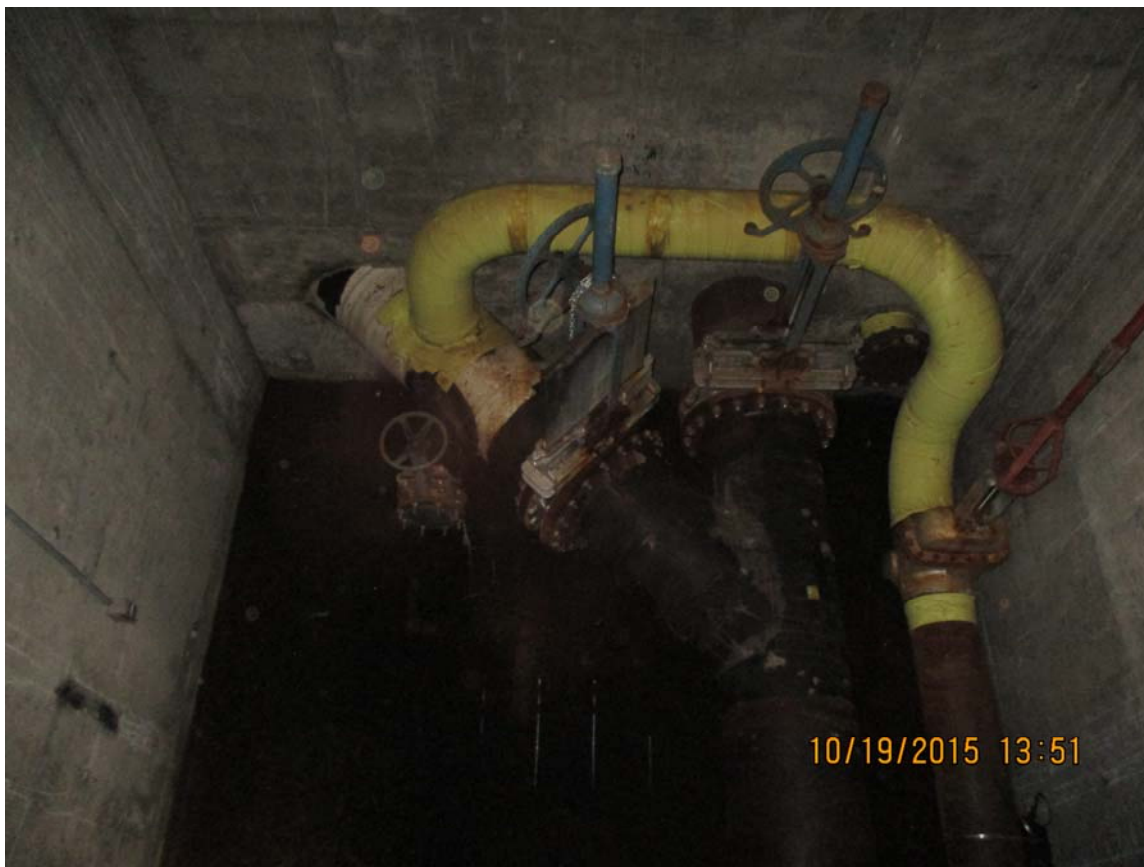
Photo 9	Pond vault looking through manhole shown on photo 8. Left pipe is from Pond 3, middle pipe is from Pond 2 (closed). Water depth in vault was estimated at less than 6 inches. Source of water is shown on photo 10.

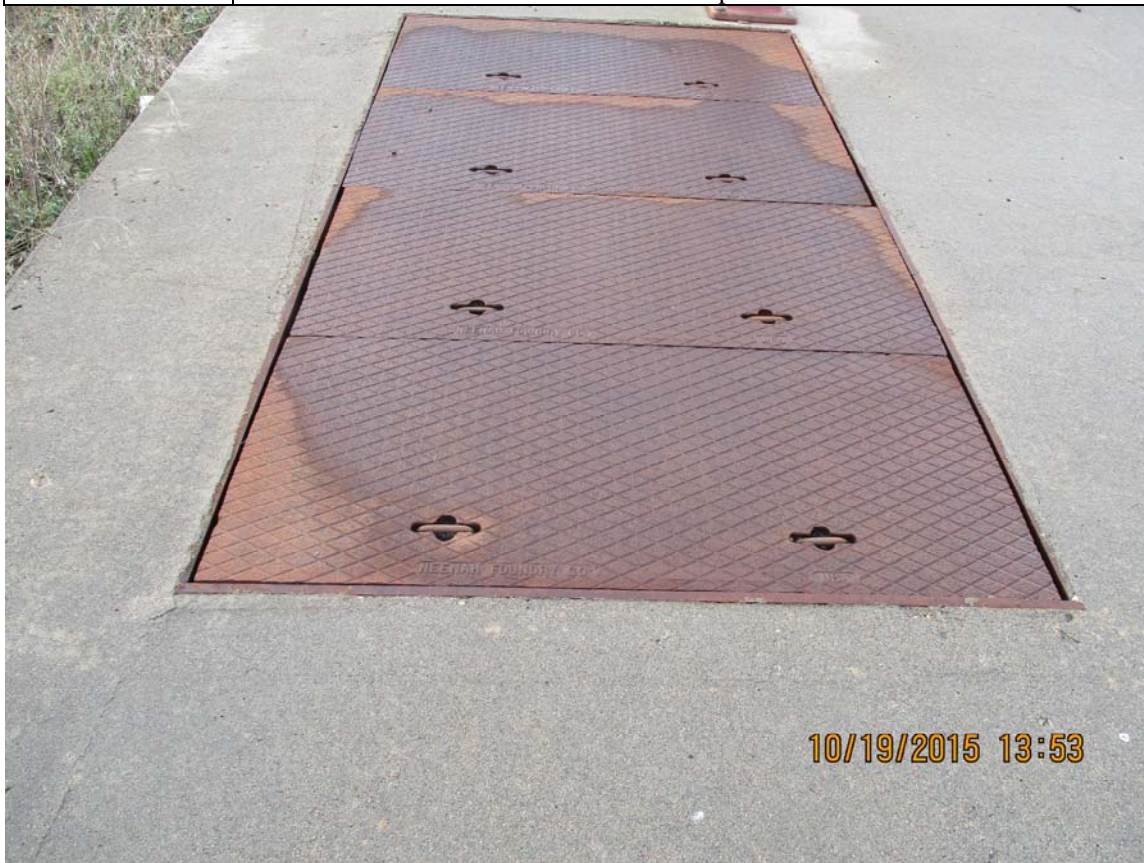
Photo 10	Steel cover over pipes shown on photo 9. Trace amounts of rainwater that falls on the cover will drip through and enter vault.

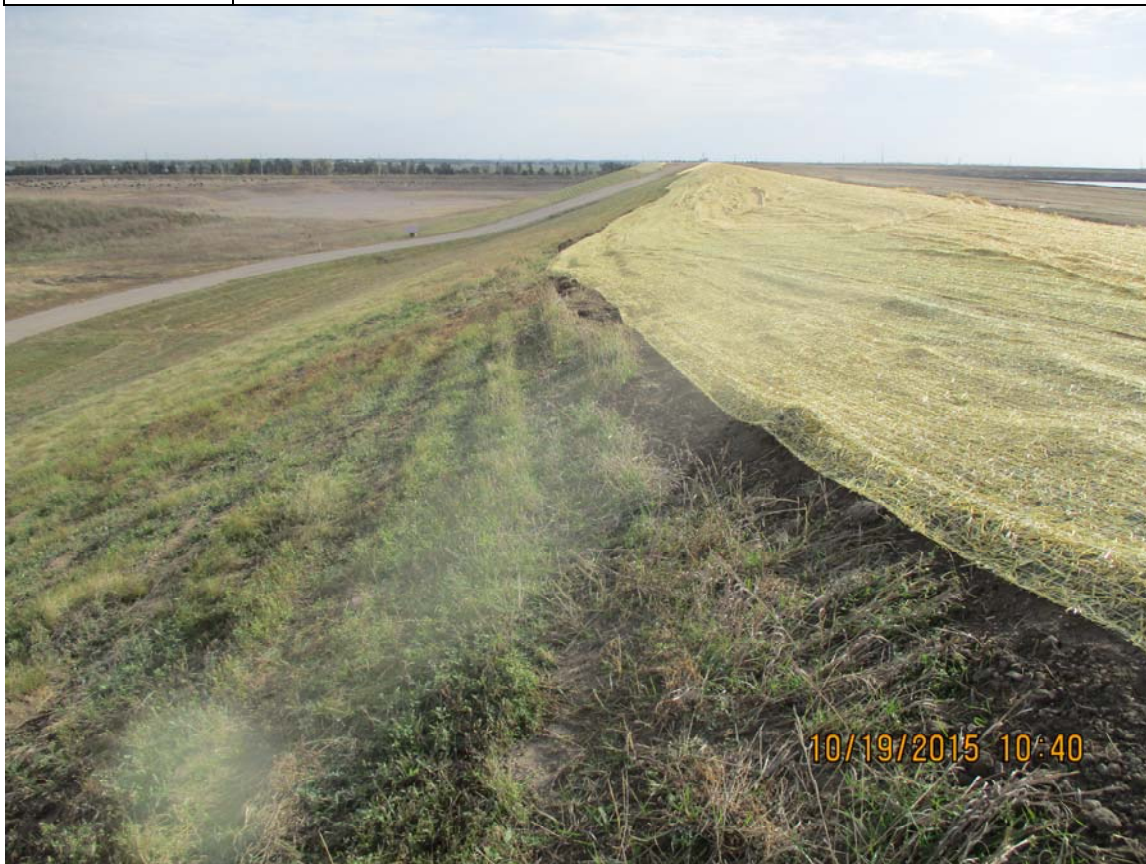
Photo 14	Erosion blanket installed on new pond vertical expansion, looking east
----------	--

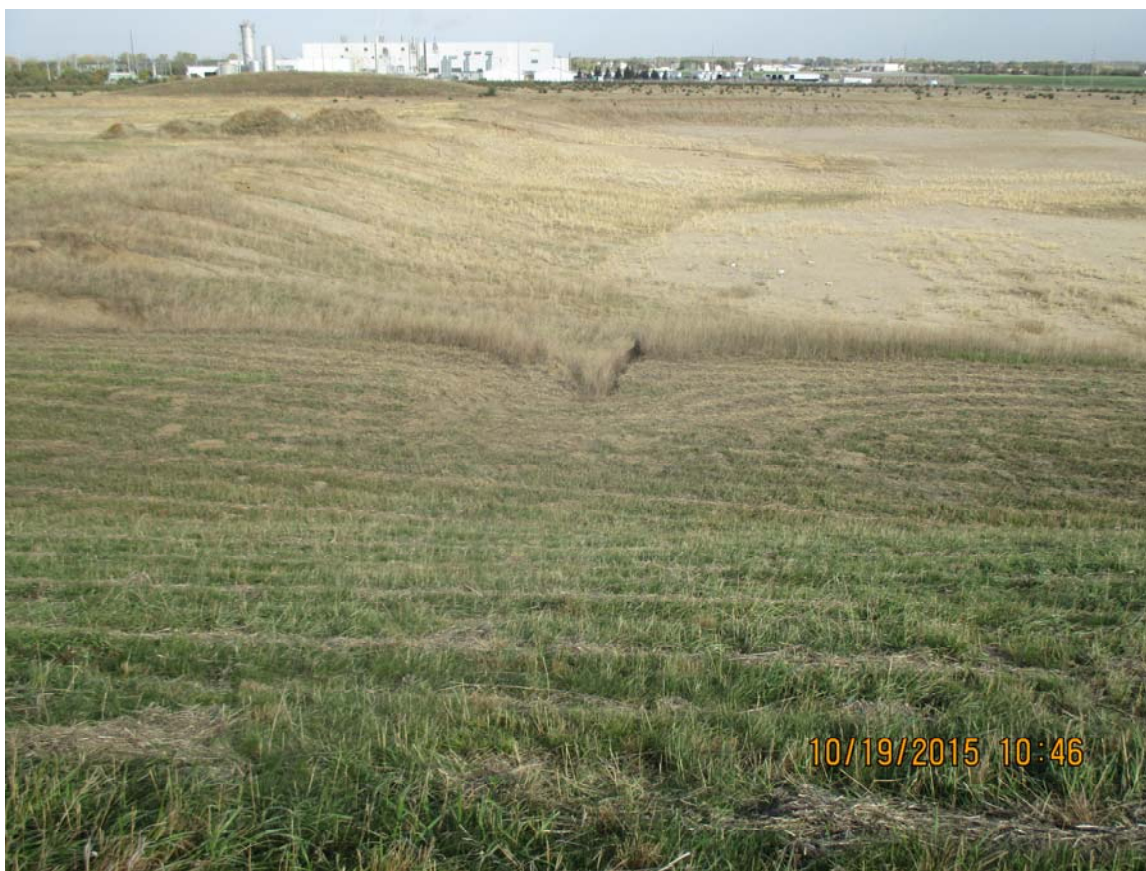
Photo 15	Erosion in the bench between the pond embankment and borrow area.
----------	---

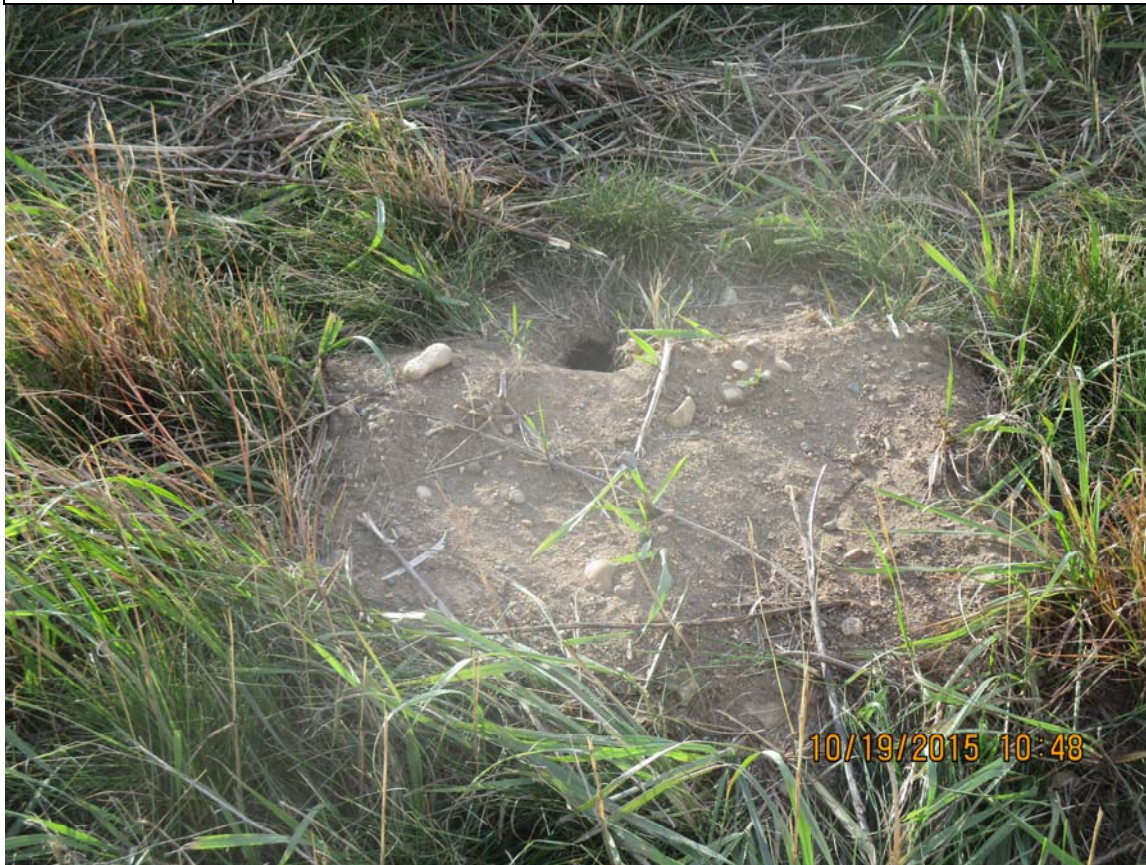
Photo 16	Gopher hole on north embankment
----------	---------------------------------

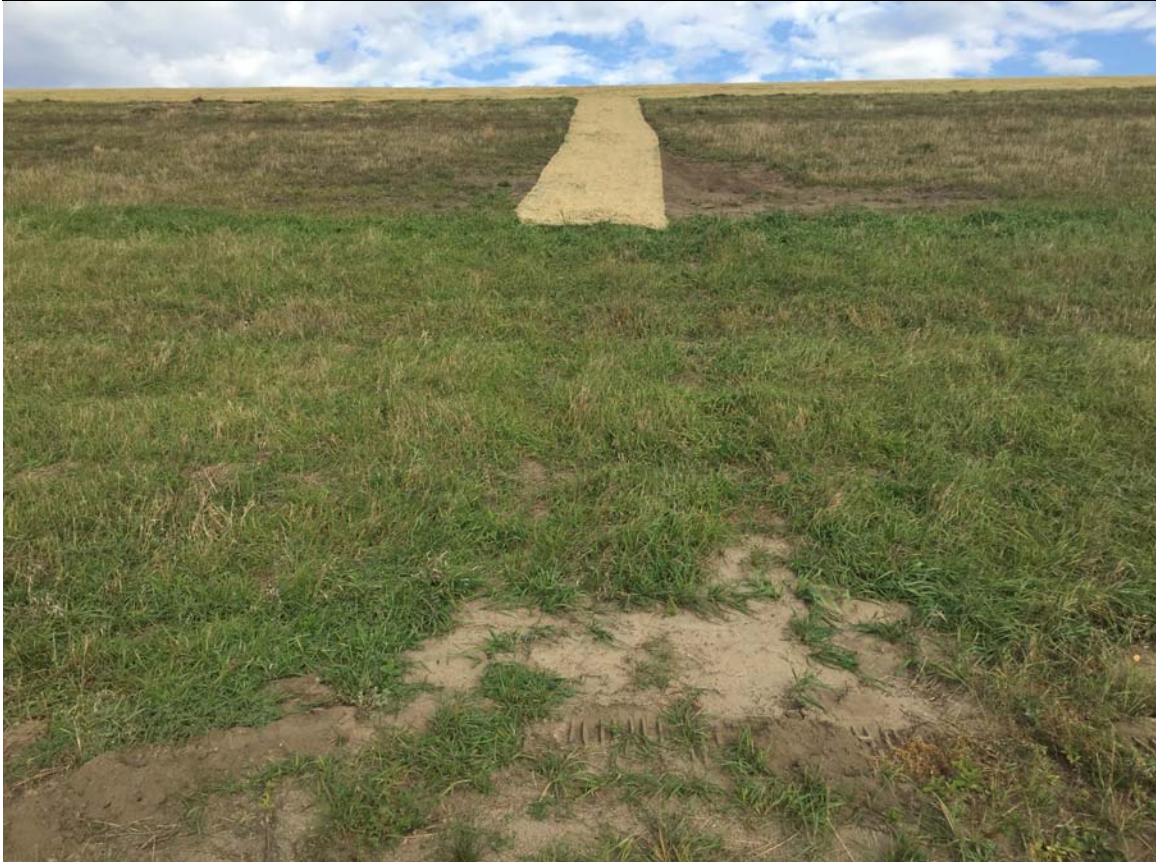
Photo 24

Blanket installed to fix erosion on upper portion of south embankment

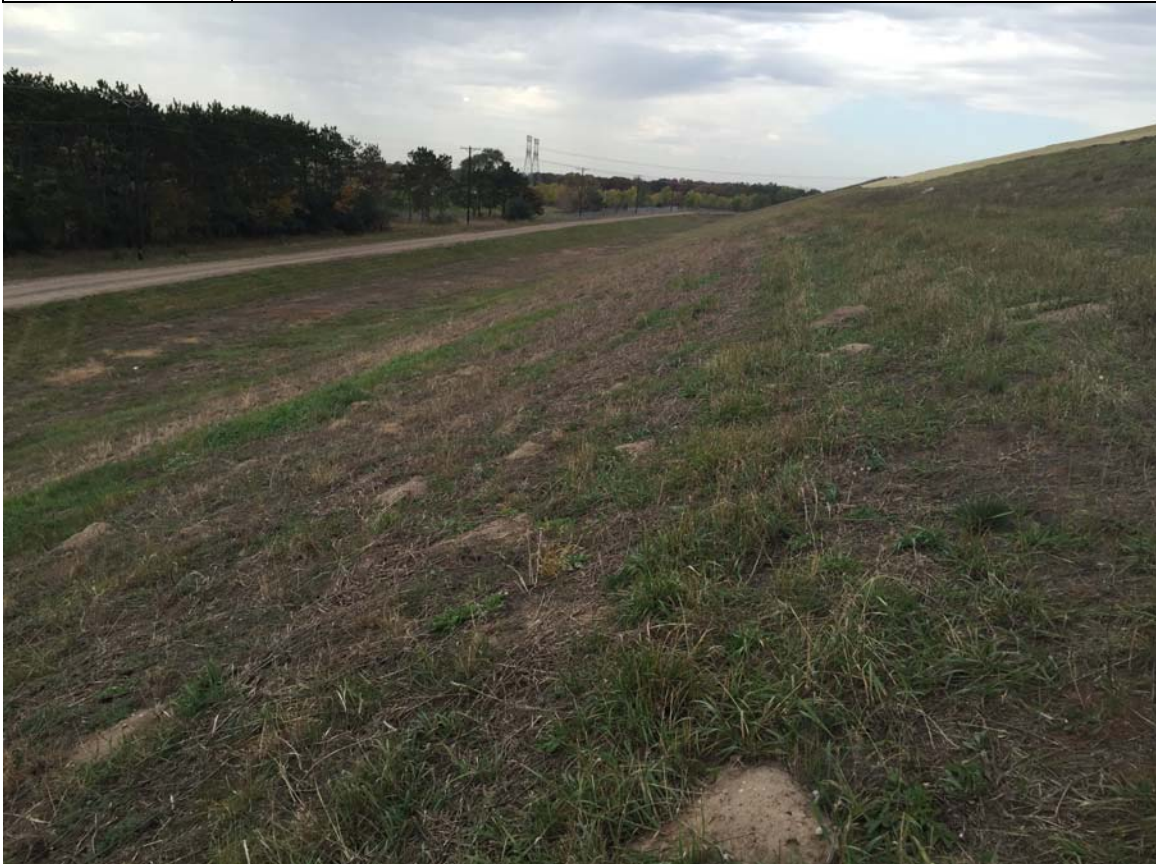
Photo 28

Gopher mounds, south embankment looking west

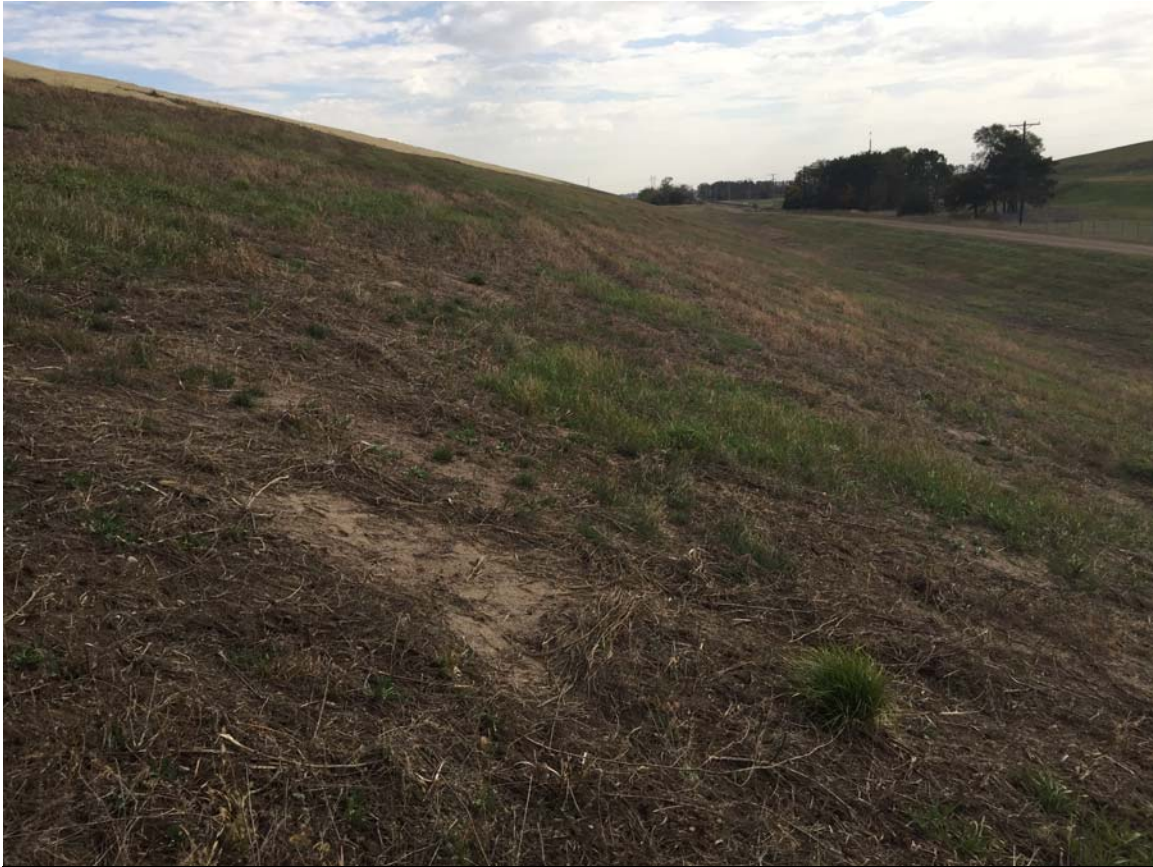
Photo 29

Areas of sparse vegetation on south slope, looking east.

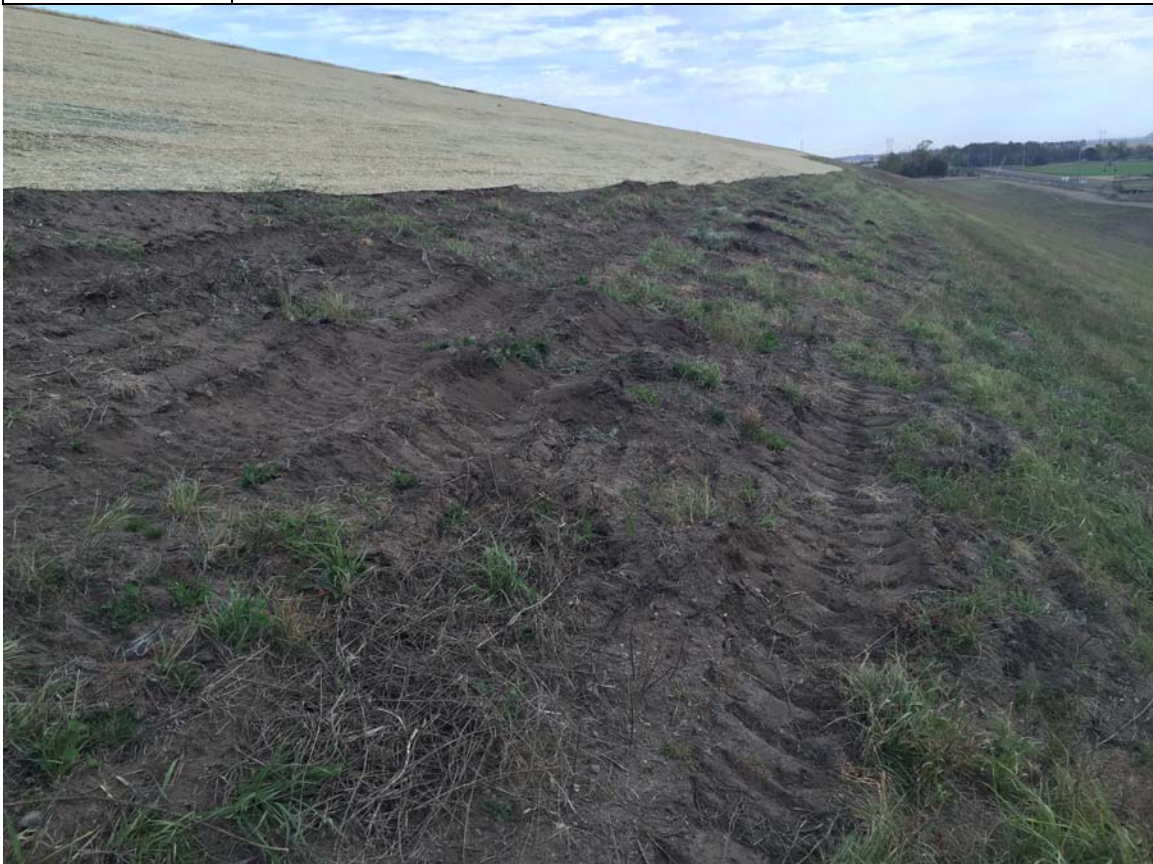
Photo 30

Left: newly constructed vertical expansion. Middle: disturbed vegetation caused by construction activities.

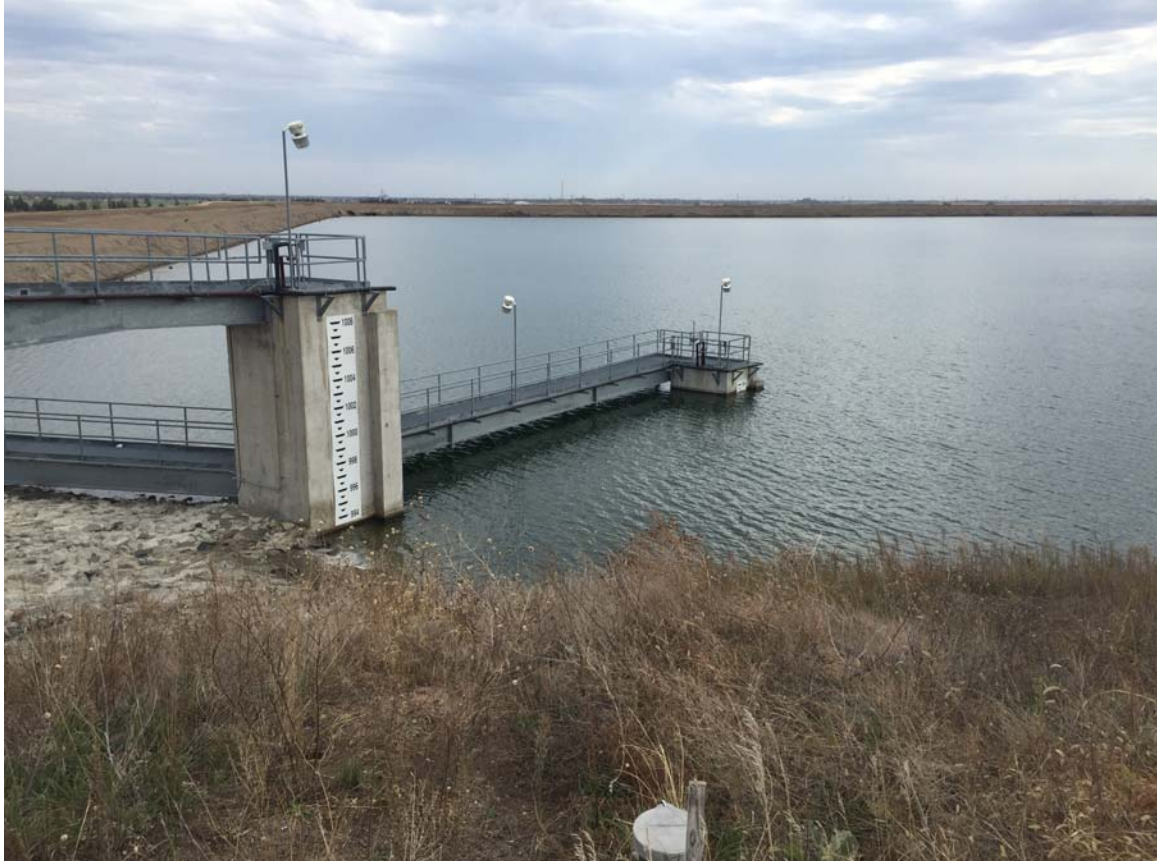
The only instrumentation on Pond 3 is a staff gauge used to determine water surface elevation, located on the west side of the discharge structures. The minimum elevation measured since the last inspection was 990.5 mean sea level (MSL) (October 2014), and the maximum elevation was 993.2 MSL (October 2015). The top of clay liner elevation from October 2014 to August 2015 was 998, and 1004 following the August 2015 construction event.

Photo 32	Pond discharge structure in northwest corner of pond. Water level indicates an elevation of 993.2
----------	---

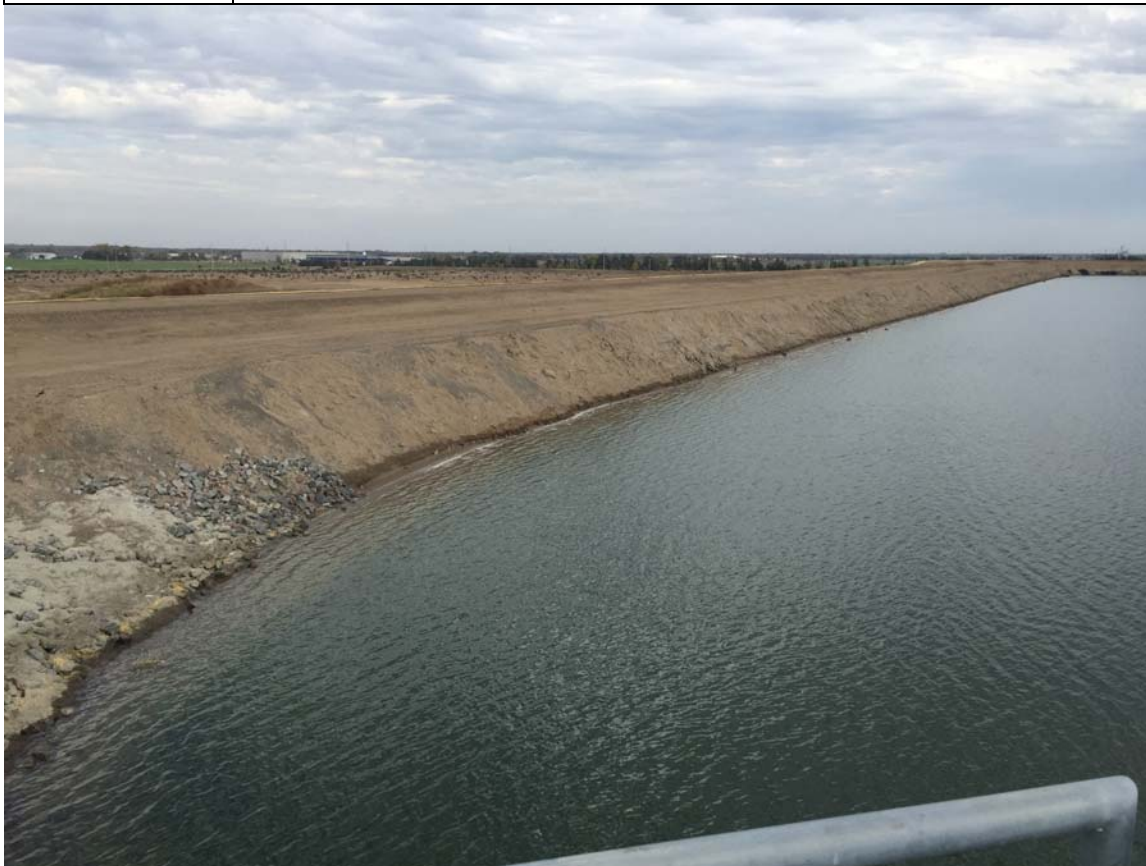
Photo 34	North interior embankment of pond (taken from discharge structure), looking northeast. Freeboard at time of photo: 10.1 feet to top of clay liner, 14.1 feet to top of embankment
----------	---
