Xcel Energy, Inc.  
Sherburne County Generating Station  
13999 Industrial Blvd.  
Becker, MN, 55308

**Re: Initial Annual Inspection of Unit 3 Landfill**

### Unit 3 Landfill Annual Inspection – October 2015

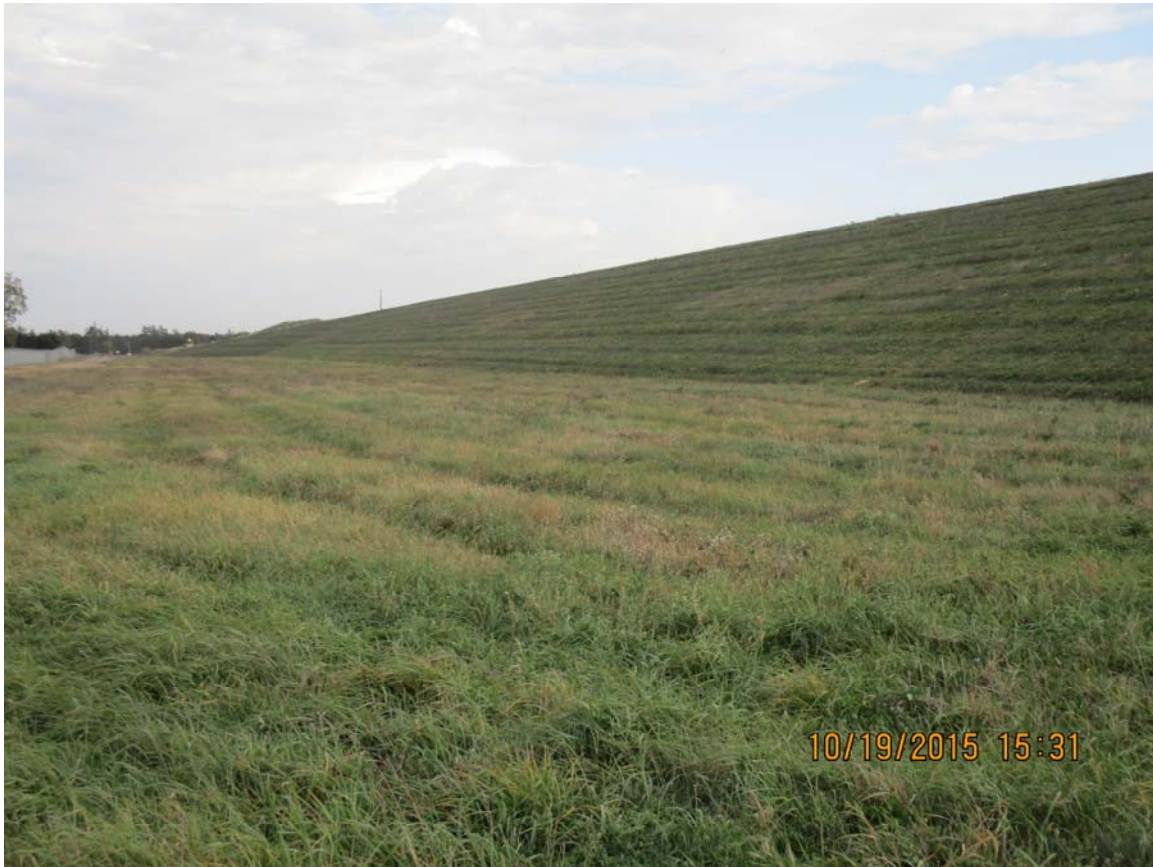
| Photo 1 | Exterior of North embankment, looking east |

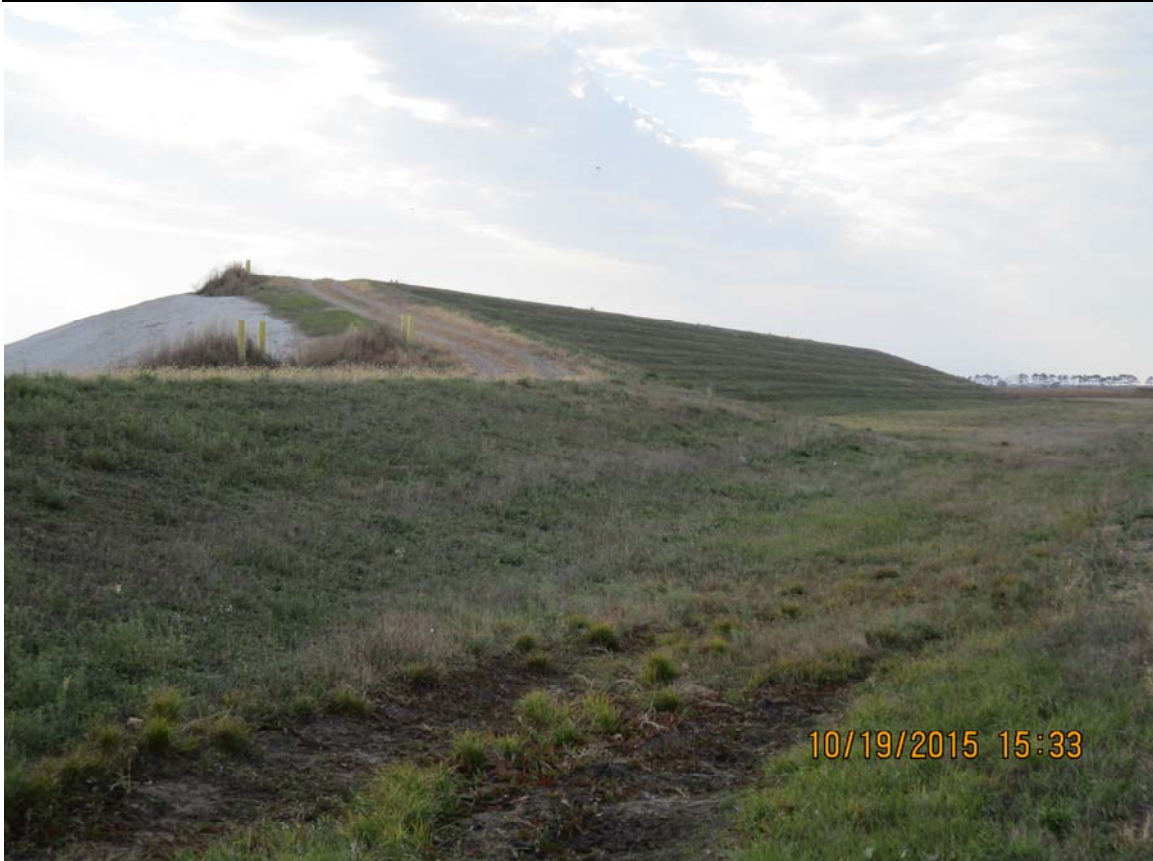
| Photo 2 | North embankment, looking west |

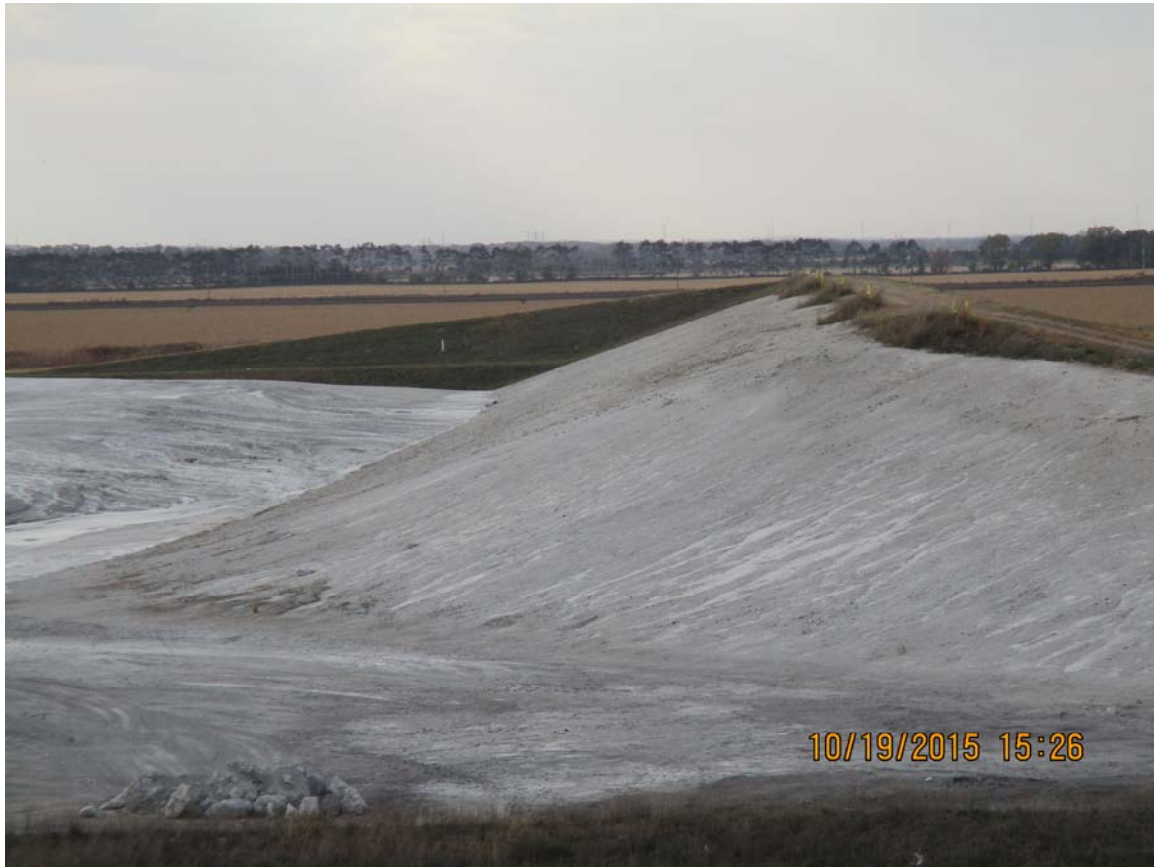
| Photo 3 | Interior of North embankment, looking west |

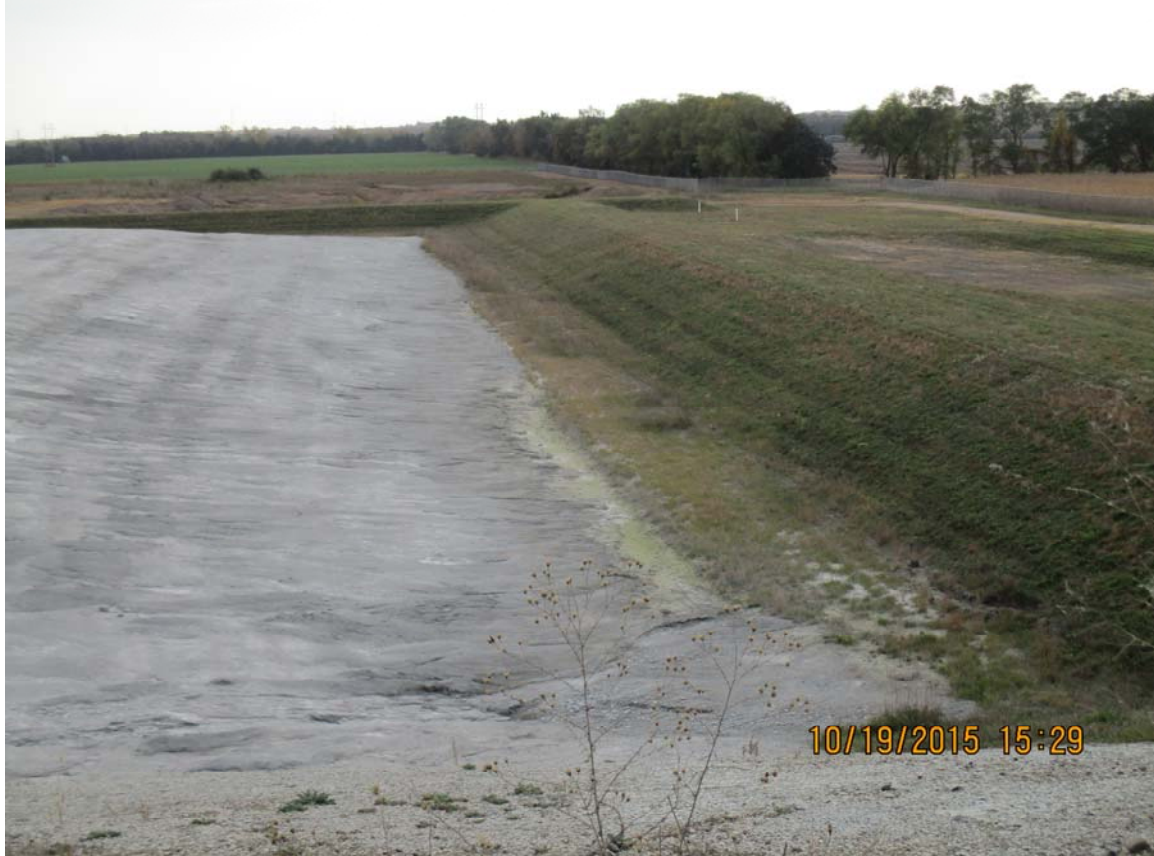
| Photo 4 | Interior of West embankment, looking south |

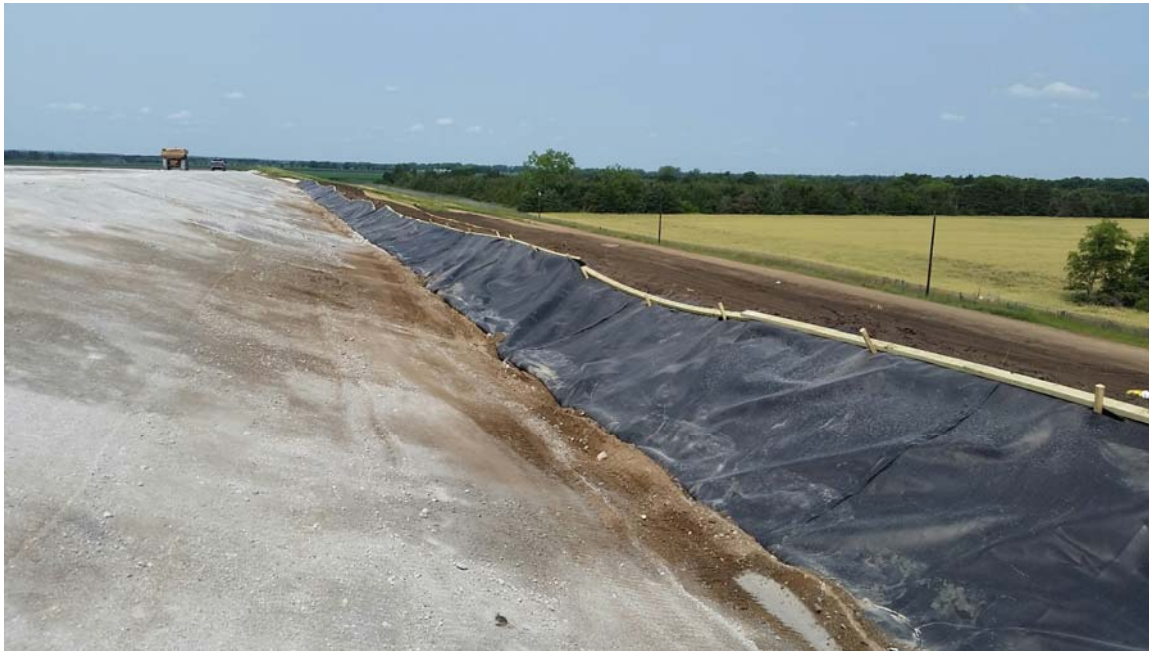
| Photo 5 | Left: Active area of the landfill. Right: Newly constructed final cover. Middle: |
| 7/2/2015 | Final cover geomembrane is flipped back to create a CCR contact-water diversion berm, looking west (Photo taken prior to inspection). |

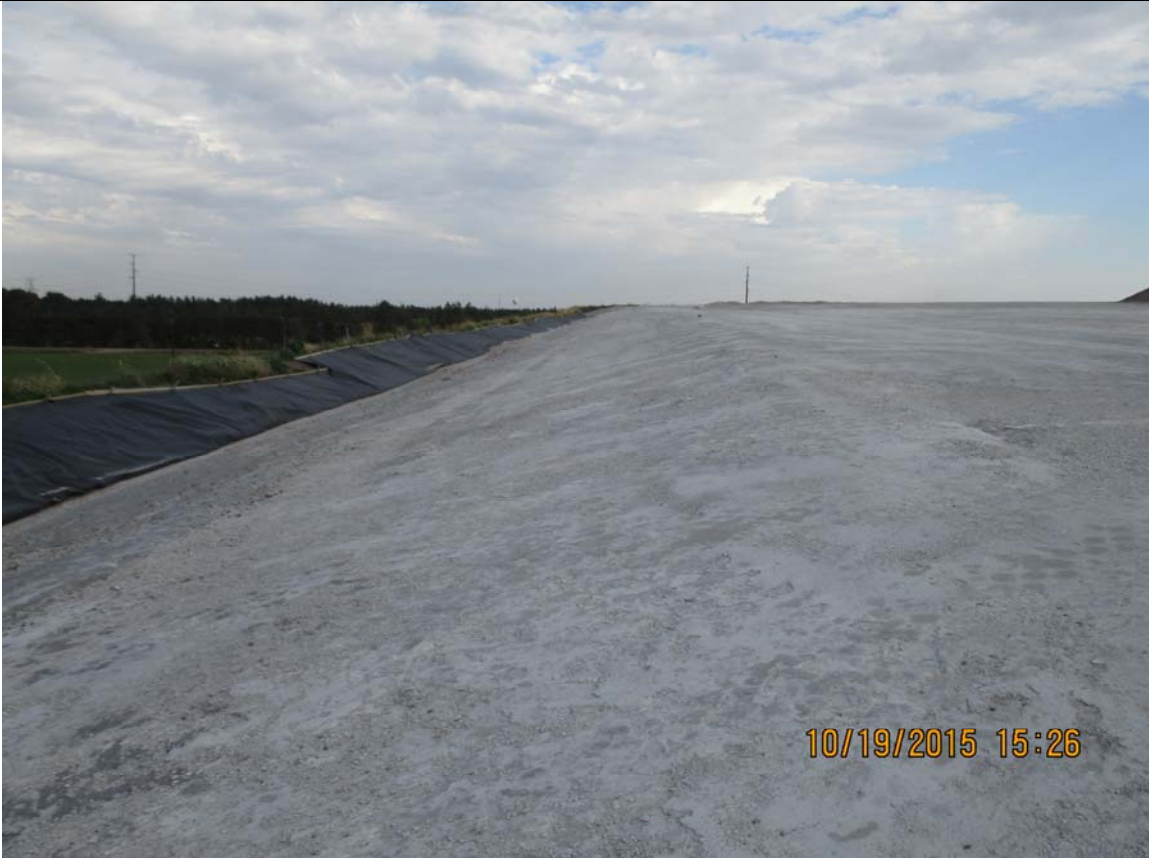
| Photo 6 | CCR contact-water diversion berm, looking east. |

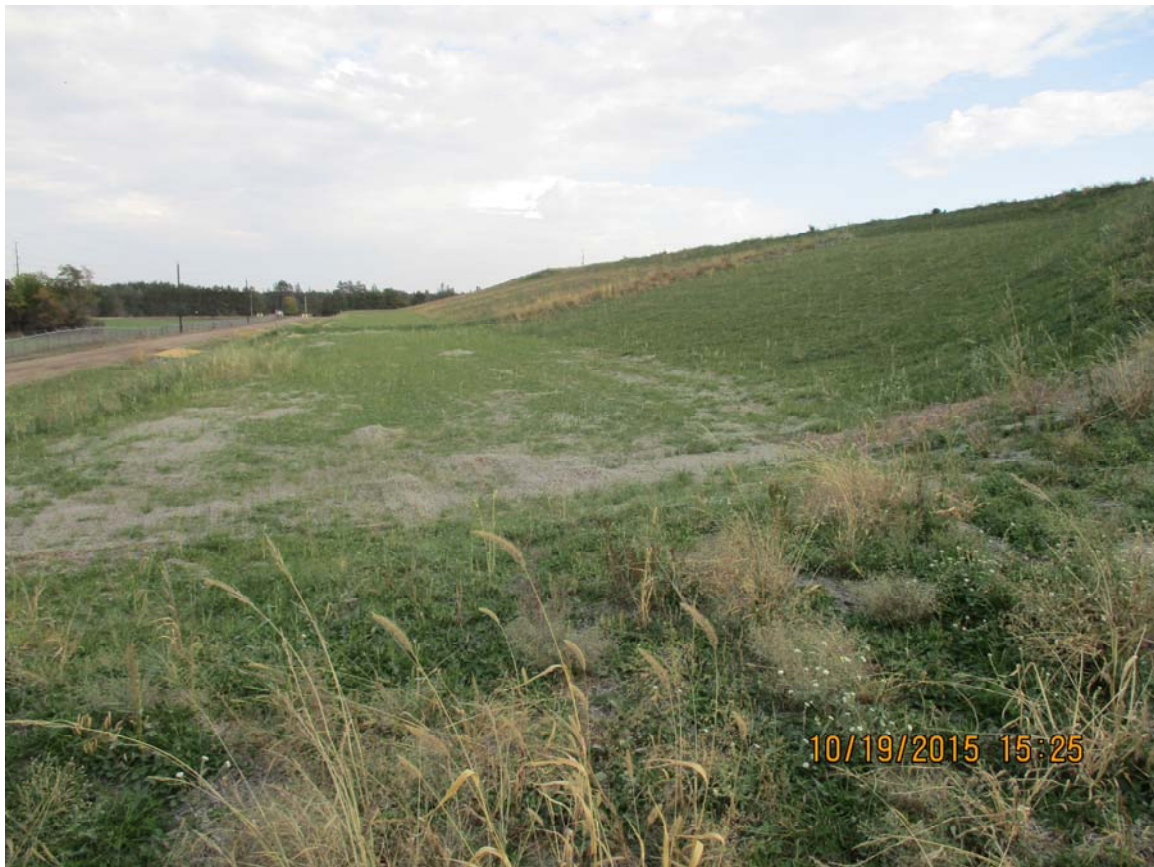
| Photo 7 | Initial vegetation on newly constructed final cover area, looking east. |

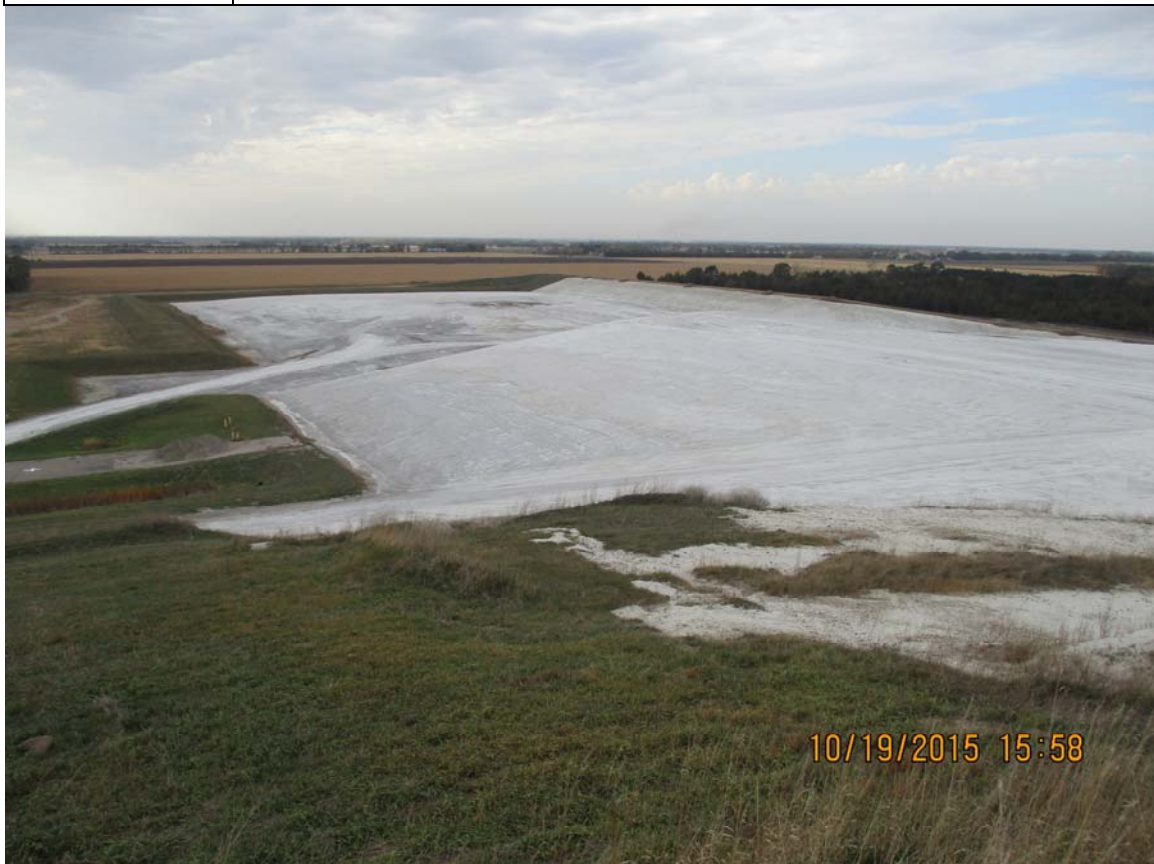
| Photo 8 | Overview of active area, looking west |

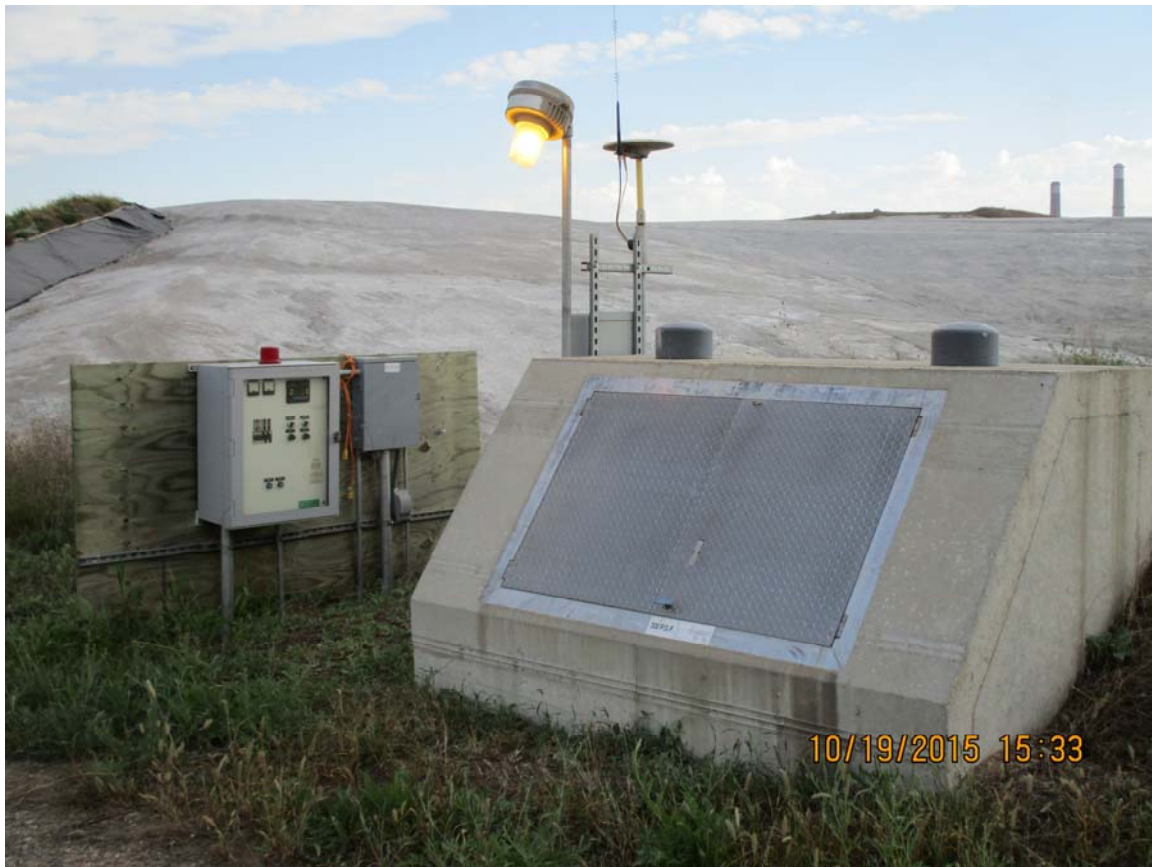
The active area sump panel controls and riser access panels were opened to verify that the leachate management system is functioning properly. There are no conditions disrupting the operation or safety of the CCR unit.

| Photo 9 | Left: Cell 2C Pump Controls. Right: Cell 2C Riser Pipe Access Panel |

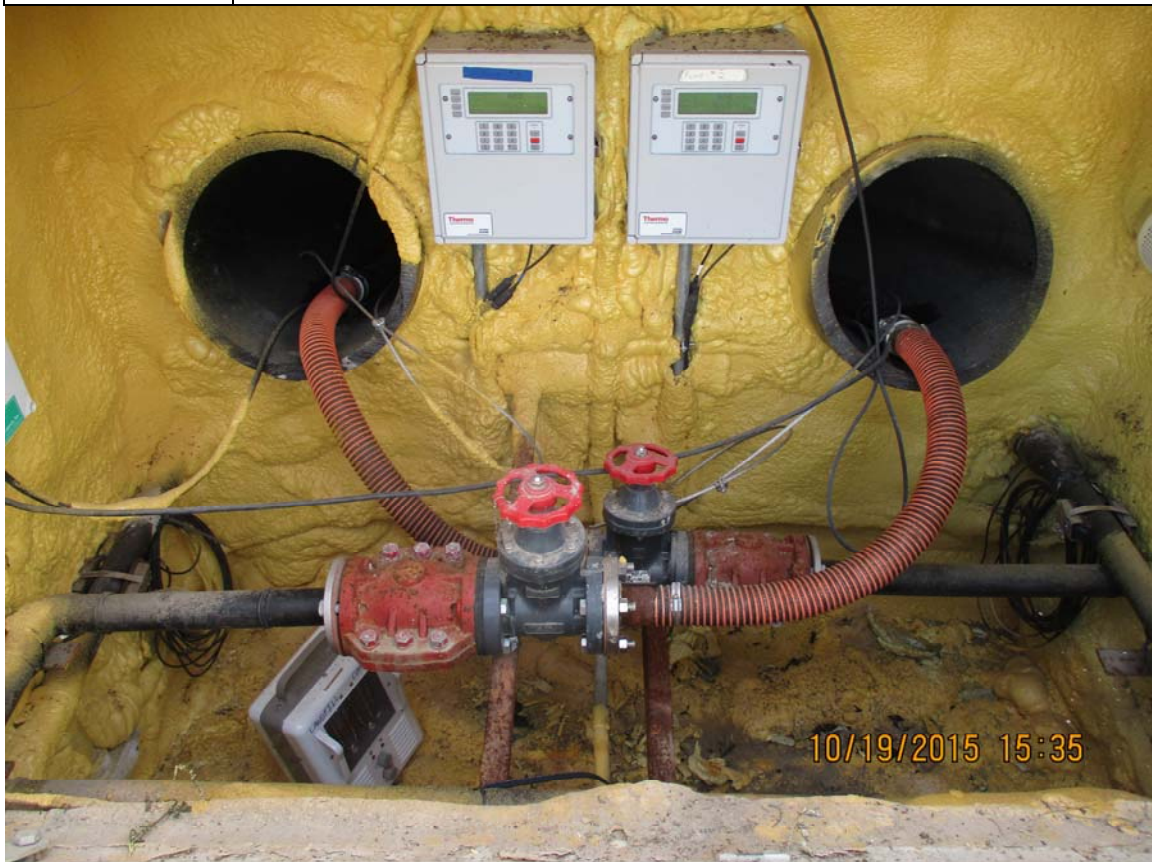
| Photo 10 | Inside of Cell 2C access panel. |

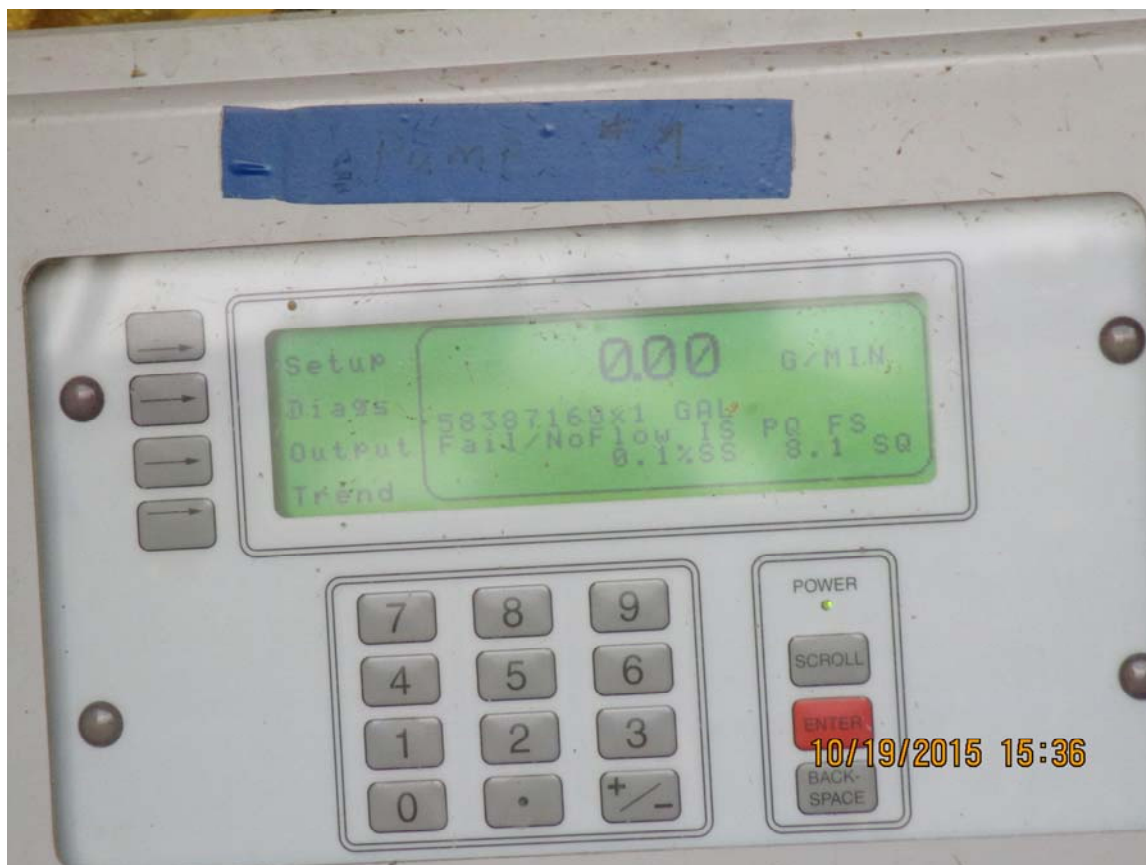
| Photo 11 | Display screen on properly function Pump No. 1 (left pump on photo 10) |

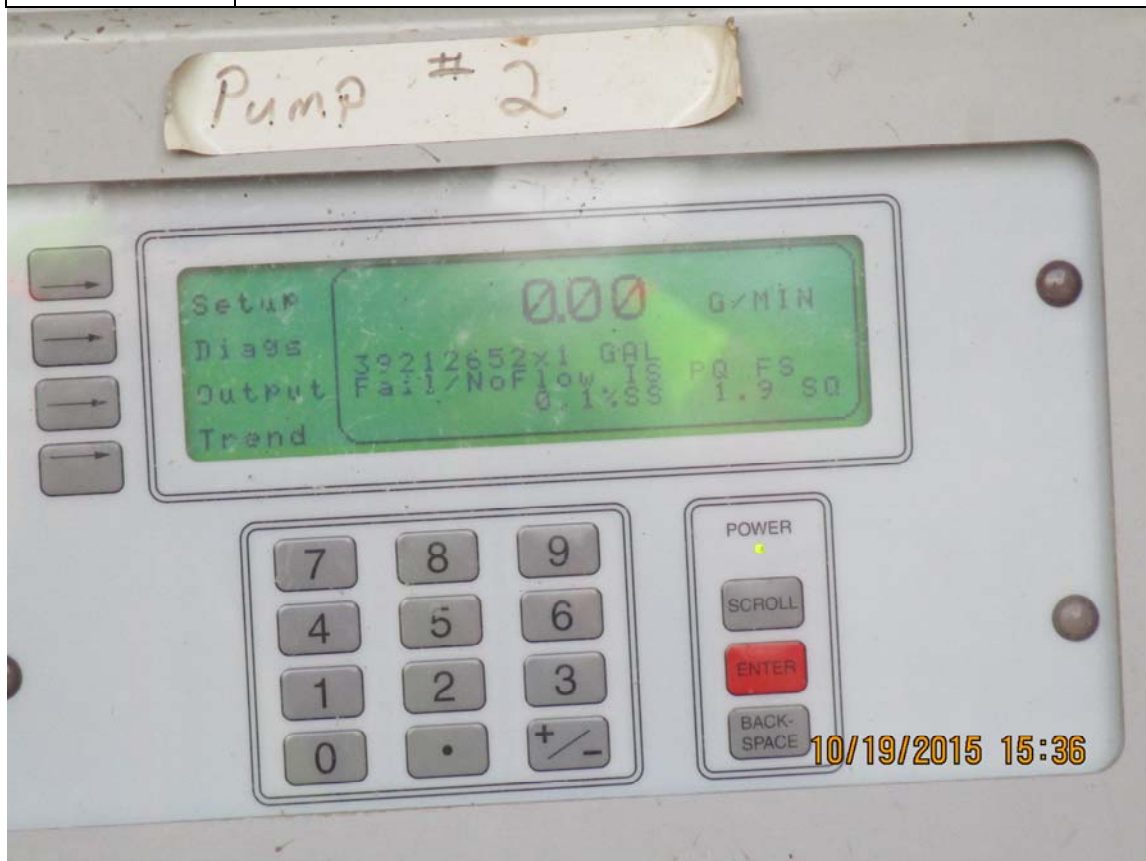
| Photo 12 | Display screen on properly function Pump No. 2 (right pump on photo 10) |
