Written Post-Closure Plan

Comanche Station - Active CCR Landfill

*Public Service Company of Colorado
Denver Colorado*

October 17, 2016

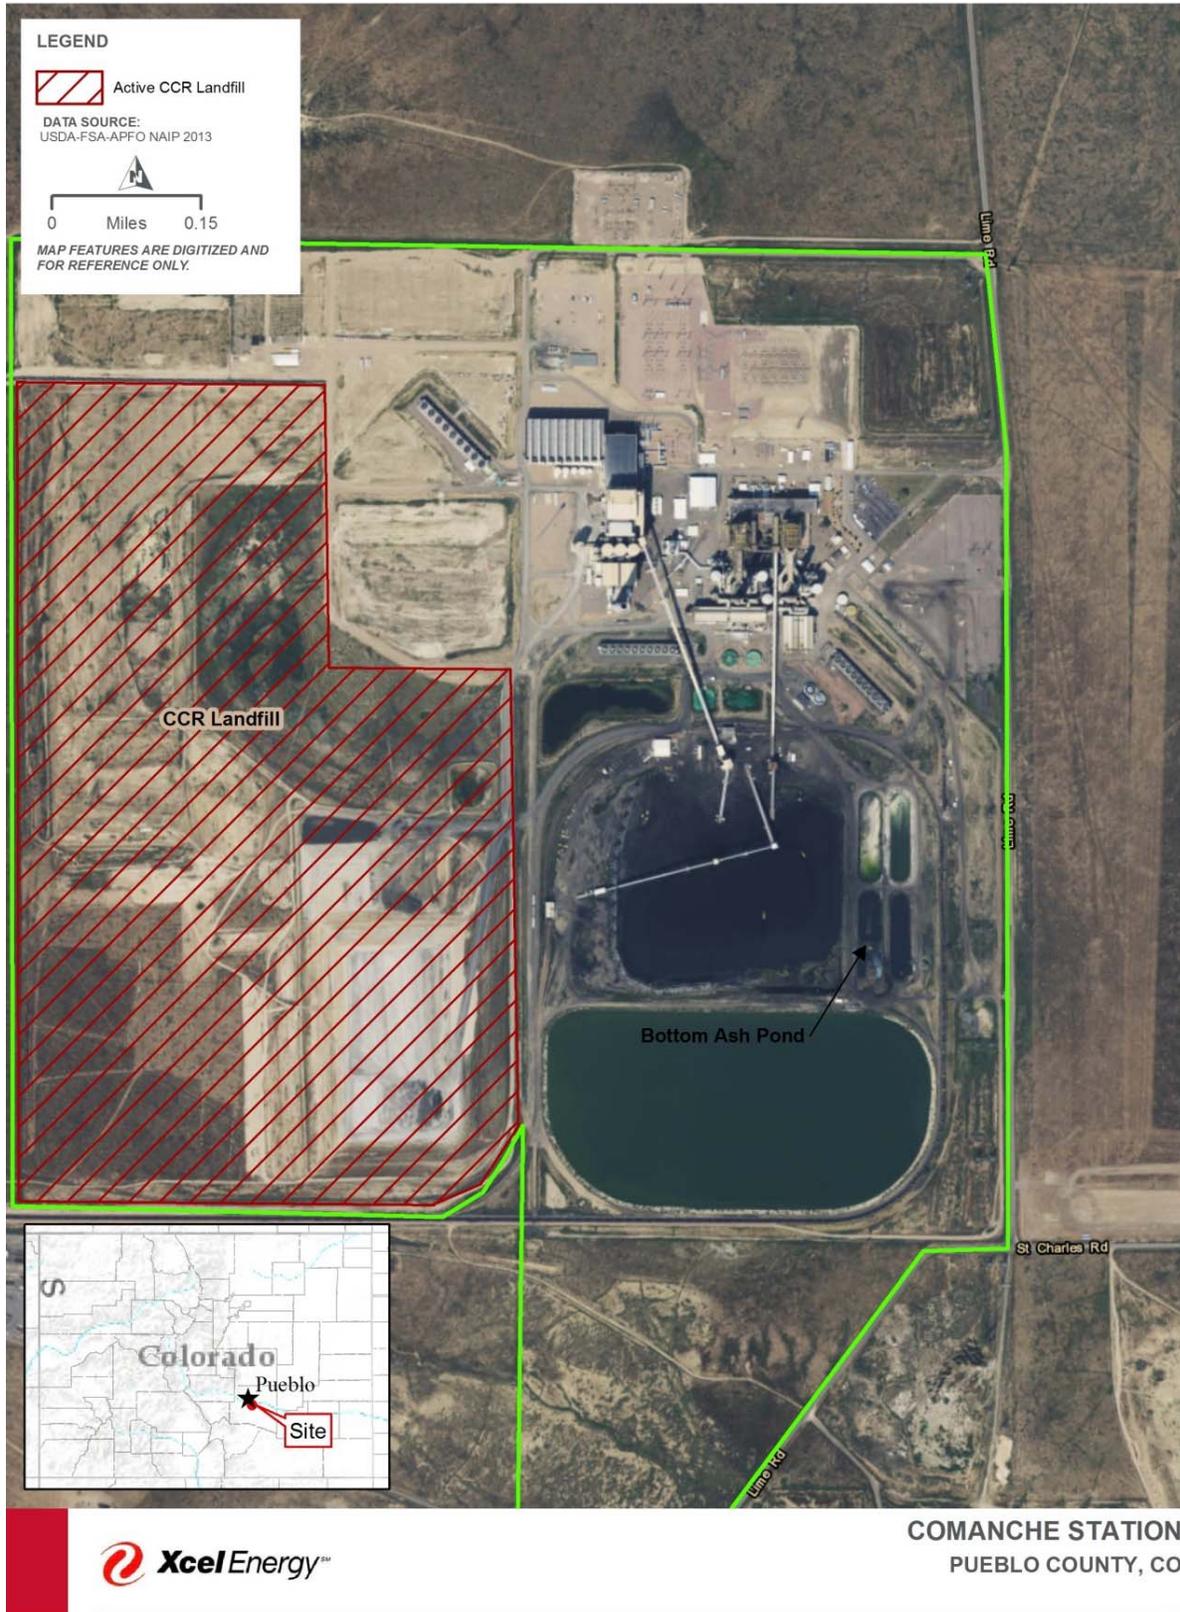
Figure 1. Comanche Power Station

The station's Ash Disposal Facility (ADF) is located on the southwest corner of the Comanche property (see **Figure 1**). The land surface elevations range from approximately 4,830 feet above mean sea level (amsl) in the southwest and northwest corners of the Site to approximately 4,800 feet amsl in the southeast corner of the Site.
