Energy Performance Systems, Inc.

Project Title: “Improving the Efficiency of Planting, Tending and Harvesting Farm-Grown Trees for Energy”

Contract Number: RD-50 Milestone: 17 Report Date: 31 August 2012

MILESTONE 17 – SUMMARY REPORT Harvester Testing and Modification

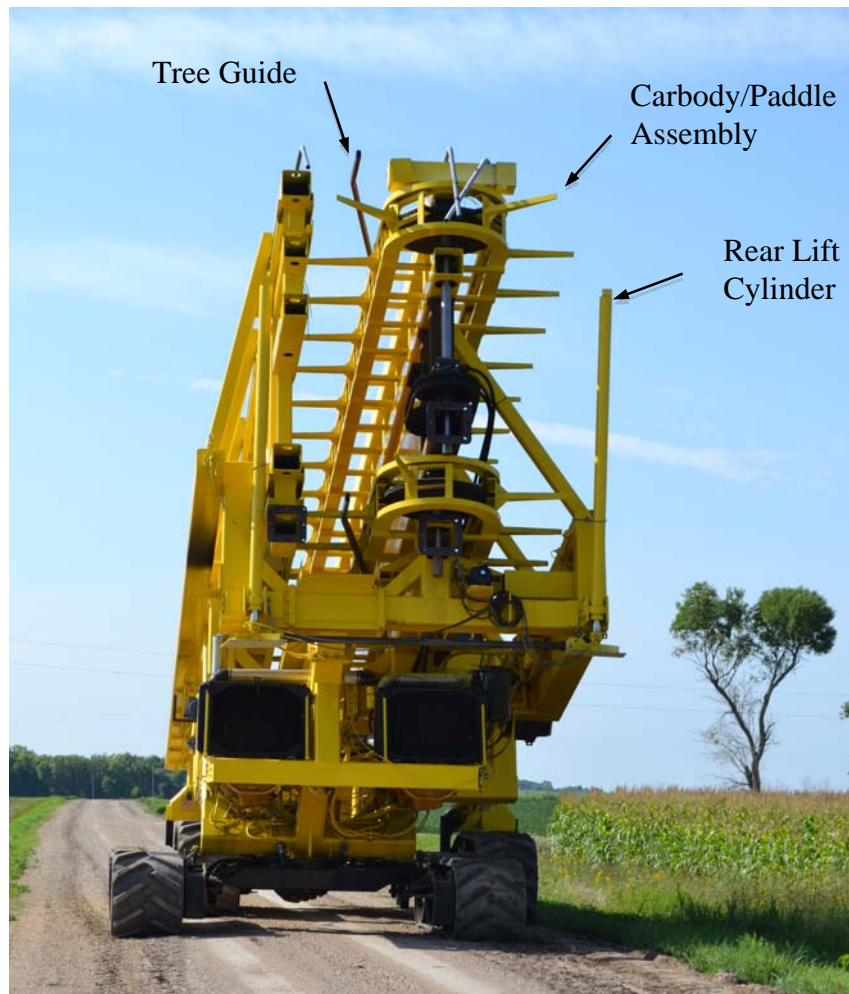
Figure 1. Rear of Harvester

Prior to milestone 17 testing, several components of the harvester fabrication and assembly were completed. First, fifty-six car body/paddle assemblies were built and installed in both the upper and lower rails, followed by the installation of a 150 hp hydraulic drive motor. The drive motor was then connected to an existing pump. Next, the hubs, shafts and sprockets were installed in the accumulator section of the harvester. Installation of the chains followed, connecting the paddles to the drive motor. This allowed for the harvester to accumulate cut trees into the skidpan while the machine was moving continuously along a row of trees. Figure 1 shows the carbody/paddle assemblies.

Following the accumulator section assembly, three large lift cylinders were added, two at the rear of the harvester and one toward the front of the harvester. The front 4-stage lift cylinder was modified to eliminate side-to-side movement. This keeps the harvester from moving left or right while the cylinder is actuated. The rear single stage, dual-acting cylinders were mounted, one on each side, with x-back bracing. All three lift cylinders aid in assembly and disassembly of the harvester and can also be used in the field for most harvester or track lifting needs. The two rear lift cylinders are shown in Figure 1.

The harvester is designed to accommodate a wide range of tree sizes. To efficiently handle small, fast growing trees such as five-year-old poplar, steel guides were mounted above the top paddles and just above the skidpan. These guides ensure that the smaller trees are steered toward the left side of the harvester as they are pushed off of the skidpan and do not get caught as the paddles accelerate through the turn on the back sprockets. A future modification of these guides may include adding springs or making them hydraulically actuated in order to account for different tree sizes. The steel guides are visible in Figure 1.

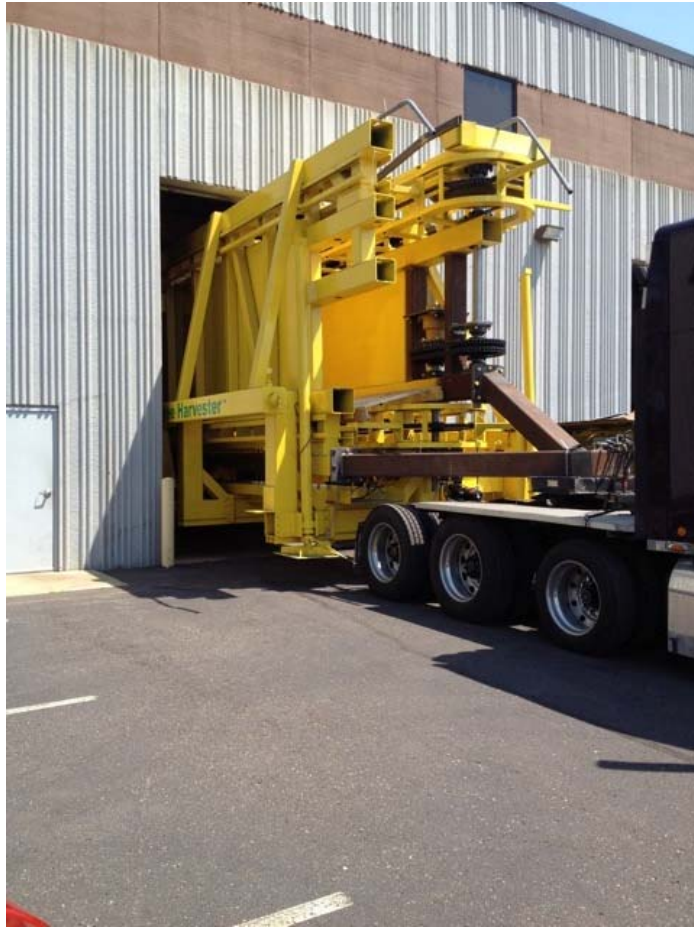
Figure 2. Move from Fabrication Shop

Due to the large size of the harvester, it was disassembled into four separate parts prior to moving it to the tree site. In order to maintain stability of the structure during transport, finding the center of gravity was necessary. This was determined by lifting the harvester several times on each end with two 50-ton jacks and finding balance points using a plum bob. The hauling assemblies were then positioned based on the center of gravity. The front structural part of the harvester was fitted with support beams that attached to a rear set of tandem-axle wheels. The rear of the harvester was fitted with three flanges that connected to structural tubing and a kingpin assembly. These fittings allowed the harvester body to attach to a trailer truck. Both the front and rear tracks were hydraulically driven onto a flatbed trailer using a remotely controlled hydropower pack. Figure 2 shows the harvester structure moving out of the fabrication shop in Big Lake, MN.

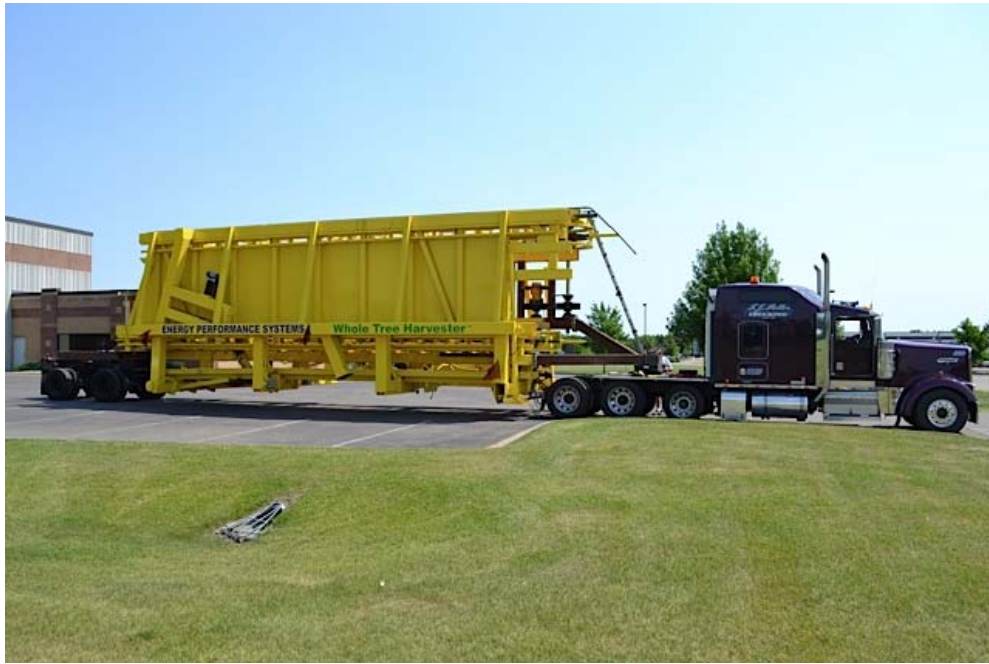
Figure 3. Harvester in Transport Mode

Finding a route and a hauler for the harvester structure quickly became a challenge. Out of date road construction information at MN DOT and a busy trucking season led to delays in the transportation of the harvester to the test site. After several different trucking companies withdrew from verbal and/or written hauling agreements, the harvester structure and rear tracks were finally hauled to the assembly site via T.J. Potter Trucking out of Becker, MN. Lange and Sons Transport, from Rogers, MN, hauled the front tracks. The harvesting head was loaded and hauled on a smaller trailer pulled by the EPS 3/4-ton pick up truck. A photo of the harvester during transport is shown in Figure 3.

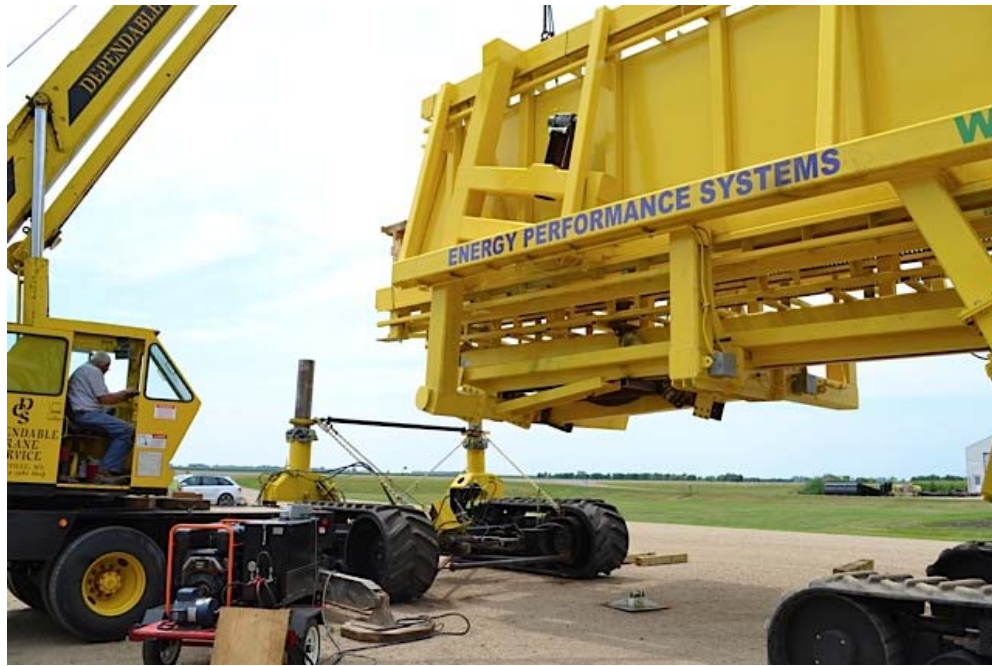
Figure 4. Installing Front Tracks During Field Assembly

Upon arrival at the assembly site near Graceville, MN, a crane operator was disassembling grain bins that were damaged in a recent storm. As a result, EPS was able to utilize the services of the crane in order to expedite reassembly of the harvester. First, the harvester structure was disconnected from the transport attachments. Next, the rear tracks were installed, followed by the front tracks. The use of the crane allowed all of this work to be completed in one day. The following days involved making all of the other structural, hydraulic and electronic connections. Figure 4 shows the crane helping with the assembly.

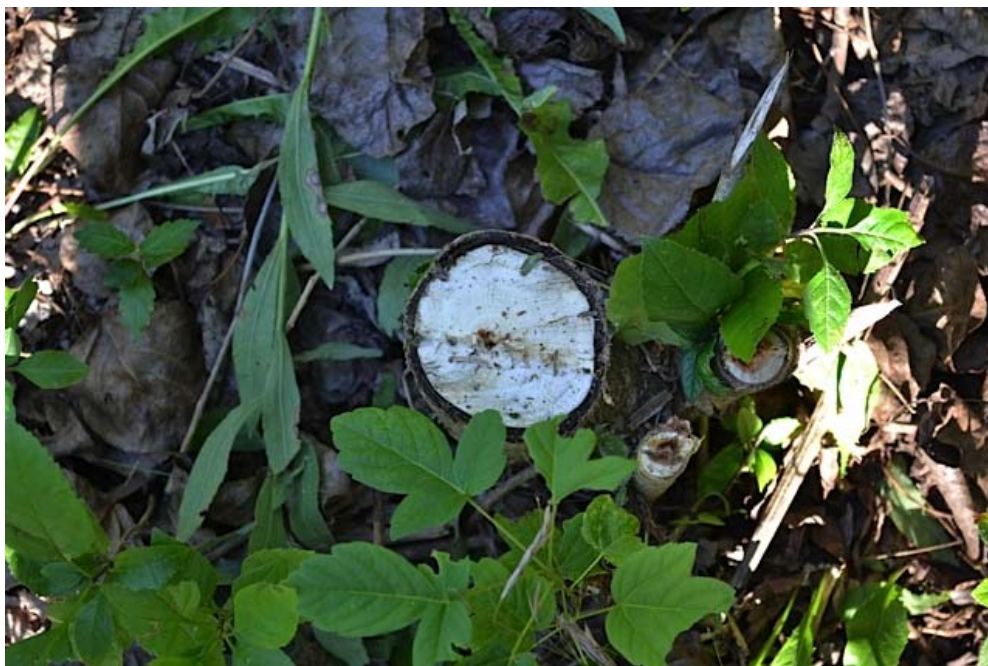
Figure 5. Stump From Whole Tree Harvester™ Cutting

The first field test of the Whole Tree Harvester™ was successful. It included cutting approximately 20 small trees on an end-row of the tree plantation. Figure 5 shows a photo of one of the tree stumps after the harvester pass. The harvester cut cleanly through the trees at approximately 3 inches off of the ground and the paddles pulled the trees onto the skidpan as the harvester moved continuously forward. Throughout the test, trees from approximately 1.5 to 4 inches in diameter (measured at the base of the tree) were easily severed by the twin cutting disks. A gap between the cutting head and the skidpan proved to be a catching point for the smaller trees and caused several trees to lie down rather than stand as they slid along the skidpan. The trees that made it across the gap were pulled up the skidpan and delivered off the back of the harvester, where they fell to the ground. As the small trees in the prone position filled up the skidpan, they began to block larger trees as well. The harvesting was then stopped in order to keep the prone trees from damaging the hydraulic and electronic lines running along the inside of the harvester structure. All remaining trees were cleared from the skidpan by hand.
