# Memorandum

**Subject:** Remedy Completion Memorandum, Former Heartland Apartments Property, Fargo MGP Site, Fargo, North Dakota

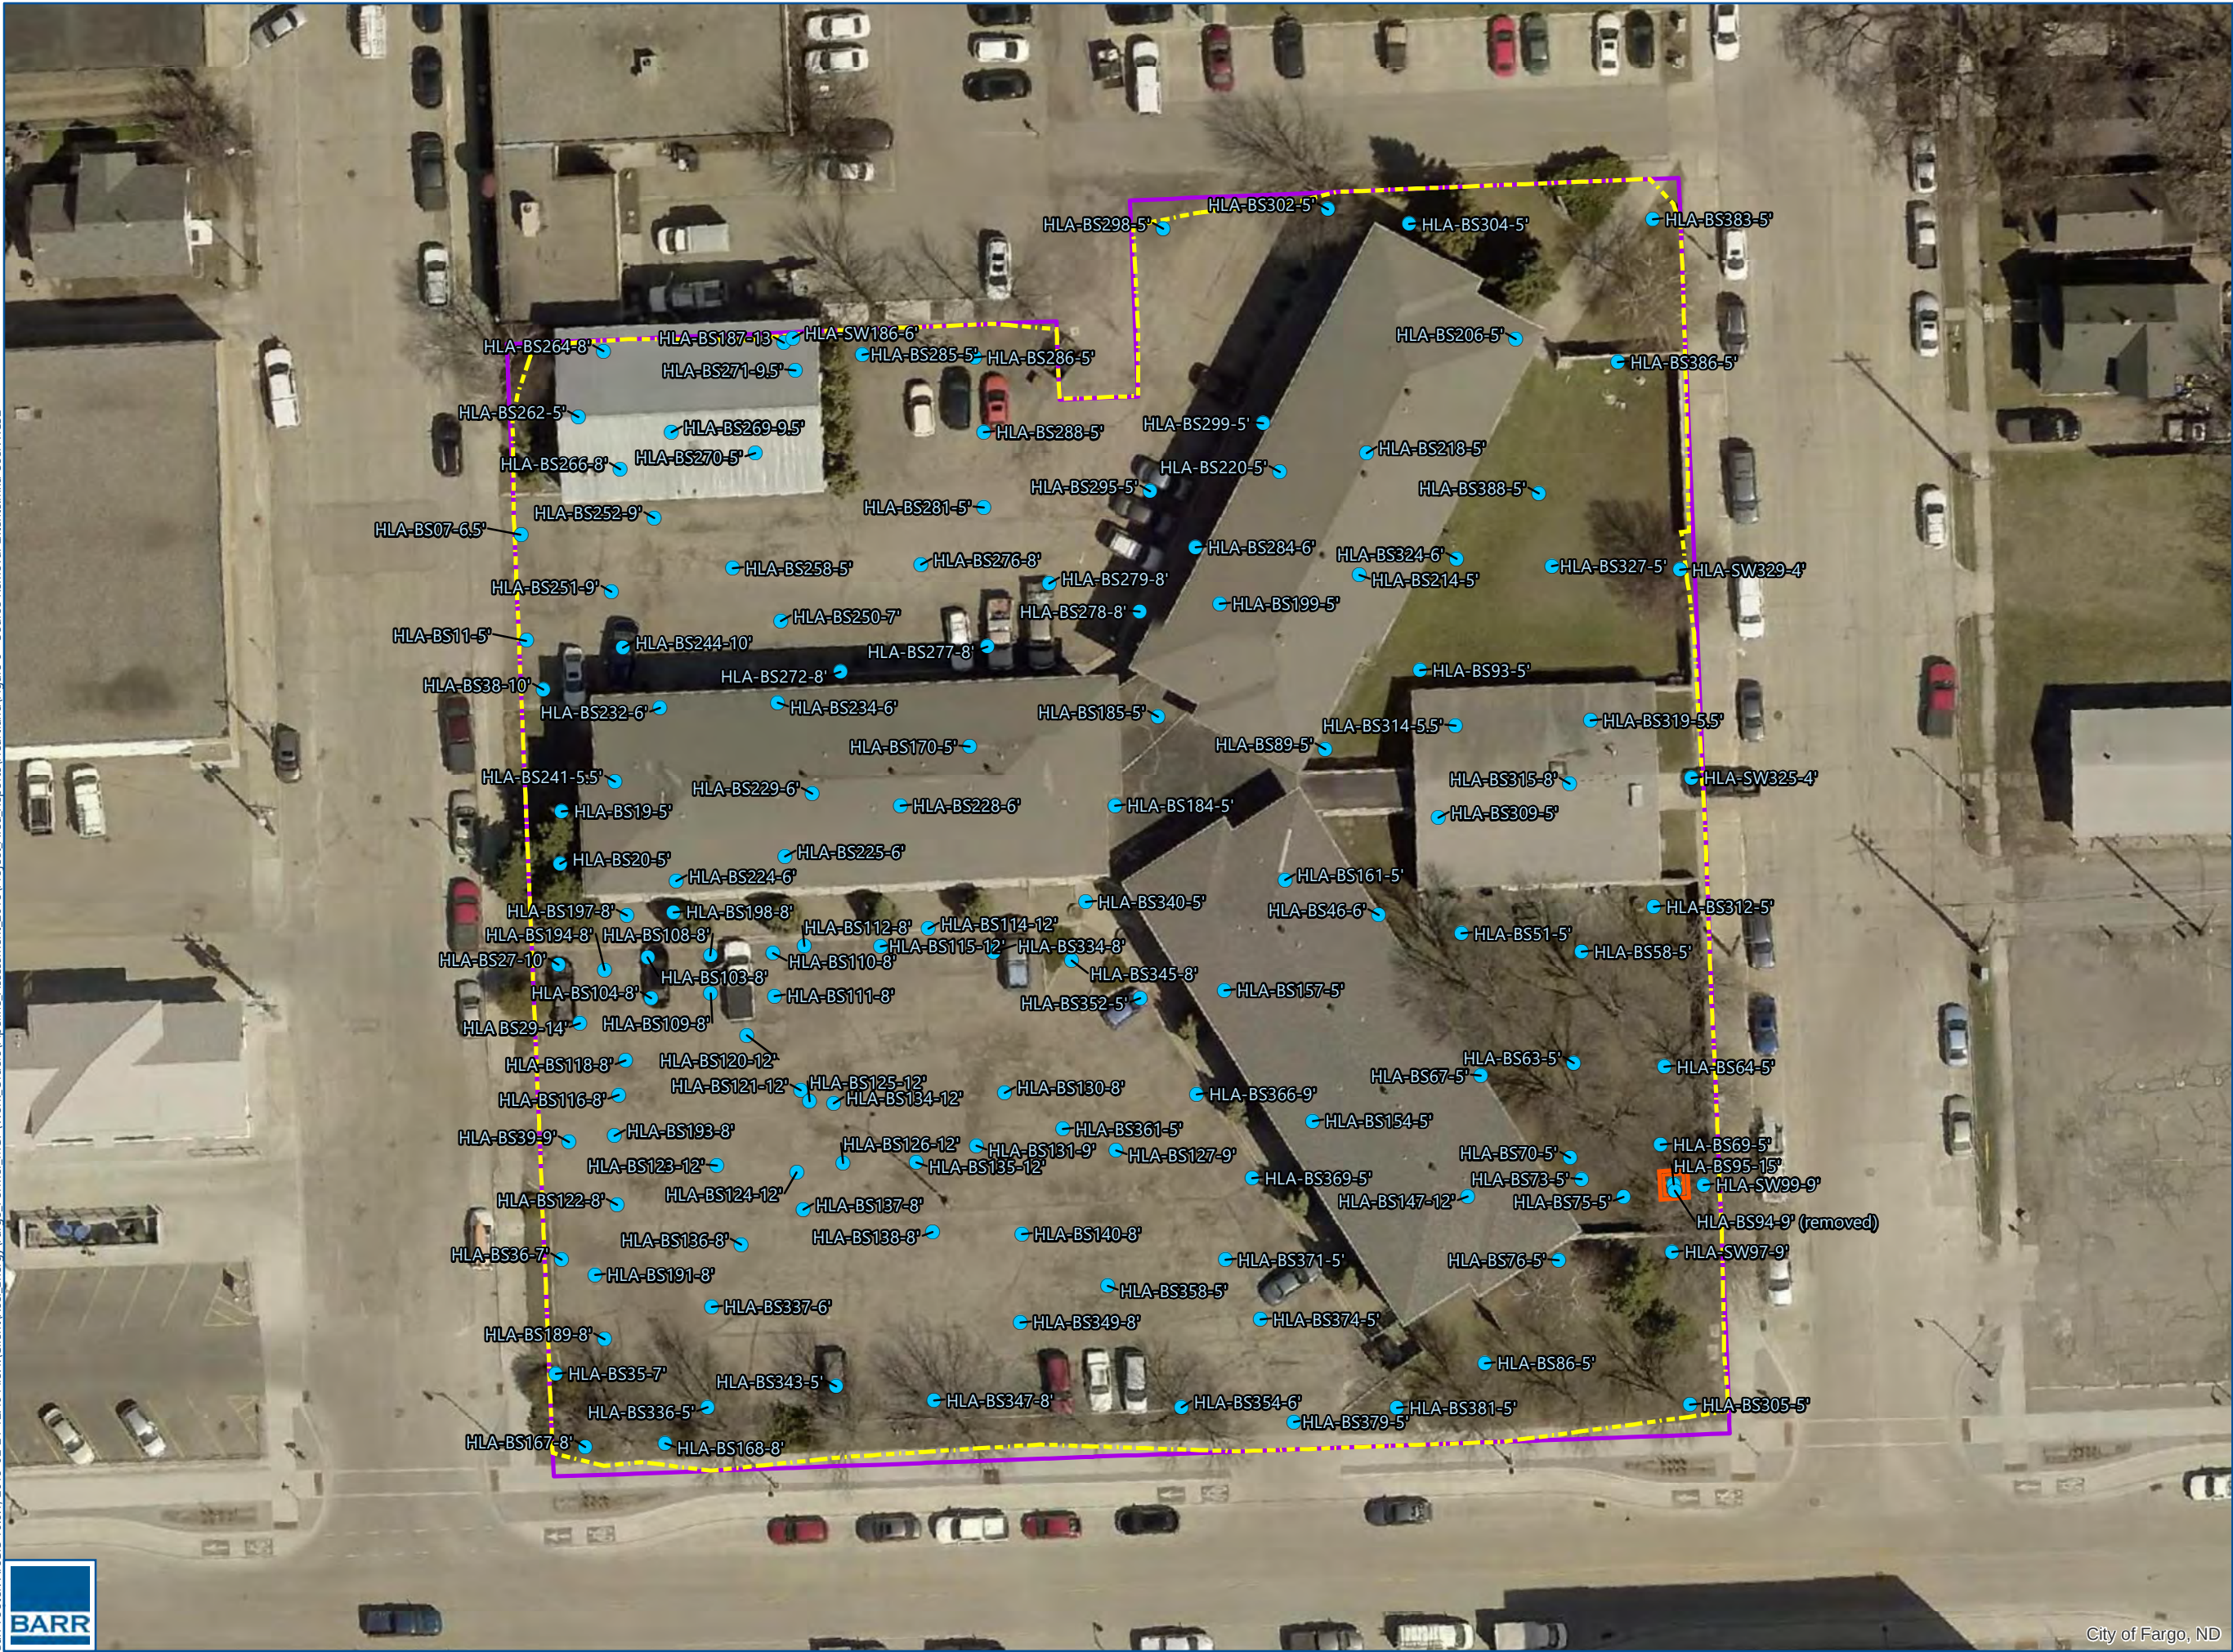
FIGURE 6

- Lab Sample
- ▨ Former Underground Storage Tank (UST) Area
- ⊕ Heartland Property
- - - Excavation Extent

Four soil samples were collected in the vicinity of the UST. Soil sample HLA-BS94-9' was collected to document conditions directly below the UST. Soil from this sample interval was removed as the excavation proceeded as noted on Figure 6 as removed. Sample HLA-BS95-15' was collected from the base of excavation below the tank. Sample HLA-SW97-9' was collected south of the UST from the south sidewall and sample HLA-SW99-9' was collected east of the UST from the east sidewall. Soils to the north and west of the UST were being removed as part of the remedial excavation; therefore, no north or west sidewall samples were collected.

The Heartland Property sanitary sewer line was excavated from Wing C of the former Heartland building to the property line along 11th Street N (Figure 6). Due to concerns with excavation under the sidewalk and other utilities in 11<sup>th</sup> Street N, the service connection at the main was exposed, disconnected, and plugged as requested by the City. Upon completion of the work and notification to the City, the excavation was backfilled and compacted and the concrete road surface was replaced.

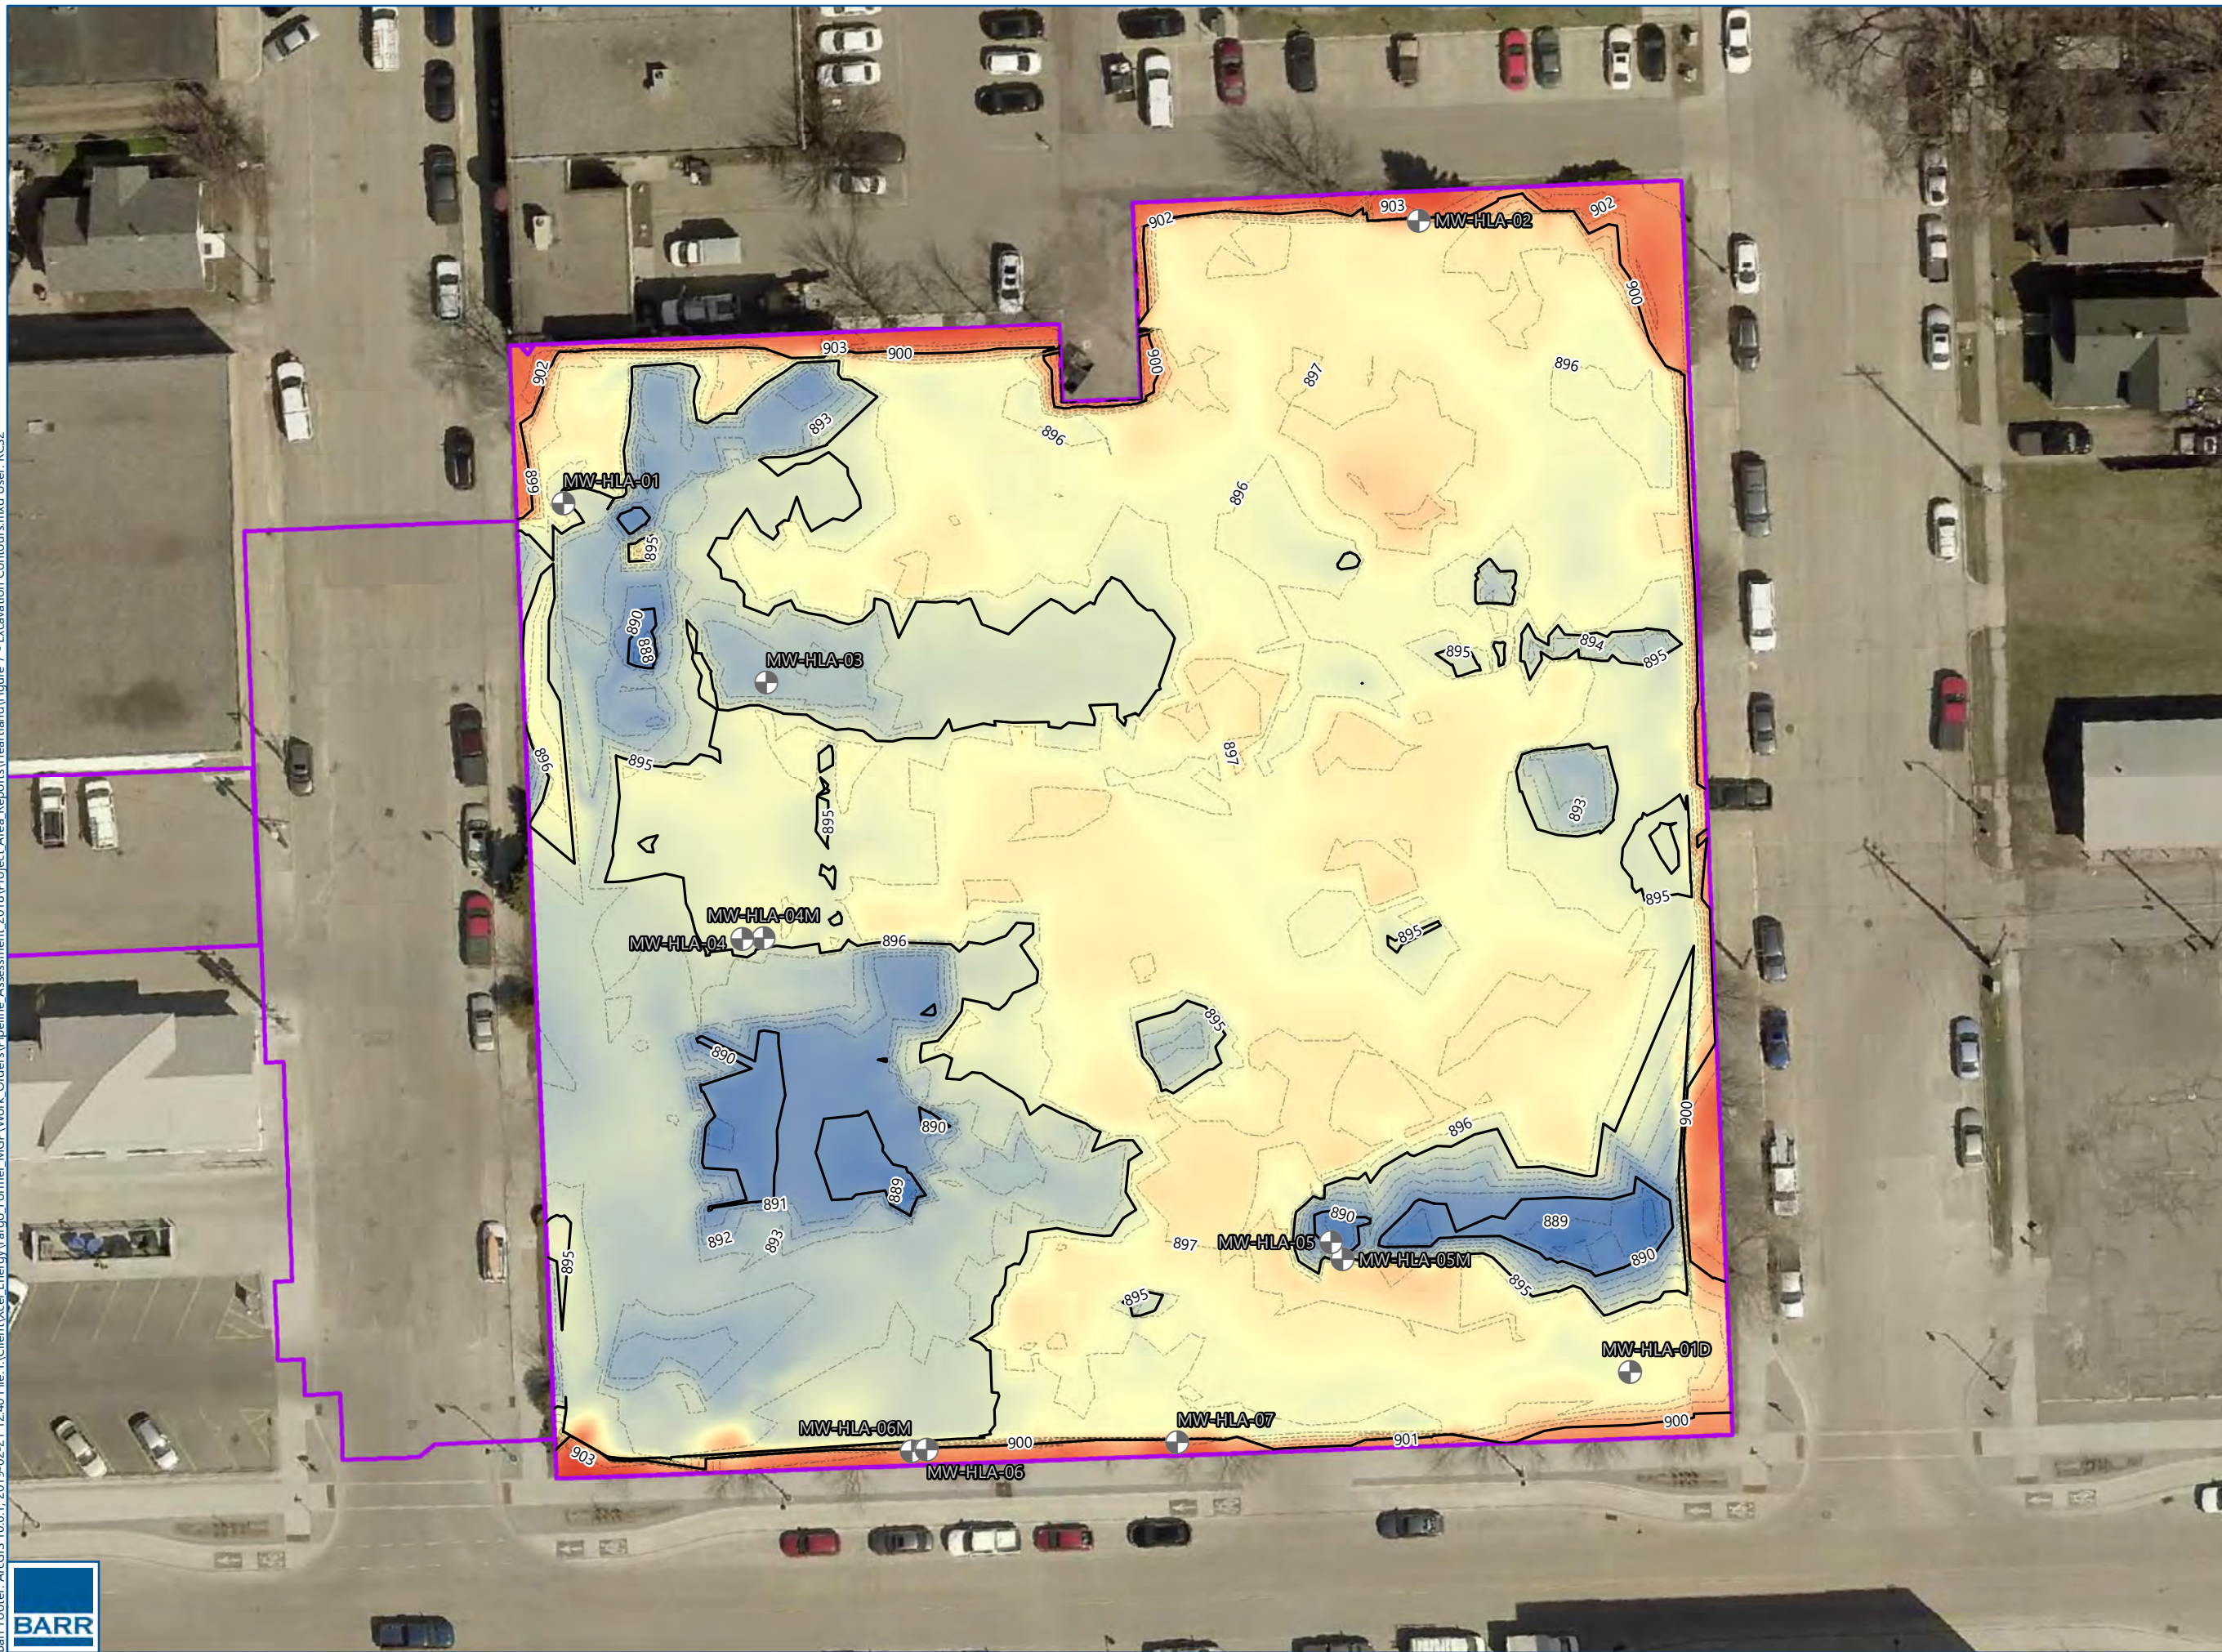
FIGURE 7

EXCAVATION  
CONTOURS  
Heartland  
Fargo MGP Site  
Fargo, MN

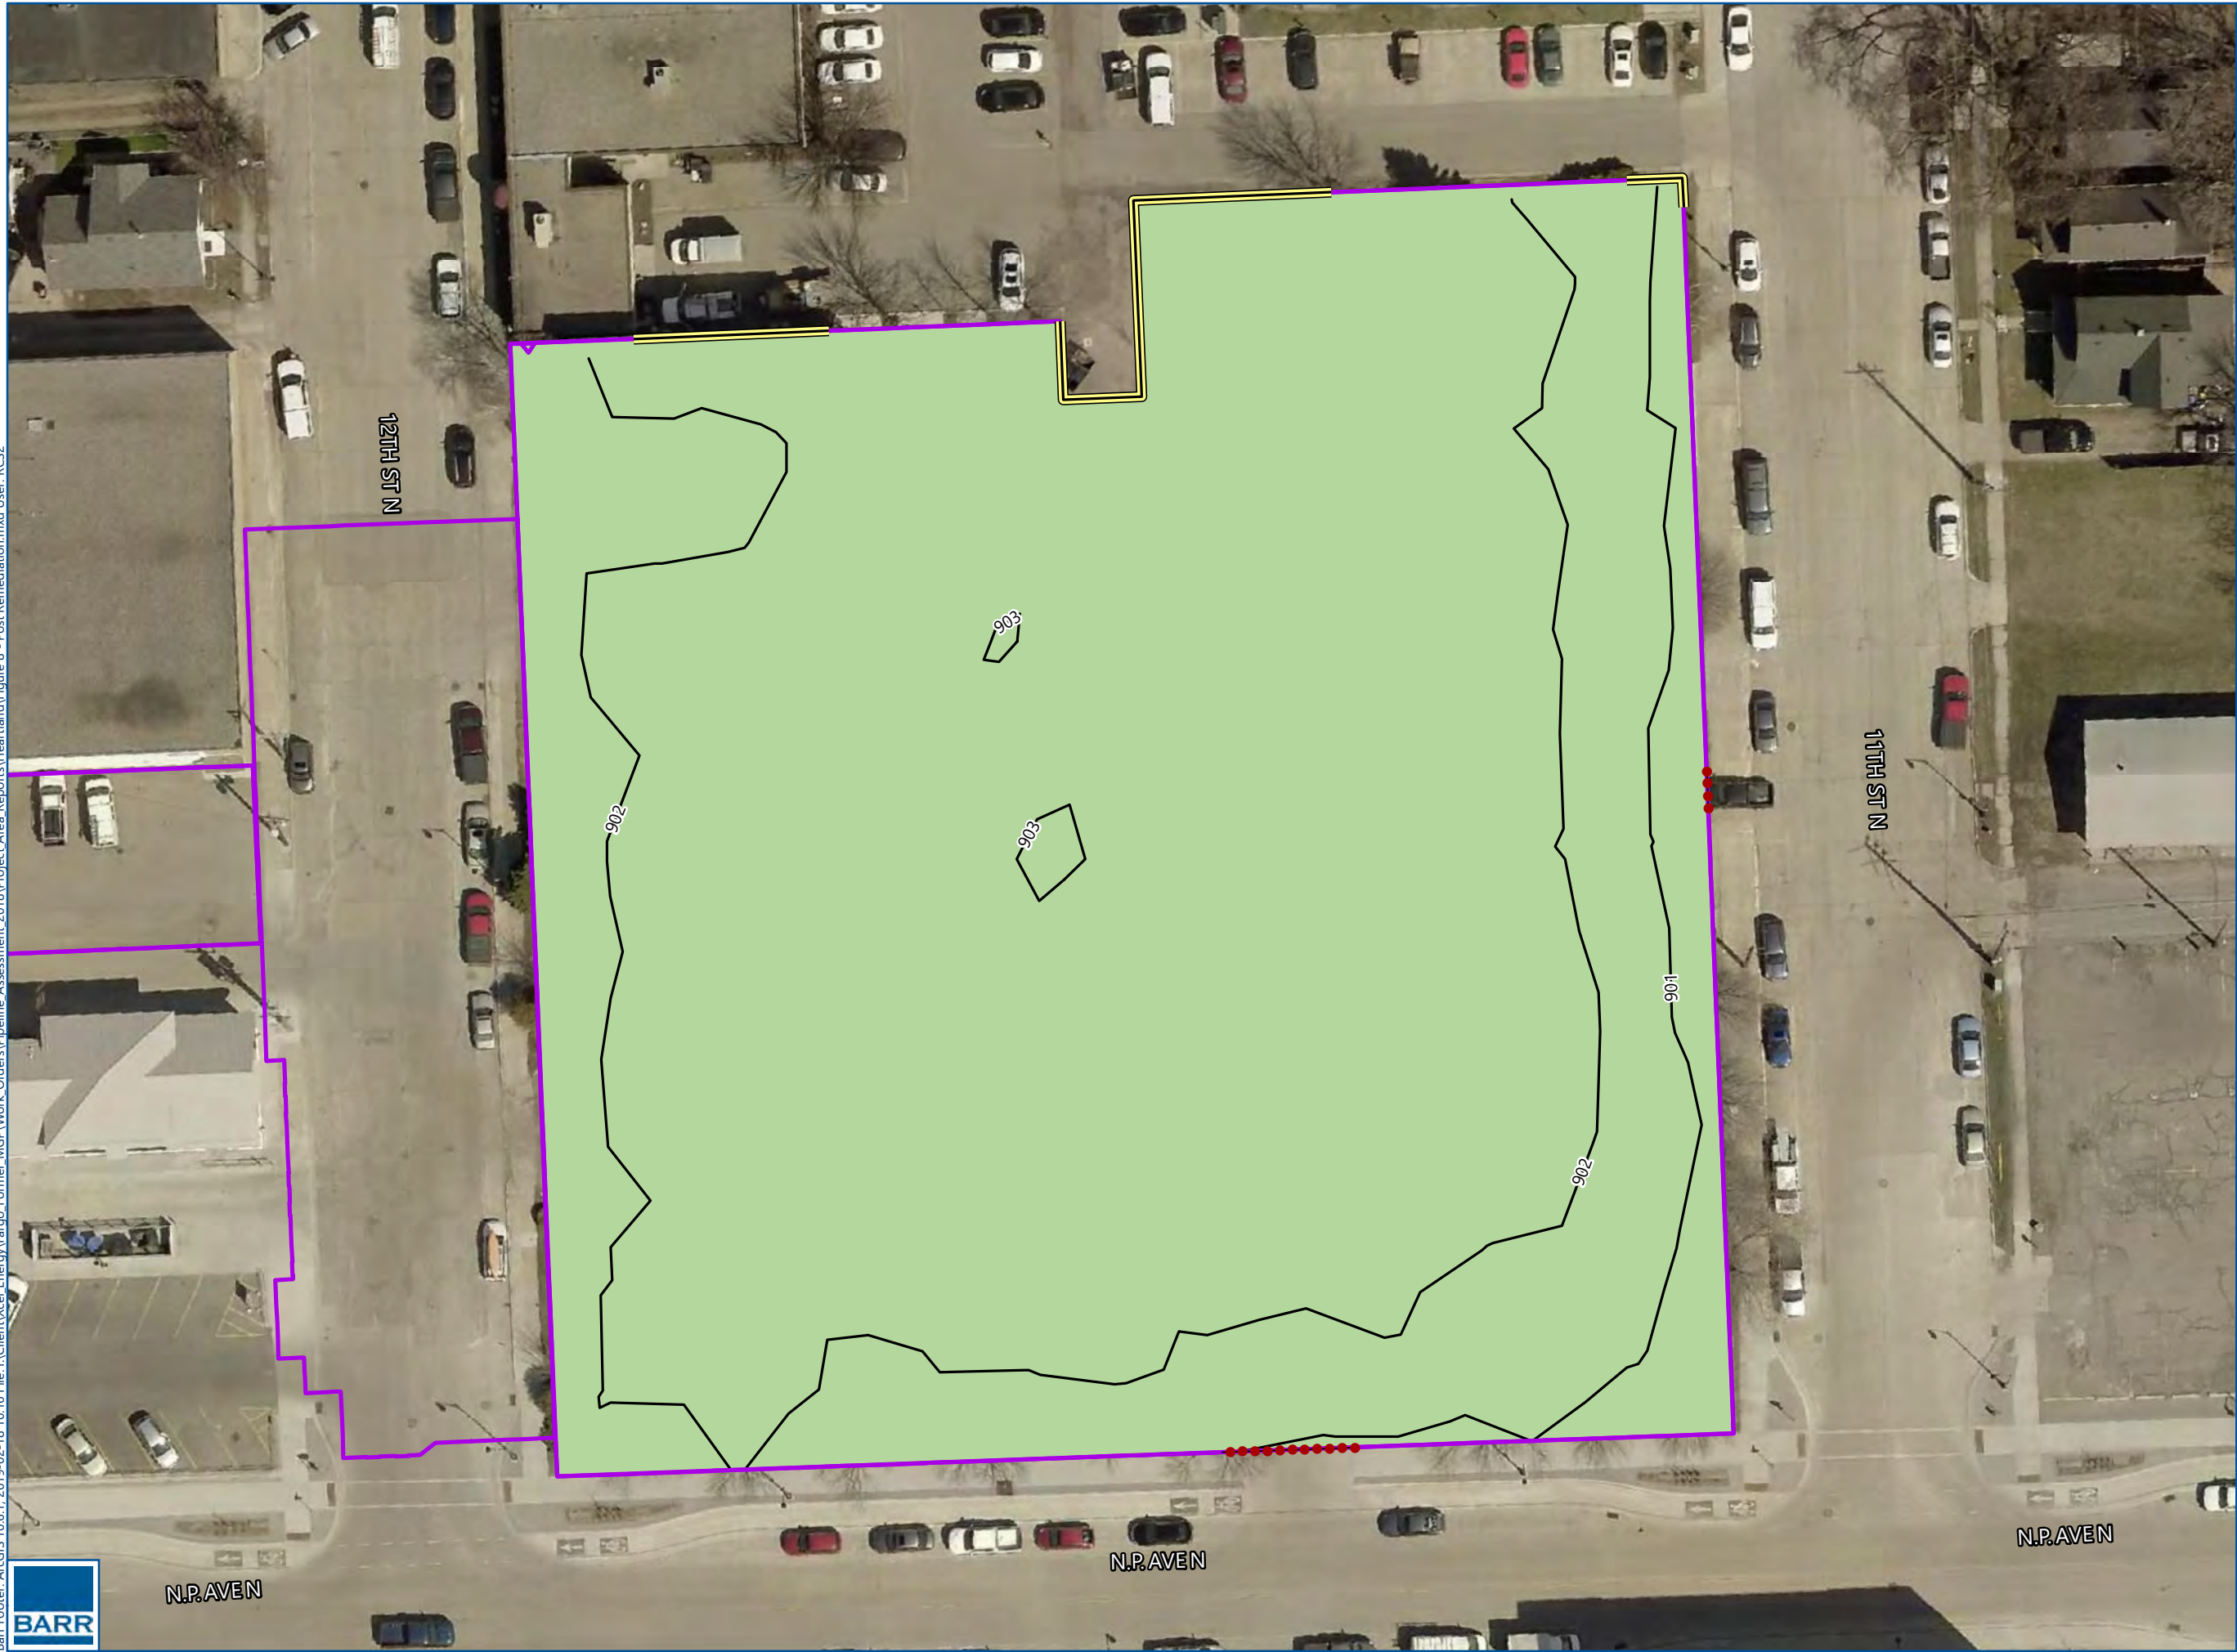
- Bollards
- ==== Split Rail Fence
- Finished Ground Contours**
- 1-ft
- ✚ Fargo MGP Remedy Boundaries 2018

Excavation areas were backfilled as work progressed to maintain excavation stability. In general, excavations were backfilled in 6-inch lifts and compacted to 95% of Standard Proctor density. Ground surfaces were restored to grade and seeded to establish vegetation. Post remediation site conditions are shown on Figure 8 and record drawings showing final grade are included as Attachment 6.
